FEASIBILITY STUDY  
WASHINGTON IRVING MIDDLE SCHOOL  
105 CUMMINS HIGHWAY  
ROSLINDALE, MA

JULY 21, 2022

**BOSTON PUBLIC SCHOOLS  
CITY OF BOSTON  
WASHINGTON IRVING SCHOOL RENOVATION/ADDITION PROJECT  
ROSLINDALE, MA.**

**FEASIBILITY STUDY**

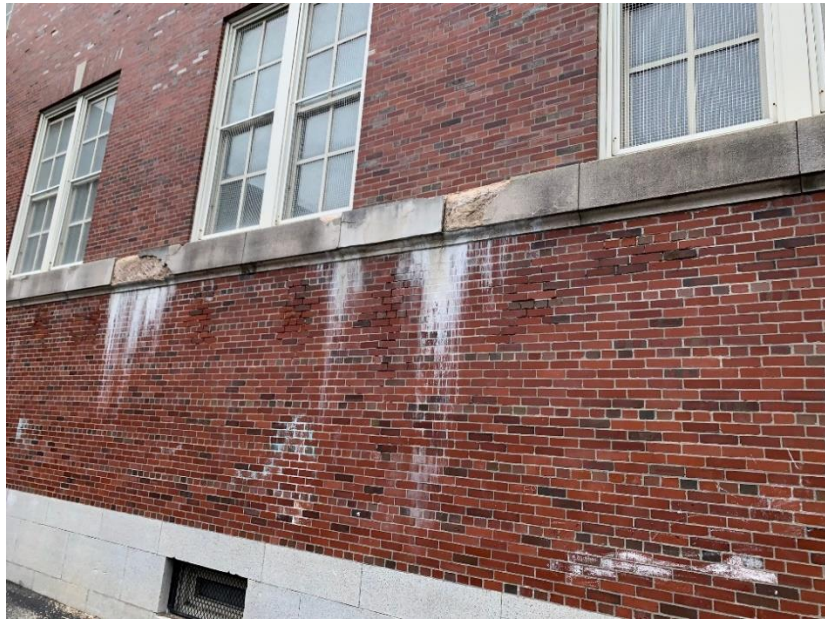
Spalled cast stone sills and deteriorated brick wall along exterior of building will require repairs / replacement.

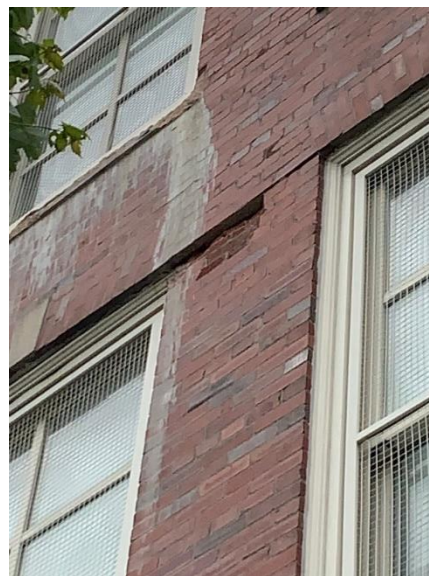
Major spalls and corroded relieving angle will require repairs / replacement.

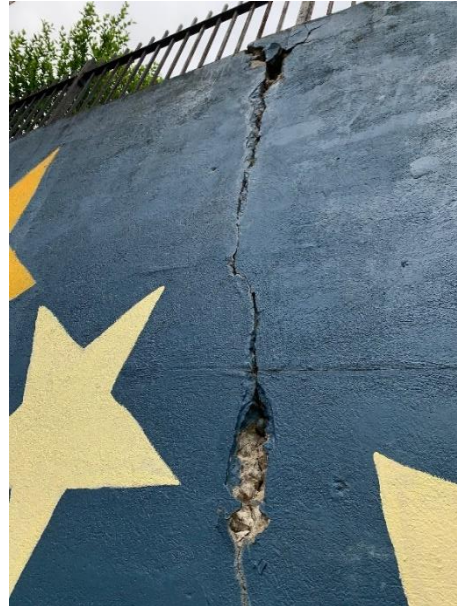
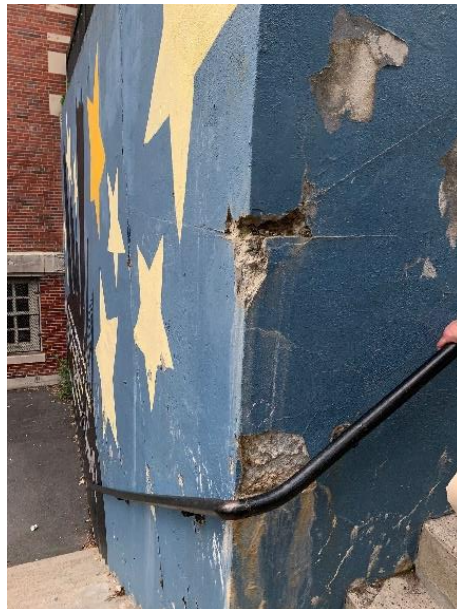
Significant cracks in concrete retaining walls will require structural repairs / replacement.

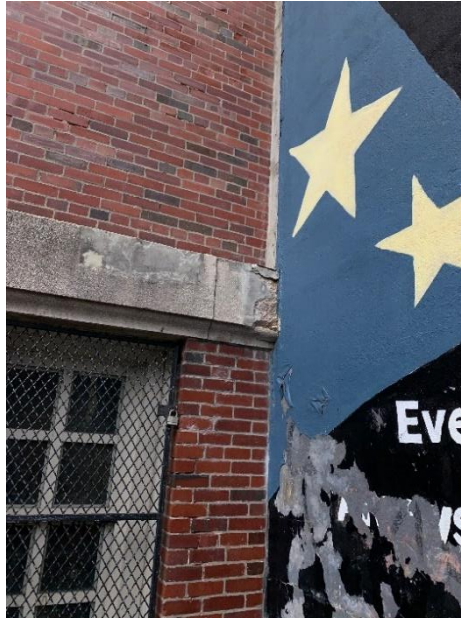
Spalled cast stone cornices and headers will require structural repairs or replacement.

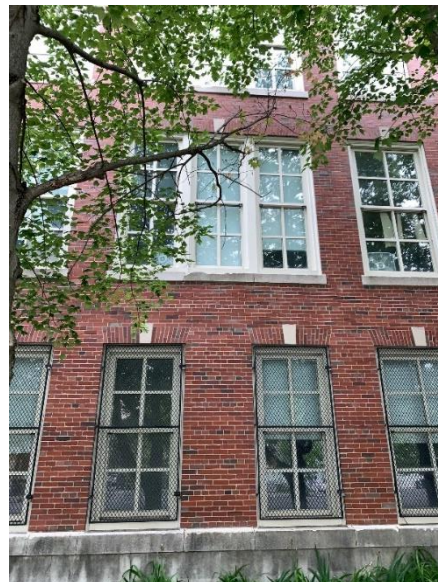
View of exterior portion of building showing large windows at level 2 where brick above is supported by continuous steel relieving angle. Structural repairs will be required.

All structural deficiencies will require structural repairs in order to comply with the MSBC.

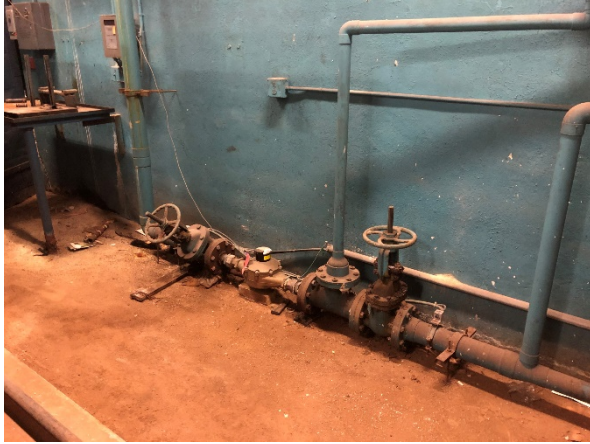
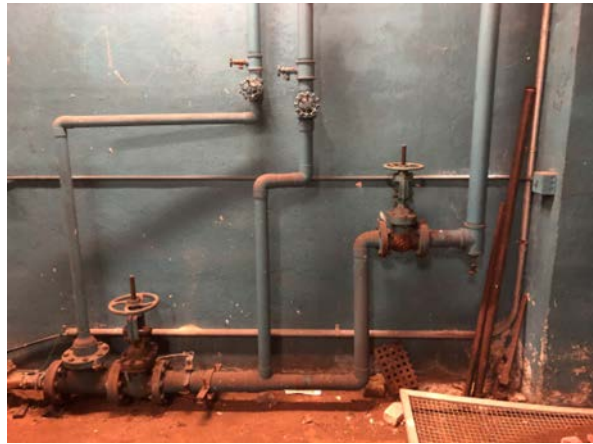
*Photos 1 & 2: Domestic Water Service*

Only the exposed piping scattered throughout the building could be observed and evaluated. The domestic water piping appears to be a mixture of either lead or galvanized steel piping and hard drawn copper tube. Piping appears to be in fair to good condition.

There are various signs throughout the building which indicate that this water is not potable, and is to be used for washing only. We suspect that this is due to a high lead content of the water caused by the piping.

There are various signs throughout the building which indicate that this water is not potable, and is to be used for washing only. The cause should be investigated and corrected. We suspect that this is due to a high lead content of the water caused by the piping. If this is the case, all of the existing domestic water piping should be replaced.

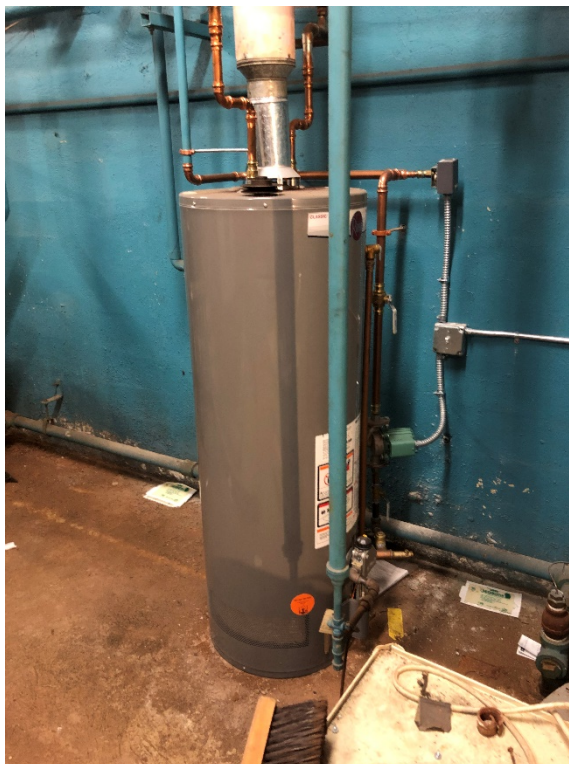
*Photo 3: Gas Fired Water Heater*

Domestic hot water for the building is provided by a single Rheem PROG50-38N RH60 gas-fired natural draft water heater with a 50-gallon storage capacity and 38,000 btuh gas input. The manufacture date on the water heater is August 2019. The water heater appears to be in good condition.

The water heaters are fairly new and in good condition and should last for many years to come, although the venting needs to be corrected. The building water heater should be equipped with a thermostatic mixing valve in order to increase the stored water temperature to prevent Legionella, and to provide tempered water to the building fixtures.

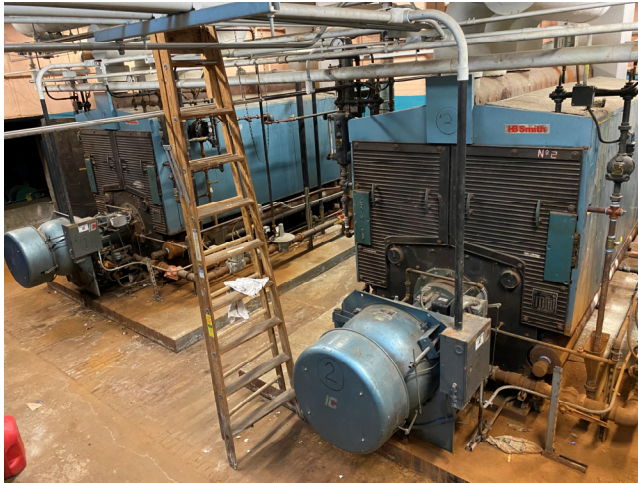
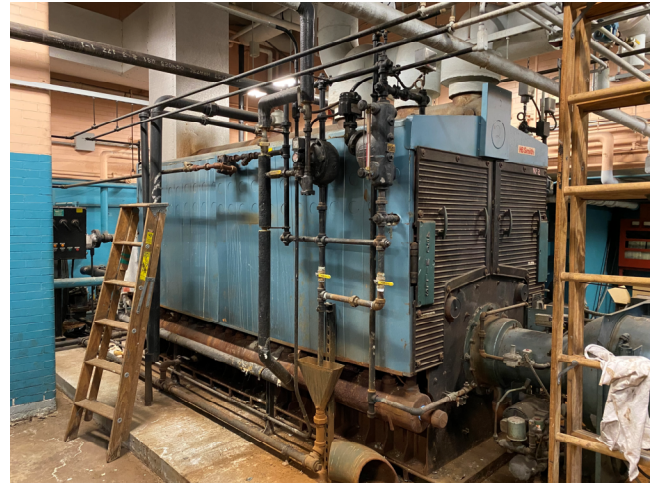
Photos 1 & 2: Existing steam boilers.

There are two (2) existing steam heating boilers serving the building. The boilers are each HB Smith, 450 Mills standard efficiency cast iron sectional boilers with 22 sections and have a net IBR capacity of 4,394.4 MBH. The boilers include a gas/oil burner (dual fuel), Model #MM-105S as manufactured by Industrial Combustion Inc. It was noted that currently the boiler operates only on natural gas. The sectional boilers and burners seem to be original to the building and were observed to be old but in fair condition. Each boiler was observed to be equipped with a McDonnell & Miller (M&M) low water cut-off (LWCO) and flow controls. The existing return headers under the boiler were observed to be in deteriorating condition with rust and leaks.

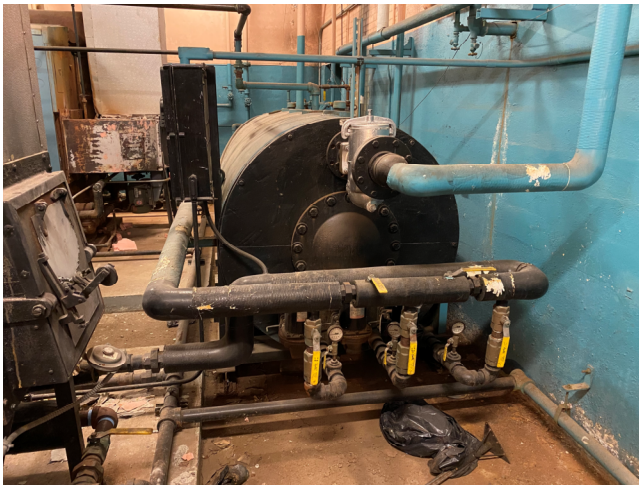
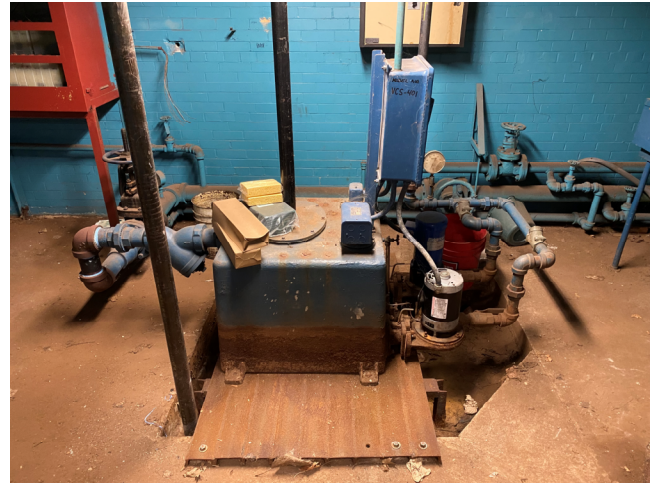
Photos 7: Existing condensate recovery tank and boiler feed unit.

boiler feed unit is located in separate area in the Boiler Room. Condensate from the building is routed back to this system. The condensate recovery tank and associated piping, pumps and accessories were observed to be old but in fair condition. The boiler feed unit was observed to be in deteriorating condition.

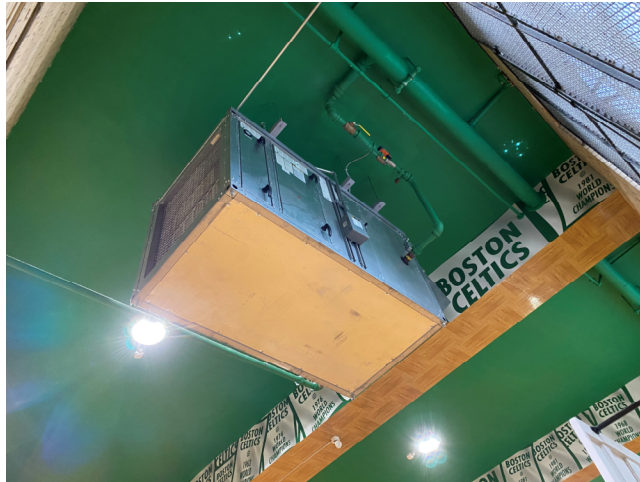
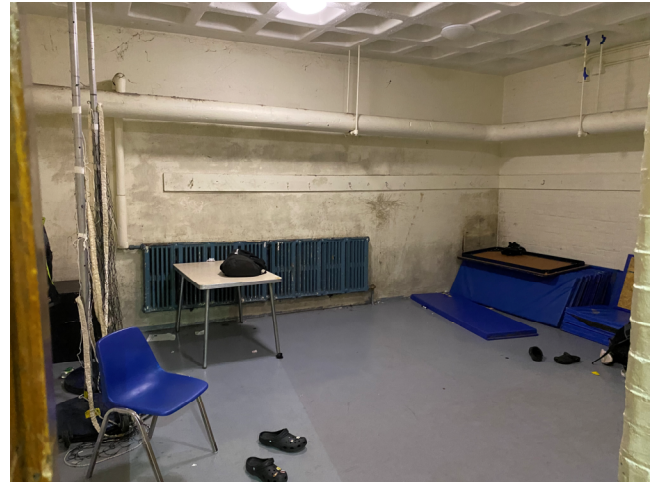
Photos 8 & 9: Existing gymnasium and Locker Room systems.

connected to the units. The unit was observed to be in fair condition. There was no mechanical ventilation observed in the gymnasium. During the site visit, it was observed that the exterior doors were opened to provide natural ventilation. The area of operable openings into the gymnasium needs to be evaluated to ensure compliance with mechanical code with regards to natural ventilation requirements. The Locker Rooms are served by steam radiators. The steam radiators were observed to be old and in deteriorating condition. There is no mechanical ventilation observed in the locker rooms.

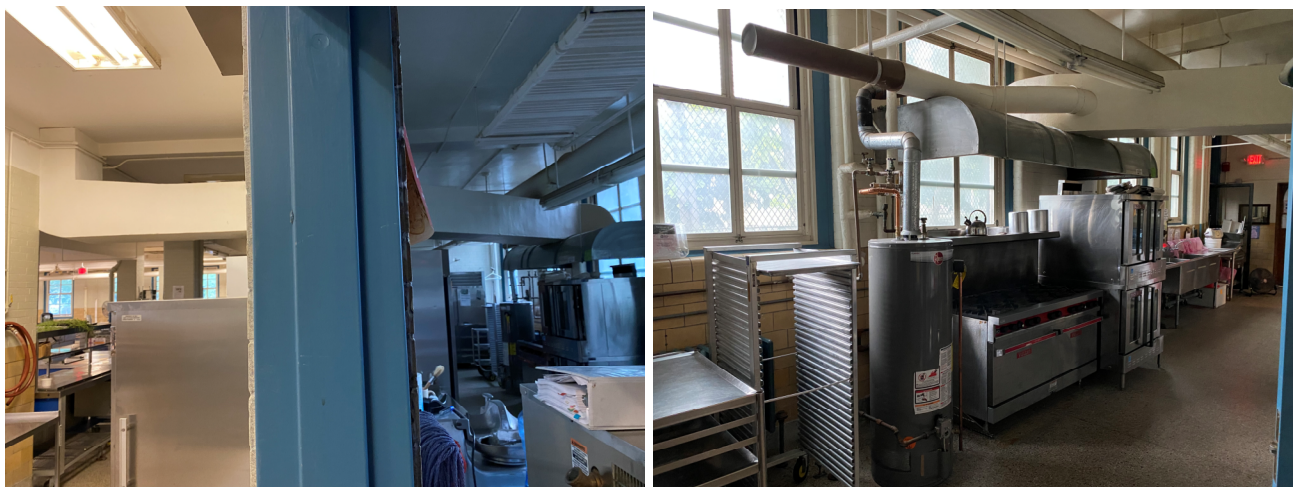
Photos 11 & 12: Existing Kitchen exhaust and DWH flue.

It was observed that the cafeteria is served by steam radiators located along the exterior wall. The radiators were observed to be old but in fair condition. The Kitchen is located within the cafeteria and was observed to be served by a ceiling hung steam radiator. There is an existing sheet metal hood construction that encompasses the cooling range and other cooking equipment. The hood structure is not a Type I hood as required per code and was observed to be a field fabricated sheet metal hood. The hood exhaust ductwork routed to the outside of the kitchen and rises up. There is an existing gas fired standard efficiency domestic water heater (DWH) located next to the cooking equipment. Flue vent associated with the DWH was observed to be connected to the kitchen hood exhaust ductwork. This arrangement is not code compliant and is recommended to be corrected immediately.

1. Kitchen - It is recommended to replace the existing kitchen hood with a new Type 1 hood and proper code compliant kitchen exhaust system.
2. It is recommended to provide mechanical ventilation to all occupied zones.
3. Based on the age and condition of the existing central heating system, it is recommended to replace the entire heating system serving the building which includes but is not limited to steam boilers, steam and

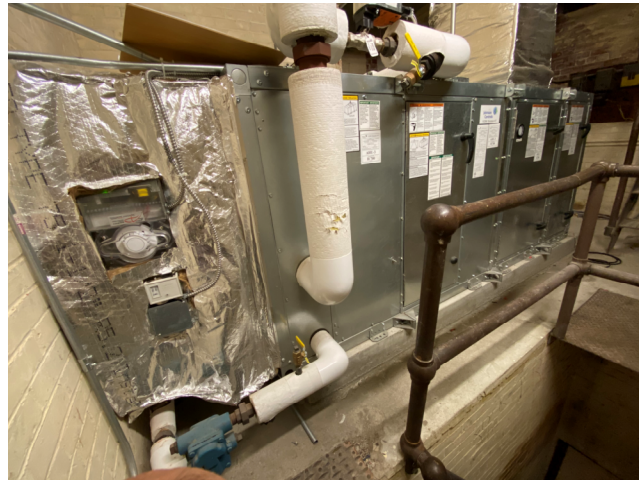
Photos 13: Existing AHU serving the Auditorium.

Auditorium: There are two (2) existing air handling units serving the Auditorium. The units are located in partial mezzanine spaces on either side of the stage. The AHUs are Johnson Controls York, Model #XTI-045X057-KAHA028A. The AHU included a steam heating coil and was noted to be a 100% OA unit. The unit was observed to be in good condition. Note that there was no exhaust component observed serving the auditorium. This would mean the space is pressurized when the unit is in operation and there is no means of relieving the air.

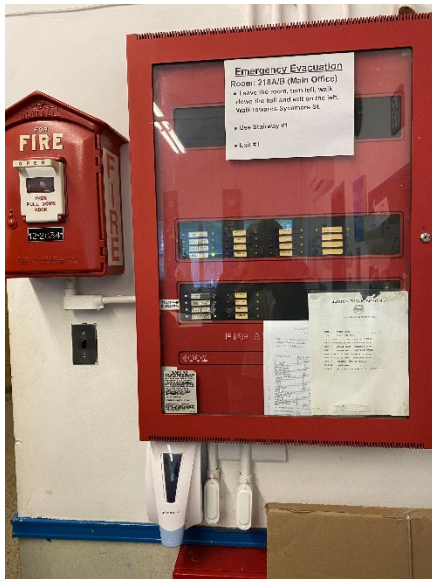
*Fire Alarm Control Panel and Master Box*

The fire alarm device coverage and system are inadequate for a school building and is not compliant with current codes for voice evacuation and notification.
