North Wall Summary 300 Summer Street

Fort Point Channel Landmark District Application for Design Approval

29 September 2016

300 Summer Street – North Wall

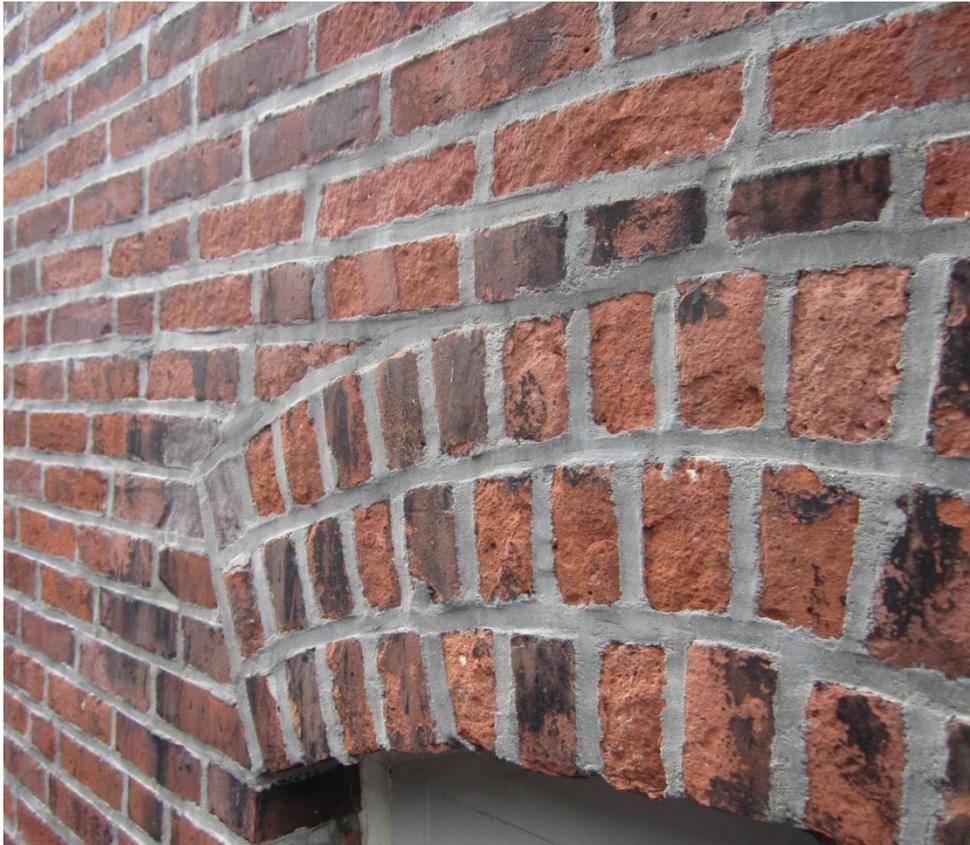
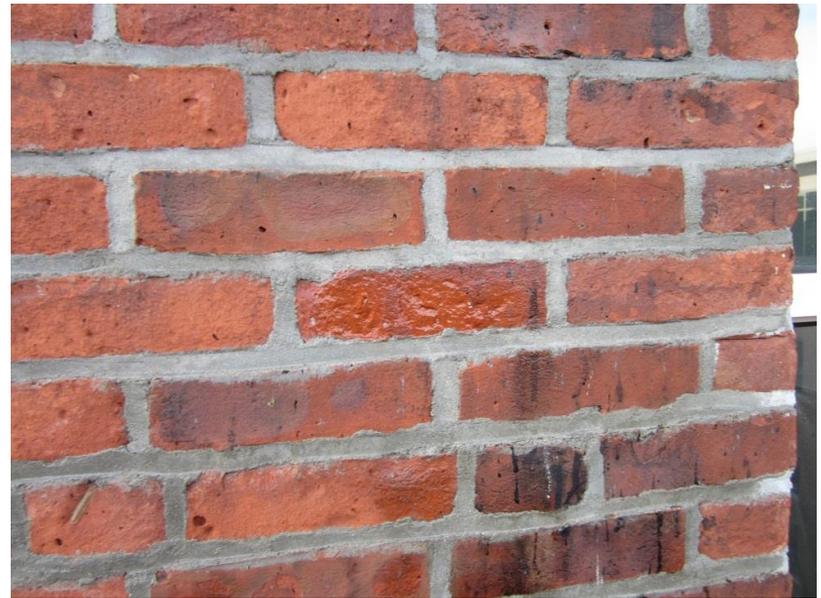
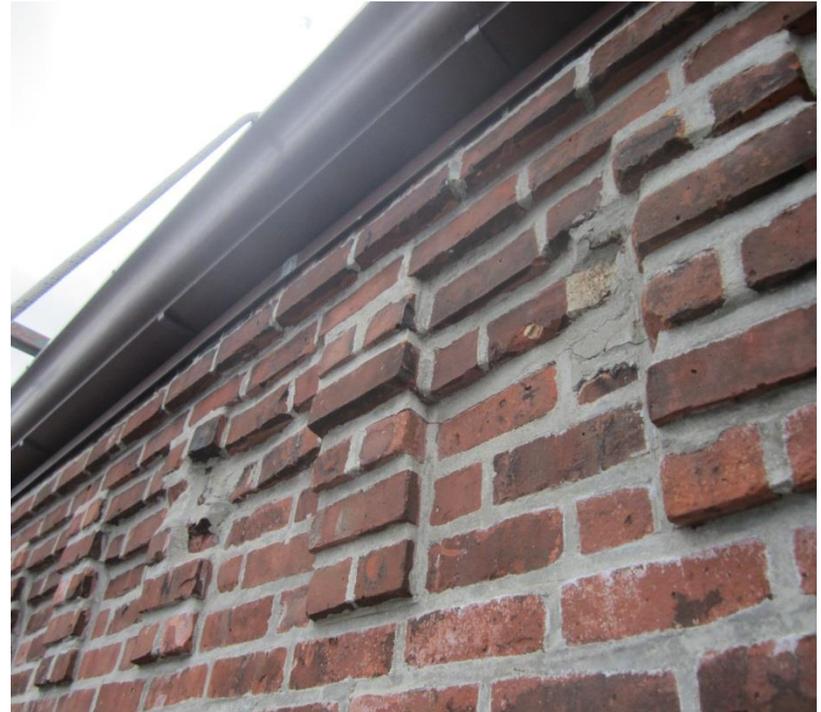
North Wall Masonry

The existing north wall has full mortar joint. The brick masonry units are typically "soft" or a lesser quality brick with higher absorption properties. Some brick have a loss of the fireskin and some spalling, which increases absorption through the brick.

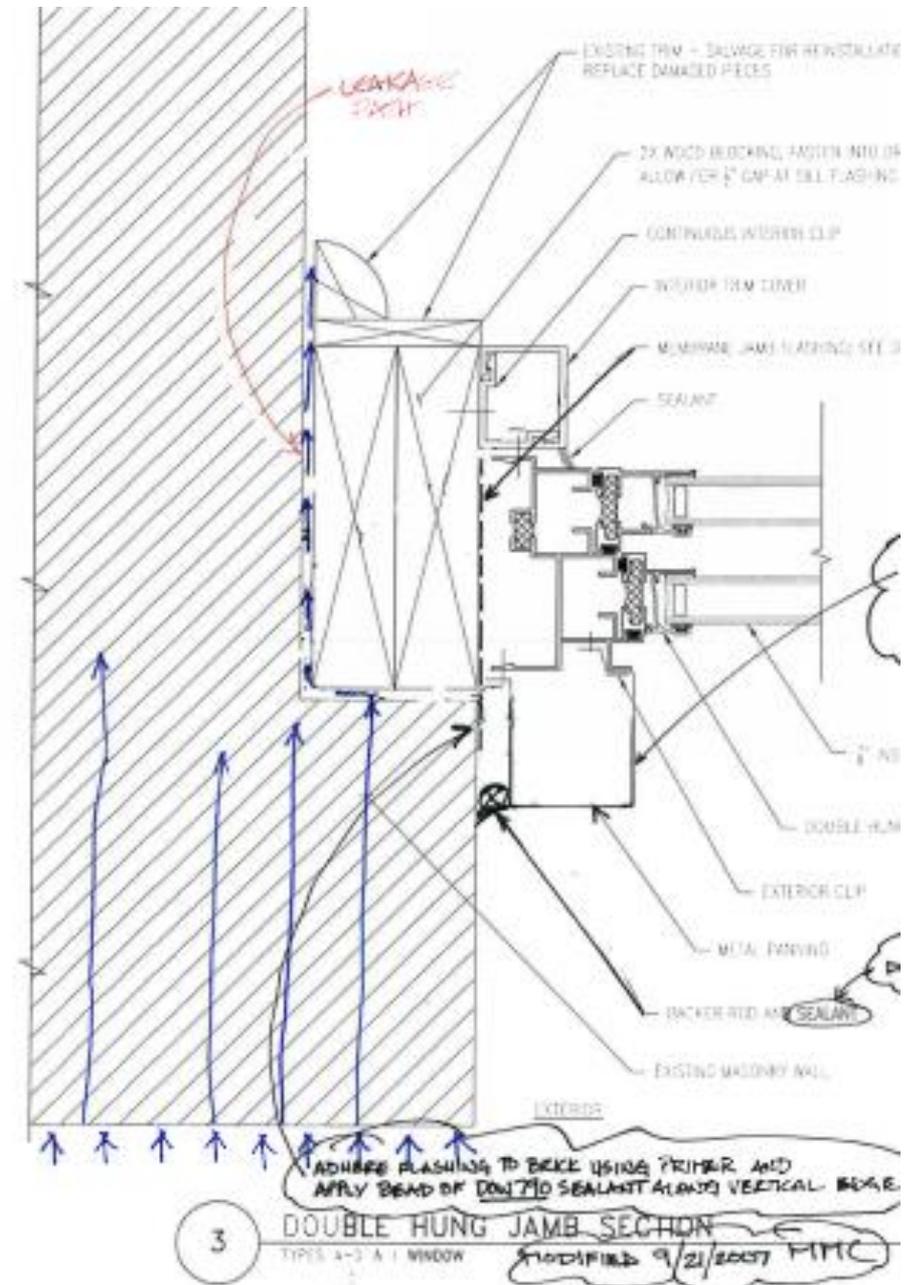
Typical Jamb Detail

Even with a properly maintained wall, leakage can occur through the brick masonry if it is exposed to a sufficient volume of water. The vulnerability depends upon the wall thickness; the walls at 300 Summer are thinner at upper floors and become narrower at window jambs and beam pockets.

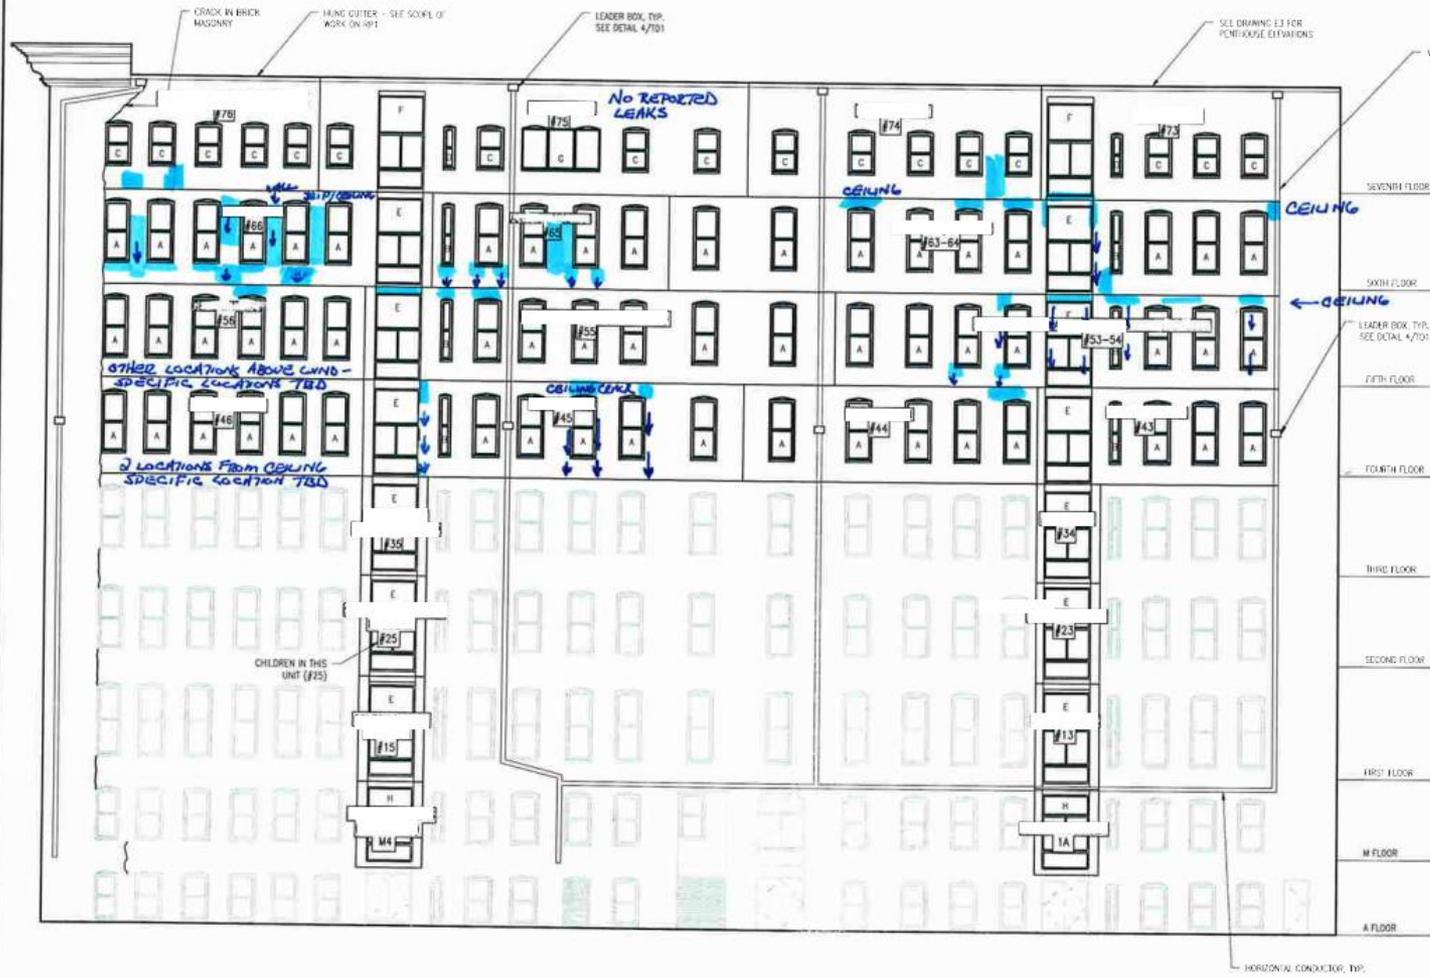
LEAKAGE SUMMARY
24/25 FEBRUARY 2010 STORM

LEAKAGE LOCATIONS AS REPORTED BY OWNERS/OCCUPANTS

GENERALLY LEAK REPORTS STARTED AROUND 8:50/9 pm ON 2/25/2010

NO REPORTED OVERRUN FROM GUTTER.

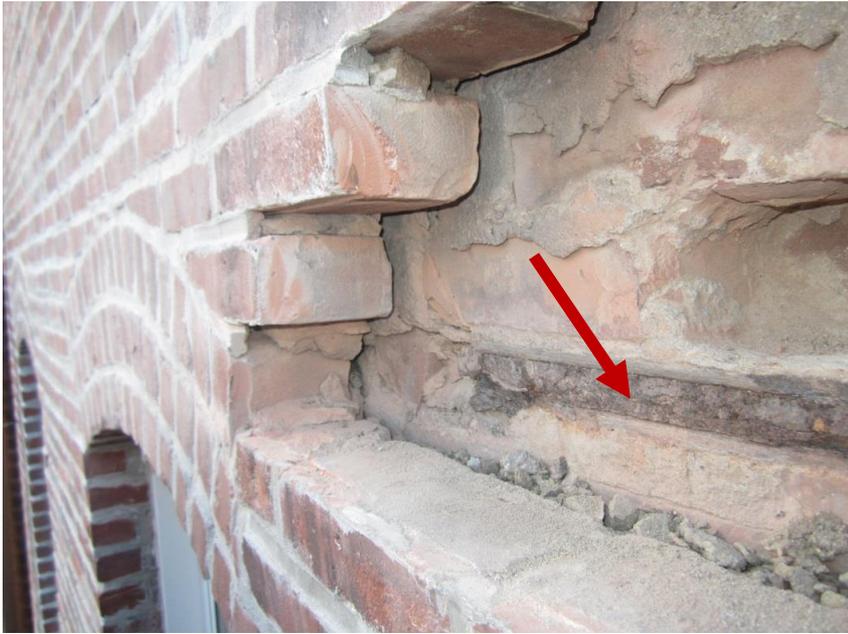
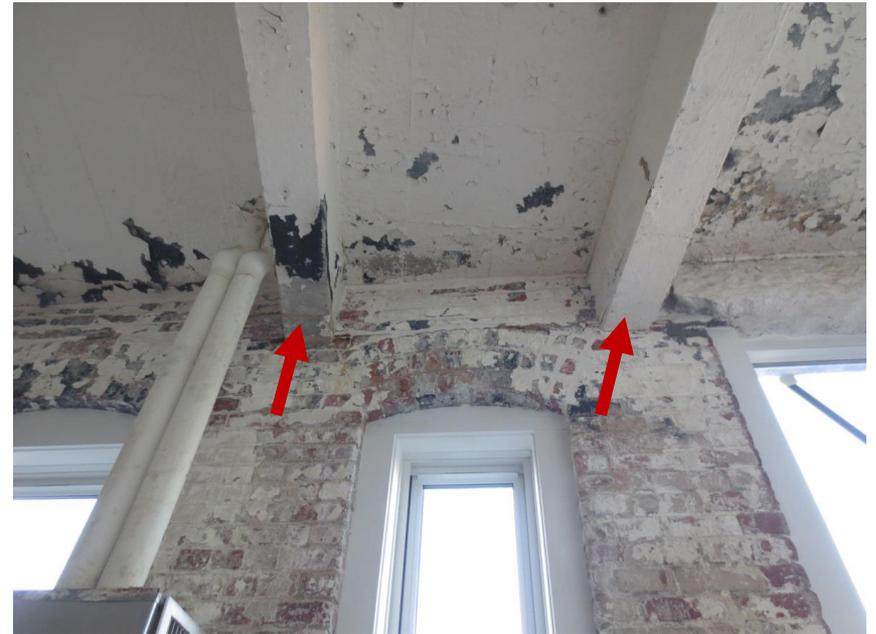
North Wall Masonry – Embedded Structure

Structural steel floor framing is embedded into the mass masonry wall. Embedded steel is subject to a damp environment, which causes corrosion and secondary damage (bulged and displaced brick).

The current level of visible corrosion and resulting masonry damage indicates minimal section loss of the embedded members, but the steel corrosion and masonry damage will continue until the steel elements are protected.
