Field Report

Client:	Westbrook Properties	Report Date:	02-12-18
Project:	The Aberdeen	A&M Project #:	1687-07
Location:	1650 Commonwealth Avenue, Boston, MA	Contractor:	Dellbrook JKS
Weather:	Sunny, Cold, Partial Snow Cover	Temperature:	30°
Date of Site Visit:	February 8, 2018		
Time:	From: 12:00 PM To:	1:00 PM	
Present at Site:	Steven Lee (A&M) and Kenny I	Roche (Dellbrook JKS)	
Reported by:	Steven Lee

The purpose of this field report is to provide written documentation that the subsurface material in front of 1650 Commonwealth Avenue in Boston is not suitable for the installation of trees.

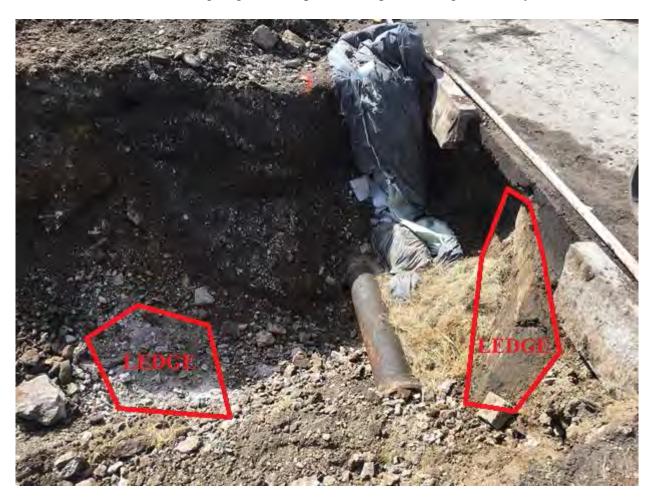
• 6" Fire Protection Water Service (Figure 1) = 6" Depth to Ledge

Figure 1 – View of existing 8" water line beneath the existing sidewalk at the fire protection connection point (See Test Pit Locations Plan – Sheet TP-1 for location)

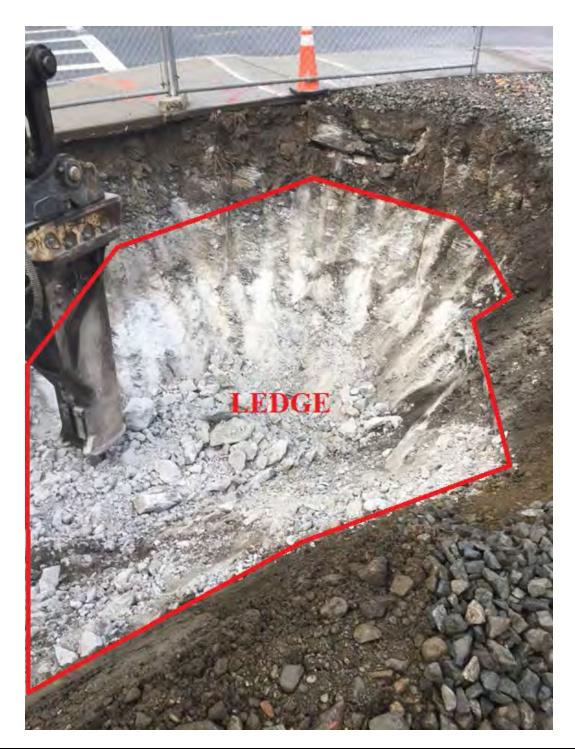
• Drywell #3 and #3B (Figure 2), =30" Depth to Ledge

Figure 2 – View of excavation of Drywell #3 and #3B at the back of sidewalk on the corner of Commonwealth Avenue and Mount Hood Street. A jackhammer was needed to remove between 24-36" of ledge to provide room for the drywells in this area. The proposed trees are approximately 20' from this area.

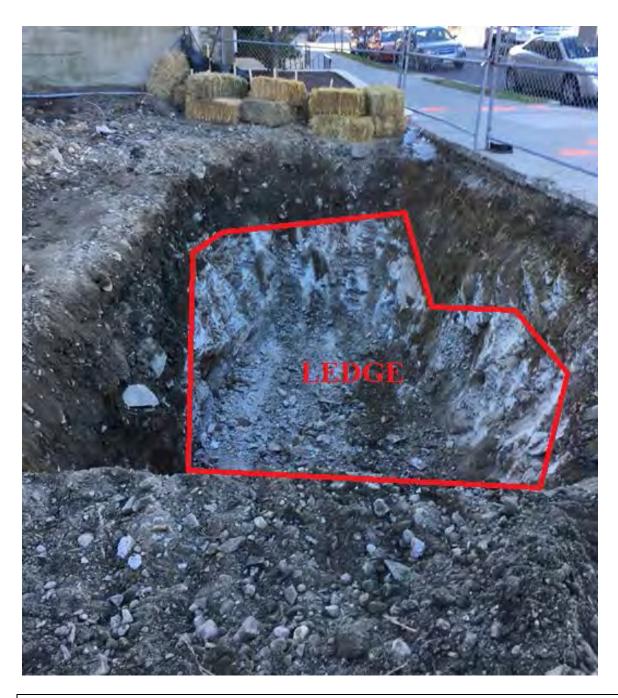
• Drywell #1 and #1B (Figure 3), =36" Depth to Ledge

Figure 3 – View of excavation of Drywell #1 and #1B located at the back of sidewalk. A jackhammer was needed to remove between 24-36" of ledge to provide room for the drywells in this area. The proposed trees are approximately 17' from this area.

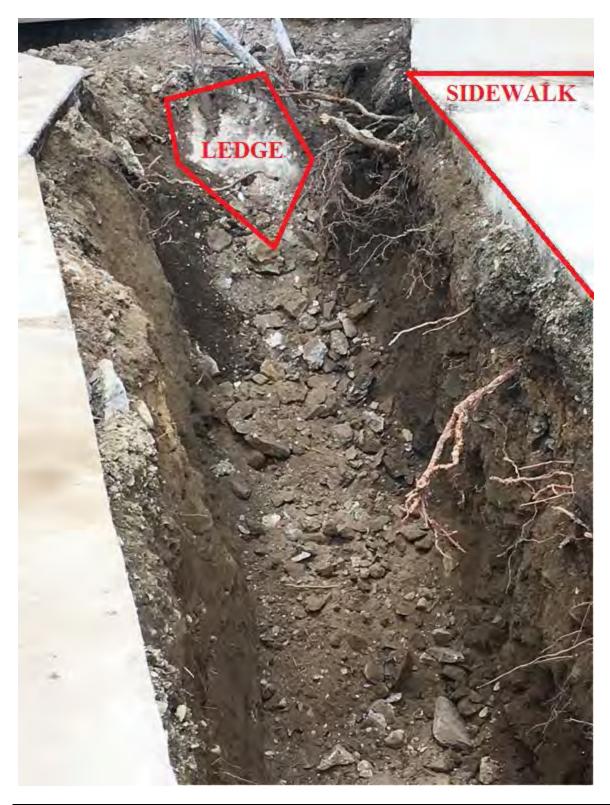
• 12" Storm Drain (Figure 4) =12" Depth to Ledge

Figure 4 – View of trench for 12" PVC drain line being laid in Commonwealth Avenue (connecting DMH#4 to the drainage infrastructure in Commonwealth Avenue). Ledge is within 12" of the sidewalk in some places.

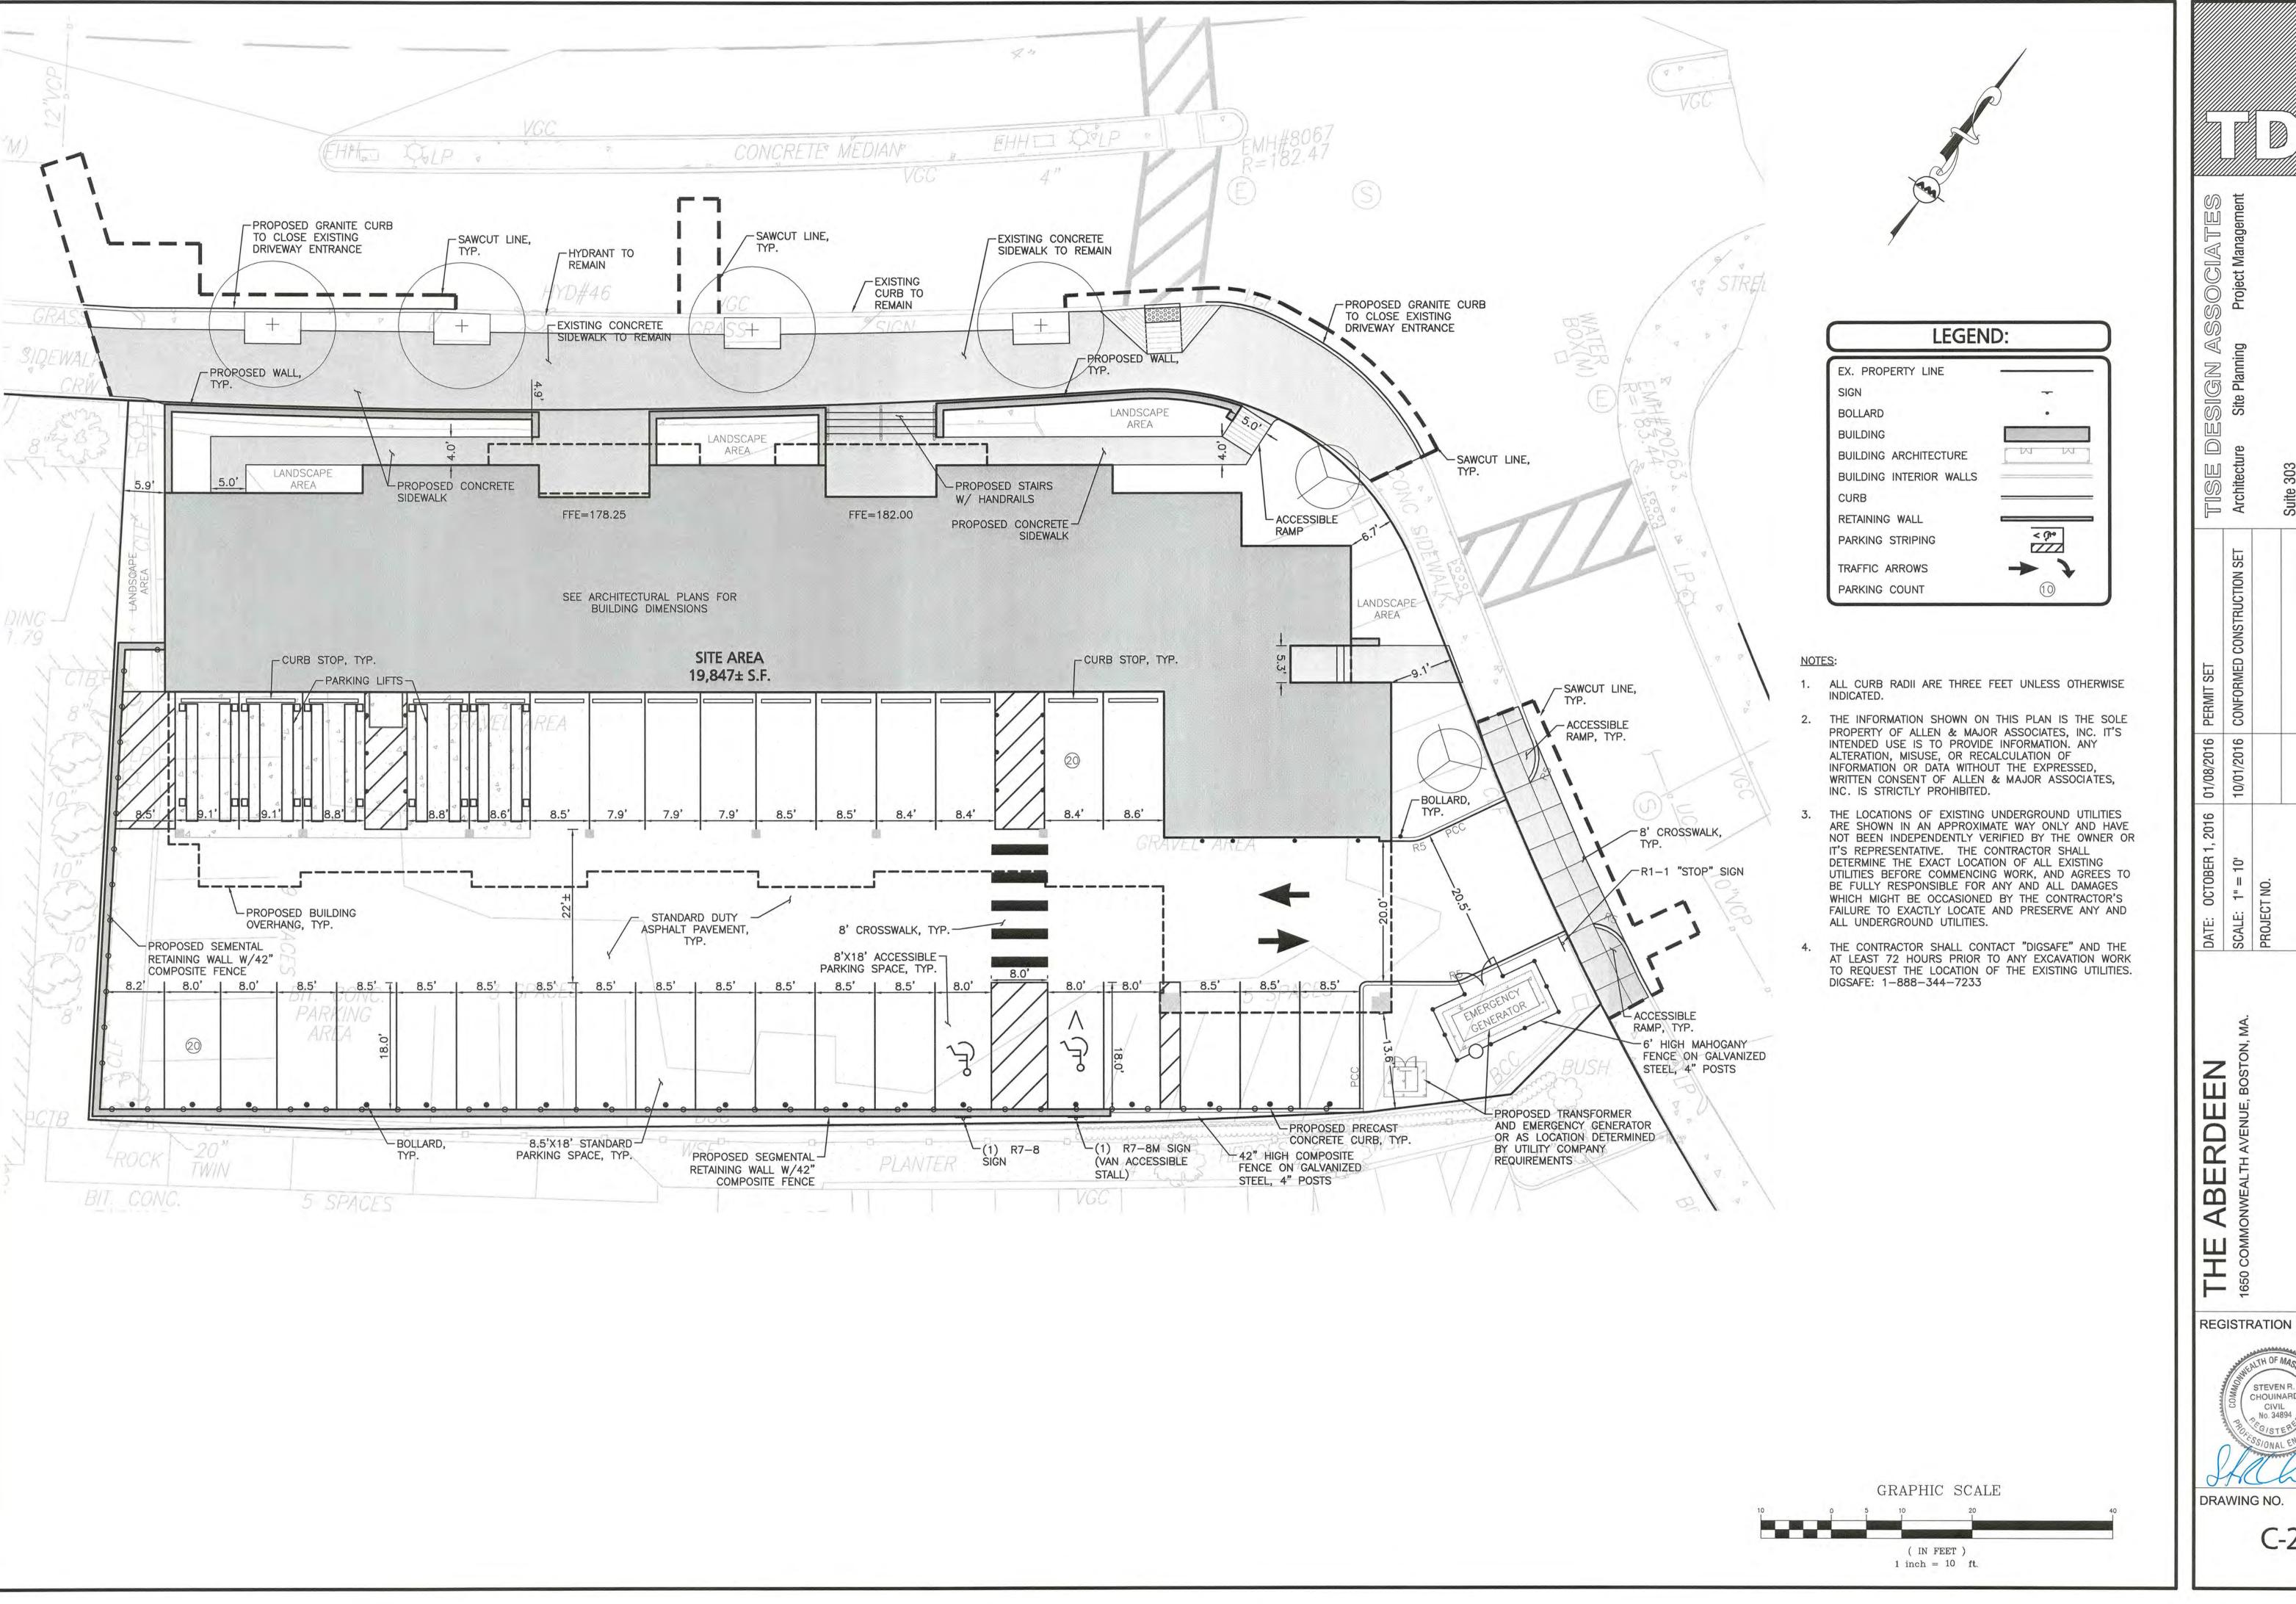
PROPOSED TREE & EXISTING LEDGE SKETCH

Documentation provided in this report includes site photos taken by the contractor during the installation of utilities, as well as soil test logs and photos taken by a licensed soil evaluator. In addition, a Proposed Tree and Existing Ledge Sketch (SK-1) has been provided illustrating the proposed tree areas, areas ledge was encountered, and the depth it was encountered at.

Additionally, two (2) test pits were excavated on February 8, 2018, at two (2) tree locations abutting Commonwealth Avenue (see attached soil test logs). Refusal was met at both Test Pit #1 and #2 at 30" and 32" respectively.

Based on this information A&M has concluded that there is not enough room between the finished grade and the ledge/bedrock beneath the sidewalk abutting Commonwealth Avenue for the installation of trees. The existing ledge will not provide adequate drainage for root system of the trees.
