March 3, 2020

I, Kray A. Small, Massachusetts Certified Arborist, License # 1797, have been retained by Eric Moorehead, of MJ Nicholls Landscaping LLC. 77 Gridley Street, Quincy, MA to assess a tree located in the front of the St. Botolph Club on 199 Commonwealth Avenue, Boston, MA.

The aim of the assessment is to determine feasibility of protecting this tree during excavations for a new water main.

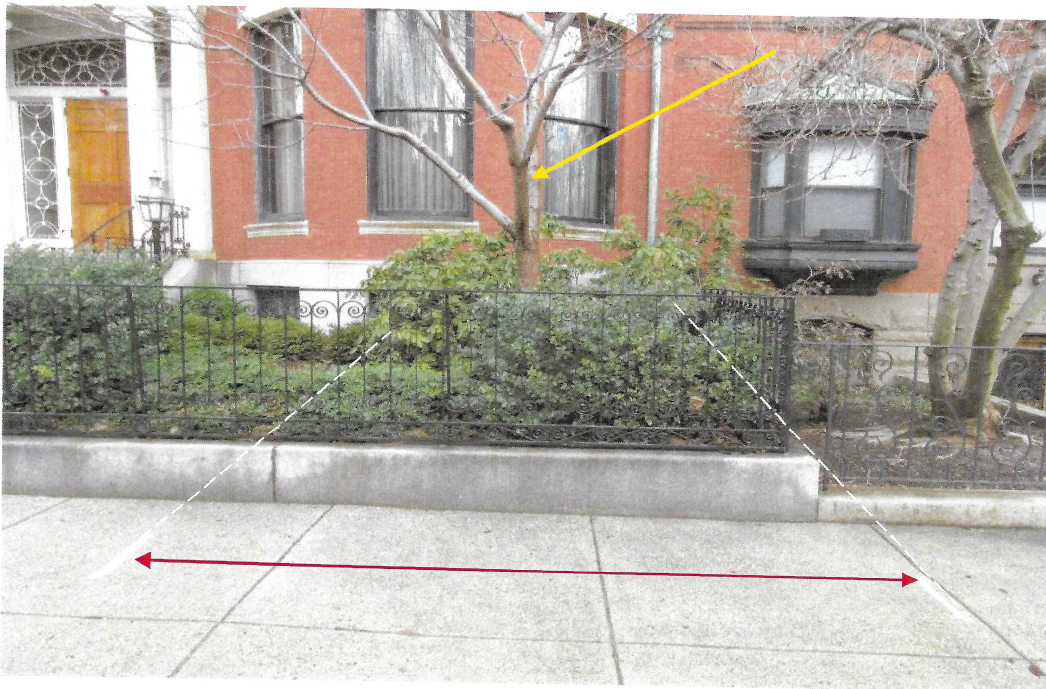
**Photo #1**

The tree is located in a small court yard, to the right of the entrance to the building on Commonwealth Avenue. The tree is shown in photo #1

The white strips on the sidewalk indicate the span of the excavation (red arrow). Pointed out is the tree directly in the path of the excavation.

The tree is a flowering cherry, either a Yoshino or Kwanzan, and is approximately 8 inches in diameter, 30 feet in height, and has a drip line of about 12 feet. The tree has been pruned properly in the past but has a girdling root at the base, at the root collar and has a cavity of decay within one of the main leaders. Eventually the girdling root will choke the canopy of both water and nutrients and the upper portion of the canopy will start to die off. Photos #2 and #3.

The tree is not more than 20 years of age and it is assumed that it is not a memorial. Preserving the tree by tunneling beneath and supporting the soil above will add both expense and safety issues to the project. The tree can easily be replaced, more cost effectively, than trying to preserve it.

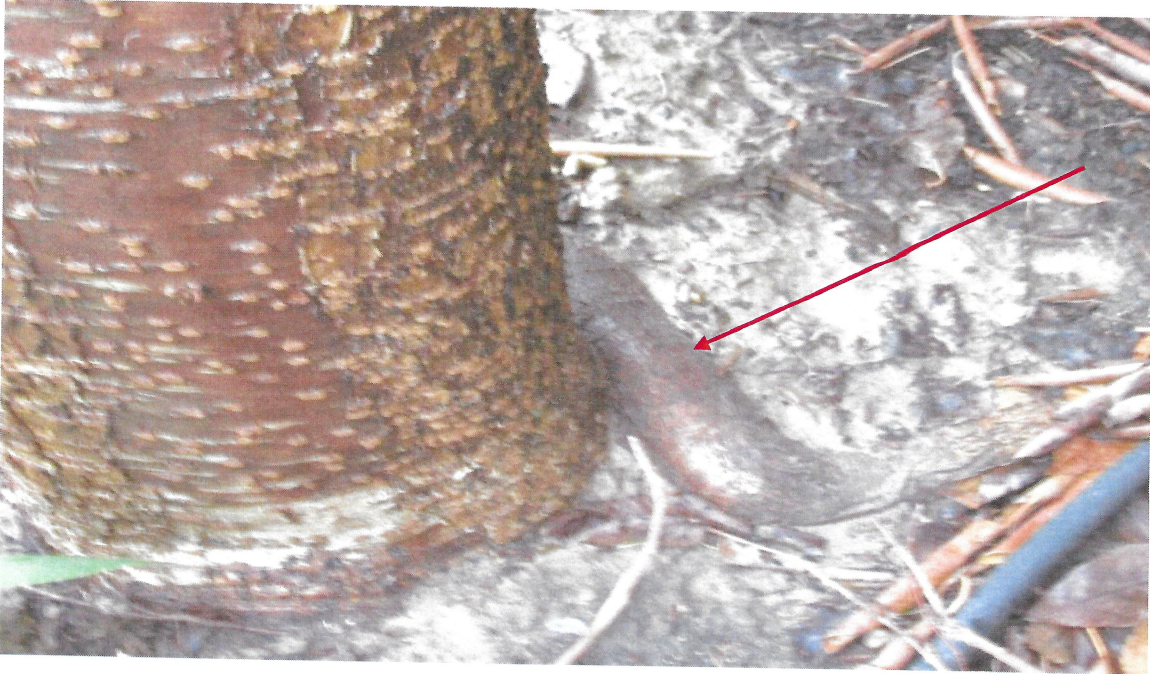
**Photo #2**

Pointed out is that girdling root. As the tree get older, the root gets larger and constricts the stem from delivering water and nutrients to the canopy.

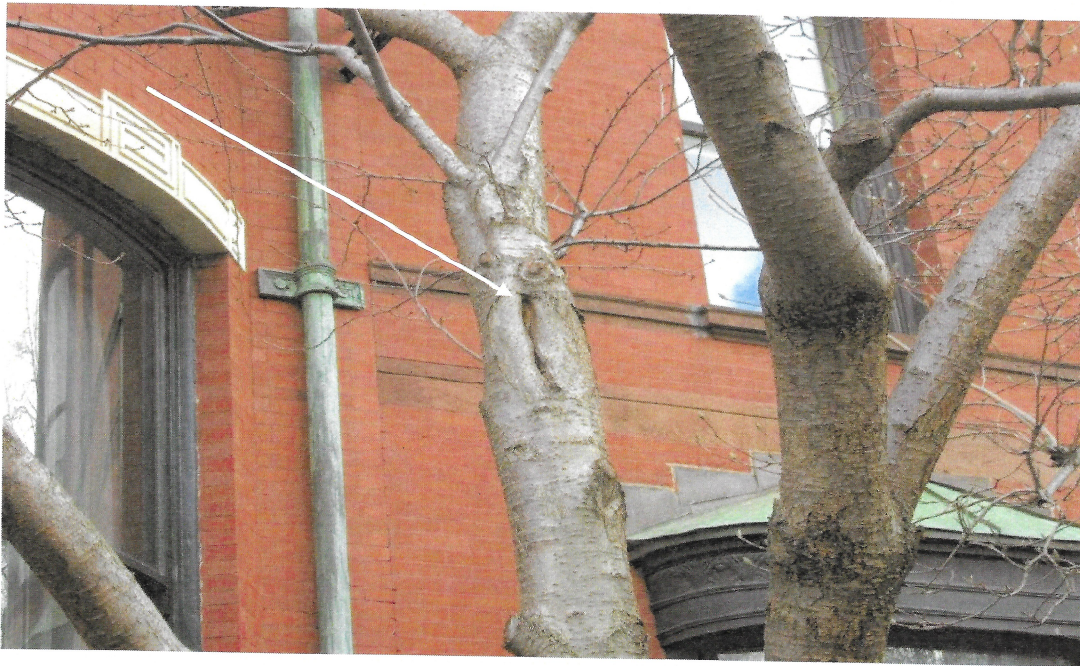
**Photo #3**

Pointed out is a cavity of decay within one of the main leaders. This will never callus (heal over) and will always be a weak area in the tree. Eventually the decay will spread throughout the leader.
