12 October 2017

PROJECT: CLOUGHERTY POOL FILTER ROOM  
331 Bunker Hill Avenue Charlestown, Massachusetts

**Re: Clougherty Pool – Charlestown – Pump Room**

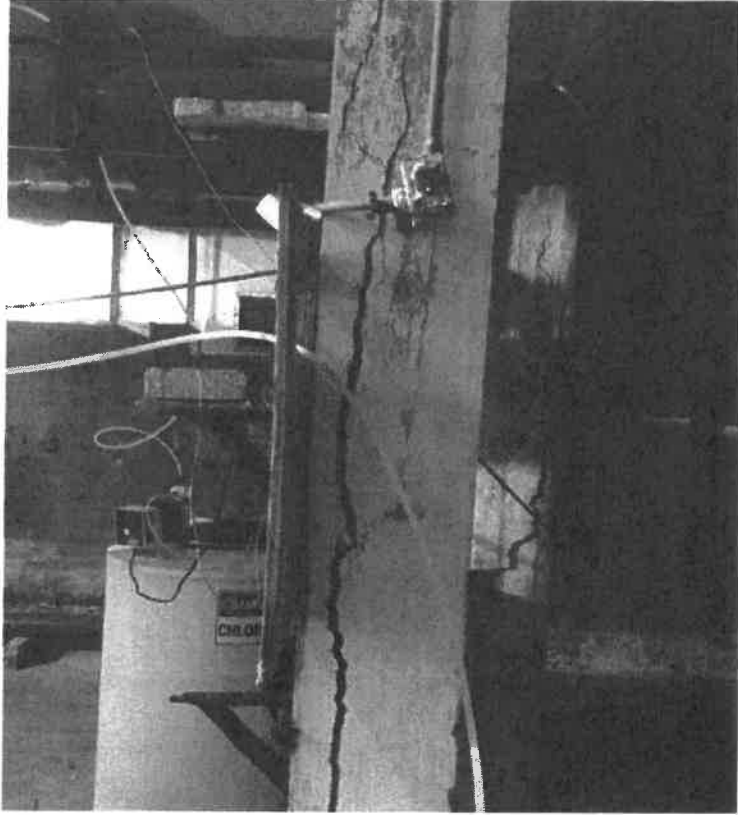
These columns exhibit large spalls, cracks and full height splitting, caused by corrosion of the reinforcing steel and subsequent rust jacking of the concrete. The capacity of these columns is severely compromised. (See attached photo)

1. The ends of the concrete beams in the filter room should be shored. The shores should be located on both the north and south sides of the columns. The shores should be designed for an assumed column load of at least 50 kips. The shores should be supported on a timber grillage on the existing concrete floor slab. At some locations, due to adjacent equipment, the shoring will require additional framing to bridge over in place equipment. The shoring should be designed and installed by a specialty company that does this type work.

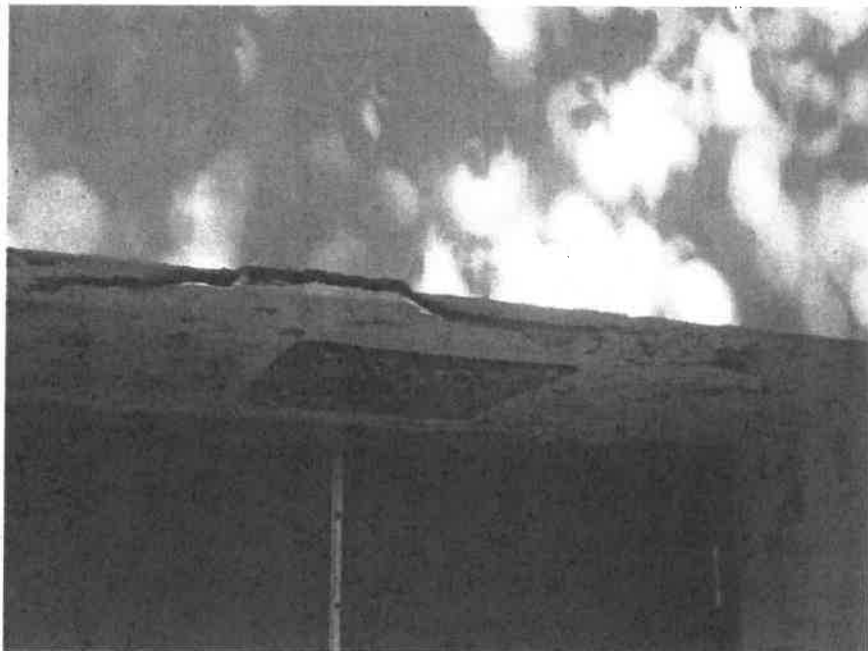
At the exterior, the exposed concrete framing is also generally good. However, there are locations where the reinforcing steel has corroded, and cracked or spalled the concrete surface. This happens predominantly at corners and soffits over openings. Some of these have been previously repaired, and the repairs are now failing, probably due to poor preparation of the substrate before applying the repair mortar. (See attached photo)

4. At the building exterior, loose concrete, at either new spalls, or previously repaired spalls, should be removed wherever there is public access below. Proper repairs, including fully exposing the reinforcing at spalls, sand blasting to remove all corrosion, applying corrosion inhibitors, and applying a suitable repair mortar, will have to be made at some point, possibly as part of a larger facility restoration or re-constructions project.
