15 April 2022

Reference: Clougherty Pool, 331 Bunker Hill Street, Charlestown, MA
Site Visit for Observation of Condition of Structure

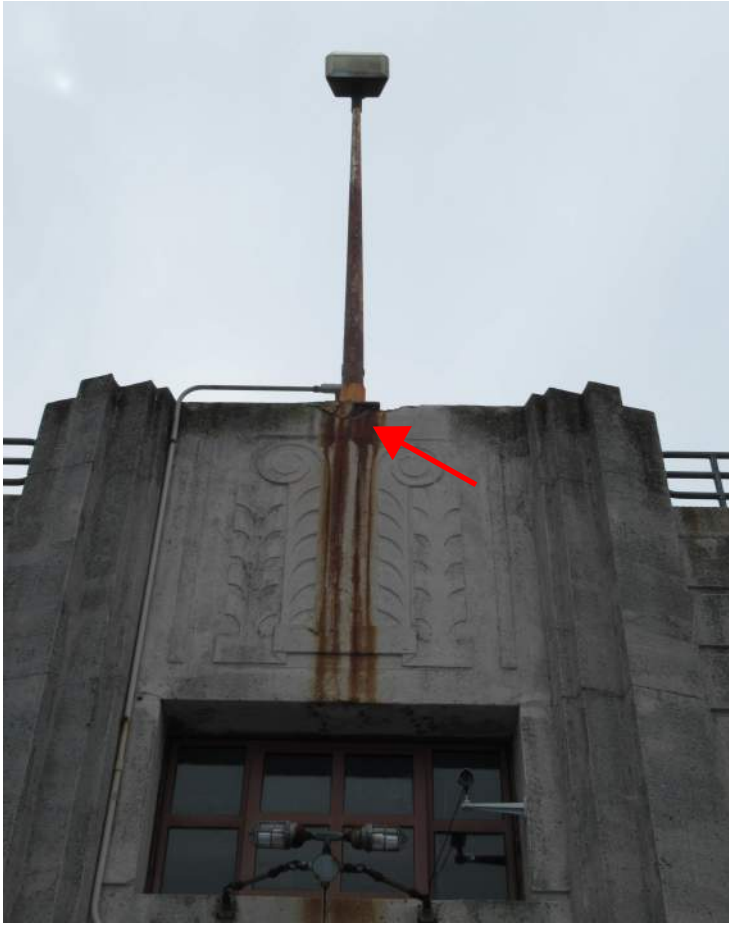
Photo 1:
Base of Flagpole Concrete
Spall, North Wall of
Bathhouse

Concrete Spalls: Spalls occur overhead in many locations and were identified in the walk-through. All overhead spalls should be removed including in the pool headhouse, filtration room, tunnels, and bathhouse. Exterior concrete spalls including the one at the base of the flagpole at the second floor of the bathhouse should also be removed (see photo 1).

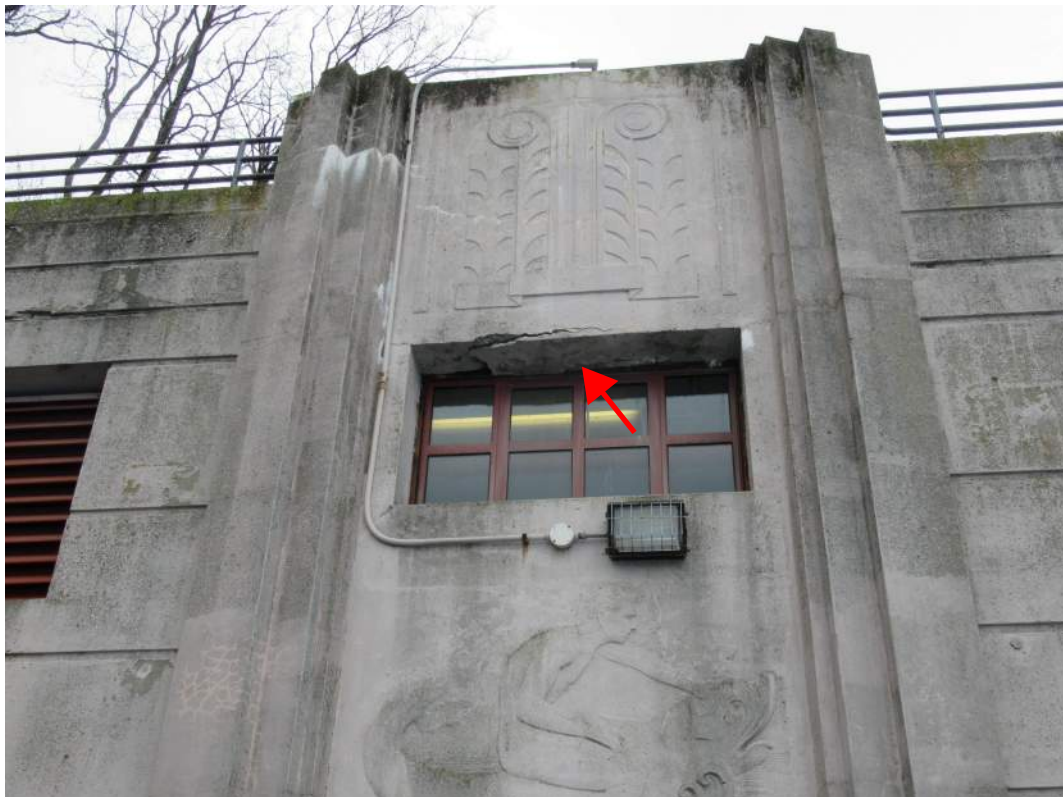
Photo 2: Soffit Concrete Spall, North Wall of Bathhouse

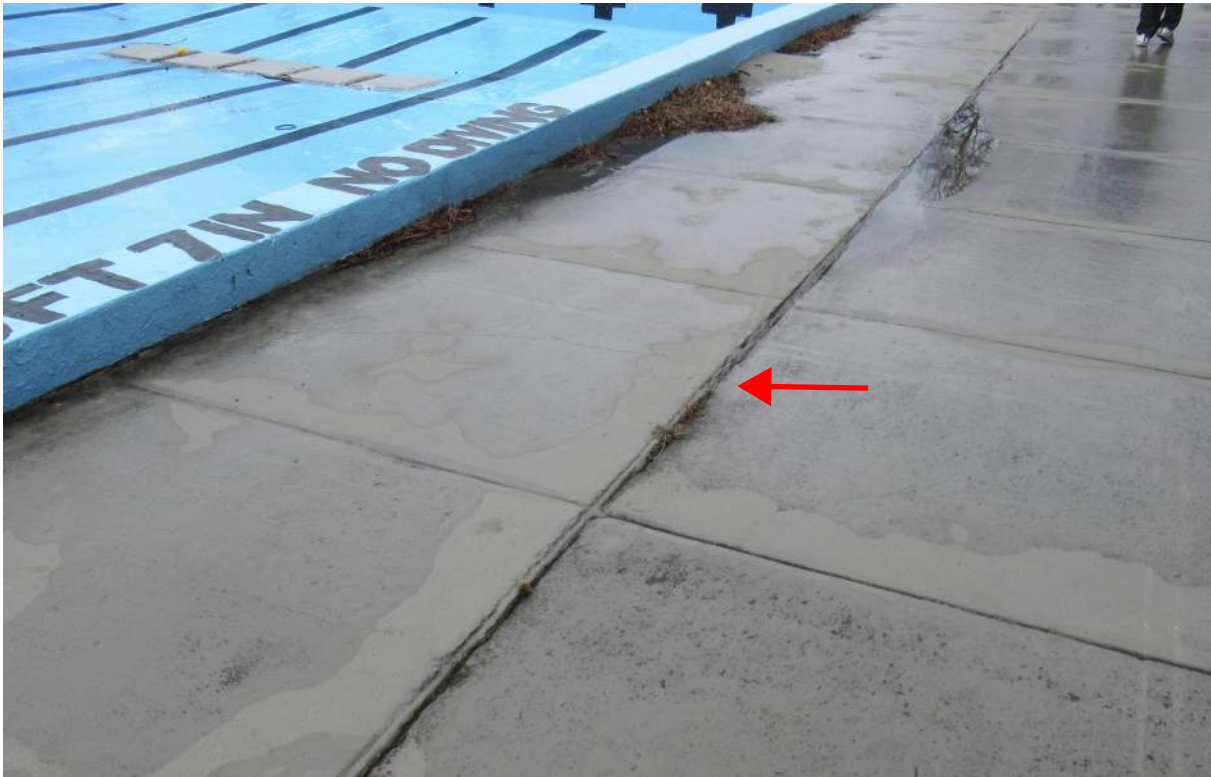
At the pool deck the surface is likely to be a sandwich slab over the structural slab, and the surface of the upper slab is irregular in areas, likely due to water getting under the slabs and freezing. The irregularity causes a trip hazard (see photo 3).

Photo 3: Irregular Apron Slab Surface - Trip Hazard

Pool Deck Irregularities: The edges of the topping slab at the pool deck that are raised should be ground to create a smooth transition to reduce trip hazards.

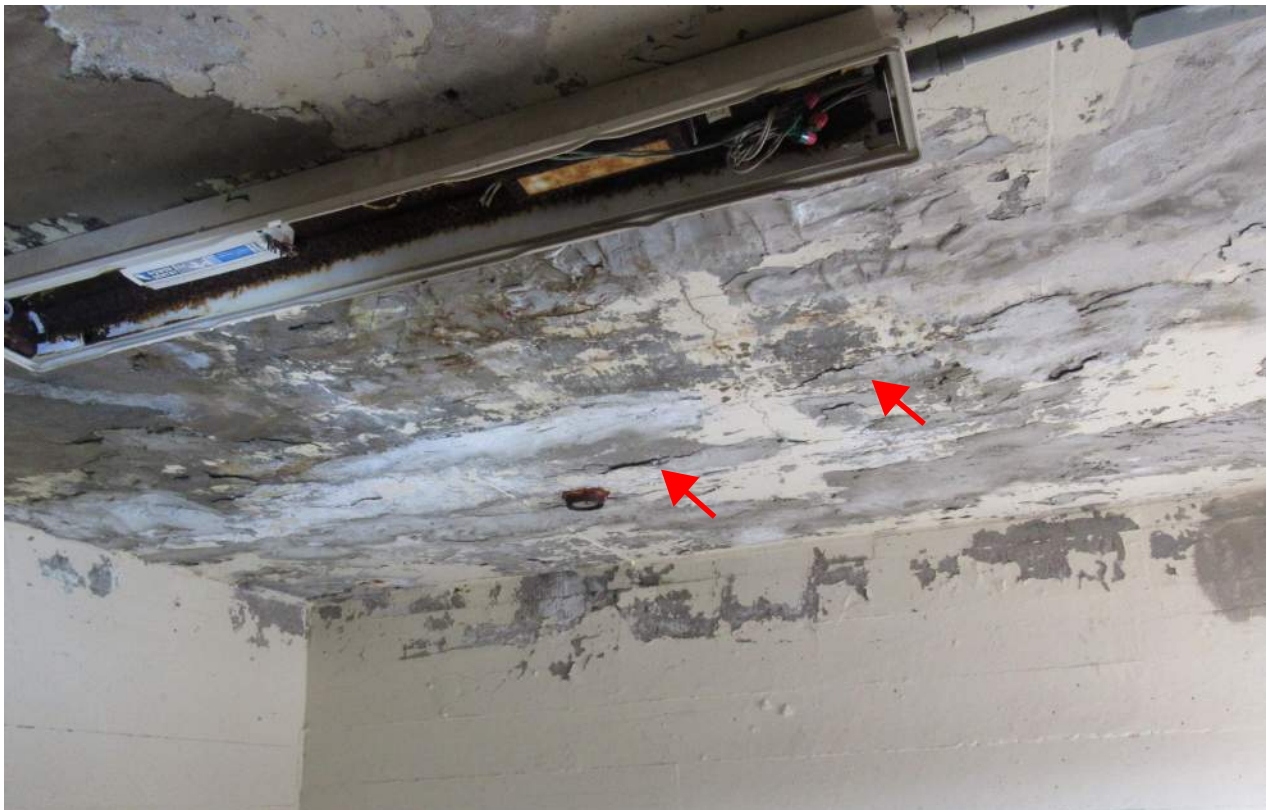
At the headhouse to the filtration room we noted spalling of ceiling and past overhead patches (see photo 4).

Photo 4: Concrete Spalling, Ceiling of Filter Room Headhouse

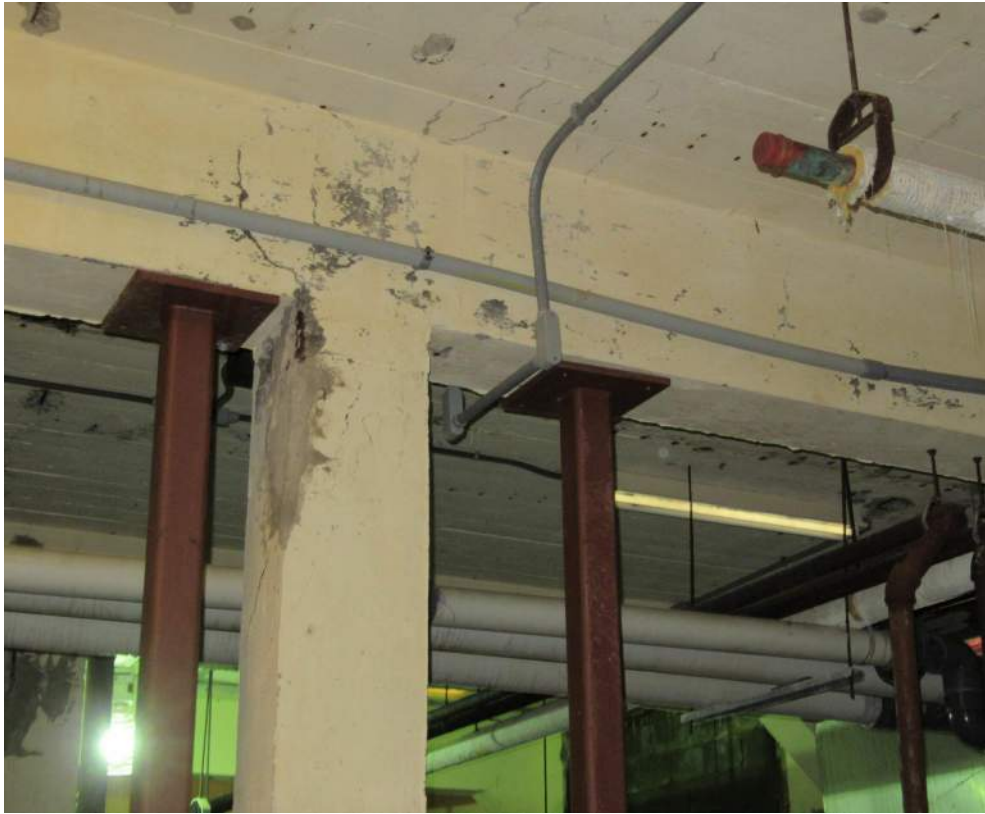
Photo 5: Typical Shoring - Filtration Room Roof Beams

Existing and Additional Shoring (filtration room): The existing shoring should be inspected by the installer to confirm that the top plates are in contact with the supported concrete beams and additional shimming should be provided if they are not. Additional shoring locations were identified and a minimum of three additional shoring posts should be placed where noted. Shoring design should be confirmed by the installer, and if not engineered, confirmation of adequate capacity should be confirmed.

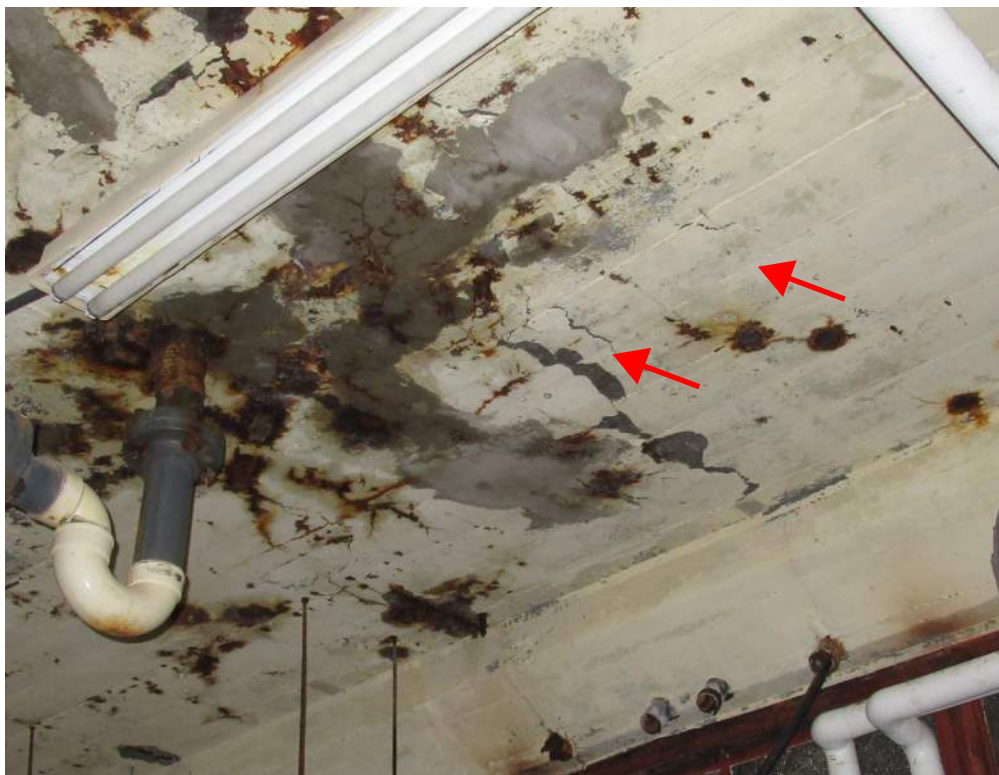
Within the pool house we noted concrete spalls on the ceiling directly over the reception desk area, and spalls within the stairwell to the locker rooms upstairs (see photos 6 and 10) .

Photo 6: Bathhouse Ceiling Concrete Spalling

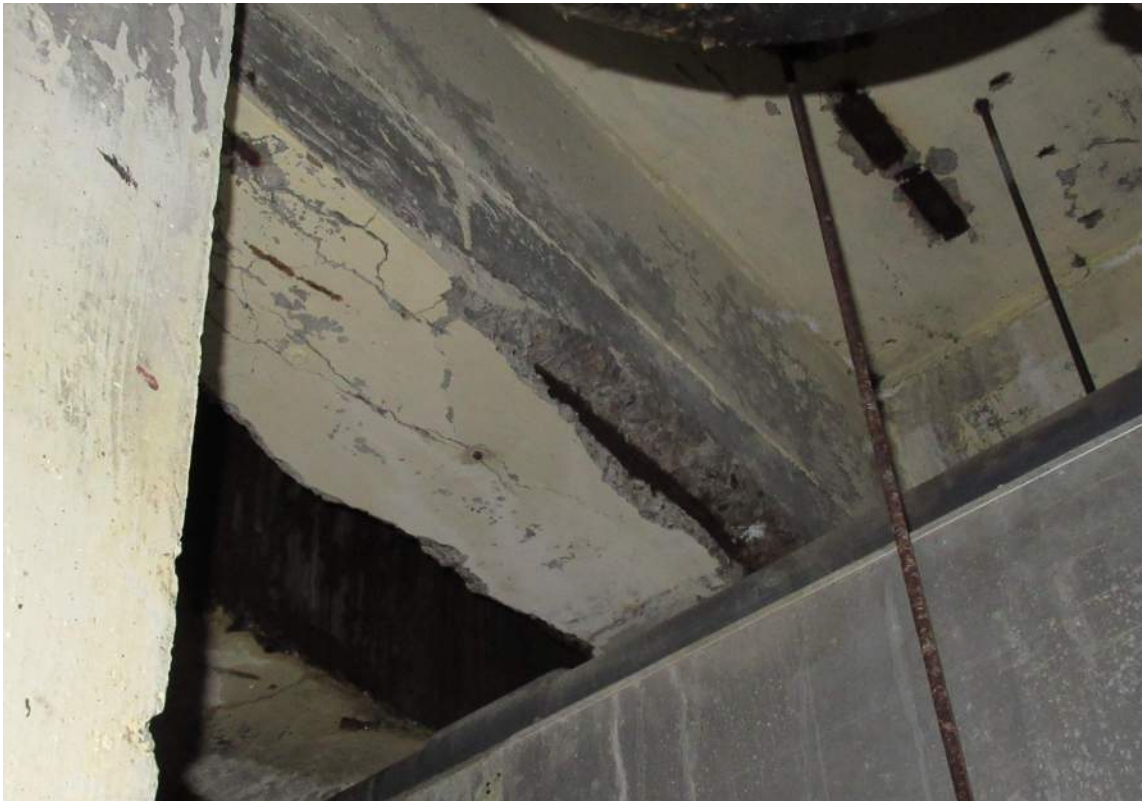
Observations: We were provided with the October 2017 Boston Building Consultants report assessing the pump (i.e. filtration) room conditions. In that report the deterioration of the concrete columns in the room was noted as well as the necessity for shoring the supported concrete beams. We understand that the shoring was installed in 2019, but we have not seen documentation or confirmation that it was engineered. It appeared that all of the beams framing to deteriorated columns had been shored with tubular steel column extending from the underside of concrete beam to the filtration room slab on grade (see photo 5). In observing the shoring in relation to the deterioration, we identified at least 3 more areas where shoring should be placed due to the condition of the concrete beams (see photo 8).

Photo 8: Filter Room Concrete (Double) Beam Requiring Additional Shoring

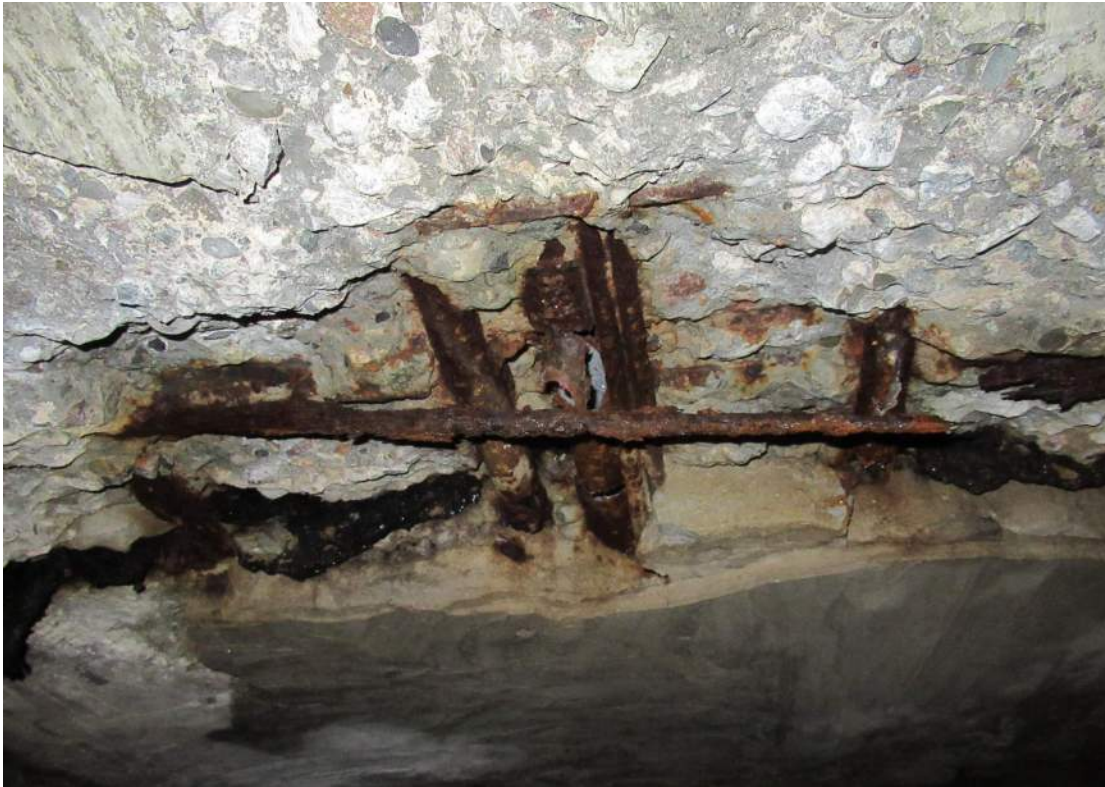
Within the tunnels that occur on the perimeter and between the pools we noted an extensive network of piping. There were three locations in the tunnels where the slab supporting the pool deck has spalled, and one location on the east side that is deteriorated badly enough to require shoring (see photo 9). On the same east side tunnel there was an electrical conduit that had broken off and a junction box that was suspended from the wiring. The wiring is reportedly live, so this is an immediate hazard and concern.

Photo 9: East Tunnel Concrete Ceiling Spall Requiring Shoring

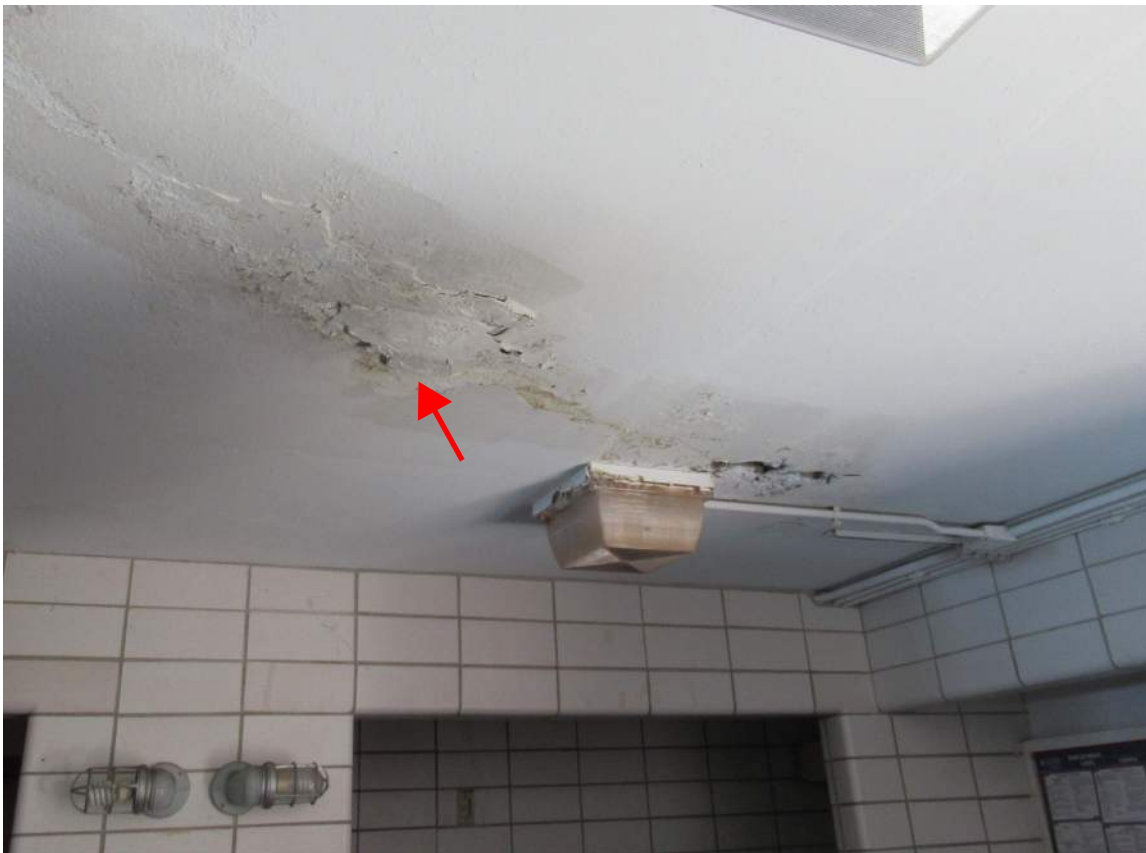
Photo 10: Bathhouse Reception Area Concrete Ceiling Spall
