16-18 & 22 GARDNER ST.

REASON FOR DEMOLITION

Structural Investigation Report

Property Address: 16-18 Gardner St, Boston, MA 02119

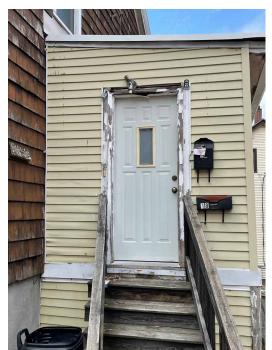
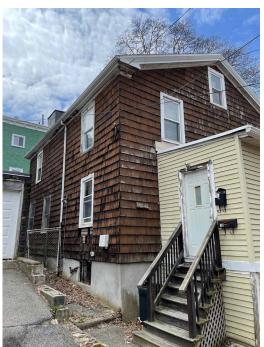
The building's exterior conditions exhibit failing materials. The wood deck, soffits, and trims are damaged, and the masonry shows signs of water leakage.

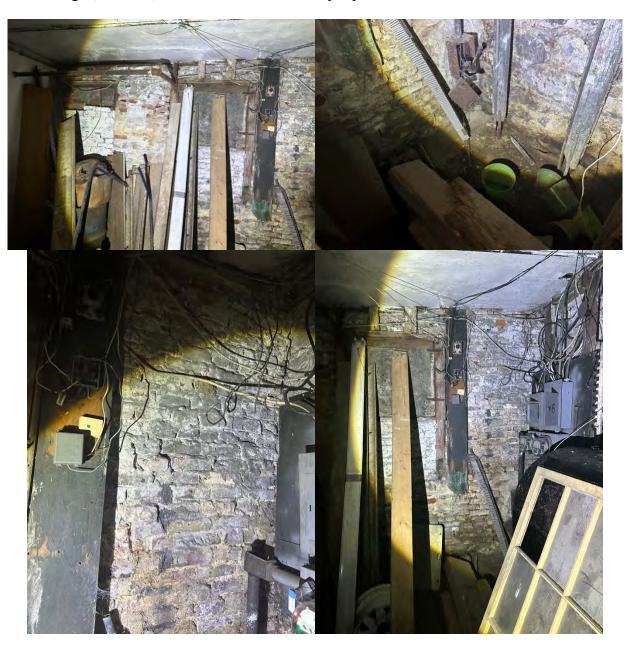
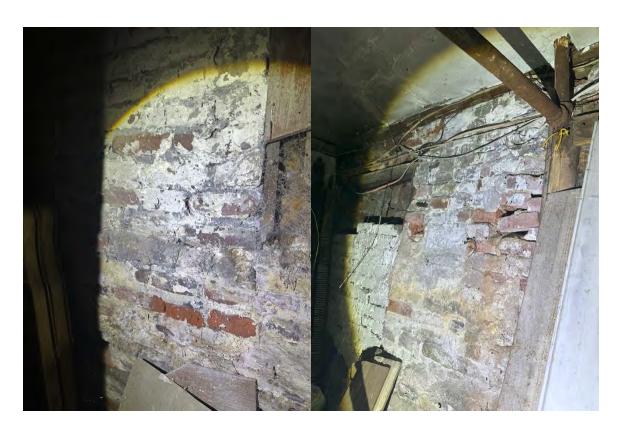
- 2. The stairs from the unit to the basement are not up-to-code with approximately 5' clearance and are not safe.
- 3. The brick foundation wall on the right side of the building is crumbling and has structural bulged, cracked, and needs to be extensively repaired or rebuilt.

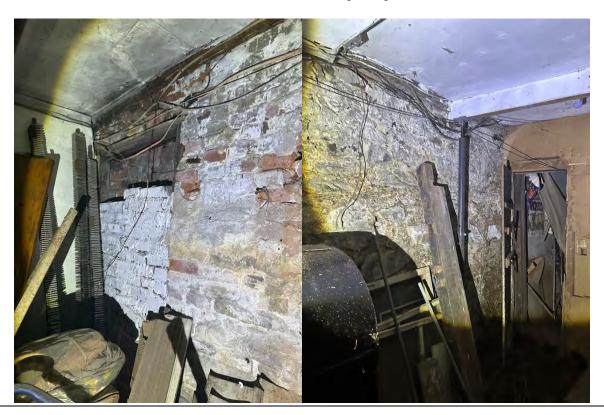
4. Extensive and long-term water and humidity exposure in the basement has caused brick foundation walls to dissolve and deteriorate. Proper repair is recommended.

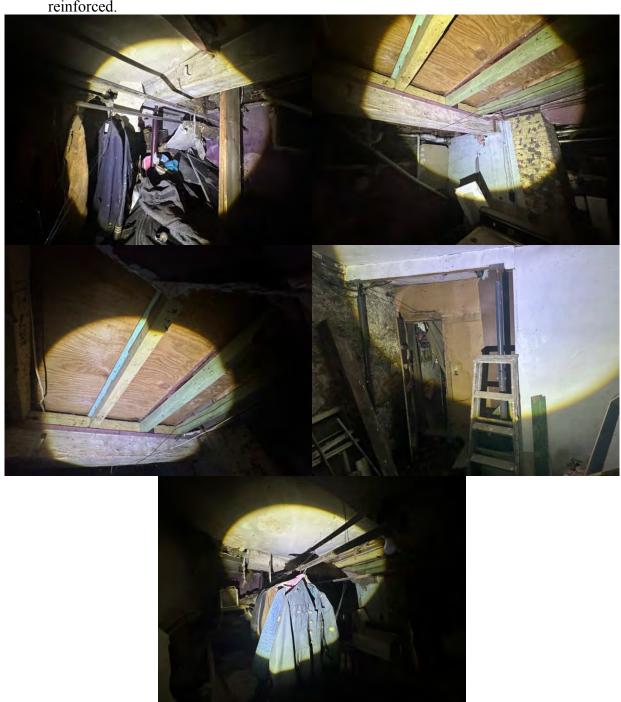
5. The main beam in the basement supporting the first-floor framing system is not properly supported and is not structurally sound. This beam is significantly slanted, cracked, and sits on a temporary screw jack. Screw jacks do not have any footing and are not permanent support. The beam end is cut at one side and floats. This beam needs to be replaced with an engineered beam to be installed on lally columns (on designed footings). The floor joists are 3x4 @ 2 spacing, are undersized for the span, and need to be reinforced.

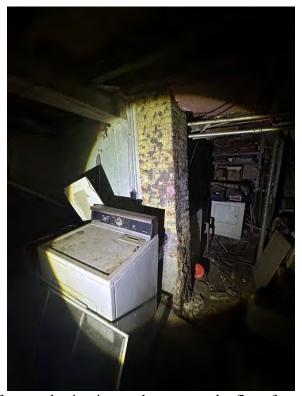
6. The chimney is significantly tilted (approximately 3" over 7 ft) and is compromised. This chimney needs to be rebuilt and is not salvageable/repairable.

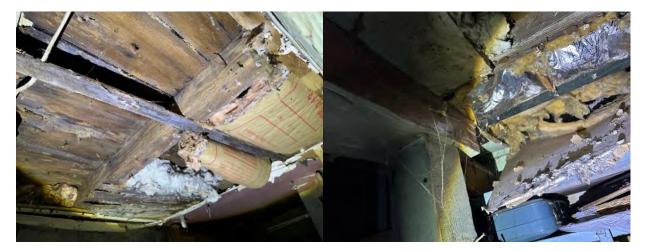
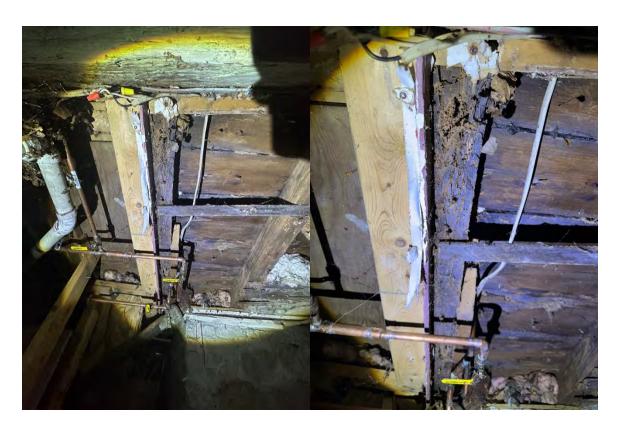
7. There are signs of severe boring insect damage on the floor framing on the southwest corner of the house. It is recommended to engage a qualified pest control contractor to inspect and treat as needed. The compromised members need to be completely replaced with designed members.

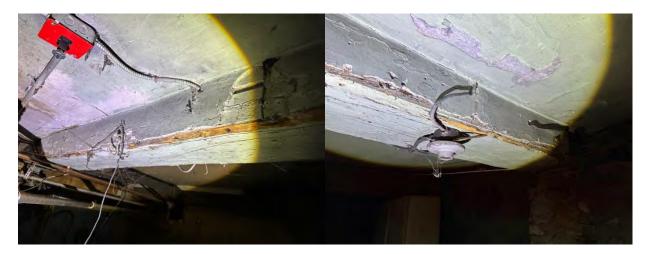
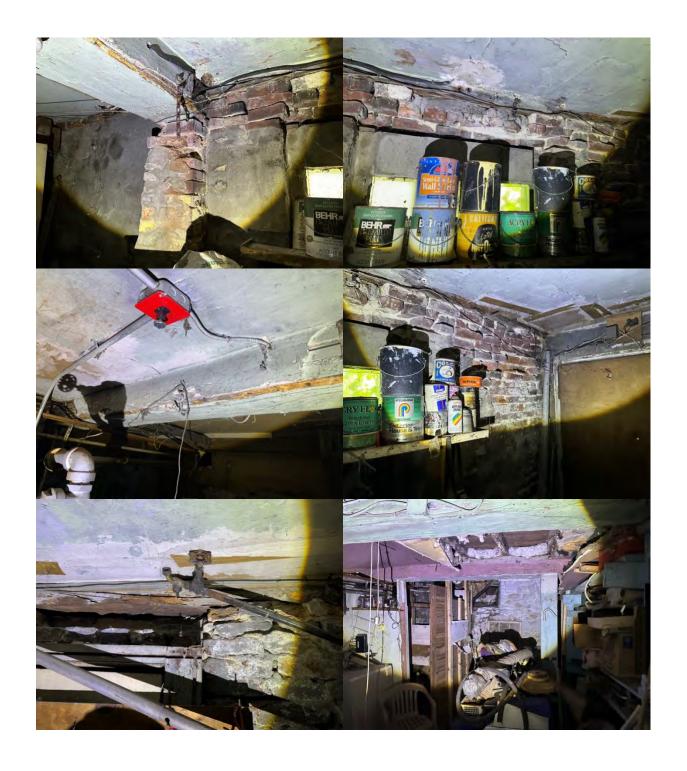
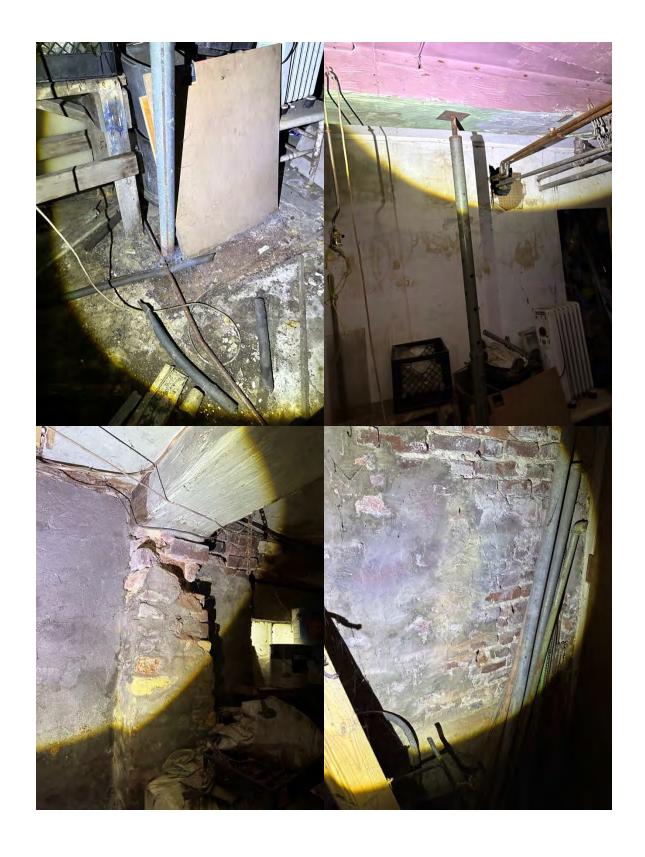
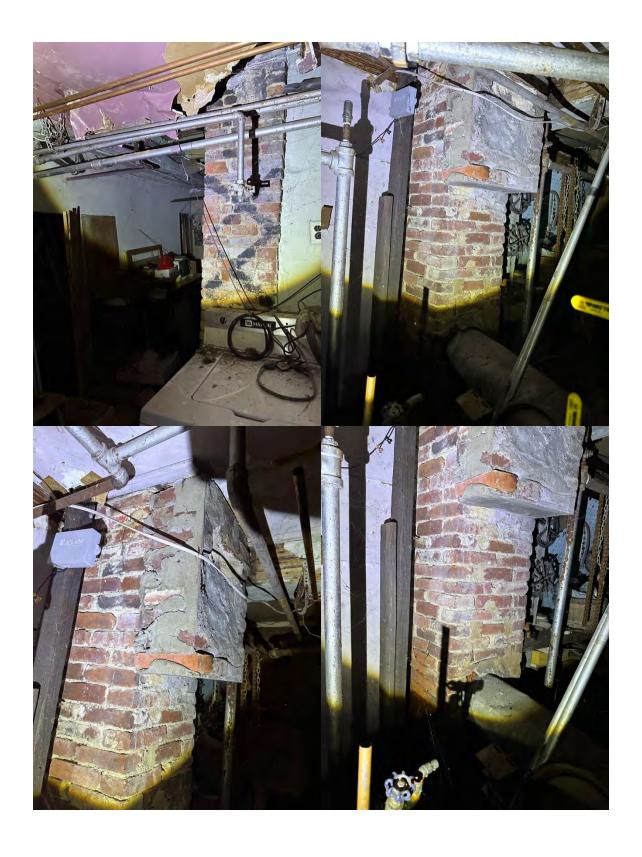
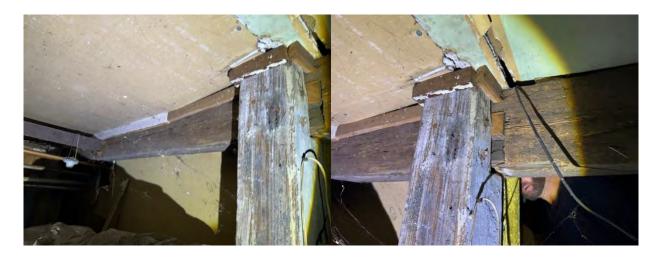
8. The two main beams supporting the other side of the house (northwest side – furnace room) are not structurally supported. One of the beams is supported by a compromised brick support at the end. This beam and the perimeter sill beam have signs of boring insect damage and need to be replaced. The existing floor framing is not safe to walk and needs temporary shoring before complete construction.

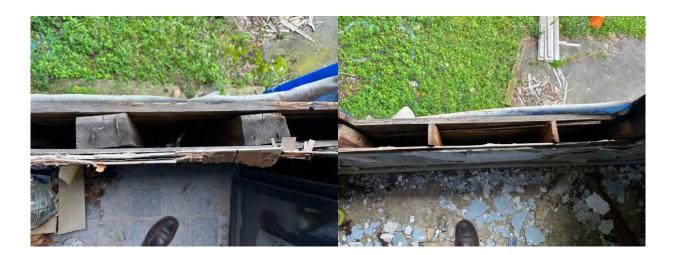
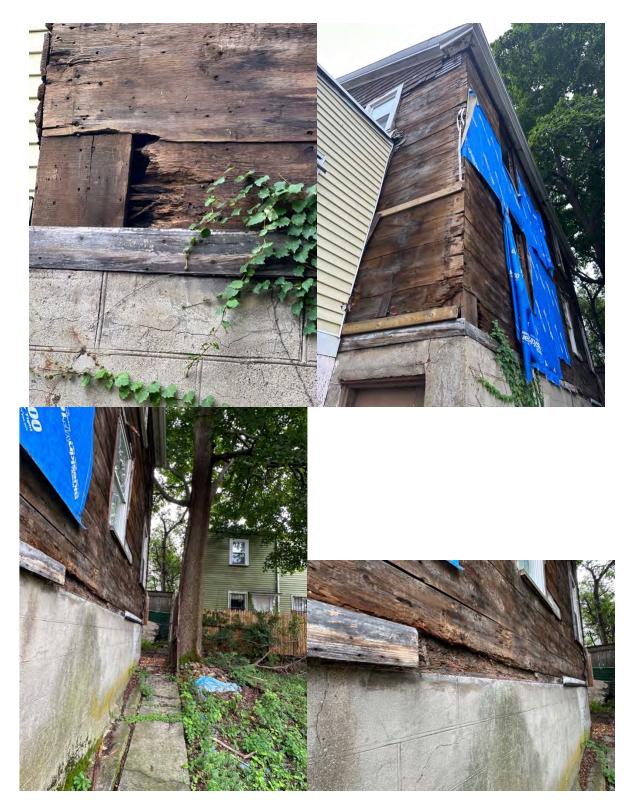
9. The Exterior wall framing exposed on the first and 2nd floor (right side looking from the front) shows a 3x4 stud on the flat. This exterior wall framing appears to be insufficient for insulation. The exterior wall studs on the 2nd floor are smaller (1" thick) and need to be reframed completely for lateral load-bearing strength. The exterior siding has signs of significant boring insects and needs to be completely redone.

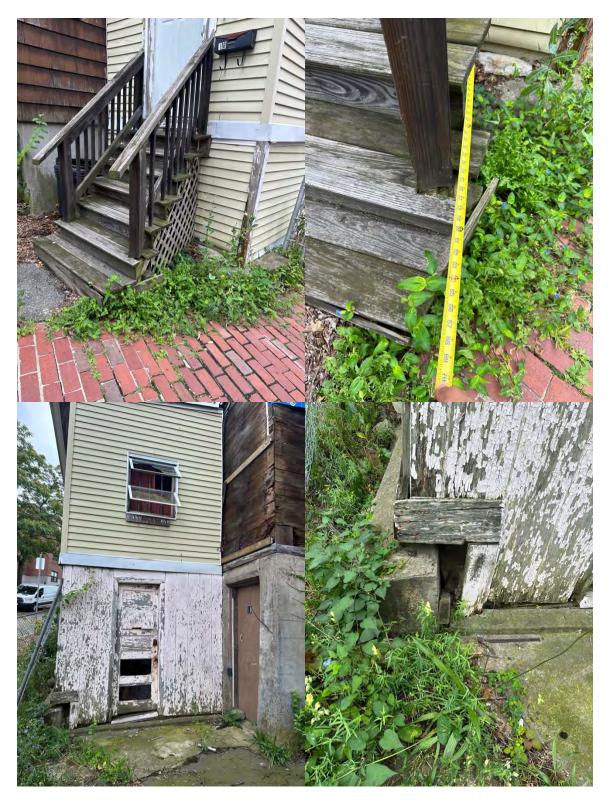
- 10. The attic was not safely accessible for inspection at the time of the visit.
- 11. The front addition appears to have not been built in a designed footing and the stairs are not up to code.
