70-72 Mt Vernon Street, Boston, MA

Investigation of Entry Steps and Platform

February, 2024

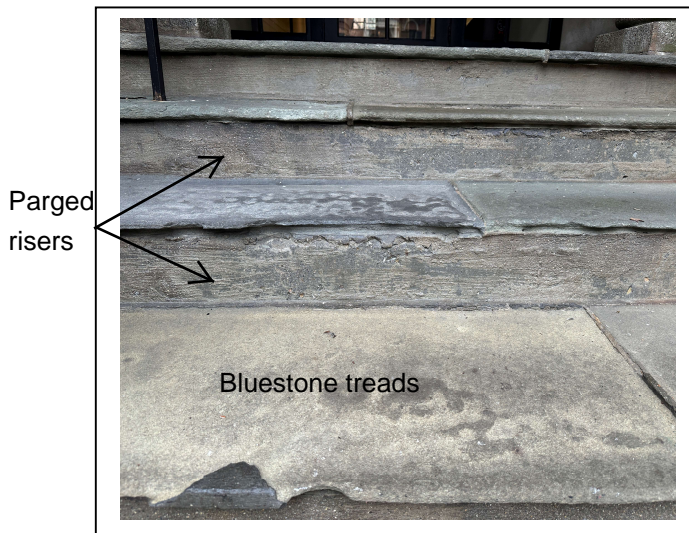
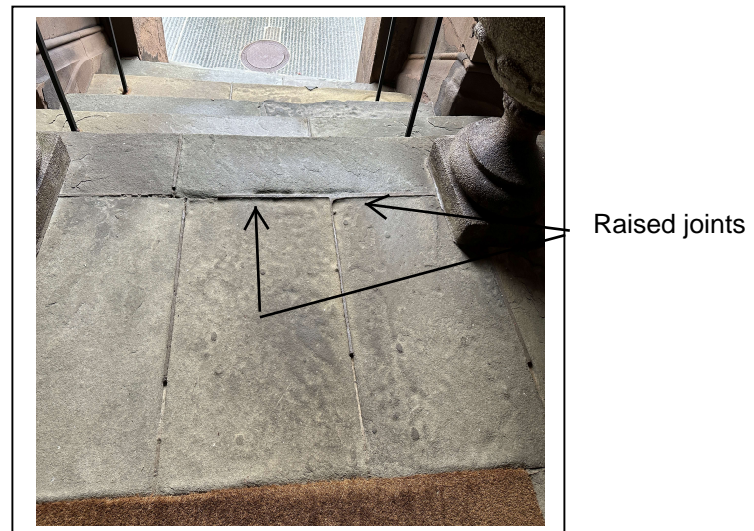
The twin houses at 70-72 Mt. Vernon Street were originally built c. 1840; they were raised two stories c. 1860 and they expanded upward again when converted to condominiums c. 1965. It is said that these houses were built on the foundation of a large barn and dairy complex behind a large mansion house on Chestnut Street and that those buildings were Beacon Hills most monumental buildings when constructed according to the design of Charles Bulfinch. Although it is unclear if the existing buildings on Mt. Vernon have the same footprint as the Bulfinch building, it does appear that portions of the basement and cellar (lowest level, below basement) retain masonry from the Bulfinch period, c. 1815. The 1840 design is by Richard Upjohn, major alterations were made when it was BU's school of Theology. The entry steps, landings and side walls of the 70-72 entries show deterioration which presents a very poor appearance and a tripping hazard. Currently the steps have bluestone treads and the risers are parged over an unknown substrate. The sidewalls are brownstone with some exfoliation and poorly done patches. The mortar joints on the upper platform have become raised due to erosion of the bluestone surface.

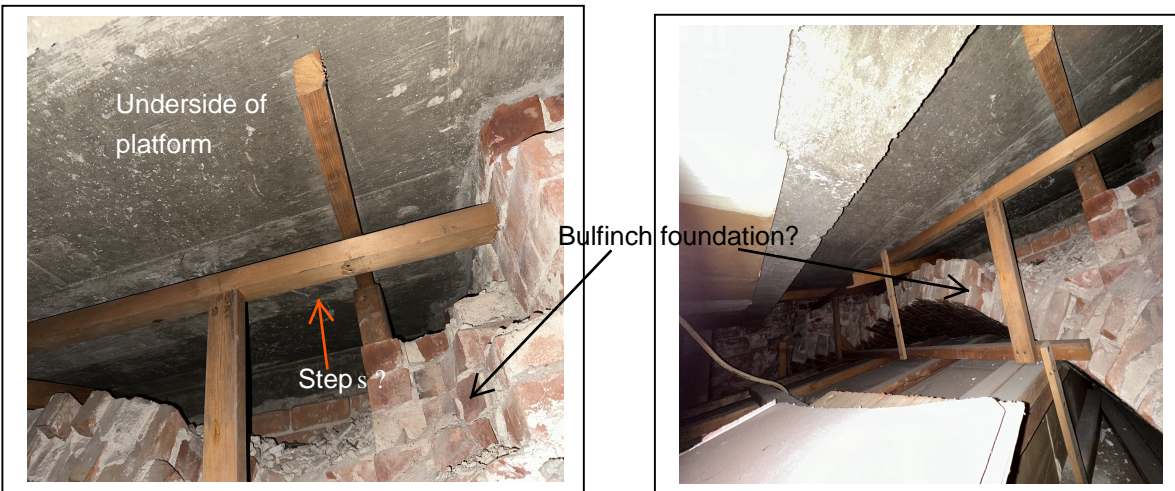
The courtyard level photos above appear to show that the current steps are founded on a concrete base and that portions of an older vaulted structure/foundation remain. Further, when the mat at the entry platform was lifted, a concrete surface was observed. At the lower cellar level, the likely remains of the Bulfinch building granite foundation is noted with a brick vault above.

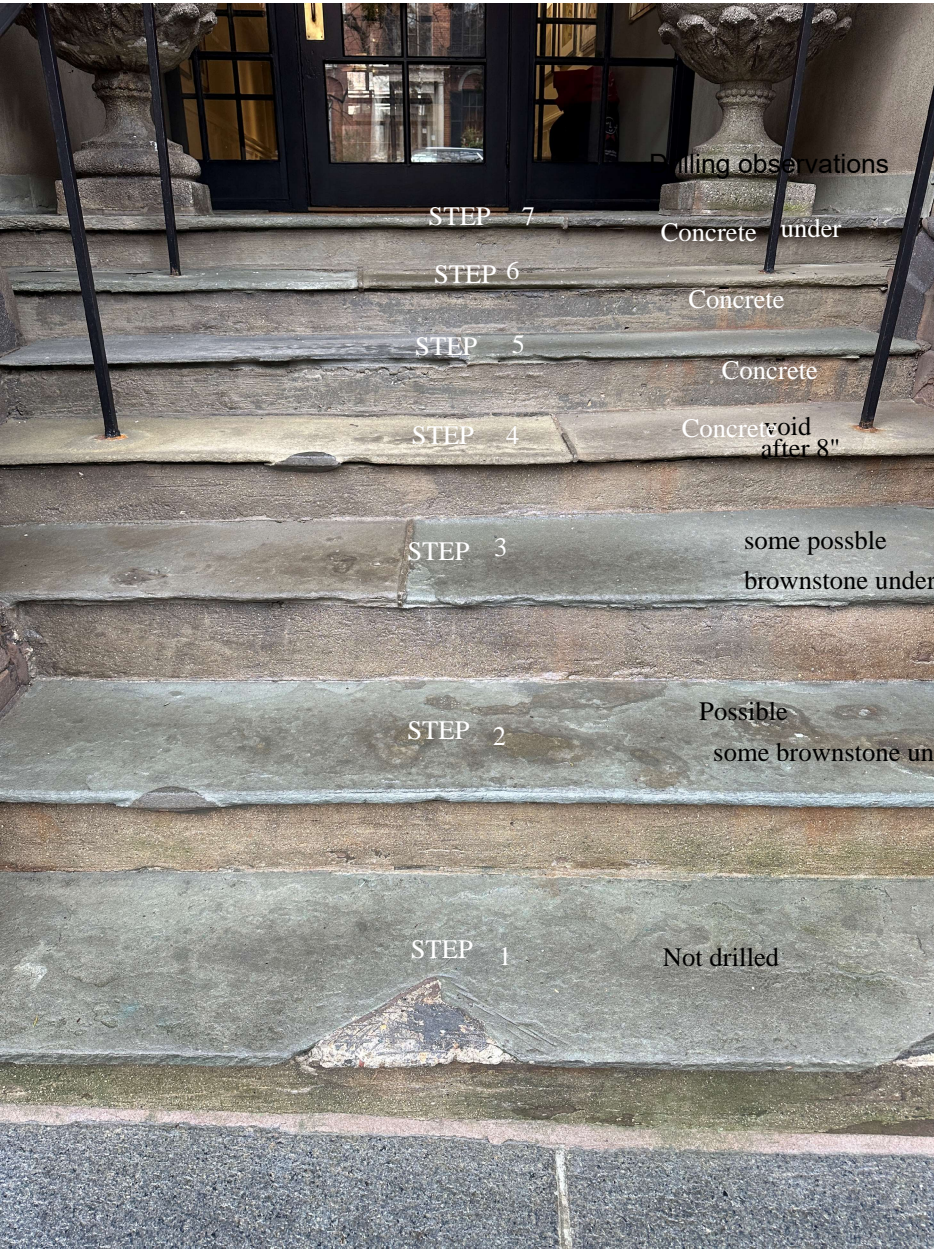
Drilling observations

At least partly, based on 2/1/24 investigation from the top at least some of these findings strongly suggest that the entry steps were substantially redone as part of the 1965 work and that the foundation for the steps is concrete and that the observed risers are just parging over the concrete and that the bluestone treads overlay the concrete. It was anticipated that the support of the steps would be some form of stringers and that there would be solid steps, and not just thin threads over the concrete. brick before the investigation

Treads vary 13"-17"
Risers vary 5"-7"

Rise -
7 X 6 = 42" rise

STEP 7

Concrete under

STEP 6

Concrete

STEP 5

STEP 4

Concrete void
after 8"

STEP 3

some possible
brownstone under?

STEP 2

Possible
some brownstone under?

On February 1, 2024 additional observation was made of the underside (courtyard level) of 72 and it appears that much of the Bulfinch area vaulting remains and that rubble from demolition of brownstone steps (?) remains stored within the brick vaulting. Aided by David DiBlasio, an experienced historic mason with extensive Beacon Hill experience, probes were made into the treads and risers of the 72 entry steps. The results were unexpected. While the lower three steps appear to have some brownstone underlying the surface, the upper steps appear to be on concrete and at one location a hollow was uncovered under the concrete. Most steps were drilled, at the far right edge, beyond the railing, and the holes later filled. Thus, it appears that the foundation under the steps and platform is not uniform and that the lower part may be built-up on top of remaining Bulfinch area materials - including possibly brick vaults. It is clear that the full condition underlying the steps will only be known when full demolition is completed. Observed conditions are noted on the photo above.

1. Replace existing non-historic stairs and platform surface with granite stairs and platform surface matching existing dimensions. The goal of the project remains to provide as many full granite steps as possible, but it may be necessary to retain existing concrete at the upper treads and landing to avoid substantial demolition and to not disturbing the concrete or early vaulting. Where full steps cannot be provided, granite treads will be used. The bluestone on the platform will be replaced by granite units of like dimension.
2. Remove non-matching in color or profile existing patches on the stair side walls with color, texture and profile matched Jahn (or similar) repair. Provide limited repair to additional stair side wall stones showing deterioration.
