FEASIBILITY STUDY  
WASHINGTON IRVING MIDDLE SCHOOL  
105 CUMMINS HIGHWAY  
ROSLINDALE, MA

FINAL REPORT

JULY 21, 2022

**BOSTON PUBLIC SCHOOLS  
CITY OF BOSTON  
WASHINGTON IRVING SCHOOL RENOVATION/ADDITION PROJECT  
ROSLINDALE, MA.**

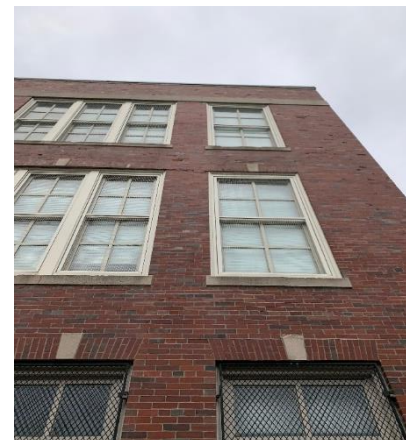
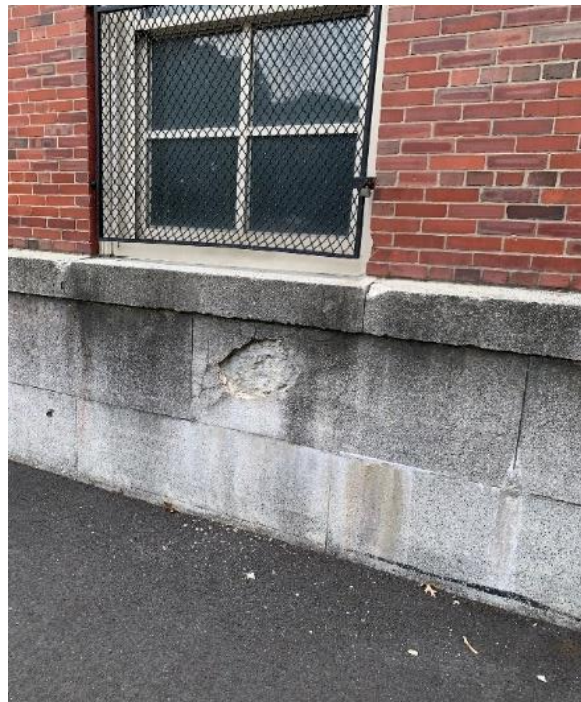
At several locations around the perimeter of the building, the exterior steel lintels (over window and door openings) were observed to be moderately to severely rusted with a noticeable downward deflection. In some locations at the bearing ends of

the loose steel lintels, the mortar is dislodged and loose as a result of jacking forces from the rusted steel lintels.

Moderate sized cracks and concrete spalls in the exterior foundation walls (slightly above the exterior grade level) were observed at a few locations at the perimeter of the building. The exterior cast stone (granite in appearance) veneer is severely deteriorated and spalled.

Cracks in, and significant outward bowing of, the exterior brick walls were observed at several locations.

Rusted steel lintels above windows and damaged / weathered brick will require re-bricking and re-pointing.

Delaminated and deteriorated reinforced concrete retaining wall conditions were observed at several locations and will require structural repair or removal and replacement.

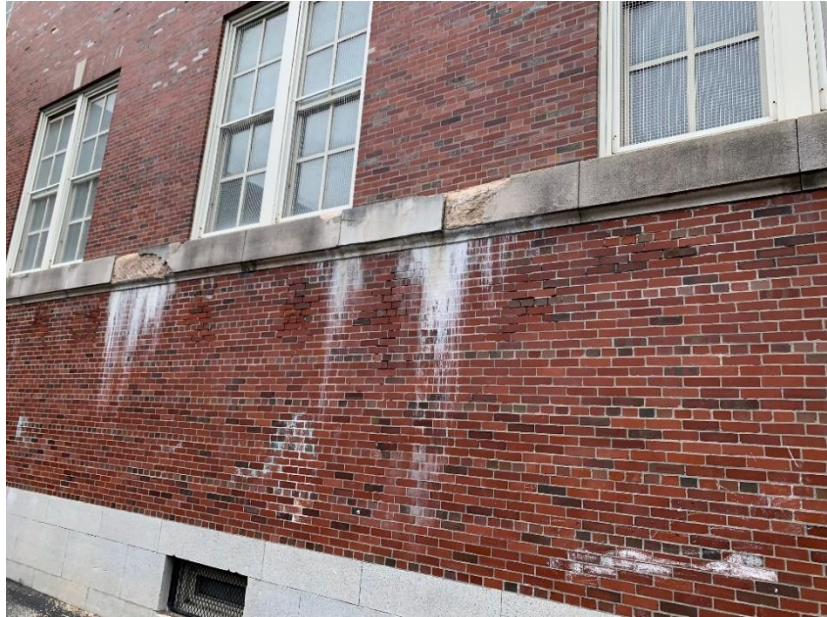
Spalled cast stone sills and deteriorated brick wall along exterior of building will require repairs / replacement.

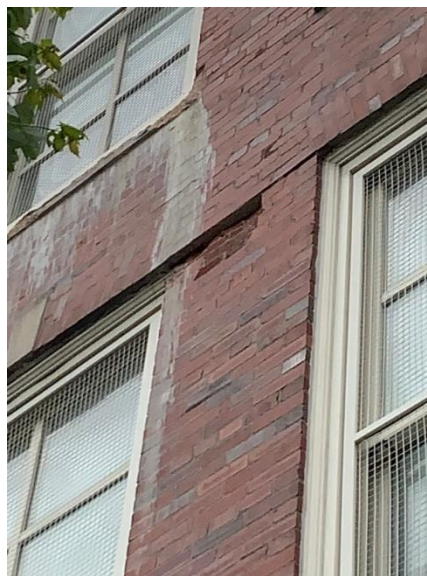
Major spalls and corroded relieving angle will require repairs / replacement.

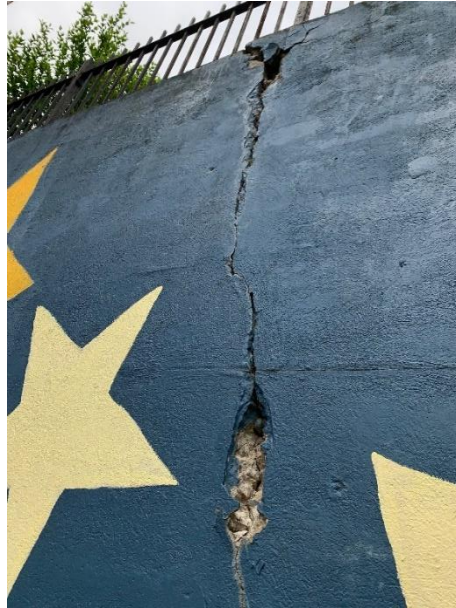
Significant cracks in concrete retaining walls will require structural repairs / replacement.

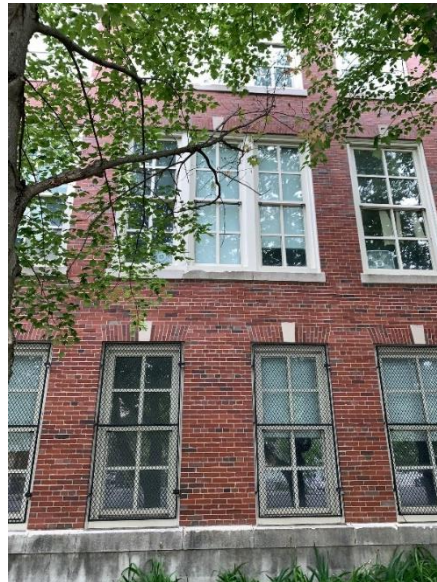
View of exterior portion of building showing large windows at level 2 where brick above is supported by continuous steel relieving angle. Structural repairs will be required.

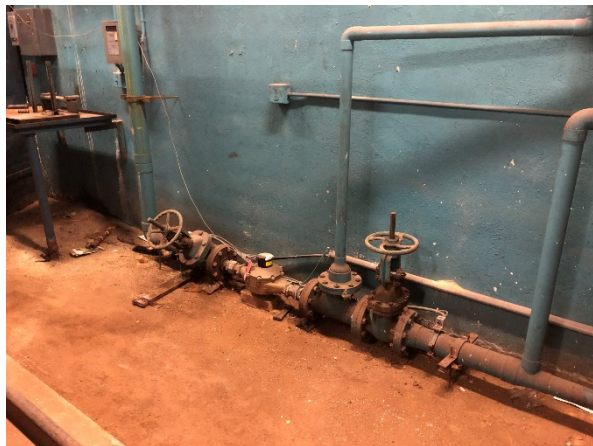
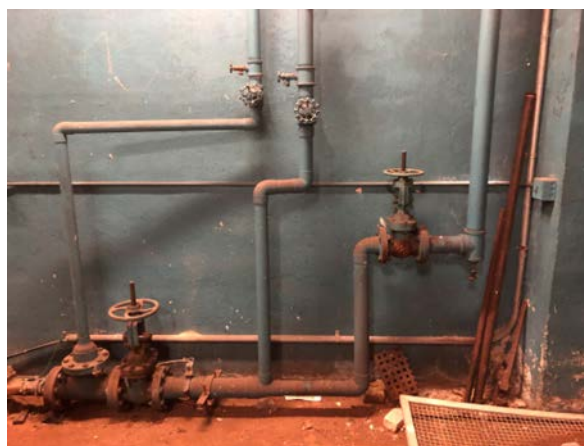
**Photos 1 & 2:** Domestic Water Service

Only the exposed piping scattered throughout the building could be observed and evaluated. The domestic water piping appears to be a mixture of either lead or galvanized steel piping and hard drawn copper tube. Piping appears to be in fair to good condition.

There are various signs throughout the building which indicate that this water is not potable, and is to be used for washing only. We suspect that this is due to a high lead content of the water caused by the piping.

There are various signs throughout the building which indicate that this water is not potable, and is to be used for washing only. The cause should be investigated and corrected. We suspect that this is due to a high lead content of the water caused by the piping. If this is the case, all of the existing domestic water piping should be replaced.

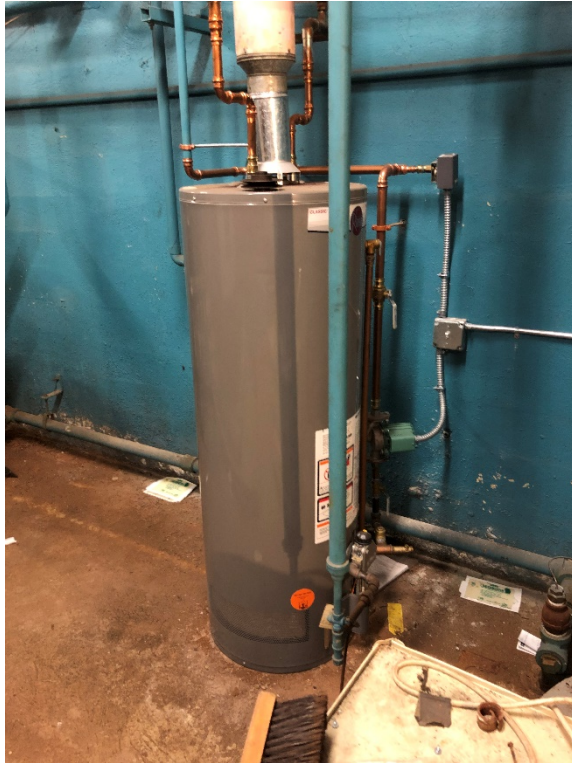
**Photo 3:** Gas Fired Water Heater

The kitchen has its own Rheem gas-fired natural draft water heater. The nameplate data has been removed. The water heater appears to be in good condition.

The water heaters are fairly new and in good condition and should last for many years to come, although the venting needs to be corrected. The building water heater should be equipped with a thermostatic mixing valve in order to increase the stored water temperature to prevent Legionella, and to provide tempered water to the building fixtures.

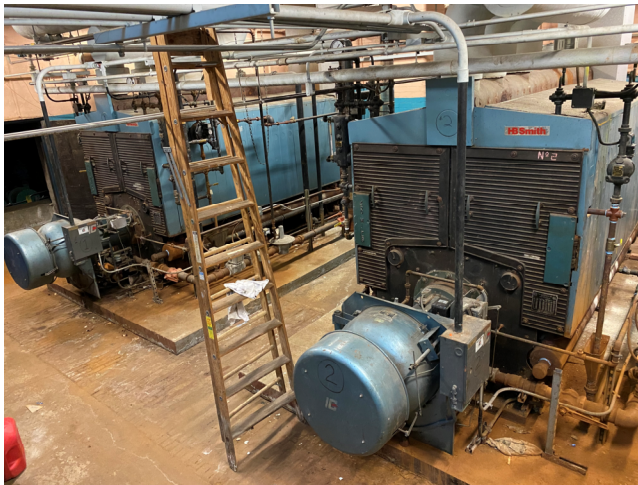
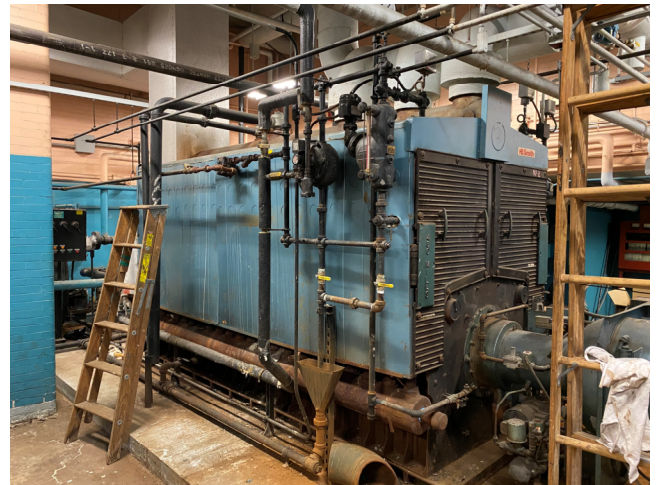
Photos 1 & 2: Existing steam boilers.

There are two (2) existing steam heating boilers serving the building. The boilers are each HB Smith, 450 Mills standard efficiency cast iron sectional boilers with 22 sections and have a net IBR capacity of 4,394.4 MBH. The boilers include a gas/oil burner (dual fuel), Model #MM-105S as manufactured by Industrial Combustion Inc. It was noted that currently the boiler operates only on natural gas. The sectional boilers and burners seem to be original to the building and were observed to be old but in fair condition. Each boiler was observed to be equipped with a McDonnell & Miller (M&M) low water cut-off (LWCO) and flow controls. The existing return headers under the boiler were observed to be in deteriorating condition with rust and leaks.

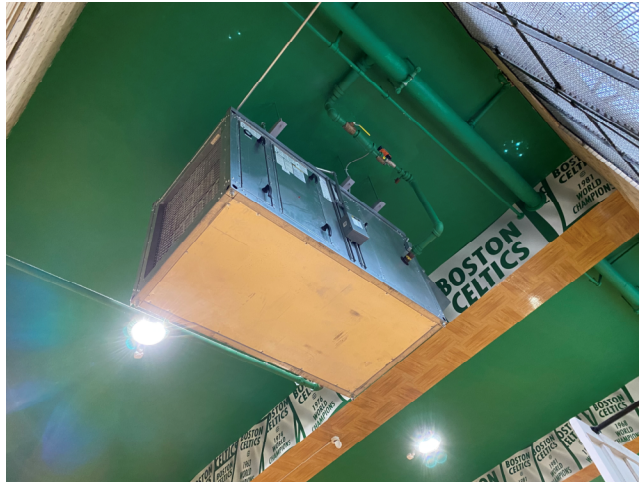
Photos 8 & 9: Existing gymnasium and Locker Room systems.

connected to the units. The unit was observed to be in fair condition. There was no mechanical ventilation observed in the gymnasium. During the site visit, it was observed that the exterior doors were opened to provide natural ventilation. The area of operable openings into the gymnasium needs to be evaluated to ensure compliance with mechanical code with regards to natural ventilation requirements. The Locker Rooms are served by steam radiators. The steam radiators were observed to be old and in deteriorating condition. There is no mechanical ventilation observed in the locker rooms.

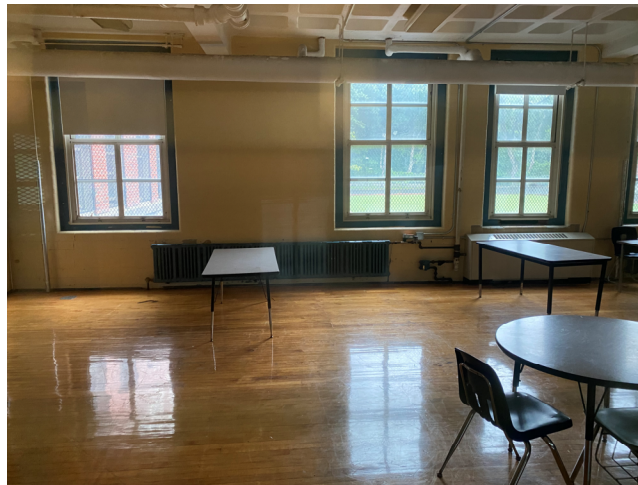
Photos 10: Typical classroom radiator and unit ventilator.

It was observed that a typical class room (all floors) is being served by a steam radiator and a floor mounted unit ventilator. There was no mechanical ventilation observed in the classrooms and the classrooms are reliant on natural ventilation. The steam radiator was observed to be provided with a modulating valve that is interlocked with a wall sensor located in the class room. The facilities personnel informed that the floor mounted unit ventilators were added solely to provide air movement in the classrooms. There was no ventilation air or source of heat observed for the unit ventilators. According to the school's facility staff, the floor mounted unit ventilator is also controlled by the wall mounted sensor. The staff informed that there is a town wide building management system (BMS) that interlocks and controls the HVAC systems serving the school. Thus, it is believed that the occupied/unoccupied schedules and temperature setpoints for each classroom are provided by the town BMS.

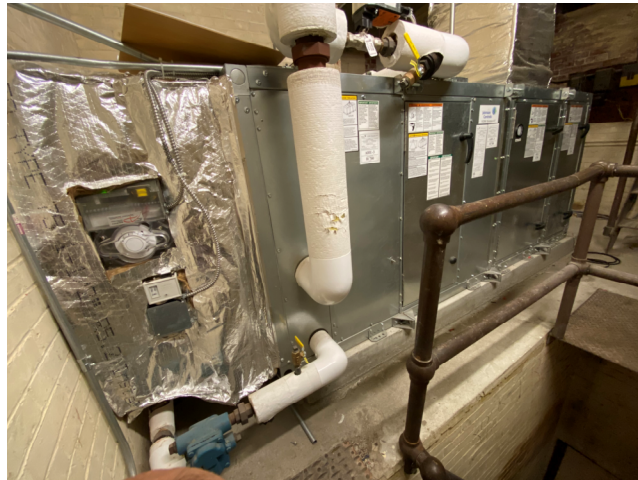
Photos 13: Existing AHU serving the Auditorium.

Auditorium: There are two (2) existing air handling units serving the Auditorium. The units are located in partial mezzanine spaces on either side of the stage. The AHUs are Johnson Controls York, Model #XTI-045X057-KAHA028A. The AHU included a steam heating coil and was noted to be a 100% OA unit. The unit was observed to be in good condition. Note that there was no exhaust component observed serving the auditorium. This would mean the space is pressurized when the unit is in operation and there is no means of relieving the air.

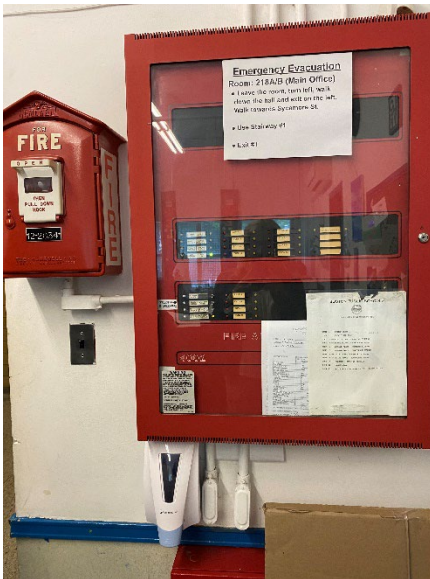
*Fire Alarm Control Panel and Master Box*

The fire alarm device coverage and system are inadequate for a school building and is not compliant with current codes for voice evacuation and notification.
