EXISTING EGRESS PATH (FROM GARDEN LEVEL UNIT ENTRY TO SIDEWALK):

Diagram of Demolition Scope & Impacted Area

1 Plan of Proposed Conditions
Scale: 1/4" = 1'-0"

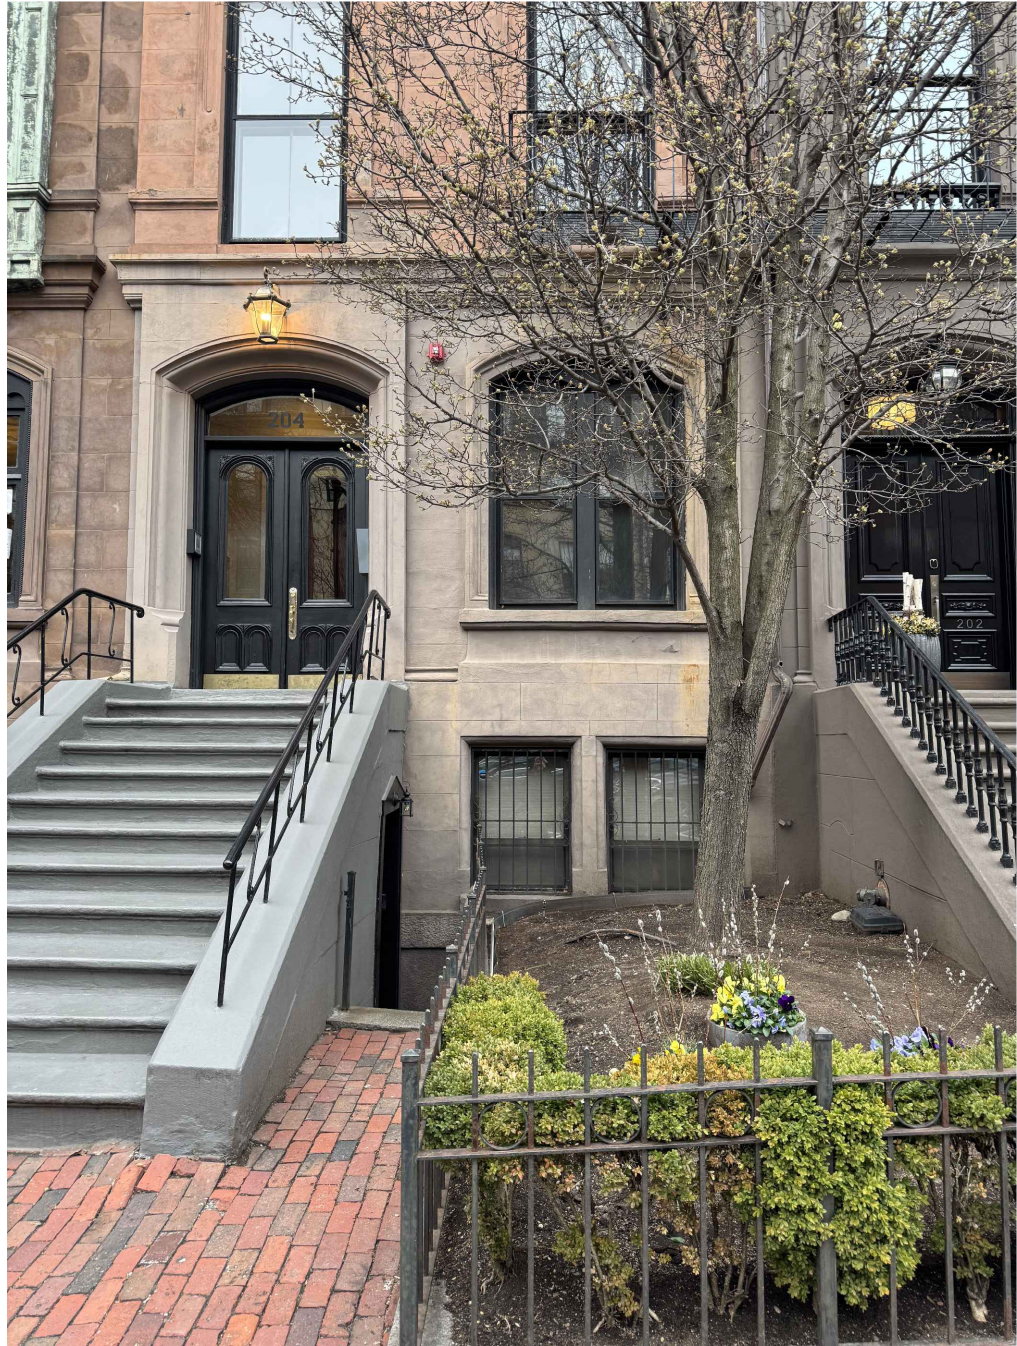
VIEW FROM SIDEWALK (PARTIAL FRONT FACADE, GARDEN, & LOWER LEVEL EGRESS PATH WHERE RETAINING WALL FAILURE IS EVIDENT)

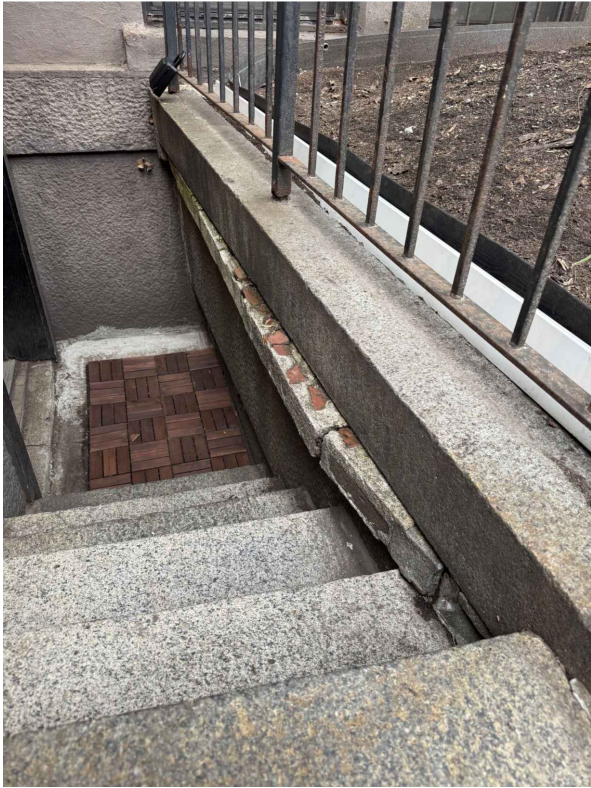
VIEW FROM SIDEWALK (TOP OF EGRESS PATH) DETERIORATION & RETAINING WALL FAILURE - PRIMARY CAUSES FOR PROGRESSIVELY HAZARDOUS CONDITIONS = EXTENDED PERIOD OF NEGLECT, LATERAL PRESSURE FROM OVERGROWN TREE ROOT SYSTEM & UNEVEN GRADE ($\pm 21\%$ SLOPE OVER SPAN OF $\pm 9'-0"$ FROM EAST TO WEST).

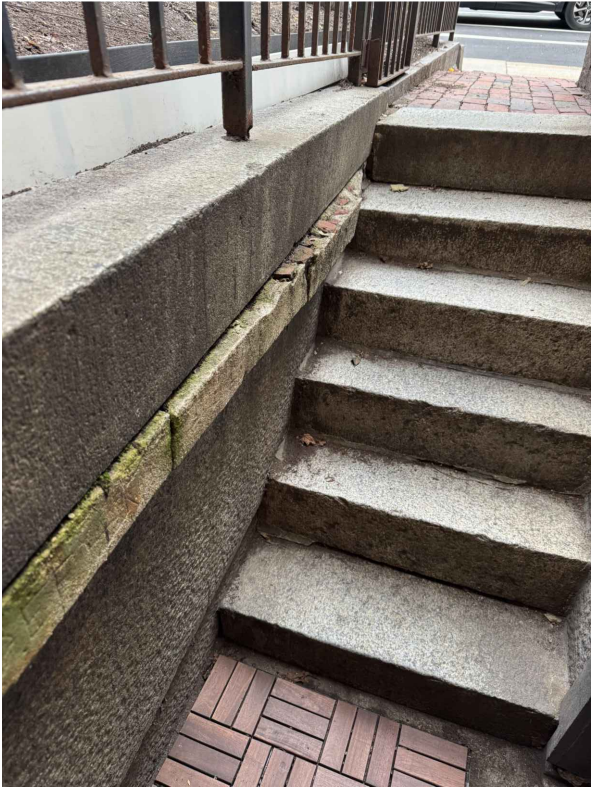
VIEW FROM LANDING (GARDEN LEVEL ENTRY) DETERIORATION & RETAINING WALL FAILURE - REMAINING MORTAR, WHICH CAN BE PHYSICALLY REMOVED & COULD FALL OUT ON ITS OWN ACCORD, HAS BEEN DEEMED "LAST LINE OF DEFENSE BEFORE COLLAPSE" BY STRUCTURAL ENGINEER.

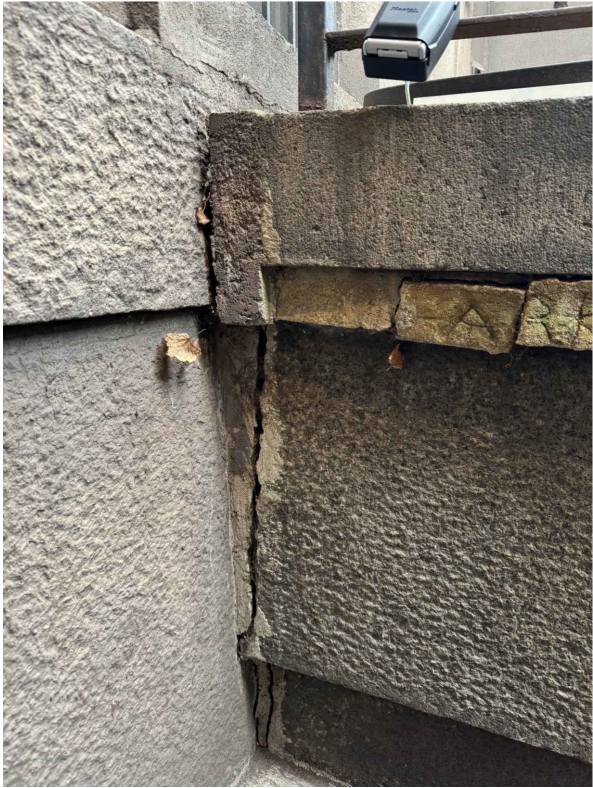
VIEW FROM LANDING (GARDEN LEVEL ENTRY) DETERIORATION & RETAINING WALL FAILURE - DISLOCATION OF EXISTING STRUCTURAL WALL FROM PERPENDICULAR FOUNDATION IS CONTRIBUTING TO WATER/MOISTURE INFILTRATION AT LOWER LEVEL UNIT. OVERGROWN TREE ROOT SYSTEM & UNEVEN/ UNSUSTAINABLE GARDEN GRADE ALSO A LIKELY CONTRIBUTOR, PER STRUCTURAL ENGINEER'S ASSESSMENT.

- RECONSTRUCT RETAINING WALL:
- FOR LIFE SAFETY & CODE COMPLIANCE AT PRIMARY MEANS OF EGRESS, NEW WALL TO BE INSTALLED 36" MIN. EAST OF STOOP SIDE WALL.
 - ASSEMBLY TO CONSIST OF REINFORCED CONCRETE MASONRY STRUCTURAL WALL WITH SALVAGED GRANITE REINSTALLED (AS VENEER OR OTHER APPLICATION) TO RESEMBLE FORMER MONOLITHIC APPEARANCE (SEE GENERAL NOTE ON SHEET 3 FOR ALTERNATE APPROACH).
 - REINSTALL SALVAGED GRANITE CURB AS RETAINING WALL CAP. CURB TO EXTEND PERPENDICULARLY FROM FRONT FACADE TO EDGE OF SIDEWALK.
 - INTRODUCE WATERPROOFING ALONG BELOW-GRADE PORTION OF BUILDING FOUNDATION & INCORPORATE PROPER DRAINAGE AT LANDING (WITH BRONZE FINISH AREA DRAIN COVER). REPAIR BUILDING FOUNDATION/FACADE AS REQUIRED WHERE EXPOSED AT LANDING.

NOTE: REPAIR DRAINAGE AT FRONT FACADE (IF DEEMED NECESSARY / CONTRIBUTING) TO FURTHER MITIGATE INFILTRATION & RUNOFF ISSUES.

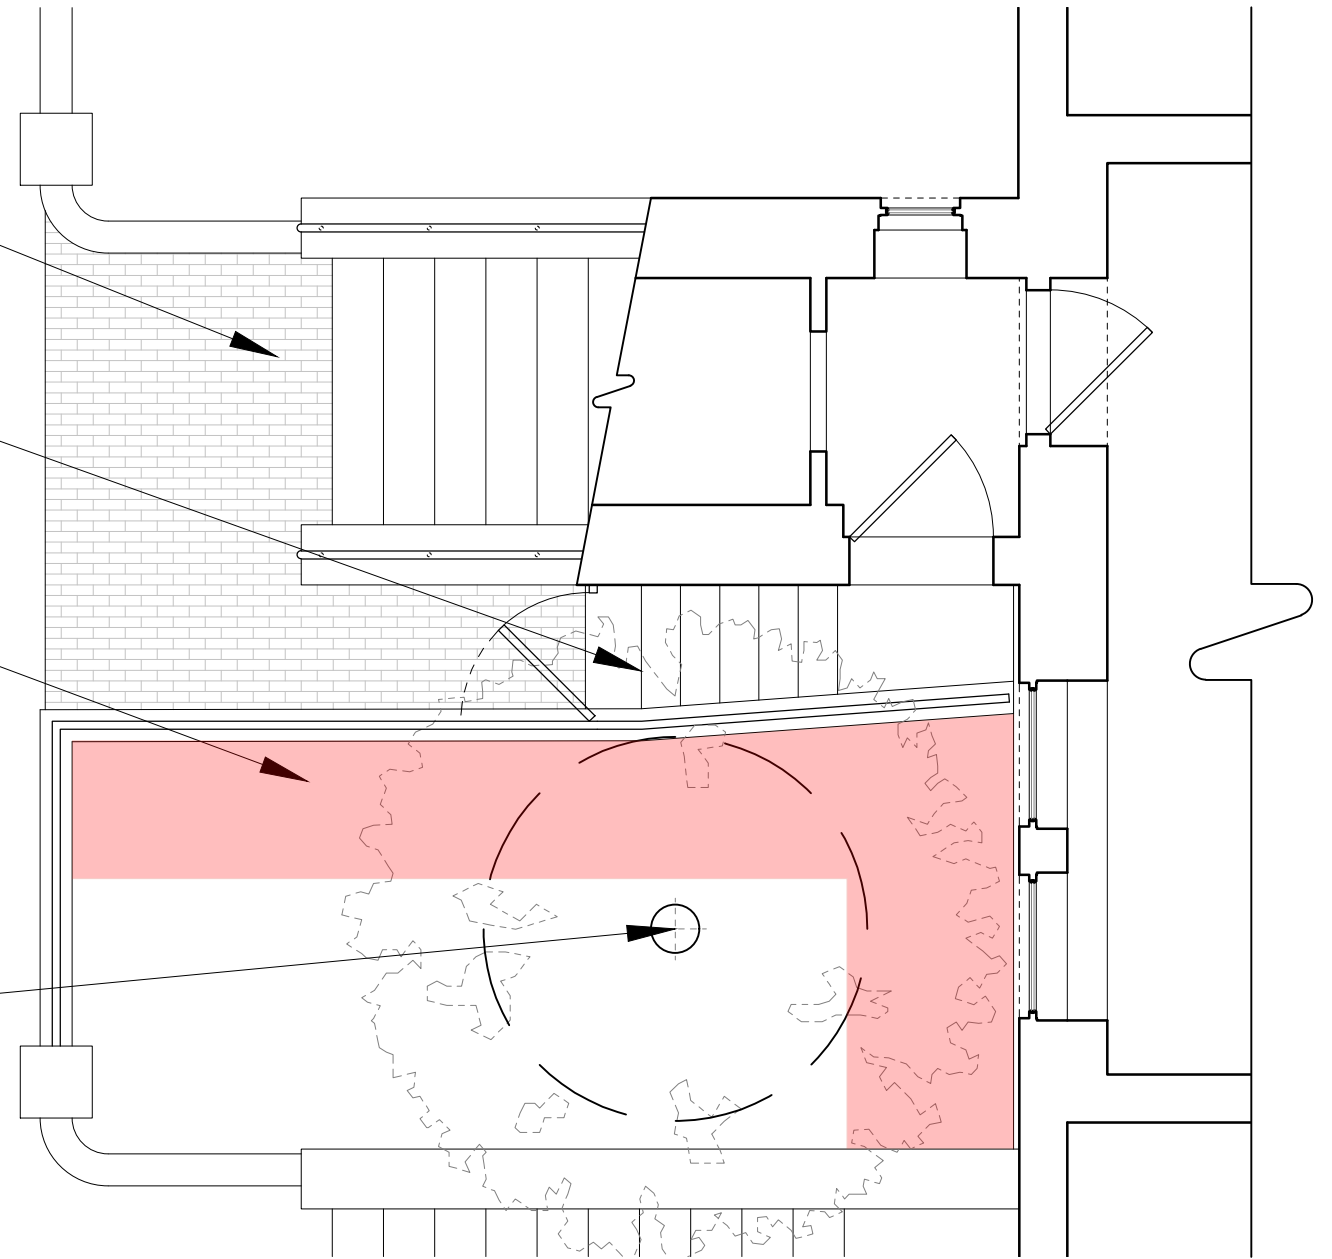
- TRENCHING OVERLAPS WITH ROOT SYSTEM (BASED ON VISIBLE LATERAL / OBLIQUE ROOTS).
- SIGNIFICANT PORTION OF EXISTING ROOT SYSTEM TO BE CUT BACK (POSES RISK OF COMPROMISING TREE HEALTH & STABILITY PER ARBORIST'S ASSESSMENT) SHOWN DIAGRAMMATICALLY IN RED.
- REMOVE EXCESS SOIL AND PREPARE GARDEN FOR REGRADING & LEVELING.
- ±10" OF ROOT COLLAR TO BE EXPOSED & PARTIALLY CUT BACK (POSES RISK OF COMPROMISING TREE HEALTH & STABILITY PER ARBORIST'S ASSESSMENT)

- REMOVE EXISTING DISPLACED RED BRICK PAVERS & REPLACE IN KIND (PER MASON RECOMMENDATION).
- PREPARE FOR LEVELING OF WALKING SURFACE.

- REMOVE & SALVAGE EXISTING SOLID GRANITE TREADS.
- REMOVE EXISTING WALKING SURFACE MATERIAL AT LANDING.
- PREPARE FOR LEVELING OF WALKING SURFACE & IMPROVED DRAINAGE.

- REMOVE EXISTING IRON FENCE & GATE.
- REMOVE & SALVAGE EXISTING GRANITE (CURB & RECLAIMABLE PORTIONS OF WALL). *GENERAL NOTE: IF SALVAGED GRANITE IS DEEMED UNSUITABLE FOR REUSE (AS VENEER OR OTHER APPLICATION), PARGE BELOW GRANITE CURB AND TINT/PAINT VISIBLE AREAS HC-69 (OR APPROVED EQUAL) TO MATCH APPEARANCE (CONSISTENCY AND TEXTURE) OF ADJACENT STOOP AND SIMILAR CONDITIONS SHOWN IN PRECEDENT IMAGERY.*
- PREPARE GARDEN & PATHWAY BY TRENCHING ALONG WEST & NORTH PERIMETER. TRENCH TO BE 36"-42" WIDE TO ACCOMMODATE CONSTRUCTION EQUIPMENT, NEW RETAINING WALL ASSEMBLY, AND NEW WATERPROOFING & DRAINAGE.

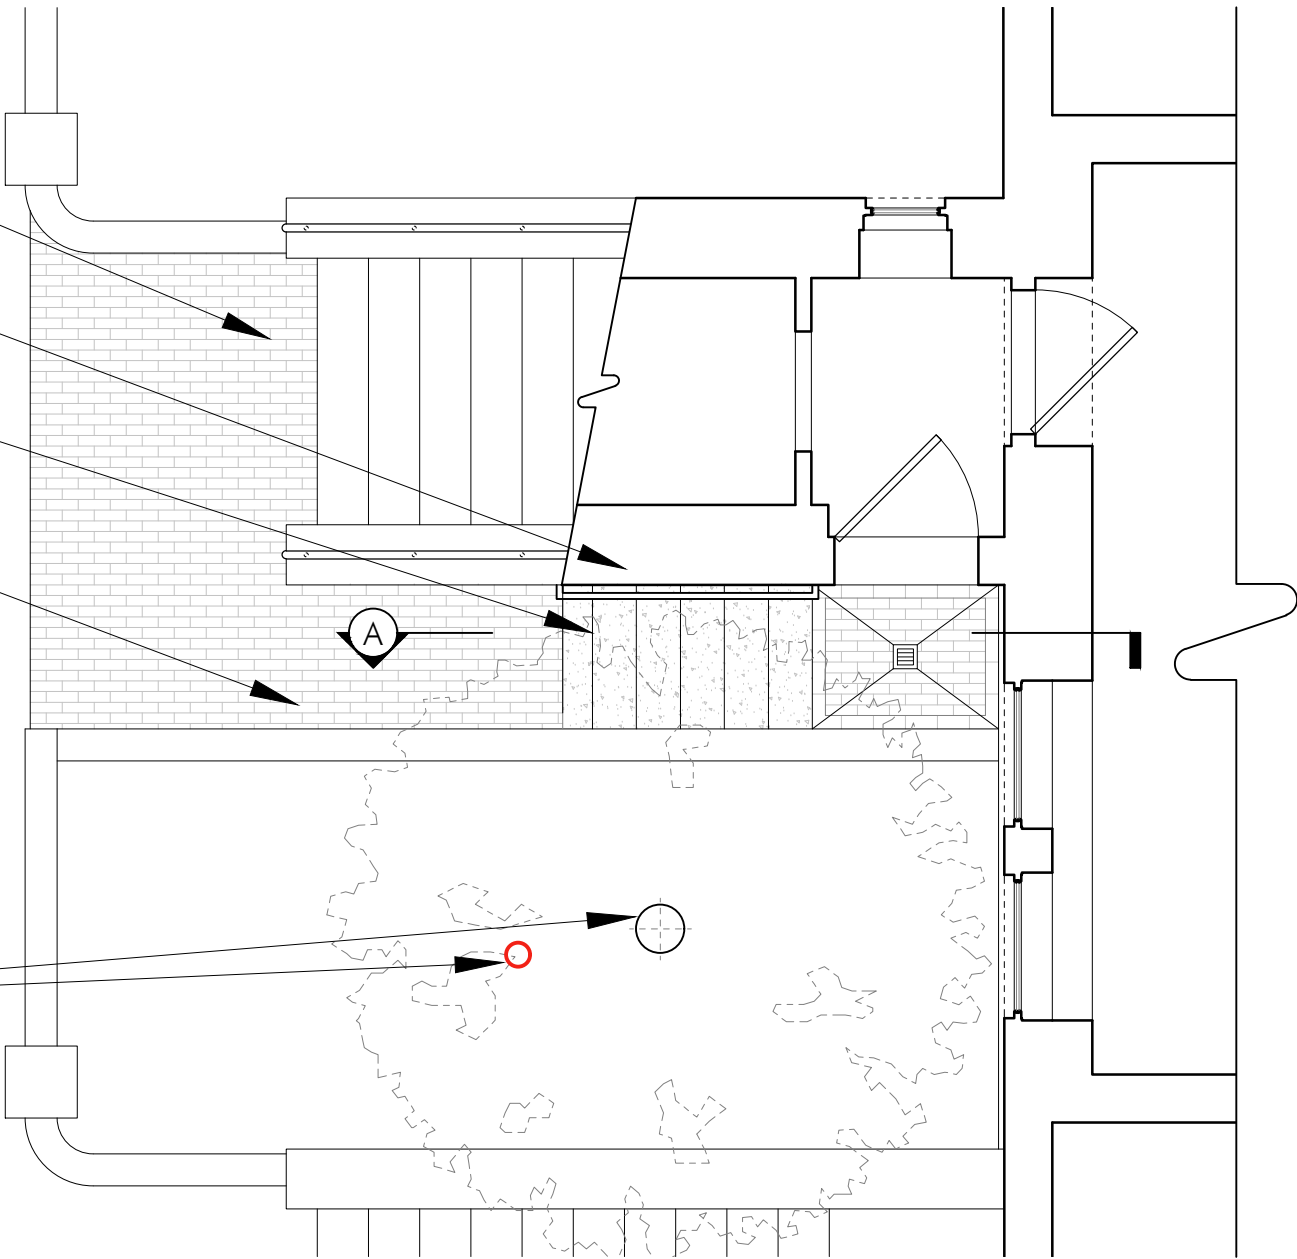
ARBORIST STATES "WORK [OCCURRING] IN SUCH CLOSE PROXIMITY TO THE PEAR TREE...WILL CAUSE A DIRECT EFFECT TO THE TREE." EXISTING TREE TO REMAIN UNLESS NEGATIVELY IMPACTED BY CONSTRUCTION AND MAKE-SAFE EFFORTS. PER ARBORIST'S ASSESSMENT, "IF THE ROOTS ARE CUT ONLY 2' FROM THE TRUNK THIS WOULD INCREASE THE LIKELIHOOD OF TREE FAILURE." IF FAILURE BECOMES LIKELY OR OCCURS, ARBORIST RECOMMENDS TREE REPLACEMENT (SHOWN IN RED; CENTERED E-W IN GARDEN AND 10'-0" MIN. SOUTH OF BUILDING FACADE.

LEVELED WALKWAY WITH RED BRICK PAVERS REPLACED IN KIND AT BASE OF STOOP / TRANSITION TO SIDEWALK.

INSTALL NEW IRON HANDRAIL (JULIUS BLUM #4530) MOUNTED TO STOOP SIDE WALL (36" AFF). GALVANIZED, PAINTED GLOSS BLACK.

REINSTALL SALVAGED SOLID GRANITE TREADS. INTRODUCE NEW GRANITE TO MATCH EXISTING AS REQUIRED (PENDING QUALITY OF SALVAGED MATERIAL AND WIDTH REQUIREMENTS).

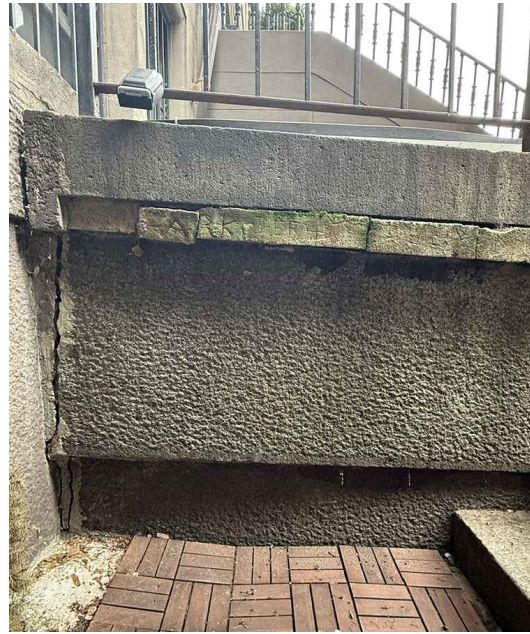
VIEW OF GRANITE AT EXISTING WALL
(CONDITION FOR REUSE TBD)
