Rehl Gardens

Tabors - 208 Beacon Street  
Scale: 1:50

4/25/2025 - Tree Report for 208 Beacon St. Boston, MA 0216  
Ryan Andrews, MCA 2613, ISA TRAQ NE-7200A

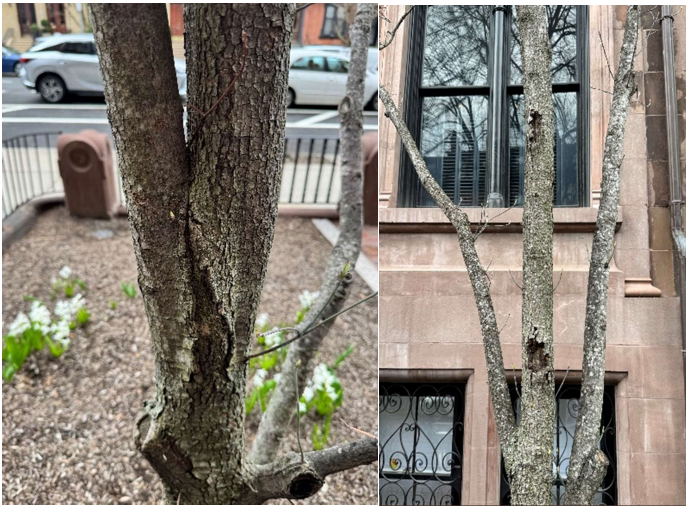
The tree has a stem that is compromised in multiple areas. There is a co-dominant stem with included bark at approximately 4' feet above grade. The tree also has an area of decay that extends vertically along approximately 20" of the main stem:

Based on these two factors, and the diminished canopy, I suspected there may also be a weakened root system. Upon gently pushing and pulling laterally on the stem at approximately 5' feet above grade, I noted the entire root ball rocking in its planting pit. I would suspect there is root rot, or perhaps a root ball that is still enclosed in a cage and/or burlap. I would recommend removal and replacement of this tree.
