403 SHAWMUT AVE
SOUTH END LANDMARKS DISTRICT
COMMISSION

PROPOSED WORK: FAÇADE REBUILD
NOVEMBER 4, 2025

SUMMARY: FAÇADE EXISTING CONDITIONS

Reference: Existing Masonry Conditions Assessment
403 Shawmut Avenue
Boston, Massachusetts

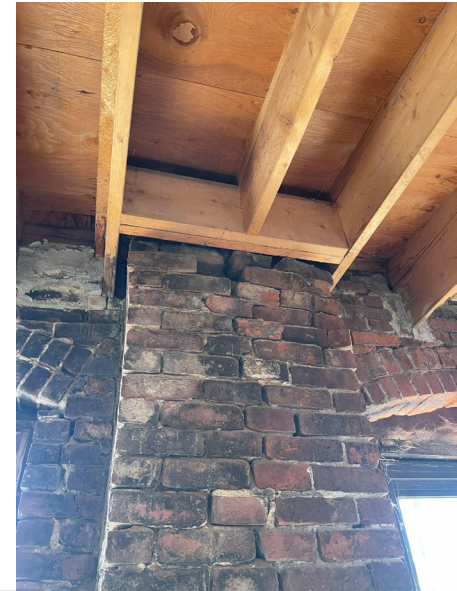
Original charred framing and roof decking alongside new framing and roof decking

Majority of roof was reframed due to extent of fire, with lightly charred section along W. Brookline remaining

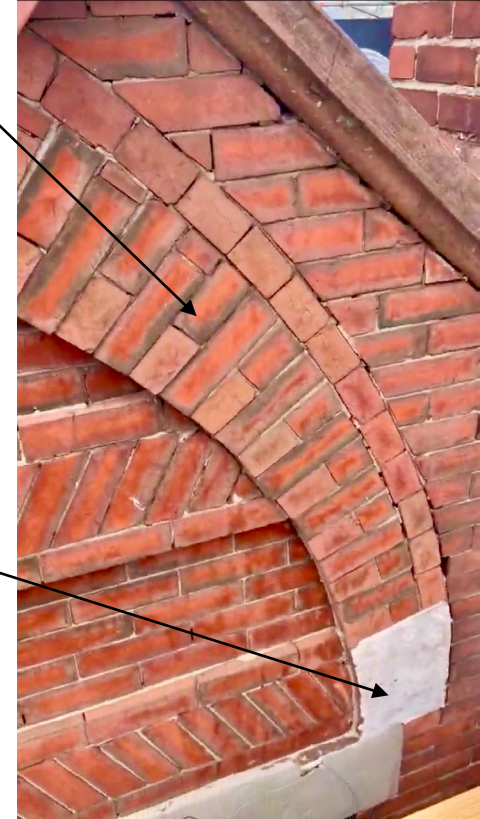
Ornate brick inlay and detailing

Unique to building, arch width increases in size from bottom to top

Brownstone was parged over at some point to protect stone, not original to structure

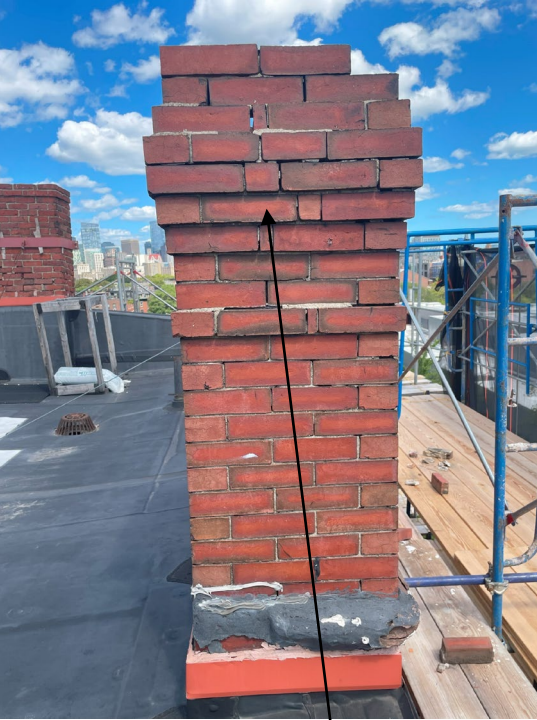
Majority of existing brick masonry on chimneys has failing mortar joints and are leaning. Several have missing bricks above roof level

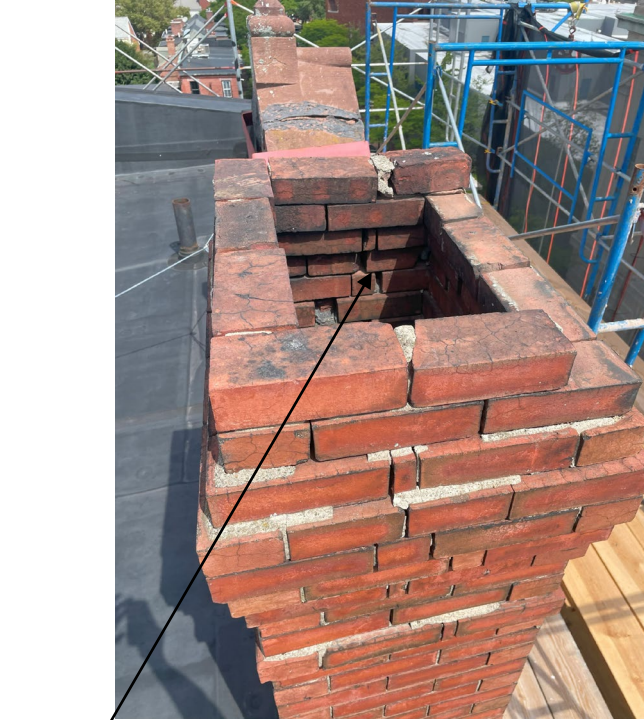
Chimneys are not capped and open to the elements. Most of the chimneys have cavities that are open through multiple floor levels

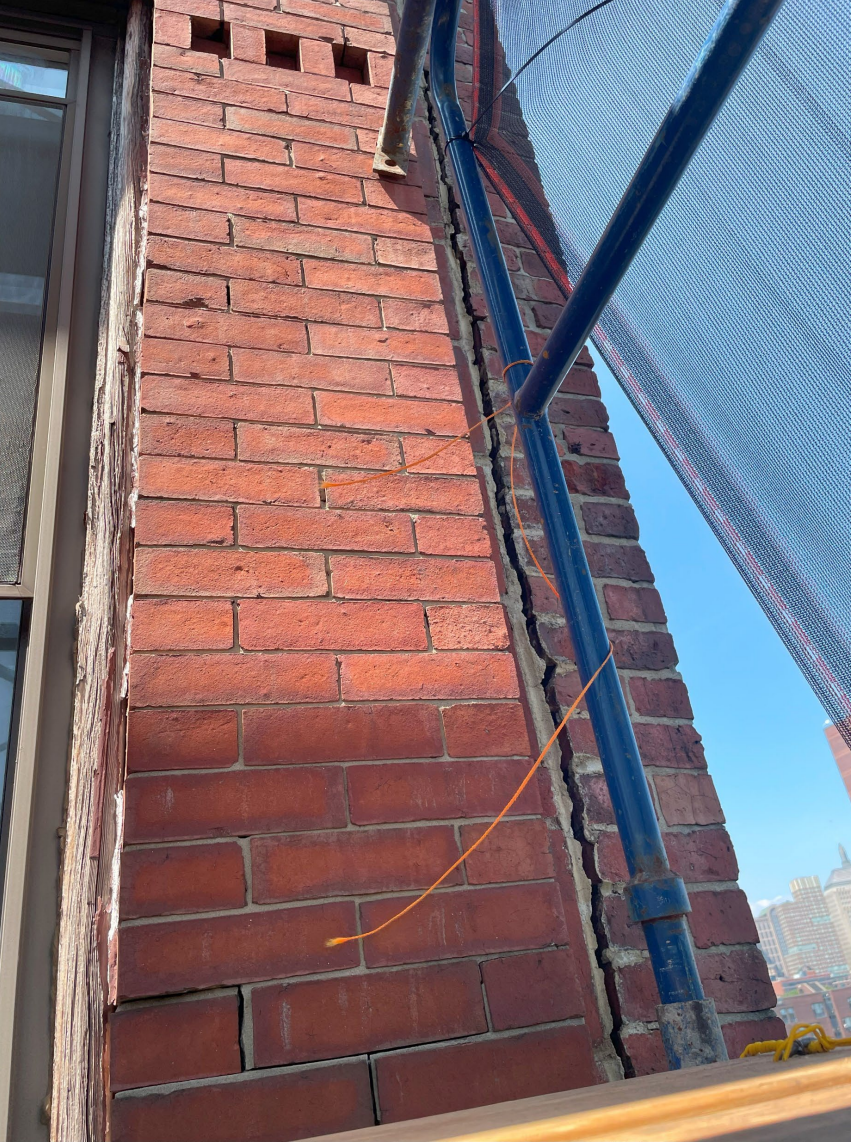
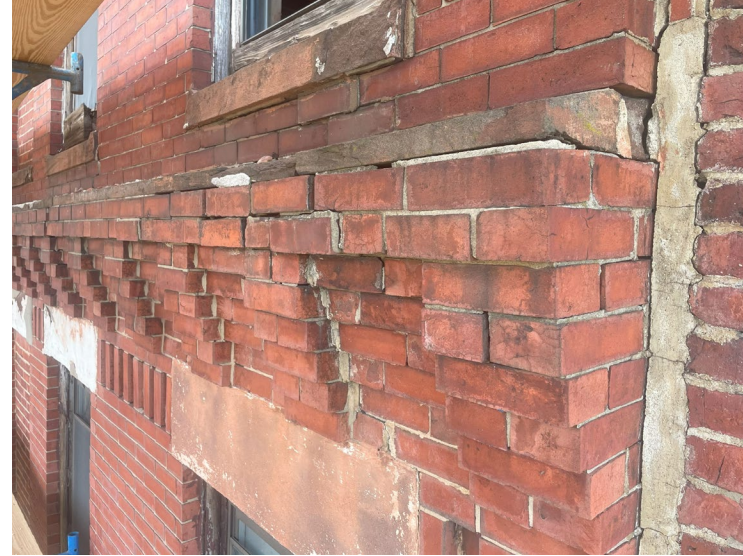
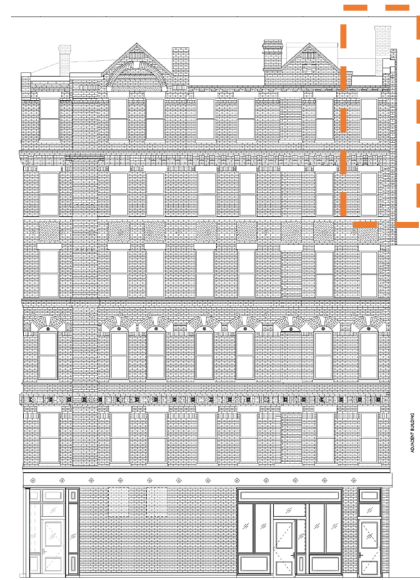
EXISTING CONDITIONS: CORNER CONDITION: 403-401 SHAWMUT AVE

- Furthest exterior wythe of brick on corner of 403 Shawmut and 401 Shawmut has been separating from the main structure causing a significant gap on the top two floors of the building
- Impacts of separation includes:
 - Chimneys on façade facing 401 Shawmut Ave
 - Parapets
 - Window conditions on 5th and 6th floors in this corner (cracked and misaligned headers and sills, non-plumb window openings, etc.)
 - Failed corbel conditions

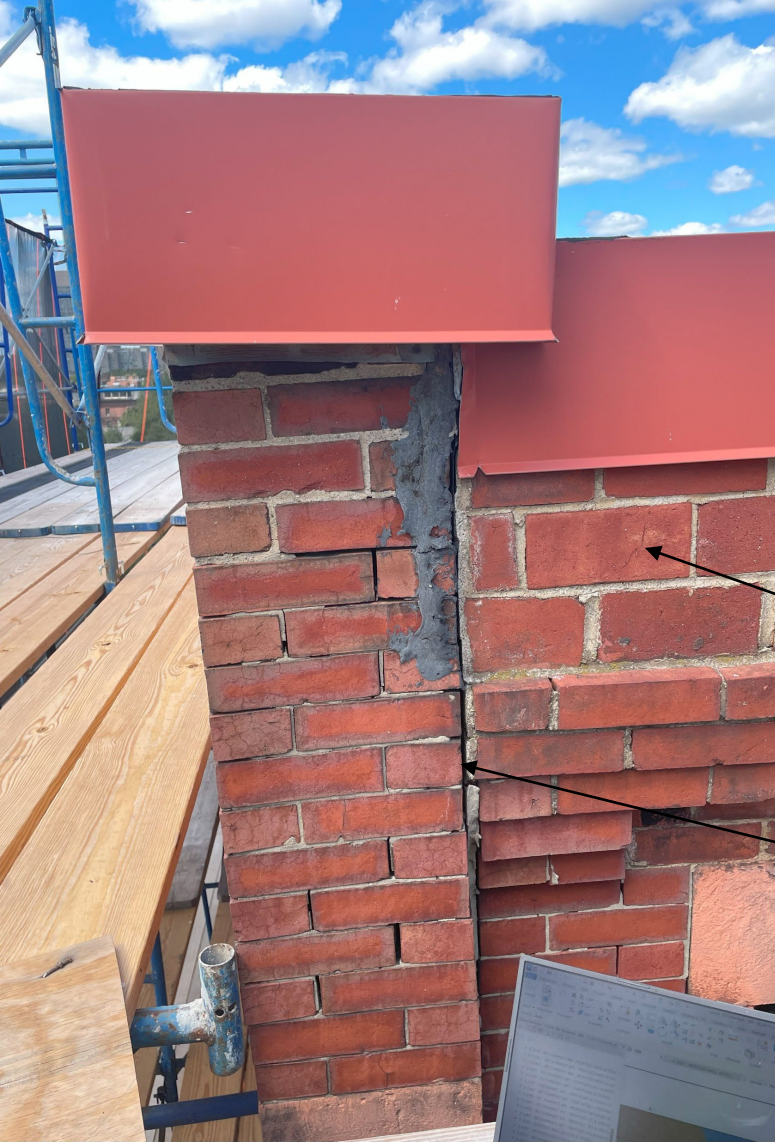
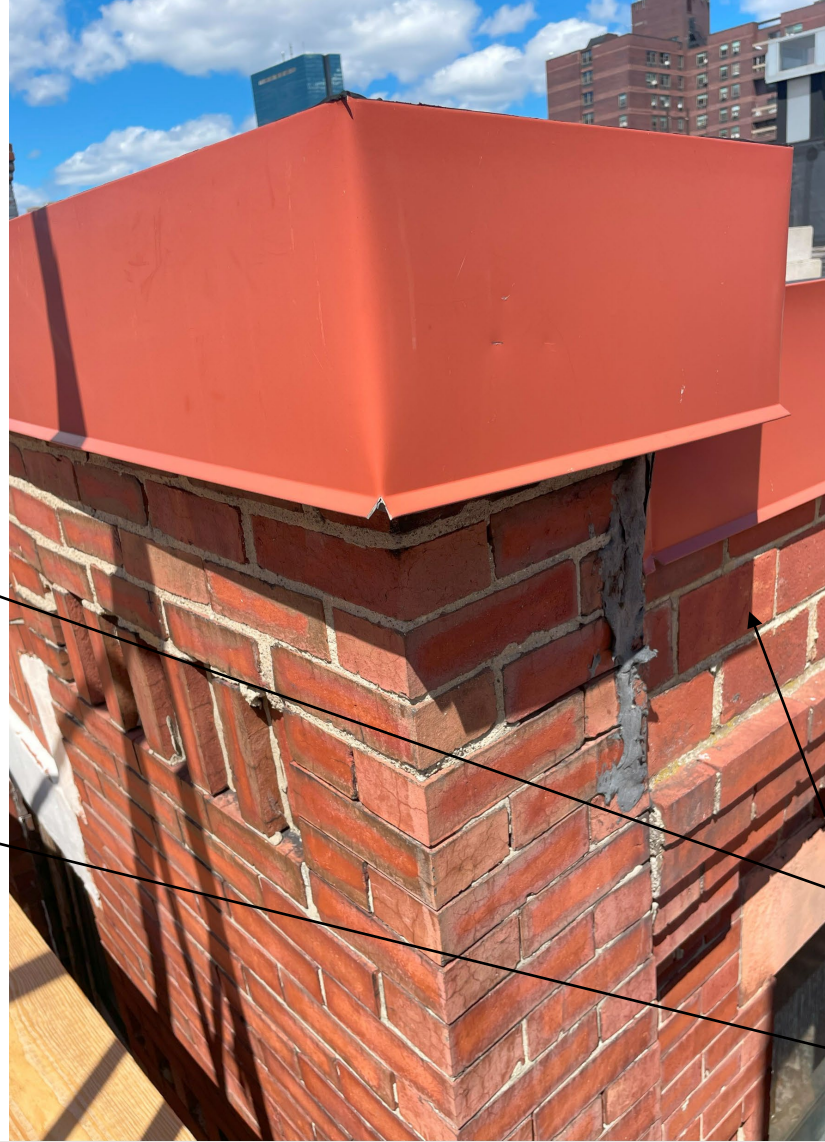
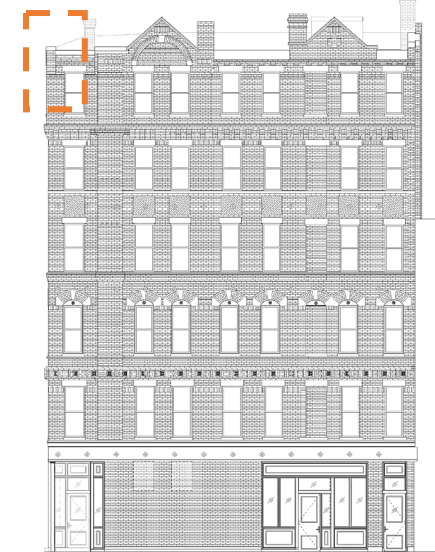
EXISTING CONDITIONS: CORNER CONDITION: SHAWMUT AVE & WEST BROOKLINE

It appears that at some point, potentially during the fire, the section above the window in the marked corner was rebuilt but not tied into the original building structure causing separation over the years.

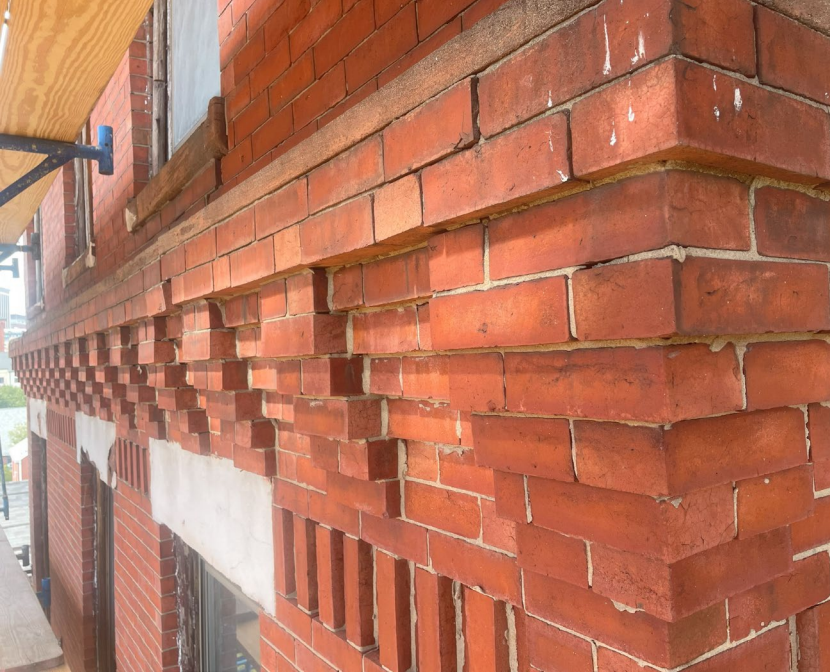
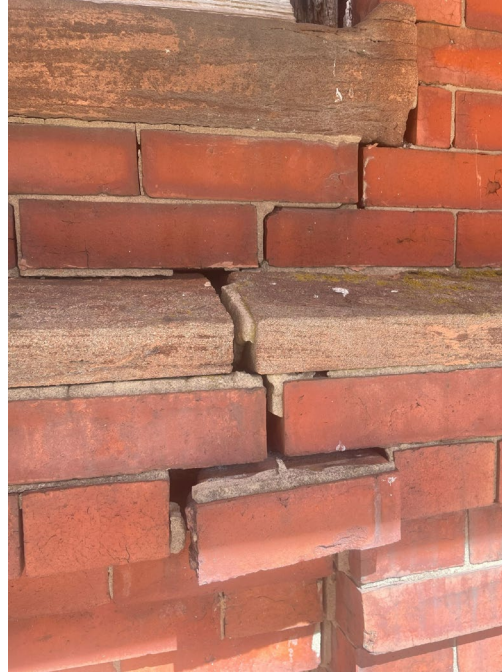
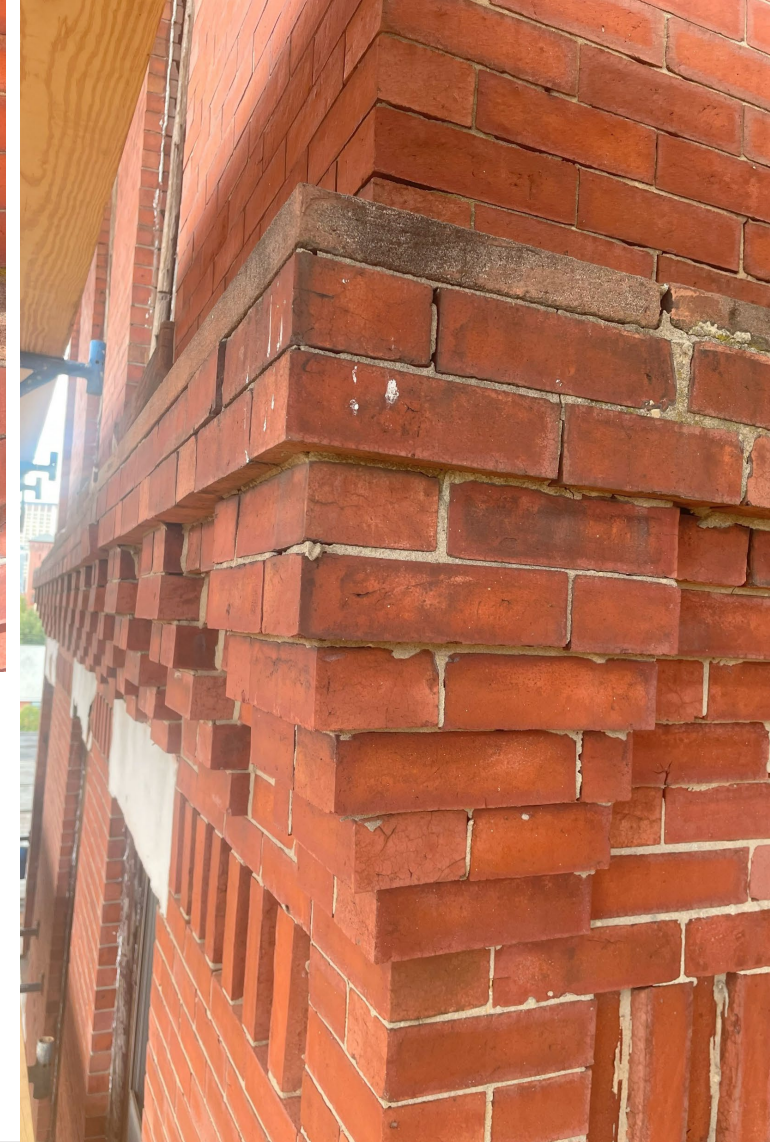
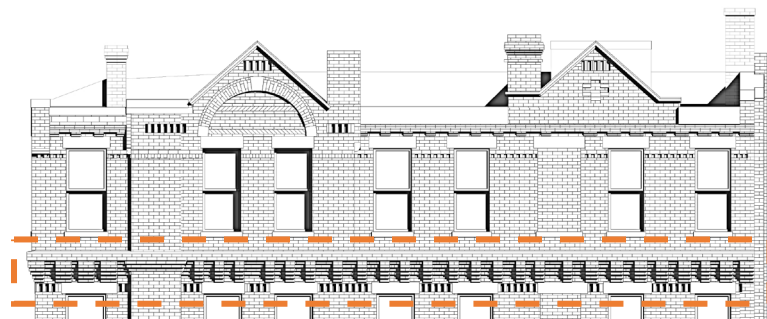
EXISTING CONDITIONS: CORBELS

This is the most pronounced and detailed corbel on the building, running the full length of the Shawmut Ave and West Brookline facades. Much of the brick masonry has deteriorated over the years due to frost-thaw action, water infiltration behind brick and within joints, and shifting exterior walls.

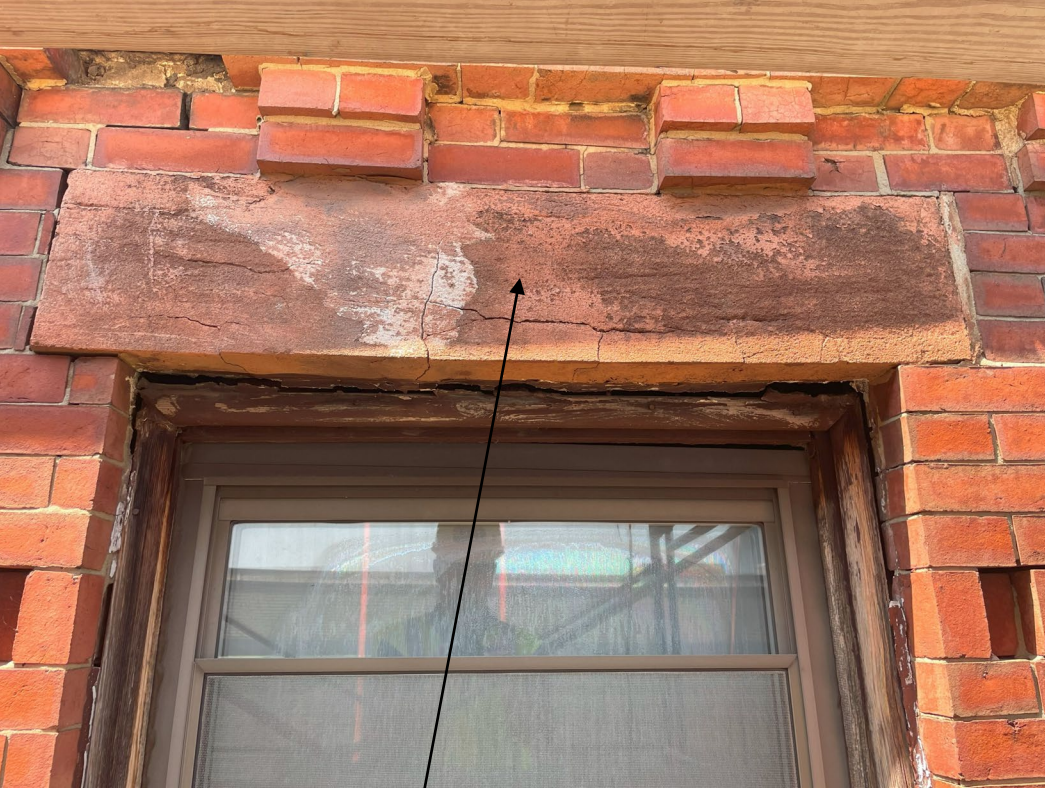
Sagging header with brick separation and window opening failures below

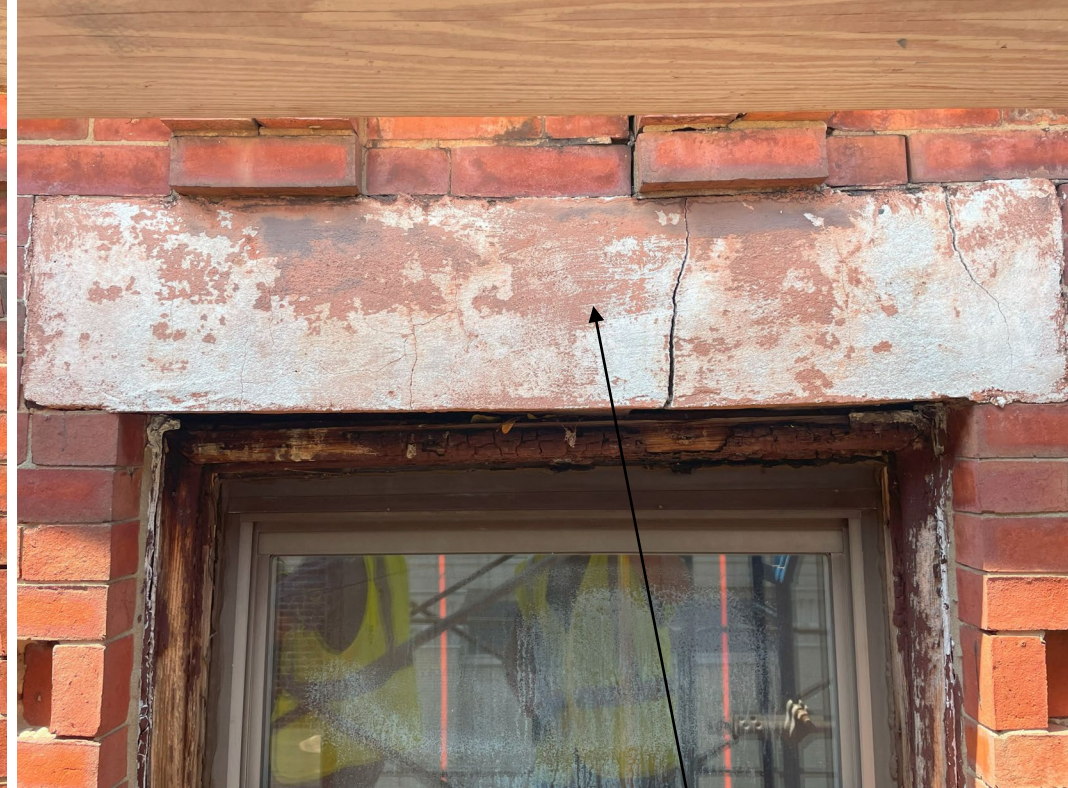
Another sagging header with non-original parging on top. Parapet corbel above has shifted due to failure of header

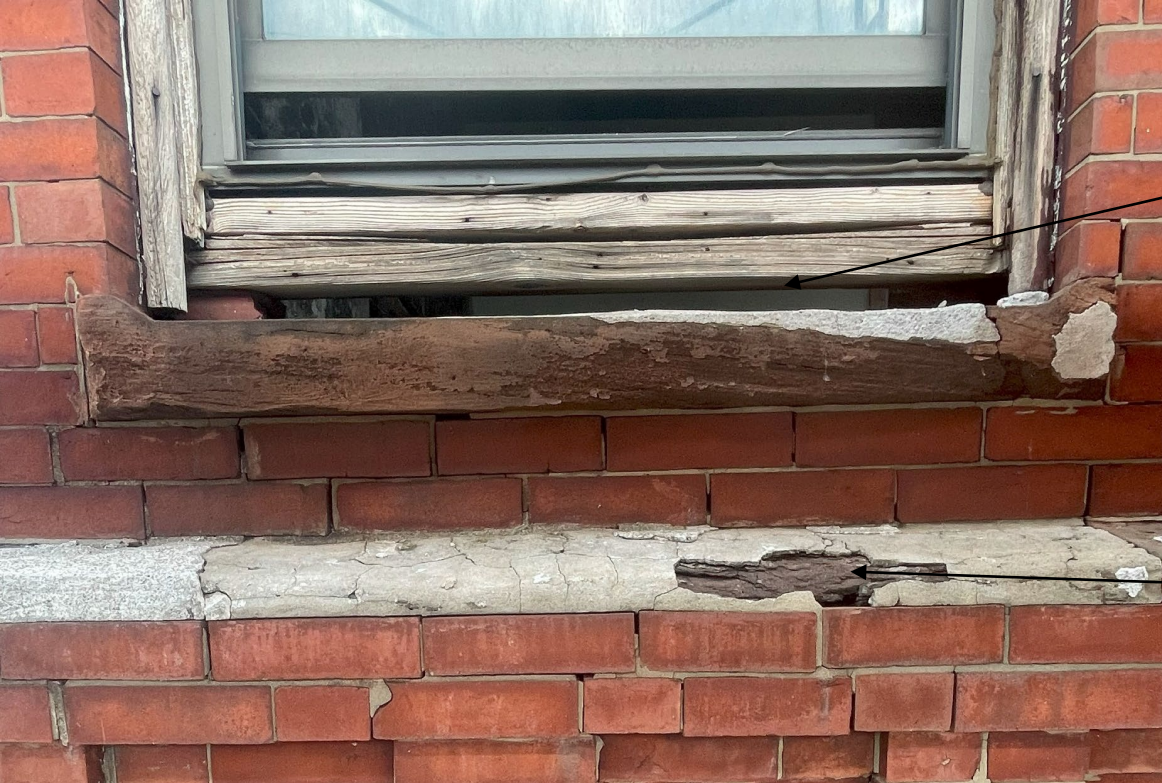
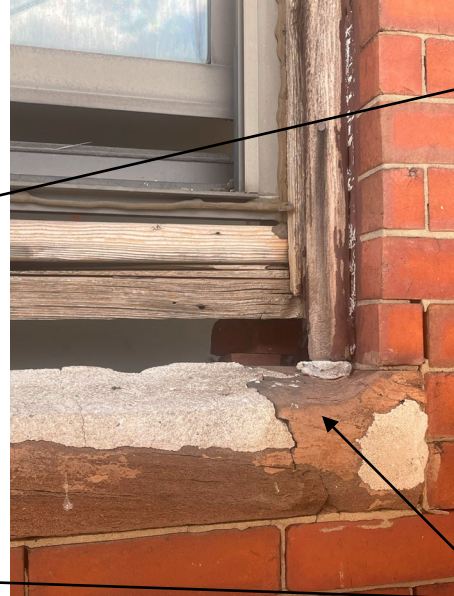
The majority of the 6th floor window sills openings are no longer plumb and with window size changes over the years, water and air has been able to infiltrate to the inner courses of brick causing significant structural damage within the exterior walls.

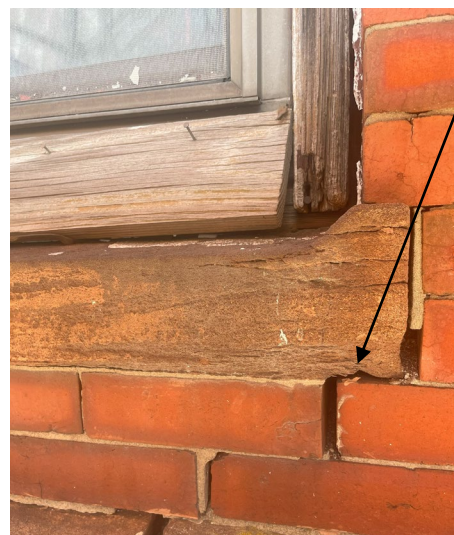
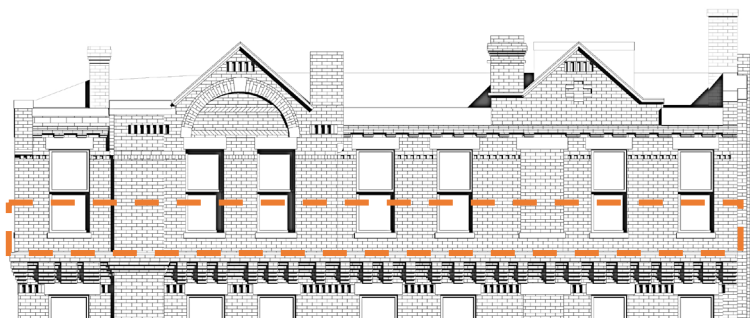
Rainwater has been able to move around/through window rough openings aiding in brick separation around window sills and the delamination of brownstone sills and headers, compounding water infiltration issues across the entire upper floors of the building.

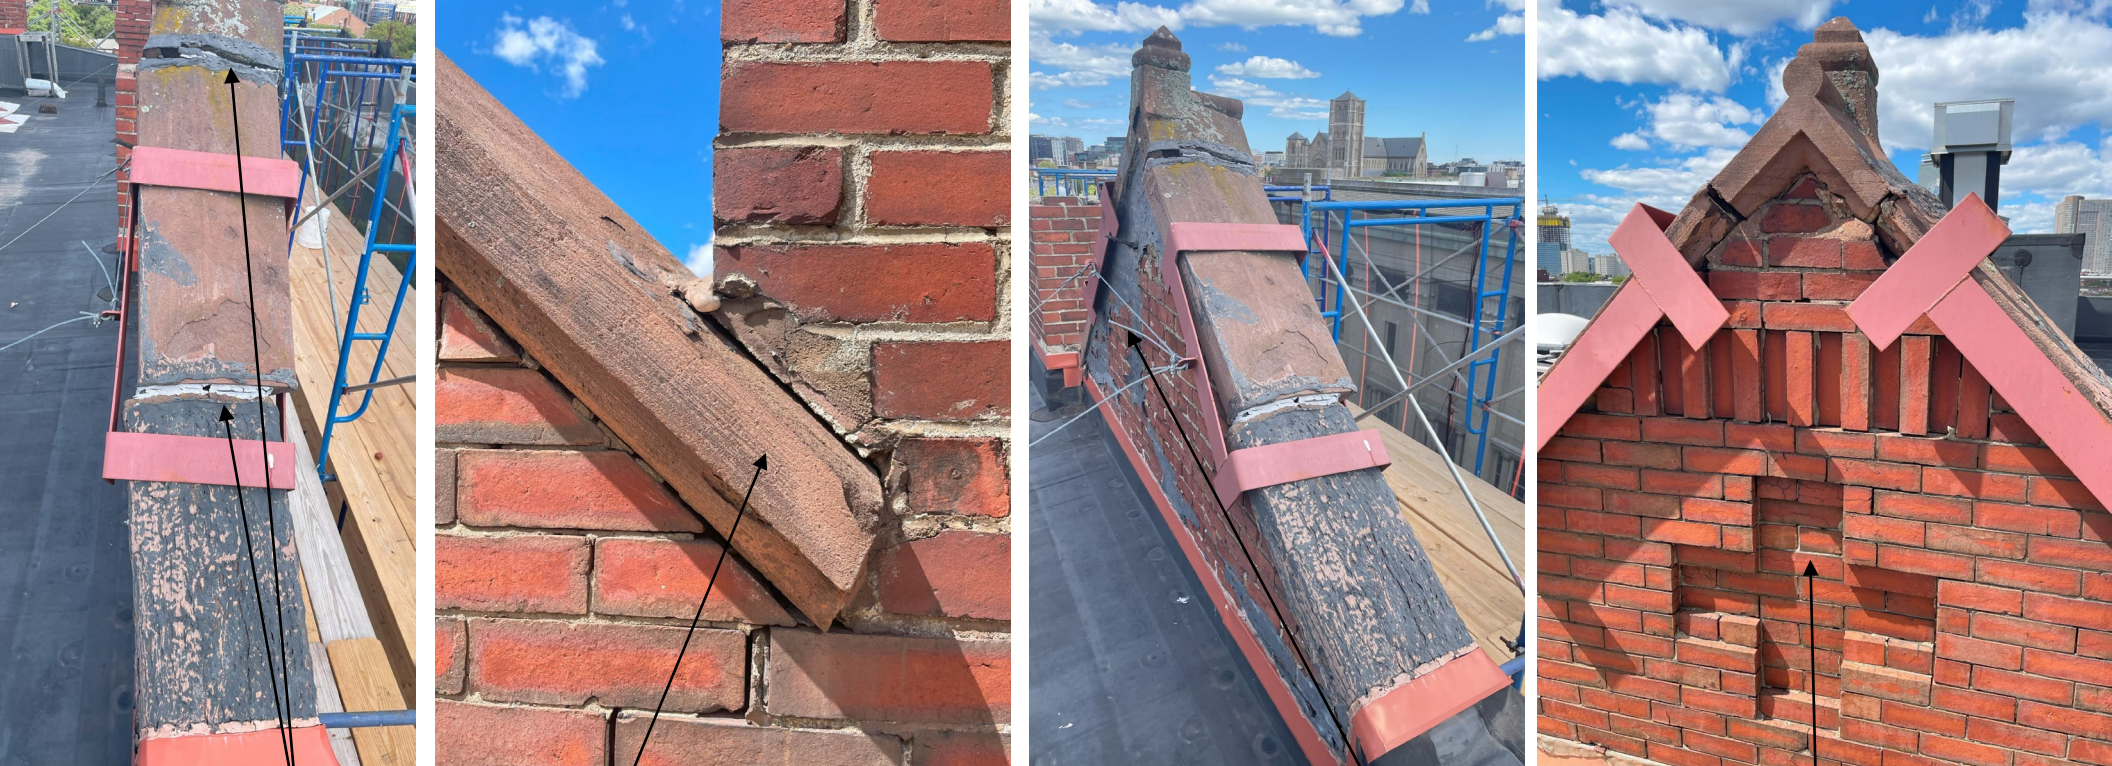
Brownstone pediment caps have separated joints and only remain due to temporary brackets

Brownstone pediment cap and surrounding masonry have become disconnected

A (failed) mastic waterproofing membrane was applied to the back and stone cap joints of the pediment

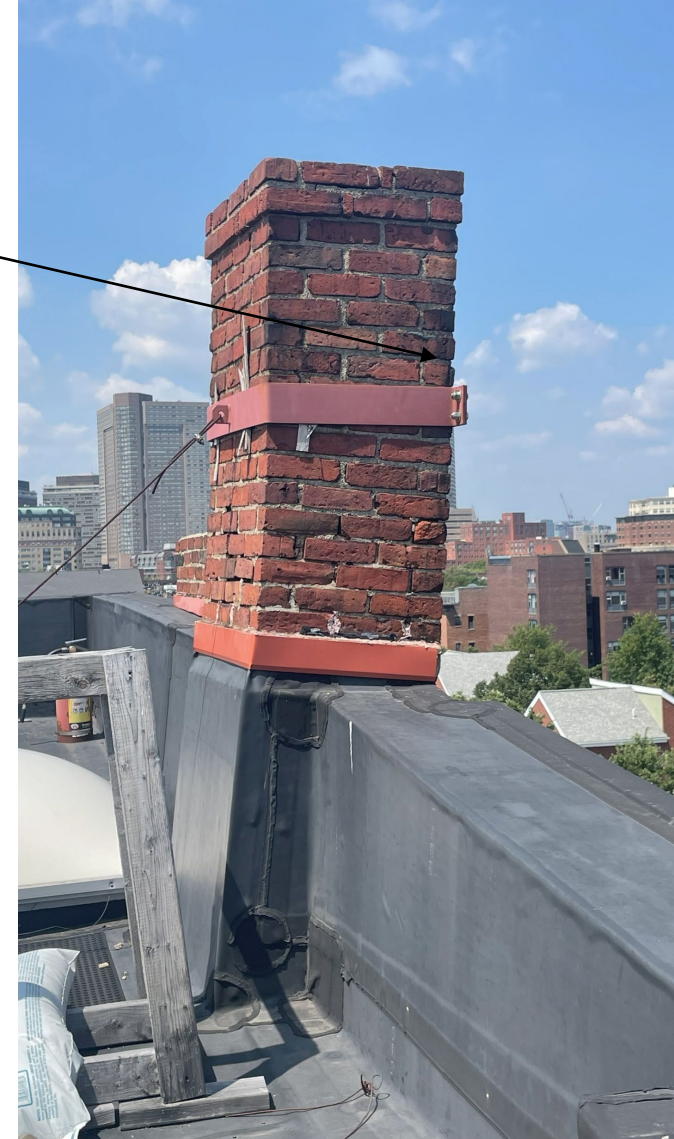
This chimney, located adjacent to the IBA-owned building at 401 Shawmut, is bowing significantly and being restrained by brackets and ties to the roof structure

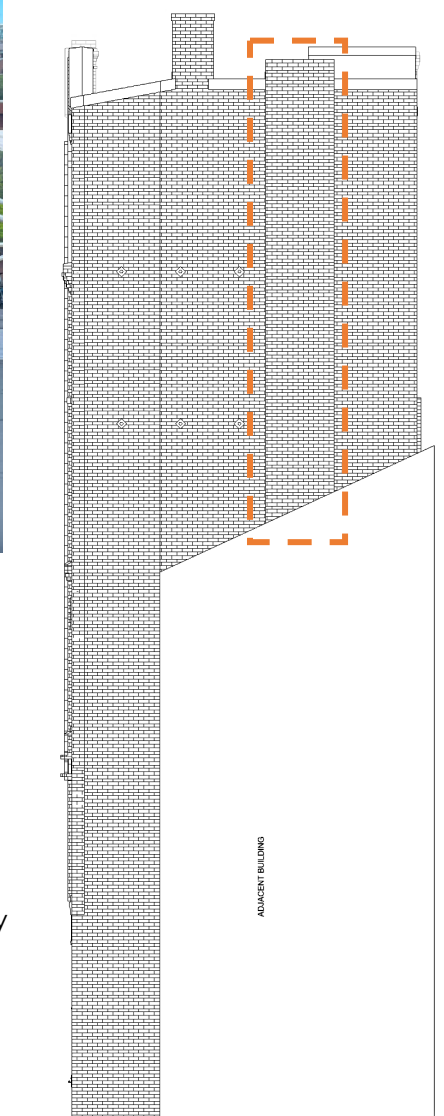
ADJACENT BUILDING CHIMNEY (401 SHAWMUT):

The chimney against the exterior side wall of 403 Shawmut, currently connected to the adjacent building at 401 Shawmut, is at risk of detaching from the face of 403 Shawmut. It may have one wythe of brick tying it back to 403 Shawmut but over its history of being exposed to the elements, especially the interior chimney shaft, that connection has weakened significantly.

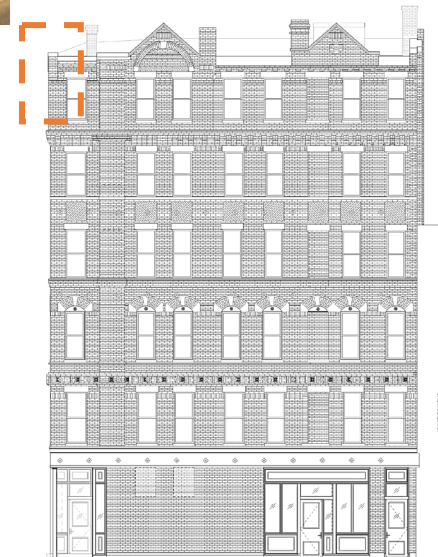
Another view looking at façade separation

At some point, caulking was used to fill in gaps between separating bricks

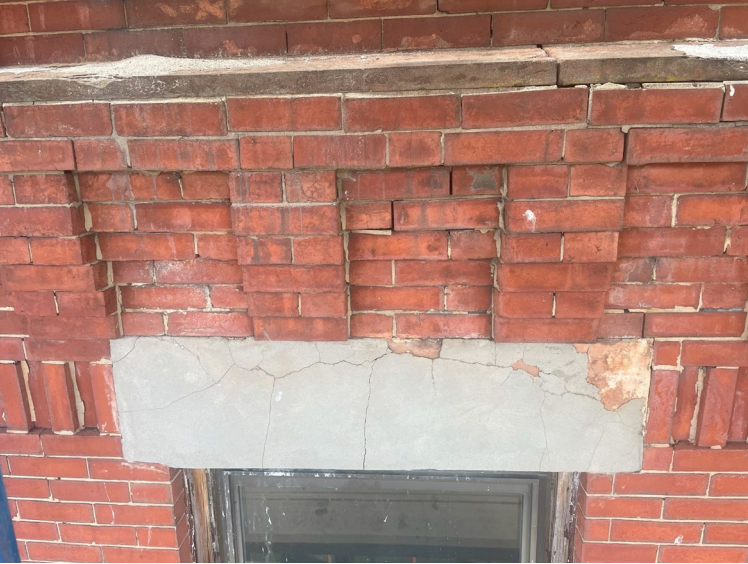
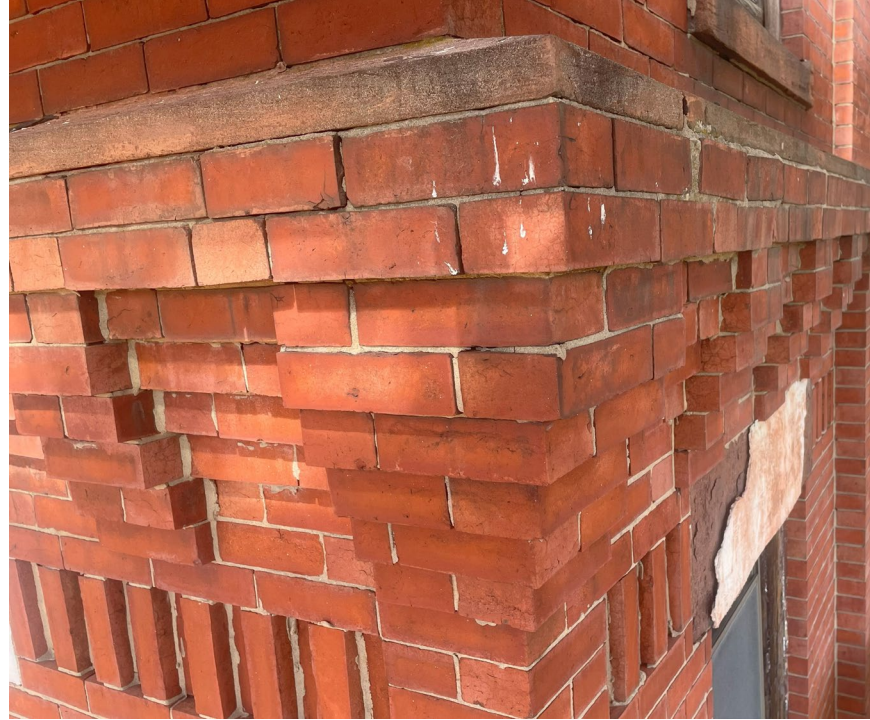
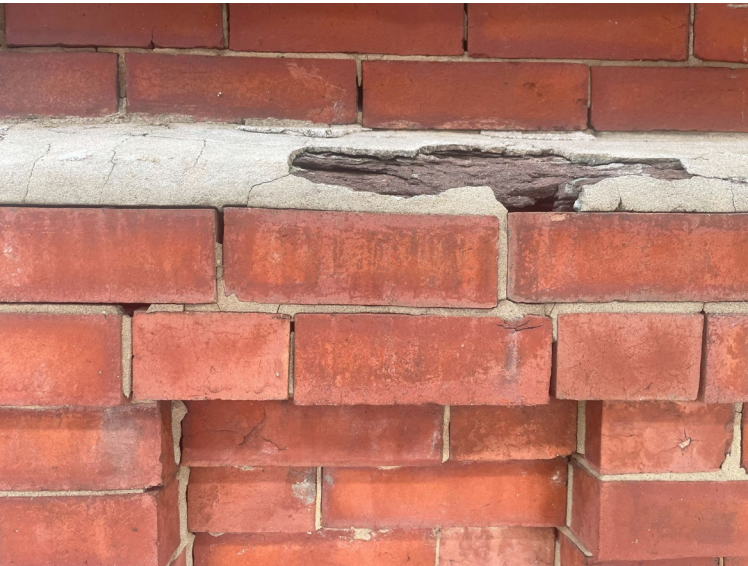
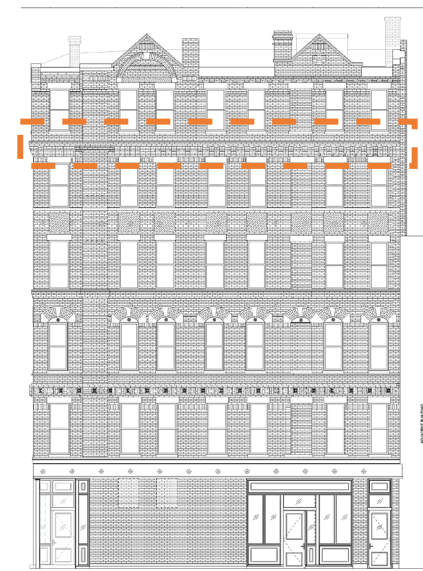
EXISTING CONDITIONS: CORBELS

Due mostly to water infiltration and exterior wall movement, many sections of the corbel on both sides of the building have separated, lost full masonry units, have deteriorated, show signs of delamination, moved/no longer aligned, and have impacted areas around it, especially window openings.

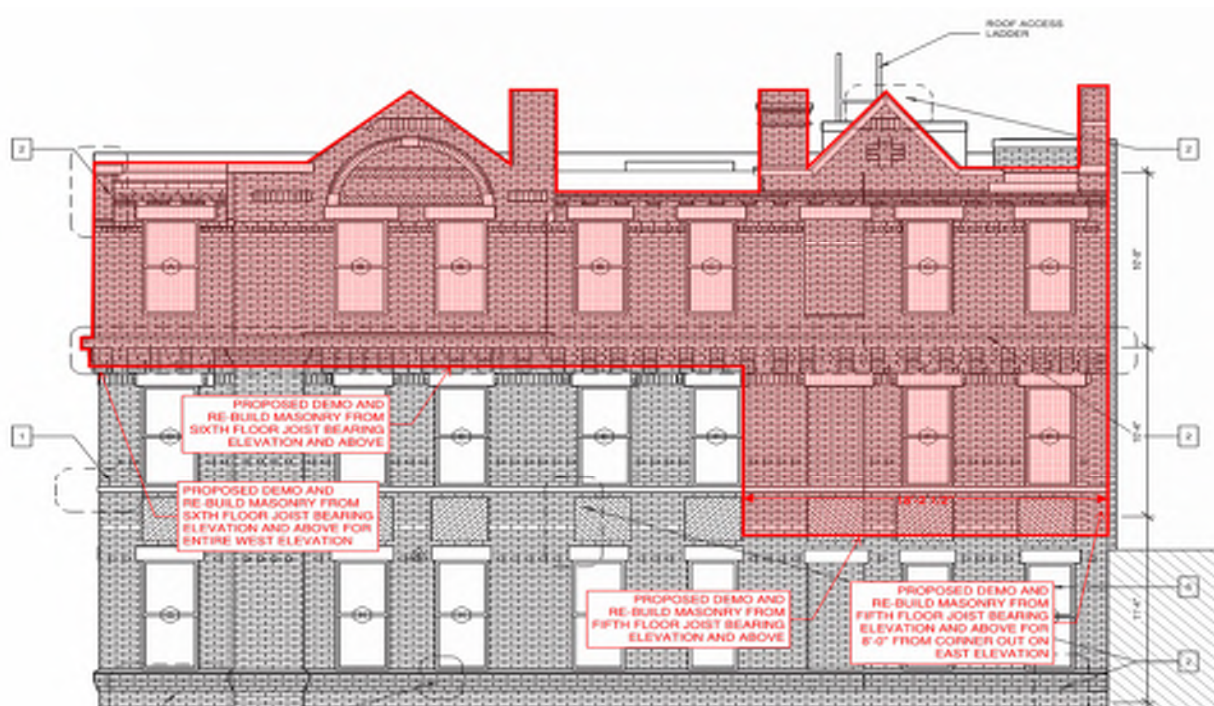
Figure #1 – This mark-up shows the proposed masonry rebuilding scope.

demolished and re-built from the bottom of the fifth-floor joist bearing elevation and above. We also recommend that a portion of the East elevation looking over 401 Shawmut be removed and rebuilt from the Southwest corner back approximately 8'-0" to the first existing masonry chimney that occurs on this face, and also from the fifth floor joist bearing elevation and above. Refer to Figure #1 below for graphical mark-up of the proposed re-built masonry scope on the architectural Shawmut elevation. Based on recent additional observations, Souza True also feel that the top 4'-0" of masonry on the Northern rear wall of the building also be removed and rebuilt in the portion from the elevator to the West Brookline end of the building. This includes the corbel and accent features at the top of masonry at the Northwest corner. We also recommend that the areas around all windows and below sills be repaired as required with new repointing required most commonly, but with approximately four windowsills requiring more extensive re-build at the fourth and third floor levels.

The new rebuilding of masonry will help to reduce and or relieve / eliminate some of the structural scope previously planned for the structural rehabilitation portion of the project. The roof level and the sixth-floor level both have new seismic anchoring required by the code. These anchors typically consist of drilled and epoxy anchored threaded rods into existing masonry. However, if the existing masonry is re-built, then new bent metal strap anchors may be more easily wet set during reconstruction of new masonry and eliminate the costly drill and epoxy method of anchoring. Additionally, a relatively more robust anchor detail was specified on the East and West sides of the building due to the leaning of existing masonry and the perpendicular connection to the existing wood floor / roof framing. Those details may be eliminated with new wall construction without leaning and with wet set bent metal anchors. In addition, recent observations and exploration of the masonry have revealed existing wall-to-floor anchors which may be tested and re-utilized so the new anchor scope can be further reduced.

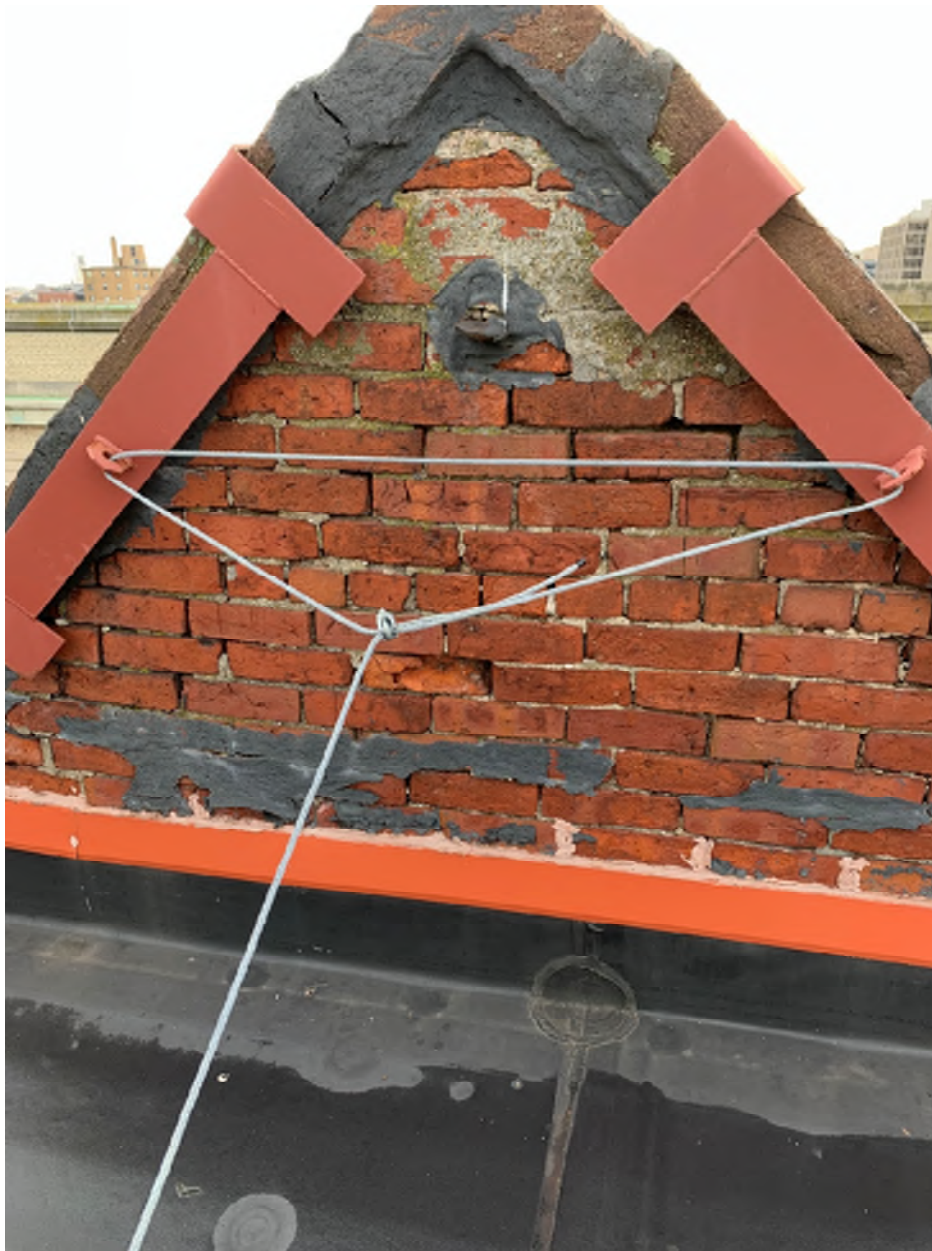
1. The existing brick masonry parapets above roof line are in severely deteriorated condition. Refer to Photograph #1 attached at the end of this report. The brick portions of the parapet have receding joints and weathered loose brick on all sides. The parapets also appear to be leaning outwards and require external existing restraints to keep stable. Additionally, there are some corbel accents at corners of the building at parapet level that have receded mortar joints and loose bricks. The original cap stones at the top of masonry parapets are damaged / deteriorated where still present, and some areas have newer metal flashing caps that are also bent, displaced, or just missing. The existing cap stones are shifted with open head joints and additional layers of troweled on mastic / sealant that was previously applied to seal the deteriorated areas, but those materials are debonding and torn as well. The top of masonry is relatively unprotected and extremely susceptible to water infiltration.

Photograph #1 – This photo shows a typical existing masonry parapet condition with existing masonry in disintegrated state along with external bracing required due to the deterioration.

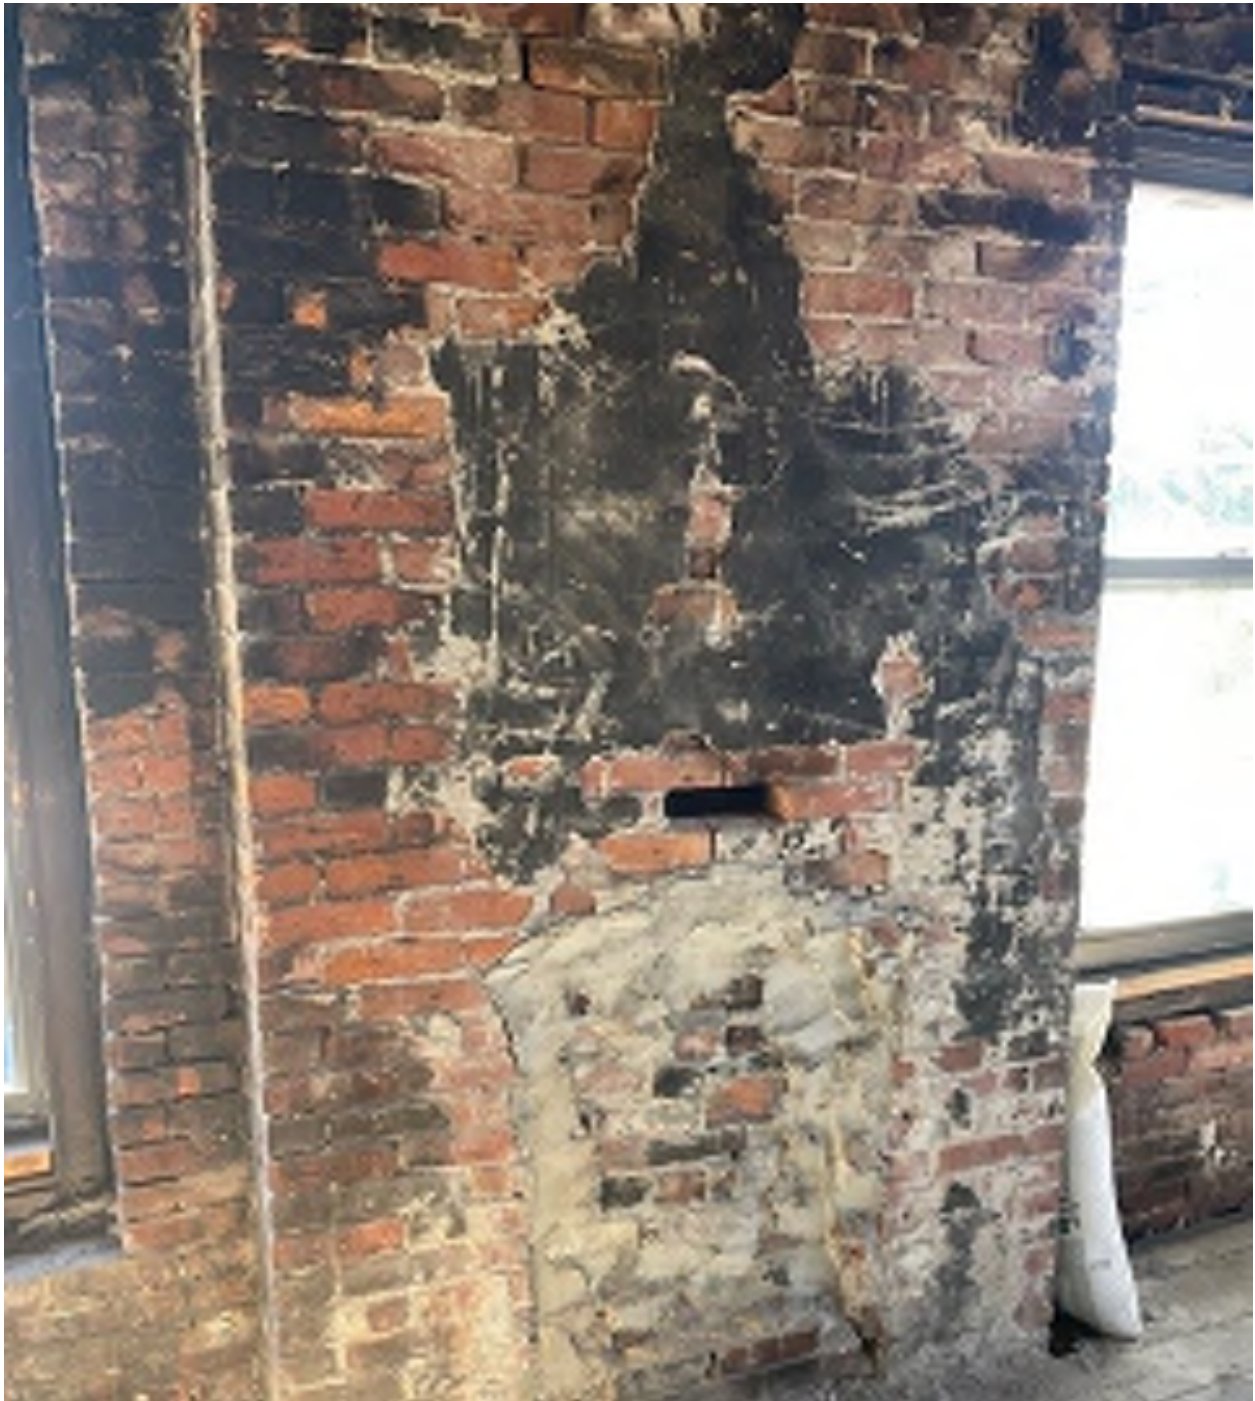
Photograph #2 – This photo shows the interior face of the existing masonry wall along Shawmut Avenue at the sixth-floor level. The masonry has receding joints, especially on the sides and below windows with dusting of mortar and loose bricks able to be removed by hand.

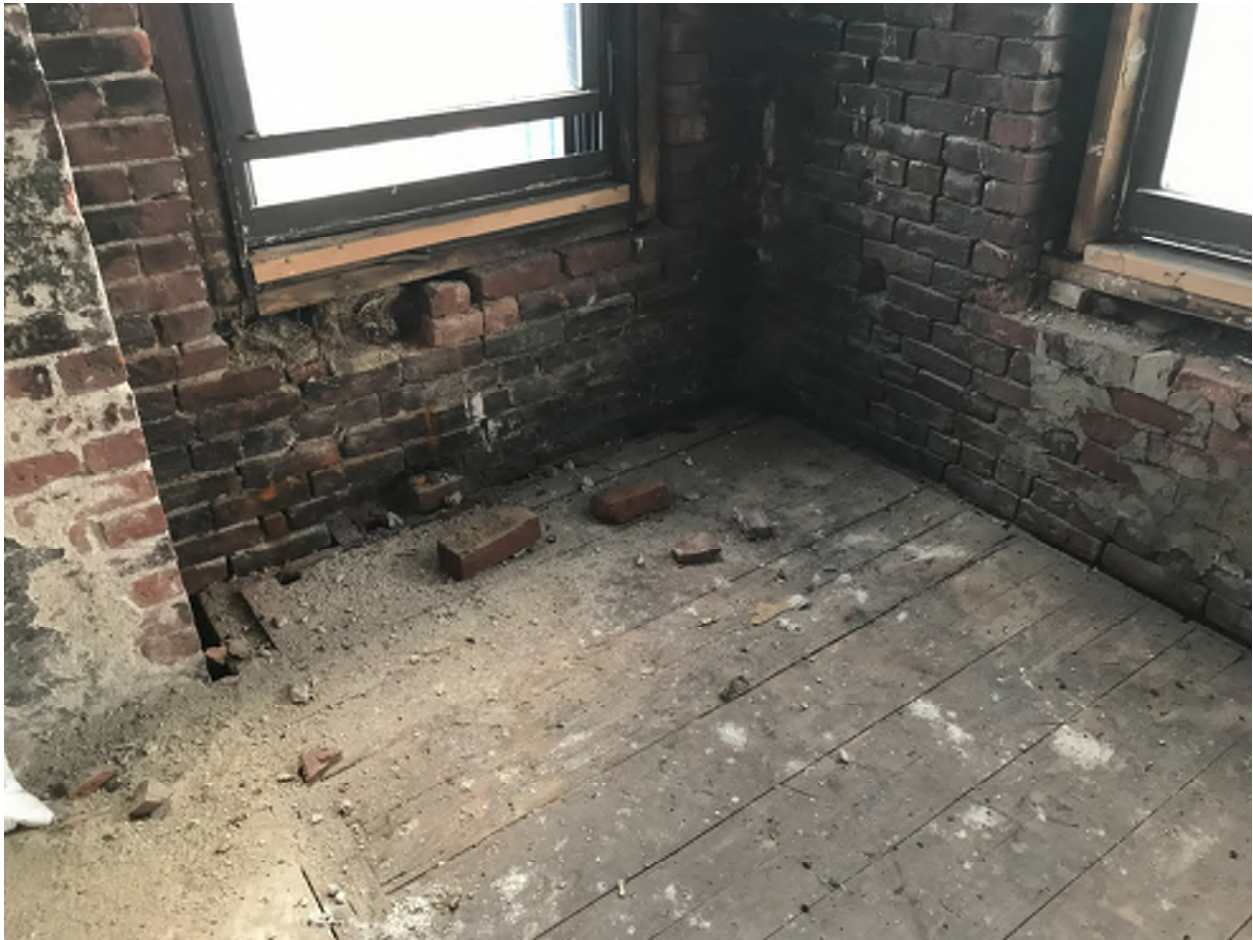
Photograph #3 – This photograph shows the masonry below windowsill at the Southwest corner of the building on the sixth-floor level. Both the sill on the lefthand side and the field of wall around the corner on the righthand side have excessive mortar recession and the righthand sill has loose and missing brick.
