403 SHAWMUT AVE
SOUTH END LANDMARKS DISTRICT
COMMISSION

PROPOSED WORK: FAÇADE REBUILD
NOVEMBER 4, 2025

SUMMARY: FAÇADE EXISTING CONDITIONS

Reference: Existing Masonry Conditions Assessment
403 Shawmut Avenue
Boston, Massachusetts

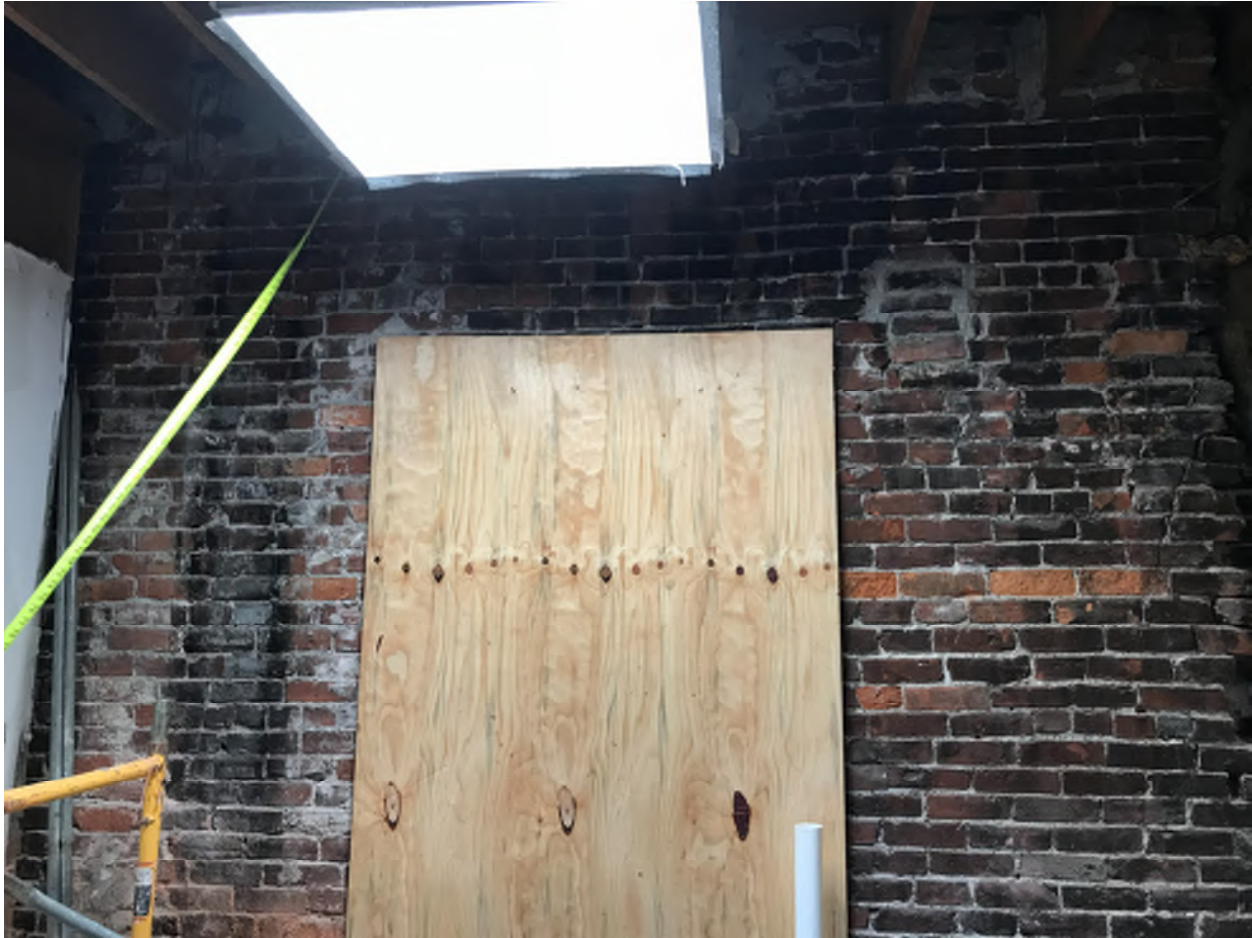
1. The sixth floor North exterior wall appeared to be in a moderately deteriorated condition near the top of wall for approximately 4'-0" below the roof sheathing line. Refer to Photograph #4 attached at the end of this report, which shows the area of wall between elevator and stairs on the sixth floor. The brick at the top of wall here has receding joints and softened bricks resulting in spalled faces to approximately ¼" depth. There are also some loose bricks in the space between joists. The entire wall appears to be stained by smoke and water. Many head joints are open to full brick depth.

Photograph #4 - This photograph shows the wall construction at the Northern / rear of the building on the sixth floor between elevator and stairs. It is not easily apparent in the photograph due to the contrast in brightness, but the upper section of wall has receding joints and loose brick. The mortar at the top of wall where in joints is disintegrating and falling out. The wall is stained with smoke and water from a previous fire event as well.

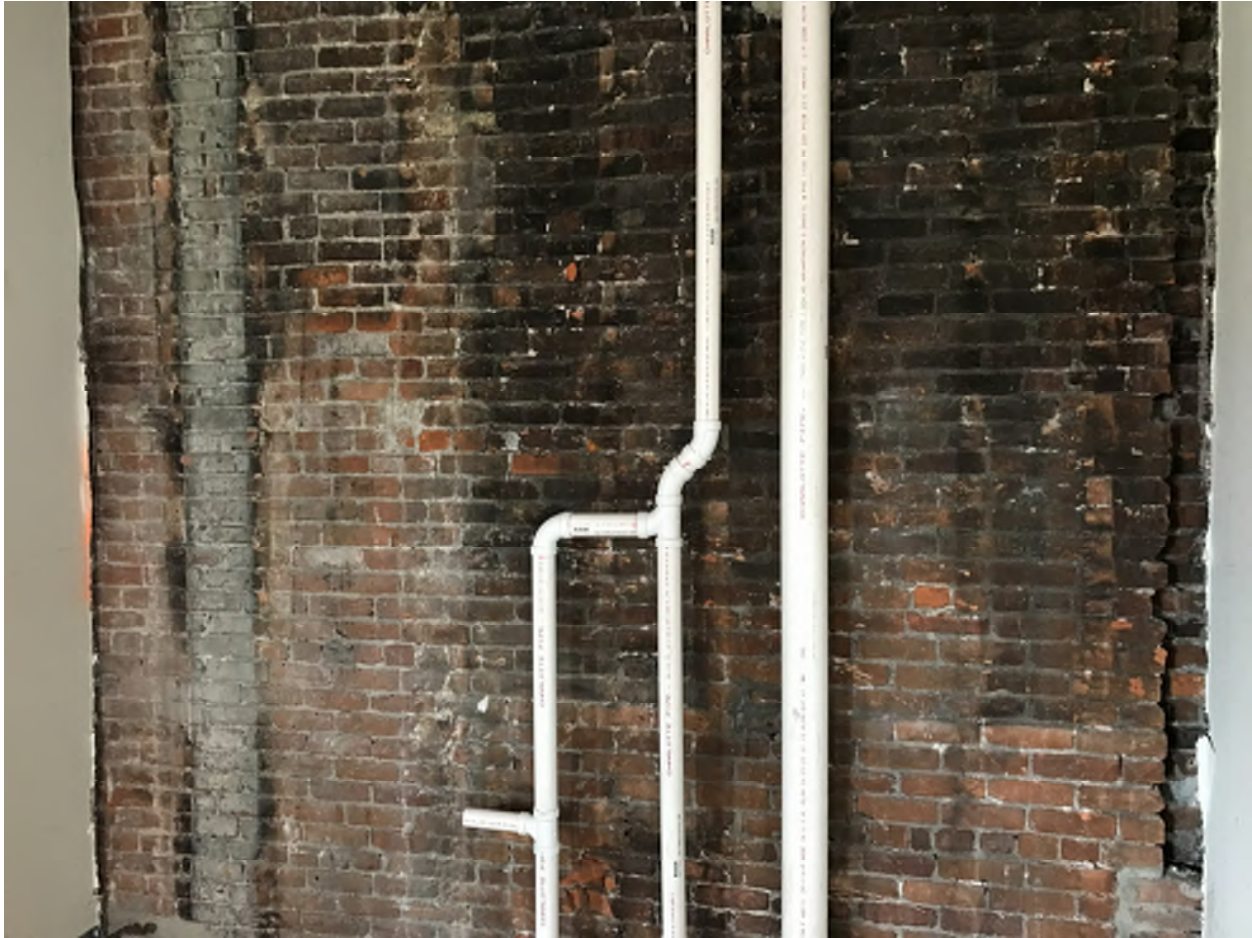
2. The rear wall at the fifth floor was observed and is in relatively better condition than the sixth-floor rear wall at top of masonry. Refer to photograph #5 which shows the same area between elevator and stair but at the fifth floor as shown in photograph #4. The fifth-floor wall has generally less mortar recession, softening and spalling of bricks, and voids or missing bricks.

Photograph #5 – This photograph shows the wall construction at the Northern / rear of the building at the fifth floor, at the same area as Photograph #4 at the sixth floor above. This section of wall is in comparatively better shape with mortar in joints that are not dusting / disintegrating. Smoke and water staining are still present at the top of wall here but dissipates as you move down the wall. Additionally, this wall contains header brick courses about every eighth coursing which are required to tie wythes of the wall together.

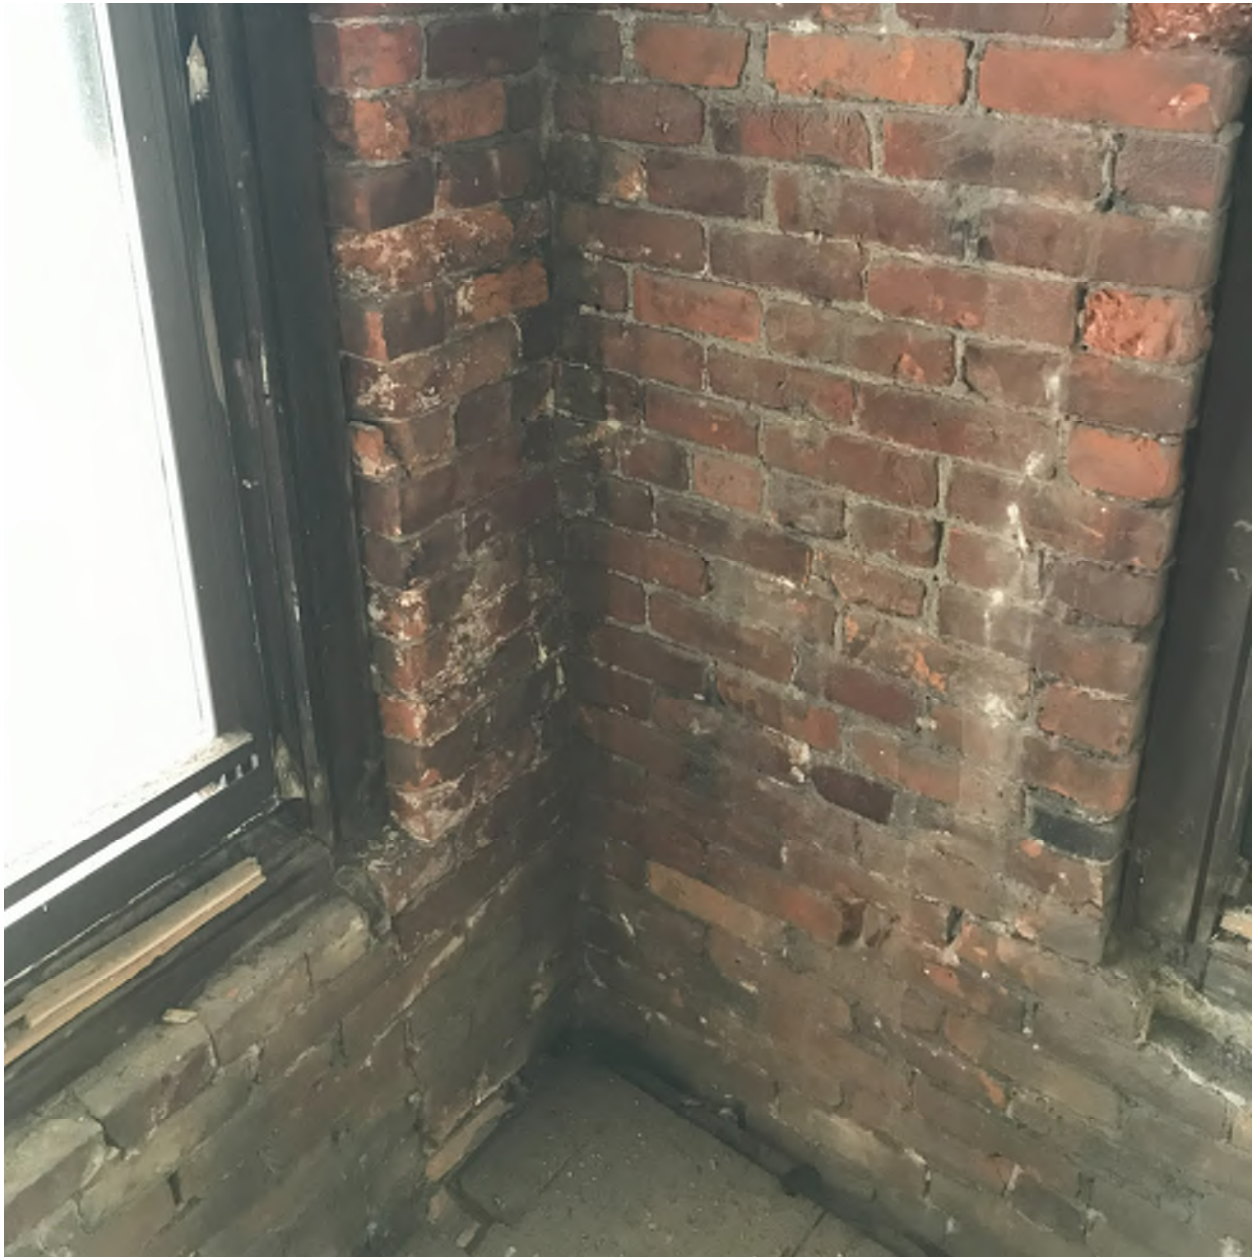
3. The corner of the building at Shawmut Avenue and West Brookline Street at the fifth-floor level appeared to be in a relatively better condition when compared to the same area on the sixth floor. Refer to photograph #6 which shows mortar in the joints of the wall and no spalls. Additional, observations along the interior surface of both the Shawmut Avenue and West Brookline walls show similar mortar in the joints without significant recession and little to no spalling or void / missing bricks. Refer to photograph #7 and #8.

Photograph #6 – This photograph shows the inside face at the Southeast corner of the building on the fifth floor, similar to Photograph #3 which was taken at the sixth floor. This section of wall is in comparatively better condition with intact brick and mortar joints without much disintegration / dusting or mortar. The area under the windowsills is intact with a few open head joints.

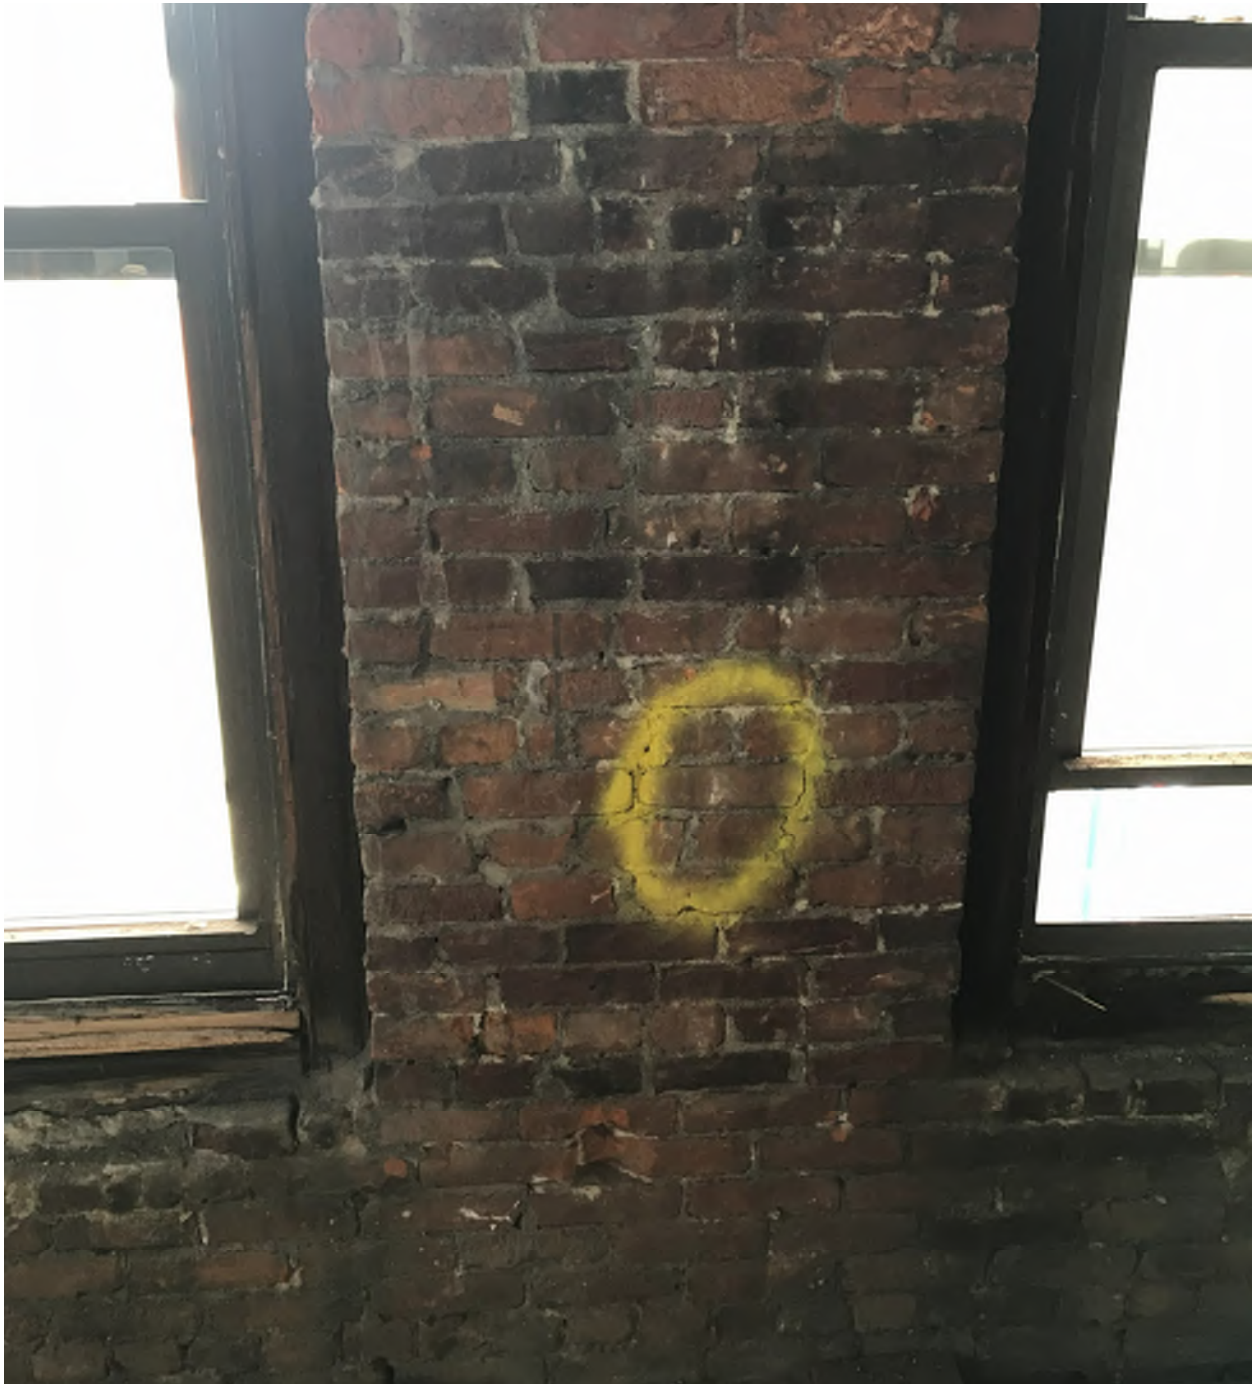
Photograph #7 – This photograph shows a masonry pier between windows on the Southern Shawmut Avenue elevation at the fifth-floor level. The brick pier appears with intact brick and mortar, and it is noted that header courses occur within the brick pier as well. Some open joints occur near the base of the pier / at windowsill level.

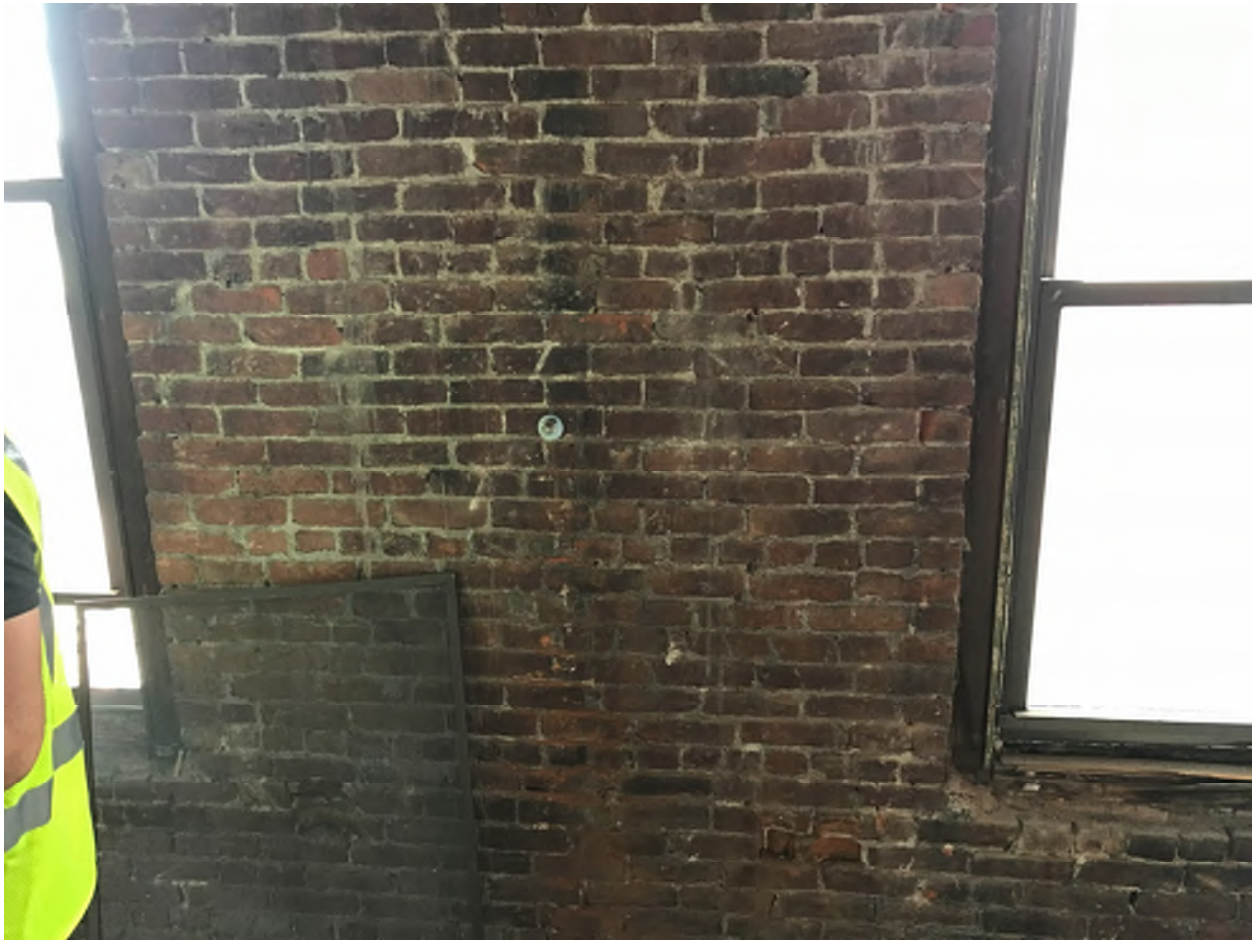
Photograph #8 - This photograph shows another masonry pier between windows on the Southern Shawmut Avenue elevation at the fifth-floor level. The brick pier here remains with intact brick and mortar, and it is noted that header courses occur within the brick pier as well. The construction at the base of the pier / at windowsill level is in good condition without open joints and significant mortar recession.

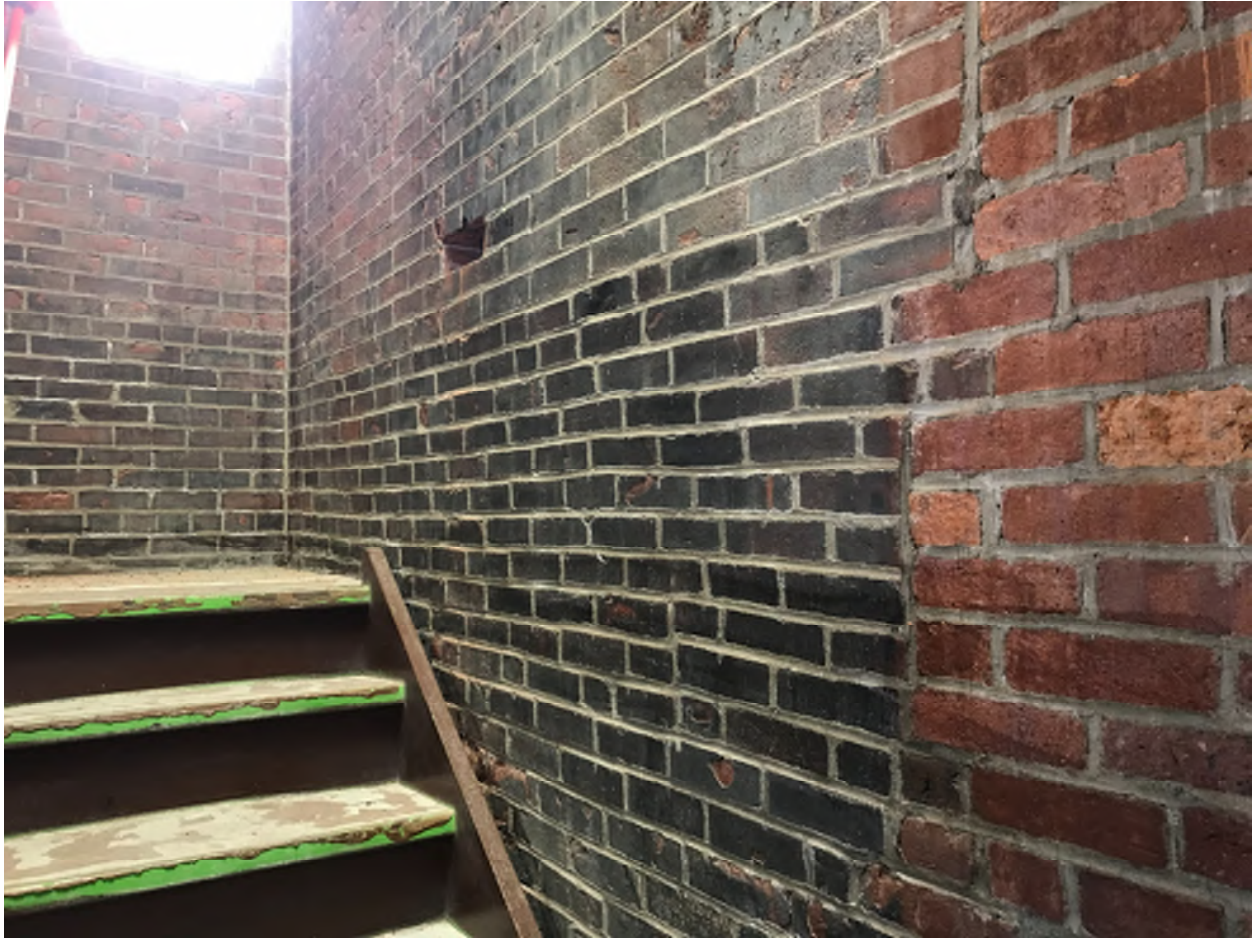
4. The interior faces of the Northeast corner stairs, including the East wall, appear to be in good condition with intact brick with full mortar joints. Previous infill of window or door openings appears evident where different color and textured brick surfaces occur in

large rectangular patches. Refer to photograph #9 for the common condition within the stairs and at this portion of the East Wall.

Photograph #9 – This photograph shows a common example of the condition of brick at the Eastern wall at the inside of the Northeast stair. The brick is intact with full joints that appear to have been previously repointed. Additionally, a different color and texture of brick occur at the righthand side of the photo which appear to be an infill or a previously existing door. This may be indication that this wall was a common “party” wall with a taller existing structure located at 401 Shawmut Avenue that has since been demolished. Also in this photograph is the location where brick was sampled for testing.

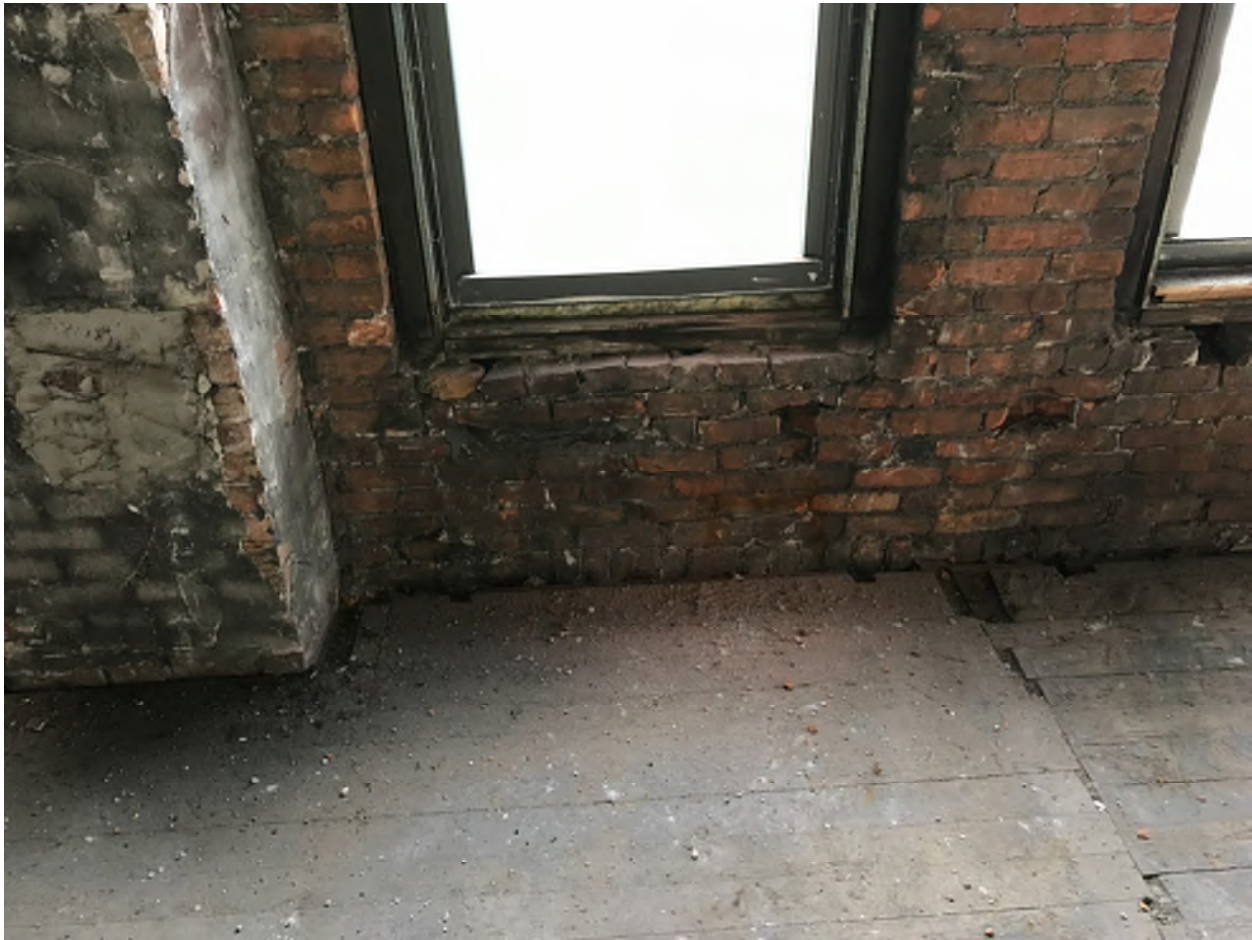
6. The Shawmut Avenue and West Brookline Street walls at the lower levels of the building on the inside face have localized areas of deterioration and other areas that appear in relatively good condition. The areas of deterioration noted are mostly located below windowsills on the Shawmut Avenue side of the building. Severe recession to depth as much as a full brick occurs at a few third-floor sills with associated loose and missing bricks. Refer to photograph #10.

Photograph #10 -This photograph shows the masonry below windowsill at the Southern Shawmut Avenue side of the building on the third-floor level. Some of the locations of masonry below windowsill in the lower portions of the building exhibit mortar recession and some loose brick. However, this sill is still in a relatively better condition than that which is shown in Photograph #3 above. This sill has more mortar in joints with some dusting and only a few open joints. All masonry within 8" of the jambs and sills of window openings I recommended to be repointed, and a few locations will require some brick and mortar rebuilding.
