Tree Health Assessment – *Ailanthus altissima*

308 Commonwealth Avenue Condominium Association
Attn: Michael Jammen

Date: April 29, 2026

Location: 301 Public Alley 431, Boston, MA

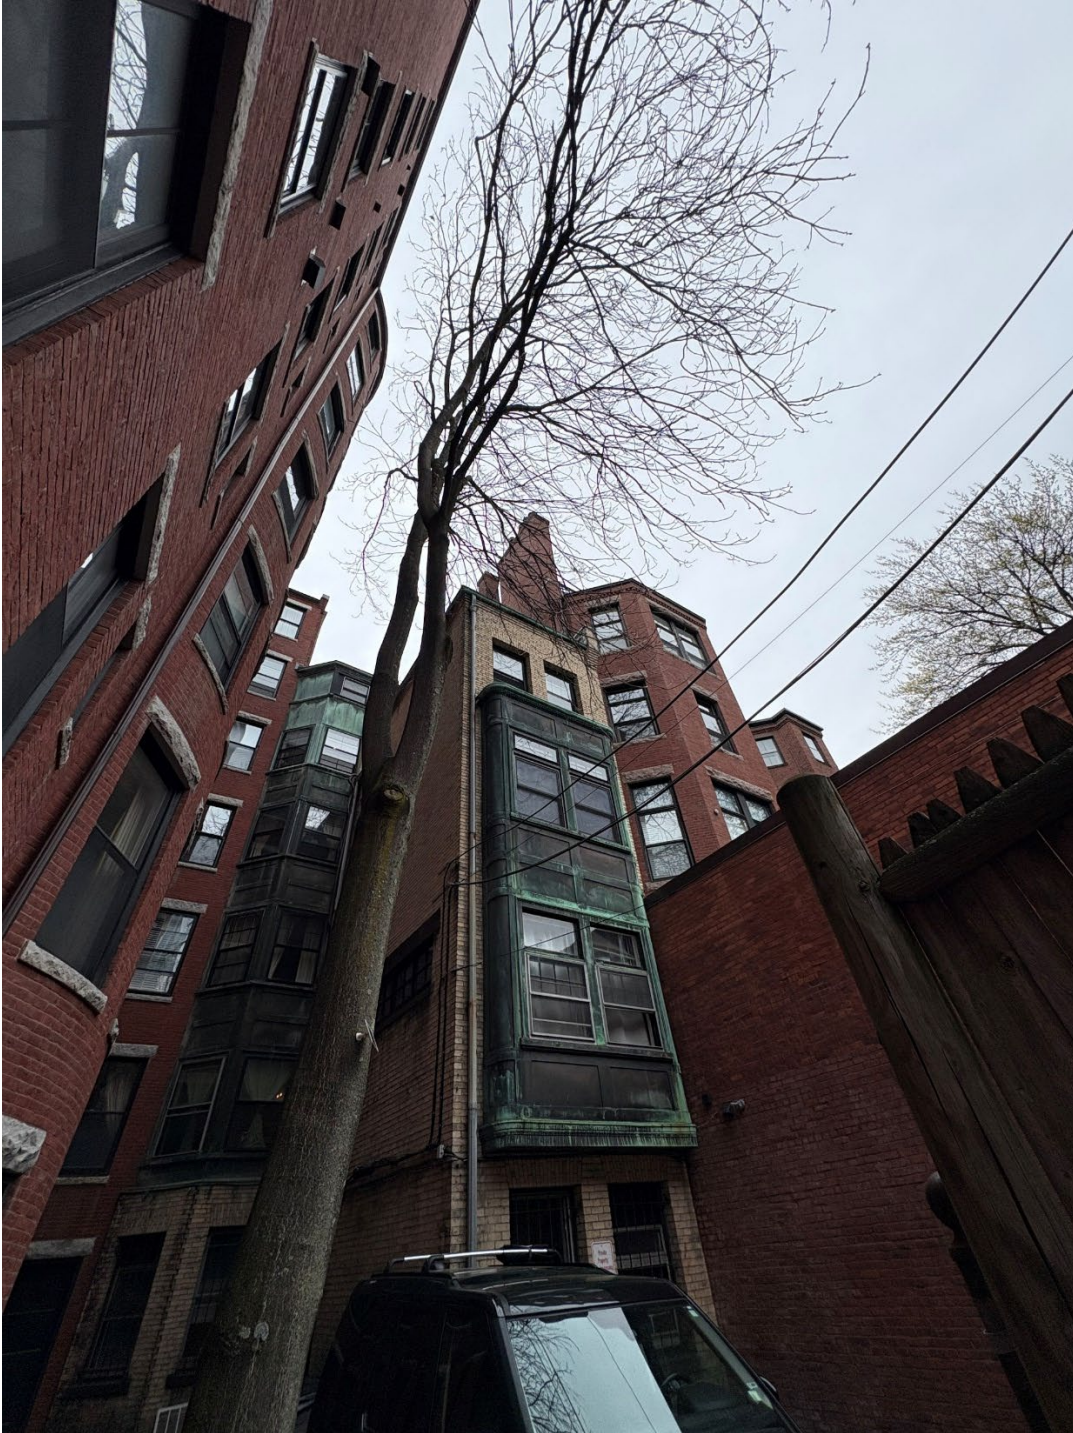
At your request, a visual arboricultural assessment was performed on a mature *Ailanthus altissima* (Tree-of-Heaven) located at 301 Public Alley 431, Boston, Massachusetts. The tree has an approximate diameter at breast height (DBH) of 23 inches, height of approximately 60 feet, and canopy spread of 30 feet. The evaluation was conducted during the spring season and consisted of a ground-based visual inspection only. (Figure 1.)

Figure 1. Subject tree: 23" DBH *Ailanthus altissima* (Tree of Heaven)

Based on the observed canopy condition, structural pruning impacts, site constraints, root-zone disturbances, proximity to structures, and the invasive status of the species, removal of the subject tree is recommended.

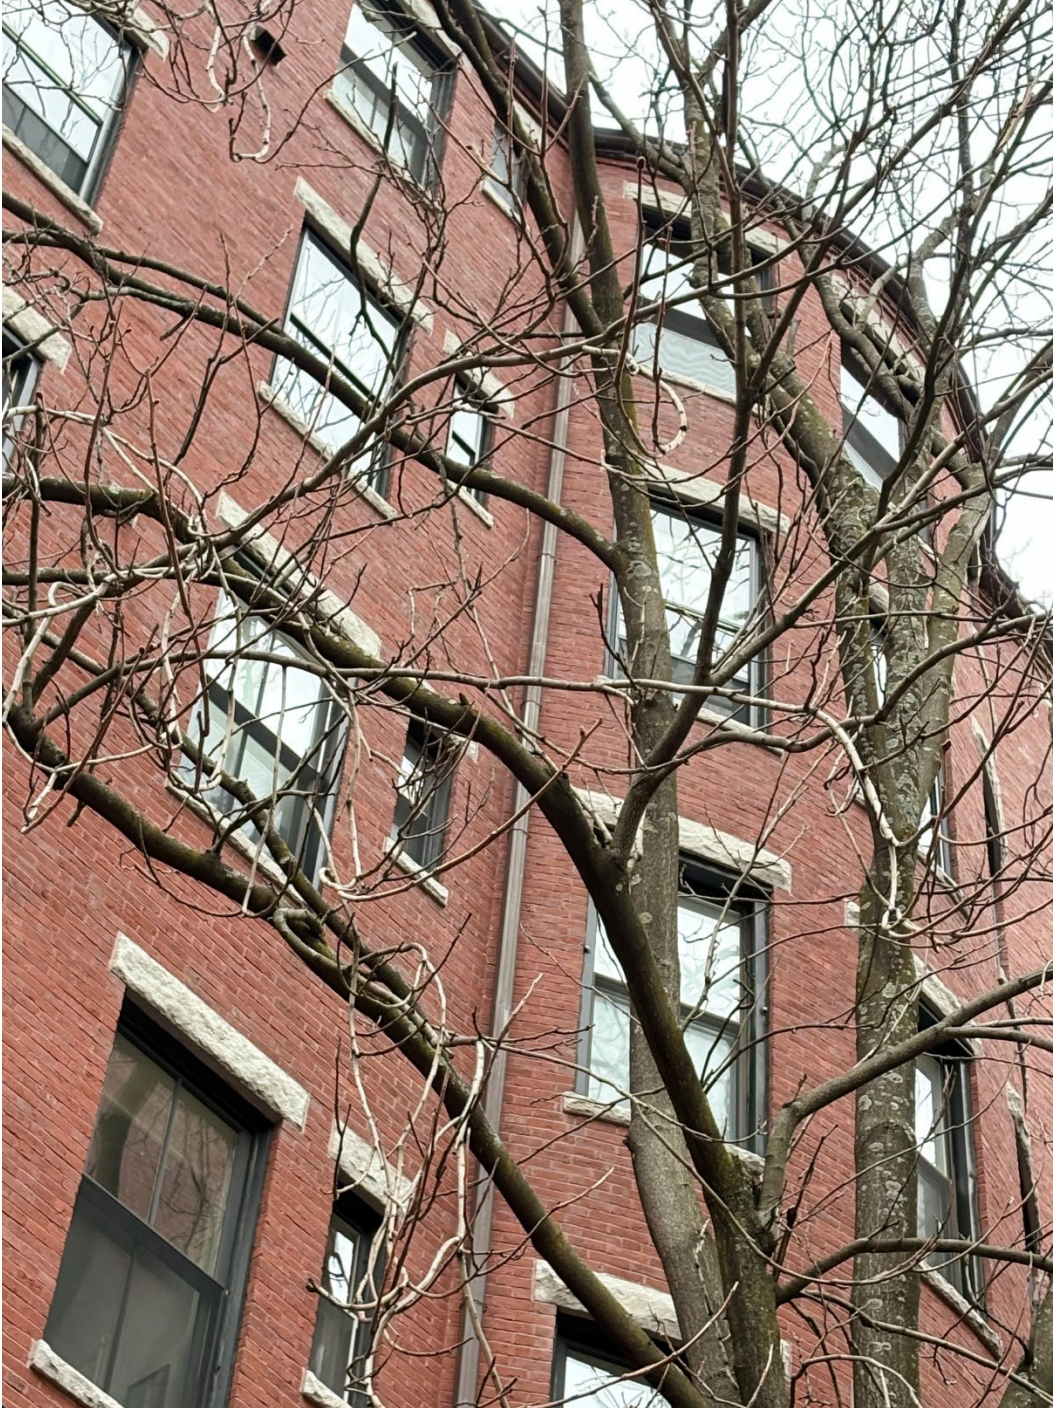
At the time of inspection, the tree was observed to be in fair overall condition. The exterior portions of the canopy exhibited normal bud swell consistent with the current stage of the spring growing season. However, multiple dead branches were noted within the interior of the canopy, indicating reduced vigor and declining interior crown health. (Figure 2.)

Figure 2. Normal bud swell on exterior branches

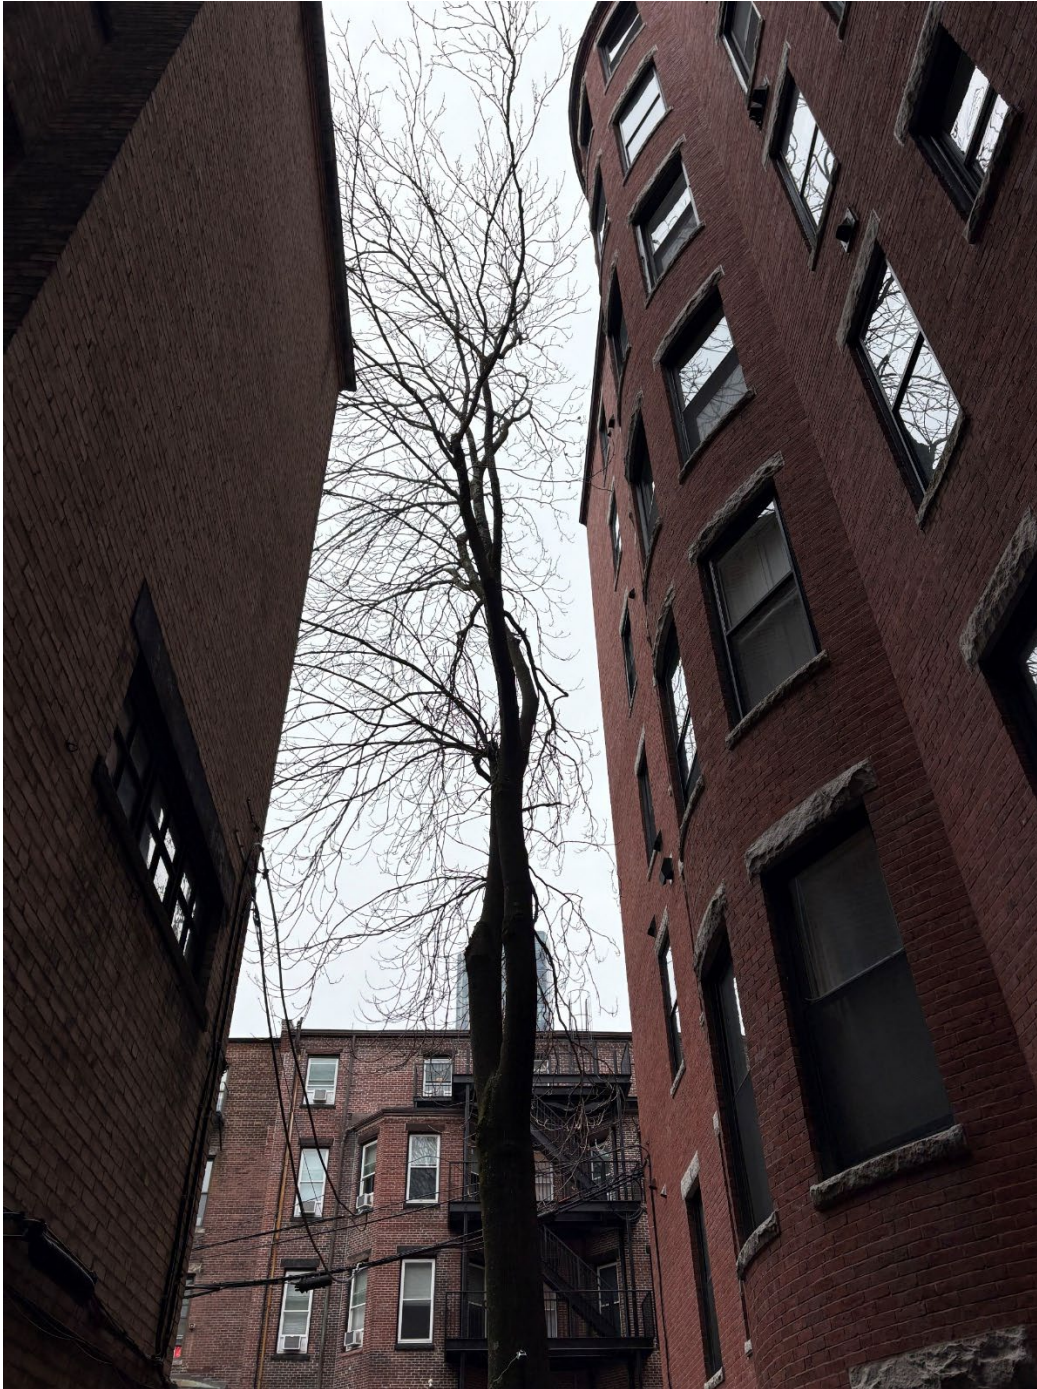
The tree has an observed history of pruning to maintain clearance from adjacent buildings. These repeated clearance cuts have resulted in a lion-tailed canopy structure, characterized by foliage concentrated at the outer ends of branches with sparse interior growth. This condition can reduce branch taper and increase mechanical stress on limbs and leaders, thereby predisposing them to failure during adverse weather conditions. (Figure 3.)

Figure 3. History of "lions tail" pruning to achieve clearance objectives

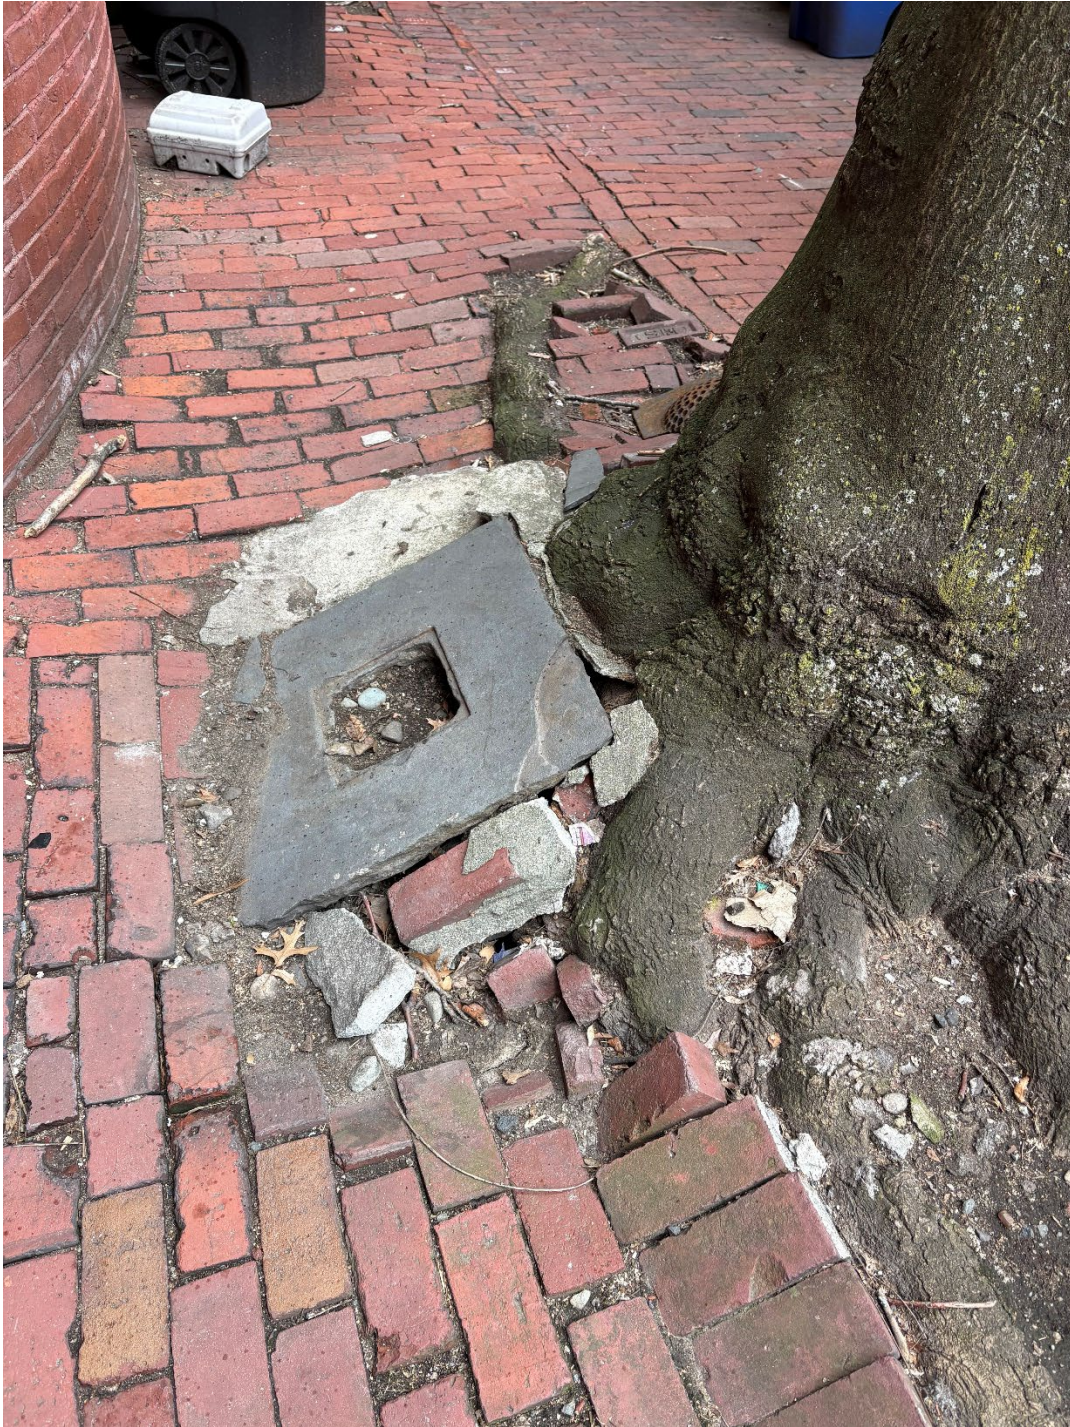
The root flare has displaced and buckled surrounding brick pavers, indicating constrained growing conditions and surface root expansion. Soil exposure at the base of the tree revealed rodent burrowing activity in the root flare zone. Due to the presence of extensive surrounding hardscape, the root system could not be fully evaluated, limiting the ability to assess structural root condition or potential decay below grade. (Figure 4.)

Figure 4. Conflicts with brick pavers and rodent burrows under the root flare
