Marriott Custom House

Exterior Repairs

BLC SUBMISSION
4 JUNE 2019

- DRAWING LIST
- COVER SHEET AND SITE PLAN
- AE1-1 ELEVATIONS
- AE2-1 DOME LEVEL ROOF PLAN
AE2-2 DOME LEVEL ROOF DETAILS
- AE3-1 OBSERVATION AND EAGLE SUITE ROOF PLANS AND DETAILS
AE3-2 OBSERVATION AND EAGLE SUITE ROOF DETAILS

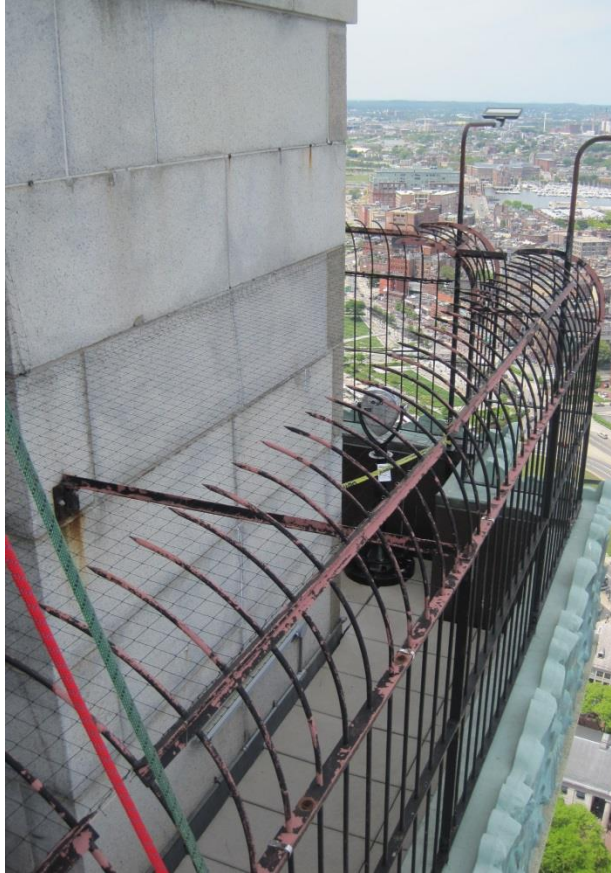
Photo 1

Observation Deck

Existing fence and bird netting. Copper parapet coping and cladding.

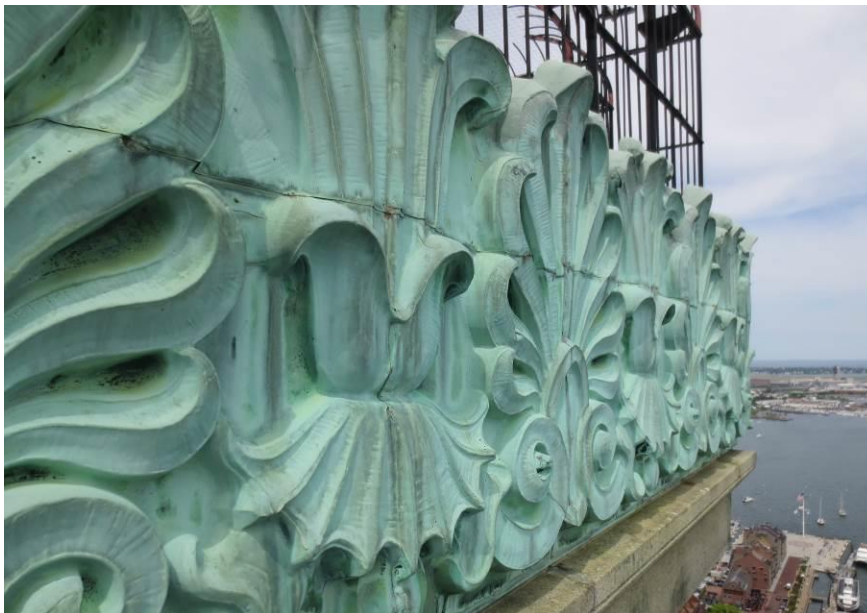
Photo 2

Observation Deck

Copper cladding. Small holes on east and west elevation.

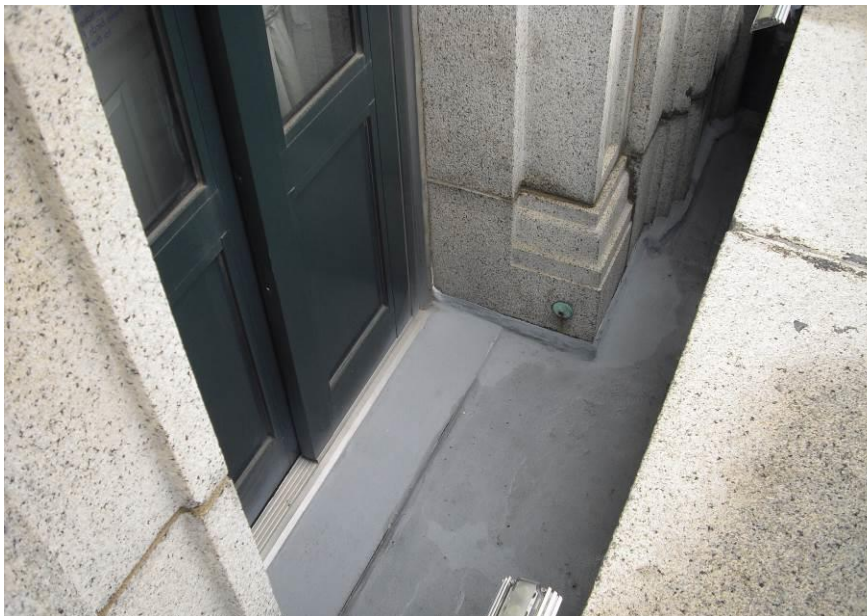
Photo 8

Level 20

Eagle Suite door and balcony with existing coating on north and south elevation.

- Remove and replace waterproofing coating at the north and south Eagle Suite balcony roofs (Level 20). Replace existing metal counter-flashing at parapet and building rising wall as required to install new roof membrane.

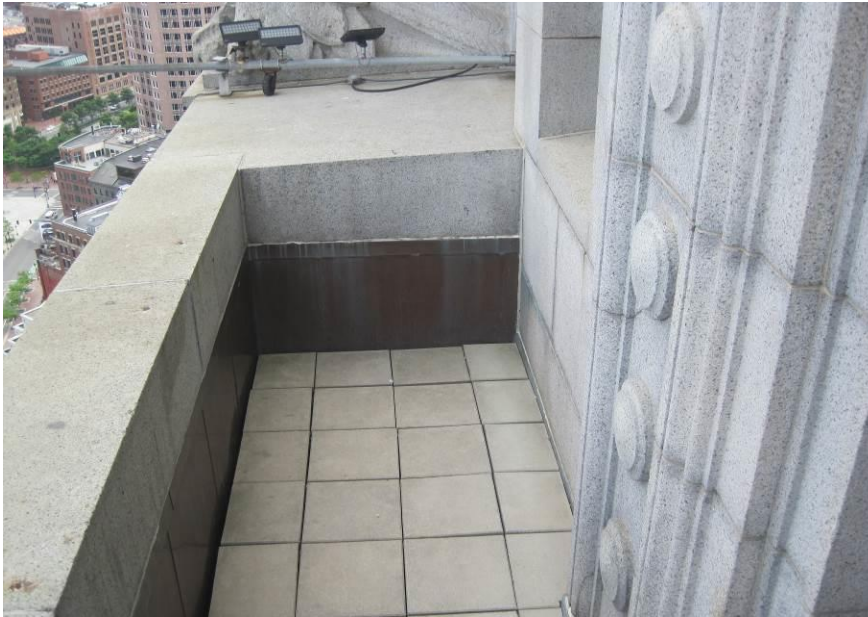
Photo 9

Clock Area

East and west Eagle Suite balcony with membrane roofing and pavers.

- EAGLE SUITE BALCONY ROOFS (LEVEL 20):
 - At east and west Eagle Suite balcony roofs (Level 20), remove (E) bituthene membrane, protection layer, concrete blocks, pedestals, and, precast concrete pavers. Provide new fully-adhered PVC membrane, protection layer, adjustable pedestals, and reinstall concrete pavers. Replace existing metal counter-flashing at building rising wall and cladding at parapet as required to install new roof membrane.

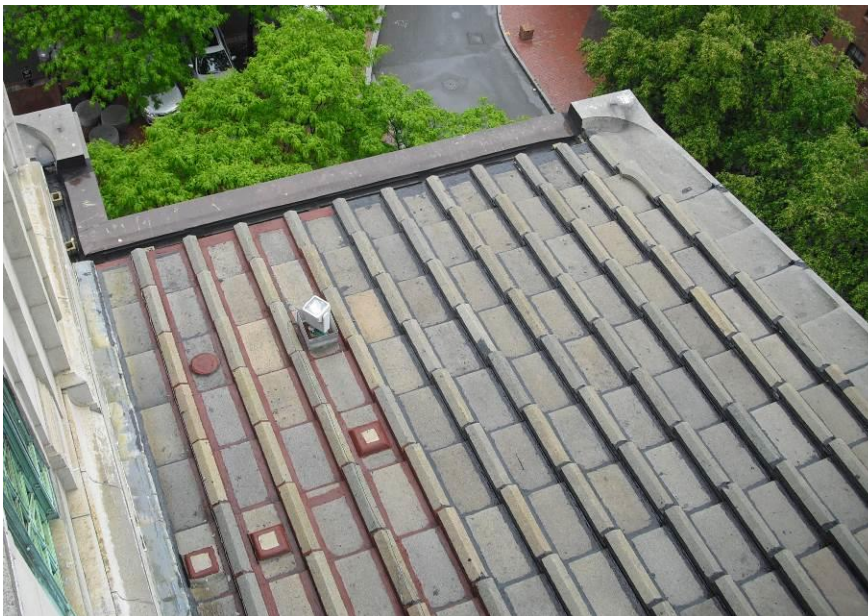
Photo 12

Dome Level Roof

North and south granite
panel roof with mastic at
joints.

1. Replace deteriorated mastic at stone joints and penetrations; assume 100% of joints require repair.
2. Remove and replace EPDM liner within built-in gutter along roof eaves.
3. Remove embedded ferrous anchors at locations noted on plan and provide mortar repair.
4. Seal all light fixtures attachment and conduit and heat trace penetration through argente.

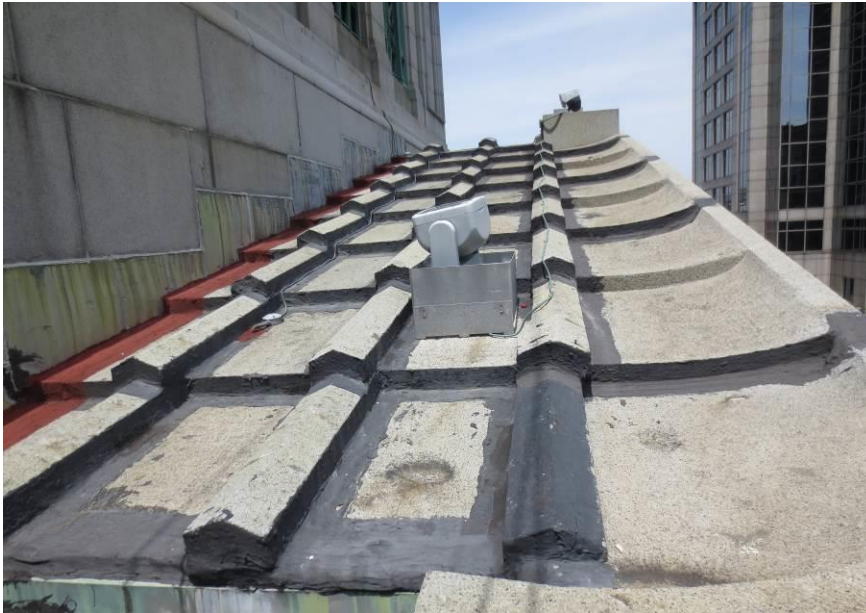
Photo 13

Dome Level Roof

East and West granite panel roof with mastic at joints.

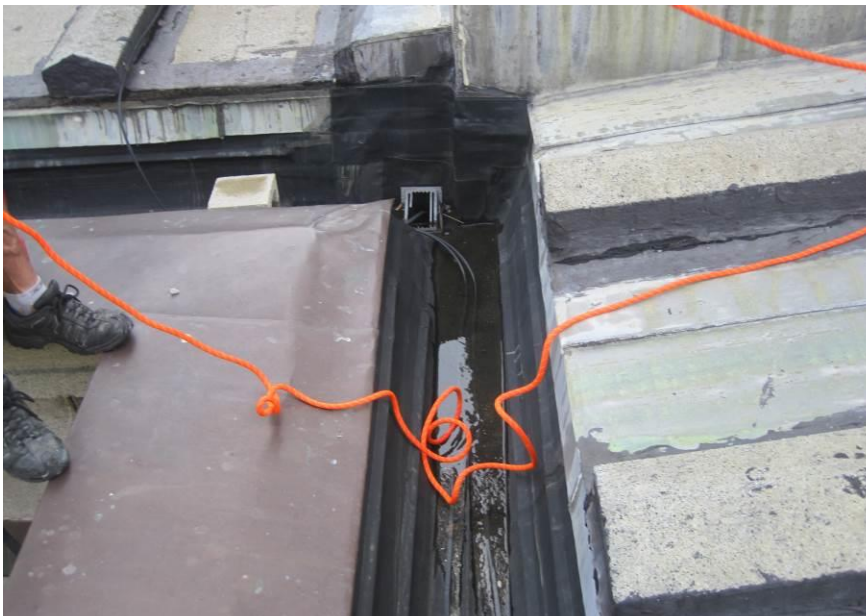
Photo 14

Dome Level Roof

Typical existing copper gutter and EPDM gutter liner.
