Fowler Clark Epstein Farm

487 Norfolk Street, Mattapan

Boston Landmarks Commission Design Review

Historic Boston Incorporated March 28, 2017

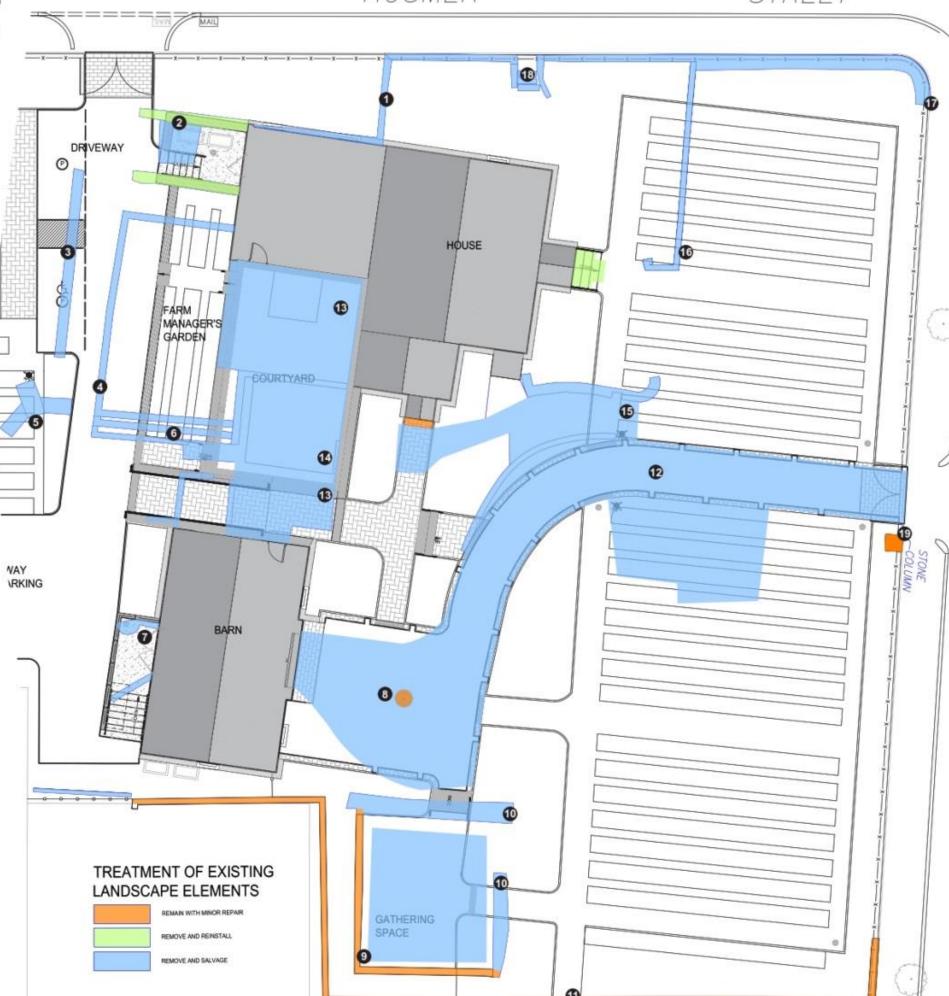
HOSMER STREET

Front stone recessed area

- · Mortared granite block retaining wall and concrete floor
- Granite wall requires minor stabilization Concrete floor is impervious
- Repair granite walls, raise grade 1+ feet. replace concrete floor with stone dust

North and East Brick and stone walls around stone recessed area

- · Mortared stone and brick walls
- · Structurally unsound
- · Complete renovation required
- Remove

Southern Stone Wall

- · Mortared stone and brick walls with carved stone panels
- Majority of wall appears to be in good repair
- · Minor repairs required
- · Excellent example of Epstein era architecture
- > Repair as required

Stone Pillars

- Mortared Granite blocks Good Repair
- Repair as necessary, cap top

Hosmer Steps

- Mortared granite blocks and steps
- Require moderate repair Current elevation of top step is higher than ideal elevation
- Remove and reuse materials on-site

Hosmer Perimeter Wall

- Interior is brick requiring major
- stabilization/renovation Exterior mortared granite requiring
- Incomplete construction
- Remove and salvage

Norfolk Stone Block Wall

- Dry-laid granite block retaining wall
- Wall in good condition Creates uneven grade in front yard
- Remove and salvage

Brick Walls and Stone Walk

- Brick walls and mortared stone walk
- Walls: Require major stabilization Walk: Requires complete resetting

- Brick walls with stone inset and mortared bluestone and brick patio
- Walls: Requires major stabilization Patio: Requires complete resetting to correct grades for ADA compliance
- Remove and salvage

House and Barn Brick Patio

- Herringbone brick patio
- Requires complete resetting Existing grades of both patios slope toward the house and barn and should be corrected for proper drainage
- Remove and salvage

Cobblestone Drive

- Granite cobbles set in concrete Uneven grade and rough surface non-
- compliant with ADA Requires major renovation

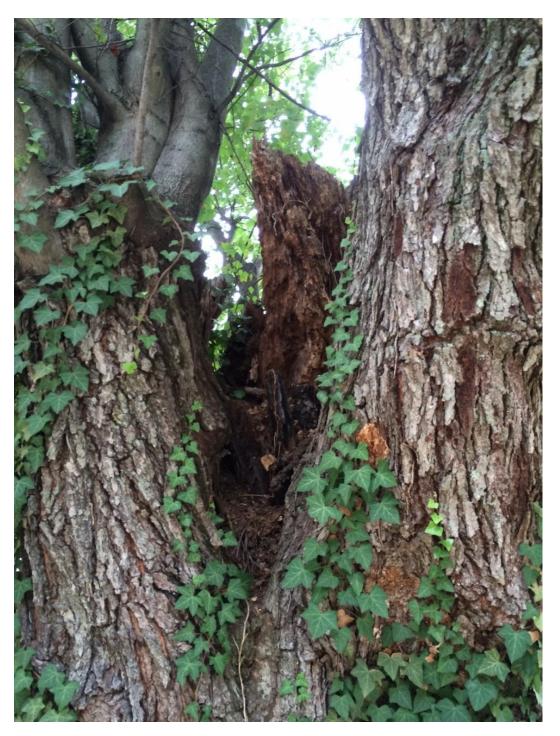
Rot in large maple in front of house

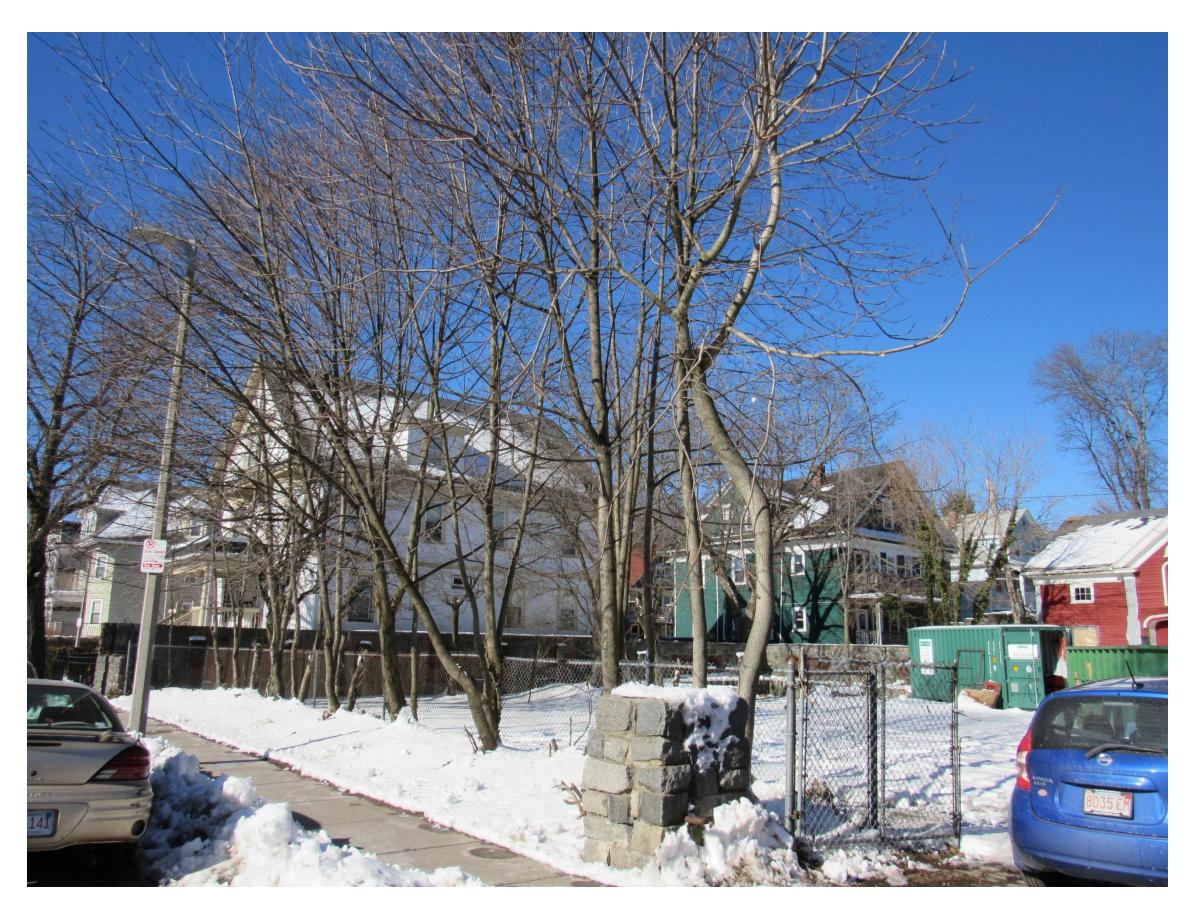
Norway maples at front of site proposed for removal
