CERTIFICATE OF APPROPRIATENESS APPLICATION

Re: 2 Park Street / Selective Masonry Repairs and Window Restoration

Park Street Church

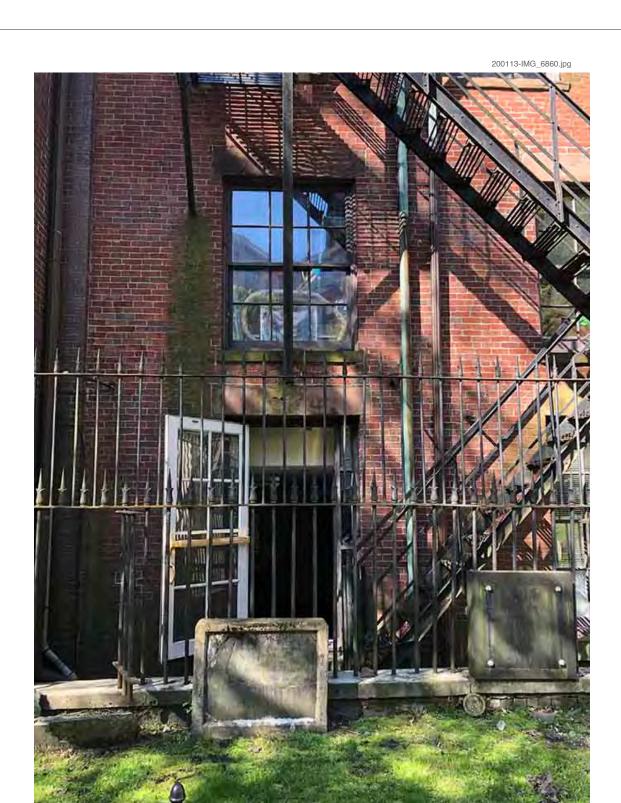
REAR FACADE AT FIRST FLOOR EXIT DOOR TO FIRE ESCAPE;
REMOVE FIRST FLOOR EXIT DOOR & RESTORE MISSING WINDOW

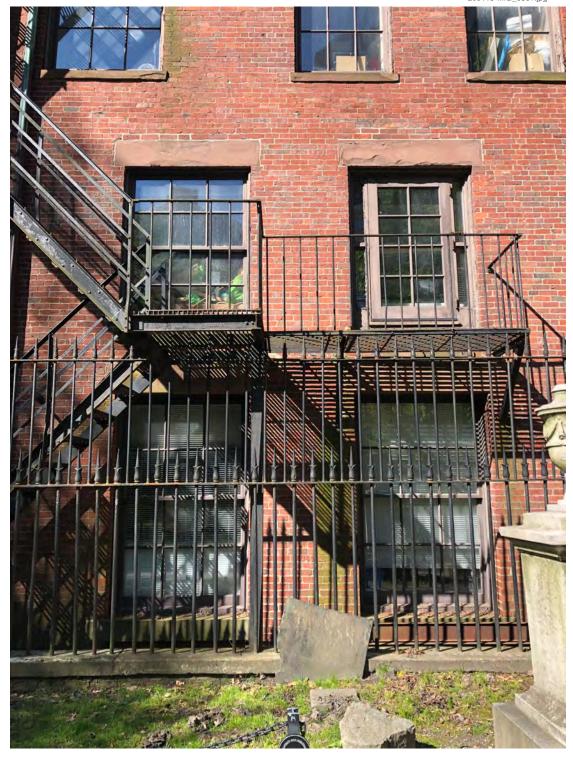
REAR FACADE AT SECOND FLOOR EXIT DOOR TO FIRE ESCAPE;
REMOVE EXTENDED FIRE ESCAPE LANDING; REMOVE EXIT DOOR & RESTORE MISSING WINDOW

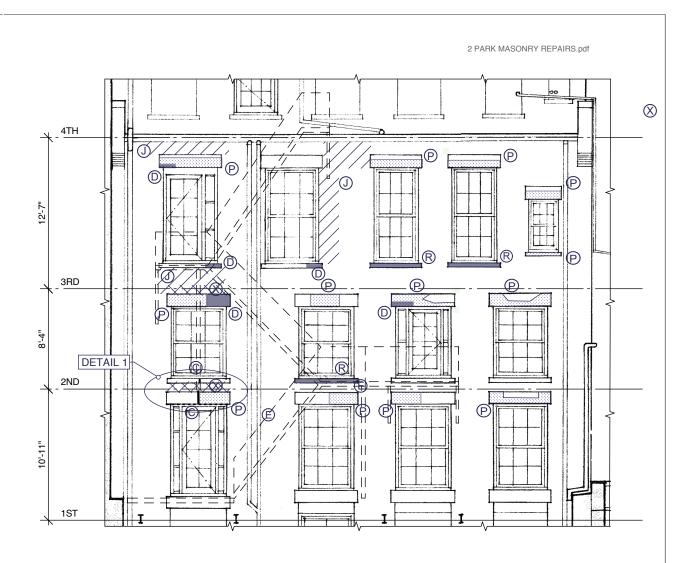
OUTLINE DRAWING AND NOTES FOR MASONRY RESTORATION AT BRICK & BROWNSTONE;

- © ADHESIVE-INJECT CRACK IN BROWN SANDSTONE UNIT.
- © SAWCUT DEEPLY ERODED PORTION OF STONE UNIT AND REPLACE WITH FITTED, BONDED DUTCHMAN.
- © REMOVE BRICKWORK AROUND RUSTING METAL EMBEDMENT, CLEAN, REPAIR, PAINT STEEL AND REATTACH EMBEDMENT, RE-SET/ REPLACE MASORNY.
- ① CUT AND POINT ERODED MORTAR JOINTS.
- © SCABBLE OFF ALL FRIABLE STONE MATERIAL AND APPLY MATCHING REPAIR MORTAR PATCH TO RESTORE SURFACE PROFILE.
- REPLACE IRREPARABLY DAMAGED STONE UNIT.

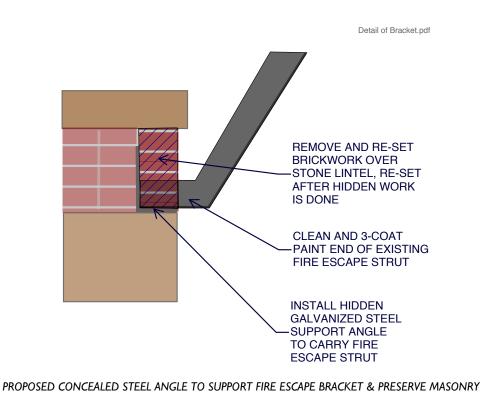
EXISTING FIRE ESCAPE BRACKET BETWEEN BROWNSTONE LINTEL & SILL EMBEDDED IN BRICKWORK

REMOVE AND RE-SET BRICKWORK OVER STONE LINTEL, RE-SET AFTER HIDDEN WORK IS DONE

CLEAN AND 3-COAT PAINT END OF EXISTING FIRE ESCAPE STRUT

INSTALL HIDDEN GALVANIZED STEEL SUPPORT ANGLE TO CARRY FIRE ESCAPE STRUT
