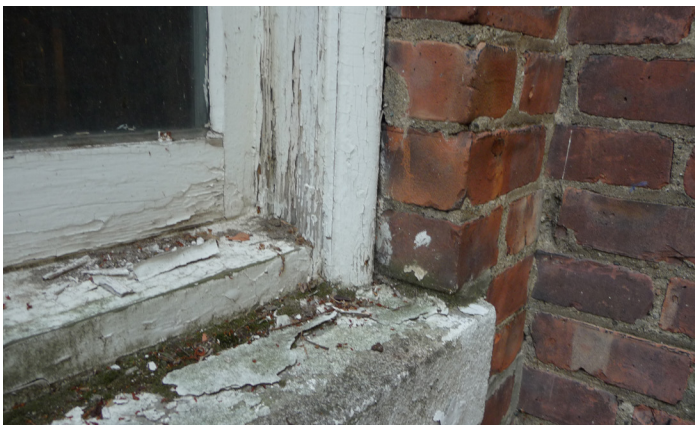
figure 7 | window A exterior deterioration

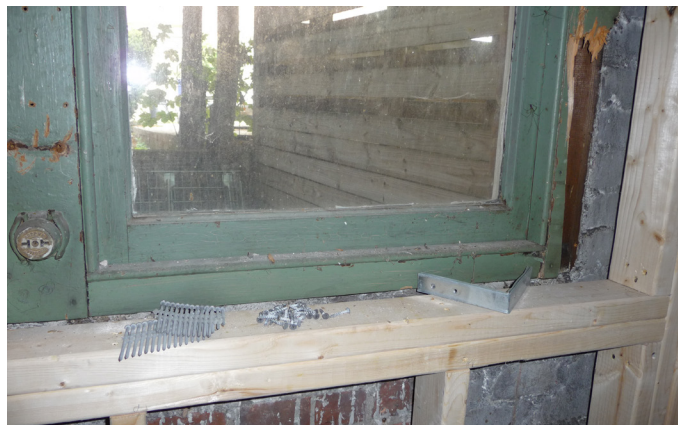
figure 8 | window A interior deterioration

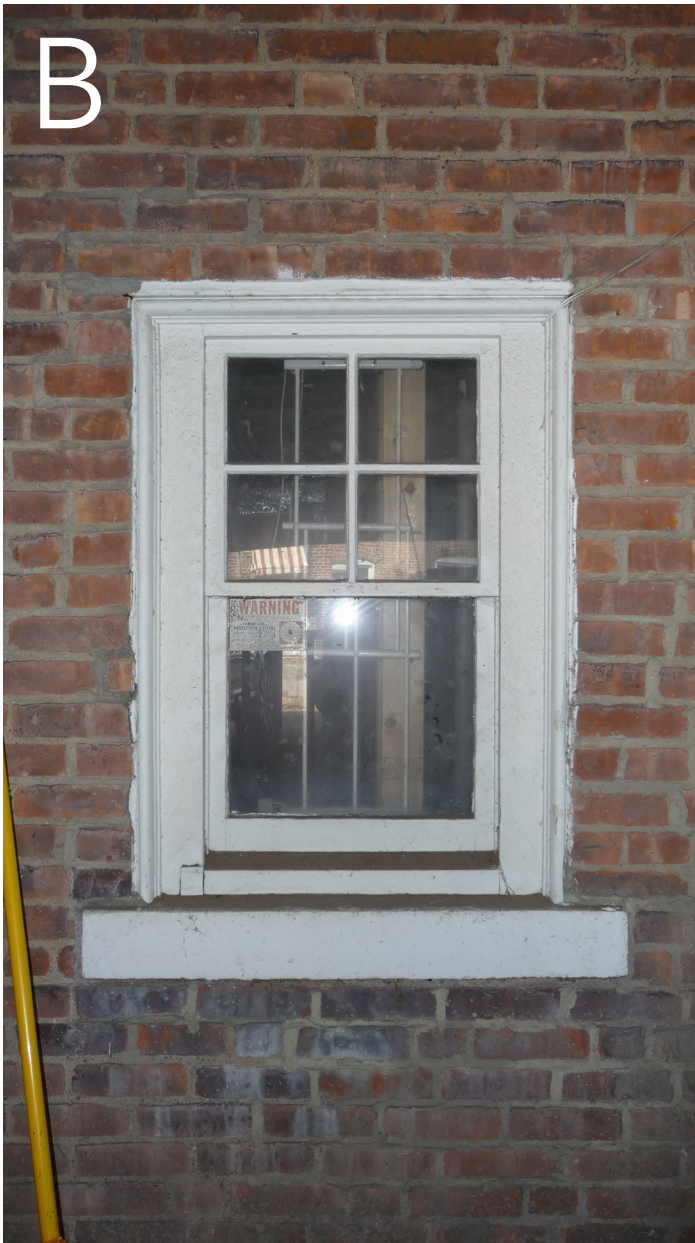
figure 9 | window B exterior view
Showing added trim in addition to brick mold.

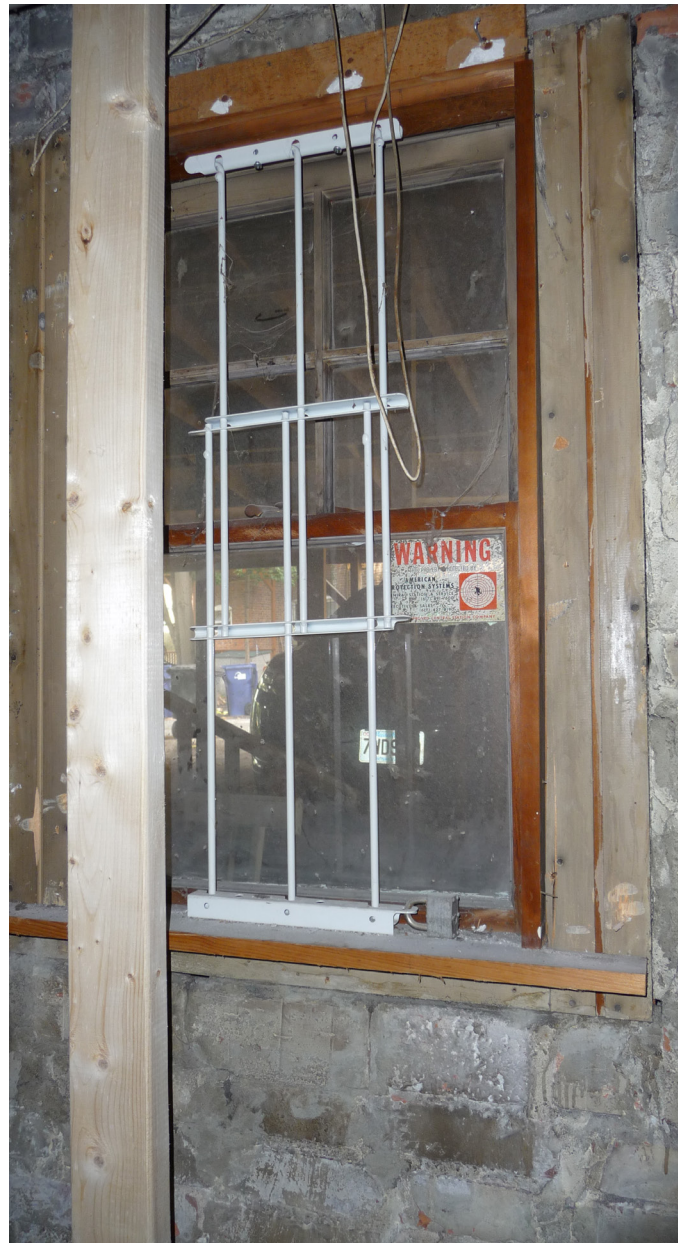
figure 10 | window B interior view
Showing modified opening

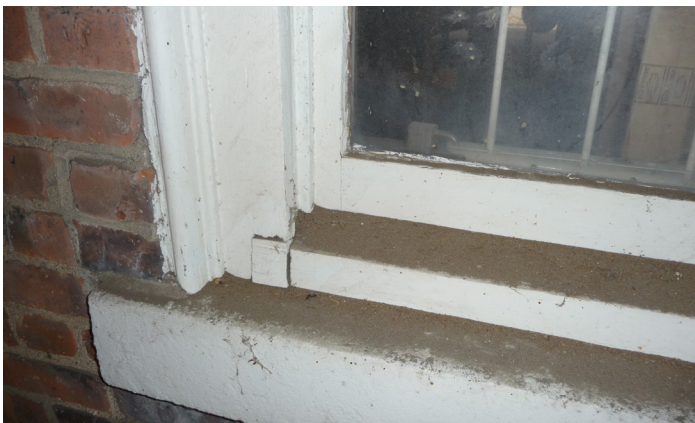
figure 11 | window B exterior sill
Showing added window casing

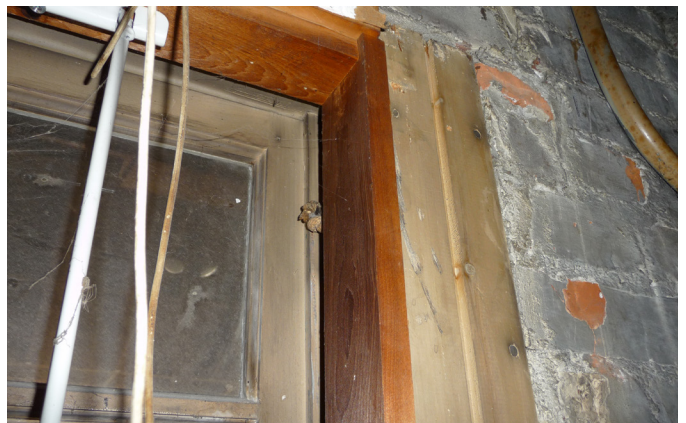
figure 12 | window B interior view
Showing damaged sash cord

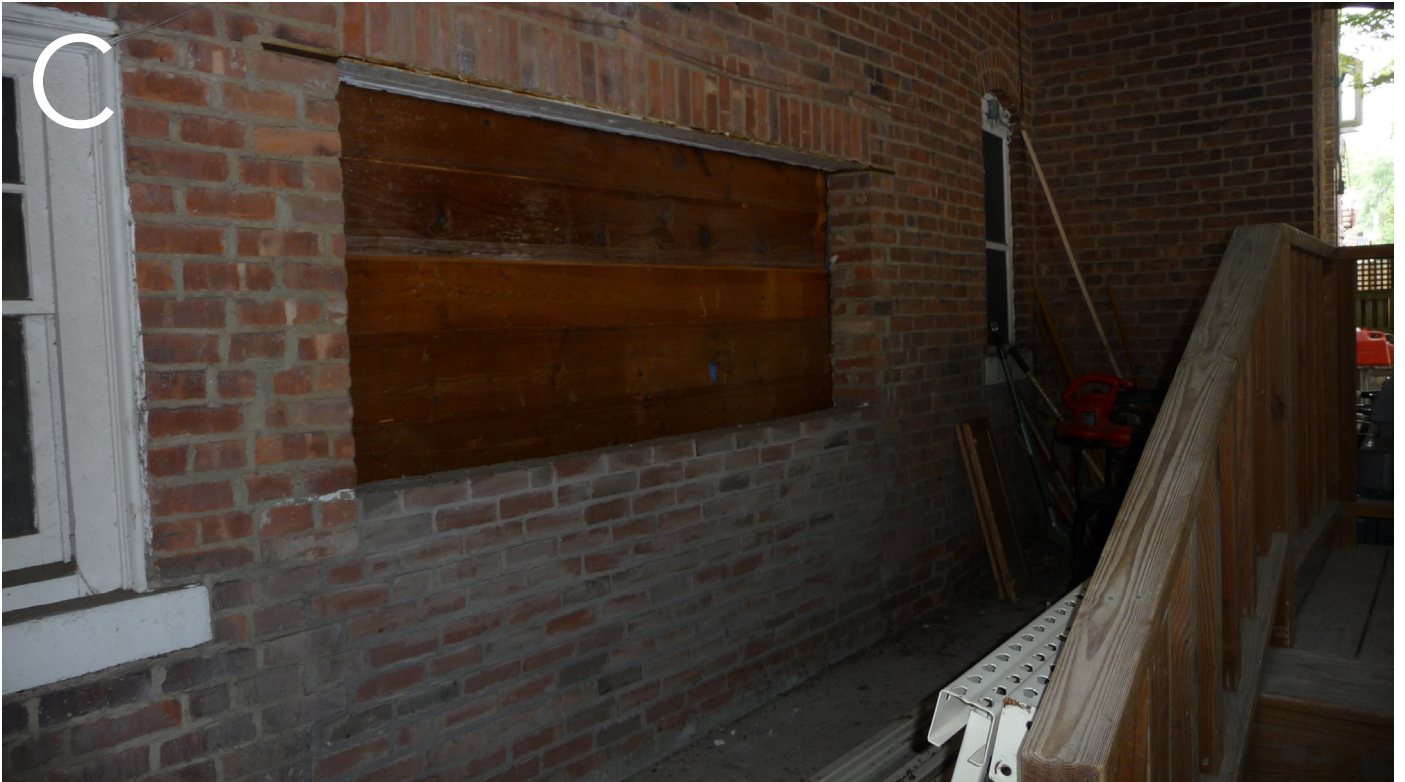
figure 13 | window C exterior view
After overhead door was removed

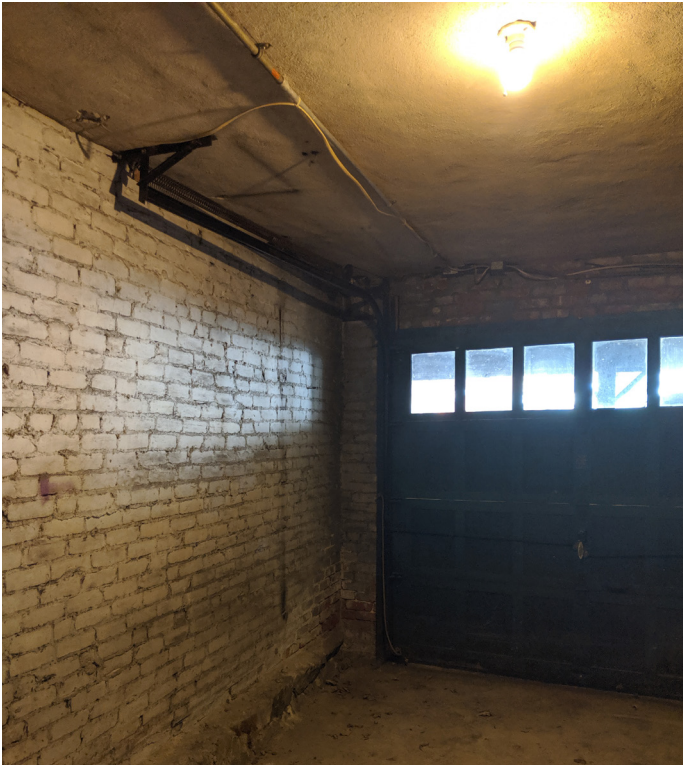
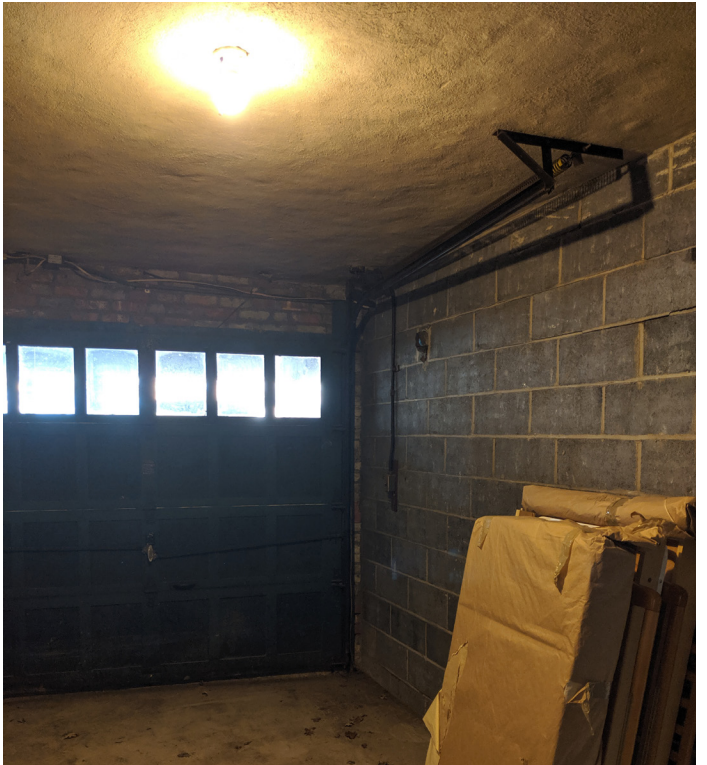
figure 14 | window C interior view
Showing overhead door
