South End Landmark Historic District Commission

Project Review Hearing

34 East Springfield Street

February 2, 2021

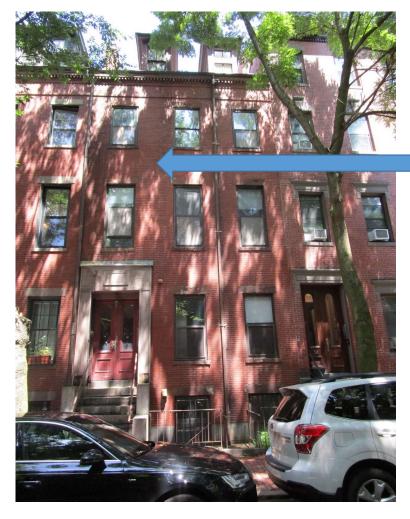
View of thirdfloor unit, cavity
between inner
and outer wythes
due to water
damage
bowing out outer
brickwork

Proposed project
would
disassemble and
reconstruct the
façade with
existing and
matching brick

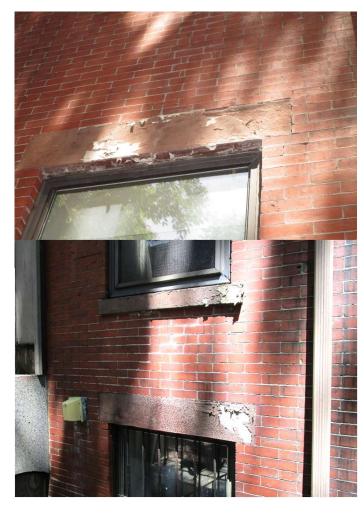
View of skimcoated and damaged lintels to be replaced with matching lintels

Granite steps to be retained and reset with new metal handrails, doors will be retained and repaired with new entry surround. New windows will be installed with 2/2 pattern

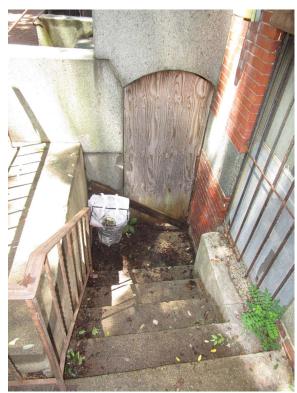
View of garden level entrance to be replaced with arched metal gate and new entry door. Steps and fence/railing to be retained

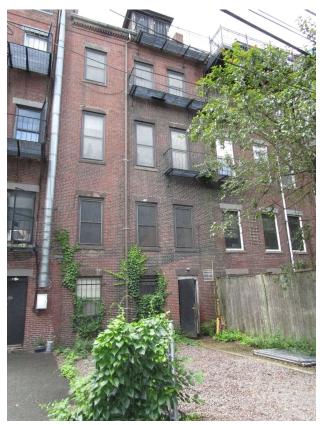
Masonry at rear elevation is in much better condition will be repointed and repaired. Entry door will be replaced and dormer will be replaced
