# West Roxbury Educational Complex

Final Report  
March 2, 2023

# Goals for WREC Study

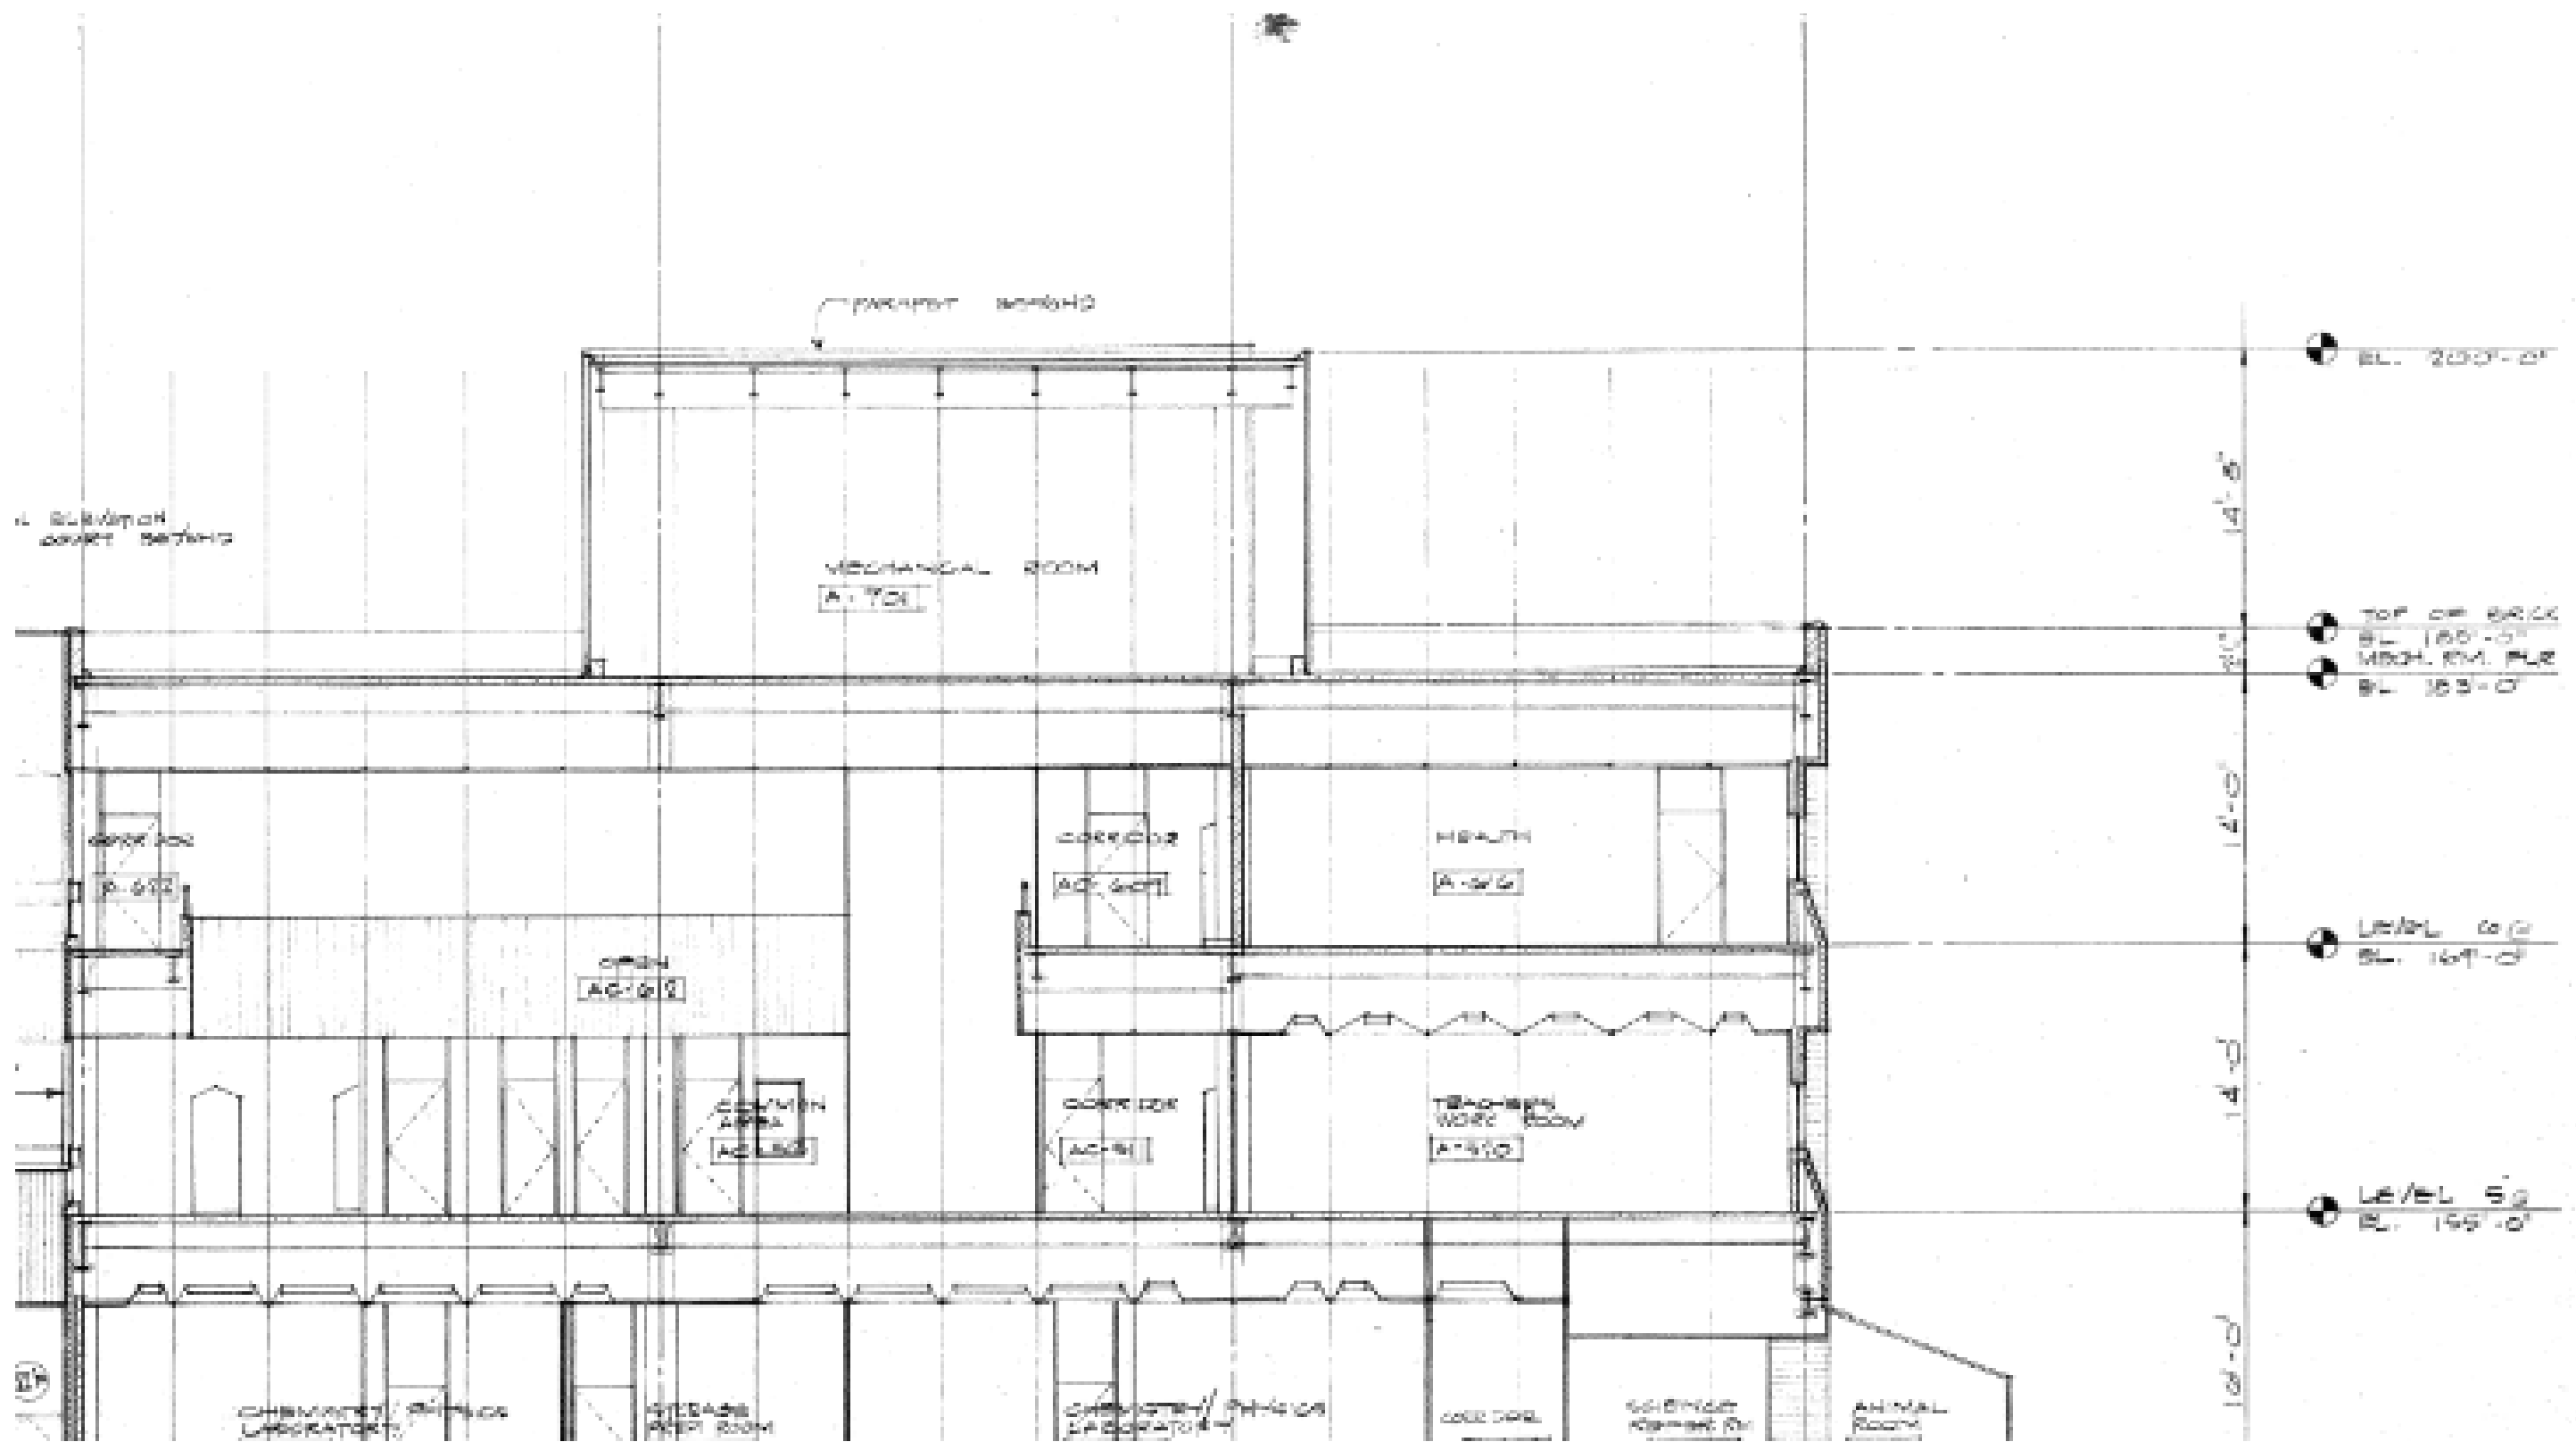
## Building Envelope - Lacking Continuous Insulation

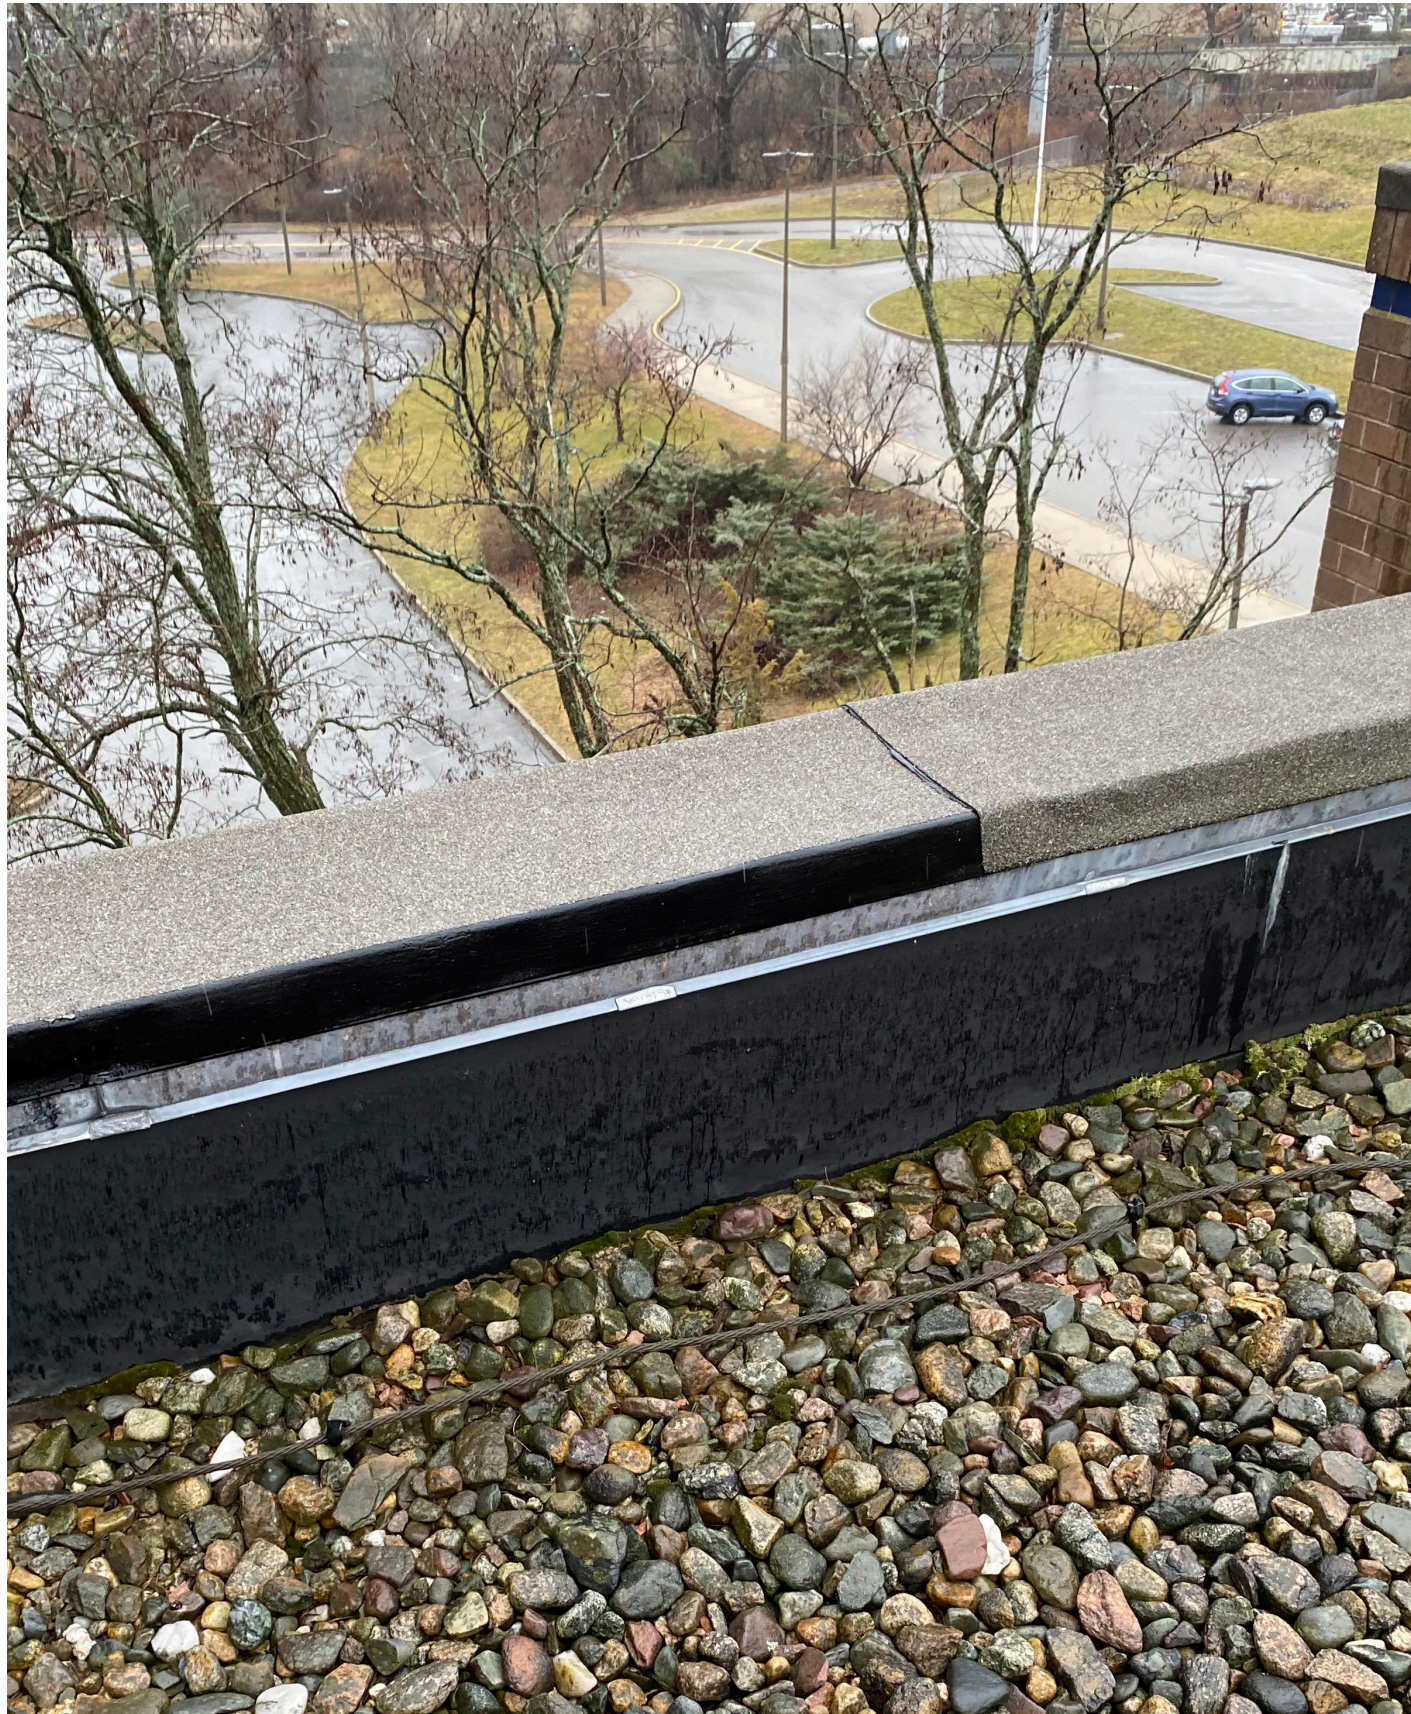
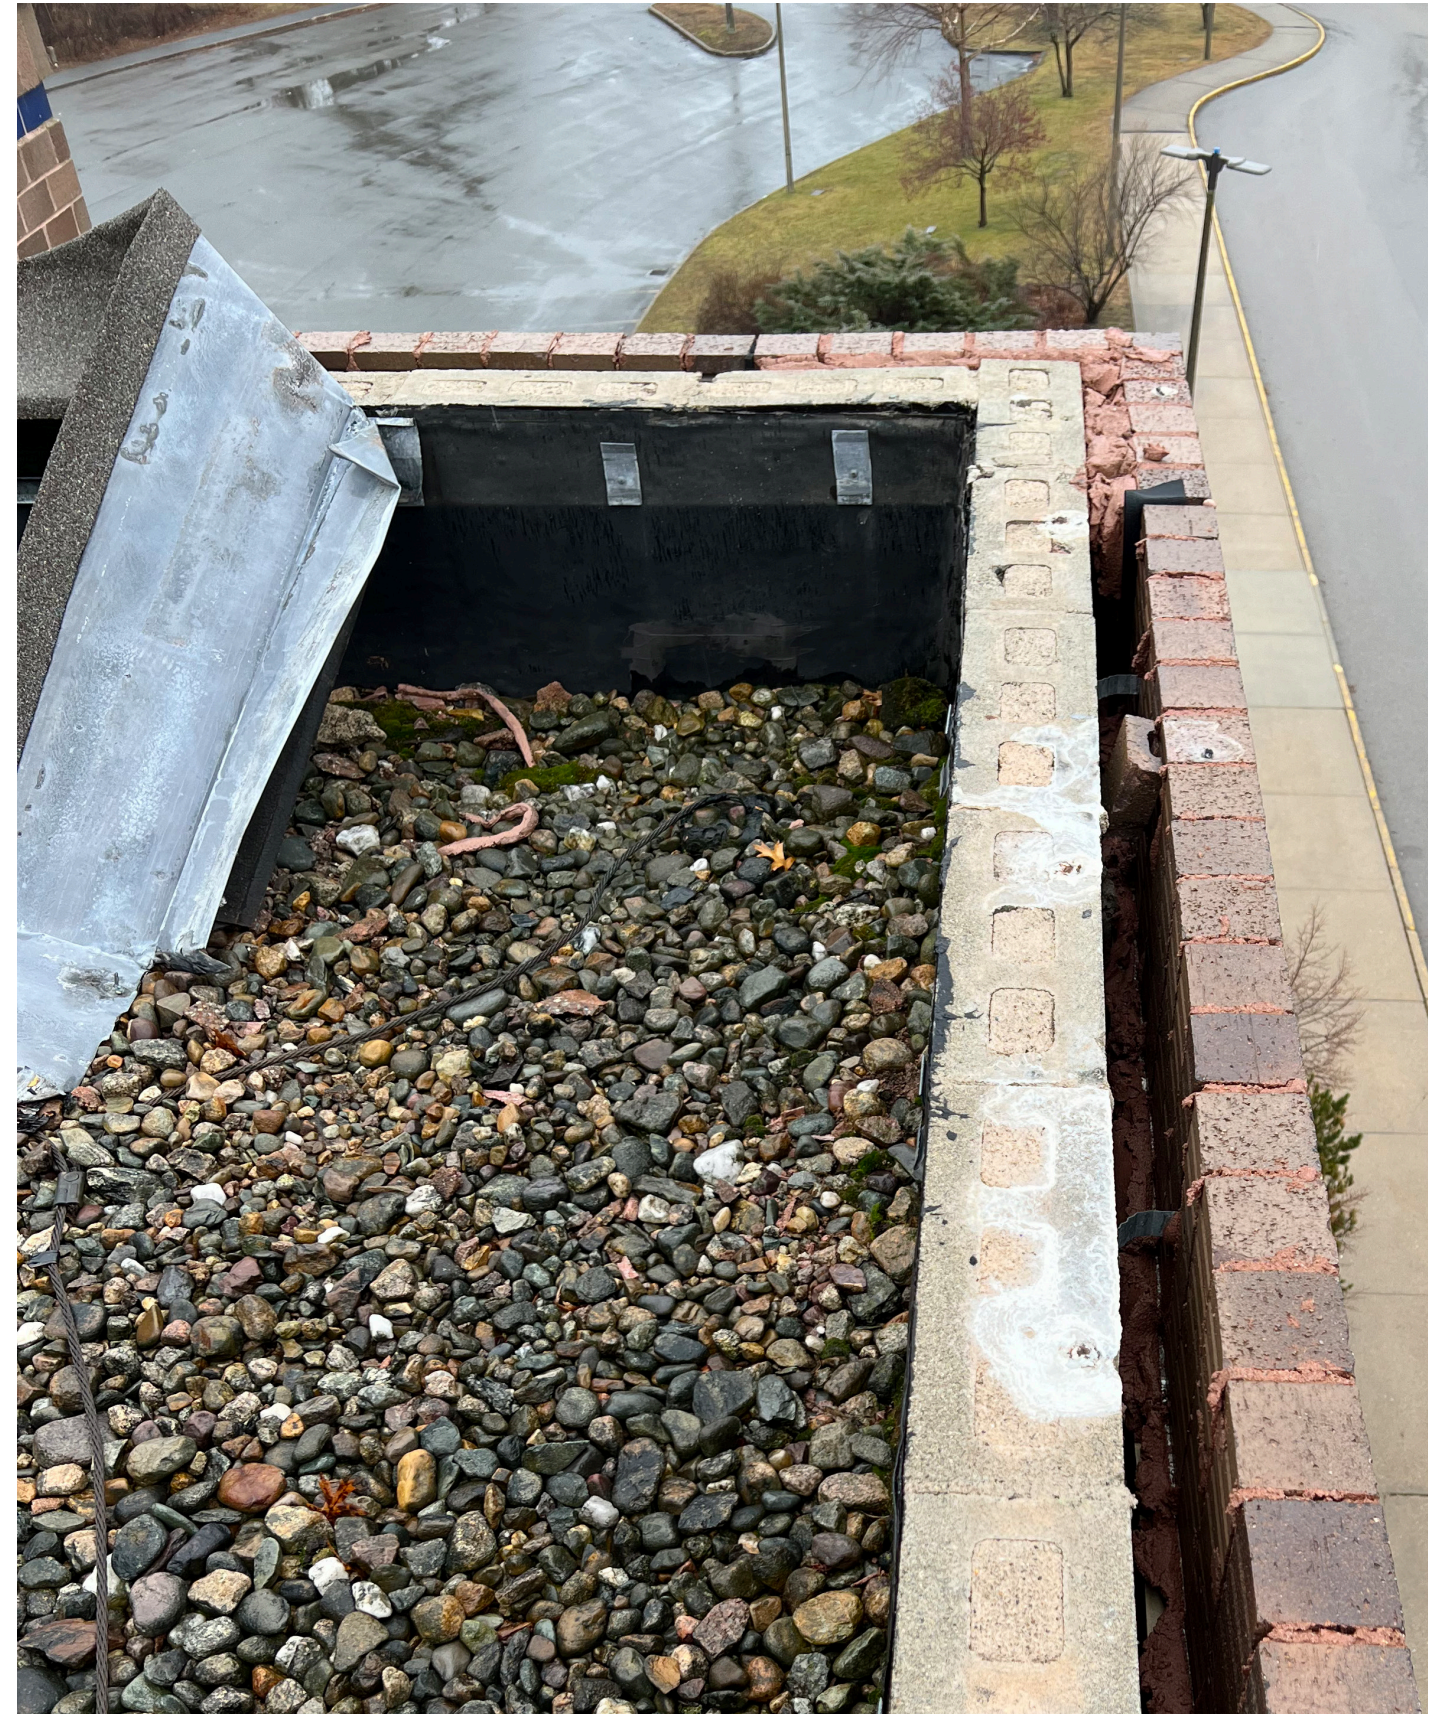
## Roof - Missing Coping

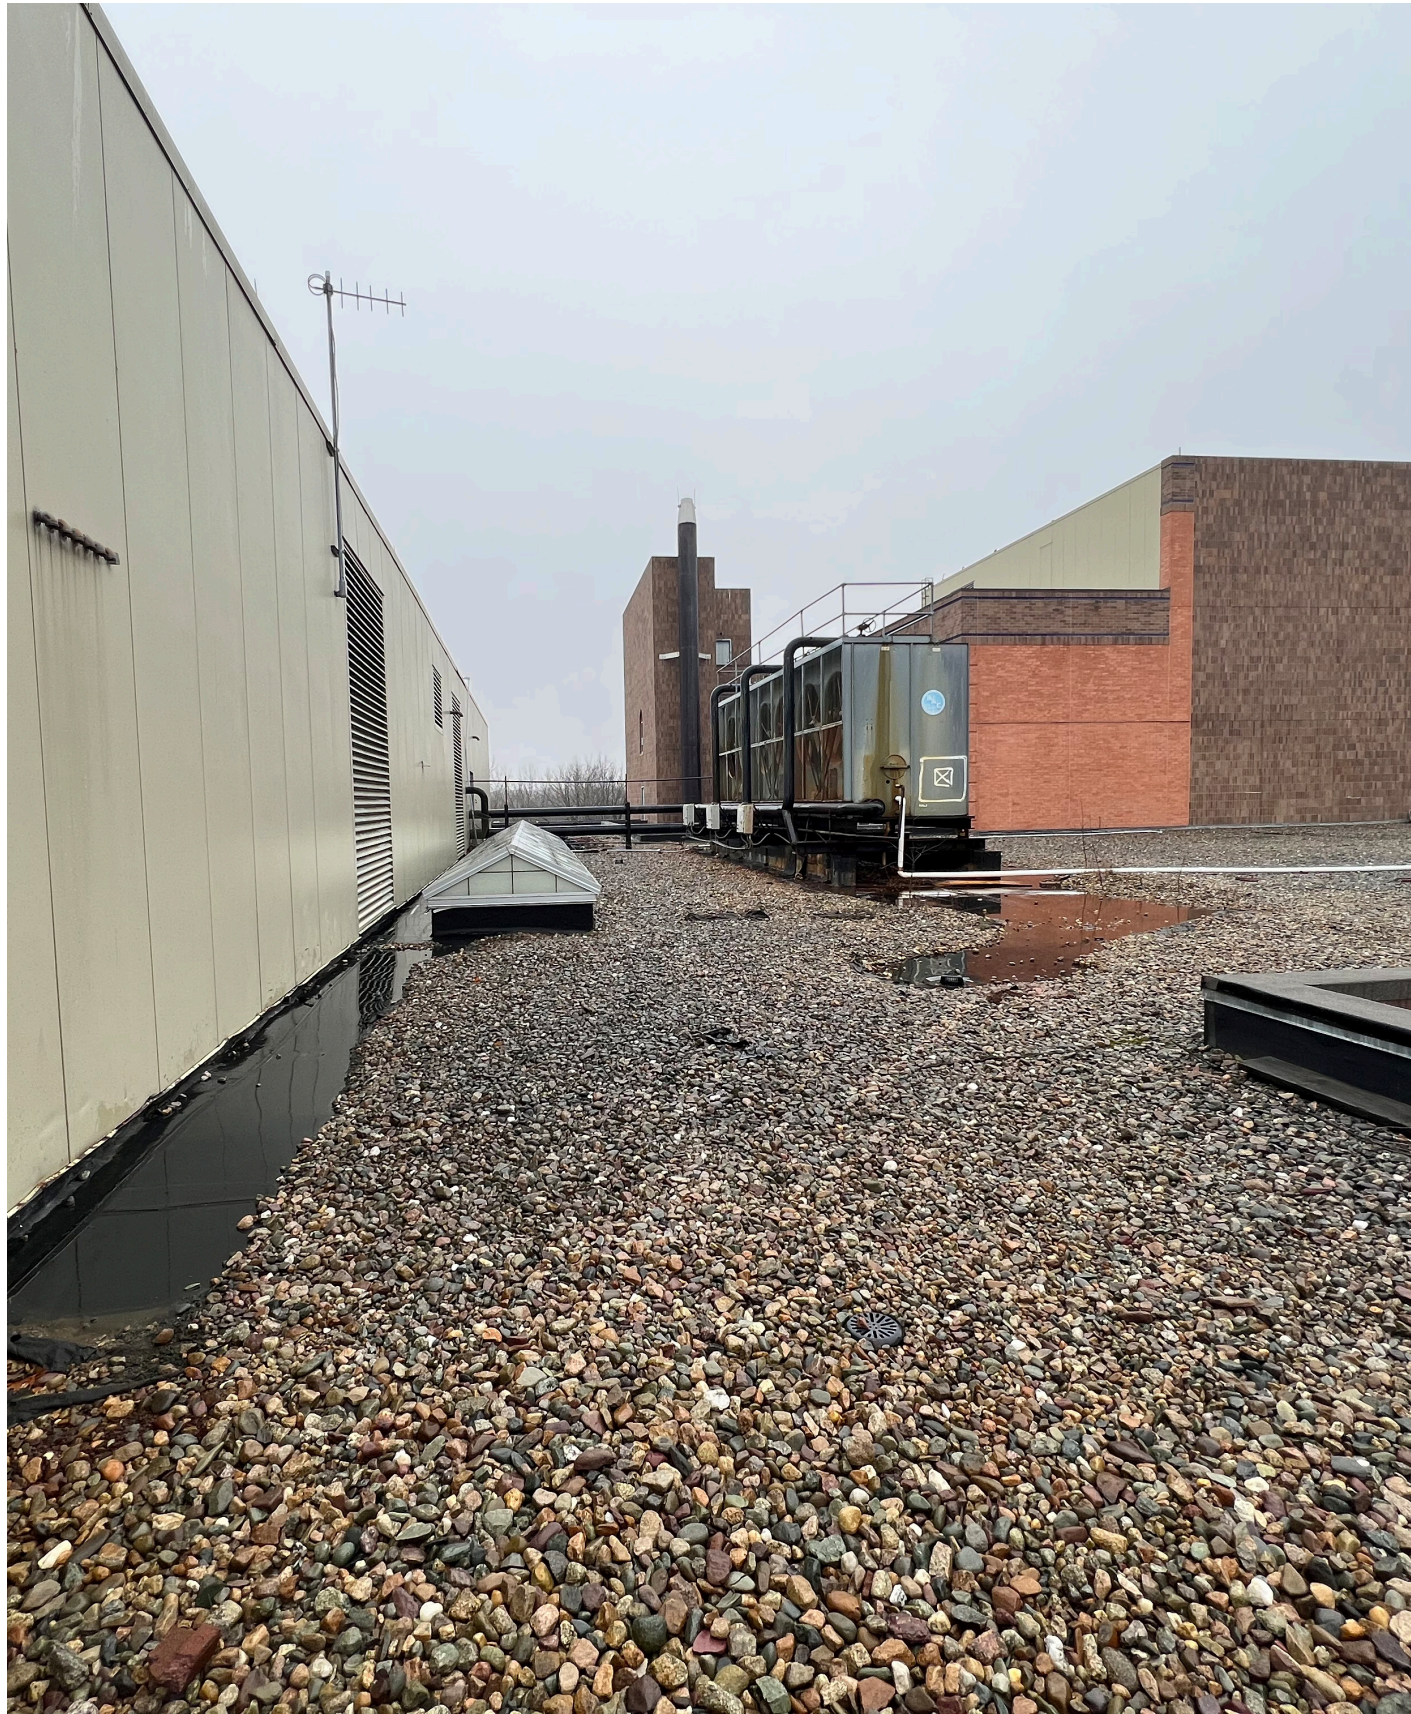
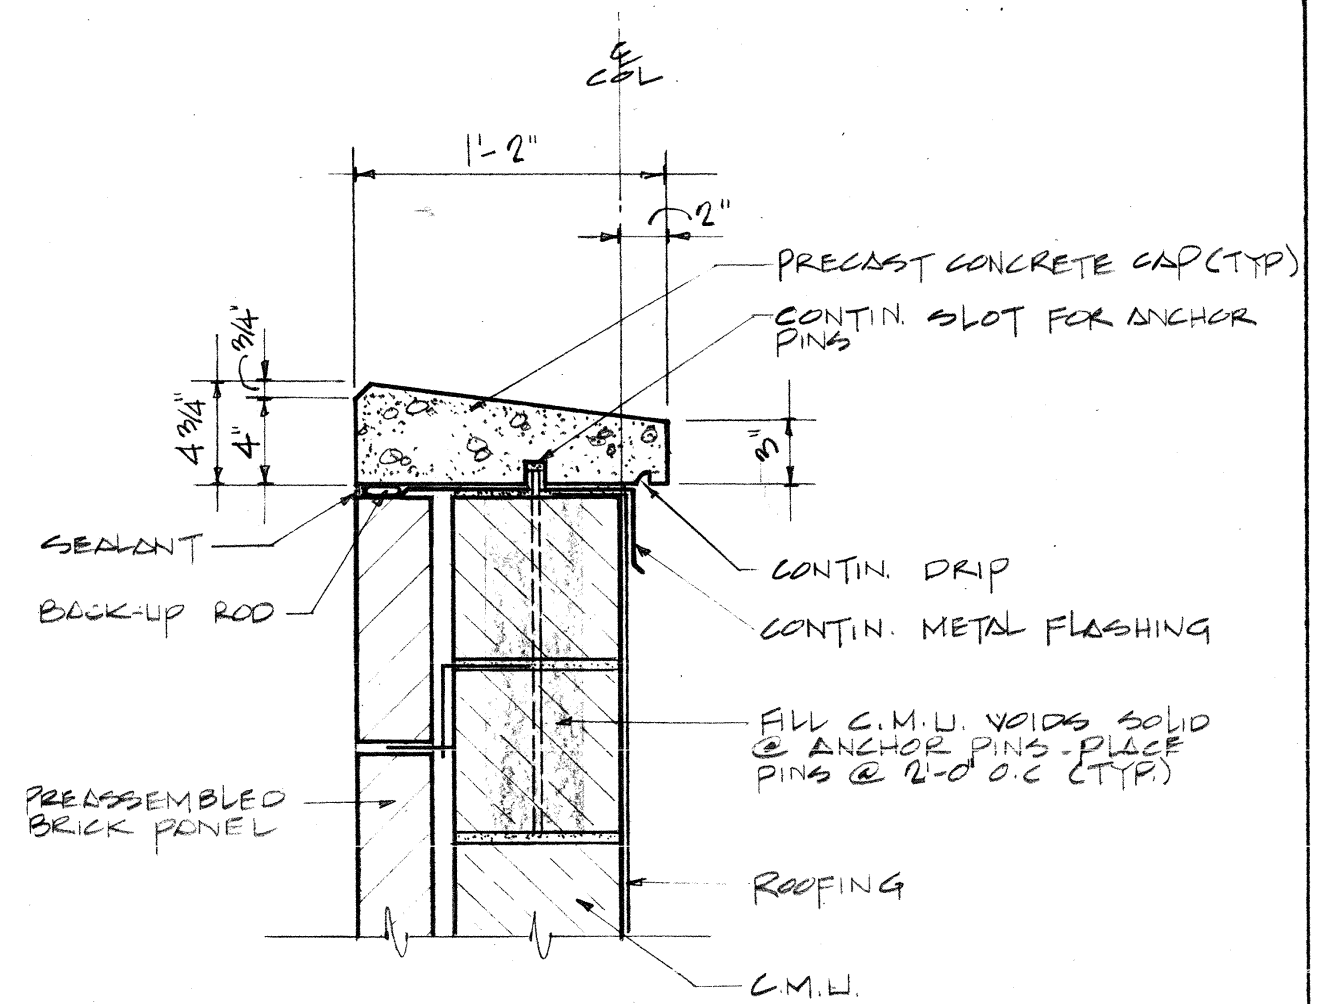
TYPICAL PARAPET DETAIL

**Roof - Pooling - Needs Sloped Insulation**
