# CHABAD CENTER FOR MISSION HILL

1615-1617 Tremont Street

Architectural Conservation District Commission

Design Review Application – Revised from March 7 Design Review

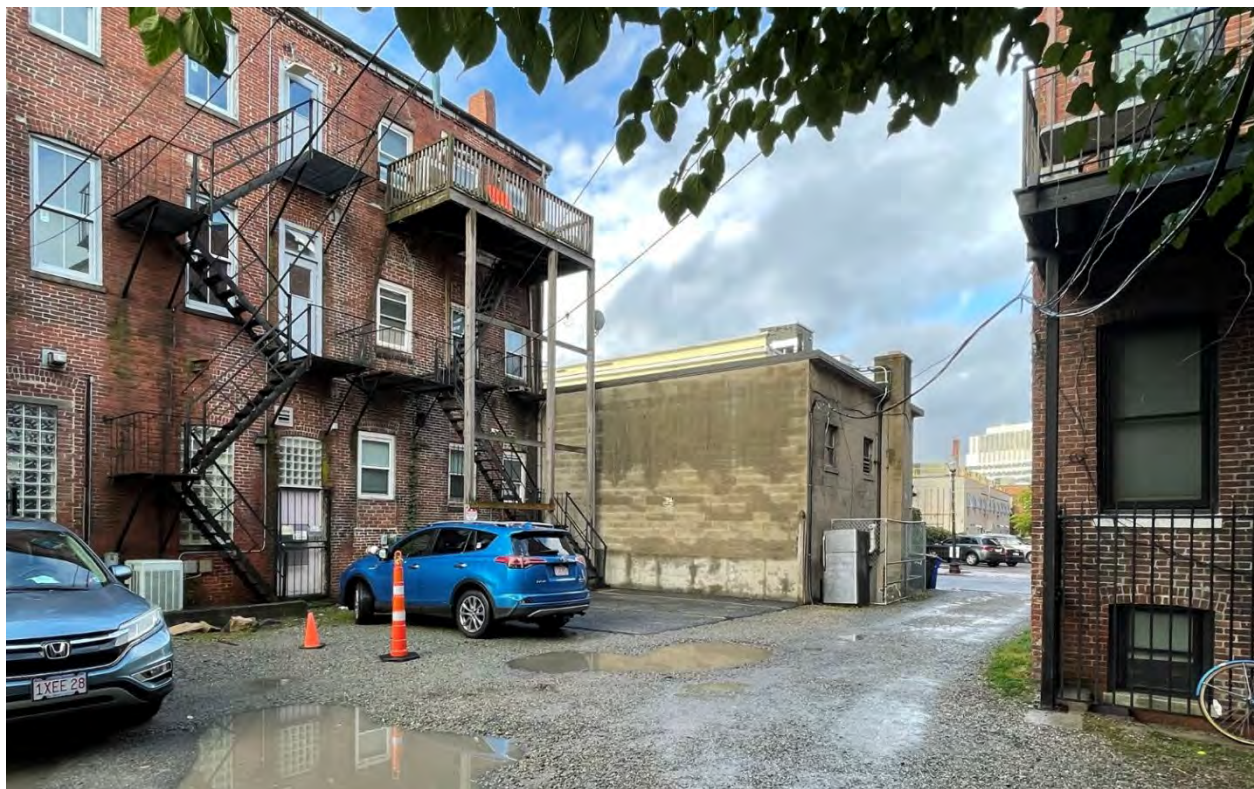
EXISTING ALLEY

Rear elevations and rear yards not subject to review per Section A.

Facades that face public streets (Tremont and Wigglesworth) are subject to review per Section A.

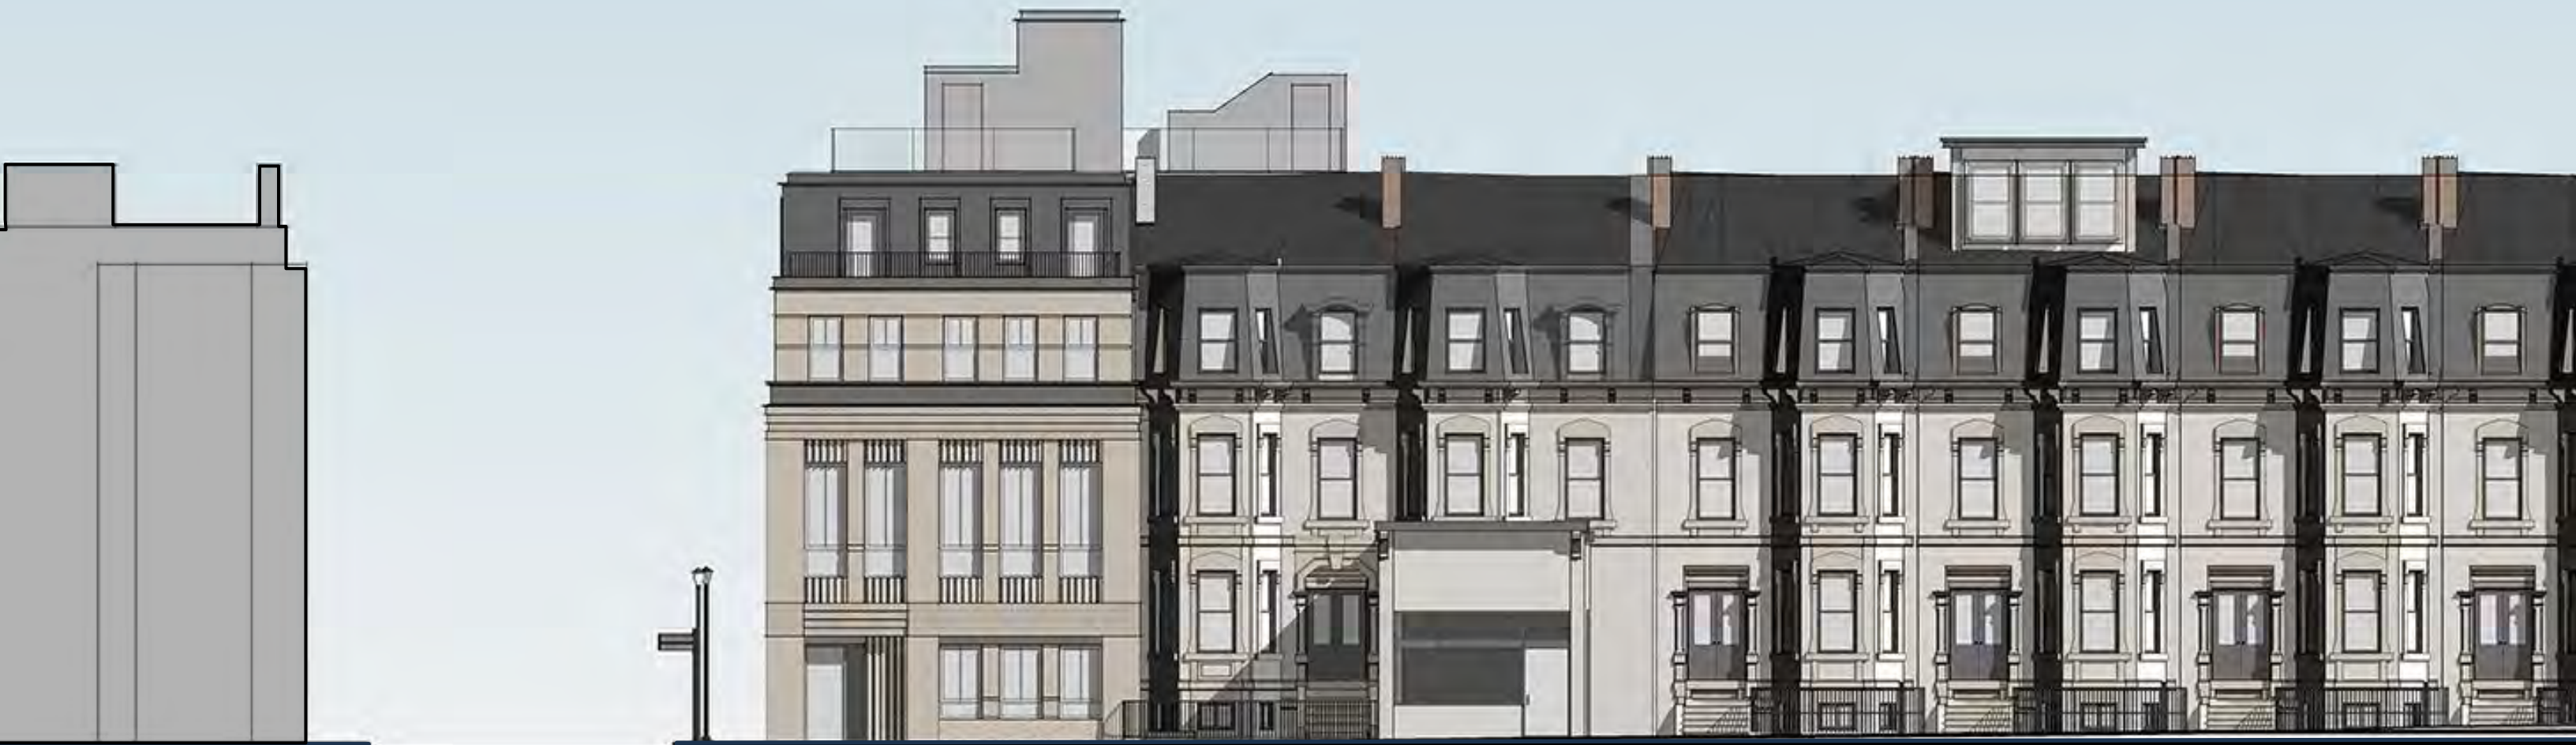
## Tremont Elevation

# Chabad Center New Construction – Previous Design (March 7, 2024)

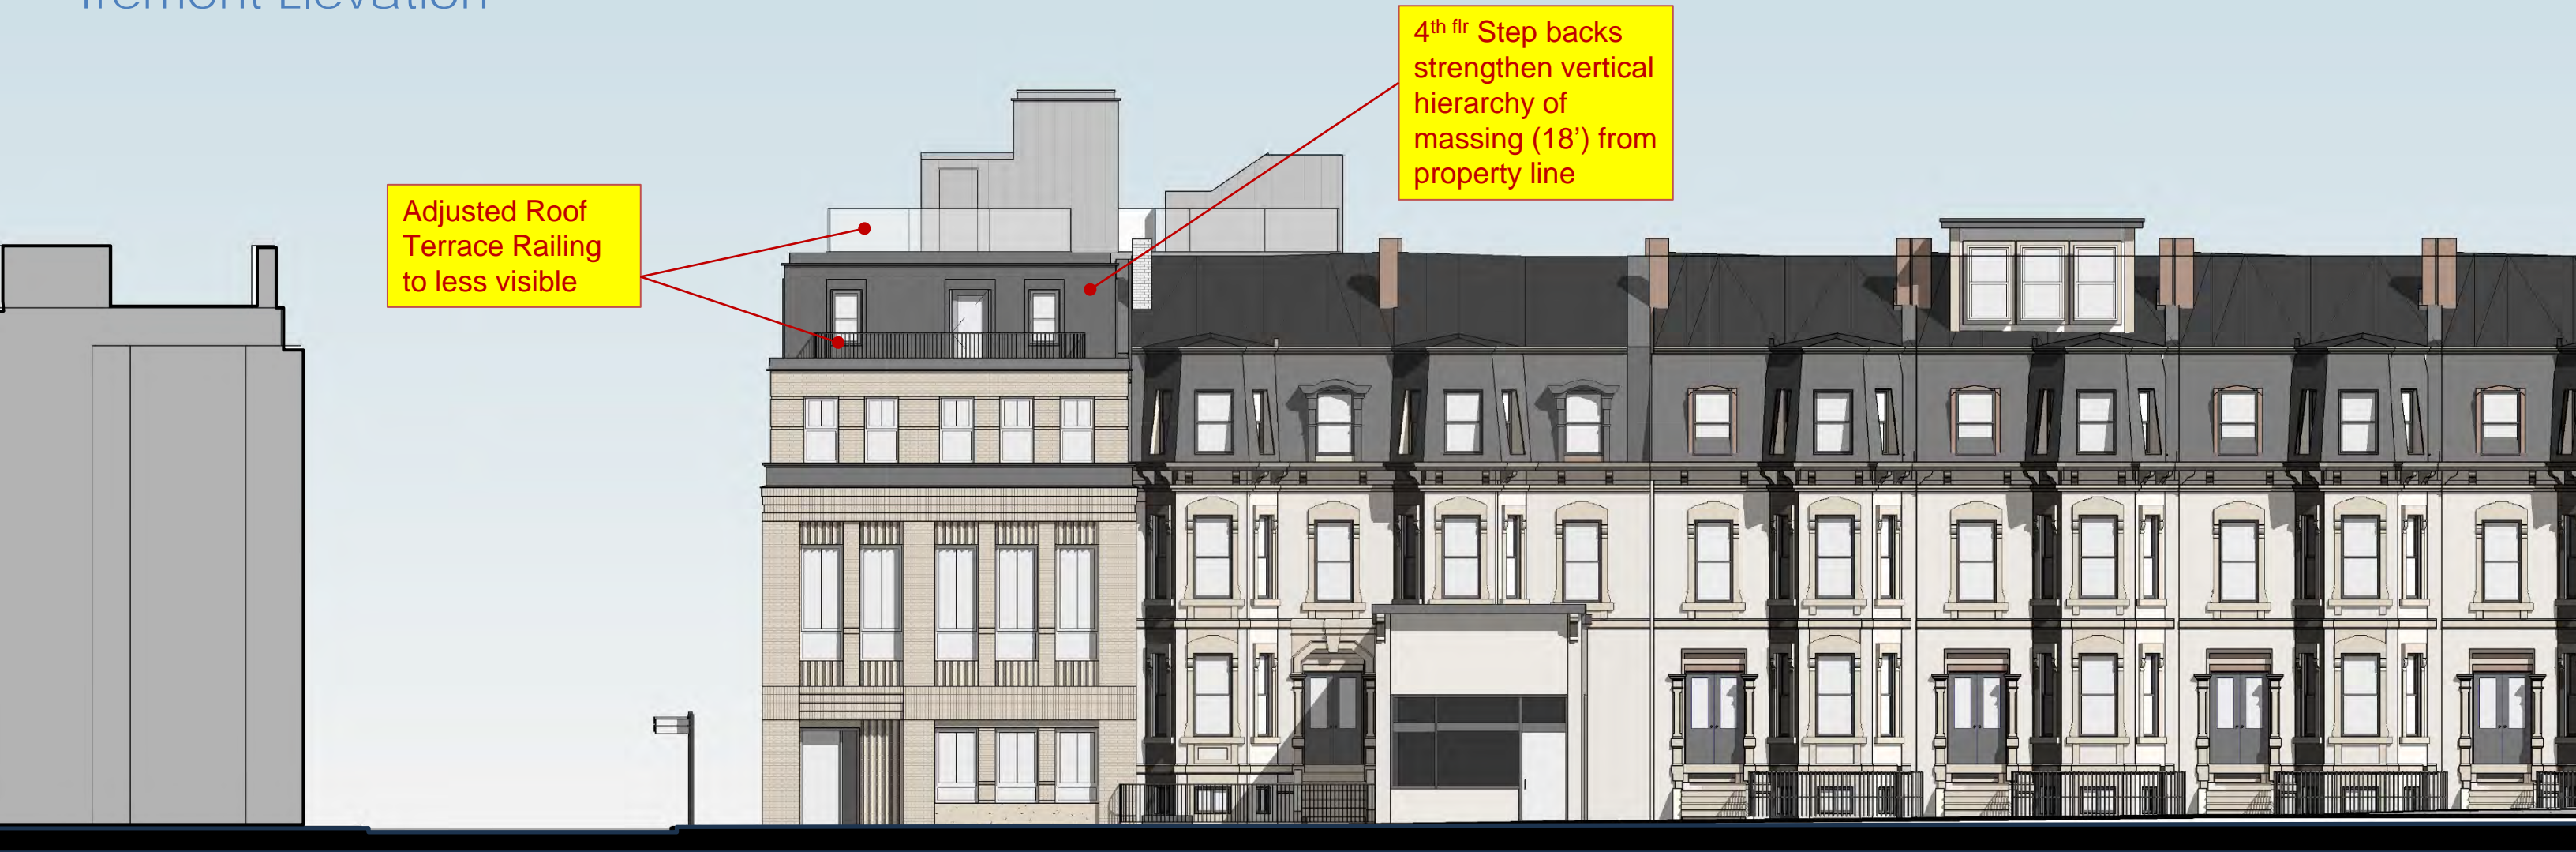
## Tremont Elevation

# Chabad Center New Construction – Proposed Design (April 4, 2024)

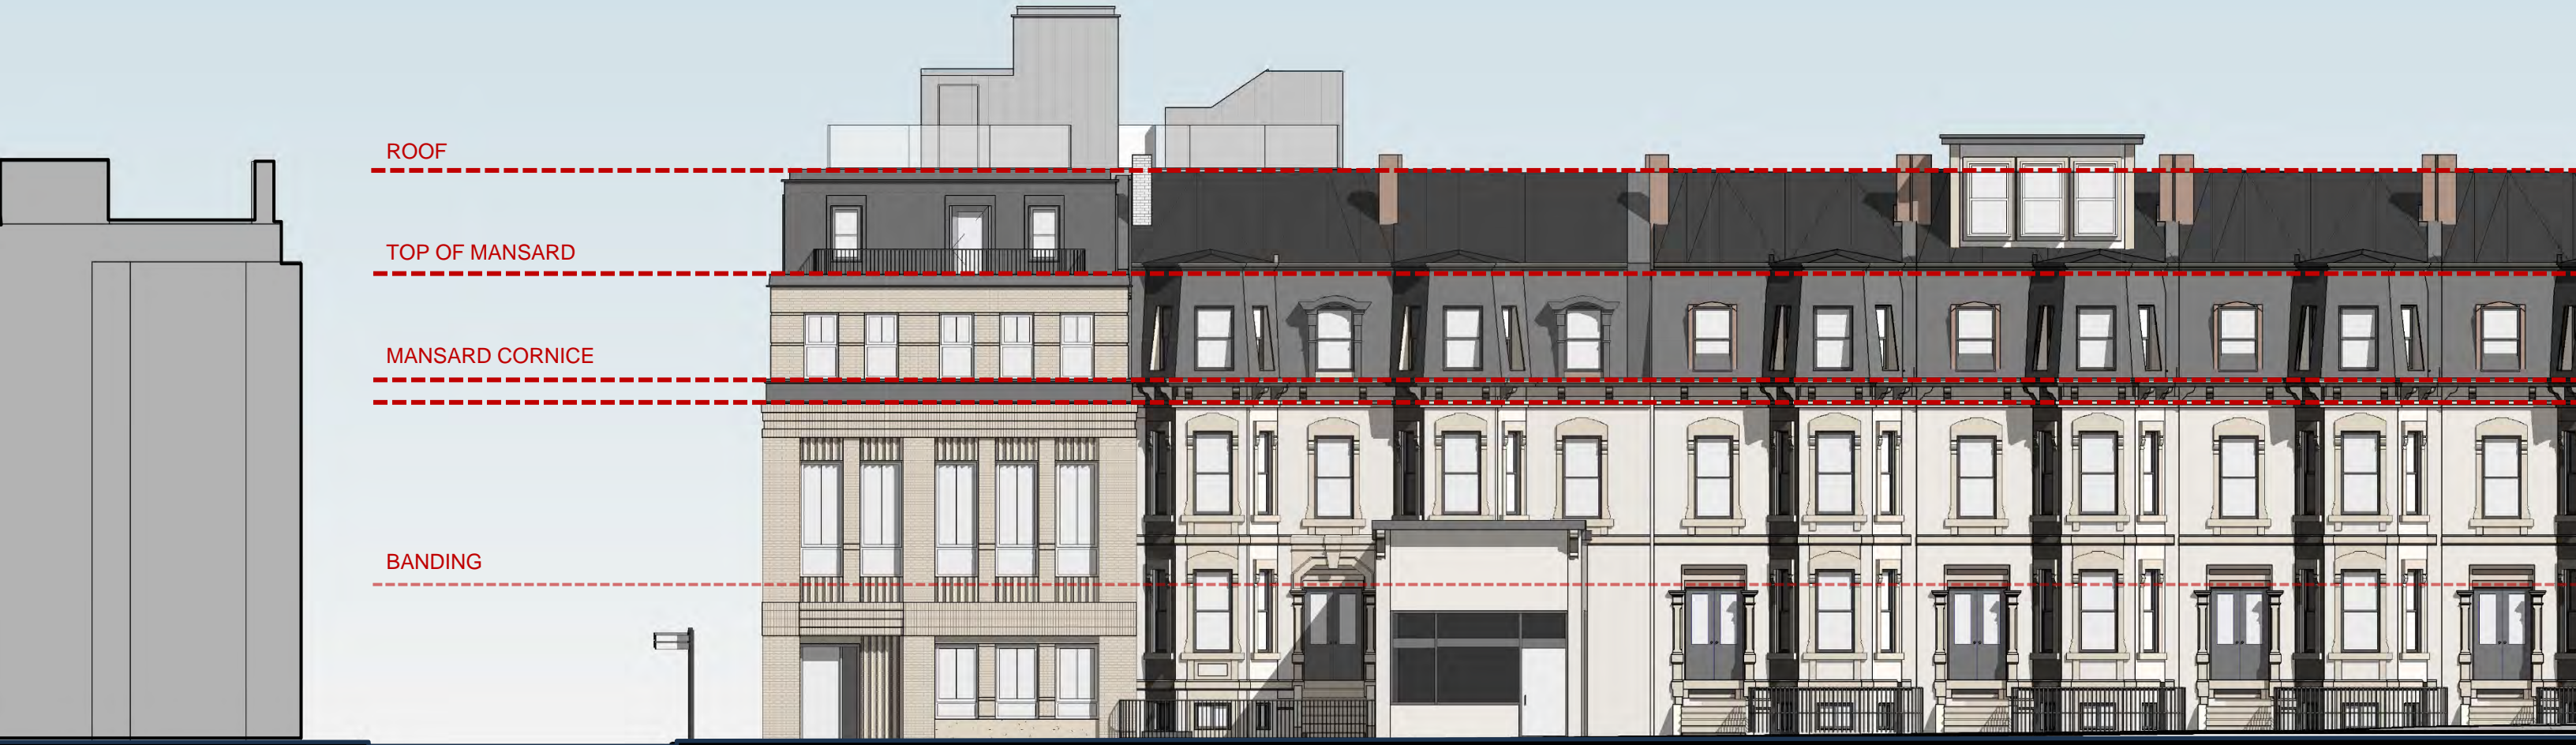
## Tremont Elevation

Entry

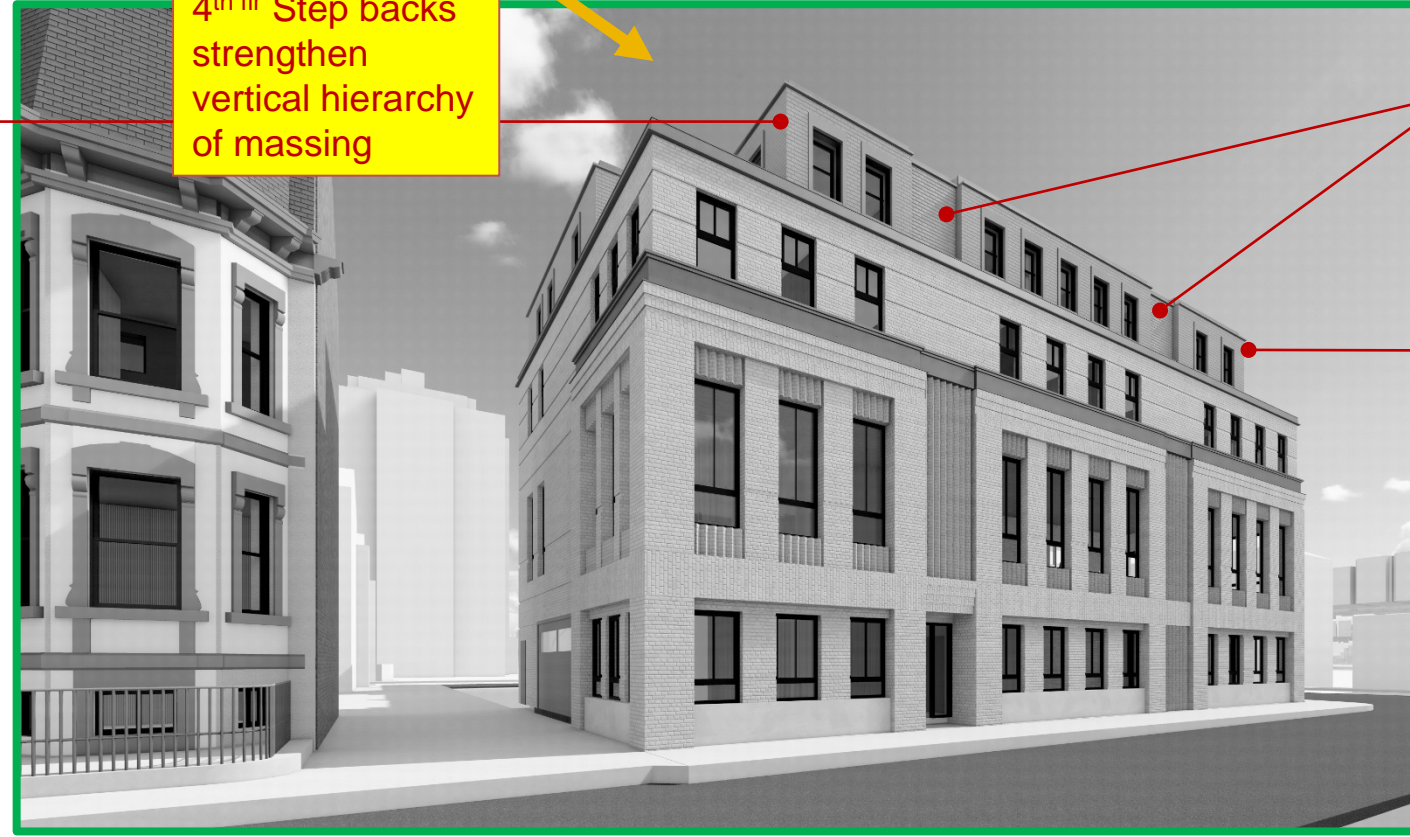
Street View – Standing on sidewalk down Wigglesworth

4<sup>th</sup> flr Step backs strengthen vertical hierarchy of massing

Recesses at wall to break down scale along Wigglesworth St.

4<sup>th</sup> flr Step backs strengthen vertical hierarchy of massing (18') from property line

Adjusted Roof Terrace Railing to less visible

Elevator headhouse visible from several rowhouses down Wigglesworth

Elevator headhouse not visible from across Wigglesworth

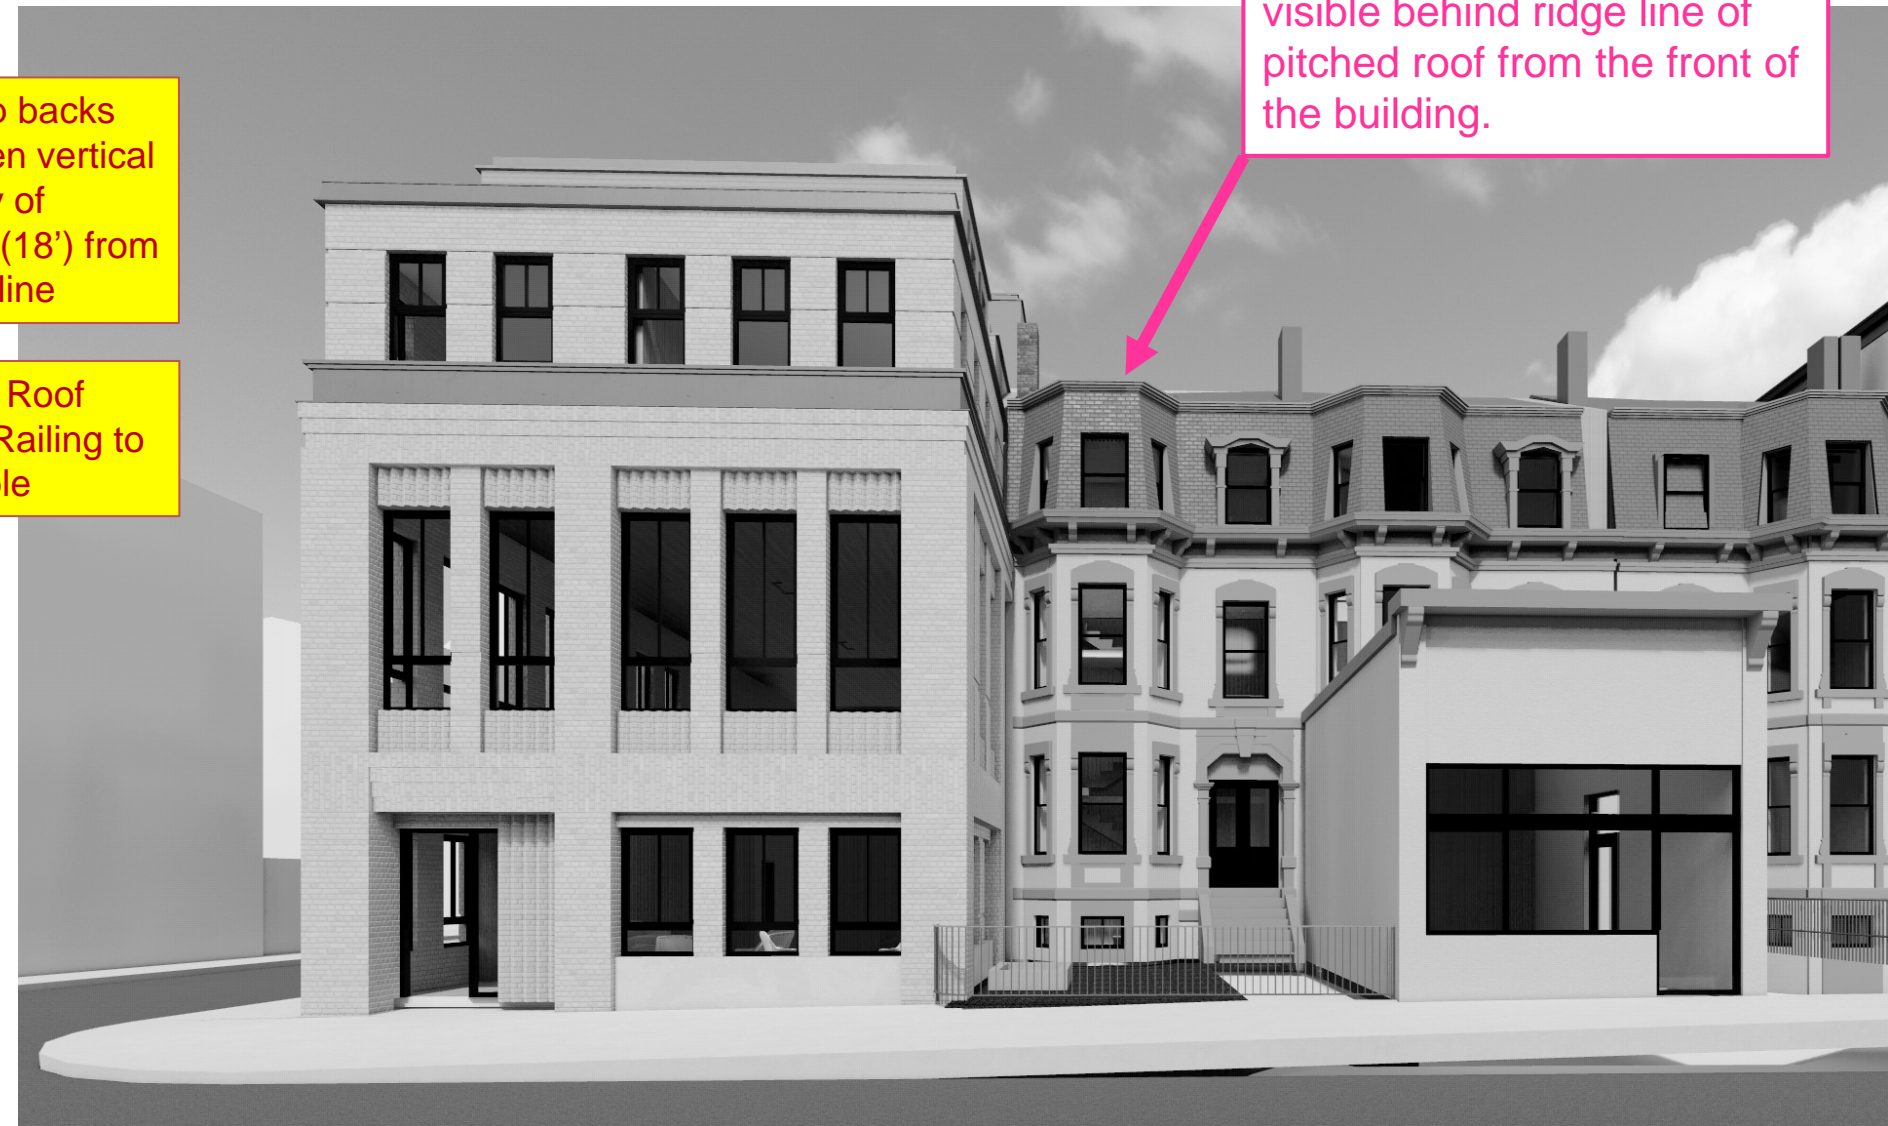
Street View – Standing Across Tremont, Looking North

4<sup>th</sup> flr Step backs strengthen vertical hierarchy of massing (18') from property line

Adjusted Roof Terrace Railing to less visible

Guideline Section E requires vertical addition to not be visible behind ridge line of pitched roof from the front of the building.

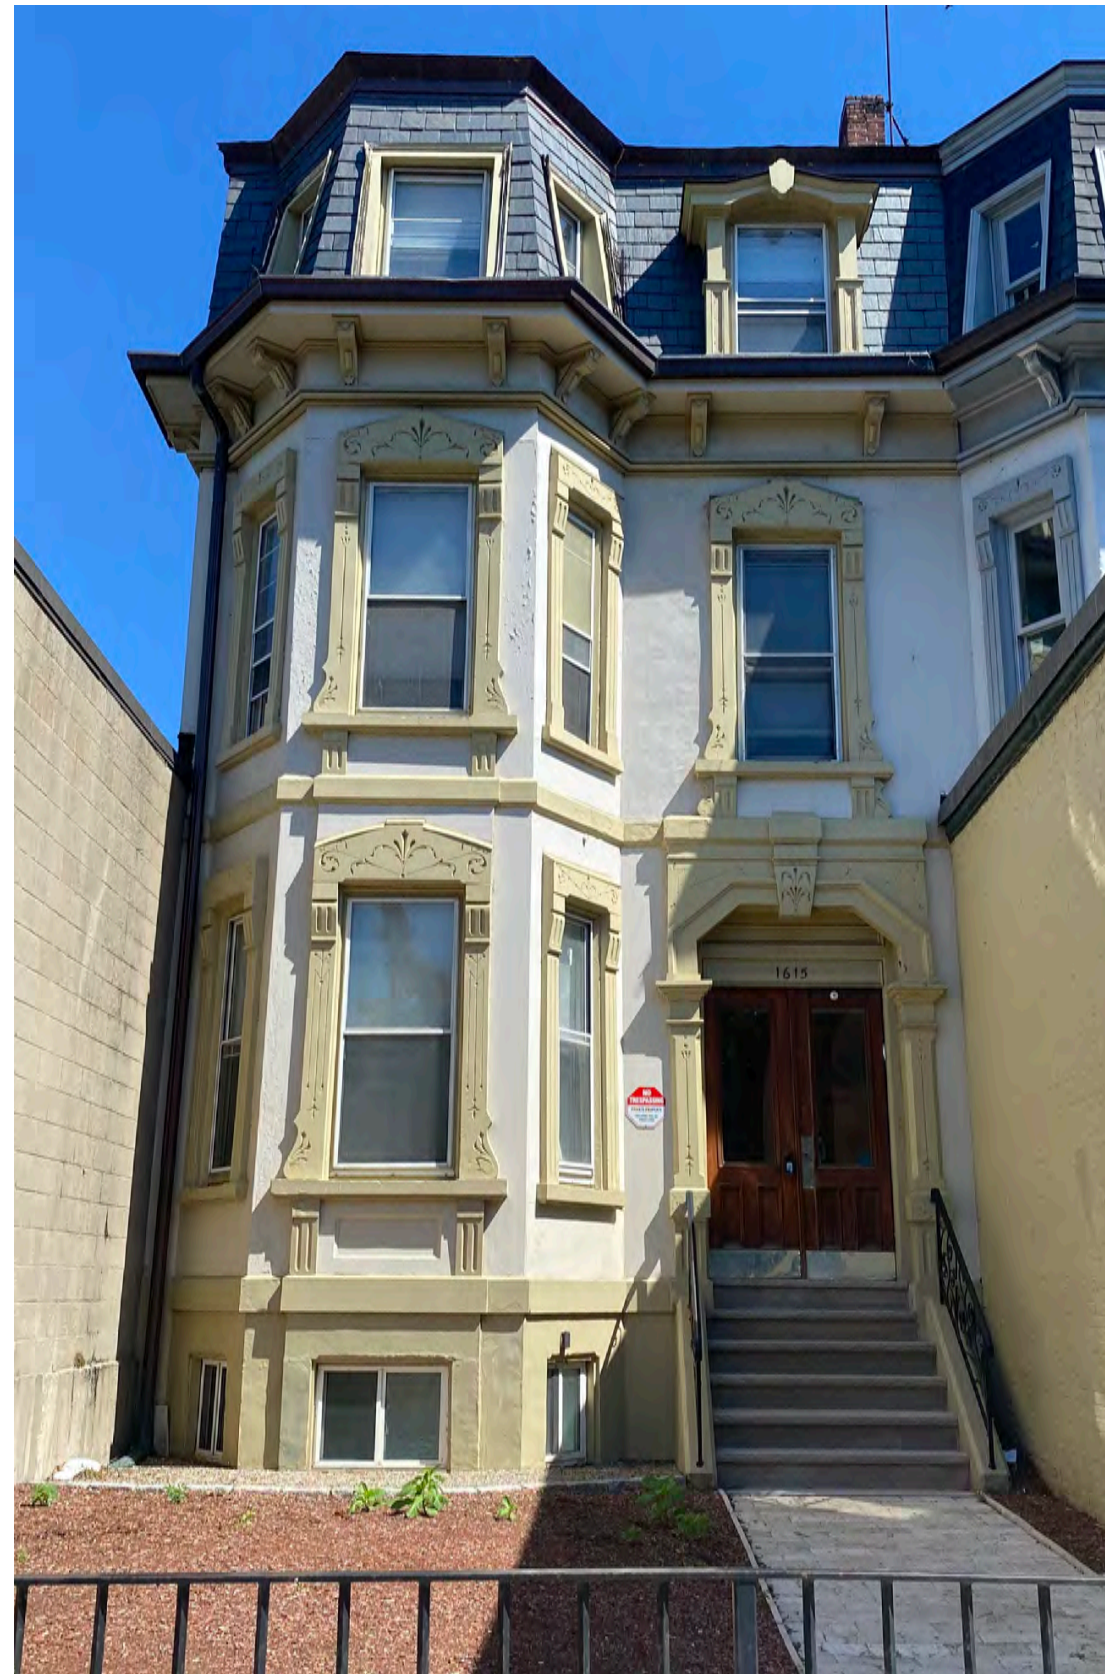
1615 Tremont St

- Lower Level
- Match stone window surrounds, Final color TBD

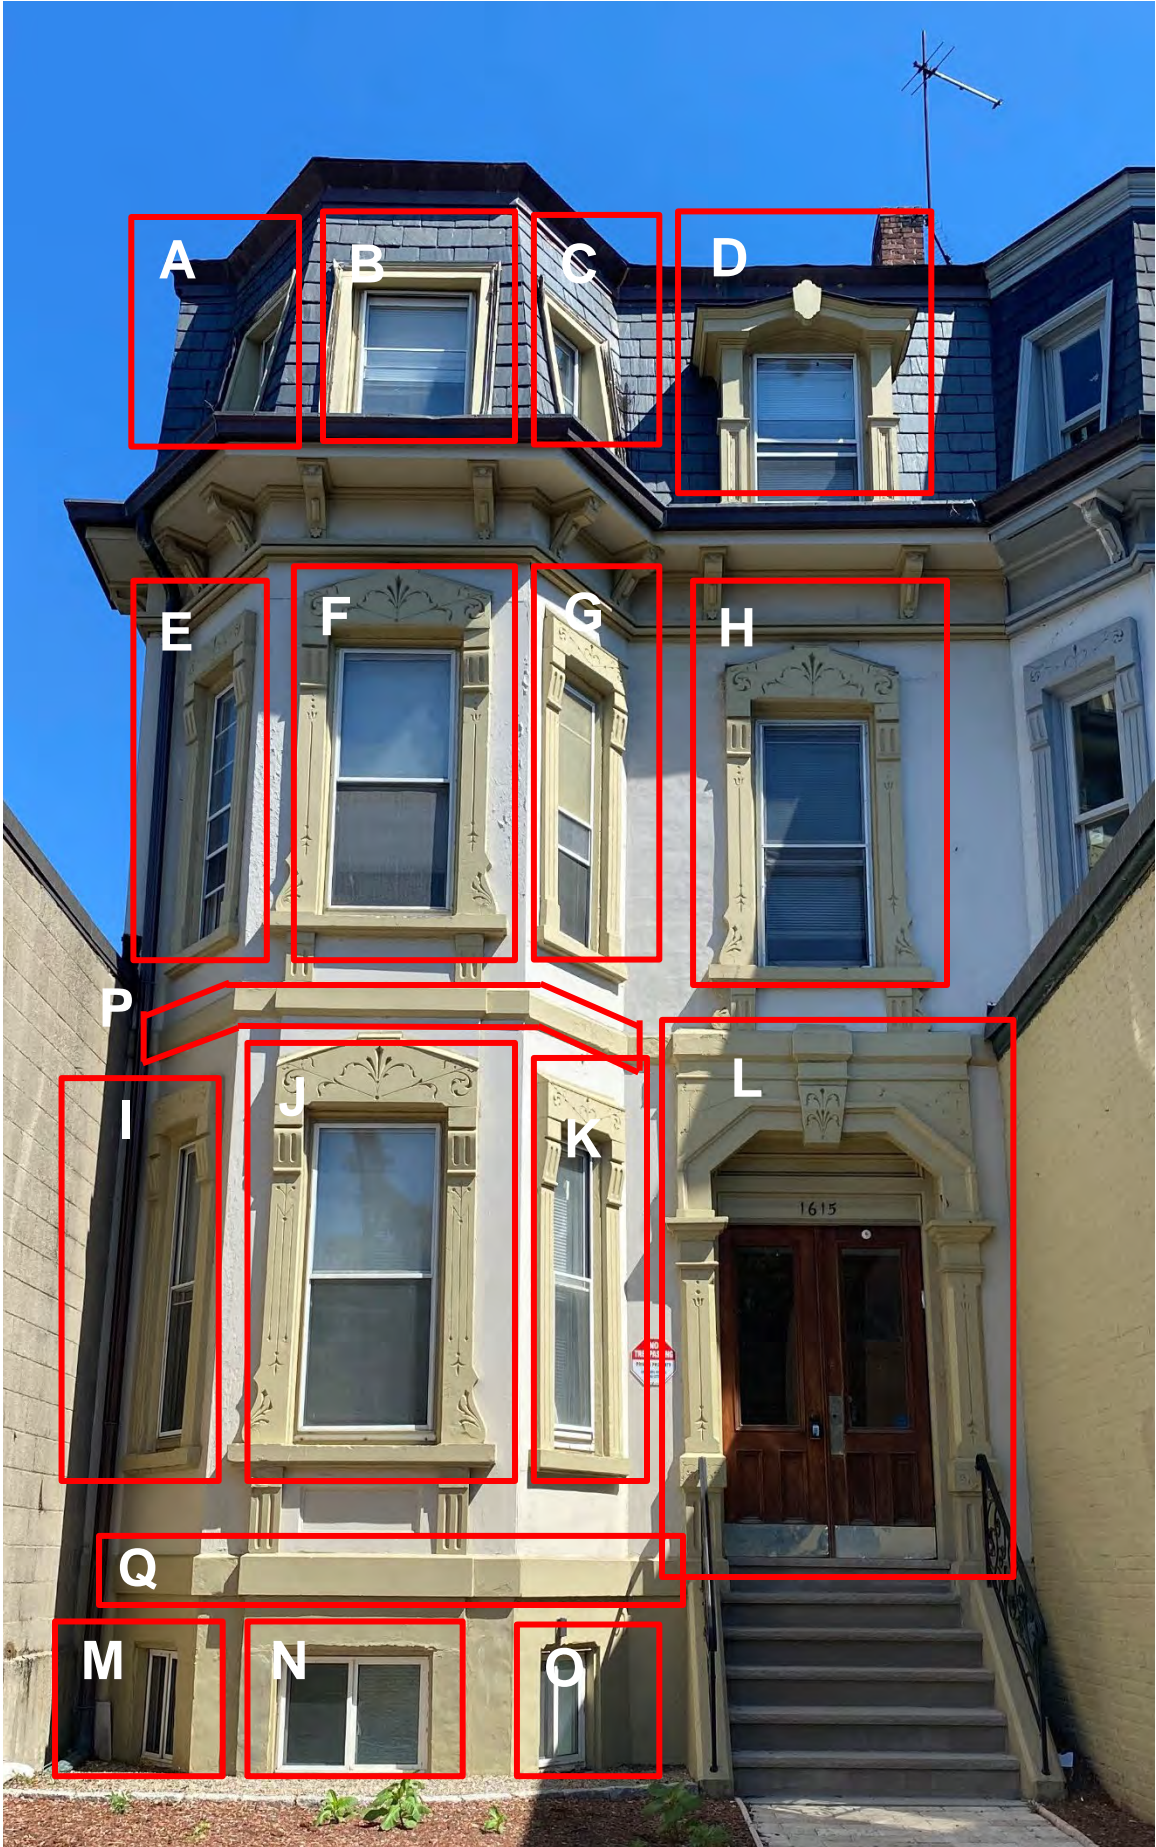
The approach to the row house façade will consist of a combination of restoration, reconstruction, and change depending on the existing condition of the building component or feature.

The interior of the row house has almost no remaining historic integrity as stair and plan arrangement have been radically altered in the past.

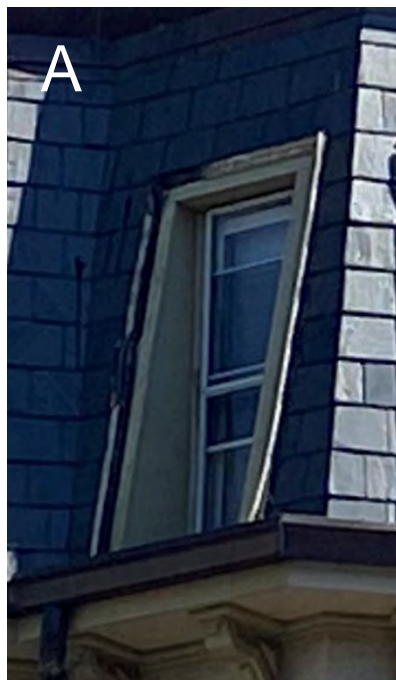
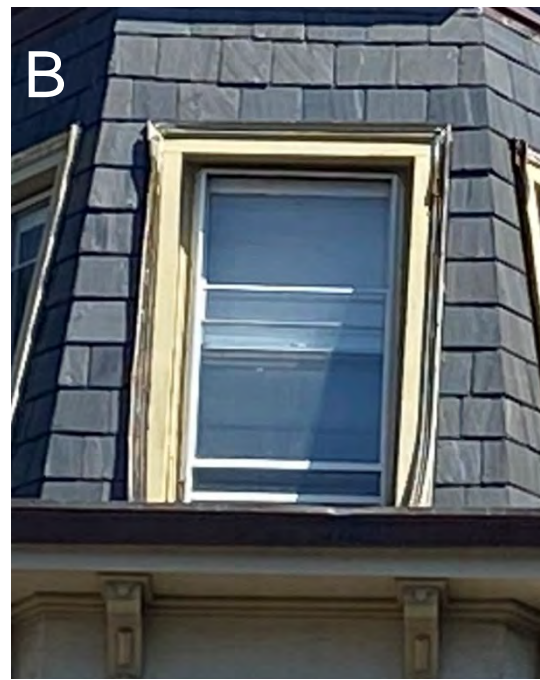
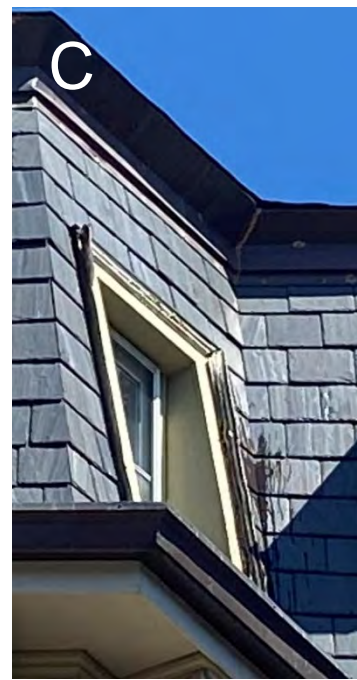
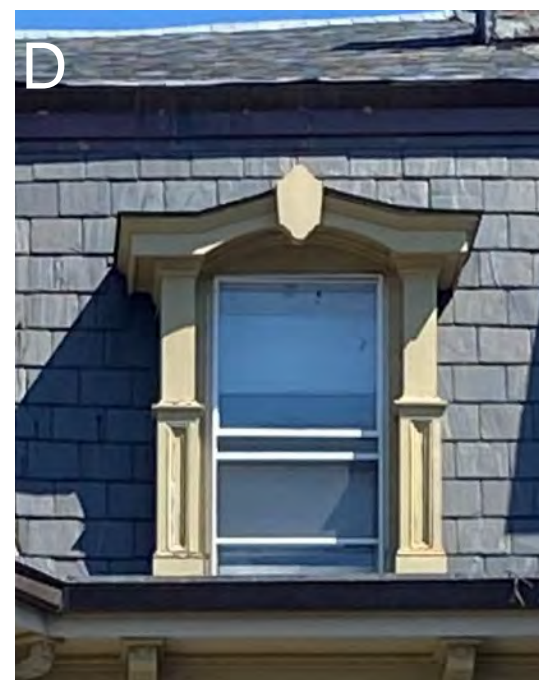
Mansard Level Windows

No.	Feature	Current Condition	Treatment
<b>1</b>	<b>Windows</b> <b>Mansard Windows</b>	<b>Exterior</b>	<b>Exterior</b>
	Window Sash	Poor condition	Reconstruct to match historic double hung two over two windows
	Sill	Poor condition	Reconstruction
	Lintel		
	Window surrounds	Poor condition	A,B,C to be reconstructed
			D to be reconstructed based on historic design to incorporate the decorative molding and medallion

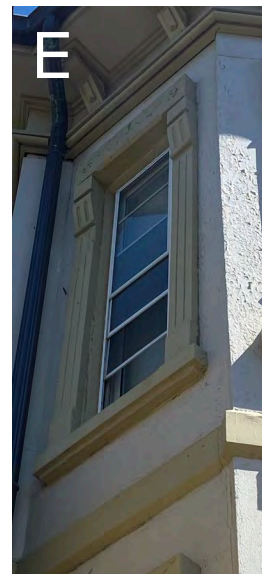
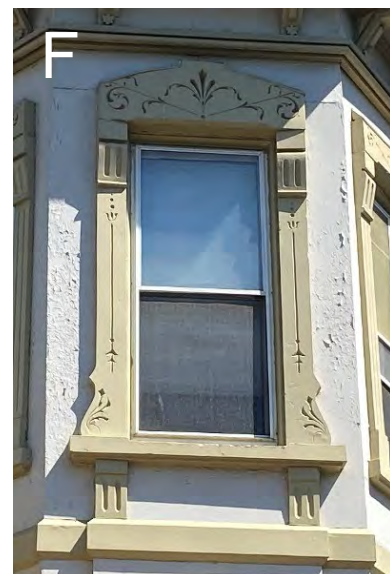
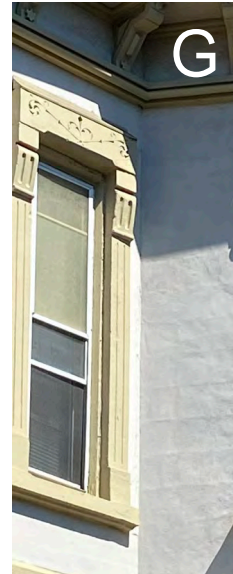
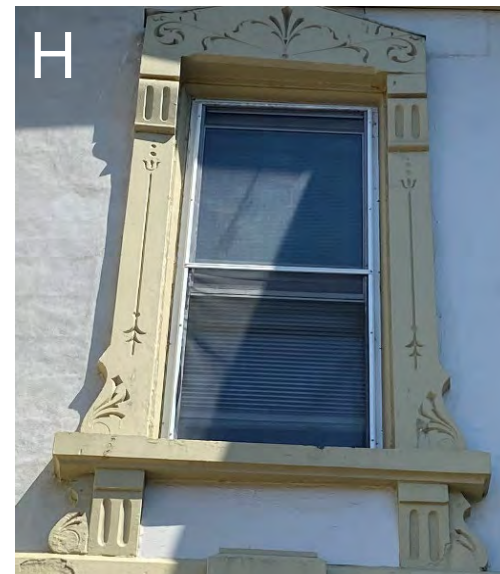
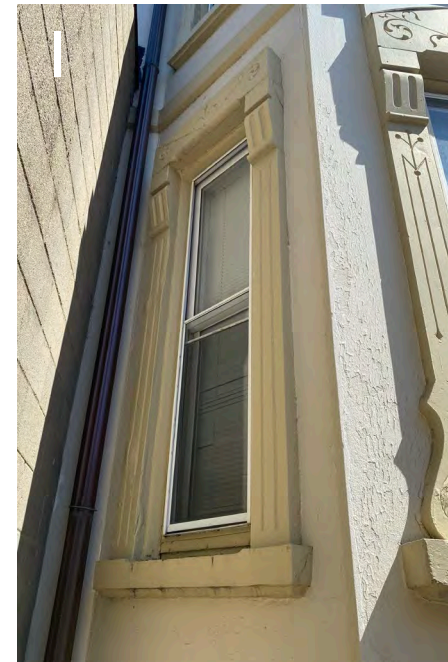
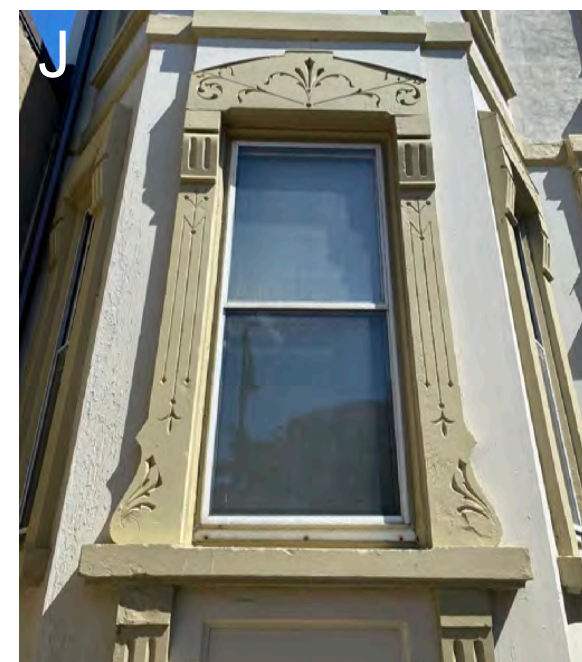
Second Floor Windows

No.	Feature	Current Condition	Treatment
<b>1</b>	<b>Windows</b> <b>Second Floor and Parlor Windows</b>	<b>Exterior</b>	<b>Exterior</b>
	Window Sash	Poor condition	Reconstruct all. F, H, J match historic double hung two over two windows
	Sill	Poor condition	Reconstruction
	Lintel		
	Window surrounds	Finish appears to be in sound condition	Remove flashing over F, G, H, J, K and replace if needed. Strip stucco/paint and leave sandstone exposed on all.

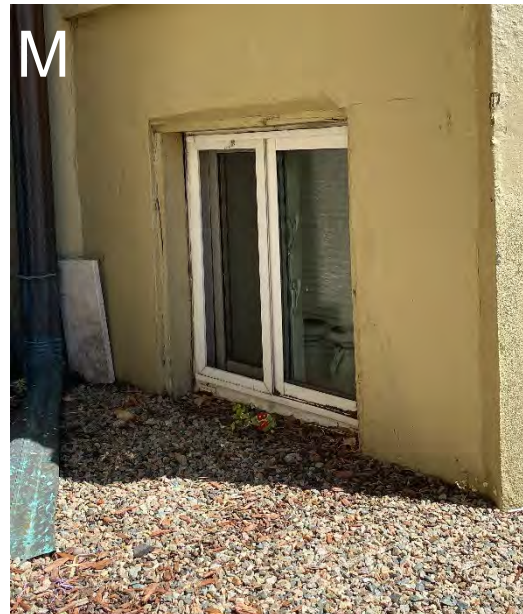
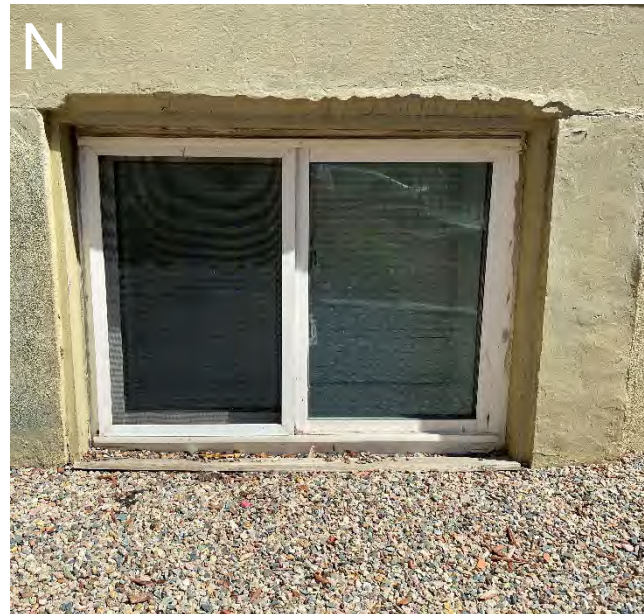
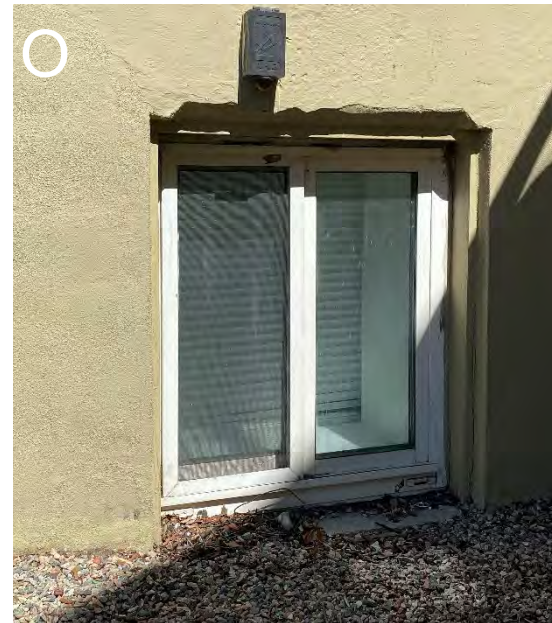
Basement Level Windows

No.	Feature	Current Condition	Treatment
<b>1</b>	<b>Windows</b> <b>Basement Windows</b>	<b>Exterior</b>	<b>Exterior</b>
	Window Sash	Poor condition	Replace
	Sill	Poor condition	Replace
	Lintel

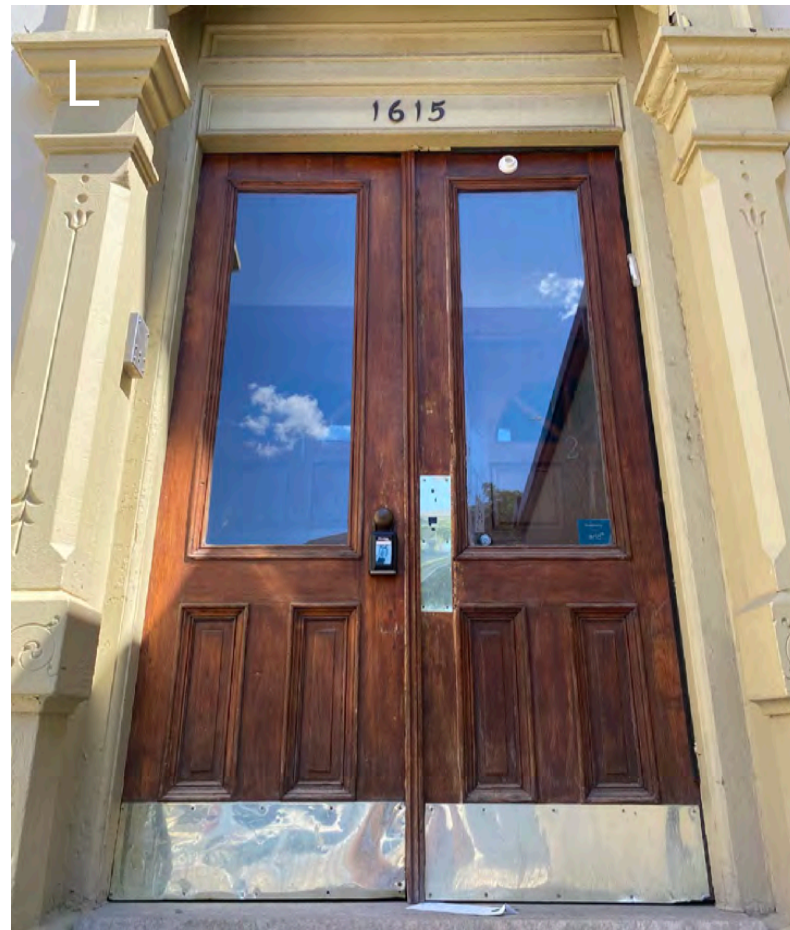
No.	Feature	Current Condition	Treatment
<b>2</b>	<b>Door</b>	<b>Exterior</b>	<b>Exterior</b>
	Paneling	Hardwood with metal kick plates	Door can be retained with all hardware replaced
	Transom		
	Vestibule Sidewalls	One side plastered; one side exposed brick

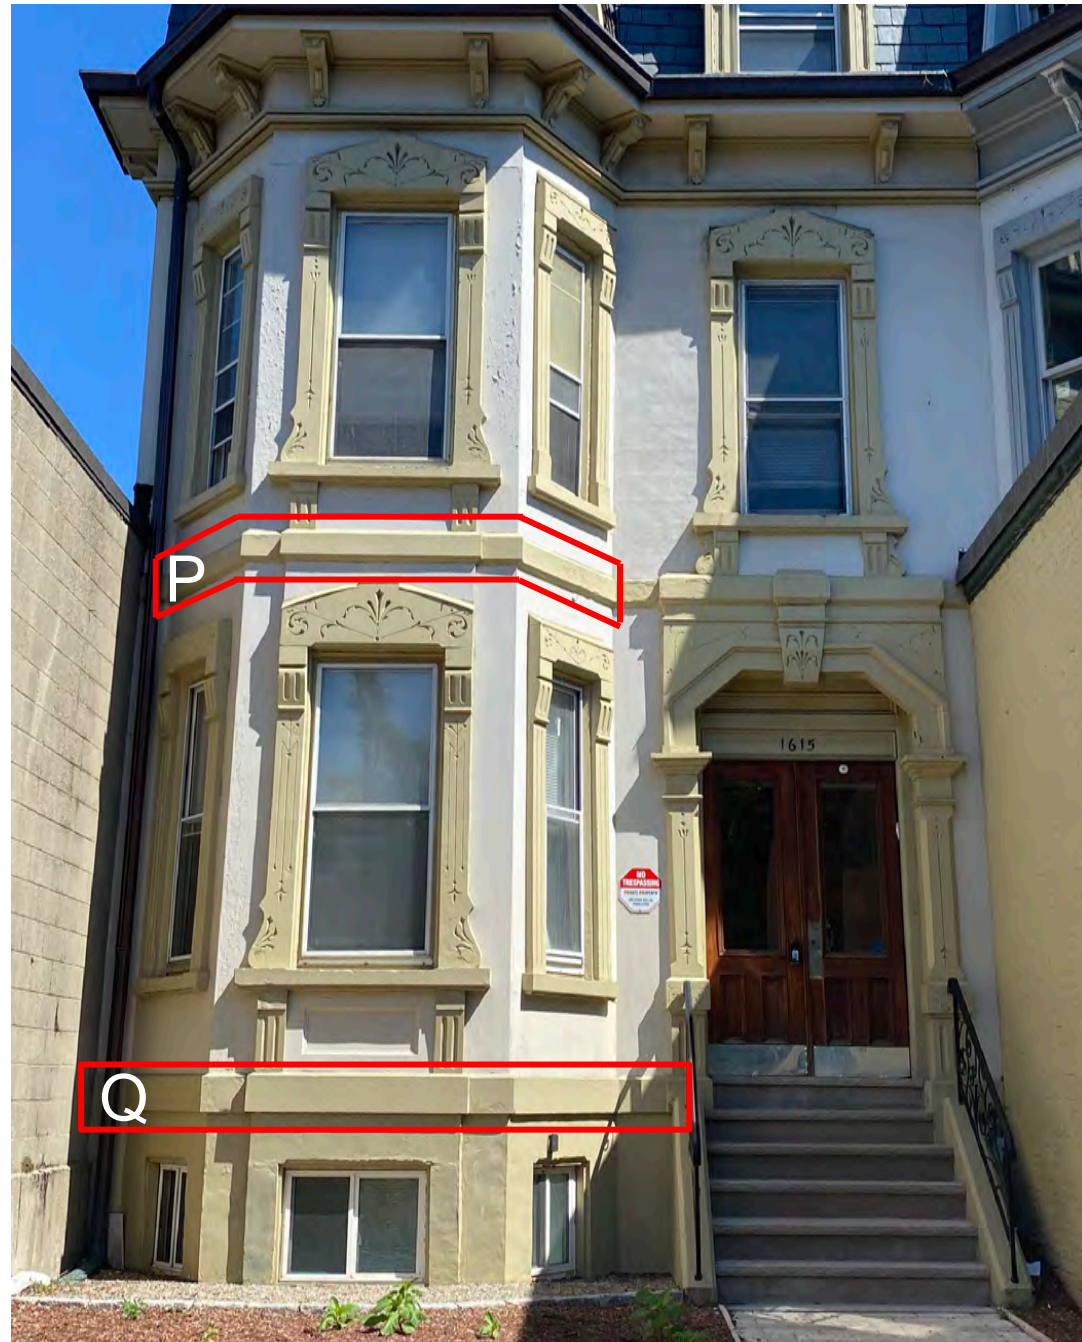
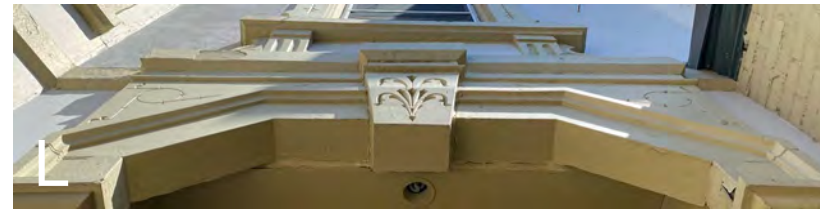
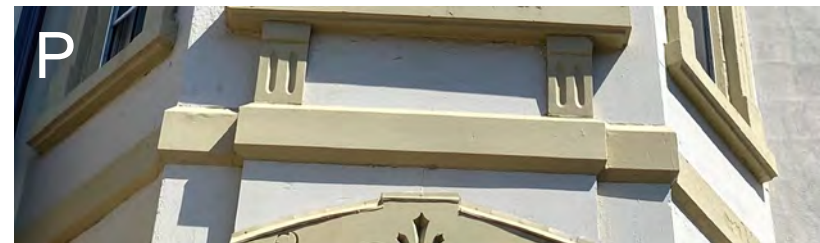
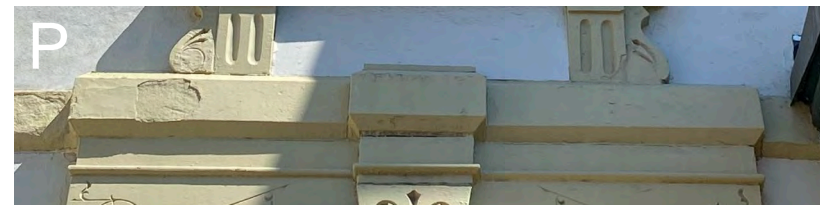
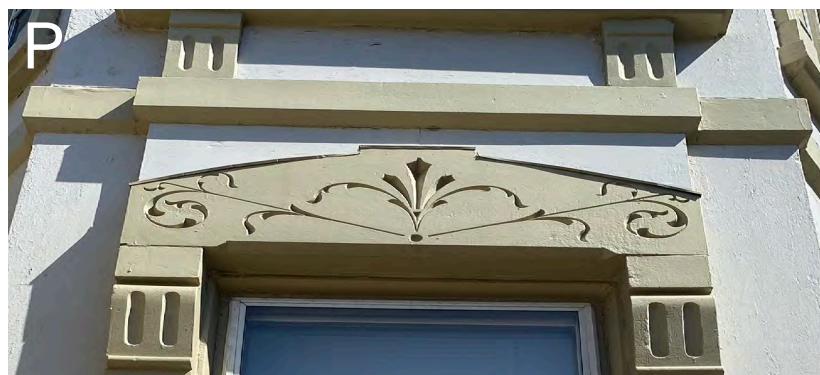
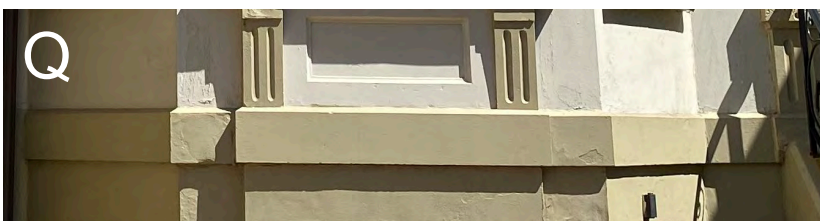
No.	Feature	Current Condition	Treatment
3	<b>Ornamentation: Stucco over stone trim on facade</b>	good condition	Stucco/paint to be stripped and left as exposed stone if exploratory work reveals suitable condition
