# CHABAD CENTER FOR MISSION HILL

1615-1617 Tremont Street

Architectural Conservation District Commission

Design Review Application – Revised from March 7 Design Review

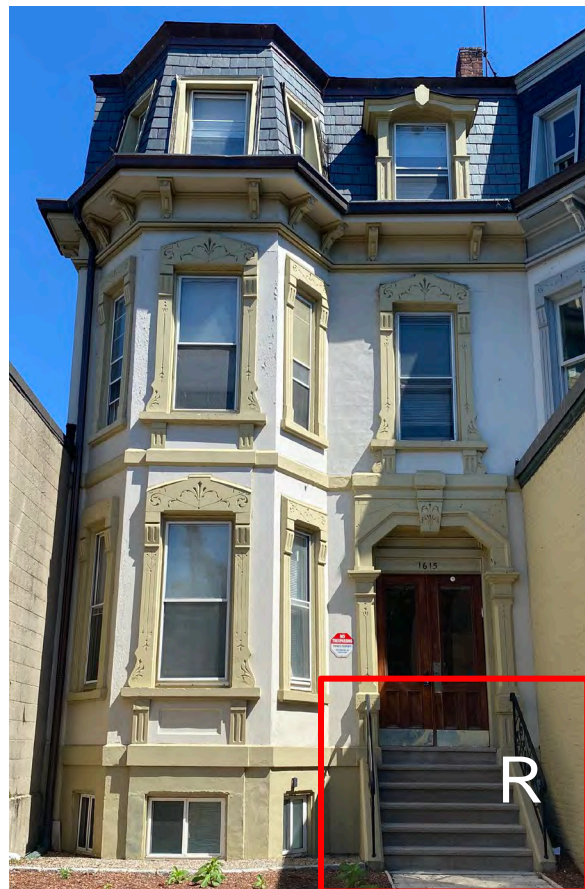
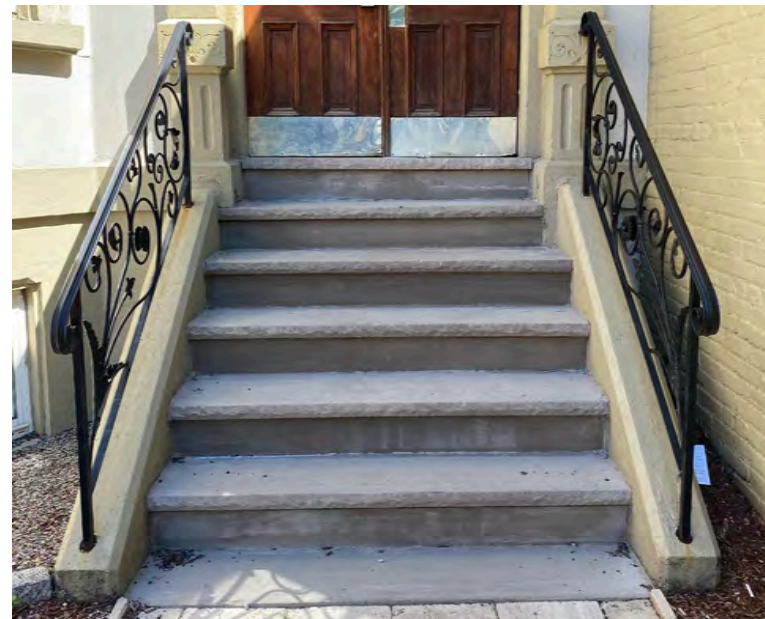
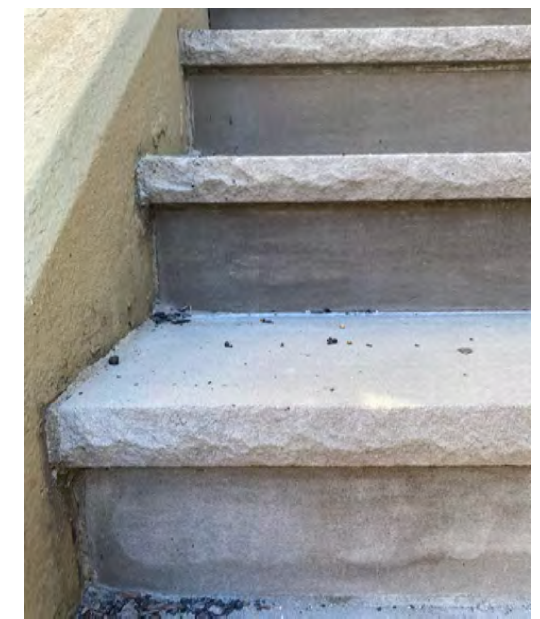
1615 Tremont St – Front Stair

No.	Feature	Current Condition	Treatment
1	Stringer	Possibly original sound condition	Exploratory work to reveal stringer material. If stone in good condition, leave exposed. If not, repaint, color TBD
2	Riser	Stone replacement (not original) Limestone sound condition	Remove and reinstall
3	Tread	Limestone sound condition	Remove and reinstall
4	Railing	Recent steel, insecure Ornamental design out of character	Remove and replace with period appropriate balustrade/handrail Relocate from stringer to treads and separate from ornamental door surround

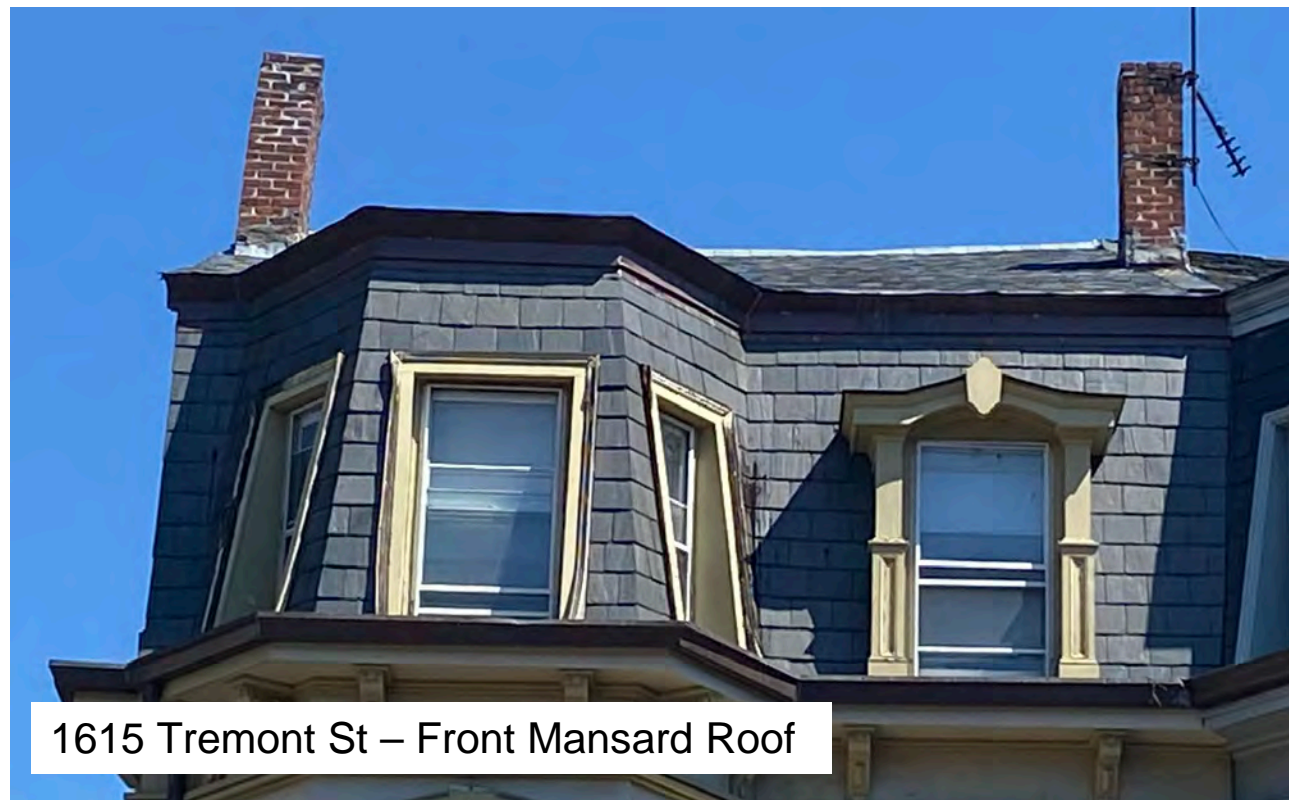
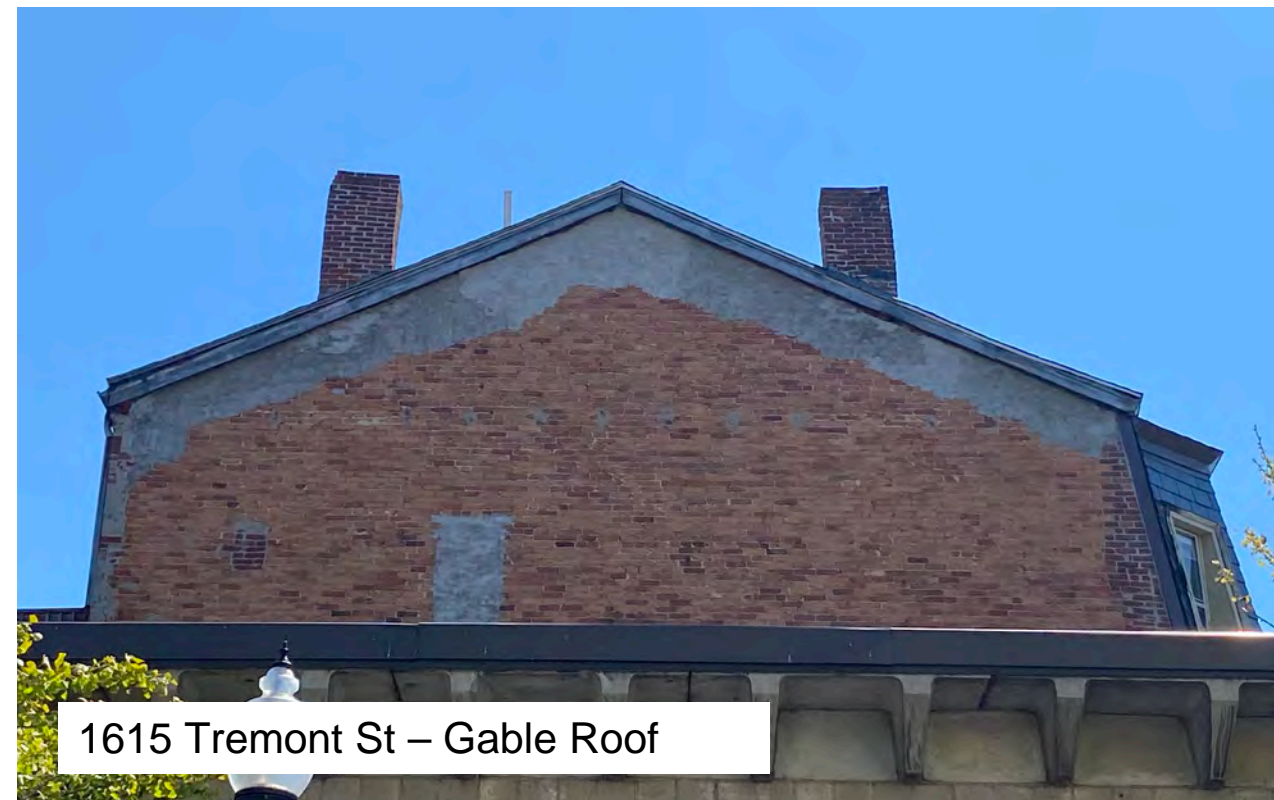
No	Feature	Current Condition	Treatment
1	<b>Mansard Roof</b>		
	Exterior	Slate appears to be in good condition Eave copper in poor condition	To be assumed that some damage will occur during demolition and new construction – reuse salvaged slate shingles or replace slate to match Replace copper trim with wood moldings
	Interior	Boarded and plastered on the inside	
2	<b>Chimney</b>	Poor condition	Rear chimney to be demolished; front chimney to be repaired
3	<b>Gable Roof</b>	To be evaluated	Front roof replacement as required to match existing

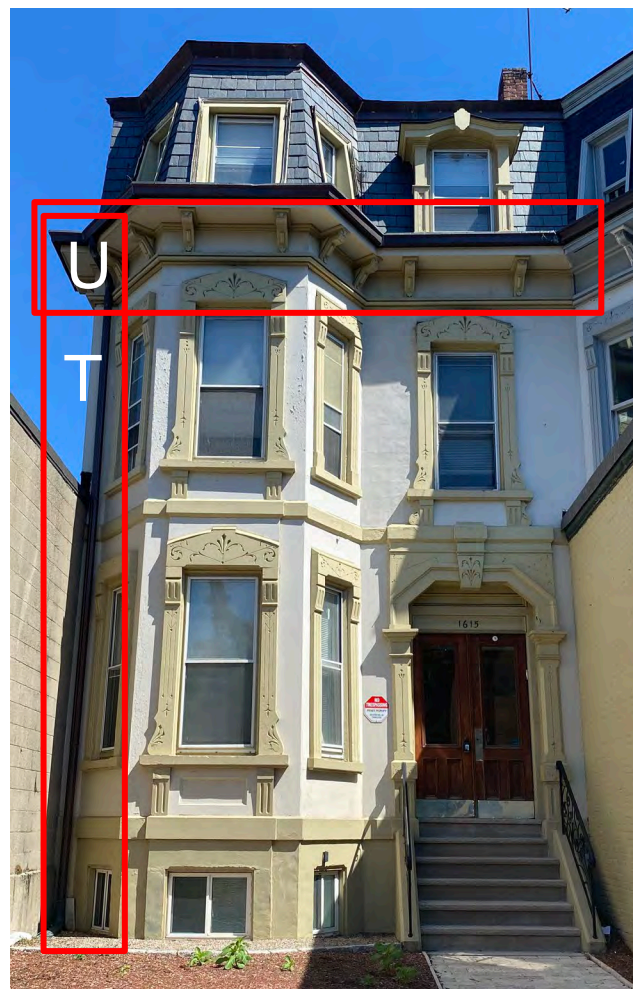
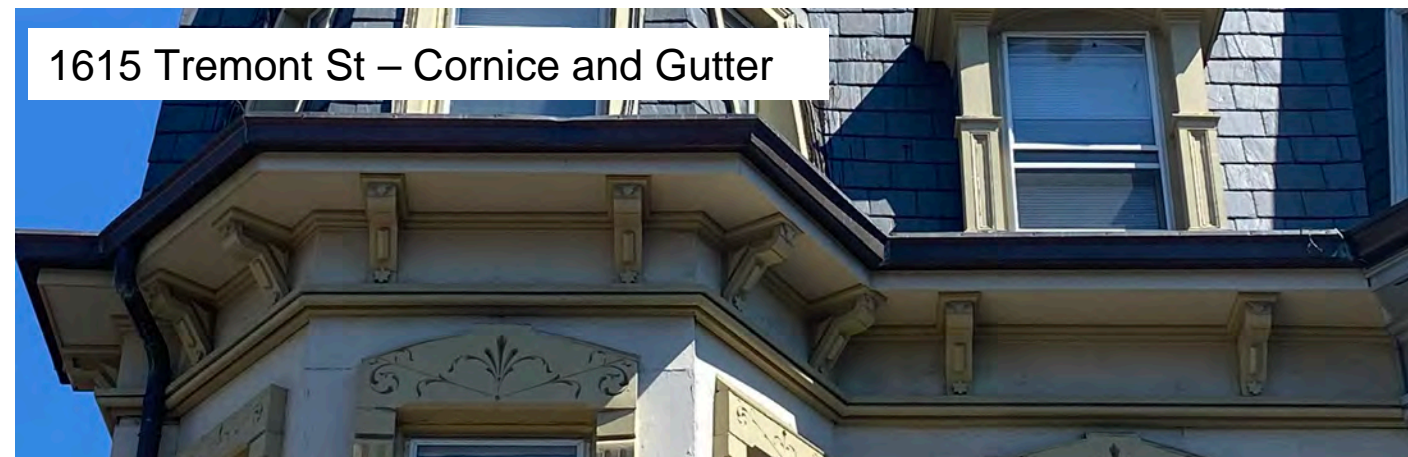
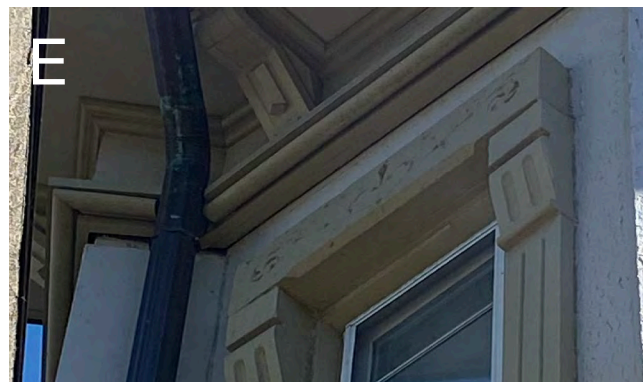
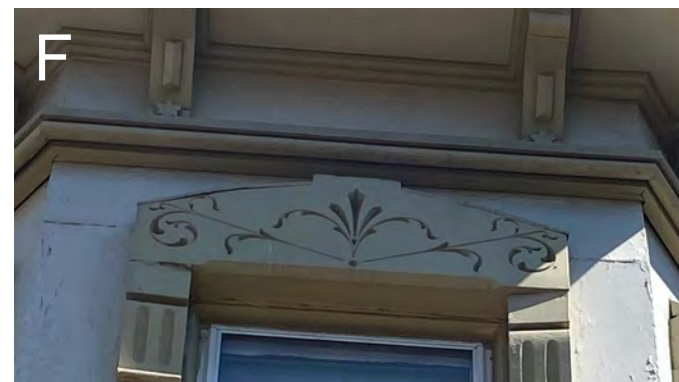
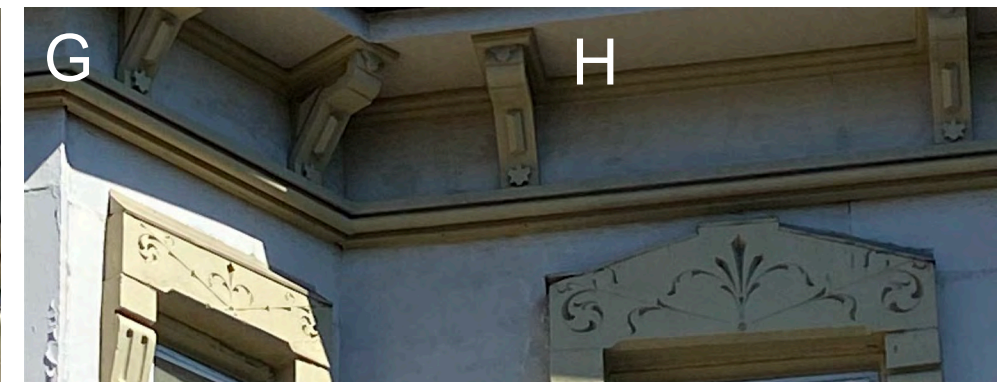
No.	Feature	Current Condition	Treatment
U	<b>Cornice</b>	Decent condition Woodwork intact	Remove return at new construction
T	<b>Gutter and Flashing</b>	Poor condition Water problem above parlor and second floor window surrounds to be investigated	Change gutter profile – similar to adjacent rowhouse Existing flashing over window surrounds to be removed and sealed
T	<b>Downspout</b>	Poor condition	Change profile

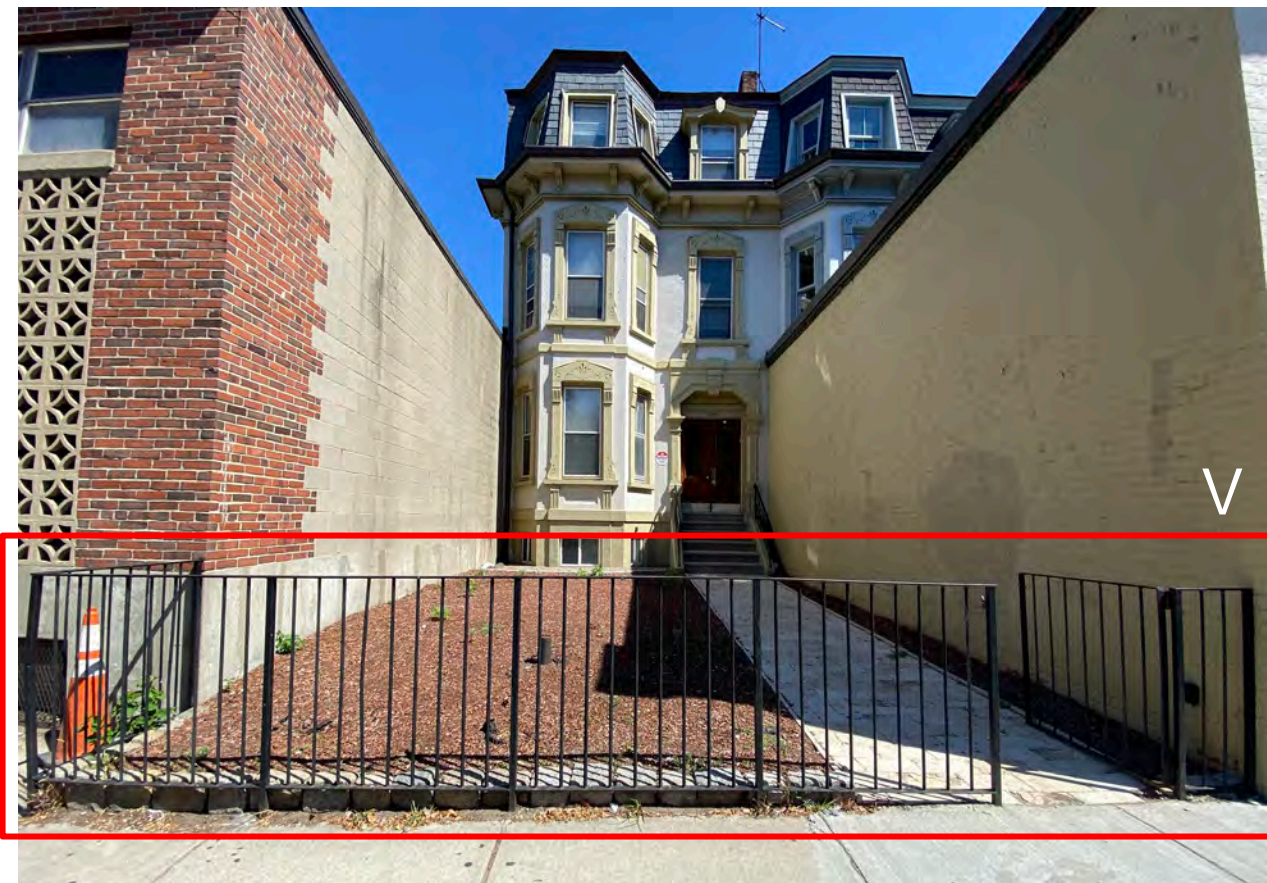
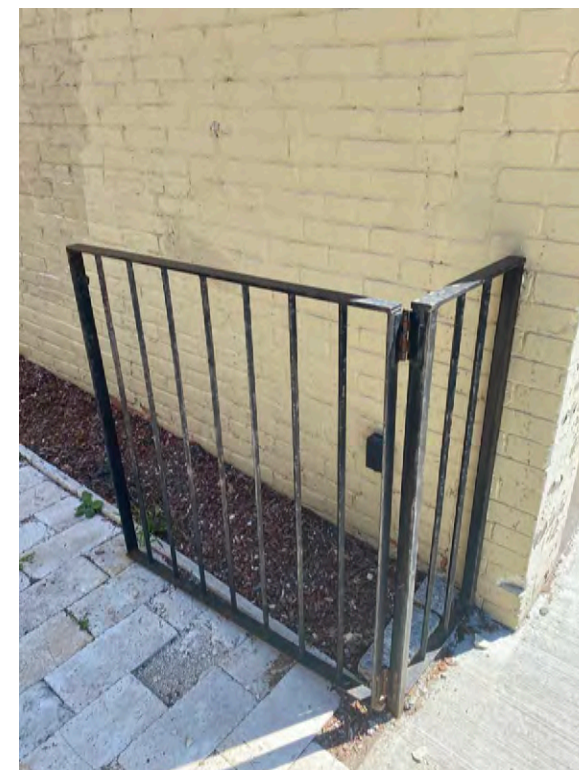
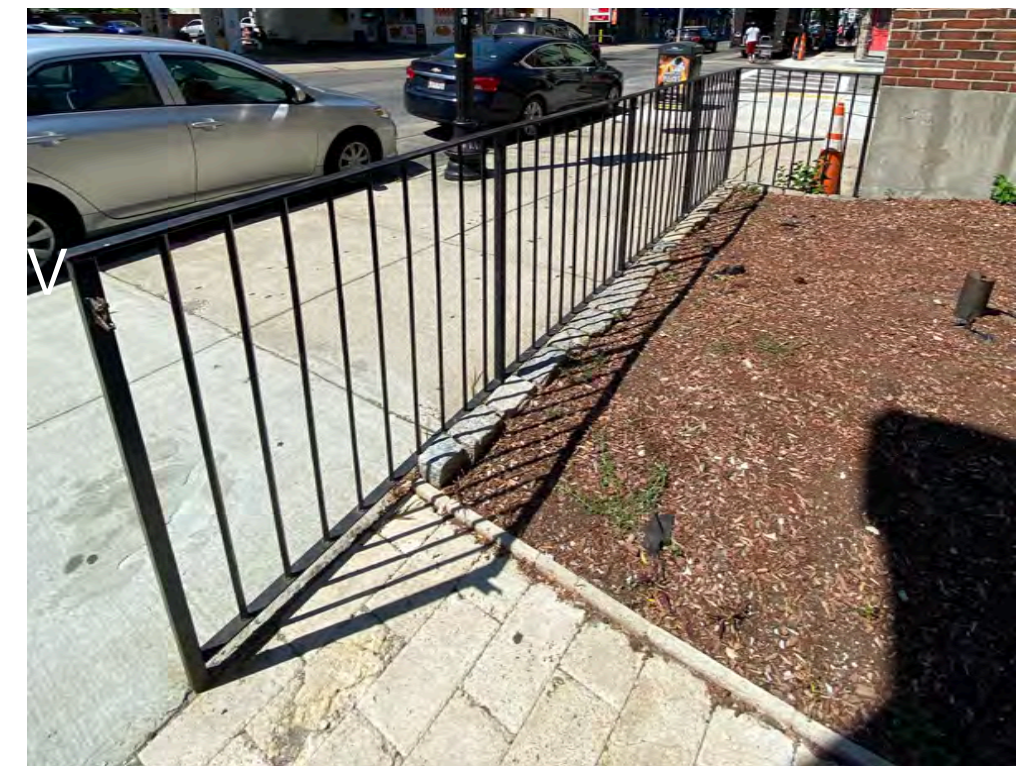
1615 Tremont St – Front Fence & Gate 1.1

No.	Feature	Current Condition	Treatment
<b>V</b>	<b>Front Fence &amp; Gate</b>		
	1.1	Recent Steel Insecure Out of historic character	Remove fence gate and replace in kind
	1.2	Recent Steel Insecure Out of historic character	Remove fence and replace in kind

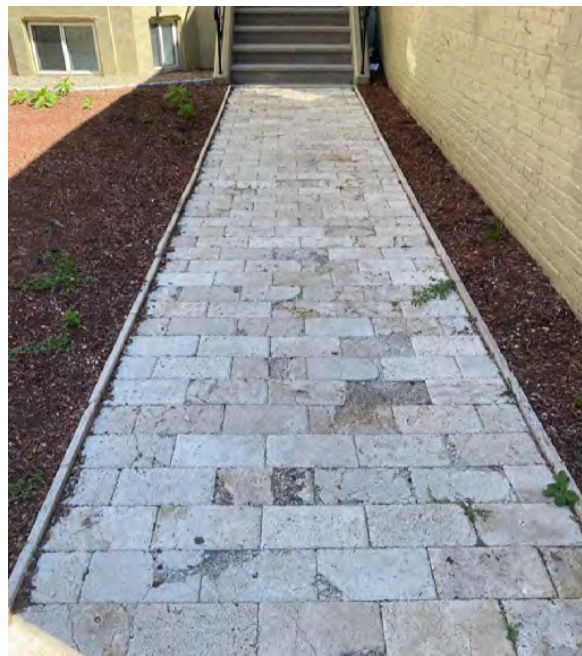
1615 Tremont St – Front Walkway

No.	Feature	Current Condition	Treatment
2	<b>Front Walkway</b>	Stone is poor condition Stone spalling due to freeze and thaw	Install new walkway pavers
3	<b>Front Yard</b>	Recent Addition – mulch and gravel	Install new green landscape planting
