Agenda

- Recap
- 100% Design Development Review
 - Portico Vestibule
 - Exterior Elevation & Material Update
 - Lighting Scheme
 - Technical Update
- Discussion

Recap Apr 2016 - Section and Elevation at Shattuck St.

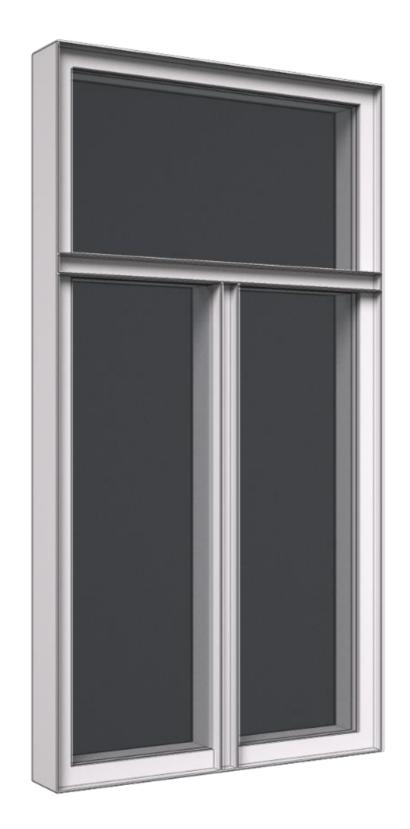
AXON - NTS

Recap Apr 2016 - Proposed Window Details

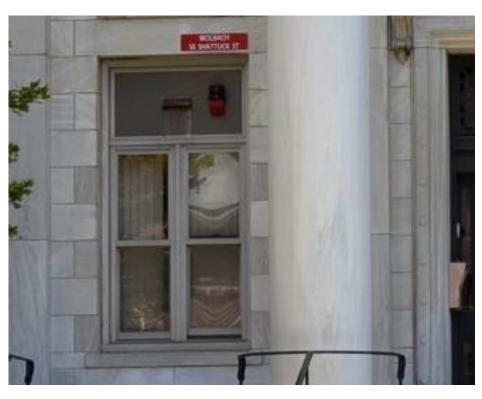
EXISITING WINDOW

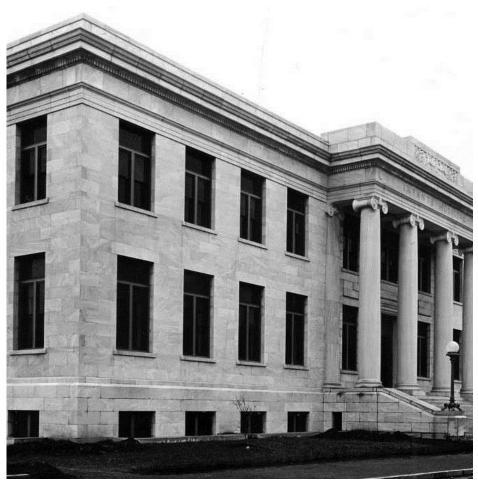
HISTORICAL WINDOW

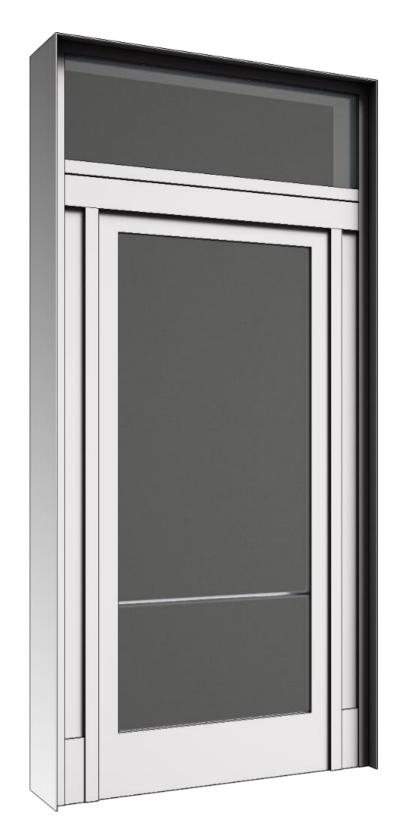
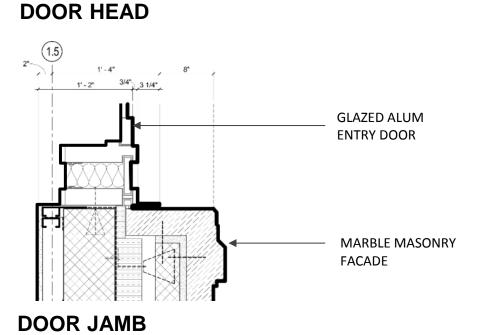
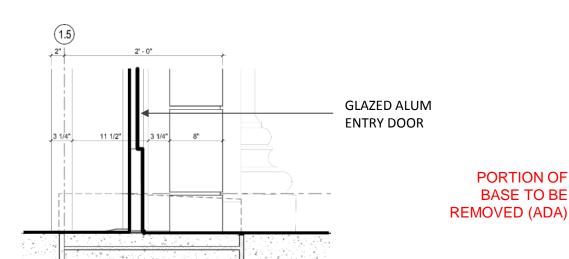
Recap Apr 2016 - Proposed Door Details

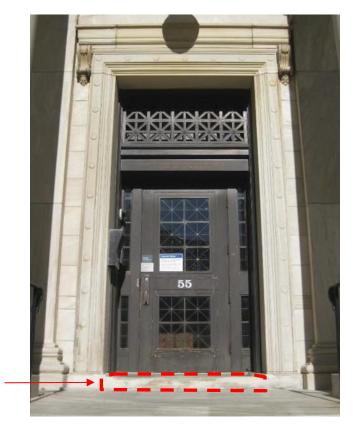
DOOR SILL

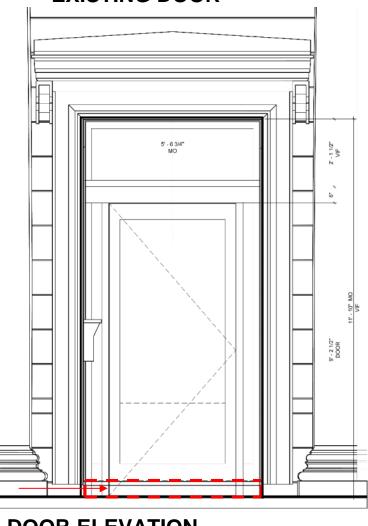
DOOR ELEVATION

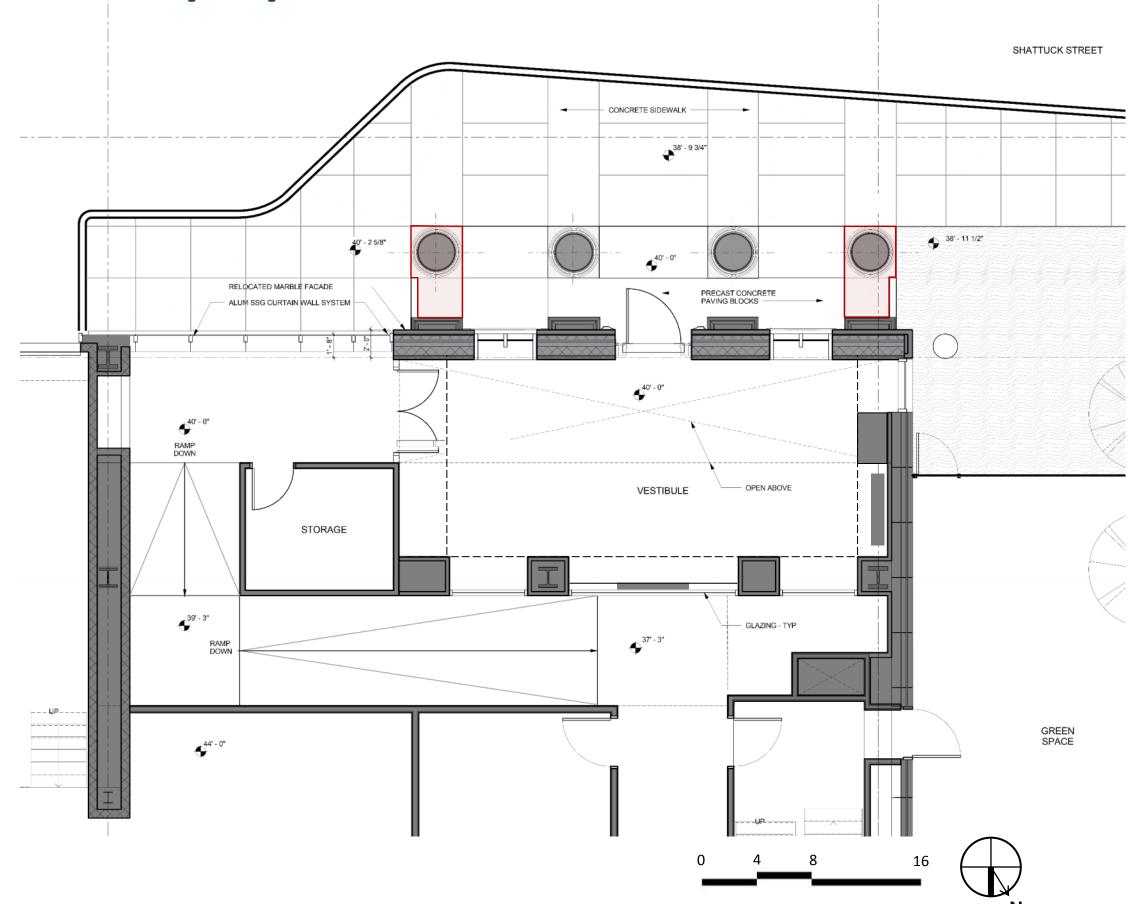
Recap Apr 2016 - Plan of Vestibule at Shattuck St.

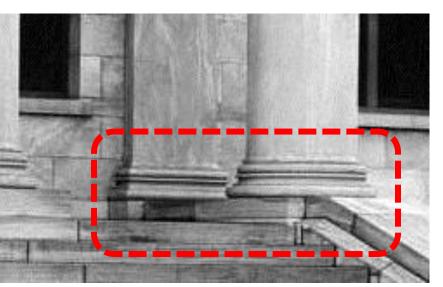
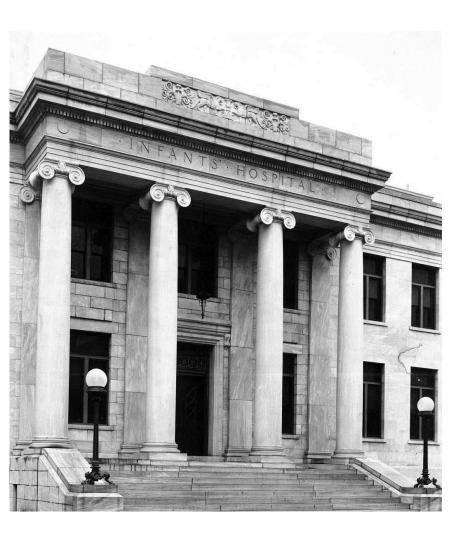
EXISTING PLINTH

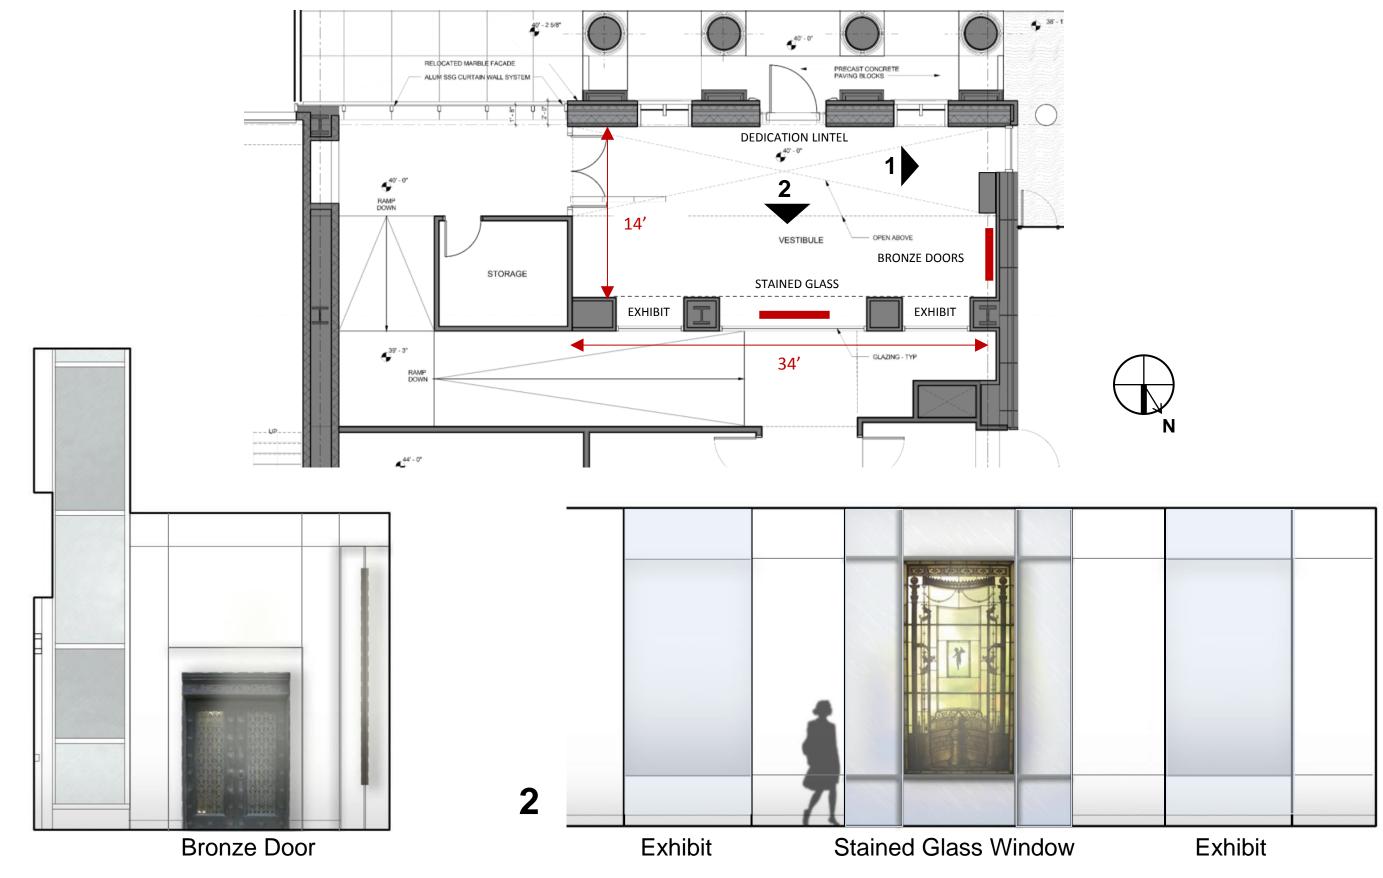
Recap Apr 2016 - Option 1 Location: Portico Vestibule

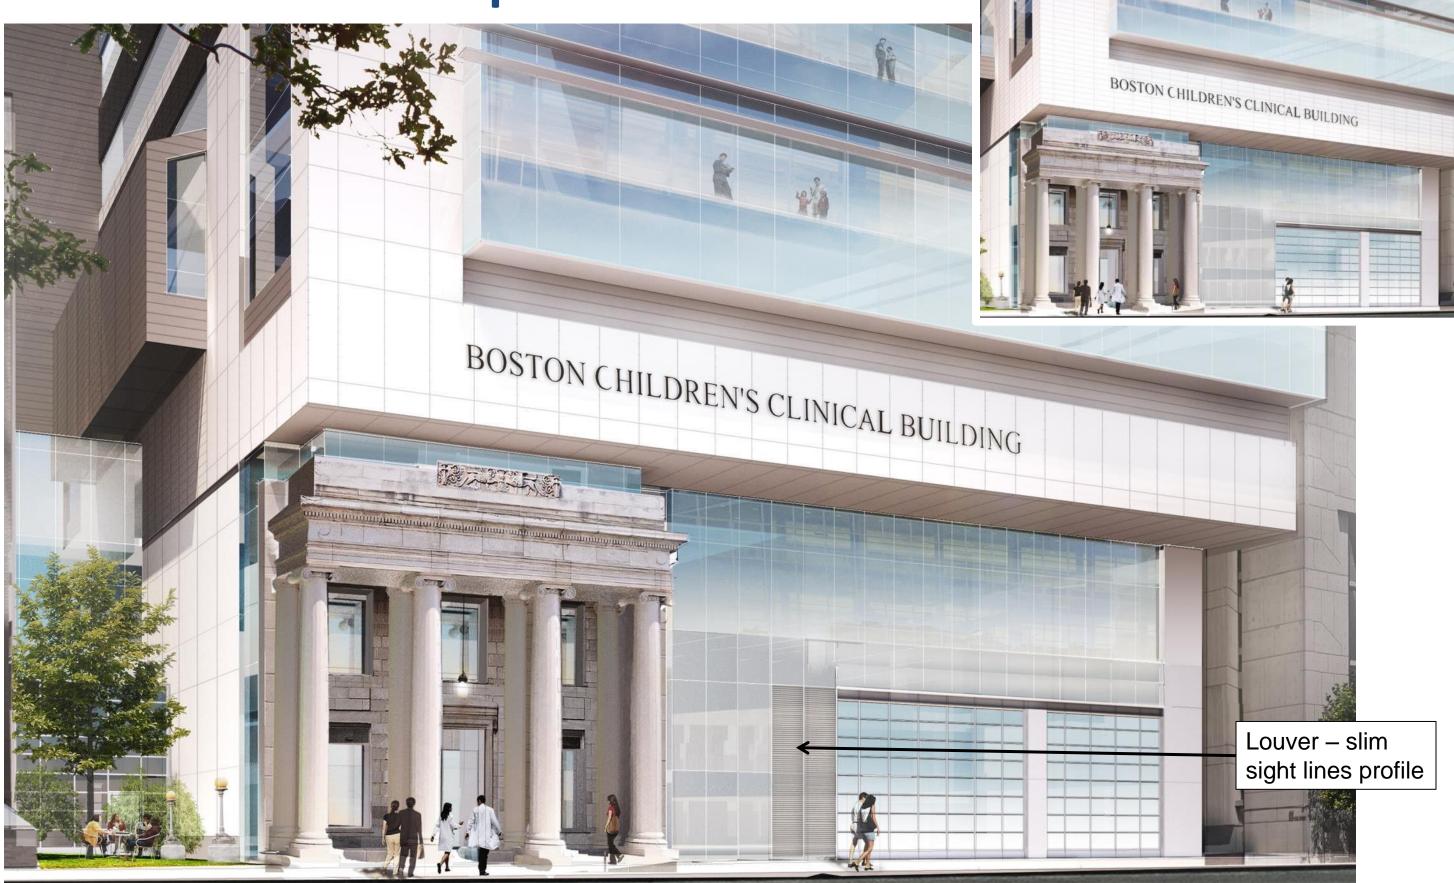
Exterior Elevation Update

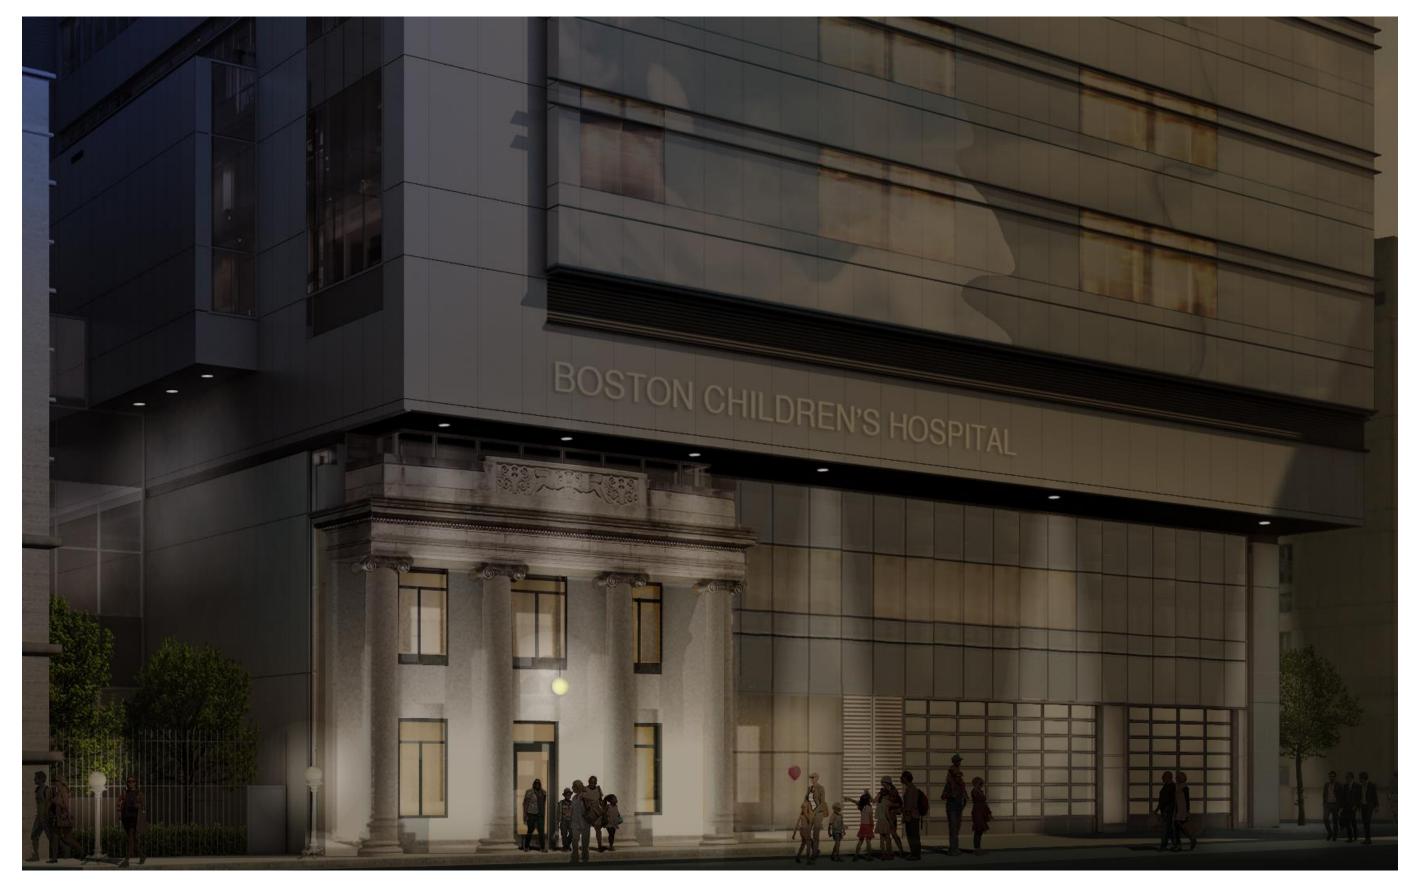
Exterior Lighting Scheme

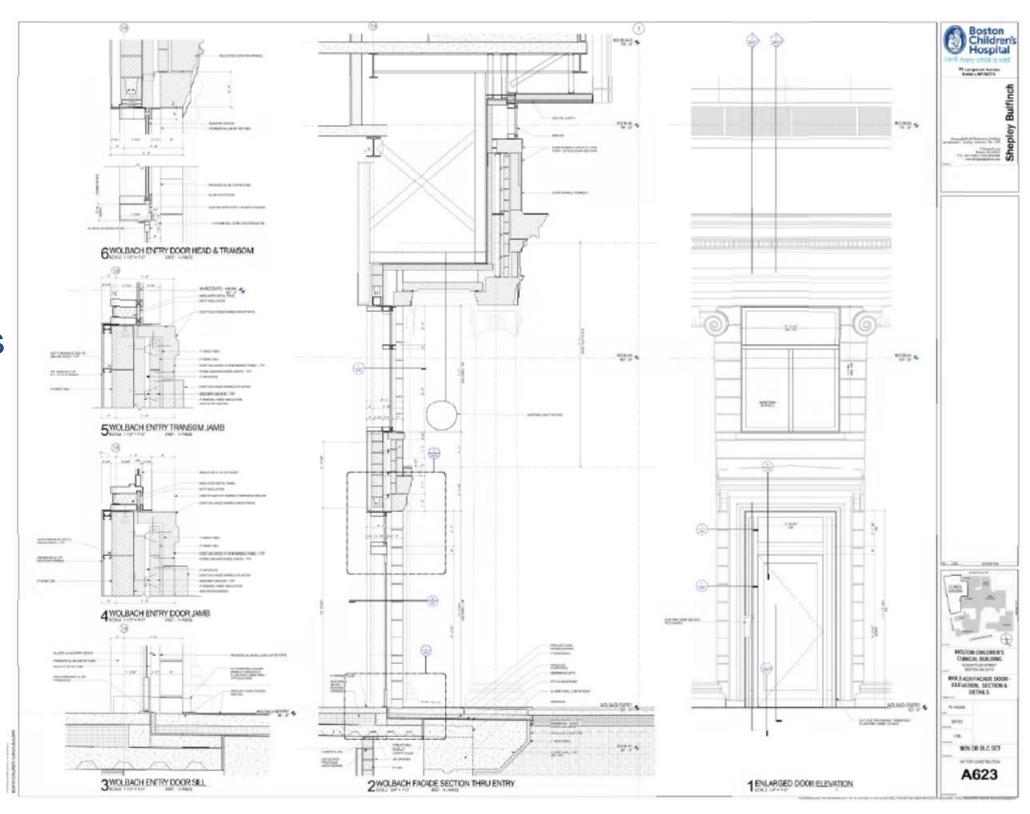
Reassembly Technical Update

Development of technical details for reassembly in attempt to match original handling and disposition:

- Minimize refabrication of pieces
- Same or less loading/stress
- Similar handling back into place
- Mason design assist to follow
- Integration with modern exterior envelope
- A mass masonry veneer
