The Wang Center for the Performing Arts/ Boch Center

Wang Theatre Seating

Design Review

March 28, 2017

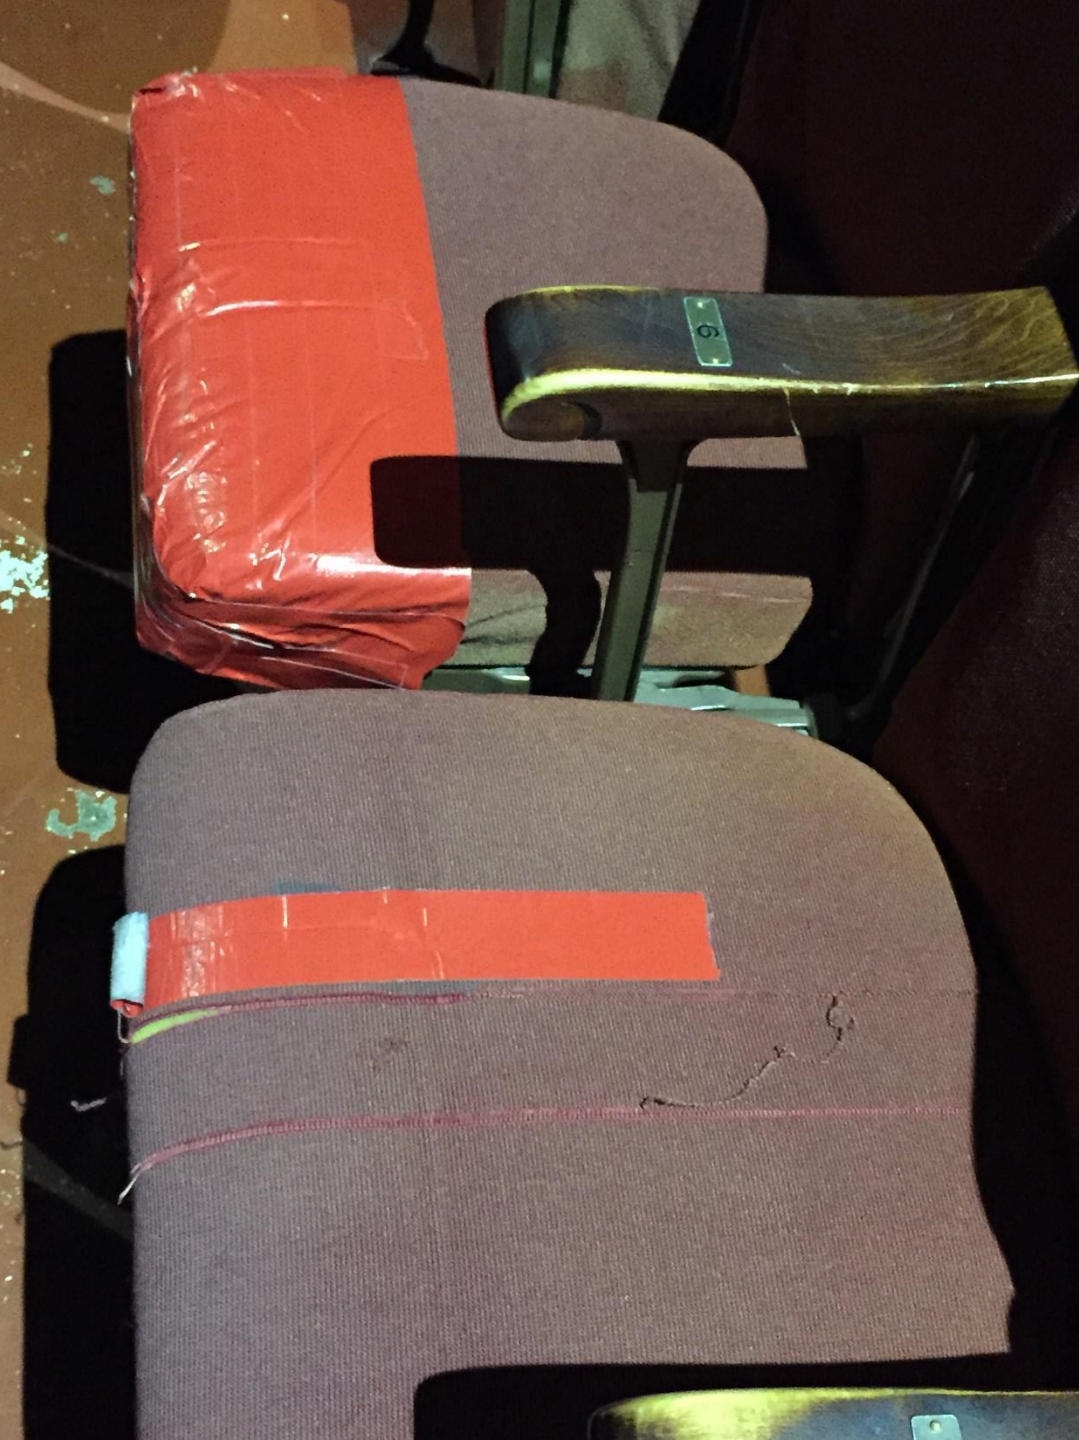
Current Condition: Wang Theatre Seats

All 3,460 seats in the orchestra, mezzanine and balcony are in poor condition and in need of replacement. The fabric of many seats is frayed, ripped and faded. Often duct tape has been used as a temporary repair.

The orchestra and mezzanine seats have been replaced several times and are not original to the Wang Theatre (then called Metropolitan Theatre).

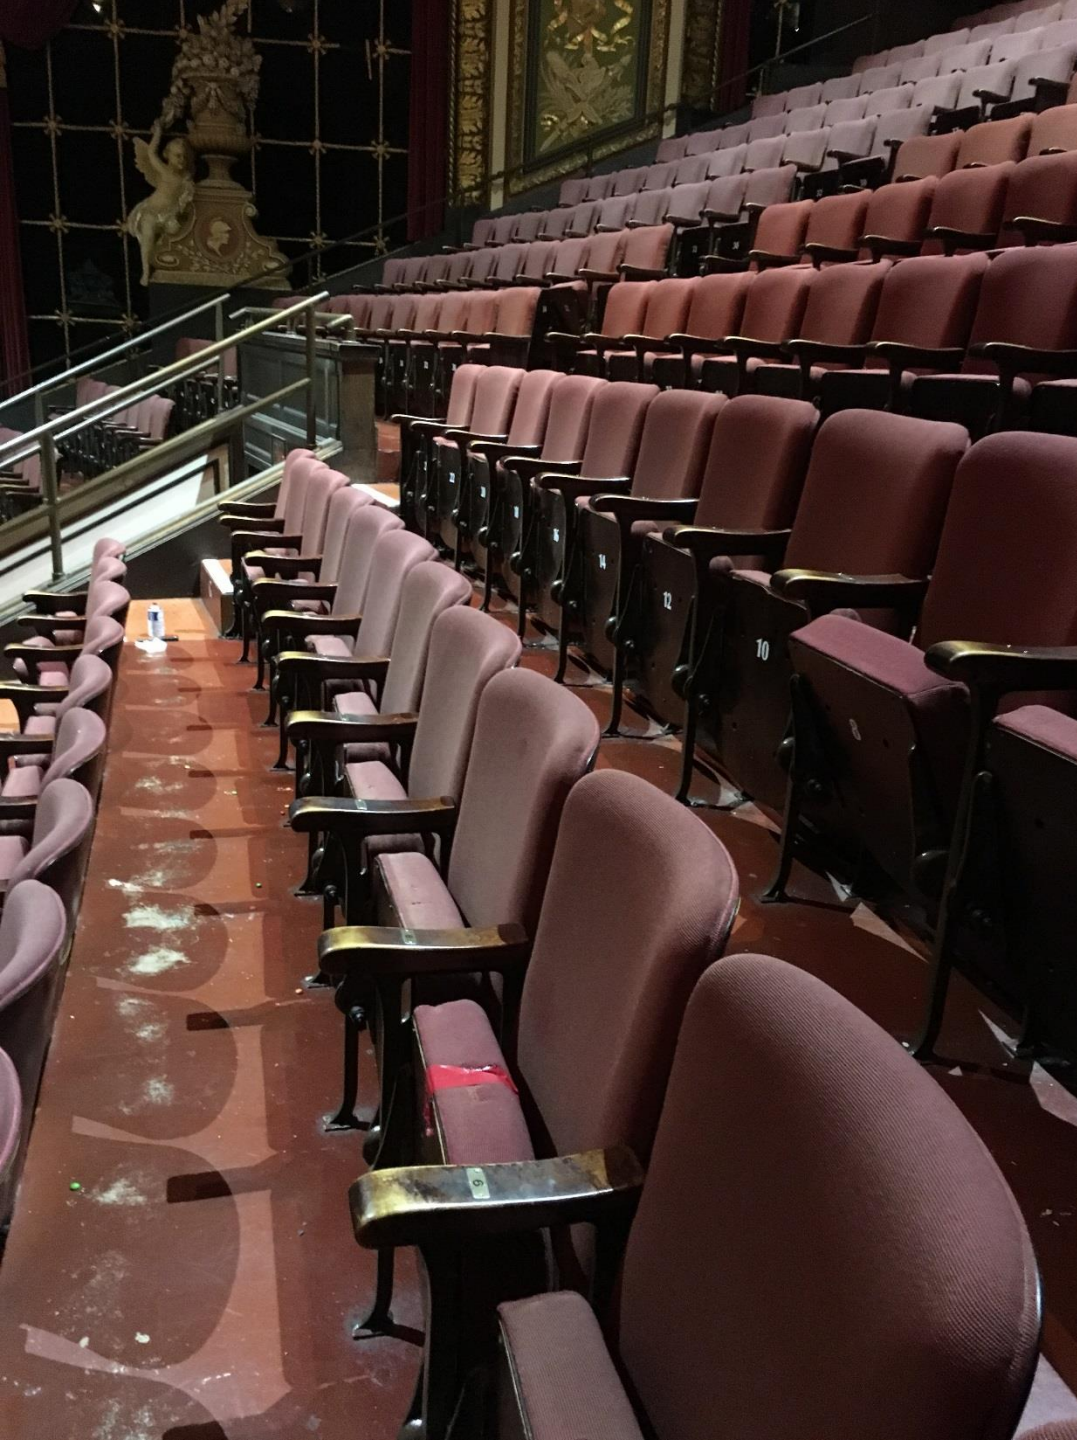
Current Condition: Wang Theatre Seats

The seats in the upper balcony (shown left) are believed to be original. However, these seats do not meet current fire code requirements.

These shall serve as the basis of design for establishing the character of the proposed new seats.

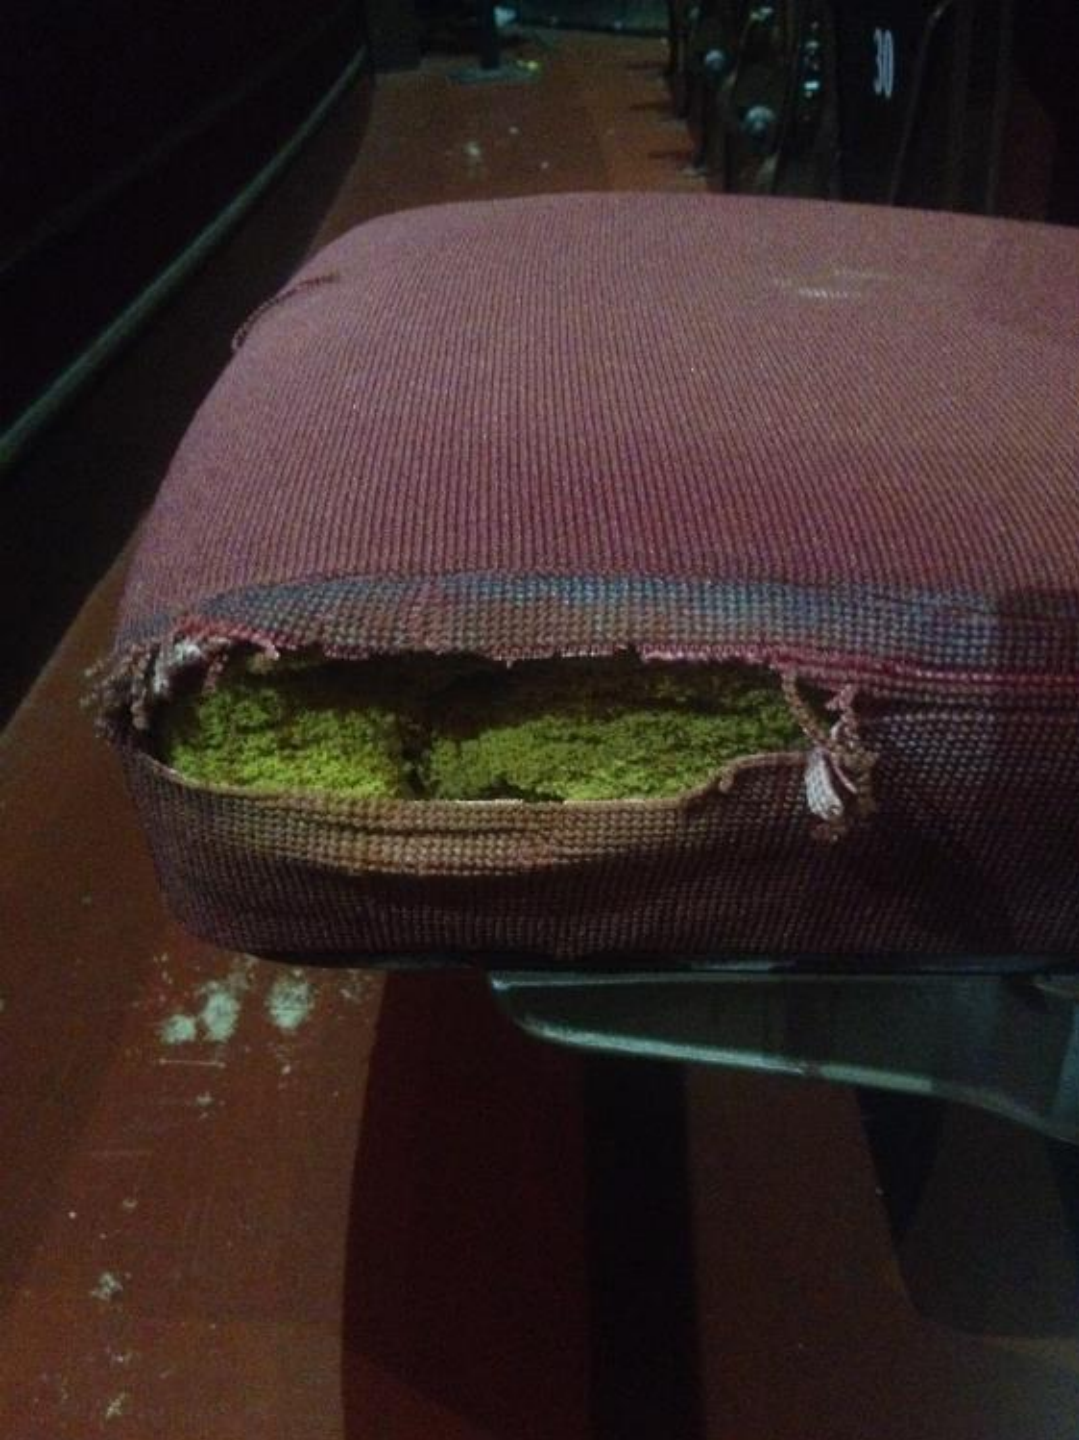
***Current Condition:
Wang Theatre Seats***

Irwin Seating, a leader in historic theater seating, has recommended replacement of the seats because many of the seats are beyond repair.

The new seats will be in the spirit of the Wang's character and similar to the existing seats.

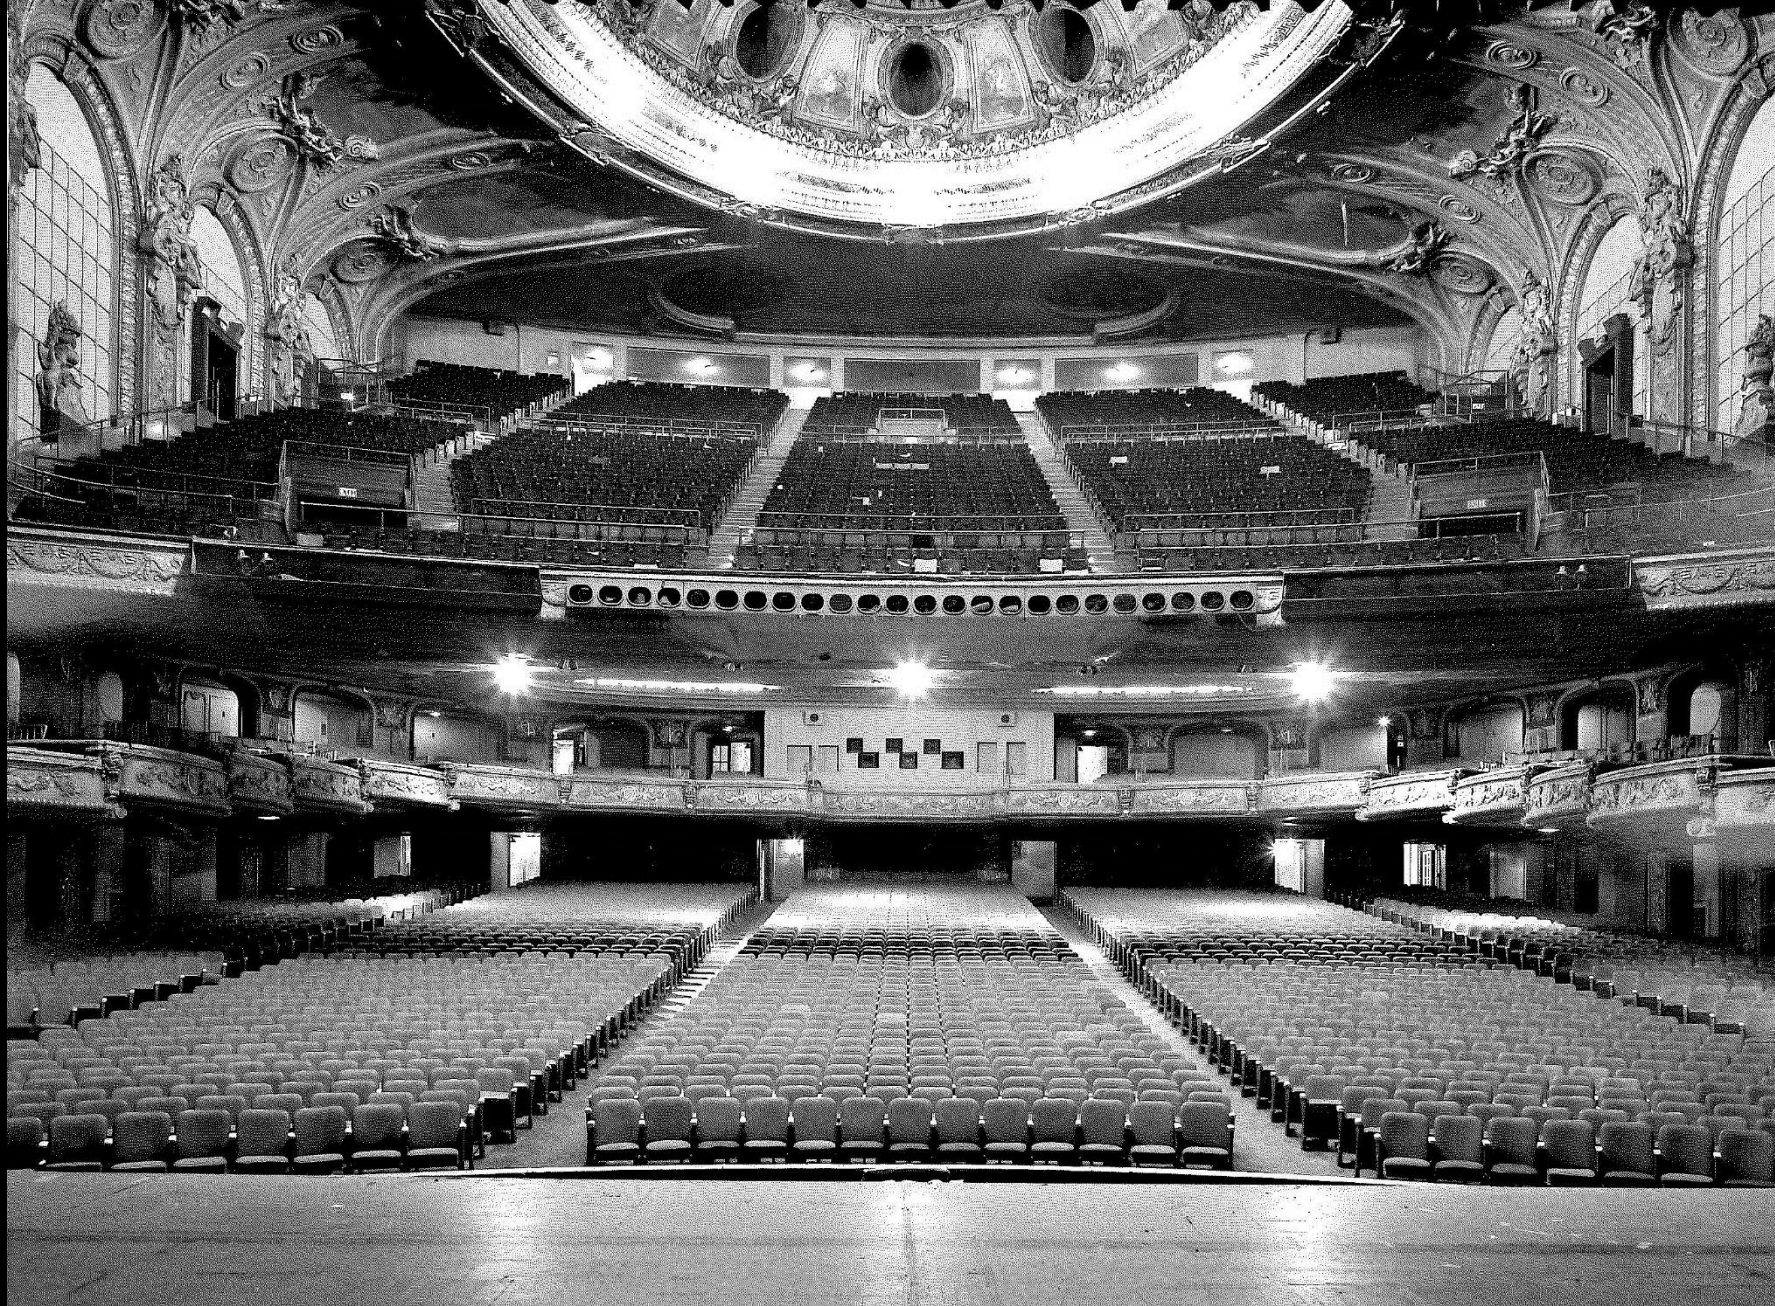
The Wang Center (then Music Hall), February, 1976 Photo: William F. Owens, Jr.

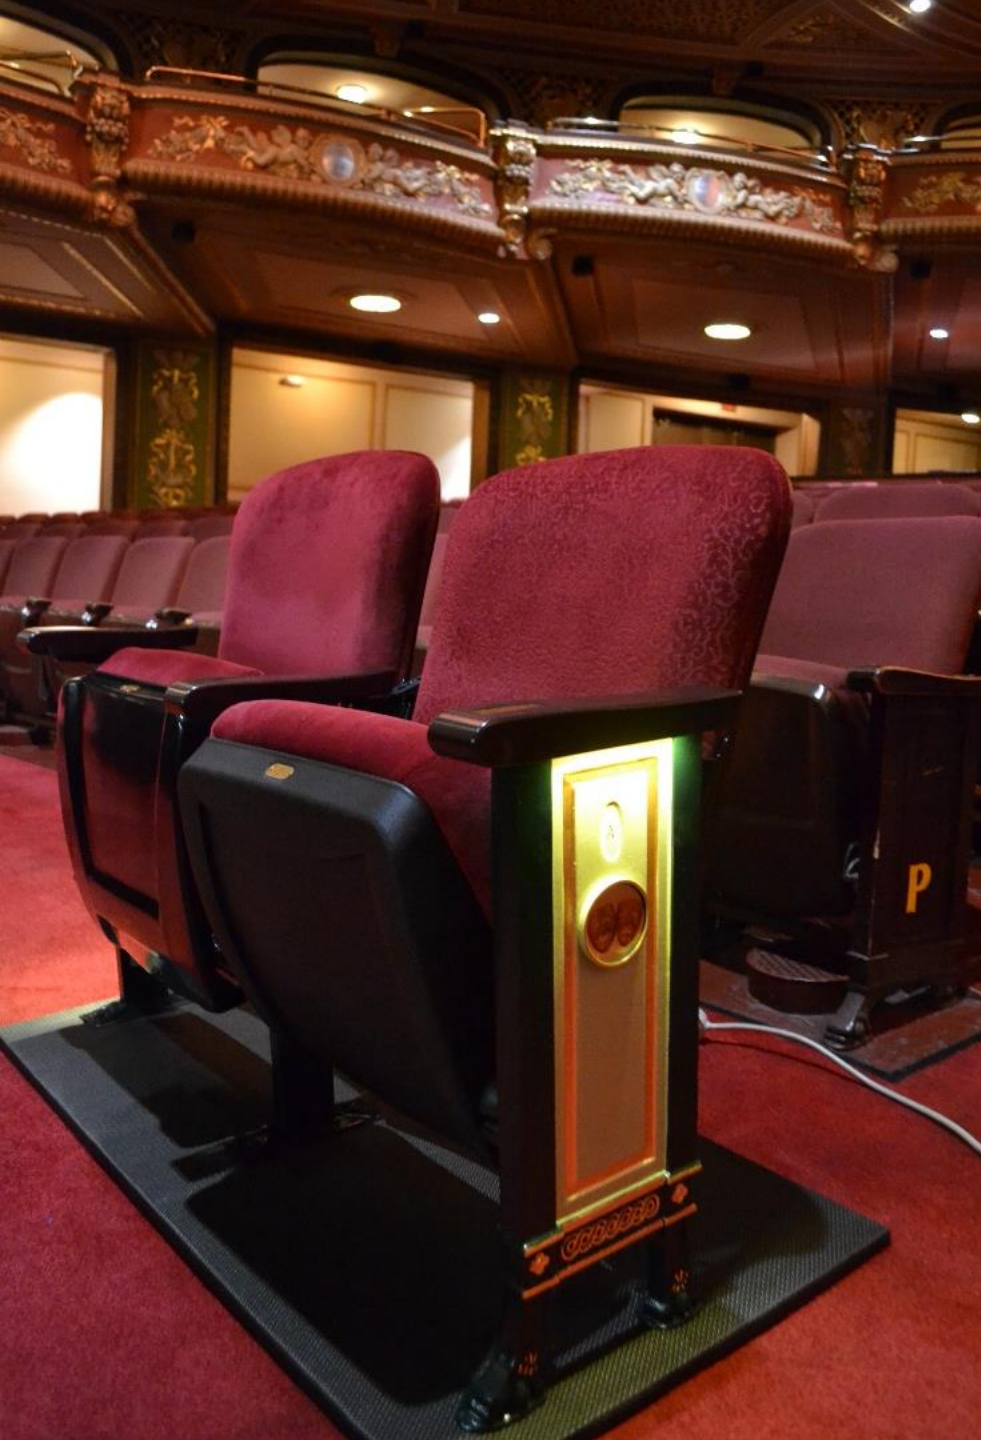
Wang Theatre Seats Proposed Design

**New theater seats would be
comprised of:**

- **Metal frames with maple armrests**
- **Ergonomic features for patron comfort**
- **Velour fabric which we believe is similar to the color before fading occurred (as well as the existing seats)**
- **Include end panel aisle lighting for safety and code requirements**

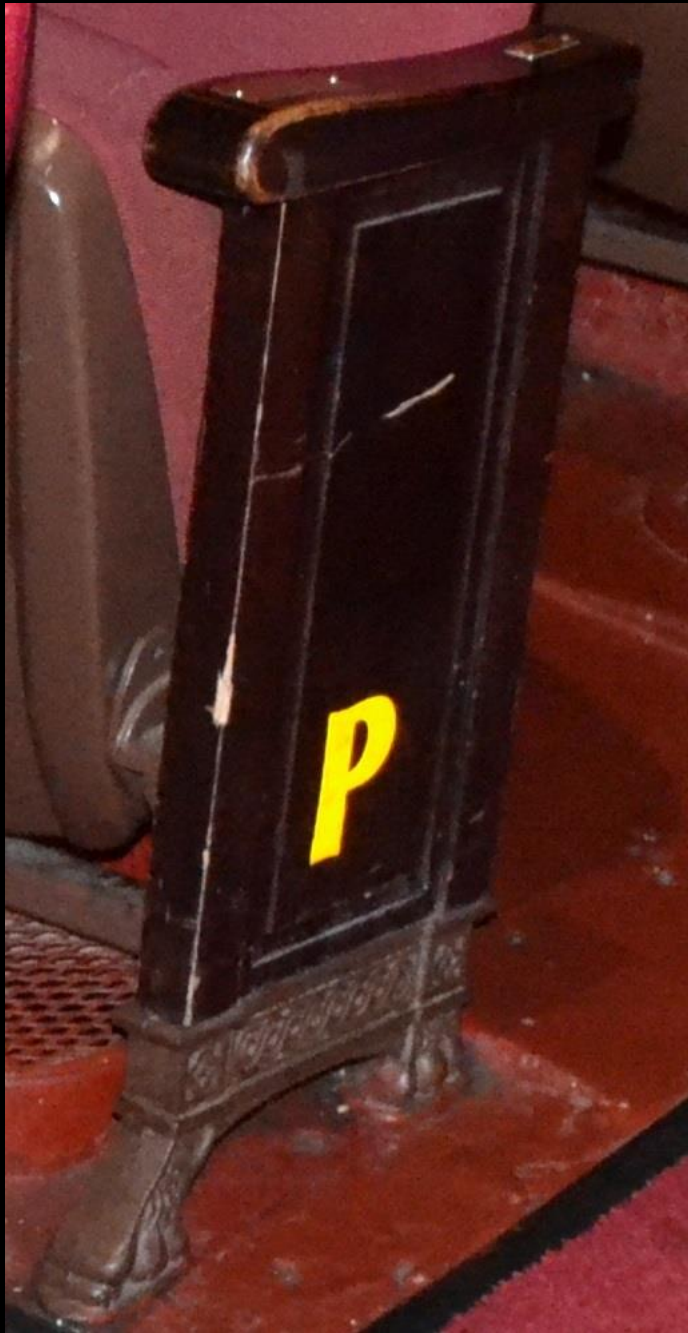
Wang Theatre Seats Proposed Design

The proposed new end standards are replicas of the original Metropolitan Theatre relief carving pattern and shape (shown left).

Paul Winter, Irwin Seating: “The end standard matches the original end standard. It is not in the style of, but a replica of the original.”

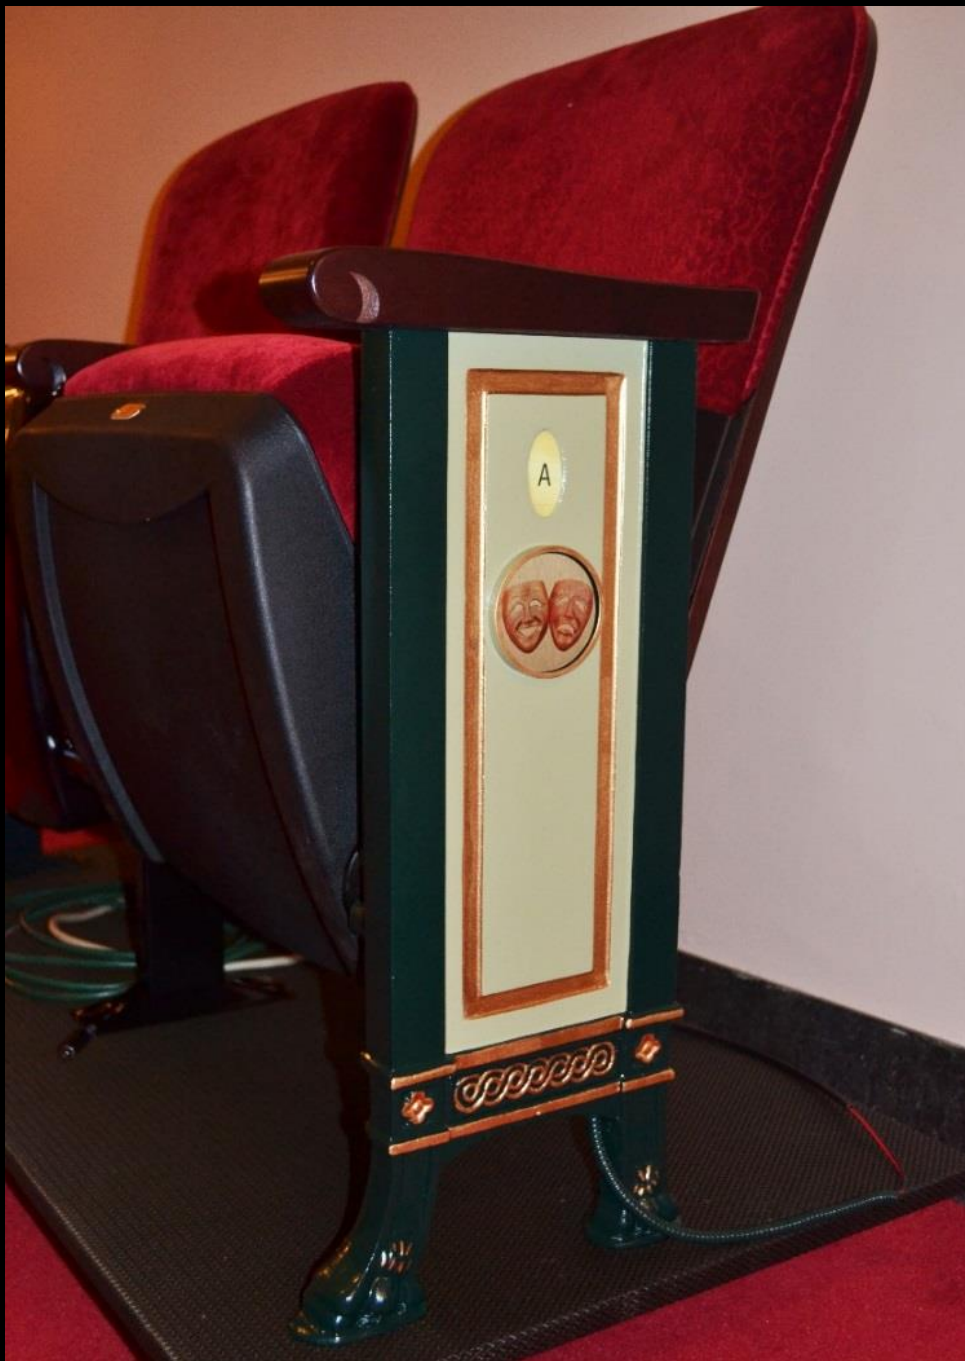
Wang Theatre Seats Proposed Design

The proposed new aisle end standards are in the style of theaters of the 1920s and match the original. Their colors mirror the green, gold and yellow details of other areas of the theatre, respecting the venue's character and ambiance as well as its history.

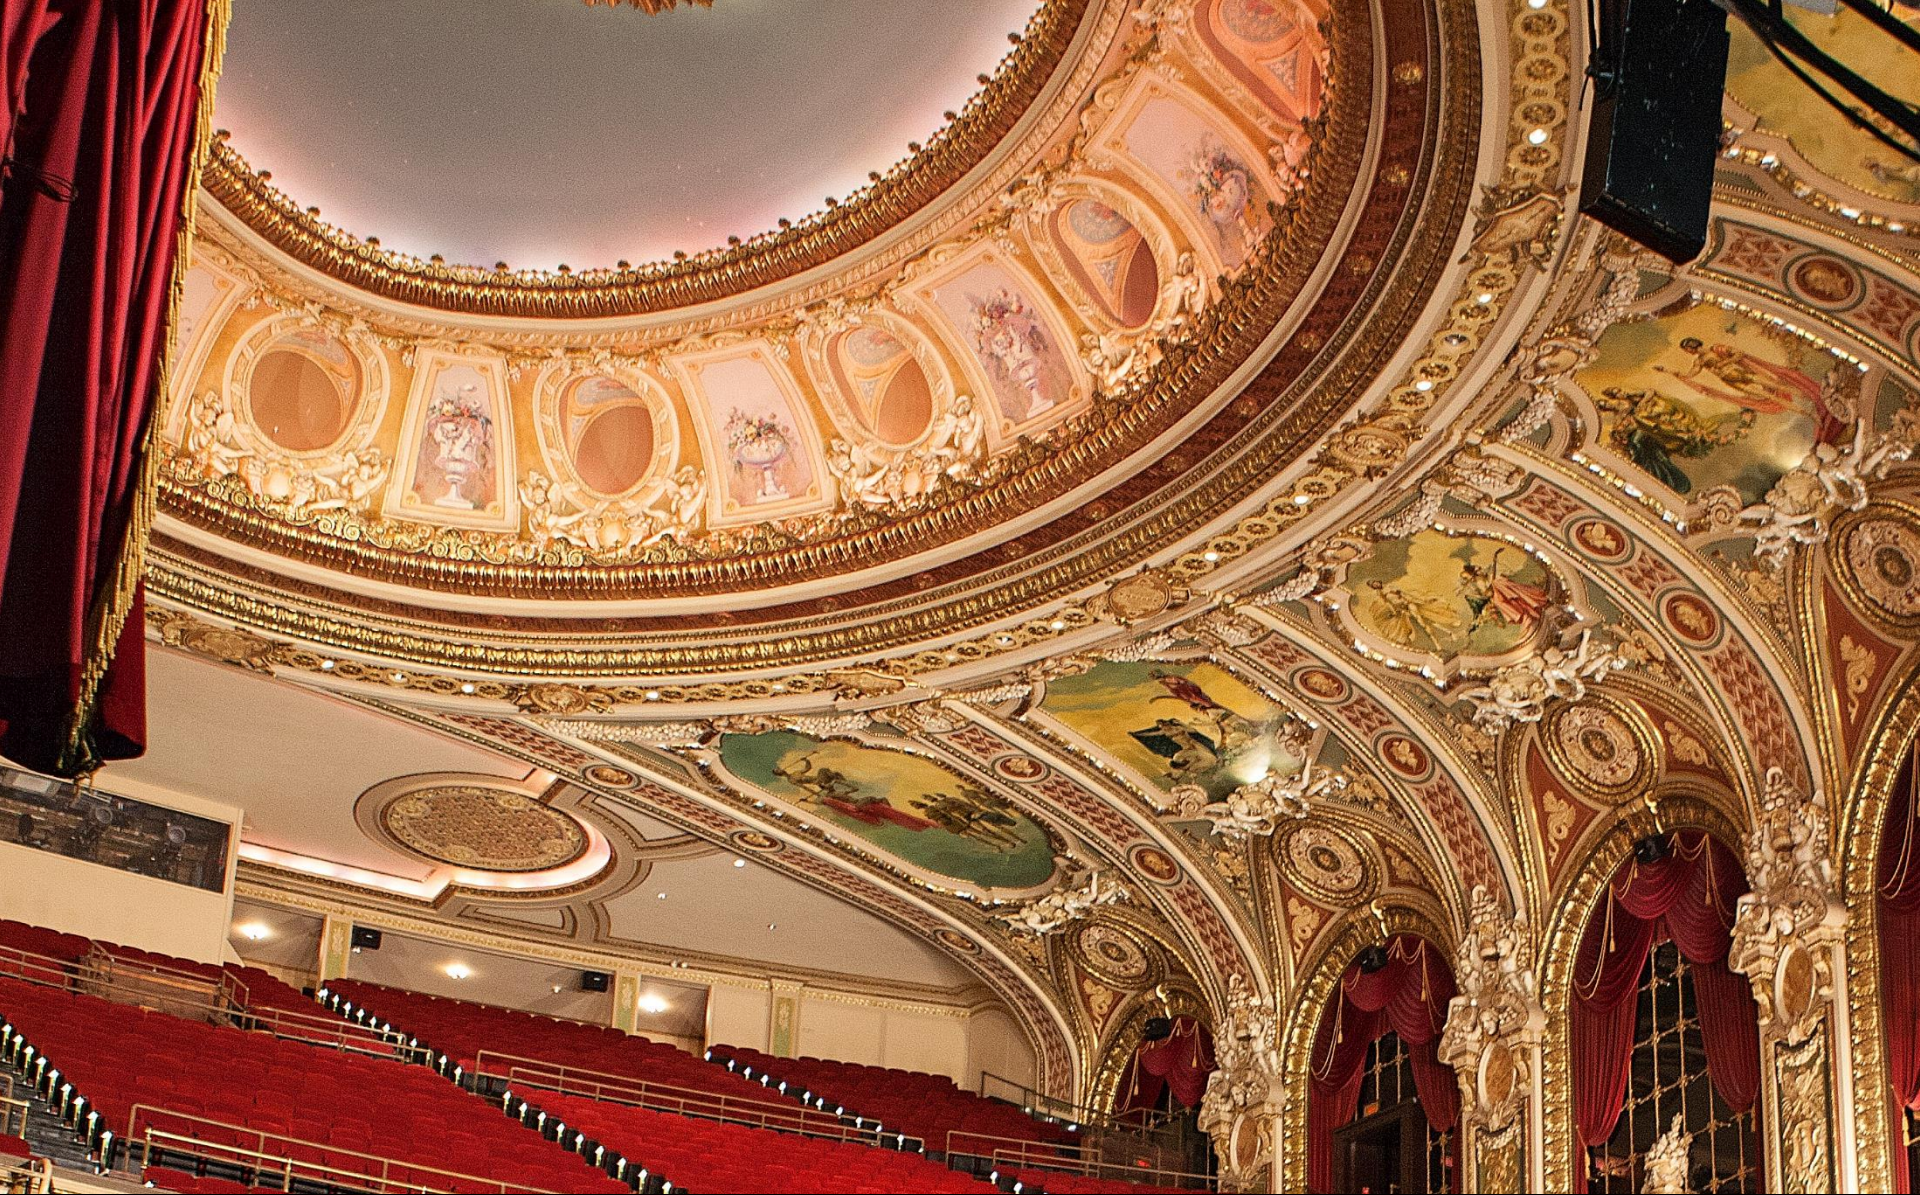
The Wang Theatre, February 2017 Photo: MEDIABOSS

End standard new colors replicate the green, yellow and gold hues of the murals found on the ceiling and restored in the late 1980s/ early 1990s.
