5 CLAREMONT PARK BOSTON, MASSACHUSETTS DJ WATSON DEVELOPMENT

SELDC

JUNE 13, 2017

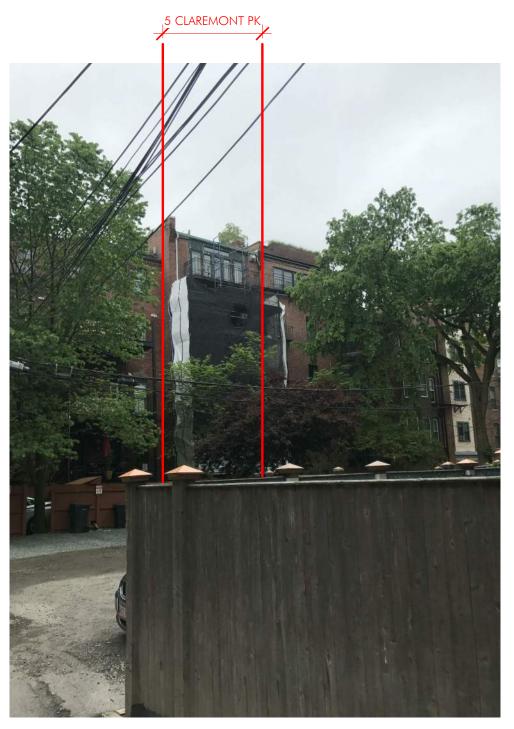
CURRENT CONDITION OF REAR ELEVATION - 5 CLAREMONT PARK

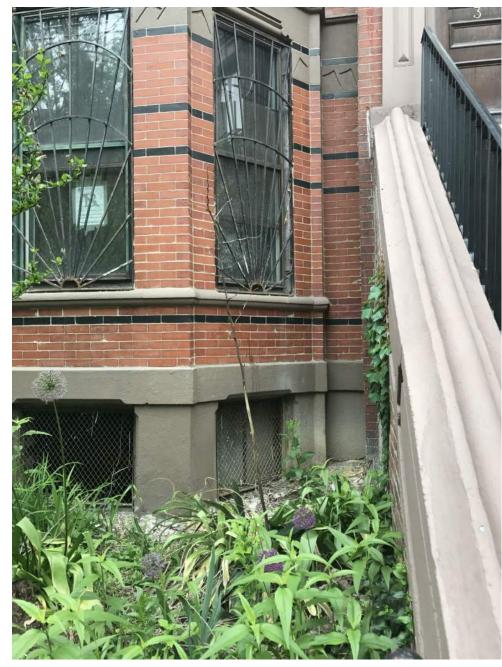
EXISTING FIRST FLOOR WINDOW GRILLES TO BE REMOVED

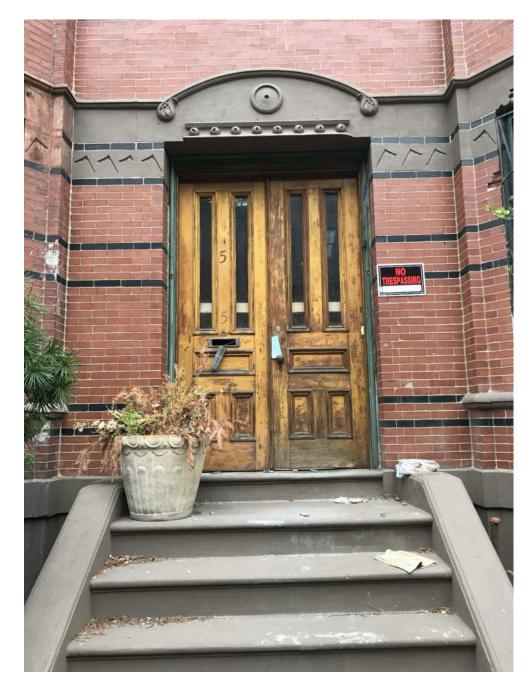
EXISTING DOOR TO BE REPAIRED AND RESTORED STOOP TO BE REPAIRED AND RESTORED

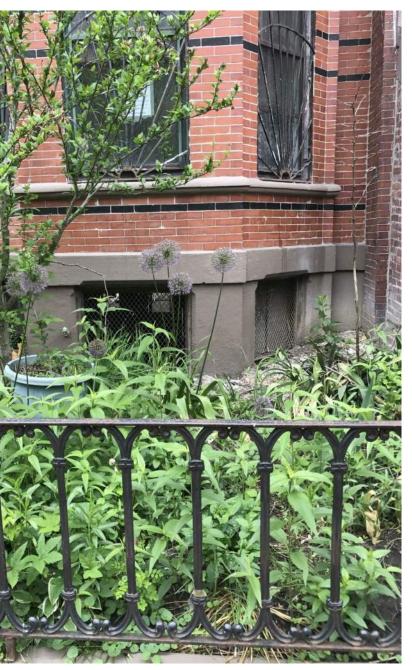
EXISTING METAL GARDEN RAIL TO BE REPAIRED AND REPAINTED BLACK

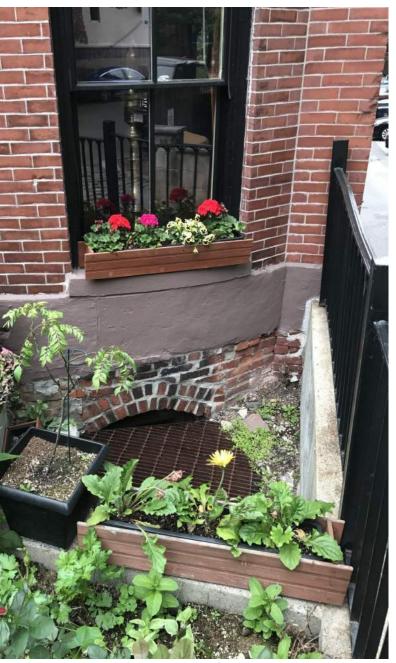
WINDOW WELL WITH WINDOW EXPOSED ABOVE GRATE AT 1 CLAREMONT PARK
