Jamaica Pond Park Pathways & Entrances: Phase 2 Work

Jamaica Pond Park, Jamaica Plain

Description of Proposed Work

November 2018

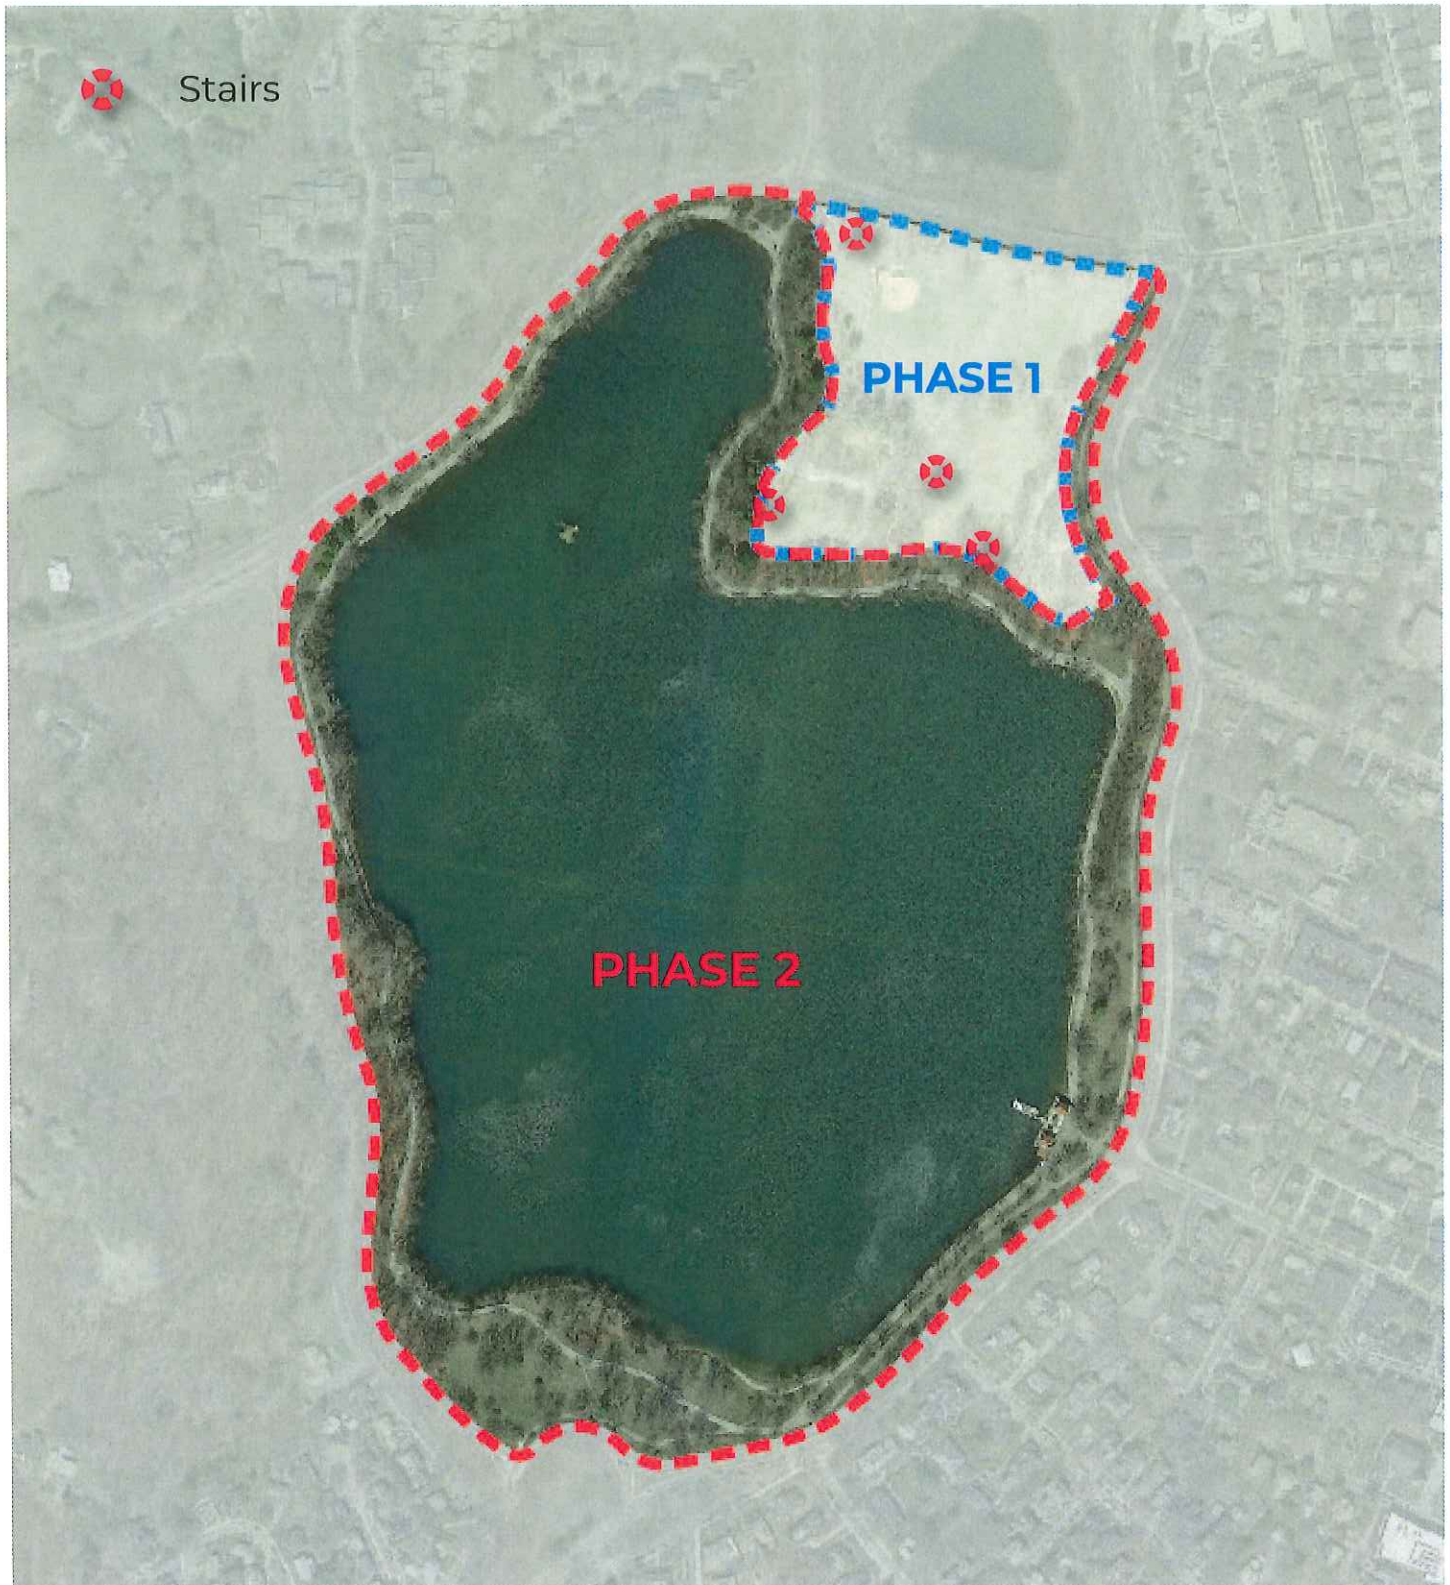
2018 Aerial photograph of Jamaica Pond Park with approximate limits of Phase 2 project area in red and Phase 1 project area in blue. The red circles identify the location of the four sets of stairs which fall in or near the Phase 1 project area, but are included with the Phase 2 project scope.

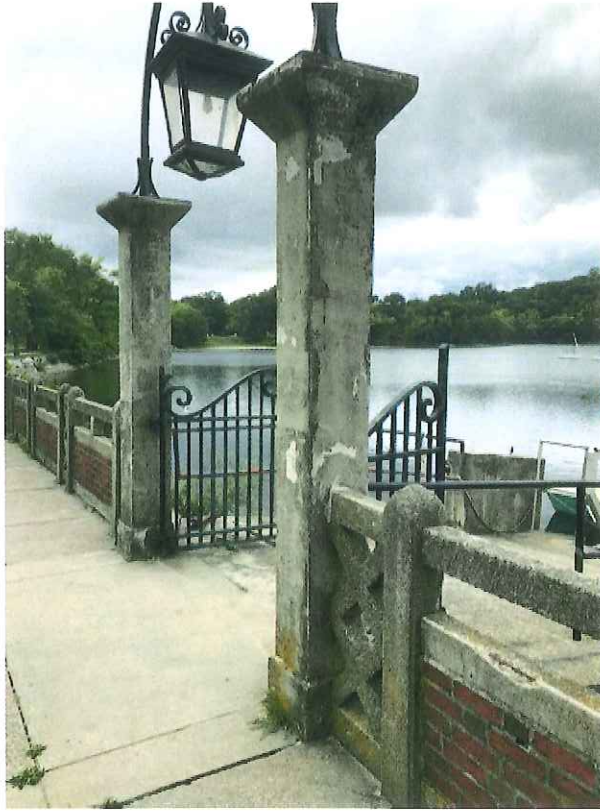
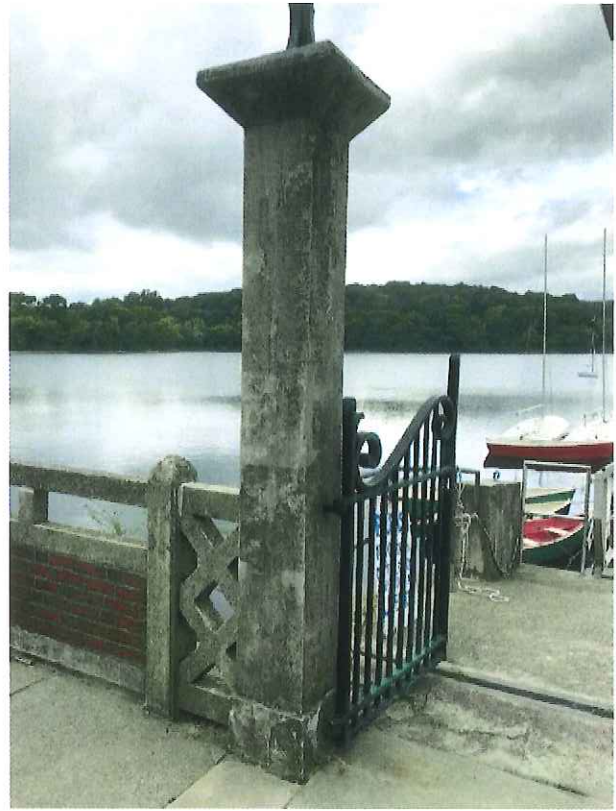
Historic “fence”, gate, archway, and pendant lantern fixture at Boathouse/Bandstand plaza, 2018

- f. Repair Olmsted Brothers' features at the water's edge: the concrete and brick "fence", the steel archway/gate, and the pendant lantern fixture on the archway.

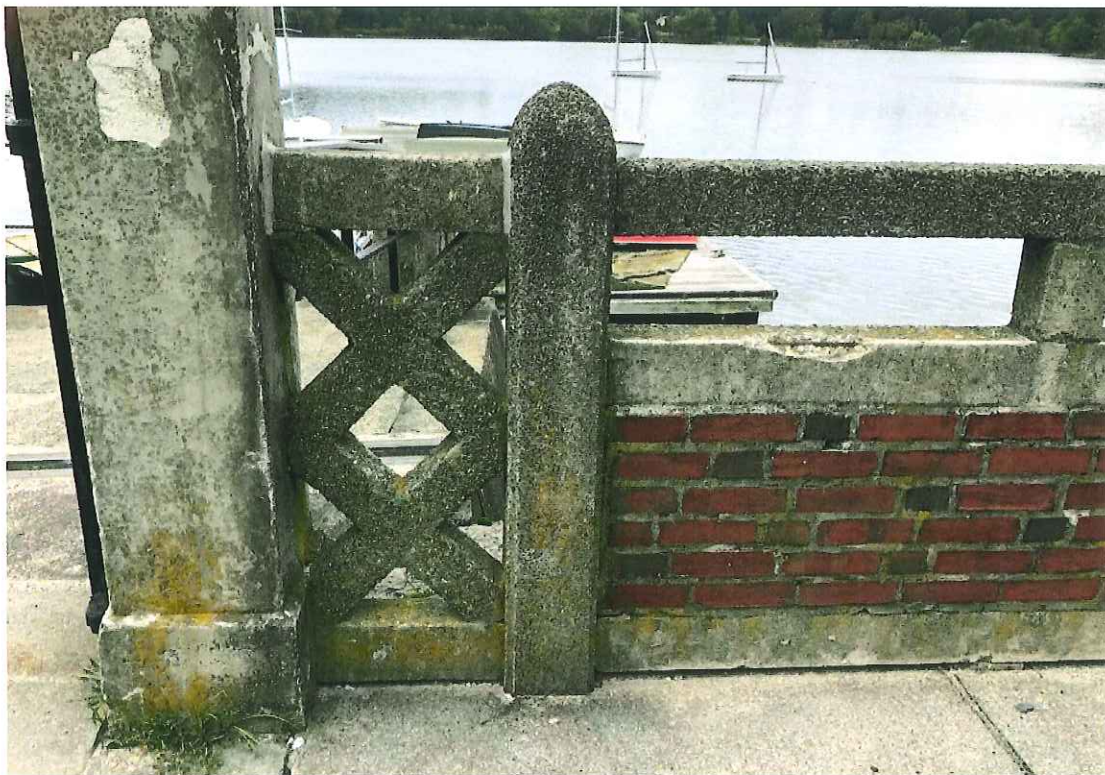
Concrete & brick “fence” at Boathouse/Bandstand plaza, 2018

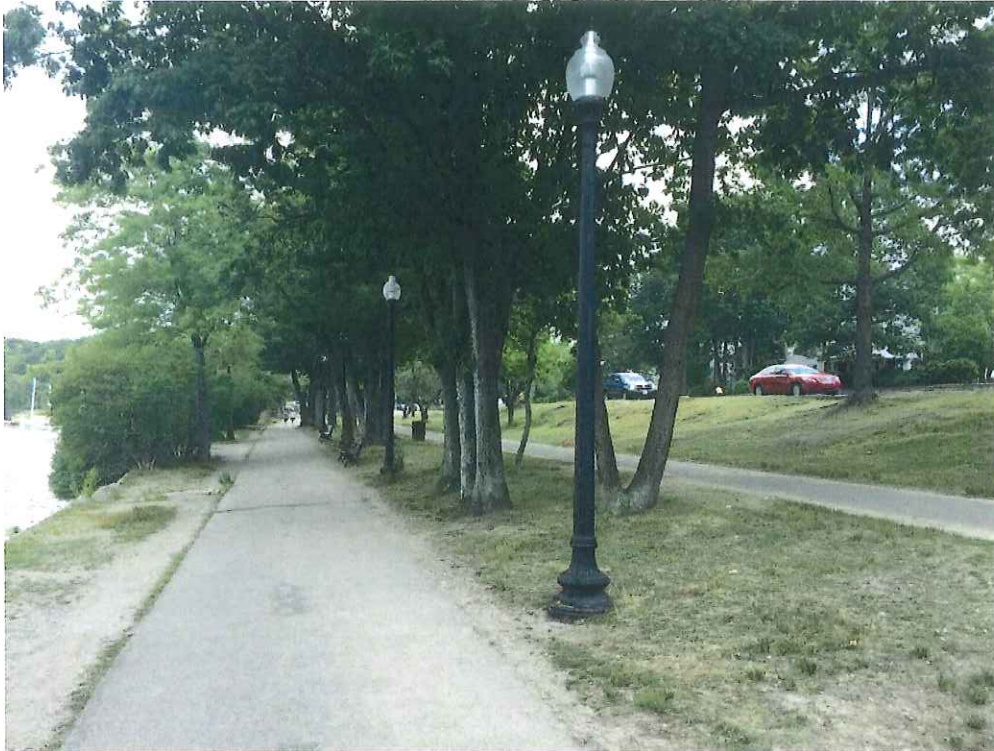
Typical condition of Jamaica Pond Park perimeter pathway near the Jamaica way, 2018

- a. The main walking perimeter pathway is to be repaved in bituminous concrete which is proposed to be a consistent width of 10 feet wide. The pathways have been paved with bituminous concrete since at least the late 1970s according to historic plans and photographs. The 1975 plan entitled "Roadway Improvements Plan" (prepared by Fay, Spofford & Thorndike, Inc.) refers to the perimeter pathway as a "roadway" and shows cross-sections of the path as between 8 to 10 feet wide and comprised of bituminous concrete.

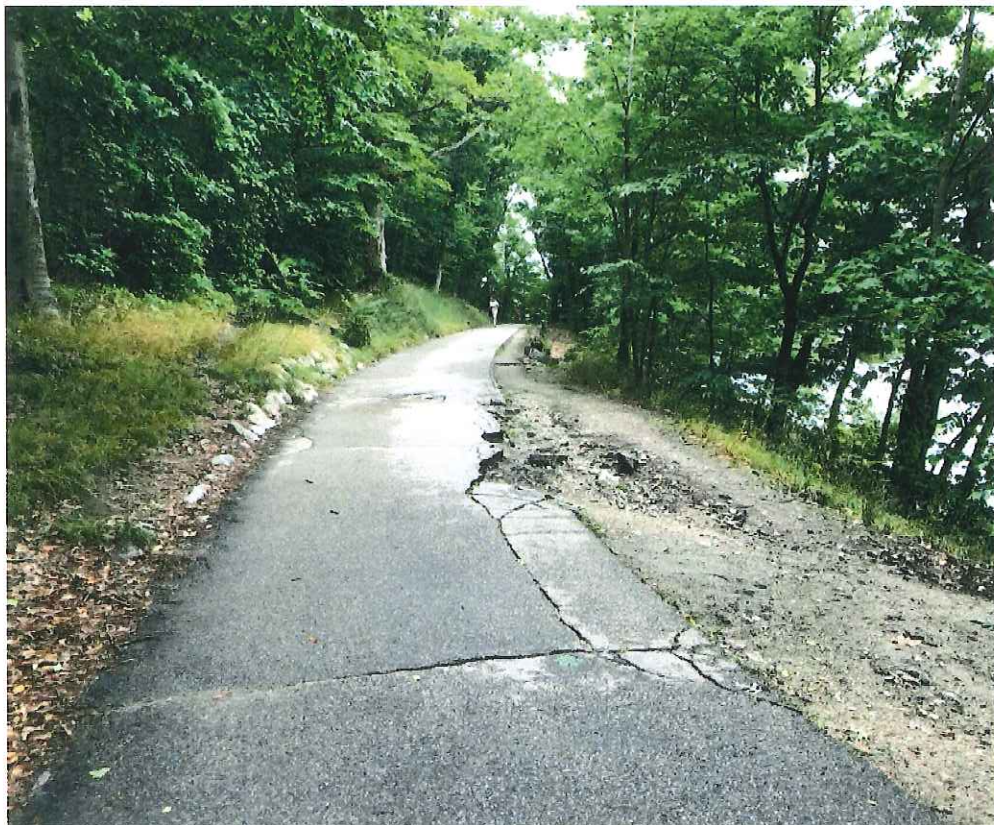
Typical condition of Jamaica Pond Park perimeter pathway below Perkins Street, 2018

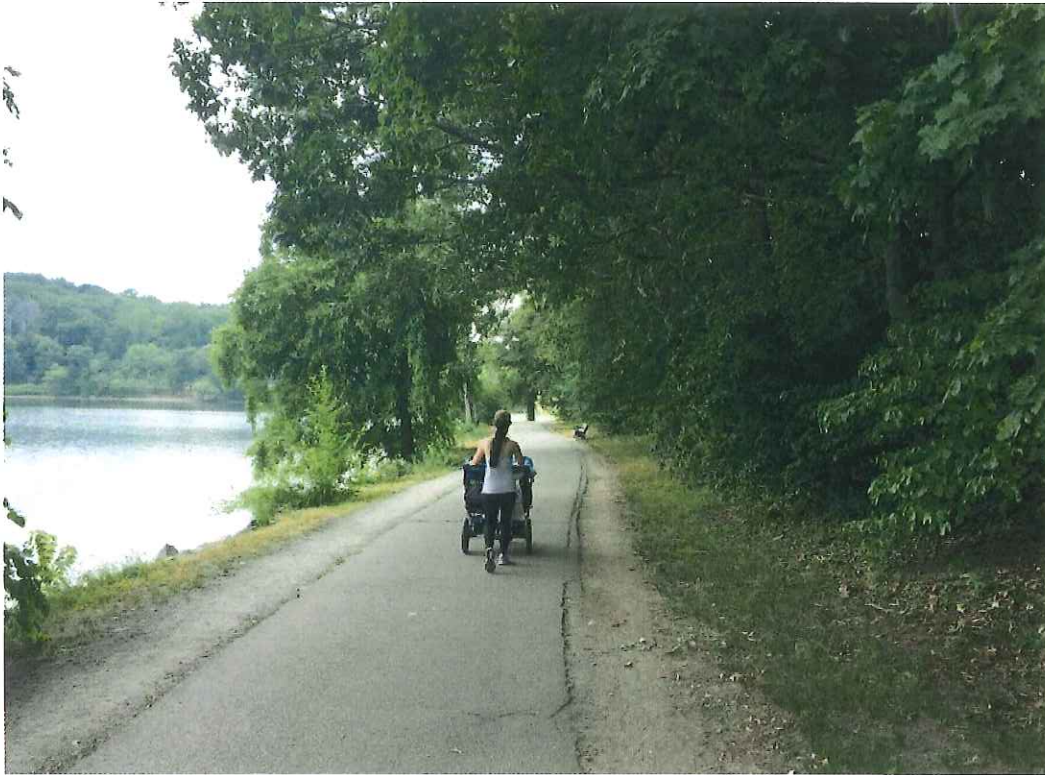
Existing conditions of pathway with runners' path on both sides of the perimeter pathway below Pinebank Promontory, 2018

- f. The proposed runners' path is to be a 24-inch wide aggregate surface (a mix of gray crushed stone sized from 3/8 of an inch to fines) which runs parallel to the perimeter path but does not extend the full circumference of the pond. The runners' path is intended to provide an alternative path with a more desirable surface for runners to run on while protecting the planted and natural areas beyond the paved perimeter path and therefore to reduce sedimentation of the pond. The 1975 "Roadway Improvements Plan" also includes a 2-foot wide runners' path which was comprised of a "Reslite or Rub-kor track surface".

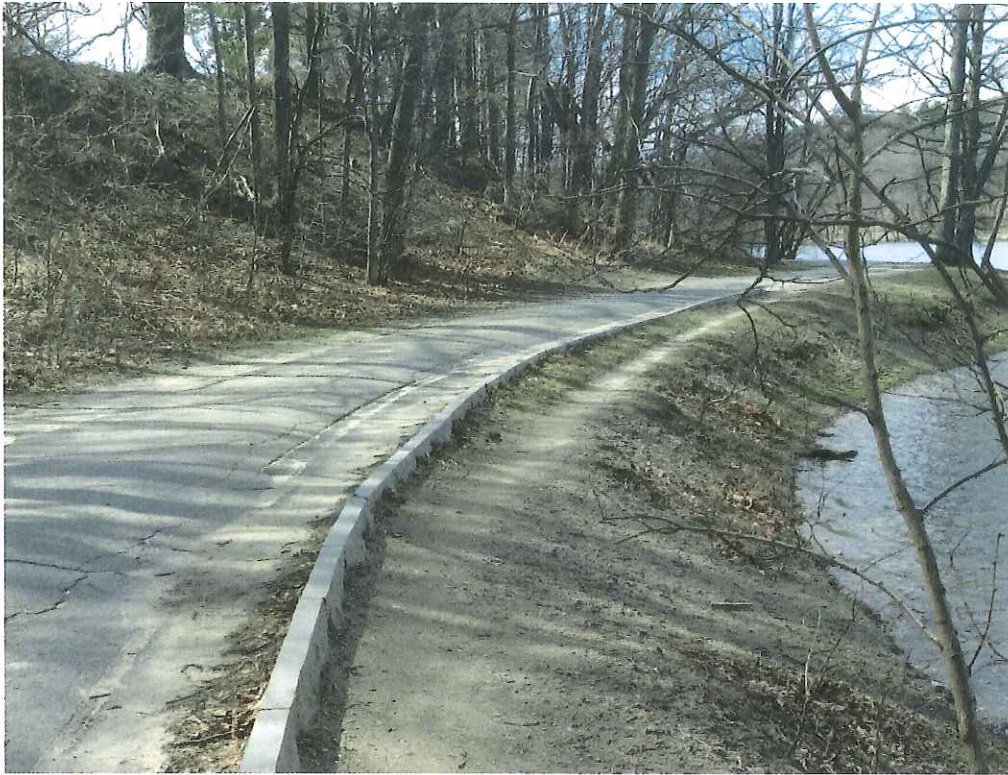
Example of running path inside of vertical granite curb along perimeter pathway below Pinebank, 2018

- e. In select locations, a hardened edge is proposed to be comprised of reclaimed jumbo cobblestones set as curbing to keep people on the perimeter pathway, as well as to manage stormwater. Existing vertical granite curbing (installed in 1989) will remain in place, unless construction pricing (via unit prices) allows for removal and replacement with the jumbo cobblestone curbing.

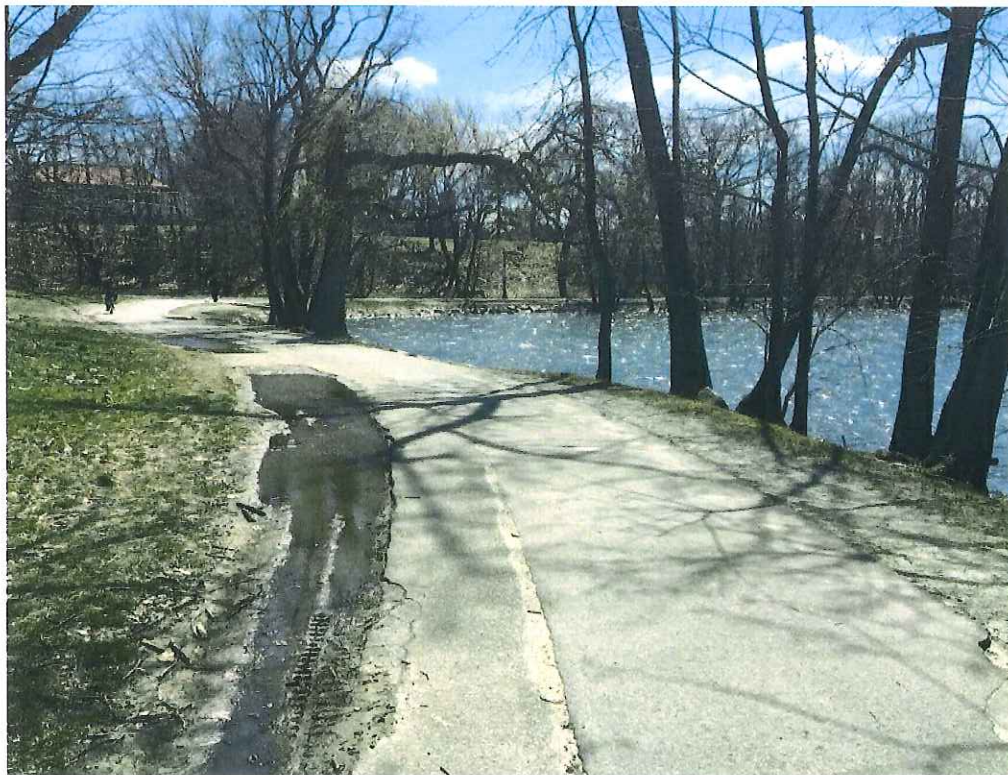
Example of puddling & rutting on inside of perimeter pathway, below Pinebank, 2018

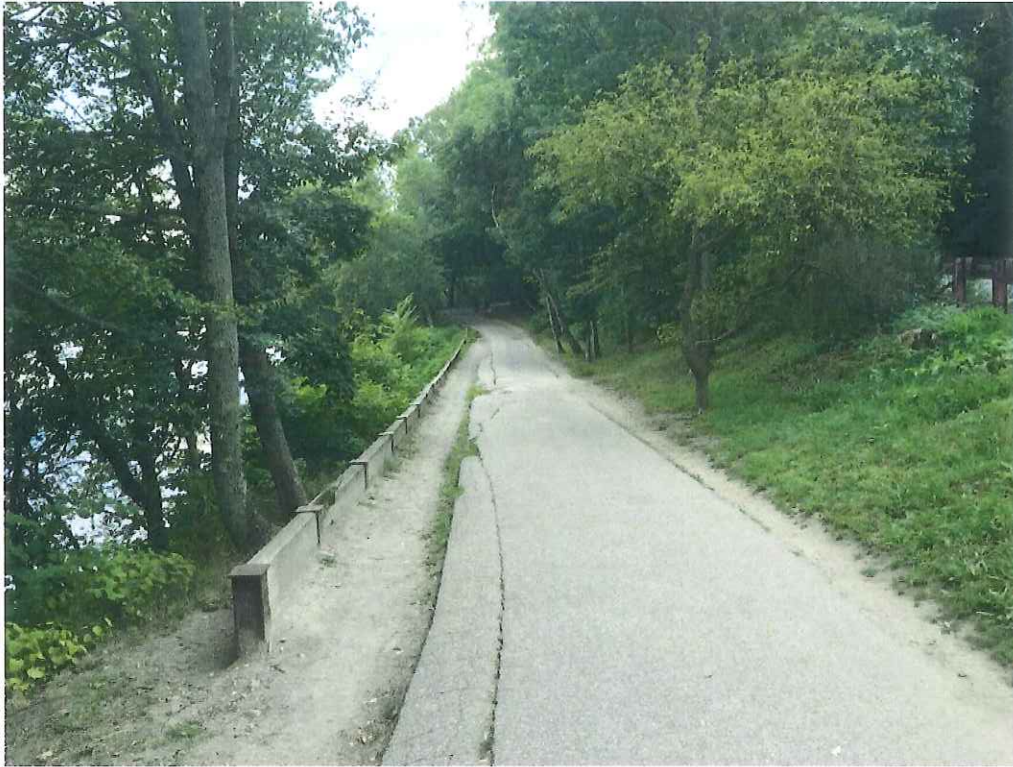
Example of timber retaining wall along perimeter pathway below Perkins Street, 2018

- b. Existing wood retaining walls, along Parkman Drive and Perkins Street, will be repaired with new timbers. The steel beams will remain in place and will receive new caps. Two short segment walls (approximately 10 feet long each) will be removed as they provide no substantial retaining; one of the long retaining wall runs will be shortened also.

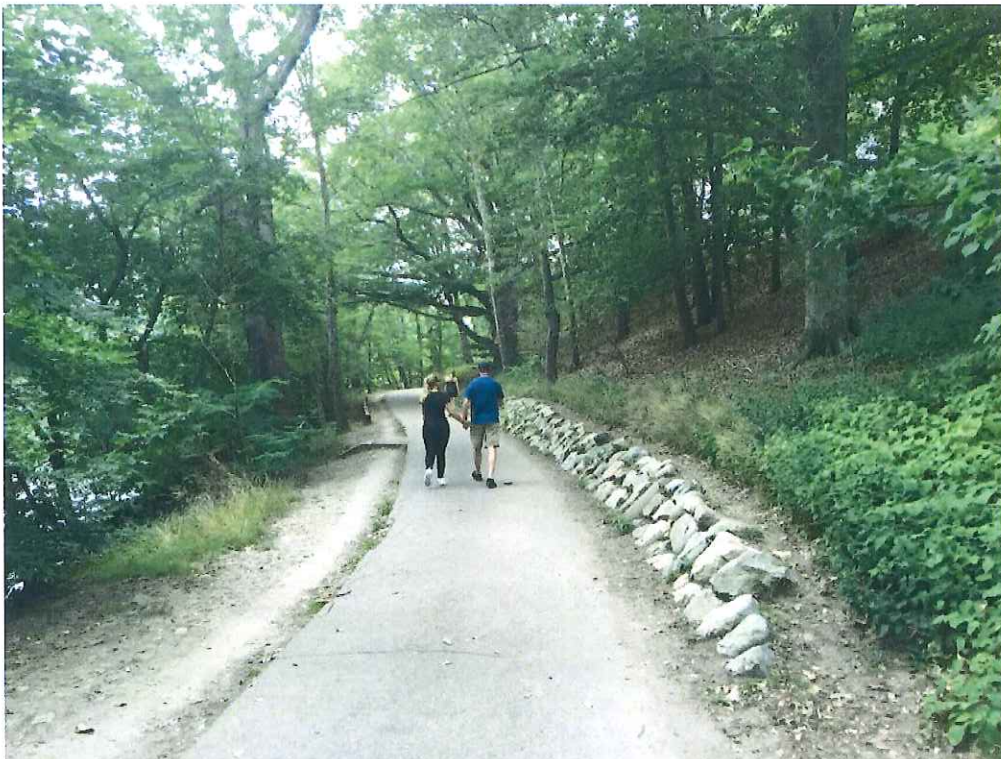
Example of stone retaining wall along perimeter path below Perkins Street, 2018

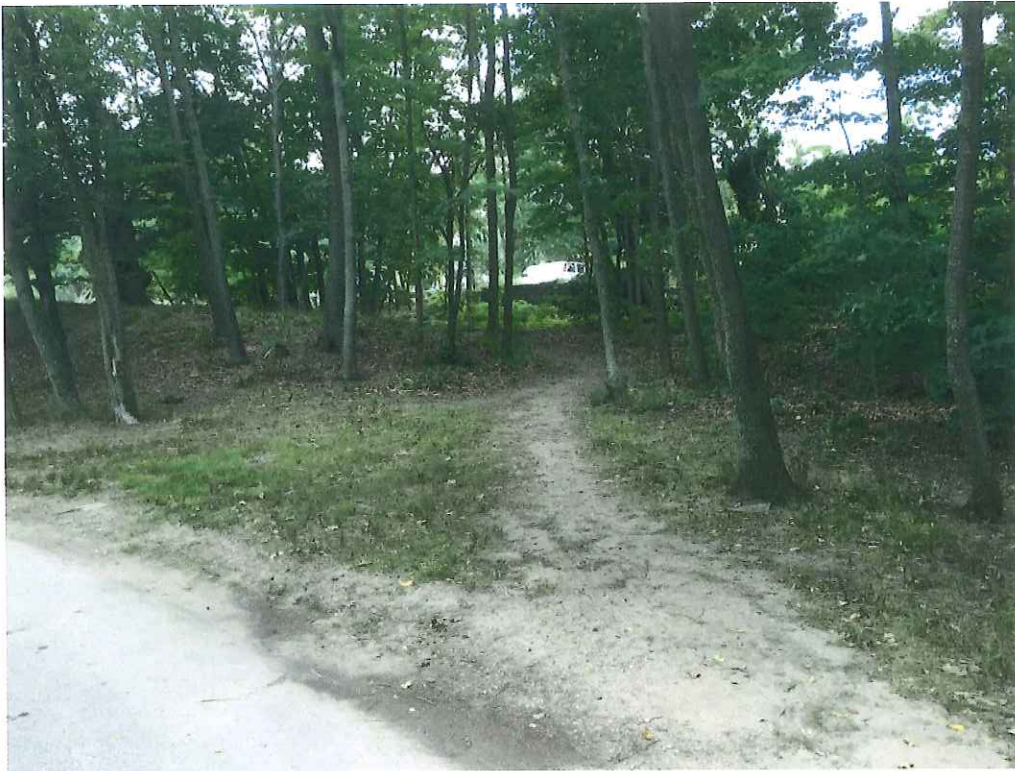
Existing conditions of social trail along Francis Parkman Drive, 2018

- c. A social trail connecting the Arborway at the William F. Kelly Circle to Jamaica Pond Park's perimeter pathway will be formalized and made accessible with a bituminous surface and grades that are MAAB-compliant.

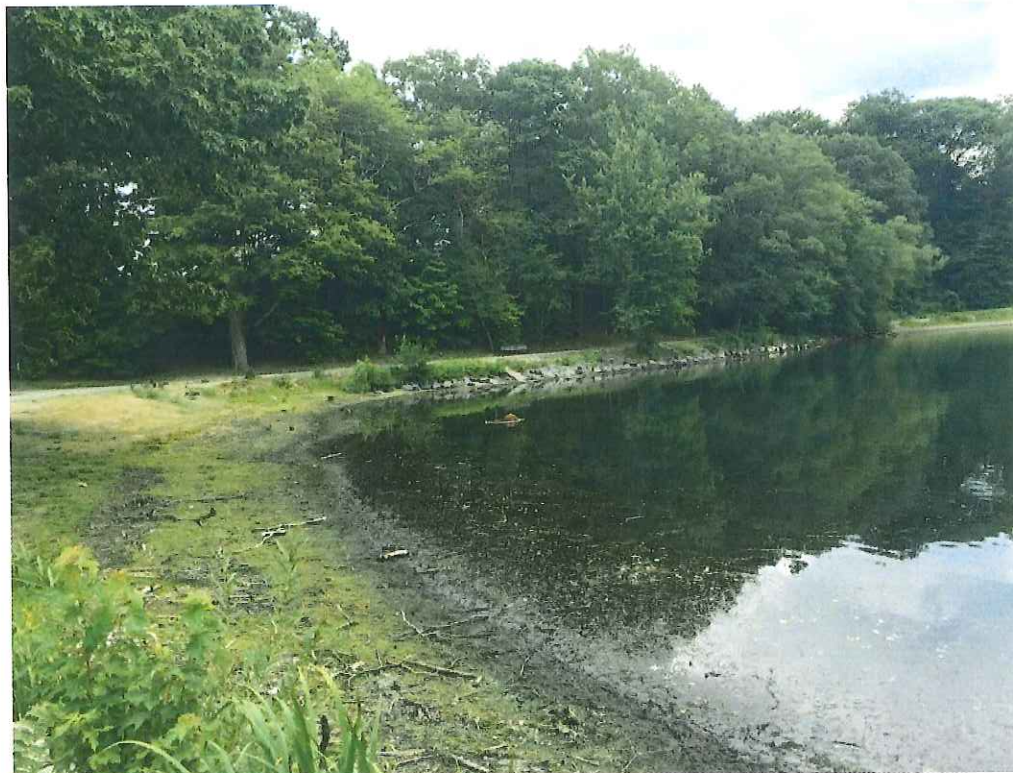
Approximate location of proposed bio-swale at pond edge near Perkins/Chestnut Streets entry, 2018

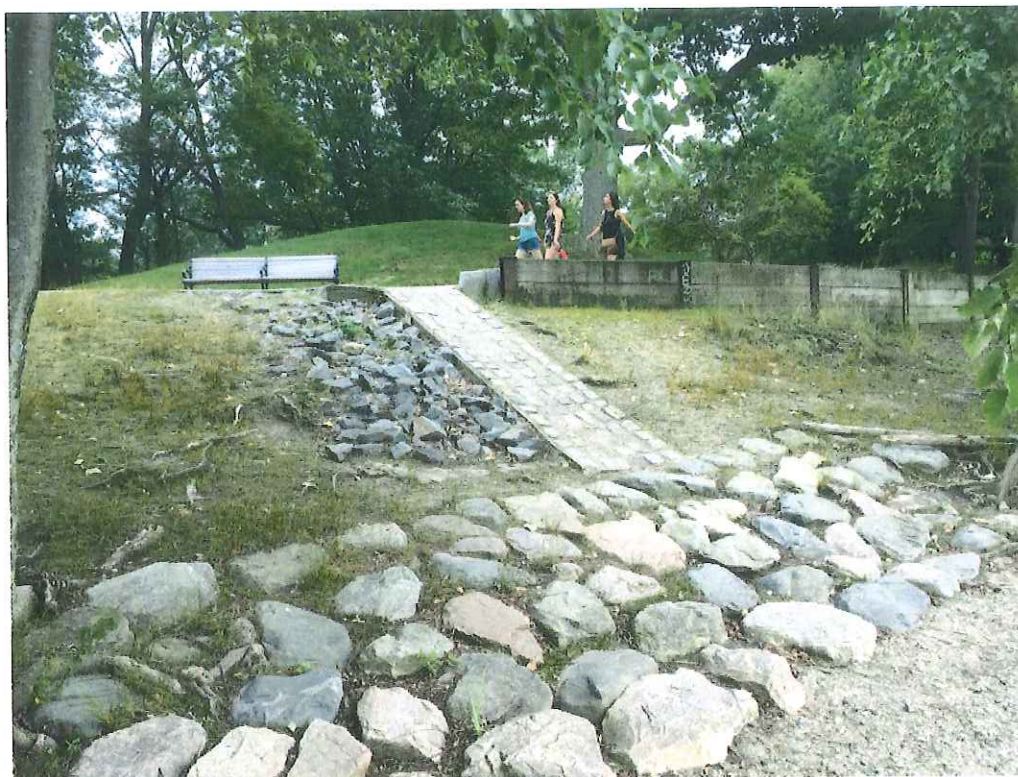
Example of cobblestone spillway below Perkins Street, 2018

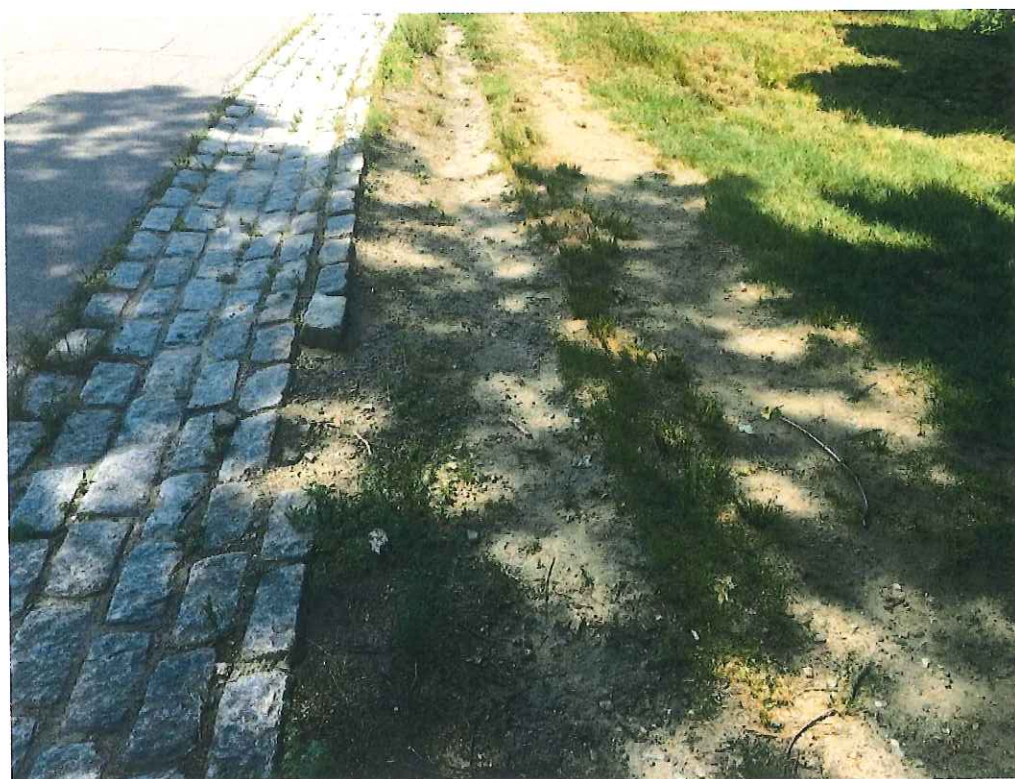
Example of cobblestone swale running parallel to perimeter path along the Jamaicaway, 2018

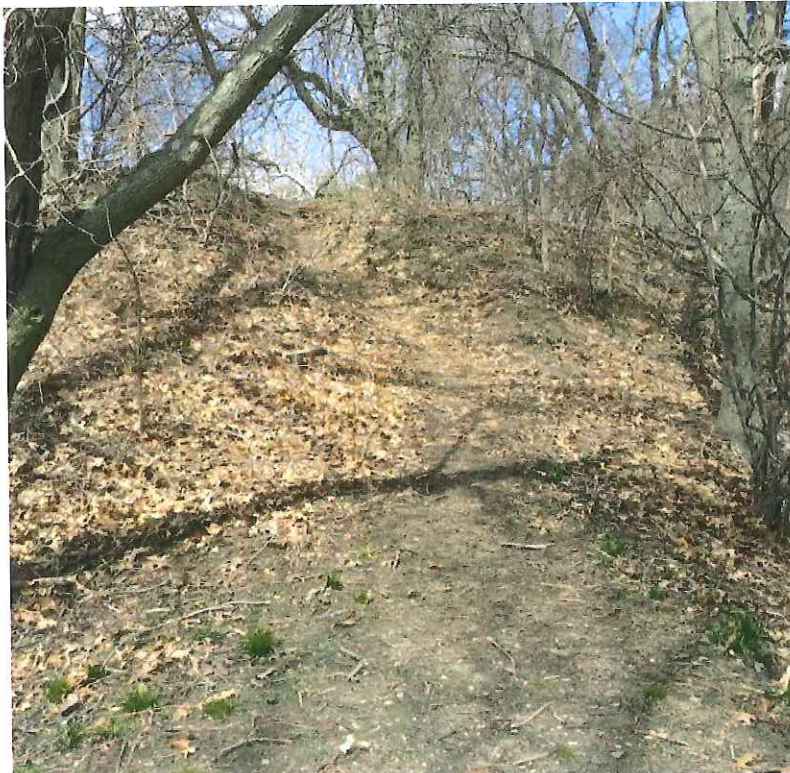
Bare slope due to social trailing below Pinebank, 2018

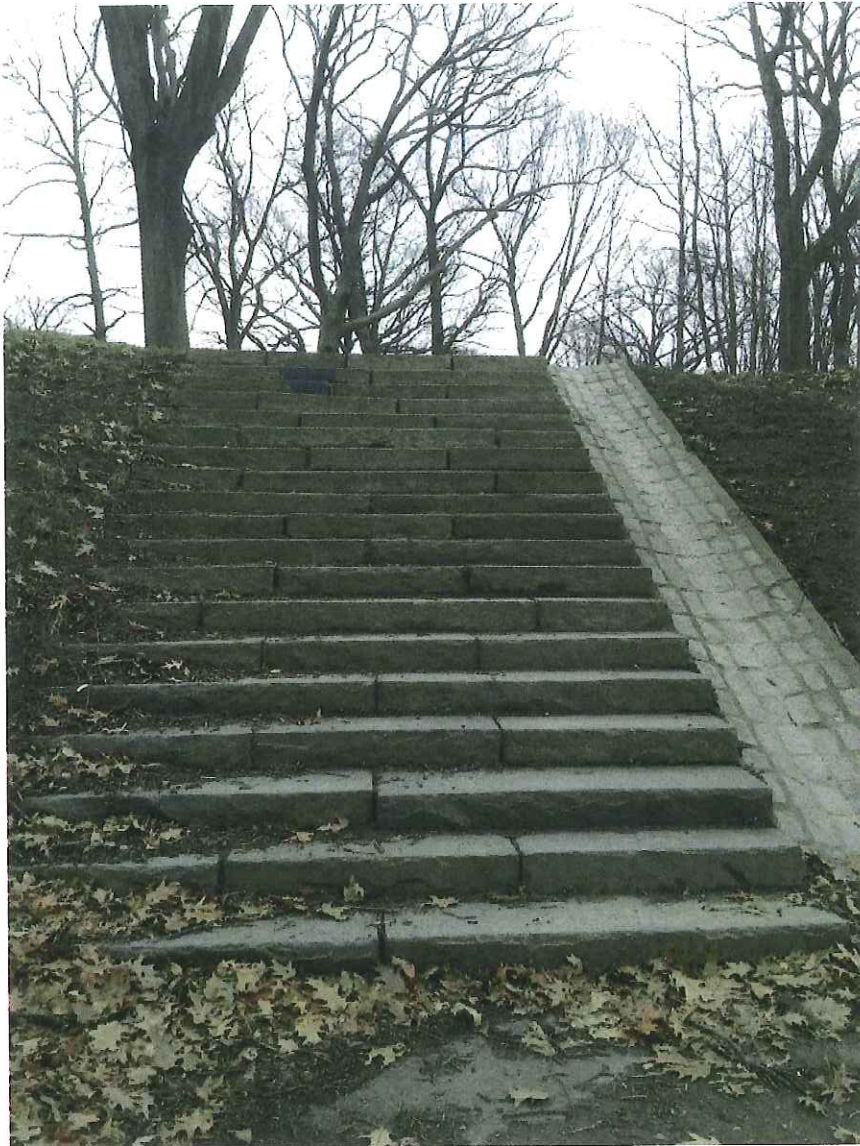
STAIRWAYS: POND STAIRS

CONCERNS:

- Stone dust pathway at top of stair is eroding onto stairs
- Treads have settled/shifted over time
- Uneven stair treads have encouraged social trails to form on the southern slope
- Armored swale is unsightly and not original to the site

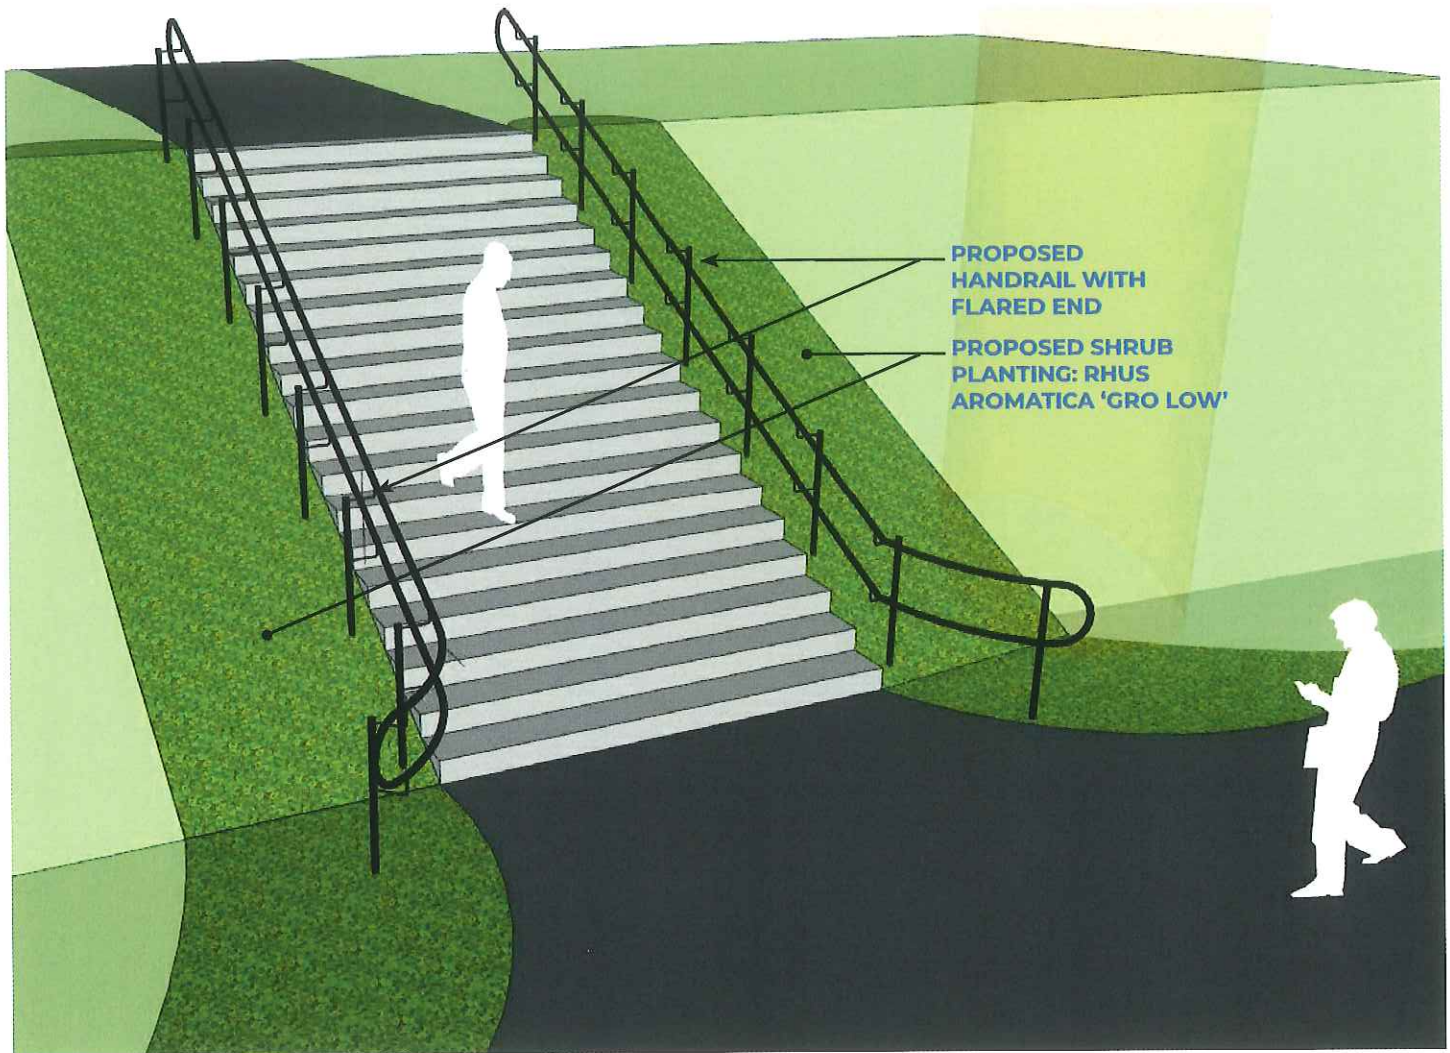
STAIRWAYS: POND STAIRS

View of rehabilitated pond stairs with shrub plantings and handrails

- g. Plant the side slopes of the stairs to deter visitors from bypassing the stairs. The slopes are eroding adding to the sedimentation of the pond. The slopes are proposed to be planted with *Rhus aromatica* 'Gro Low', fragrant sumac. Fragrant sumac was selected based its ability to stabilize slopes, as well as its ability to grow in both sun and shade conditions.

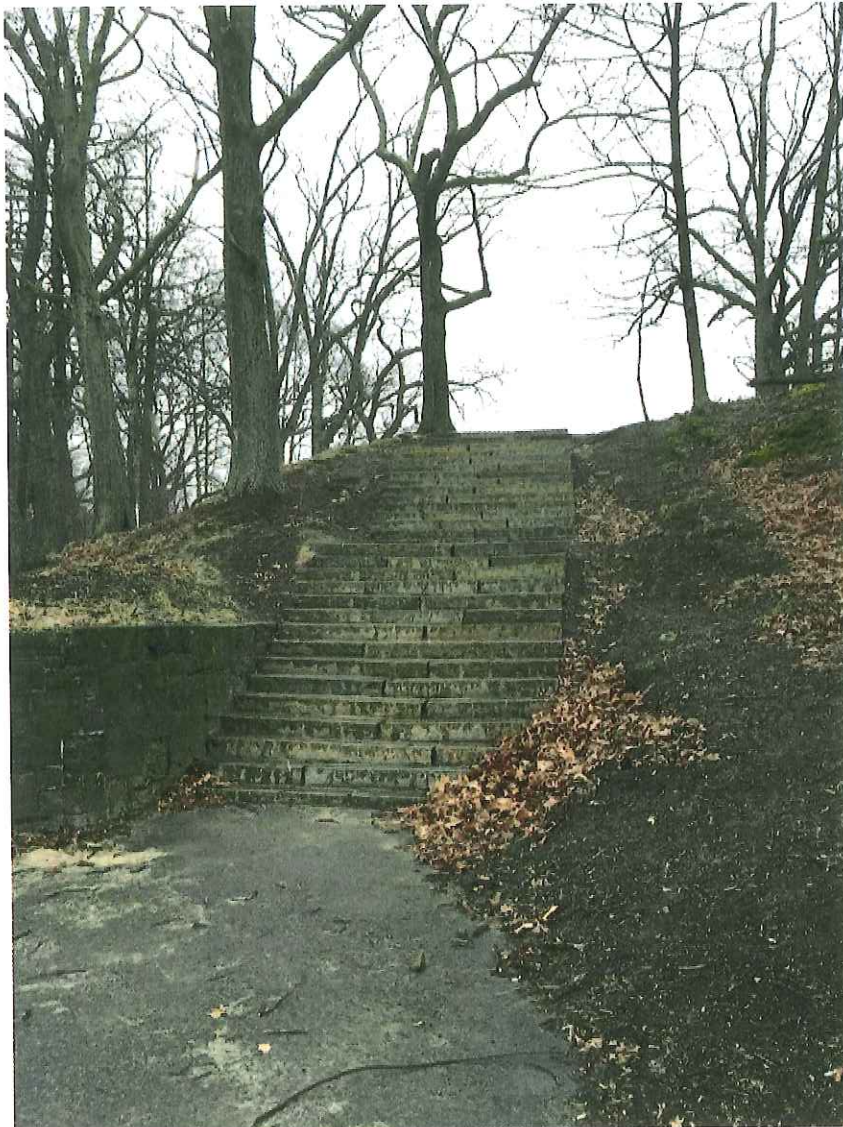
STAIRWAYS: PERKINS STREET

CONCERNS:

- Pathway at top of stair well above ADA allowed gradient
- Treads have settled/shifted over time
- Riser/tread relationship is relatively steep
- Uneven stair treads have encouraged social trails to form on the edges
- Stormwater flows down the sides of the stairs

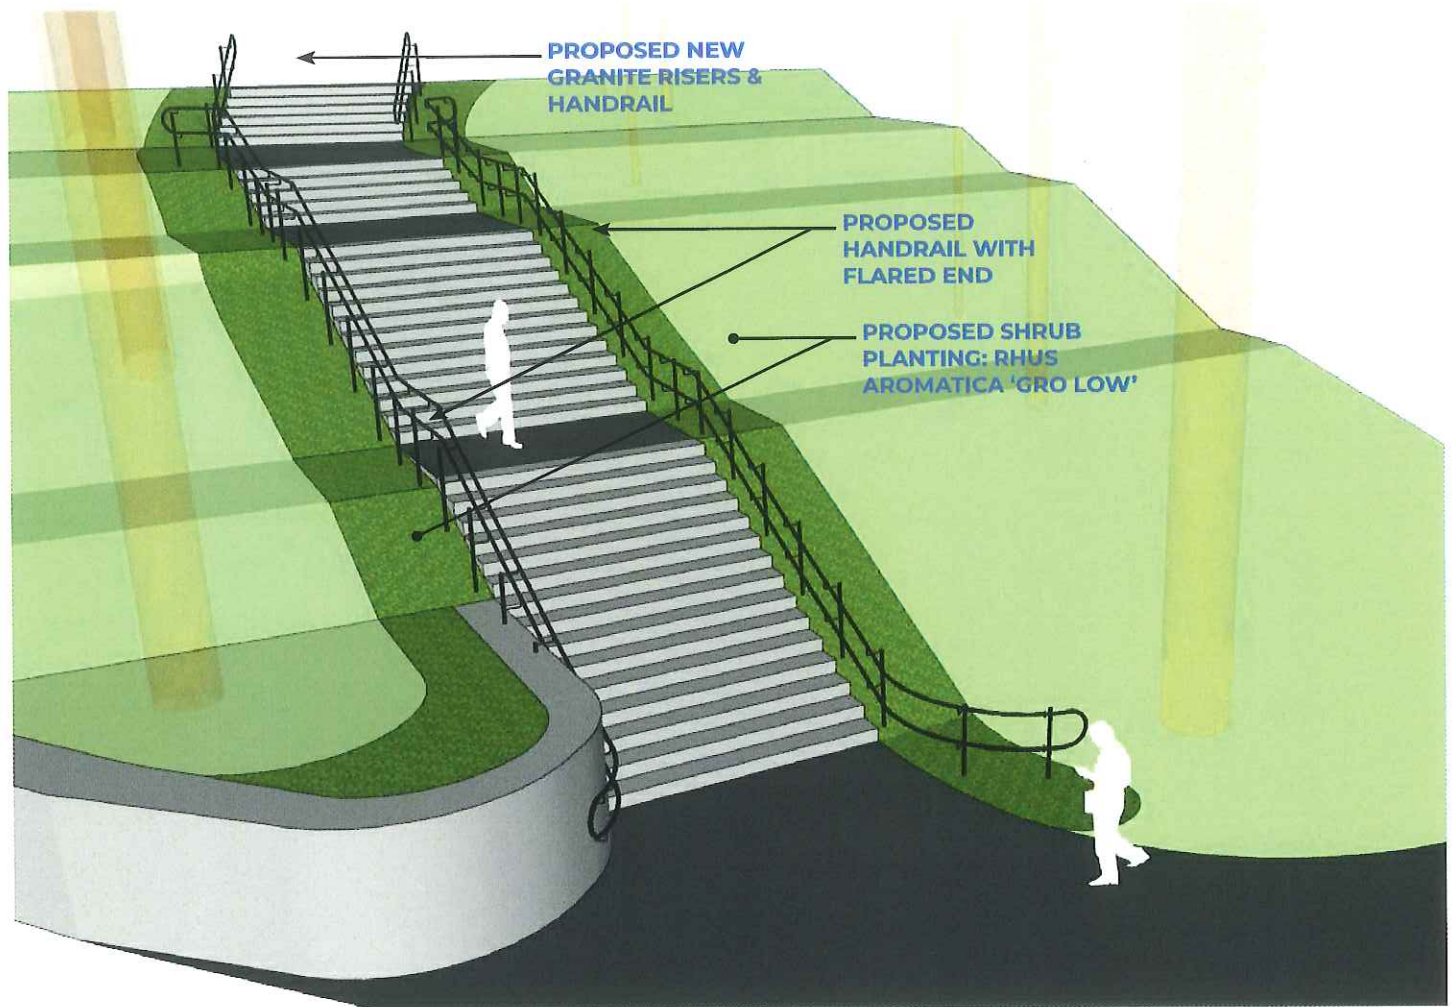
STAIRWAYS: PERKINS STREET

View of rehabilitated Perkins Street stairs with additional risers at the top, shrub plantings and handrails

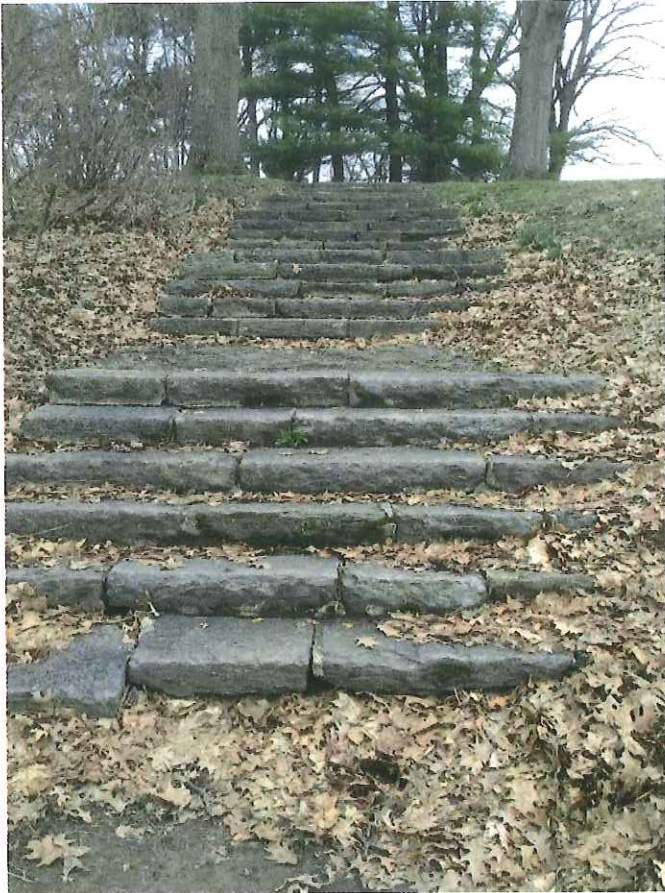
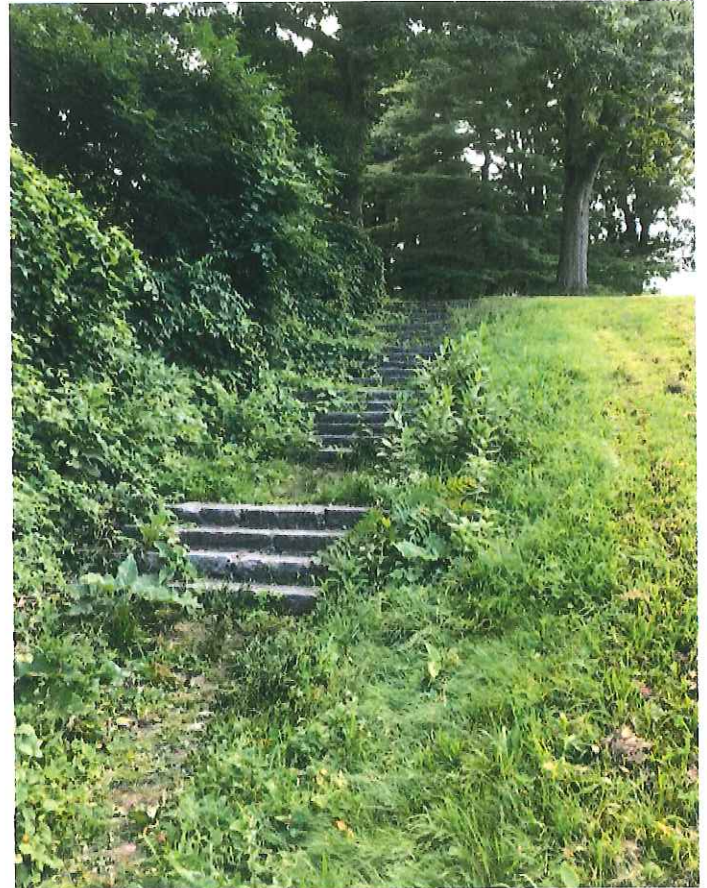
STAIRWAYS: PUDDINGSTONE

Existing conditions (May)

Existing conditions (August)

- Replace bituminous concrete landings
- Reset granite treads
- Maintain stairs as a historic remnant

Repairs to the puddingstone stairs include:

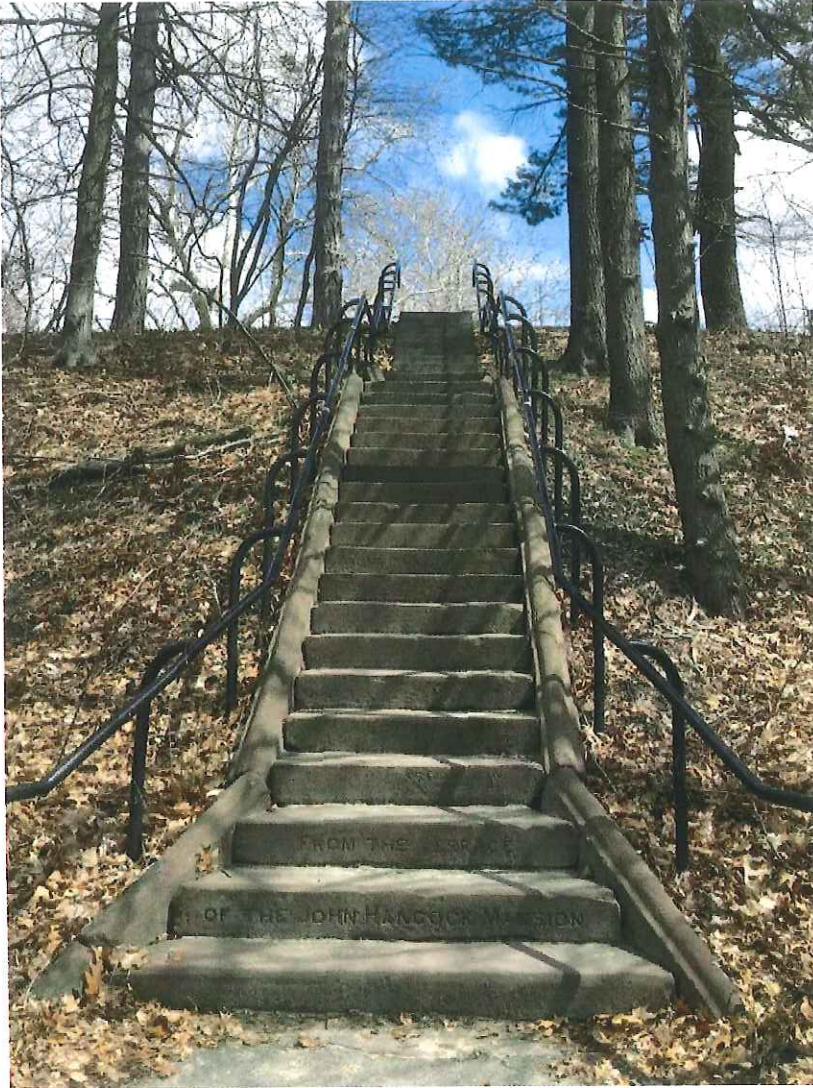
STAIRWAYS: HANCOCK STAIRS AT PINEBANK

CONCERNS:

- Select stair treads rock

Repairs to the "Hancock stairs" include:

- m. Stabilize five brownstone treads that are loose and rocking by shimming
