Jamaica Pond Park Pathways & Entrances: Phase 2 Work

Jamaica Pond Park, Jamaica Plain

Description of Proposed Work

November 2018

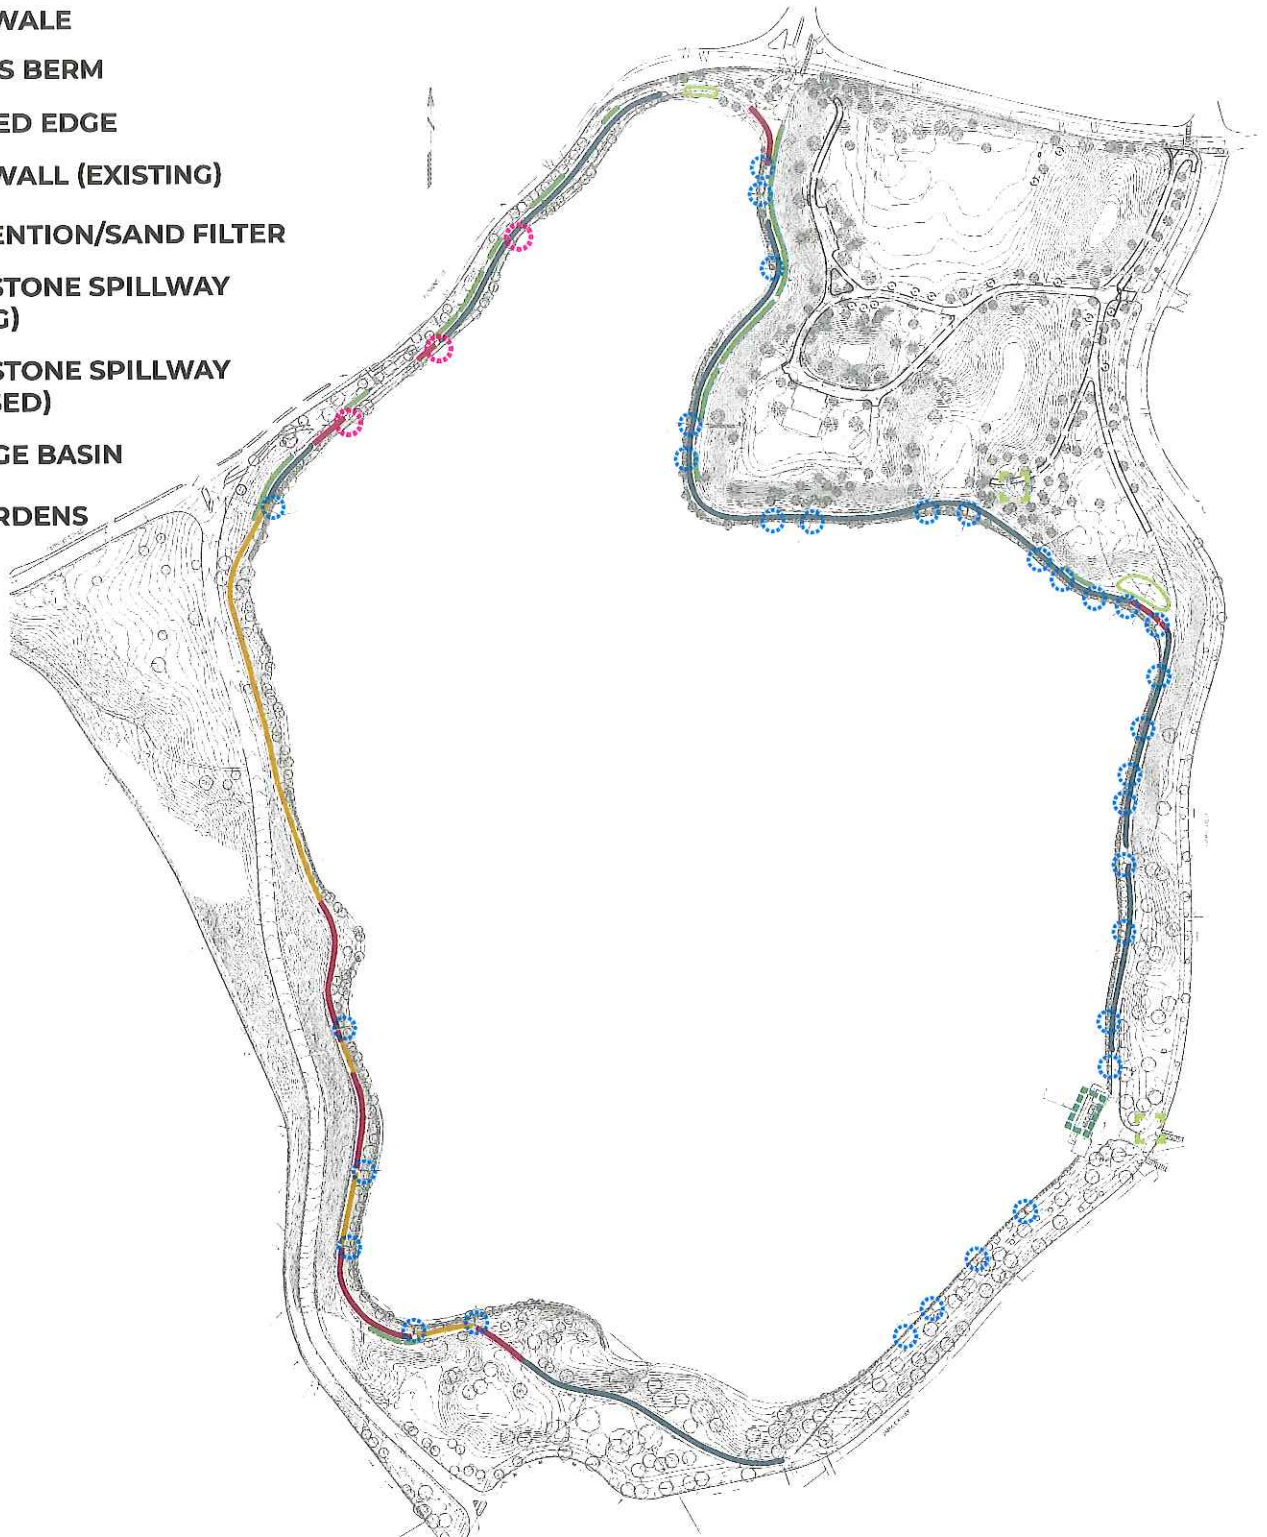
STORMWATER MANAGEMENT

-   GRASS SWALE
-   RUNNER'S BERM
-   HARDENED EDGE
-   TIMBER WALL (EXISTING)
-   BIO-RETENTION/SAND FILTER
-   COBBLESTONE SPILLWAY (EXISTING)
-   COBBLESTONE SPILLWAY (PROPOSED)
-   RECHARGE BASIN
-   RAIN GARDENS

Proposed stormwater management interventions

- e. Hardened edges will be mortared cobblestone curbing rather than new vertical granite curbing to maintain the naturalistic design intent. Select existing vertical granite curb and bituminous curbs will be replaced with cobblestone curbing as necessary and as funding allows. Hardened edges are only proposed along steep slopes where runoff could scour the side slopes of berms.

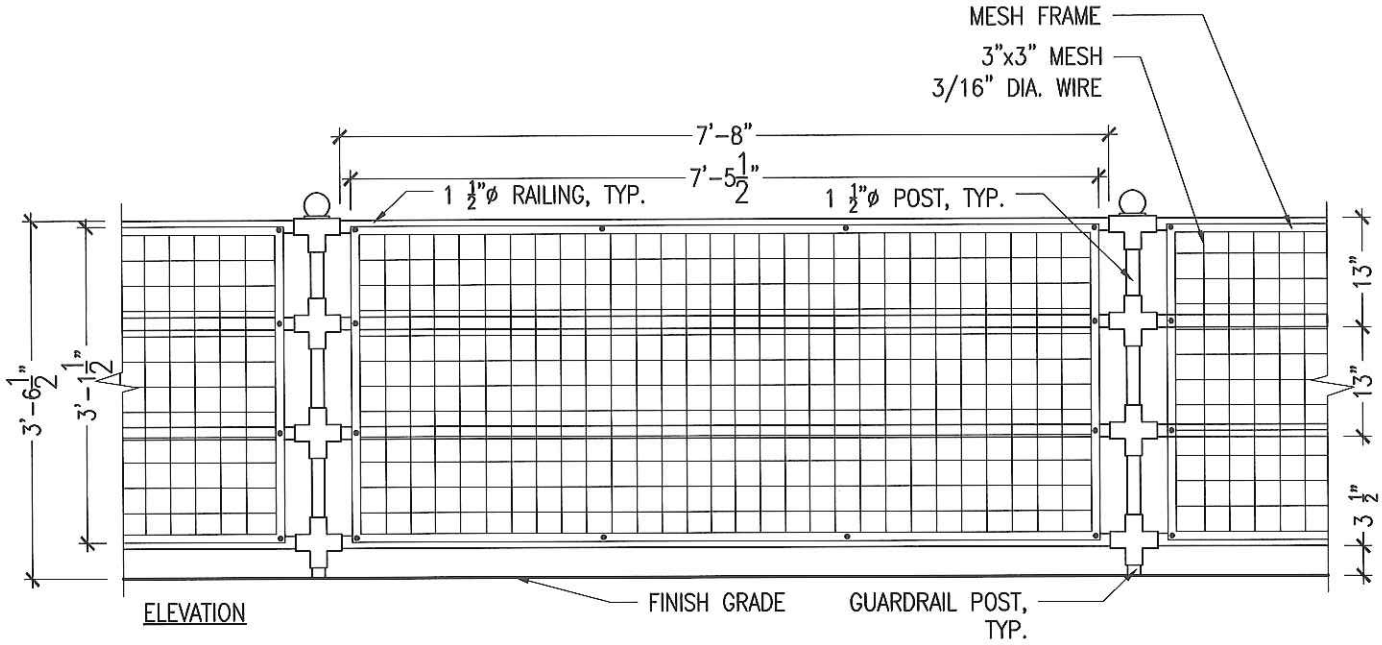
SITE AMENITIES: GUARDRAIL

Standard Guardrail

- c. Existing chain link fence at the culvert on Parkman Drive and an existing guardrail on the south side of the boathouse (which does not meet current Massachusetts Building Code 780 CMR 1012.0 for guards) will be replaced with a new guardrail which meets Massachusetts Building Code 1012.0. This guardrail will be inspired by a historic guardrail designed by the Olmsted Brothers for the site (see historic image, page 18), but will be updated to meet current Building Code requirements. See detail, page 52.

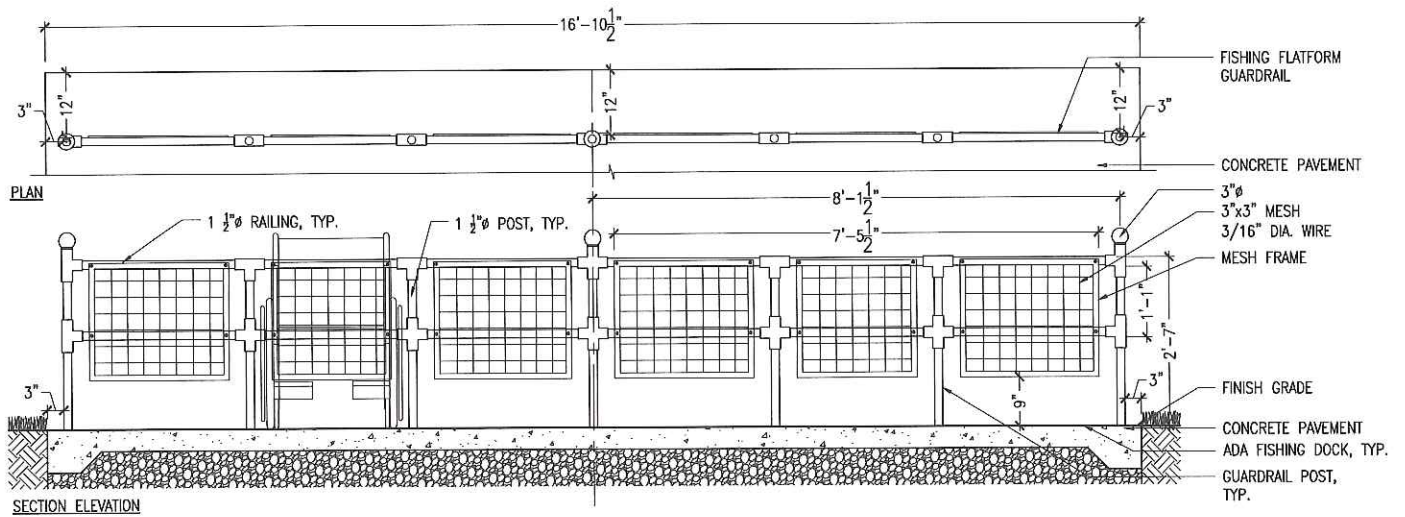
Fishing Platform Guardrail

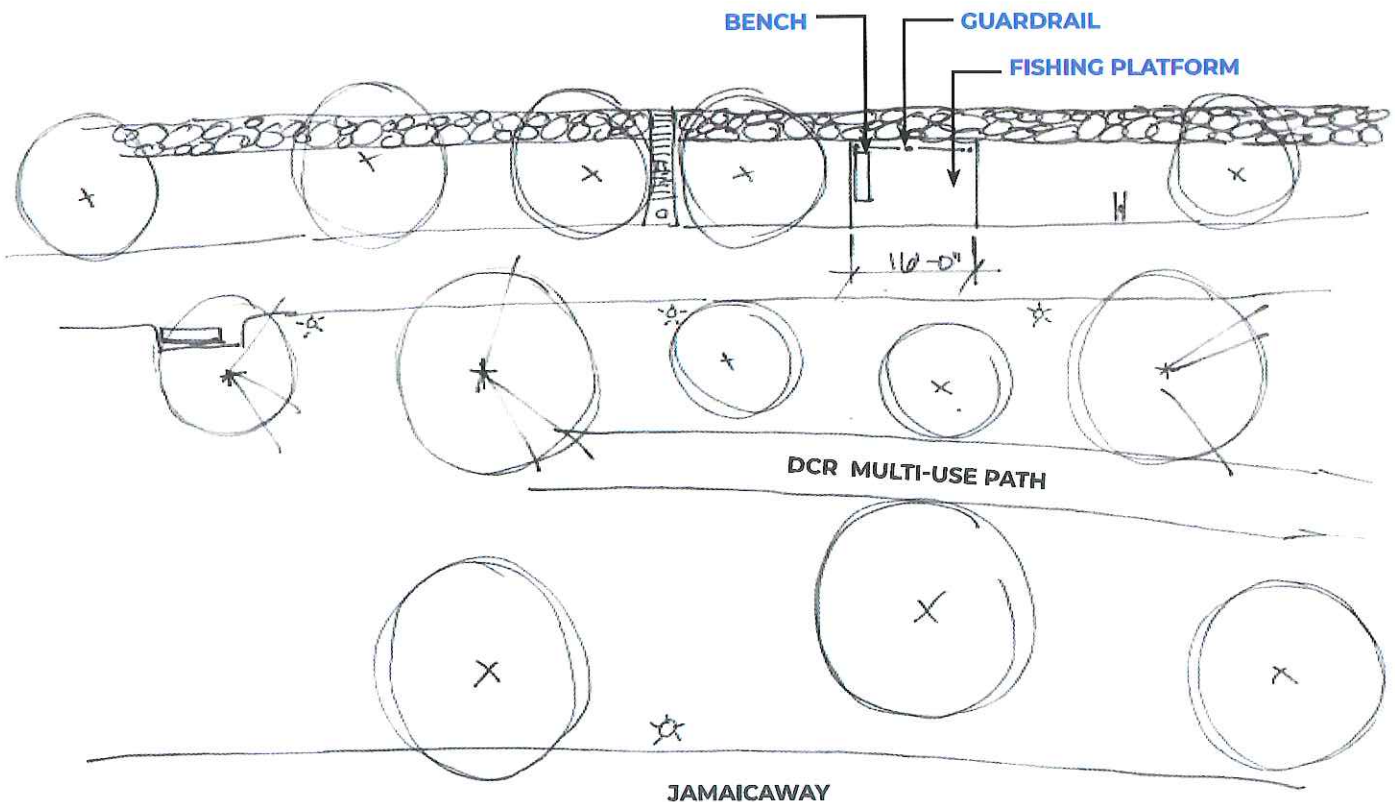
Fishing Platform Plan View

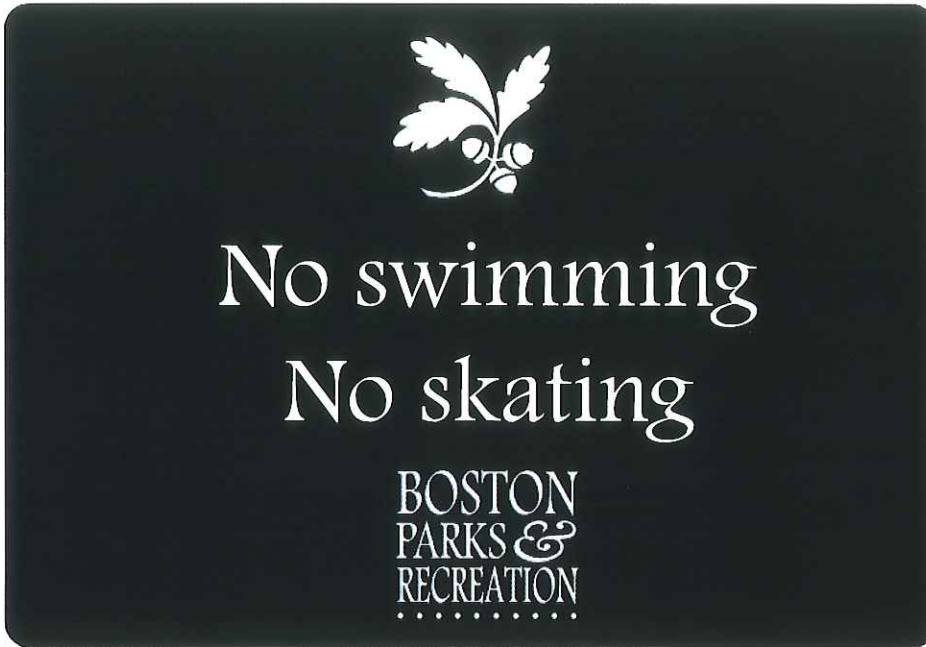
SUBSTRATE: Aluminum .080"
SIZE: 12" x 18"
COLOR: White
SIDES: 1

COPY: Screenprinted
FONT: Footlight MT
COLORS: Black
CORNER DETAIL: Radius
BACKING: N/A

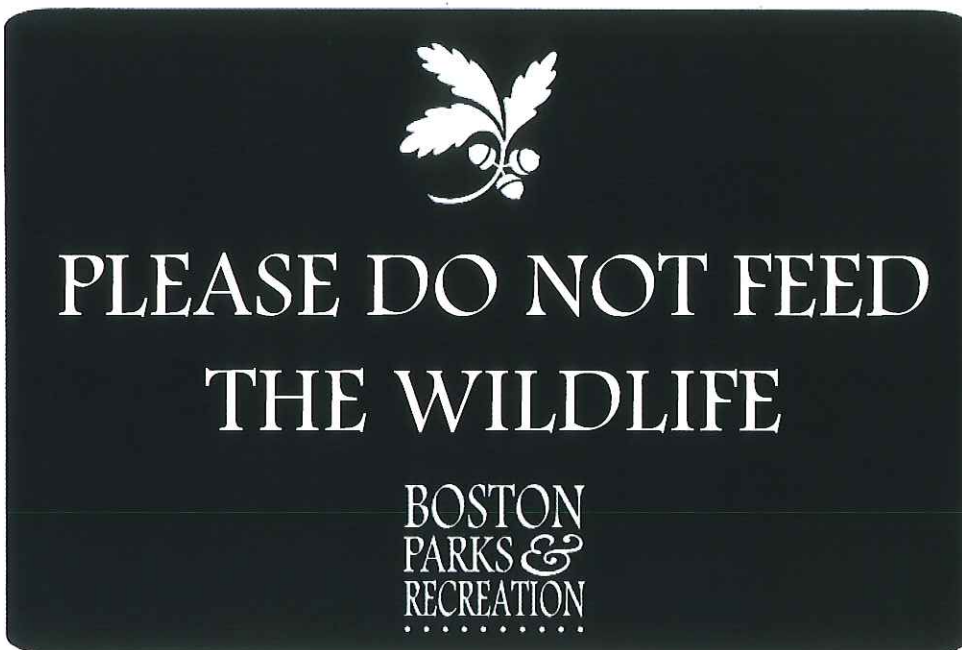
SUBSTRATE: Aluminum .080"
SIZE: 12" x 18"
COLOR: White
SIDES: 1

COPY: Screenprinted
FONT: Footlight MT
COLORS: Black
CORNER DETAIL: Radius
BACKING: N/A
