2 Worthington Street - Boston, MA.2 Worthington Street LLC Commision Hearing Existing Front Elevation and Details Landsmarks

Boston, MA Commision Hearing Street LLC Front Elevation Proposed Details Street Worthington Worthington Landsmarks

2 Worthington Street - Boston, MA.2 Worthington Street LLCLandsmarks Commision Hearing

Proposed Window Well Worthington 2 2

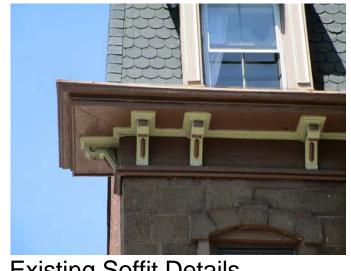
Existing Soffit Details

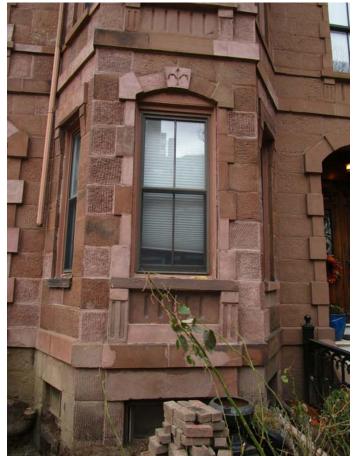
Discolored Existing Masonry Detail

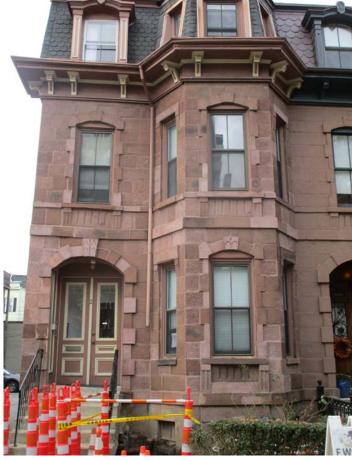
Discolored Existing Masonry

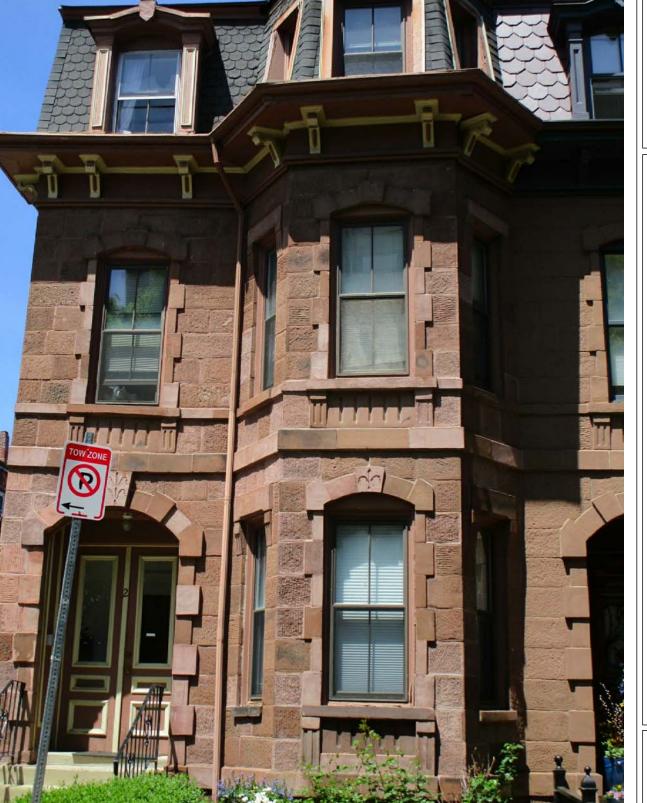
Existing Front Elevation

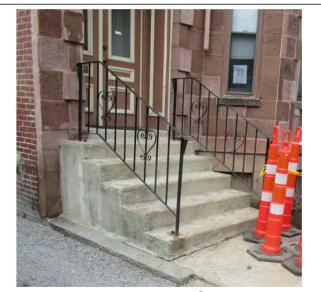
Existing Front Entry Stairs

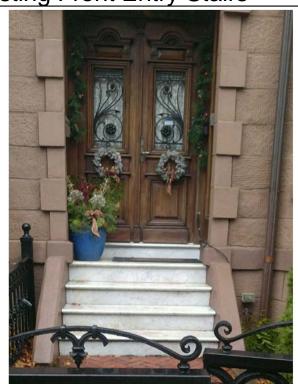
2 Worthington Street - Front Entry Sample

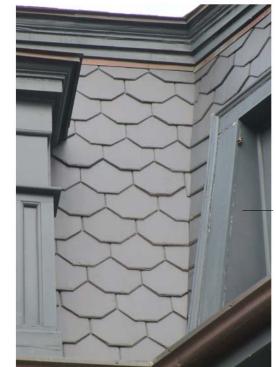
Proposed Mansard Slate Pattern

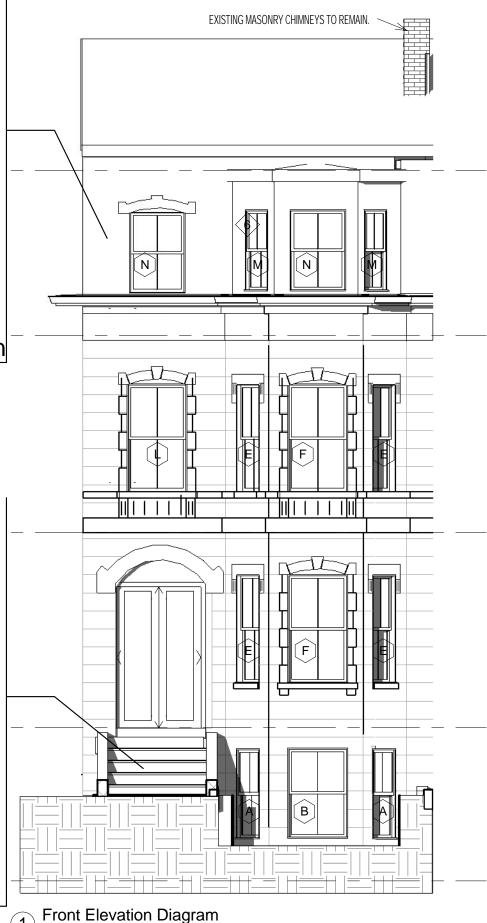
7" Wide Poured Concrete Closed Stringer Coated to Match Front Elevation Stone

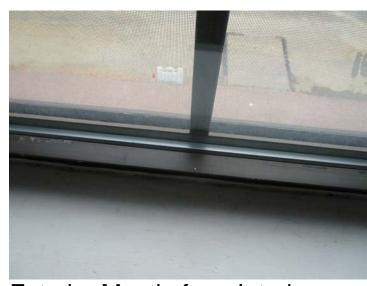
Typical Window Sill Interior

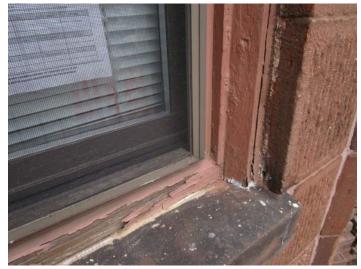
Exterior Muntin from Interior

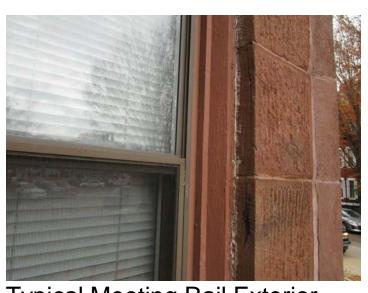
Typical Window Sill Exterior

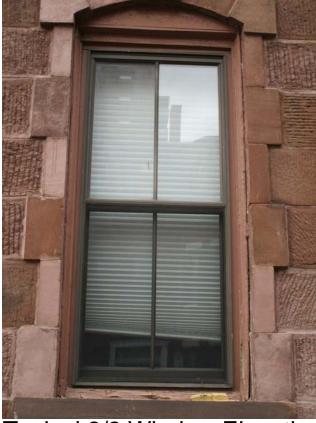
Typical Meeting Rail Exterior

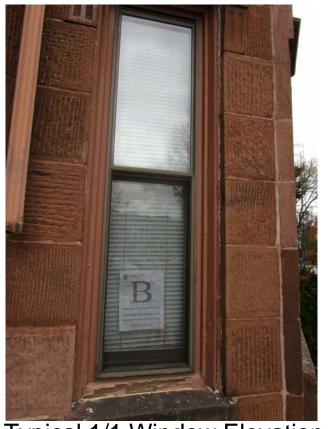
Typical 2/2 Window Elevation

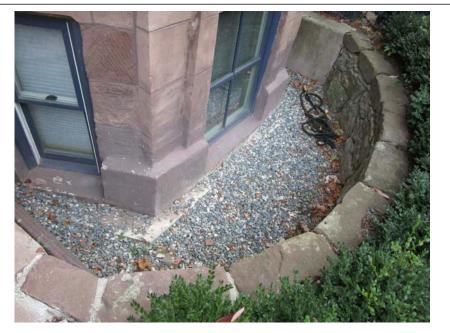
Previously constructed window well 9 Wigglesworth

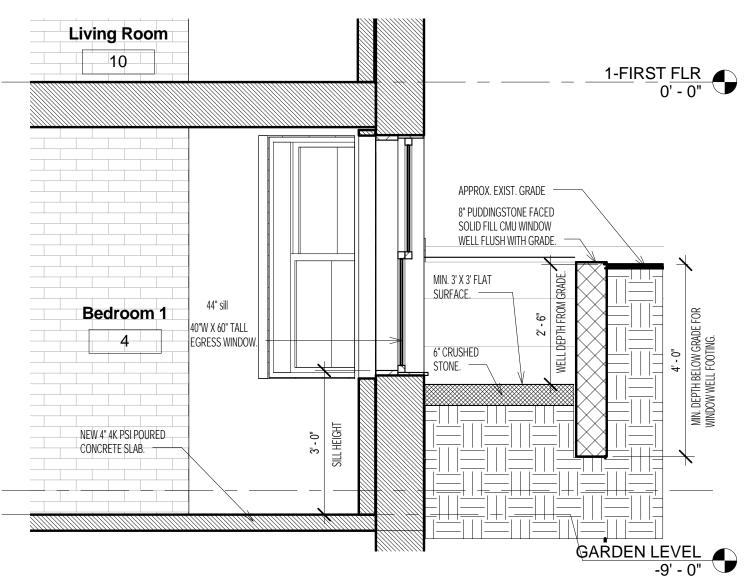
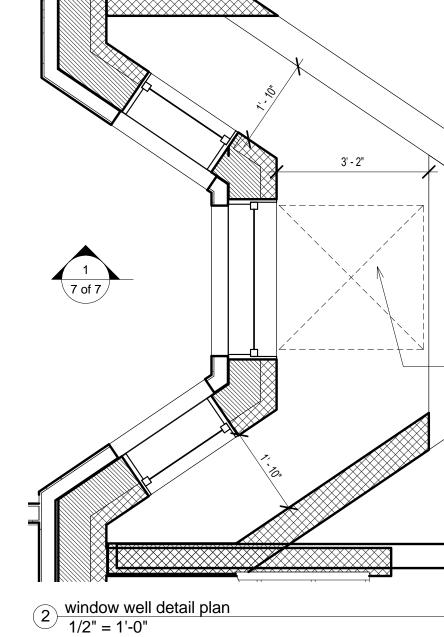
MIN. 3'X3' FLAT SURFACE AT WINDOW WELL.

Bedroom Egress Window Well 1/2" = 1'-0"
