# **HOWE-KINGSLEY HOUSE**

### **STUDY REPORT**

**The Howe-Kingsley House**  
**16 Howe Street, Boston, Massachusetts**

As a Landmark under Chapter 772 of the Acts of 1975, as amended

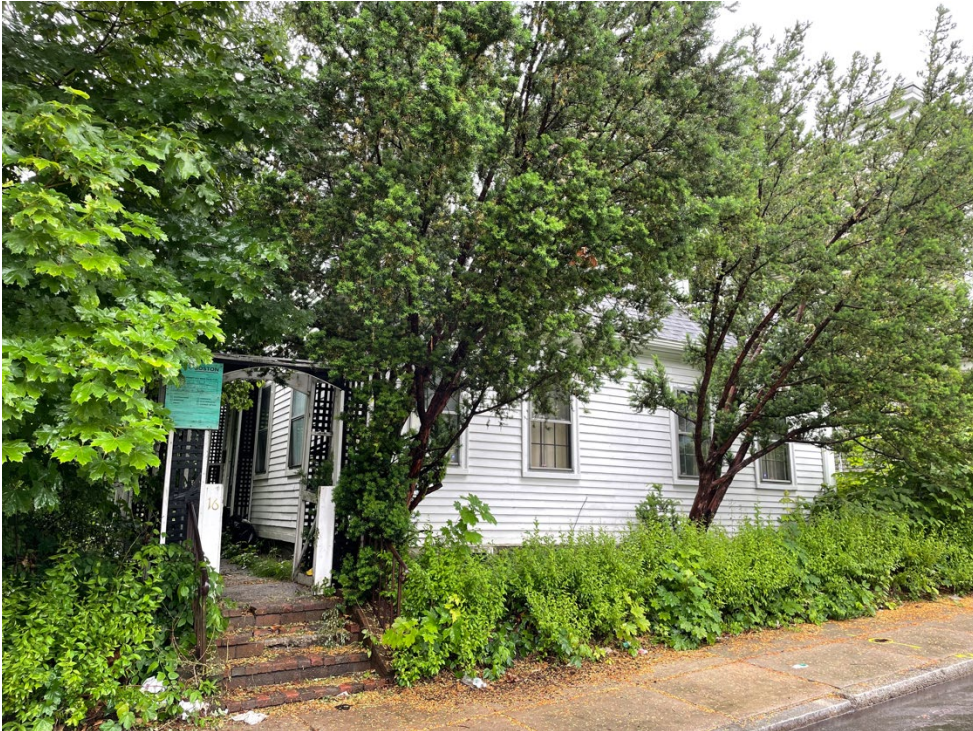
Figure 3: 16 Howe Street north facade (looking southwest). Photograph taken June 9, 2022.

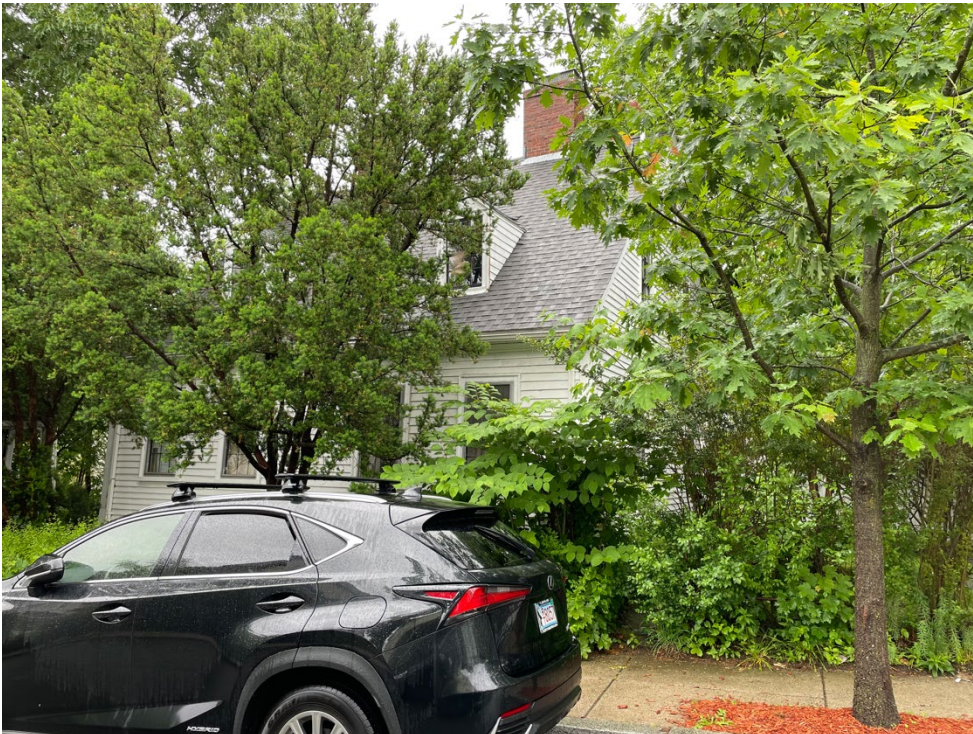
Figure 4: 16 Howe Street north facade (looking southeast). Photograph taken June 9, 2022.

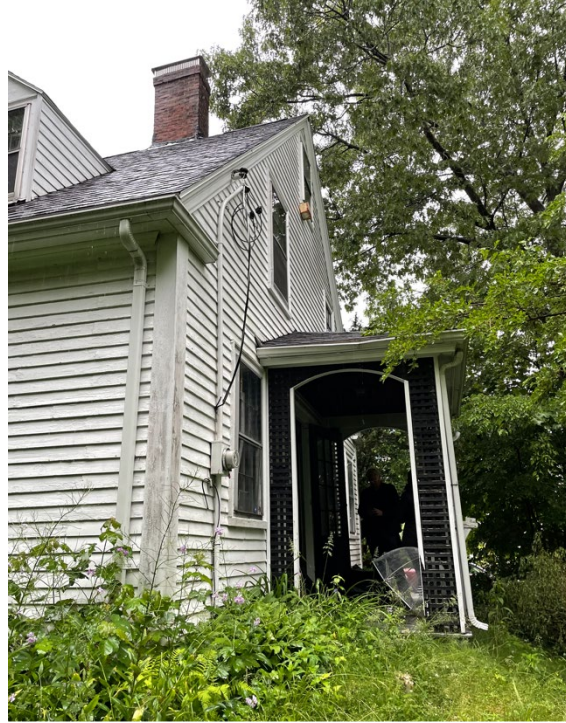
Figure 5: East facade and entry porch. Photograph taken June 9, 2022.

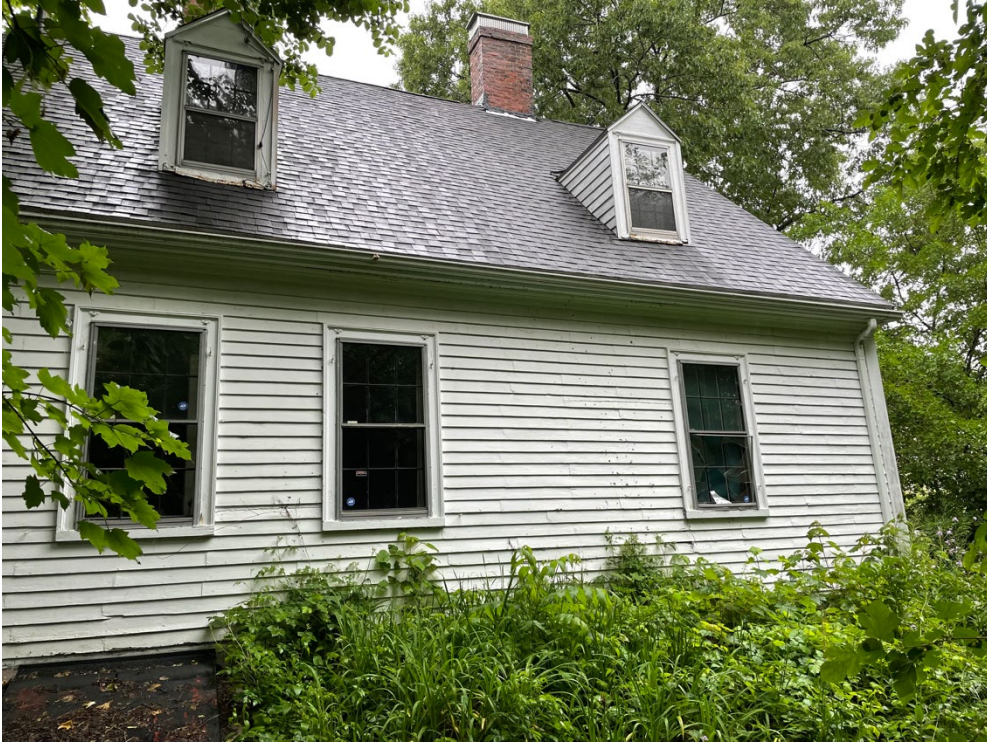
Figure 7: South facade (facing rear yard), looking northeast. Photograph taken June 9, 2022.

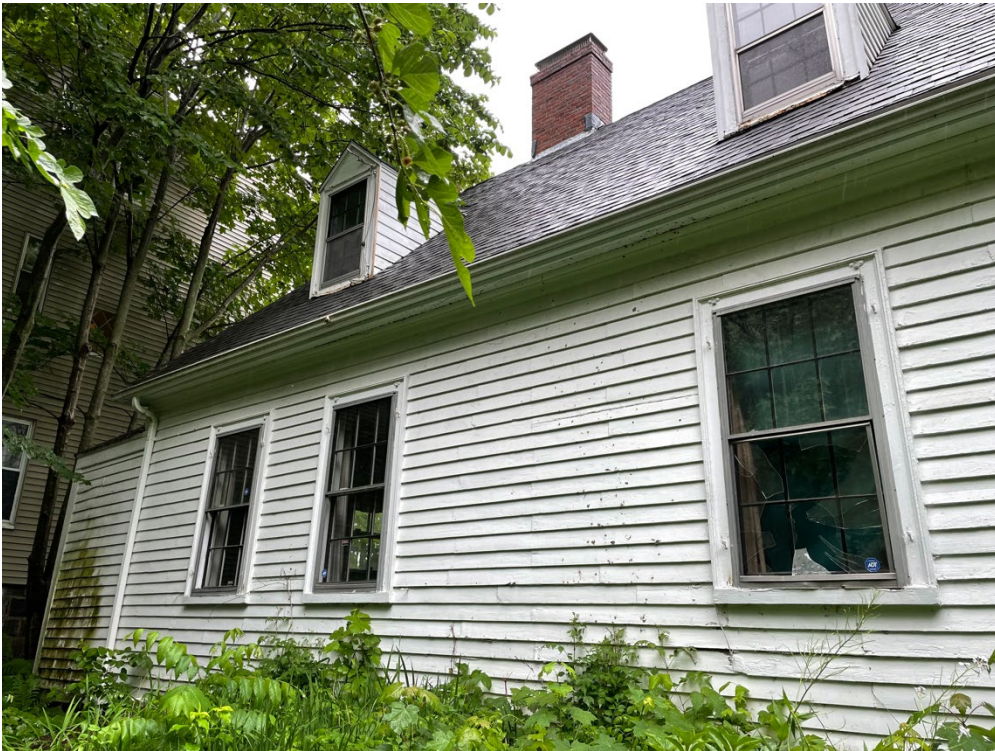
Figure 8: South facade (facing rear yard), looking northwest. Photograph taken June 9, 2022.

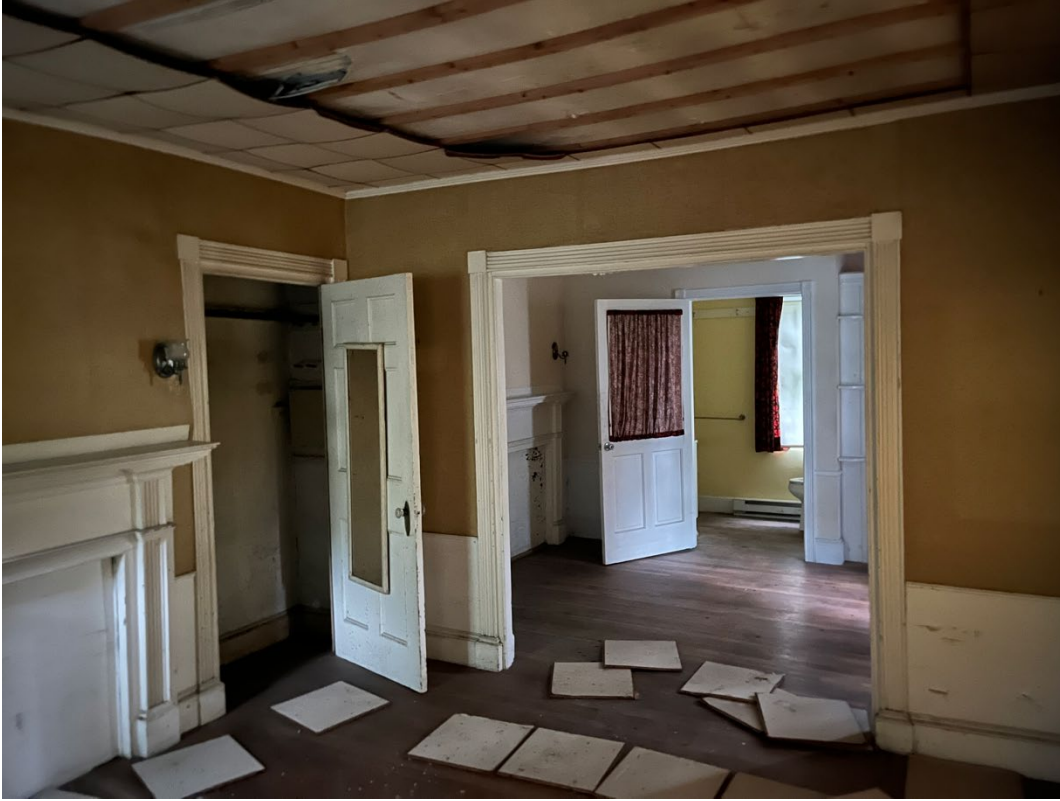
Figure 11: Northeast and northwest living room and dining room, facing west. Photograph taken by Joseph Cornish on June 9, 2022

The north side of the hallway leads to a living room and dining room (see Figure 11). These rooms were traditionally used for entertaining and therefore feature finer architectural details than other, more private rooms of the house. The rooms have the same painted mahogany dado and horse-hair plaster walls present elsewhere on the first floor. Doorways have square, unadorned, corner blocks and junctions and fluted mouldings. These design elements are consistent with early Greek Revival style. The living room (east portion) contains a drop ceiling in a deteriorated state. The original plaster ceiling is likely intact above. The fireplace in this room is closed and not functional. The mantelpiece contains both Federal and Greek Revival details including elliptical moldings and fluted pilasters. The dining room (west portion) contains a non-historic plaster ceiling. The fireplace is closed and not functional. The fireplace mantelpiece contains both Federal and Greek Revival details. The bathroom located off of this room is a modern alteration.

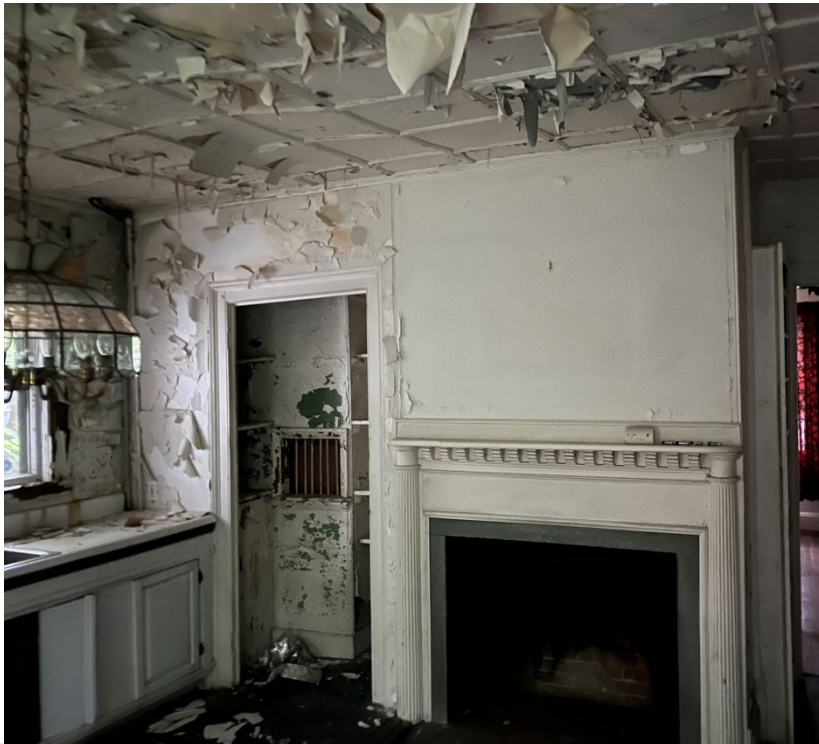
Figure 12: Fireplace and mantel in kitchen, facing north. Photograph taken by Joseph Cornish on June 9, 2022.

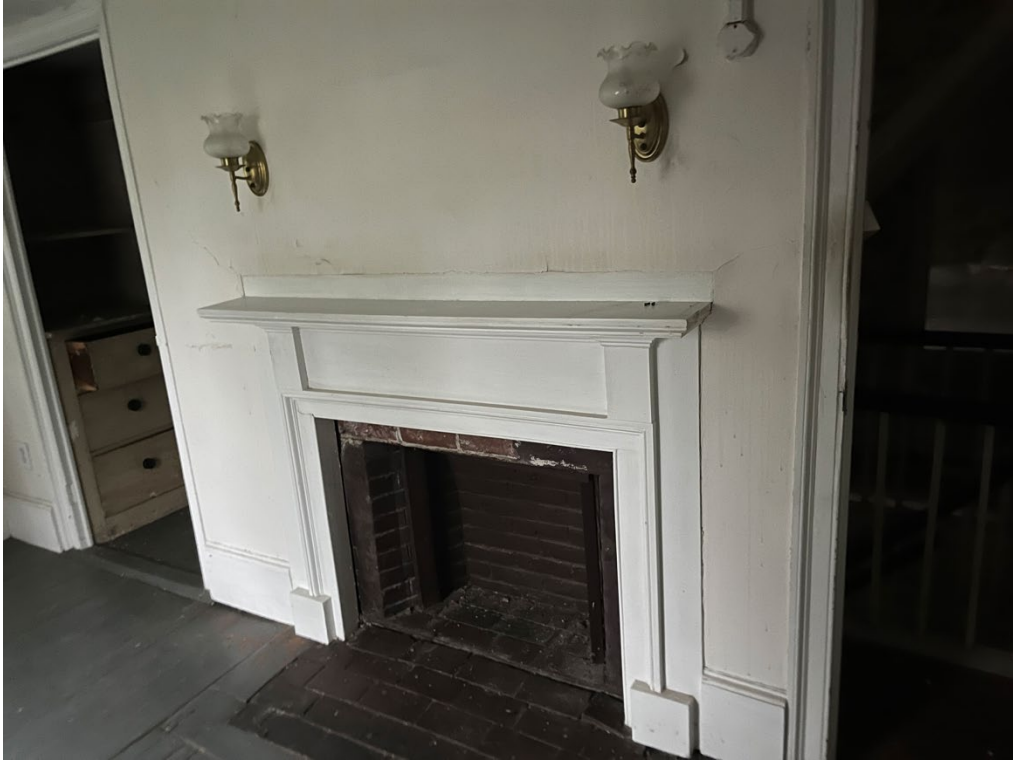
Figure 13: Fireplace in second floor northeast bedroom. Photograph by Joseph Cornish taken June 9, 2022

The second-floor landing opens to a U-shaped hallway around the staircase which provides access to the four bedrooms (Figures 13-17). Each bedroom contains a fireplace and simple mantelpiece. The ceilings are sloped in each bedroom, aside from the dormer space. At some point, the southwest bedroom was repurposed for use as a bathroom (Figure 15). A clawfoot tub and other bathroom appliances are present. Flooring throughout the second floor consists of wide wood planks. Historic wallpaper remains in the hallway and some bedrooms.

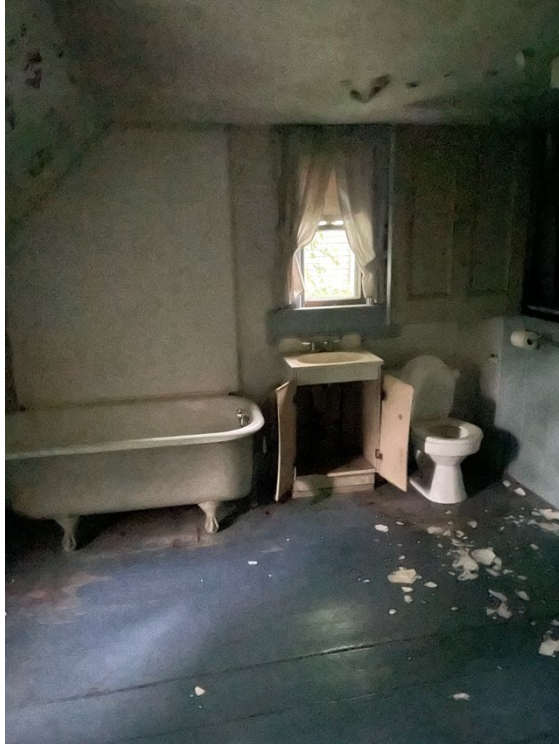
Figure 15: Second floor southwest bedroom (converted to bathroom). Photograph taken June 9, 2022.

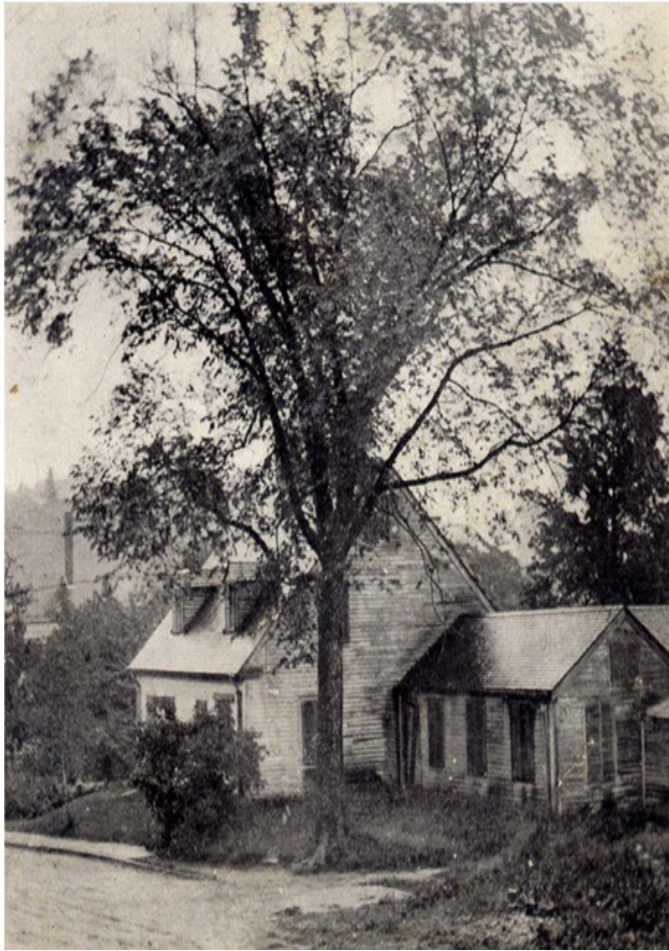
*Figure 26: Undated photograph of 16 Howe Street showing the original ell. Photograph from Dorchester Historical Society.*
