# Mt. Calvary / Shara Tfilo Campus

## BOSTON LANDMARKS COMMISSION STUDY REPORT

Report on the Potential Designation of

**Mt. Calvary / Shara Tfilo Campus**  
**9-19 Otisfield Street, Boston, Massachusetts**

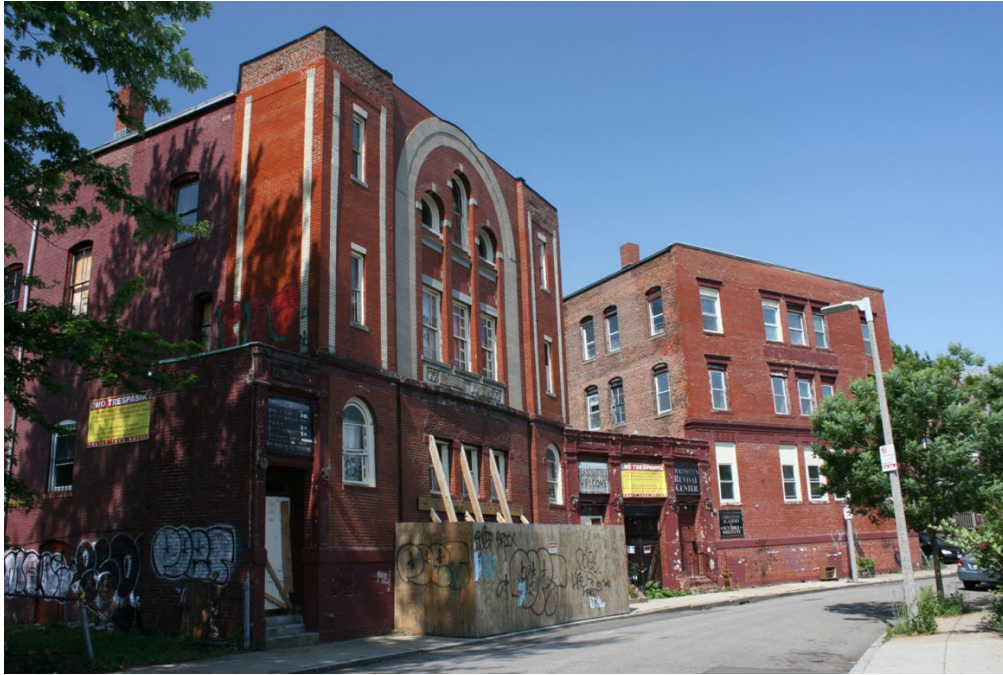
**Figure 2.** Facades (northeast elevations) of Mt. Calvary Holy Church/Congregation Shara Tfilo Synagogue (L) and Roxbury Hebrew School (R), looking west. May 2022.

The symmetrical façade of the main building is divided into three horizontal and three vertical parts. The horizontal layers consist of a concrete block foundation with a shaped, cast-stone water table, a one-story base with a minimal cast-stone entablature, and a two-story top section. Areas of rough brick at the top of the outer bays and the very abrupt top edge of the façade suggest that the building originally had a parapet here, but no photographic evidence has yet been located. There is no decorative trim at the roofline.

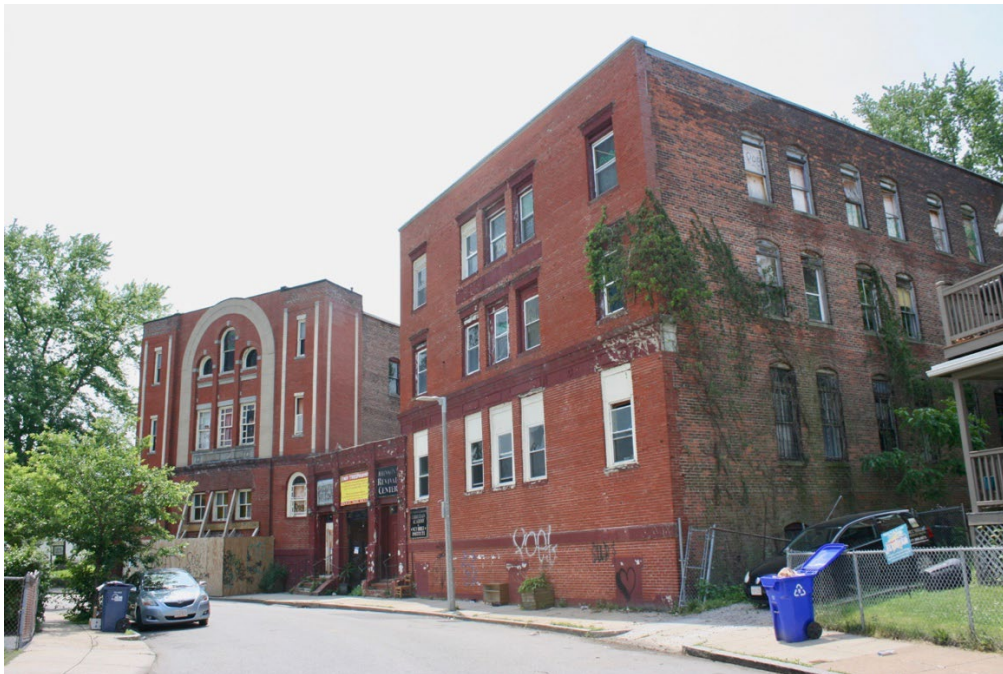
**Figure 3.** Facades (northeast elevations) of Mt. Calvary Holy Church/Congregation Shara Tfilo Synagogue (L) and Roxbury Hebrew School (R), looking southeast. May 2022.

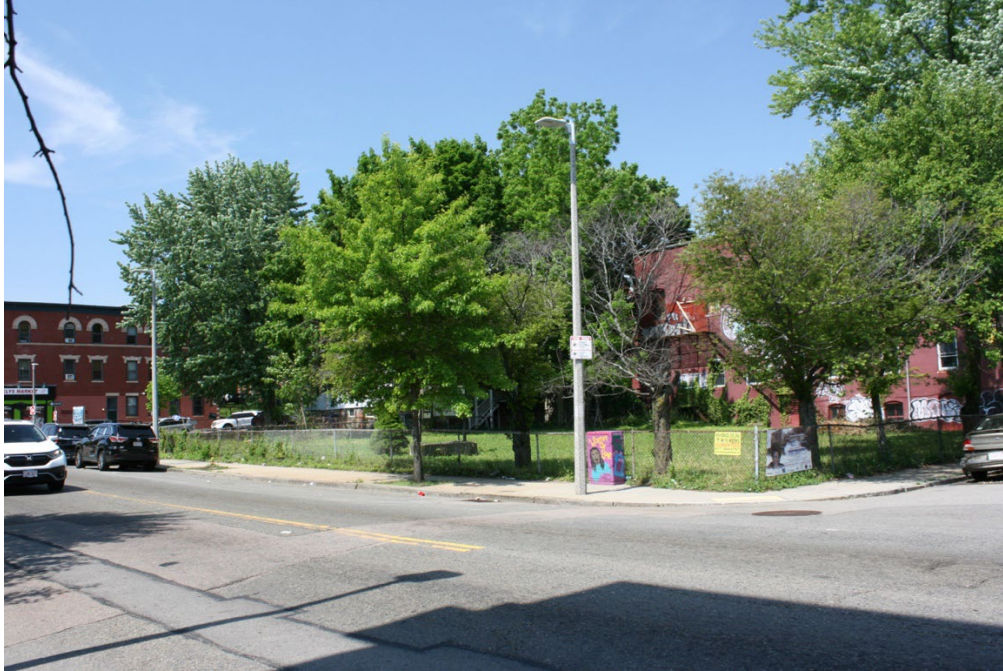
**Figure 4.** View of open space at intersection of Blue Hill Ave. (L) and Otisfield Street (R), looking southwest. 17-19 Otisfield Street at right center. May 2022.

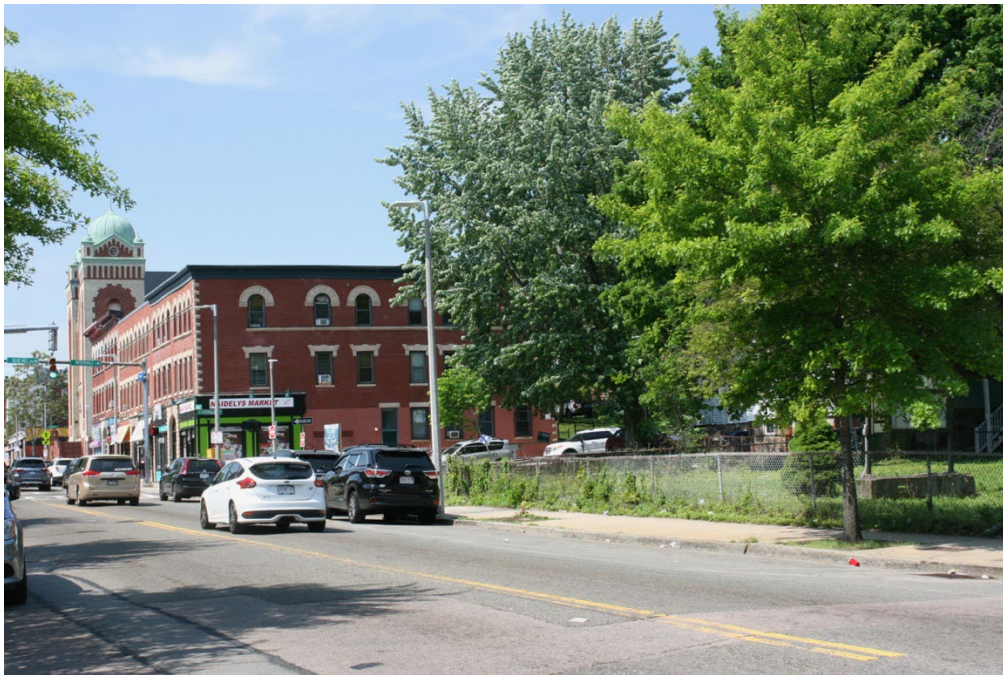
**Figure 5.** Blue Hill Avenue, looking southwest from Otisfield Street. Open space at 17-19 Otisfield Street at right; Temple Adath Jeshurun at far left. May 2022.

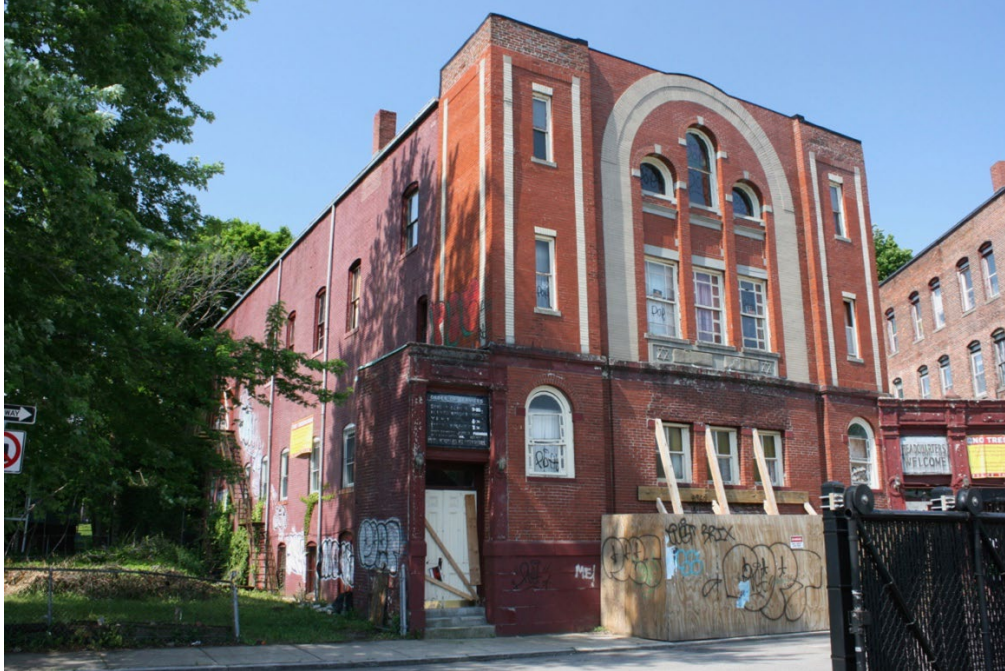
**Figure 6.** Facade (northeast) and southeast elevation of Mt. Calvary Holy Church/Congregation Shara Tfilo Synagogue. May 2022.

More utilitarian than the façade, the side and rear elevations of the church/synagogue building are constructed of a coarser, darker red brick (which is painted on the southeast elevation) and display segmentally-arched window openings. Relatively evenly-spaced and loosely grouped in pairs, these openings have cast stone sills, brick lintels with two courses of header bricks, and rectangular sash. Both side elevations feature two rows of full-height windows, taller on the upper level. The raised basement level of the northwest elevation is not clearly visible from the public way. Although a remarkable amount of original or later contributing 2/2 window sash survives, a variety of replacement wood, vinyl, and metal sash is scattered throughout the building. The staggered heights of windows in the forward-most bay of each side elevation suggest interior stairways beyond.

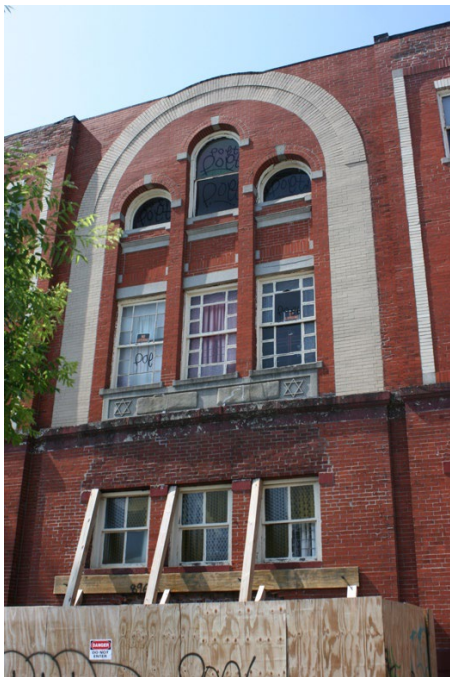
**Figure 7.** Façade detail of Mt. Calvary Holy Church/Congregation Shara Tfilo Synagogue. May 2022.

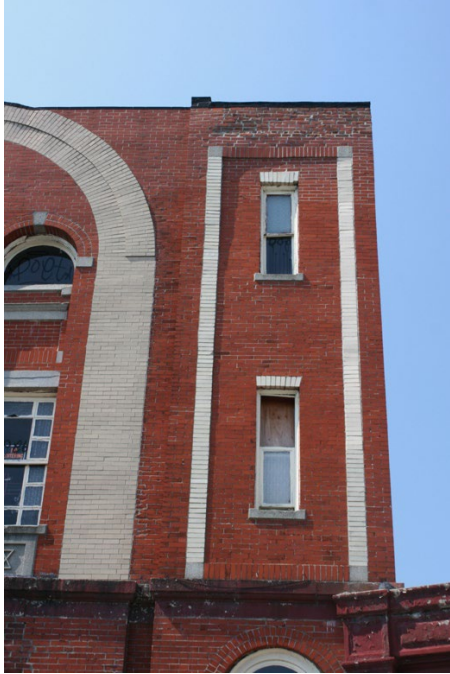
**Figure 8.** Facade detail of Mt. Calvary Holy Church/Congregation Shara Tfilo Synagogue. May 2022.

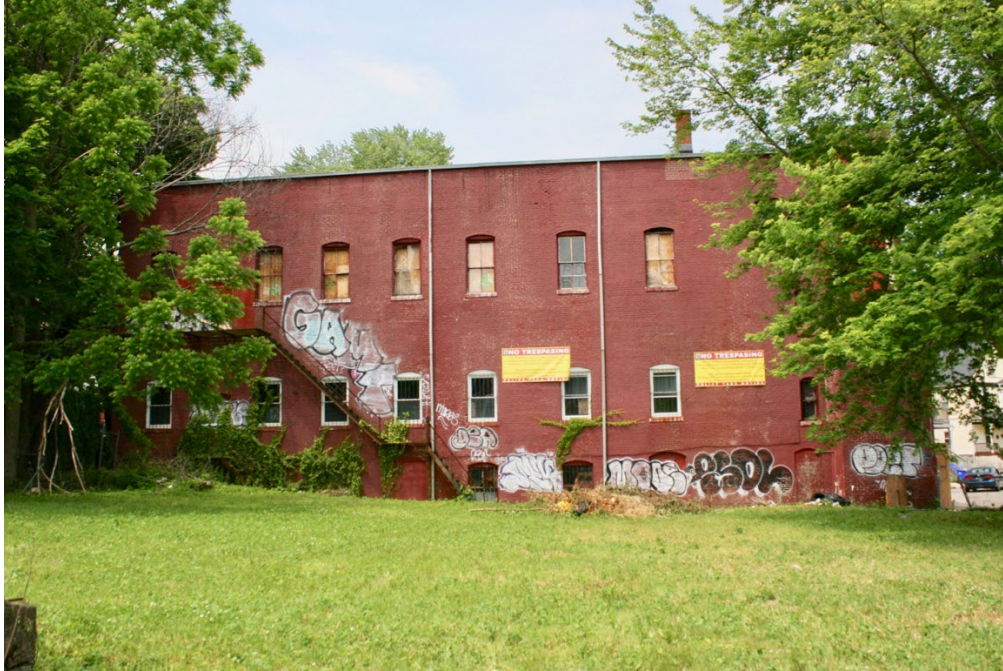
**Figure 10.** Southeast elevation of Mt. Calvary Holy Church/Congregation Shara Tfilo Synagogue, facing 17-19 Otisfield Street and Blue Hill Avenue. May 2022.

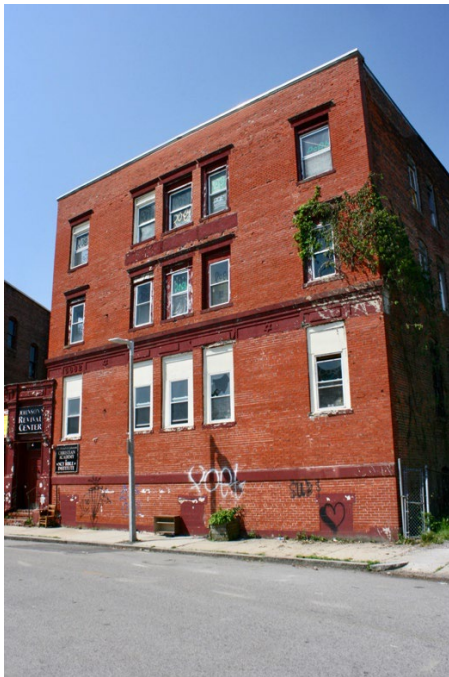
**Figure 11.** Facade (northeast elevation) of Roxbury Hebrew School. May 2022.

Like the synagogue, the façade of the school building is divided into three parts both horizontally and vertically. The horizontal layers include a brick basement level articulated by a concrete foundation, shaped cast stone water table above, and three small square windows, symmetrically placed, with plain, cast stone lintels and concrete block infill. The first floor of the facade is surmounted by a continuous, cast stone entablature that is divided into decorative panels and crowned by a pronounced rectangular cornice. The panels of this entablature contain several decorative features, including the raised numerals 5682 (indicating the date of the building in the Jewish calendar) and two Stars of David. Rough concrete rectangles positioned in the entablature above the four westernmost windows appear to cover other ornamental motifs.

The façade windows are grouped in a 1-3-1 pattern; all façade windows have been infilled with smaller modern replacement sash. The taller window openings at the first floor are trimmed with cast stone sills, with an entablature above serving as a continuous lintel. Shorter windows at the second and third stories have cast stone sills and individual lintels with pronounced cornice molding. The spandrel panel between the center trios of windows on the second and third stories contains a blank panel of cast stone or parging, which may originally have displayed a religious motif or building name. On the first story, a painted wood sign is mounted below the easternmost window on the first story; it identifies the building as “Dr. Brumfield Johnson / CHRISTIAN / ACADEMY / & / NCY BIBLE / INSTITUTE”. A photo from the 1970s shows original or later contributing window sash on the façade, consisting primarily of 2/2 sash typically occupying the entire window openings on all three floors. On the first story, all five windows had glazed rectangular transoms, and the center three windows appear to have contained pairs of 1/1 casements. The upper two stories may also have had very narrow glazed transoms; further research is merited.

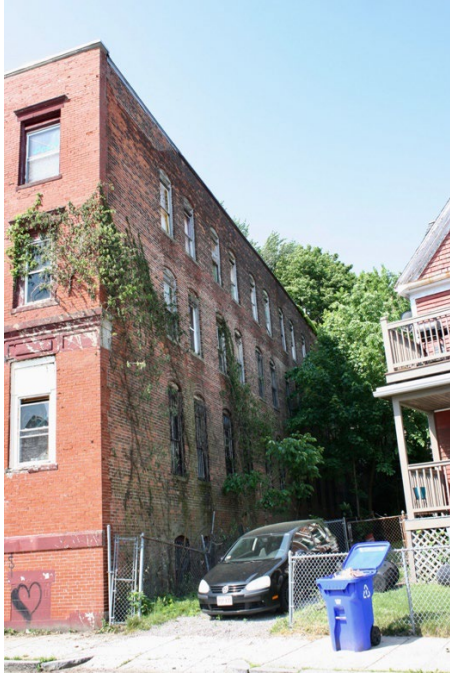
**Figure 12.** Northwest elevation of Roxbury Hebrew School. May 2022.

The side elevations of the school building feature relatively regularly-spaced windows, loosely grouped in pairs. Their segmentally-arched openings are trimmed with cast concrete sills and three courses of header bricks at the brick lintels. Rectangular, glazed transoms appear to be characteristic on all floors, although some on the upper stories have been infilled with wood.

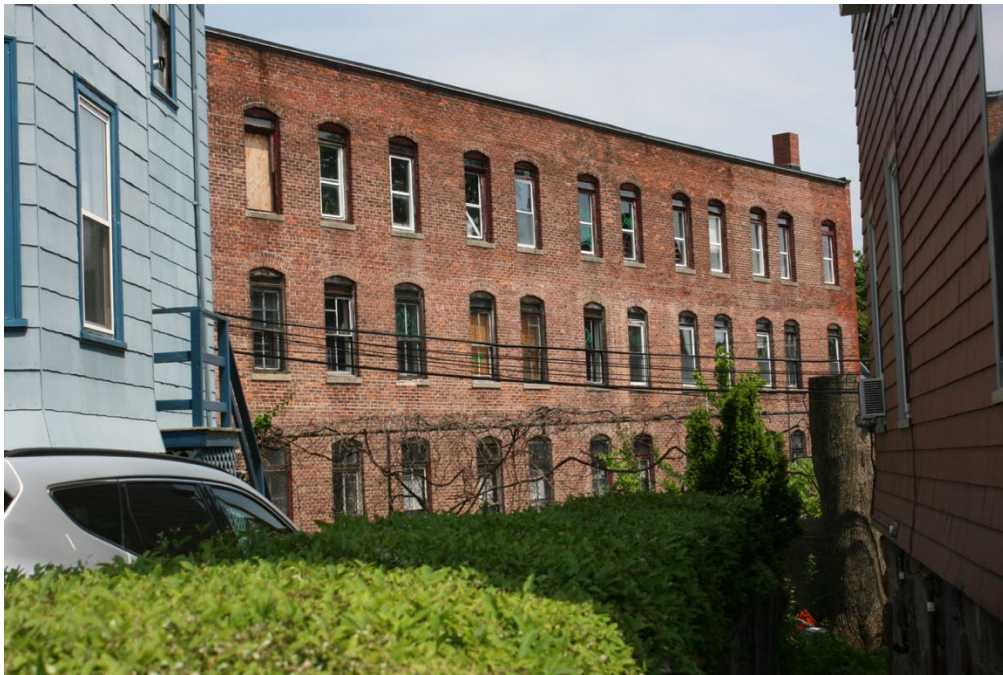
**Figure 13.** Southeast (courtyard) elevation of Roxbury Hebrew School. May 2022.

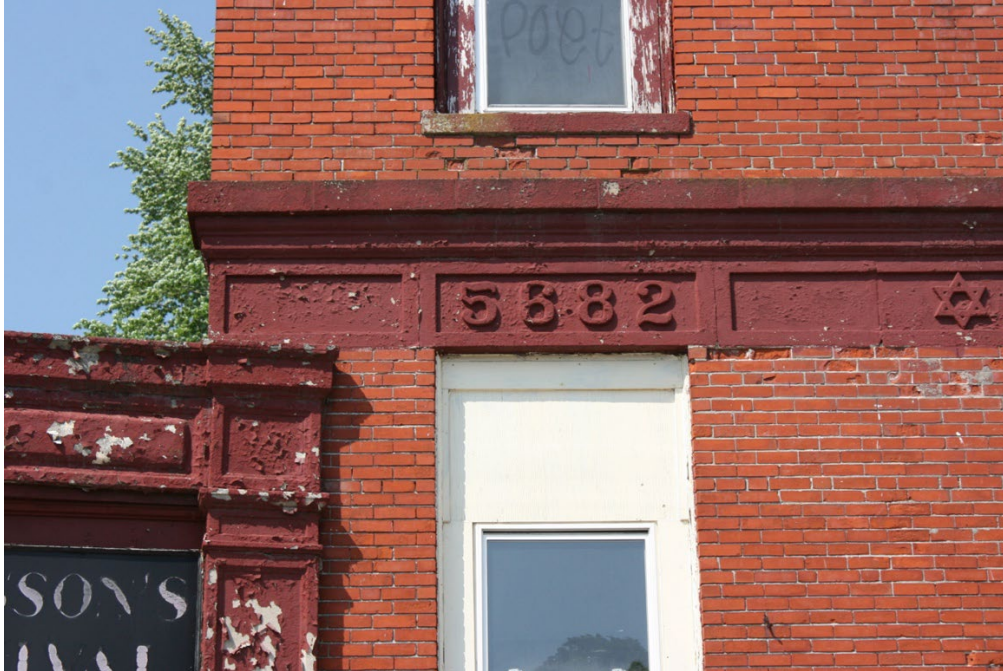
**Figure 14.** Façade detail of Roxbury Hebrew School. May 2022.

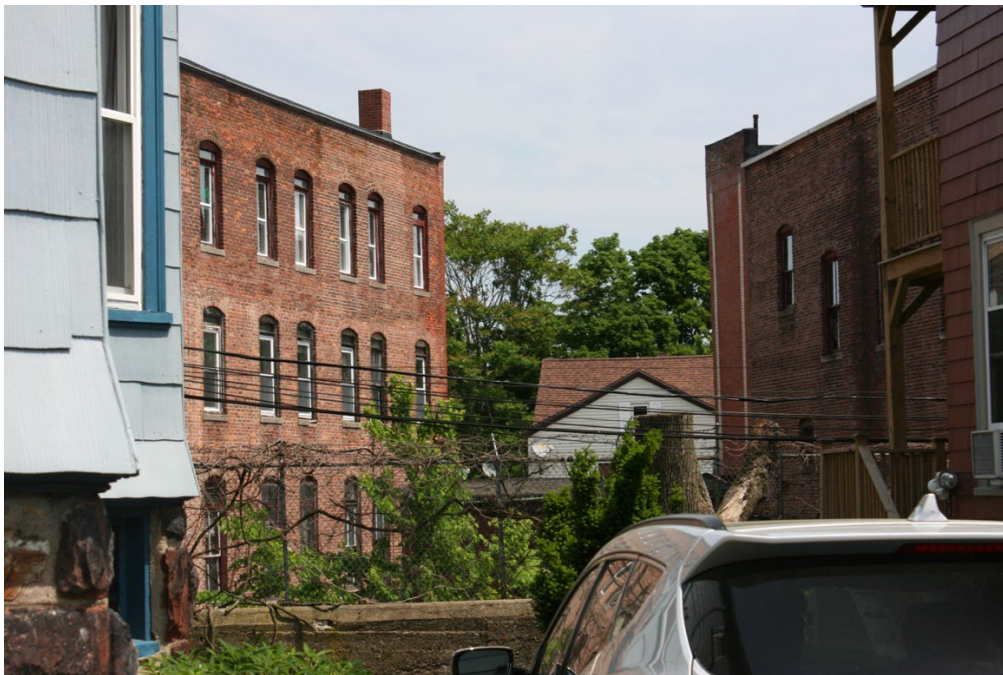
**Figure 15.** Courtyard elevations of Mt. Calvary Holy Church/Congregation Shara Tfilo Synagogue (R) and Roxbury Hebrew School (L). May 2022.

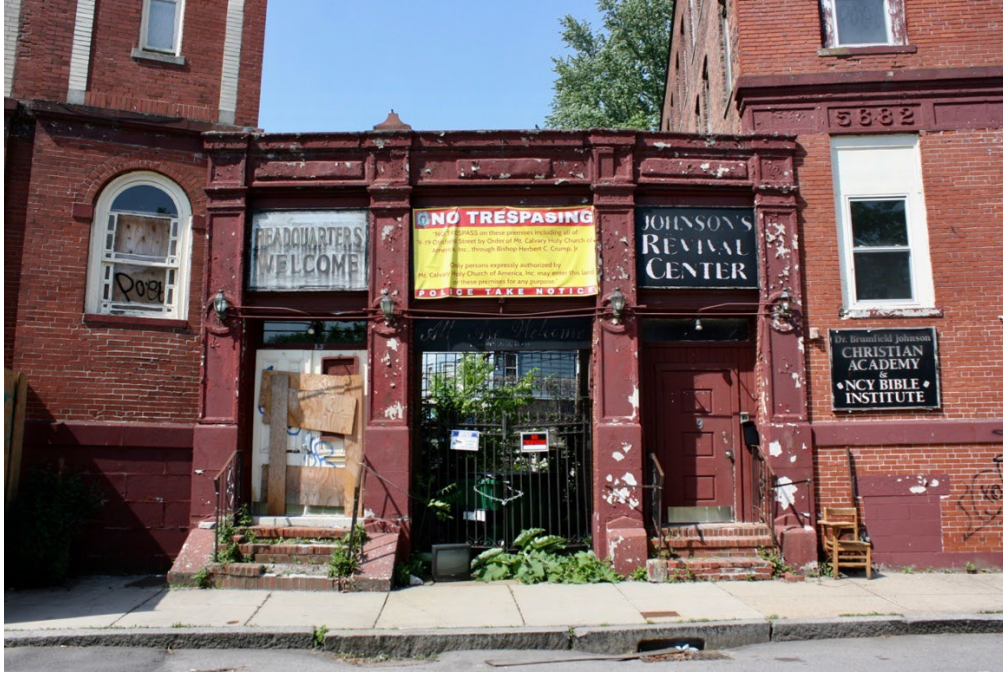
**Figure 16.** Façade (northeast elevation) of connector wall between Mt. Calvary Holy Church/Congregation Shara Tfilo Synagogue (L) and Roxbury Hebrew School (R). May 2022.

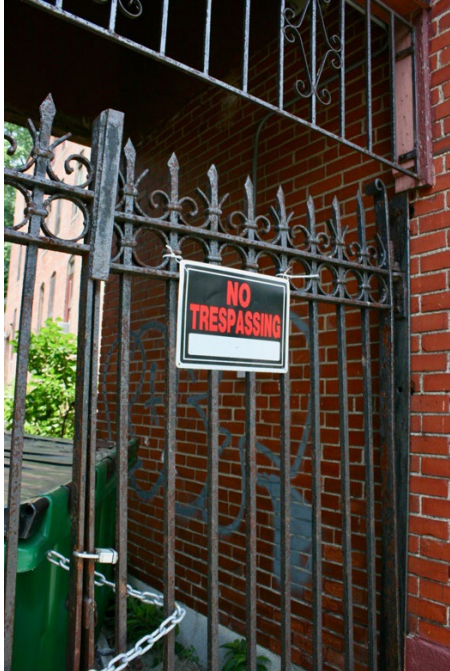
**Figure 17.** Detail of entrance gates at connector wall. May 2022.

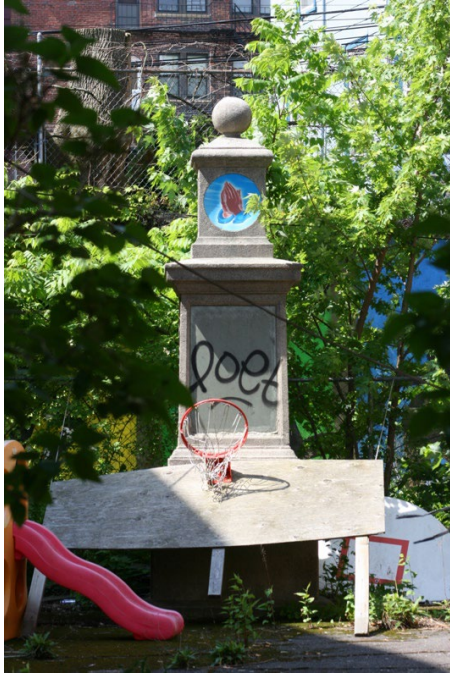
**Figure 18.** Courtyard monument. May 2022.

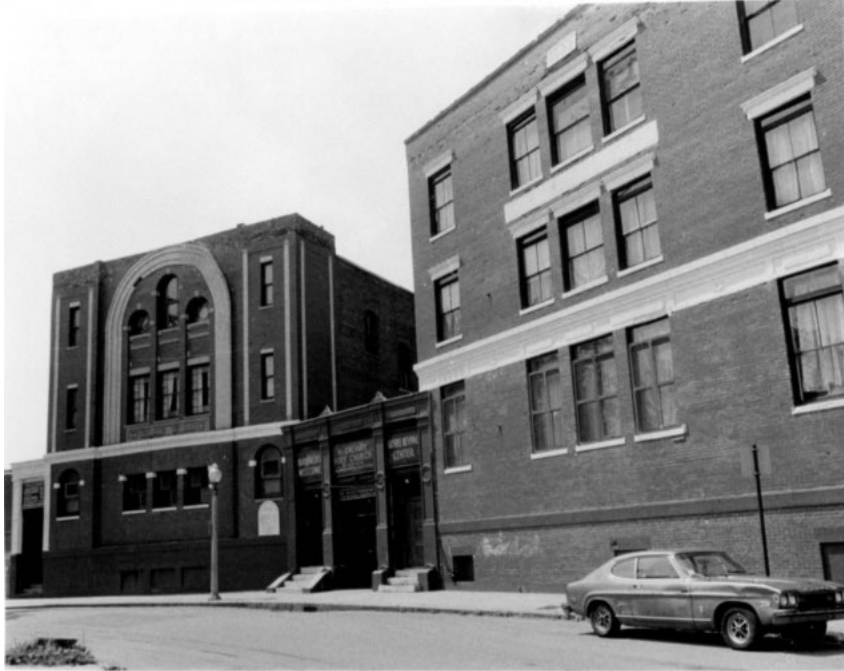
**Figure 23.** View of Mt. Calvary Holy Church / Congregation Shara Tfilo Campus, ca. 1970s, looking southeast.
