INTERCOM SYSTEM

87 Beacon Street

Re: Violation Notice / VIO.23.0641

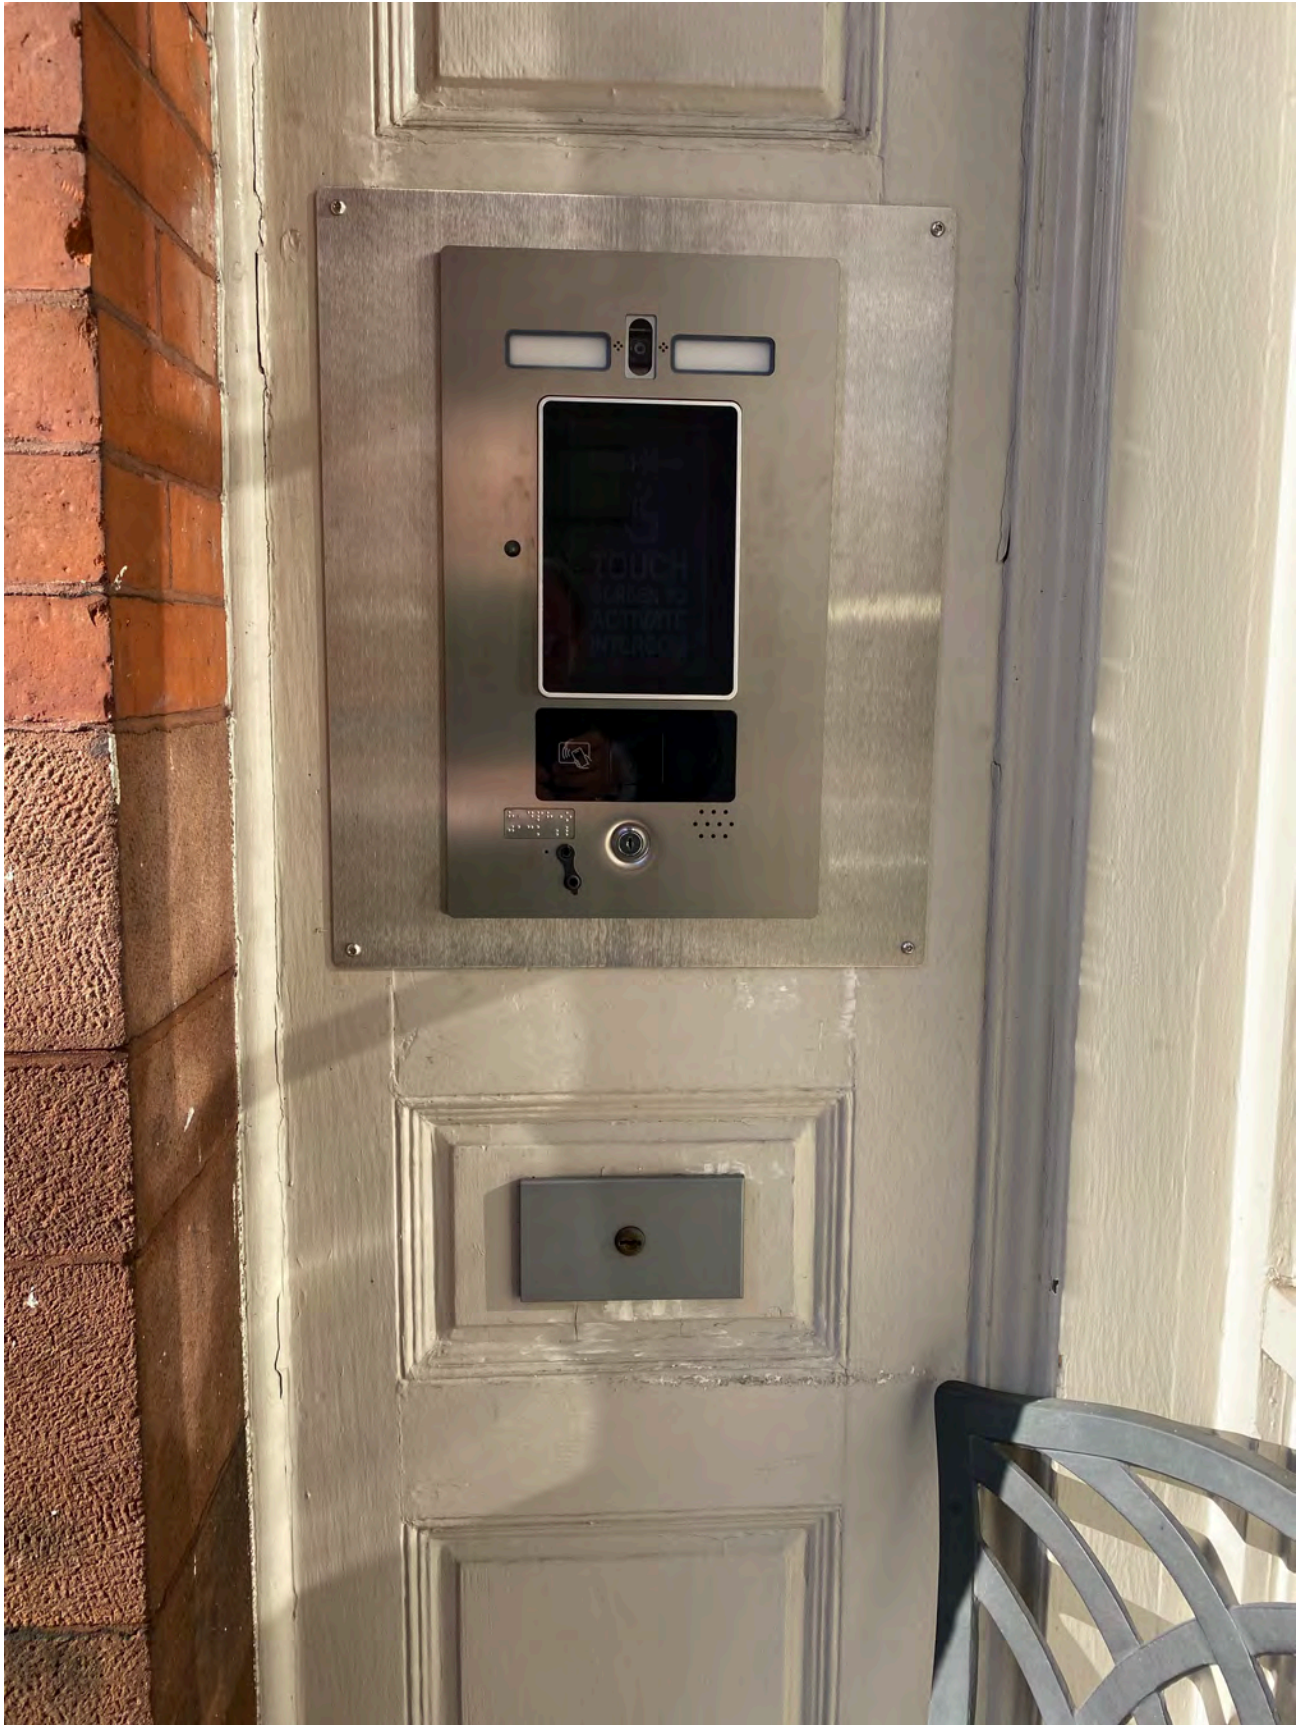
While the intercom panel is flush mounted in the wood trim and contained within the entryway, it does not conform to the allowed materials, absence of illumination, or individualized buzzers. The intercom has an interactive visual display panel in a stainless steel flush enclosure and is attached to an oversized brushed stainless steel base plate to conceal the wood cutout for the former intercom. We propose to correct this violation by providing a hinged brass cover per the attached drawings:

*Existing Butterfly MX Intercom System to
Left of Entrance in Door Surround*

The proposed hinged cover will be fabricated of solid brass and satin finished to conceal the intercom panel. Also, the key keeper in the panel below the intercom will be painted to match the wood. Please let us know if this approach will meet the guidelines in response to the violation notice. If you require any additional information in reference to this project, please contact resident Aileen Benson at 617-513-1108, or via email to aileen_lilith_benson@yahoo.com

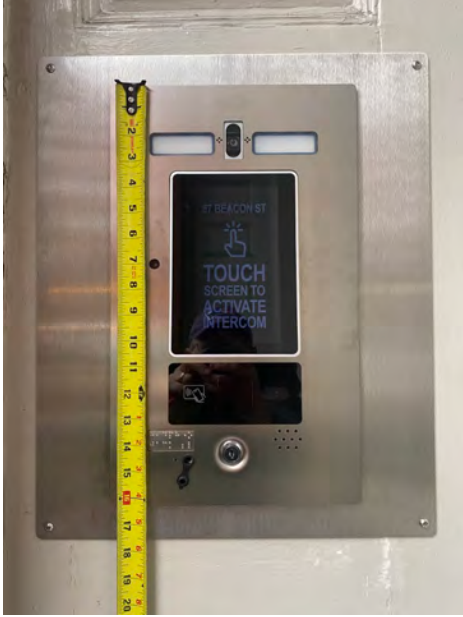
230130- IMG_2913.JPG

Butterfly Intercom Panel Set Into Larger Stainless Steel Base Plate

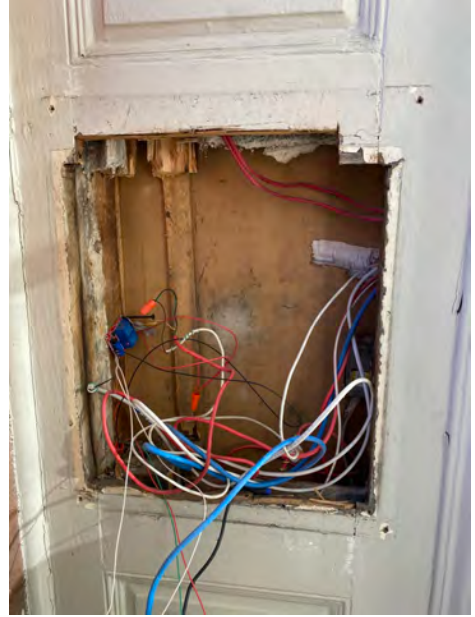
230127-IMG_3415.JPG

Existing Cutout in Paneled Entrance Surround; Former Intercom Cut into Width of Stiles and Rails; Outline of Larger Base Plate Visible at Perimeter

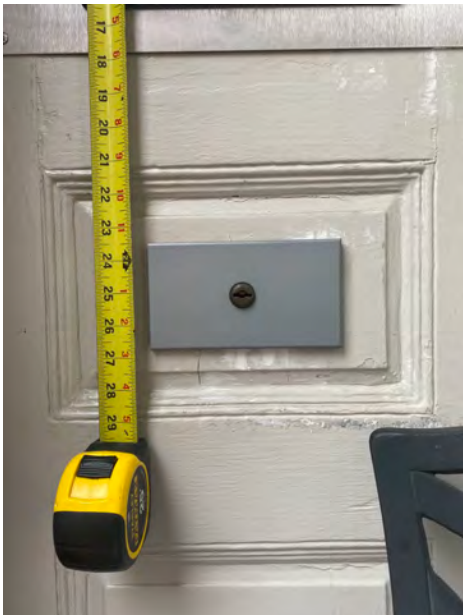
230130- IMG_2914.JPG

Detail of Intact Raised Panel and Moulding Below Intercom; Gray Box for Letter Carrier Access

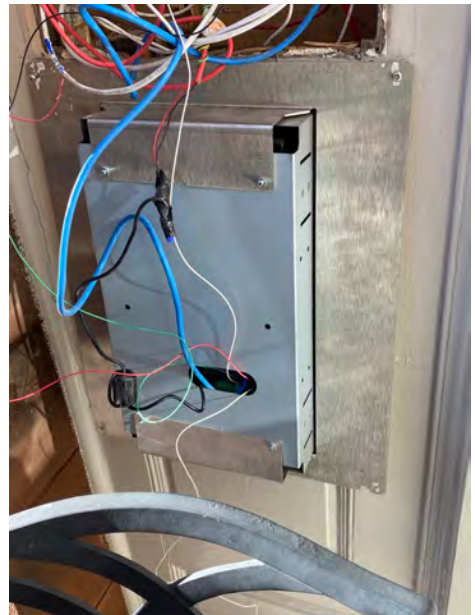
230127-IMG_3416.JPG

Concealed Side of Intercom Panel Box (Gray) with Oversized Stainless Steel Base Plate Attached

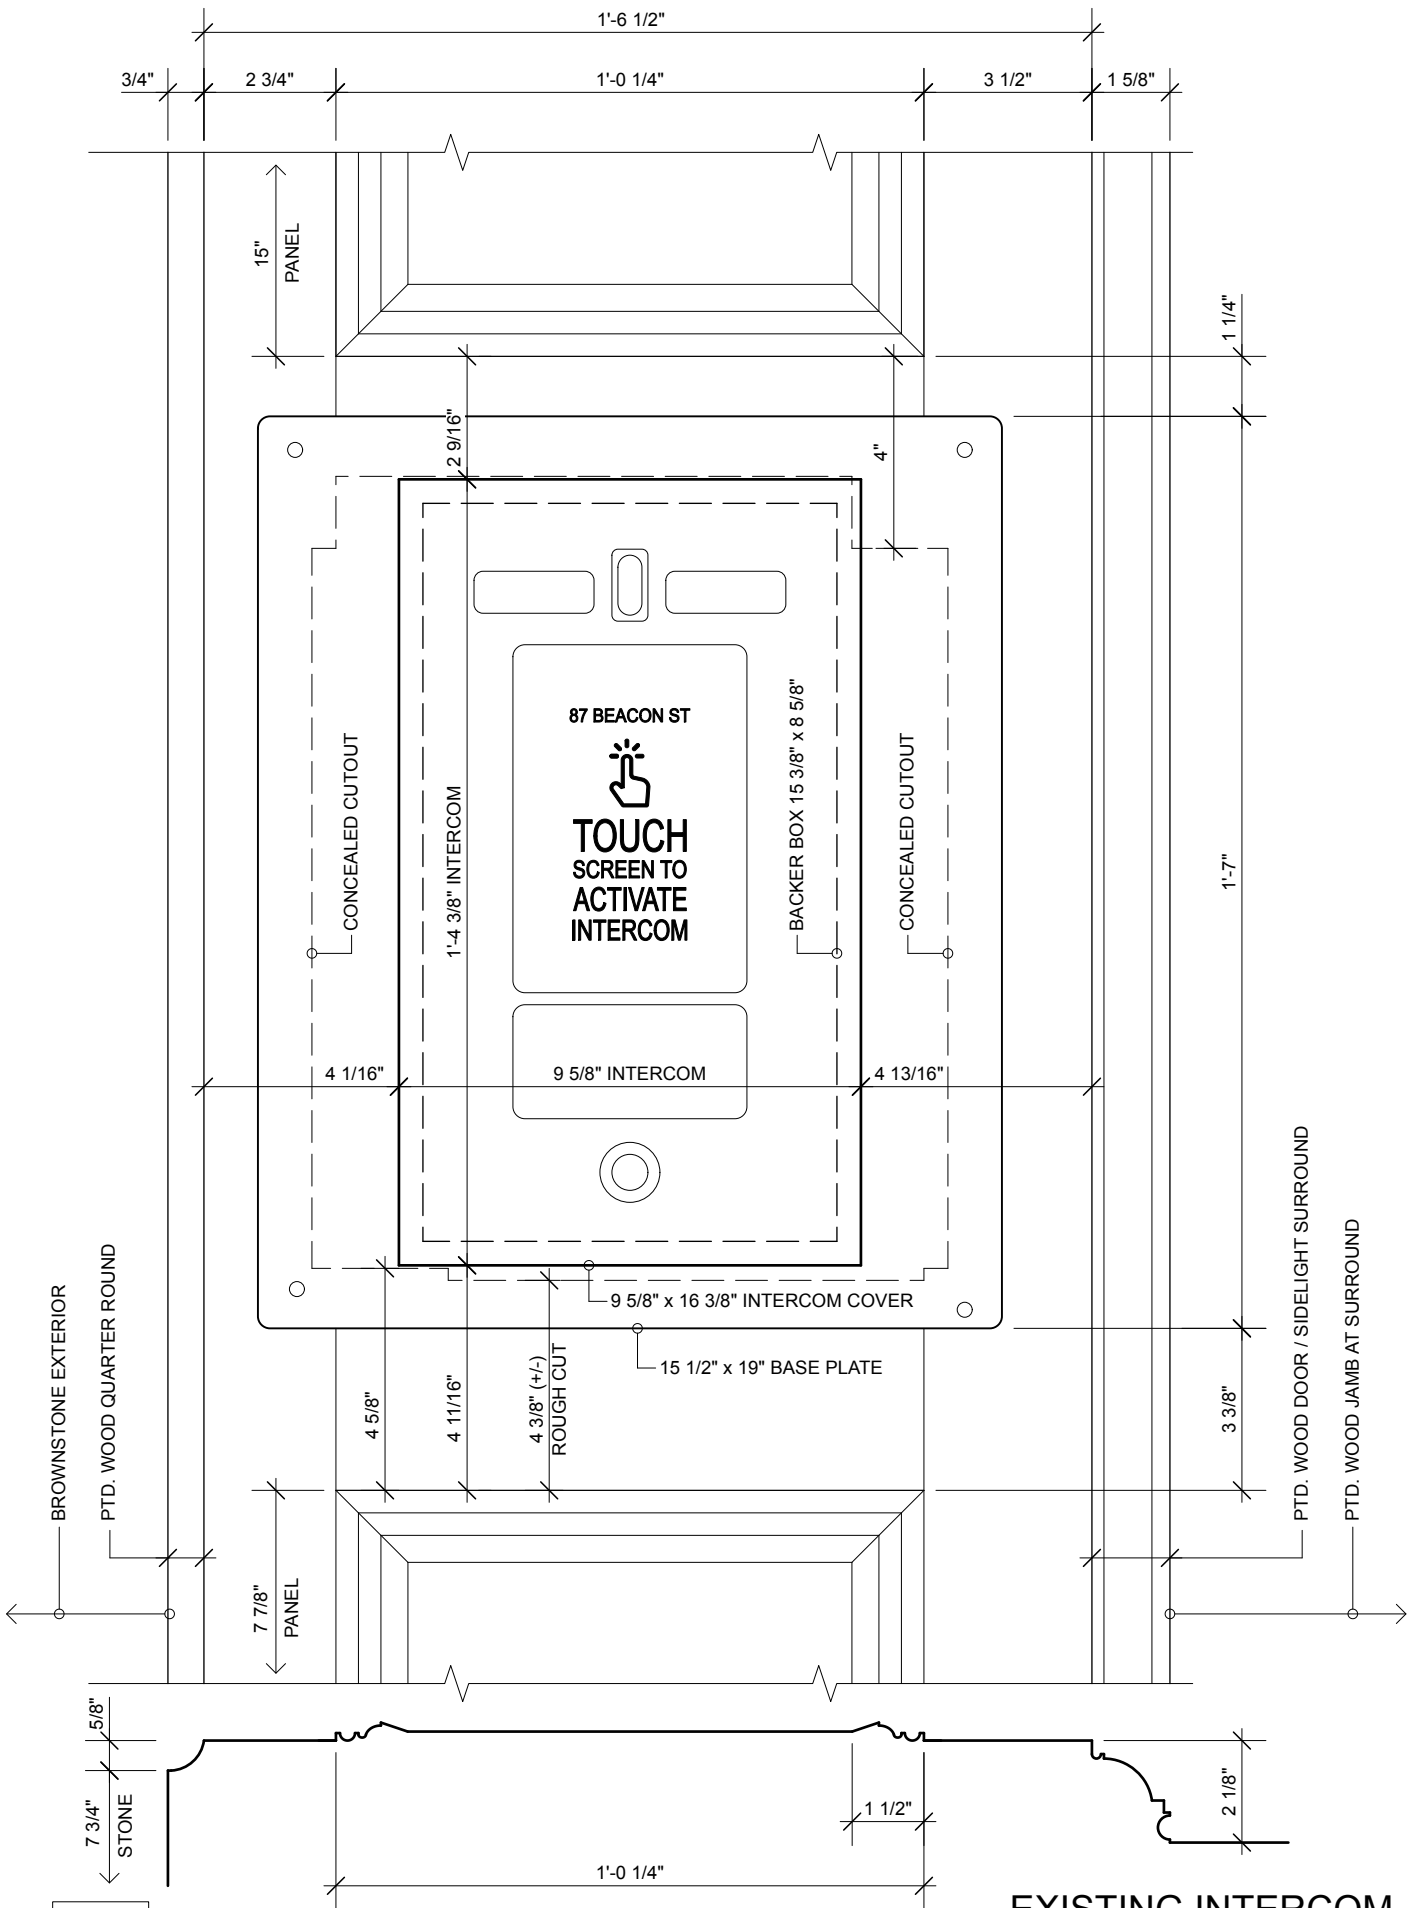
**EXISTING INTERCOM
87 BEACON STREET**

Scaled Drawing of Existing Intercom in Entrance Surround

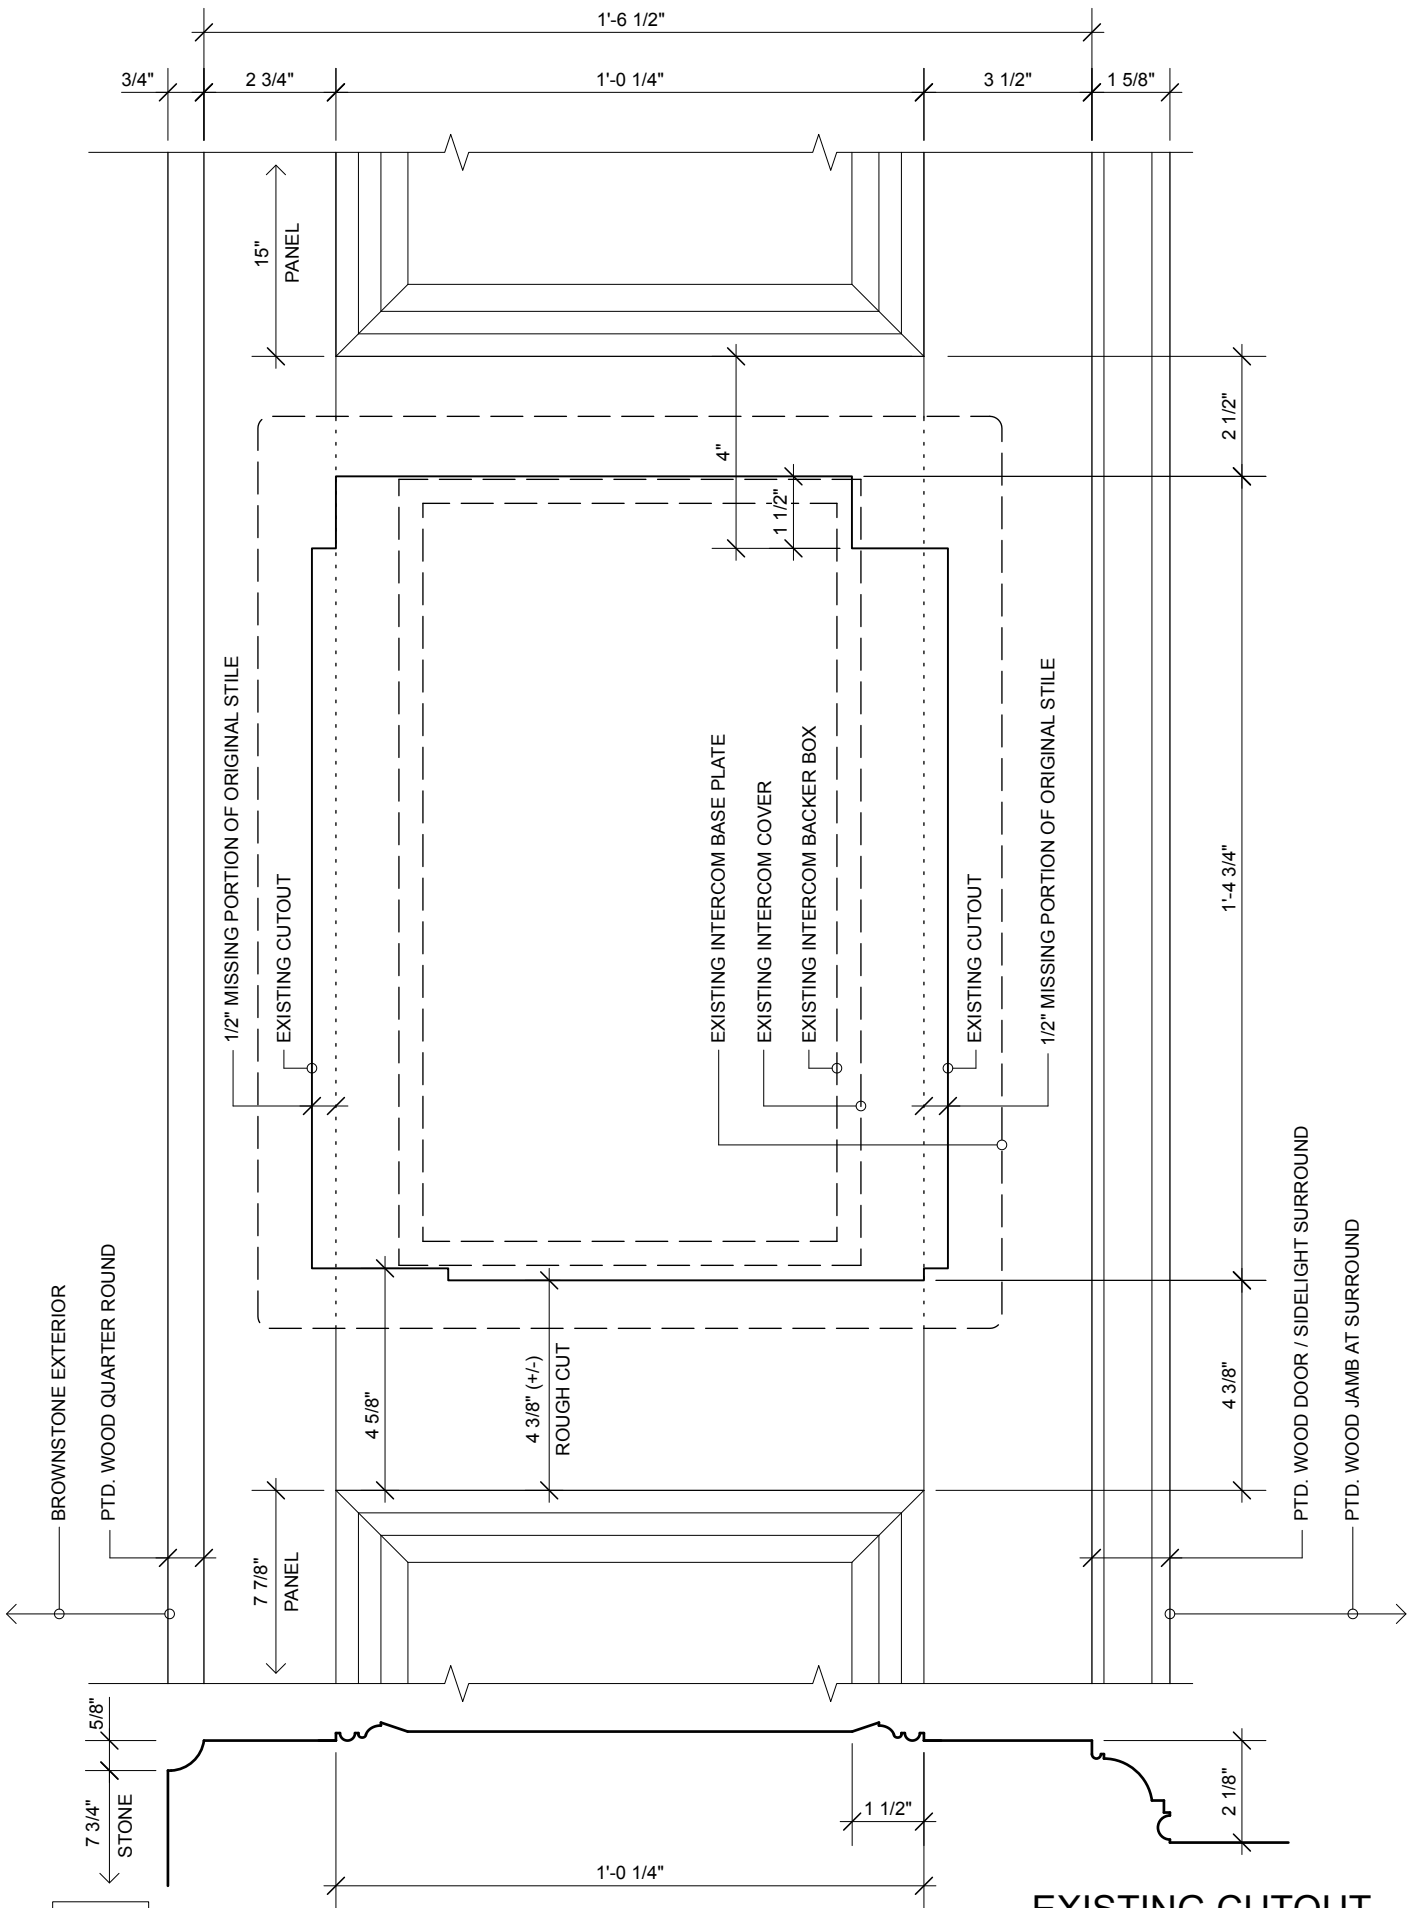
**EXISTING CUTOUT
87 BEACON STREET**

Scaled Drawing of Existing Concealed Cutout in Wood Panel
