RICHARDSON BLOCK

BOSTON LANDMARKS COMMISSION

STUDY REPORT

Richardson Block
109 - 151 Pearl Street, Boston, Massachusetts

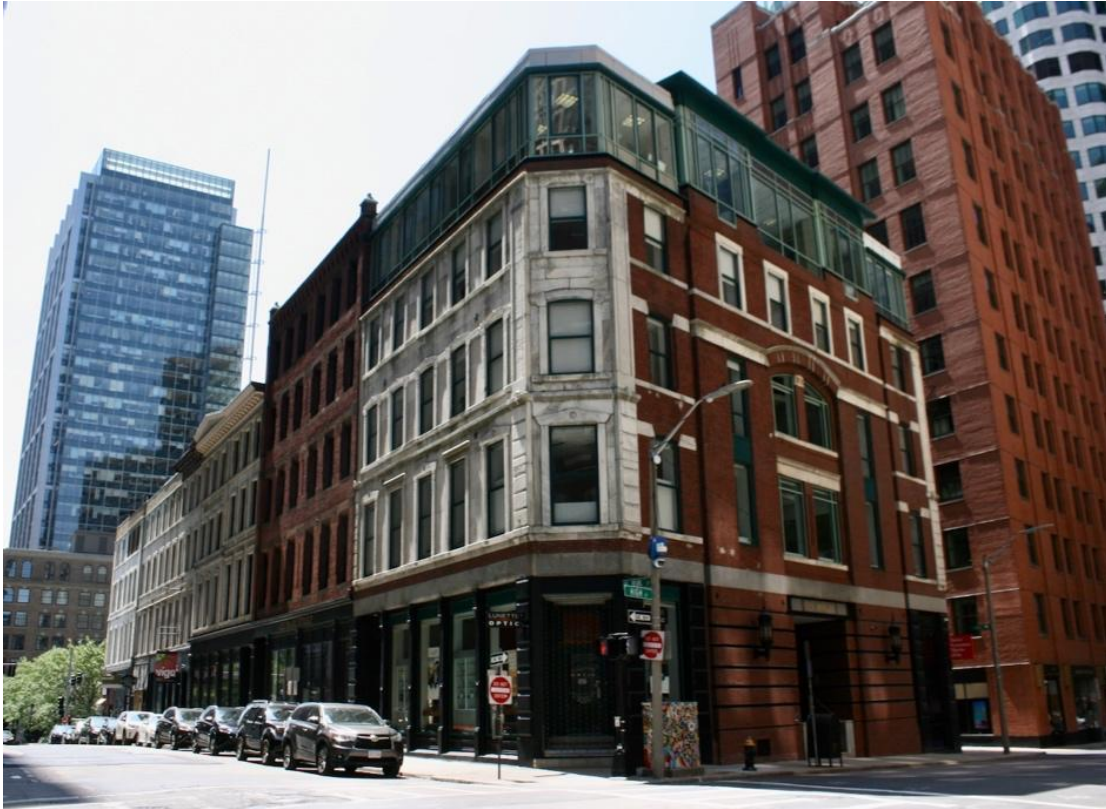
Figure 2. Pearl Street (left) and High Street (right) elevations. Photograph by Wendy Frontiero, June 2023.

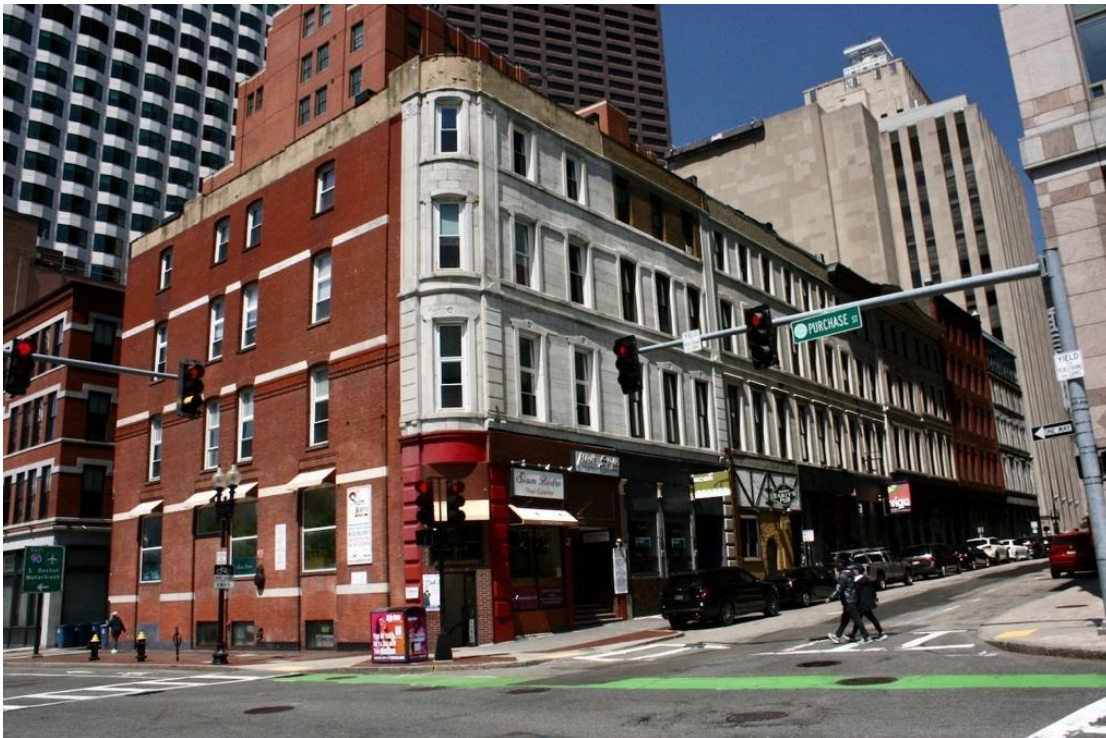
Figure 3. Purchase Street (left) and Pearl Street (right) elevations. Photograph by Wendy Frontiero, June 2023.

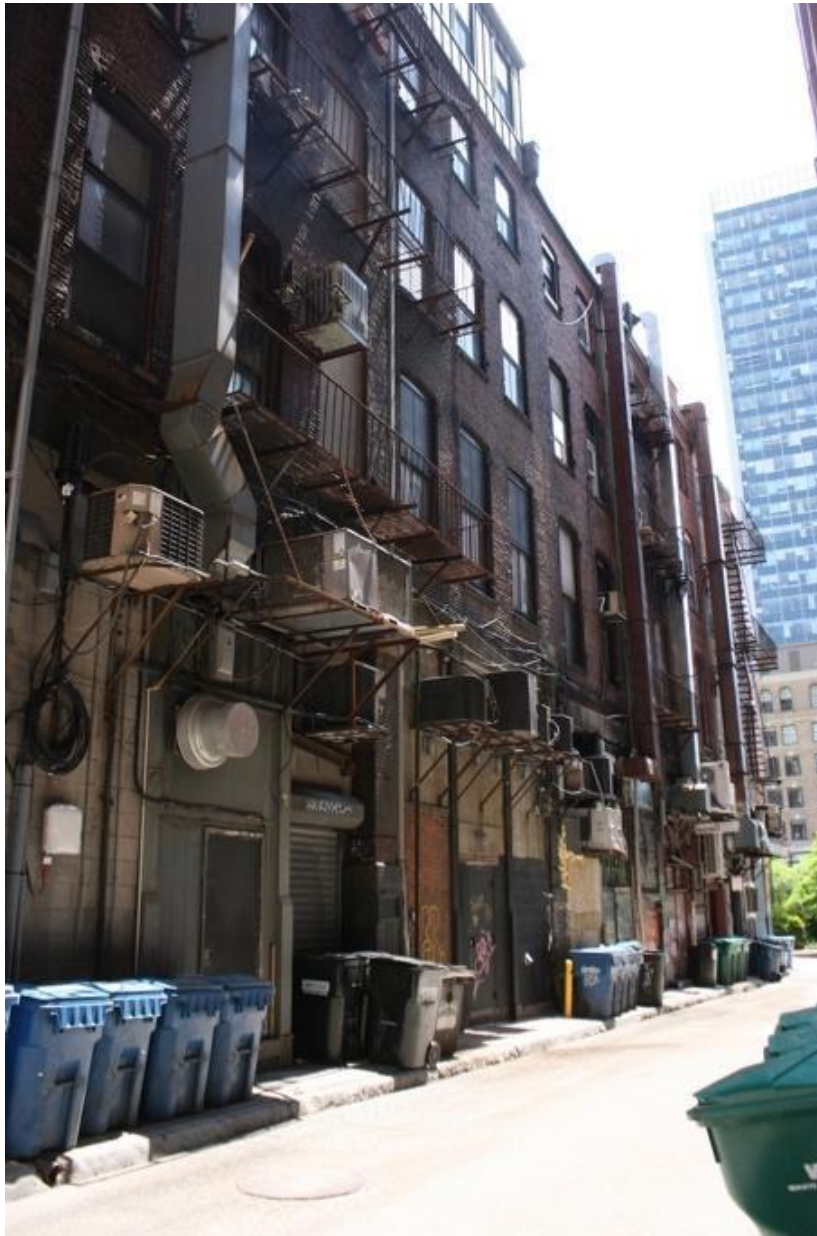
Figure 4. Gridley Street (rear) elevation of the Richardson Block, looking toward Purchase Street. Photograph by Wendy Frontiero, June 2023.

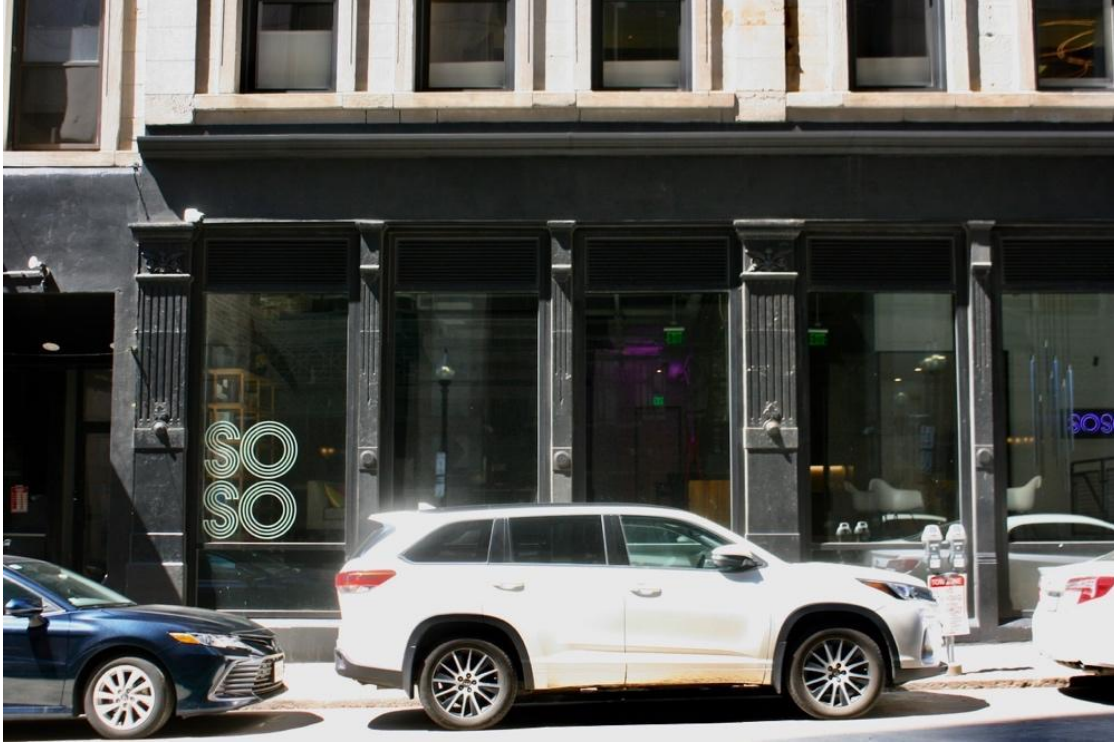
Figure 10. 129-131 Pearl St. storefront. Photograph by Wendy Frontiero, June 2023.

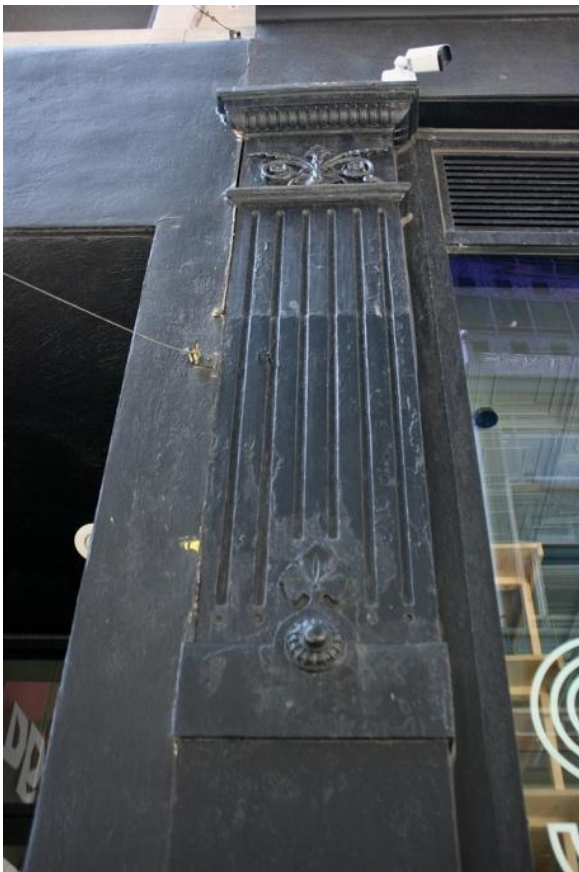
Figure 11. 129-131 Pearl St. storefront detail. Photograph by Wendy Frontiero, June 2023.

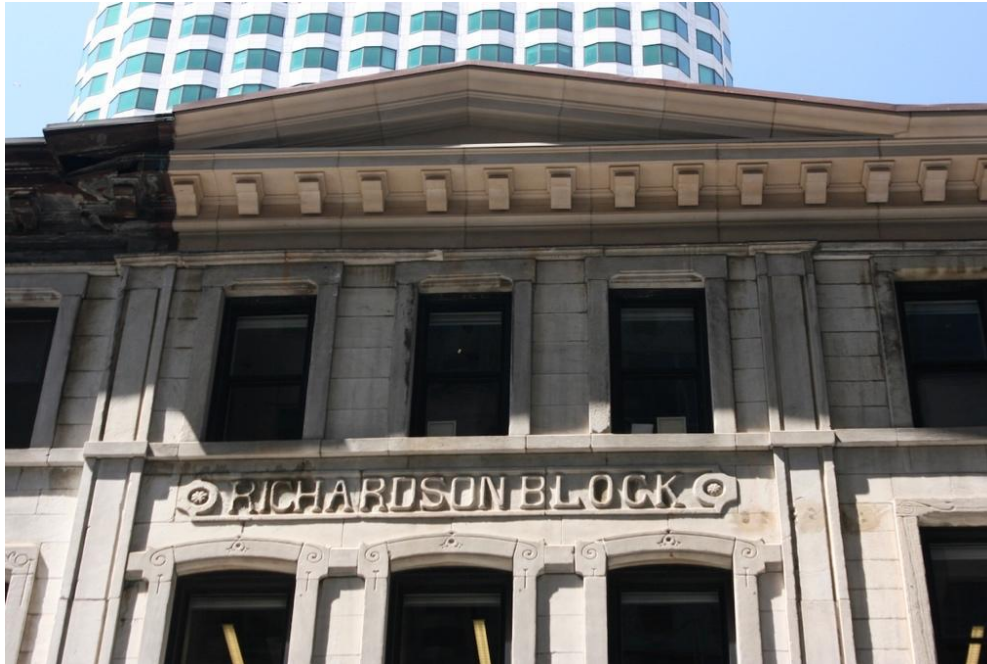
Figure 12. 129-131 Pearl St. façade, upper levels and roof edge. Photograph by Wendy Frontiero, June 2023.

Marble pilasters are rusticated on the second level and paneled on the upper floors with anthemion motifs between the second and third levels. A marble panel carved with the words “Richardson Block” is set between the third and fourth floors.

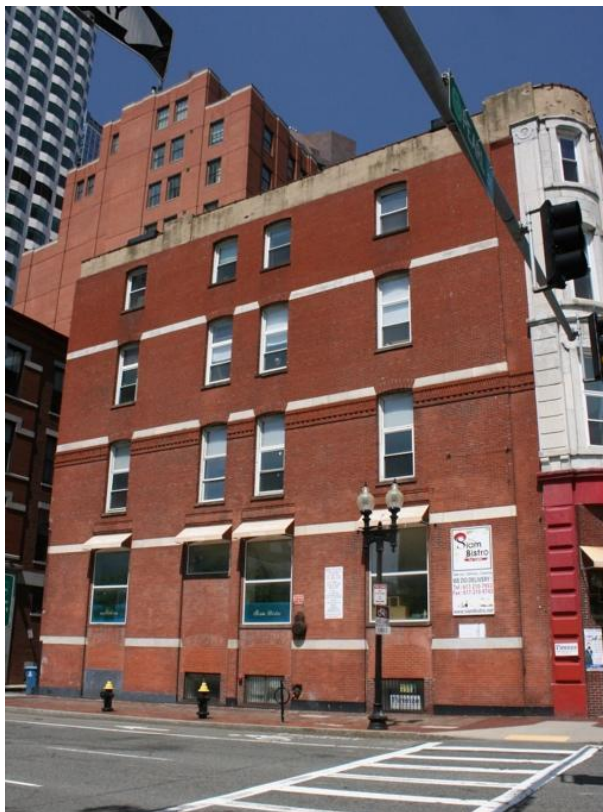
Figure 15. 149-151 Pearl St., Purchase Street elevation. Photograph by Wendy Frontiero, June 2023.

The Purchase St. façade of 149-151 Pearl St. is faced with brick. Its four window bays are articulated by flat, marble banding between the brick window lintels at the basement through third floors. A band of decorative sawtooth brickwork supplements the marble band above the second floor openings. Fenestration on the Purchase St. façade varies from floor to floor. The raised basement level features segmentally arched window openings (now mostly filled in) with gauged brick lintels. Windows on the first floor are rectangular, with flat, corbelled lintels; windows on the upper levels have segmental arches with gauged brick lintels.

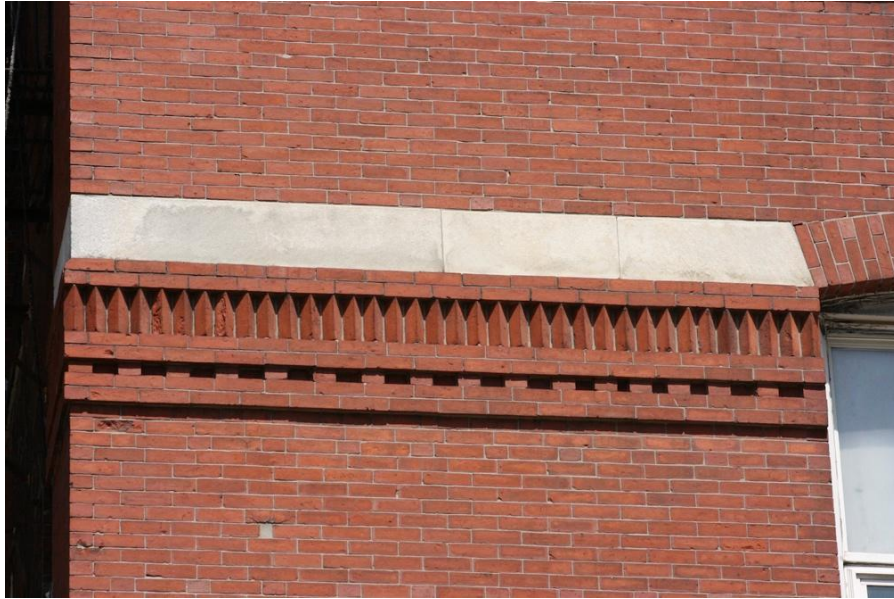
Figure 16. 149-151 Pearl St., Purchase Street façade detail. Photograph by Wendy Frontiero, June 2023.

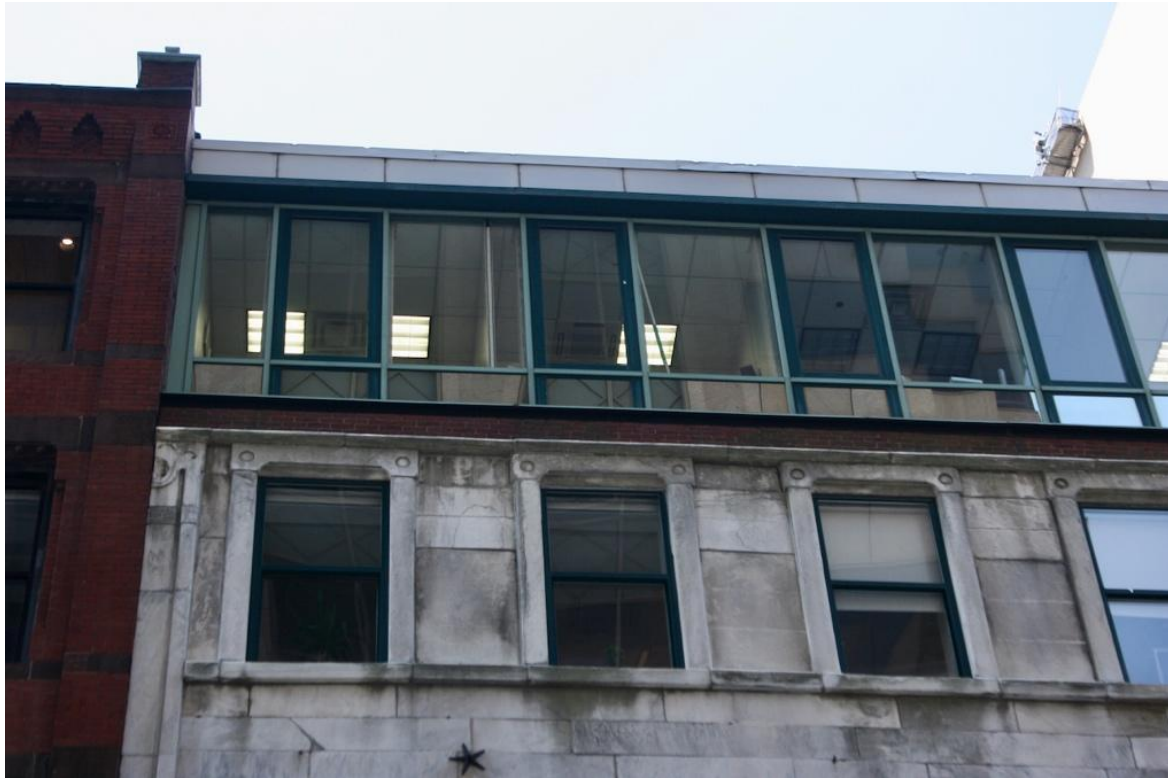
Figure 18. 119 High Street: Penthouse addition. Photograph by Wendy Frontiero, June 2023.

The architectural design of the Richardson Block is largely intact and well preserved, although most of the window openings contain modern 1/1 replacement sash and marble window trim that has suffered from weathering. Although all of the storefront windows and entrances have been extensively altered, most of the original piers, pilasters, and lintels remain. Several storefronts, at 137-139 Pearl and 141 Pearl St., still retain their historic cast iron stairs with circular glass vault lights. The original roof edges, too, have typically been modified, with many sections of the original metal cornice removed and modern parapets added. A modern glass penthouse has been added to the corner building at 119 High St.

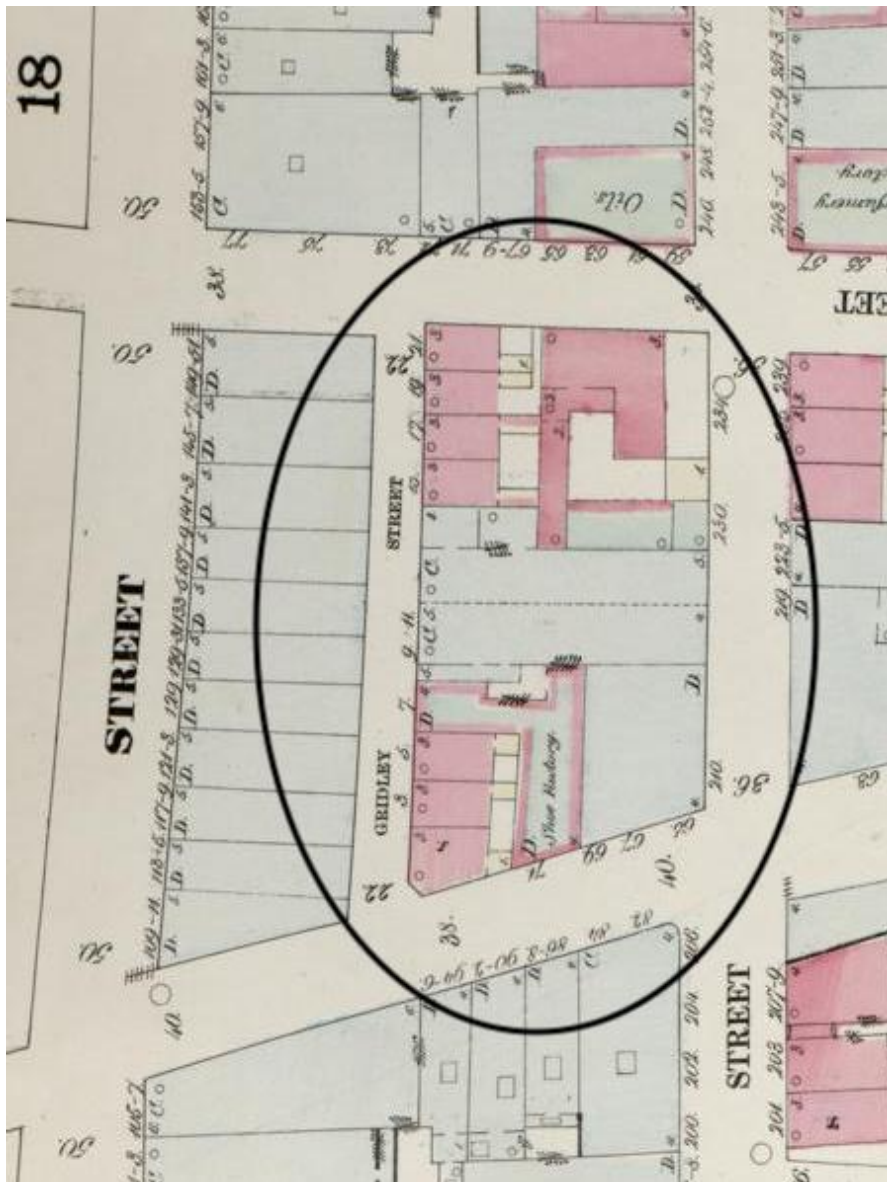
Figure 22. 1867 Sanborn map. Sanborn, D. A., -1883, Cartographer. Insurance map of Boston. Volume 1. New York: D. A. Sanborn, 1867. Map. <https://www.loc.gov/item/2010593241/>
