# **HUTCHINSON BUILDING**

## **BOSTON LANDMARKS COMMISSION**

### **STUDY REPORT**

**The Hutchinson Building  
29 Bromfield Street, Boston, Massachusetts 02108**

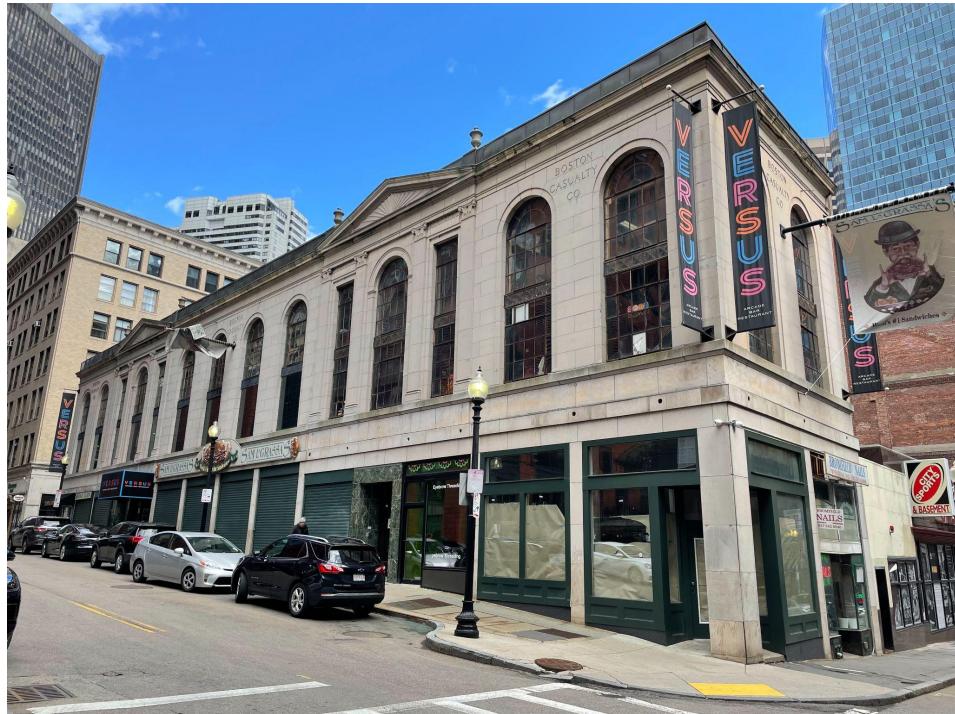
**Figure 3.** Hutchinson Building façade. Photograph taken from Bromfield St., facing northeast (March 2023) by Mary E. Cirbus.

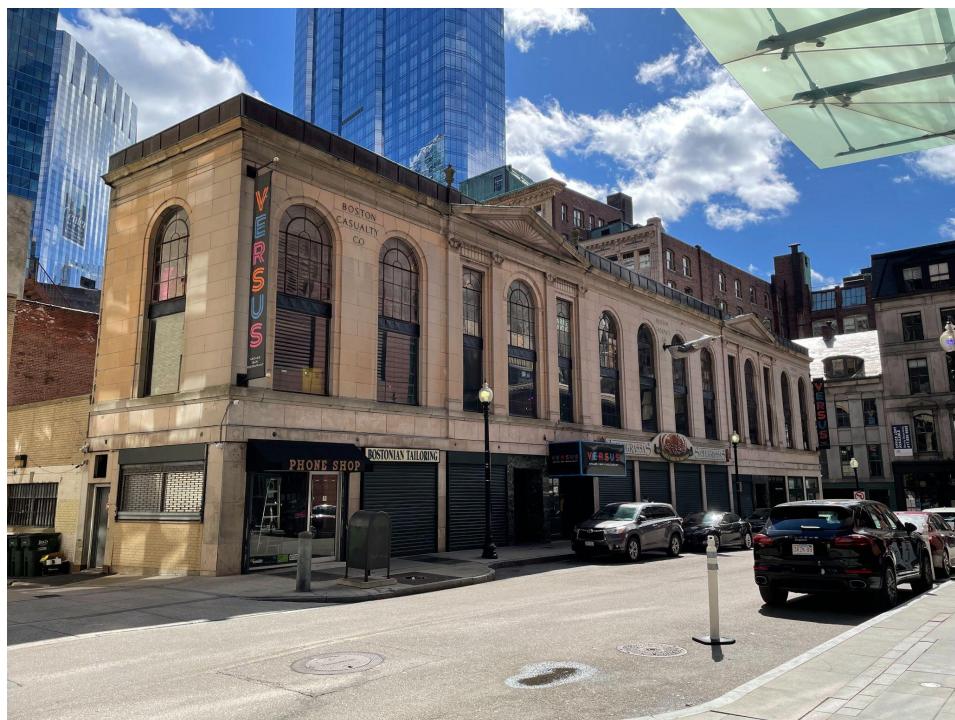
**Figure 4.** Hutchinson Building façade. Photograph taken from Province St. facing southwest (March 2023). Photo credit: Mary E. Cirbus.

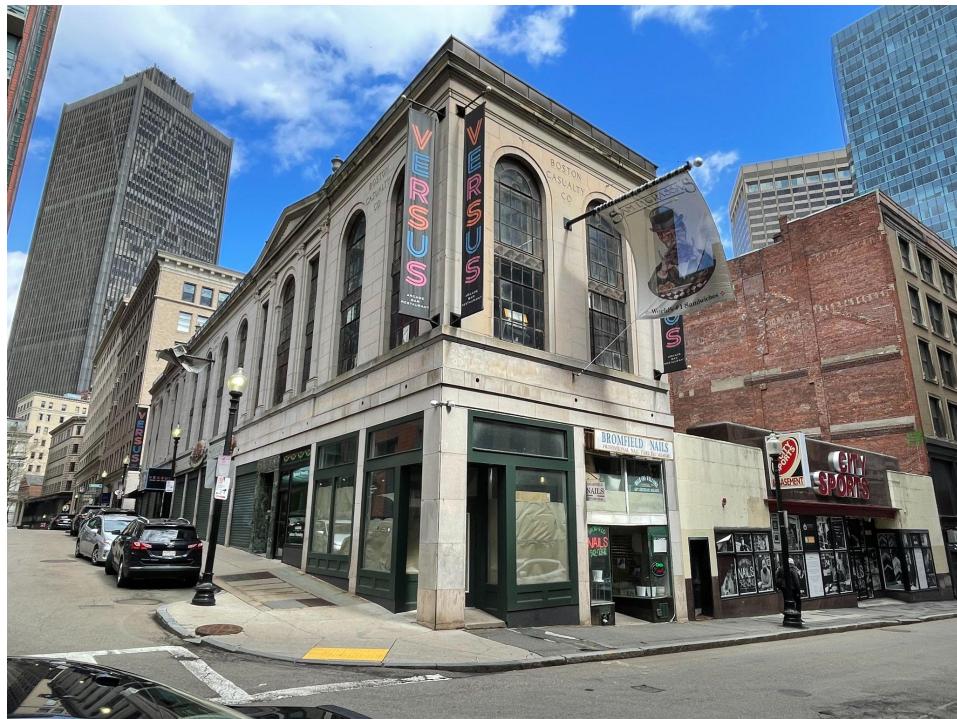
**Figure 5.** Bromfield St. elevation taken facing northeast (March 2023). Photo credit: Mary E. Cirbus.

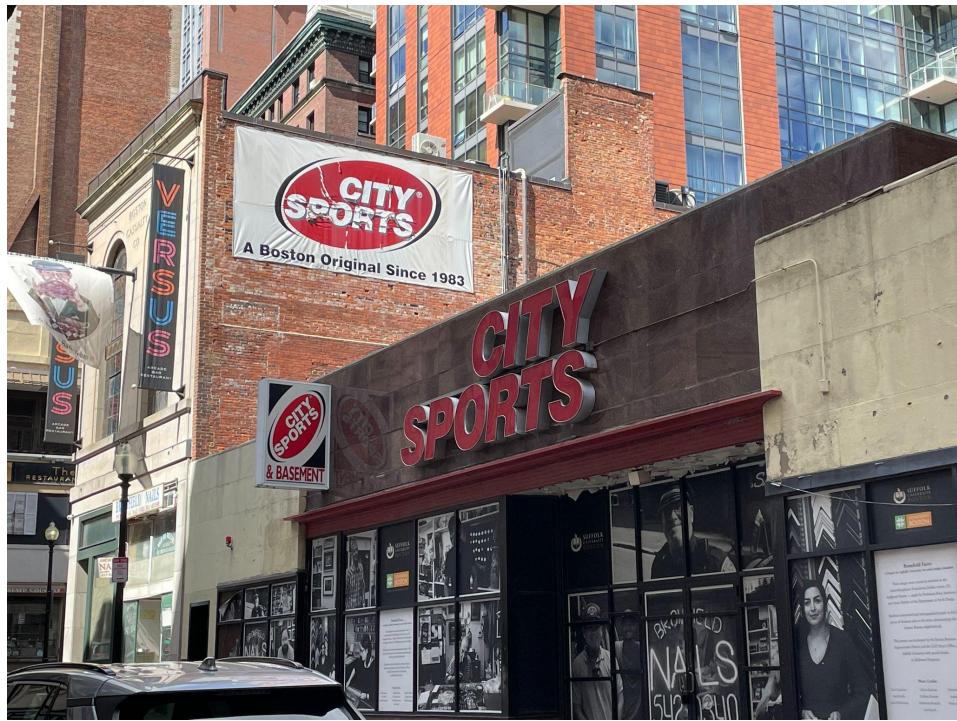
**Figure 7.** Rear elevation of the Hutchinson Building as visible from Bromfield St. Photo credit: Mary E. Cirbus.

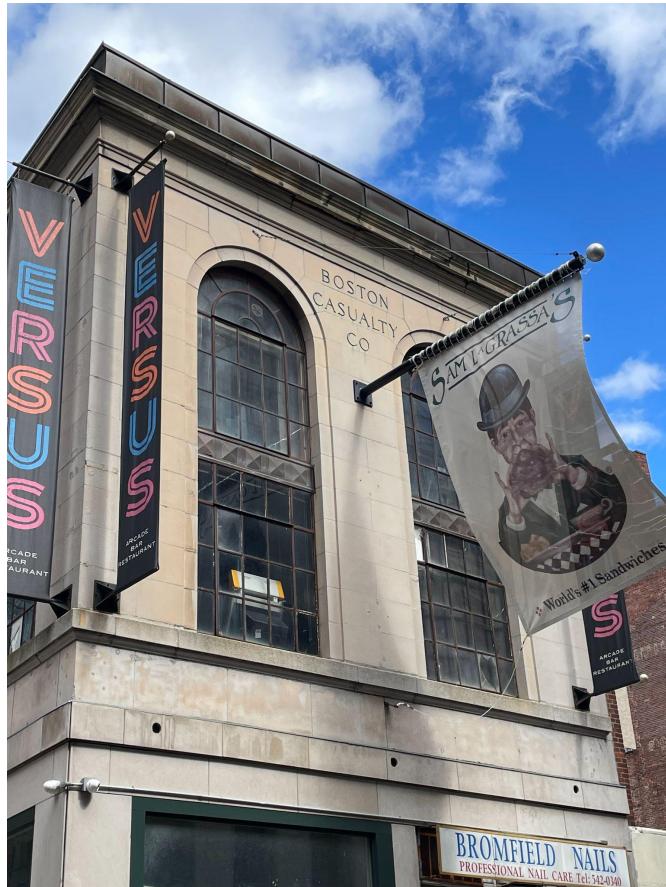
**Figure 8.** Detail of Bromfield St. elevation, upper levels. Photograph taken from Bromfield St., facing northeast (March 26, 2023). Photo credit: Mary E. Cirbus.

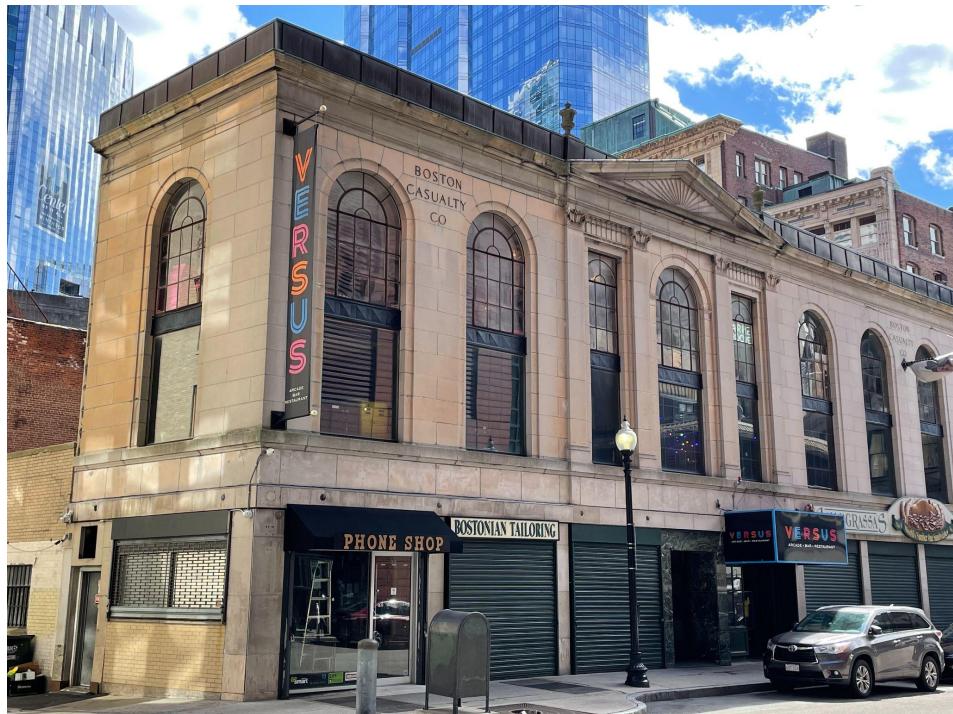
**Figure 9.** Detail showing the one bay of Province Court elevation, and (from left to right) bays 1 through 8 of Province St. façade. Photograph taken from Province St., facing southeast (March 2023). Photo credit: Mary E. Cirbus.

The north elevation faces Province Ct., a private way, and measures one bay wide. The upper stories display the same cast stone cladding, cornice, and metal-clad parapet. The single bay holds the same two-story steel arched-headed window with pressed metal spandrel to match the primary façade and south elevation, but the bottom section of the window has been removed and replaced with a single pane of glass.

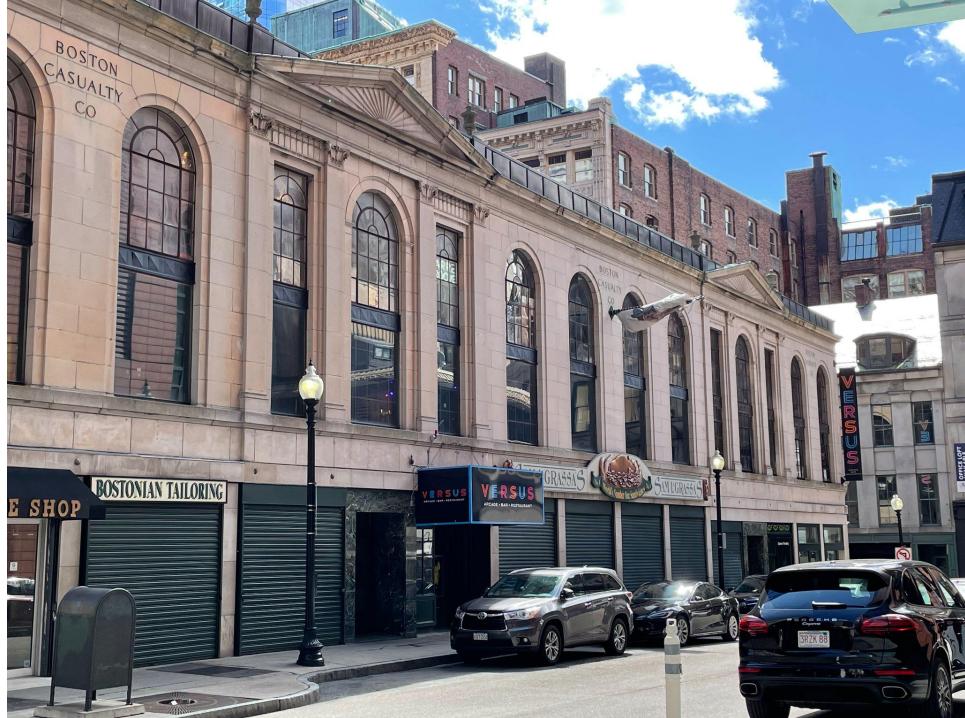
**Figure 10.** Detail showing (from left to right) bays 1 (partial) through 14 of Province St. façade. Photograph taken from Province St., facing southeast (March 26, 2023). Photo credit: Mary E. Cirbus.

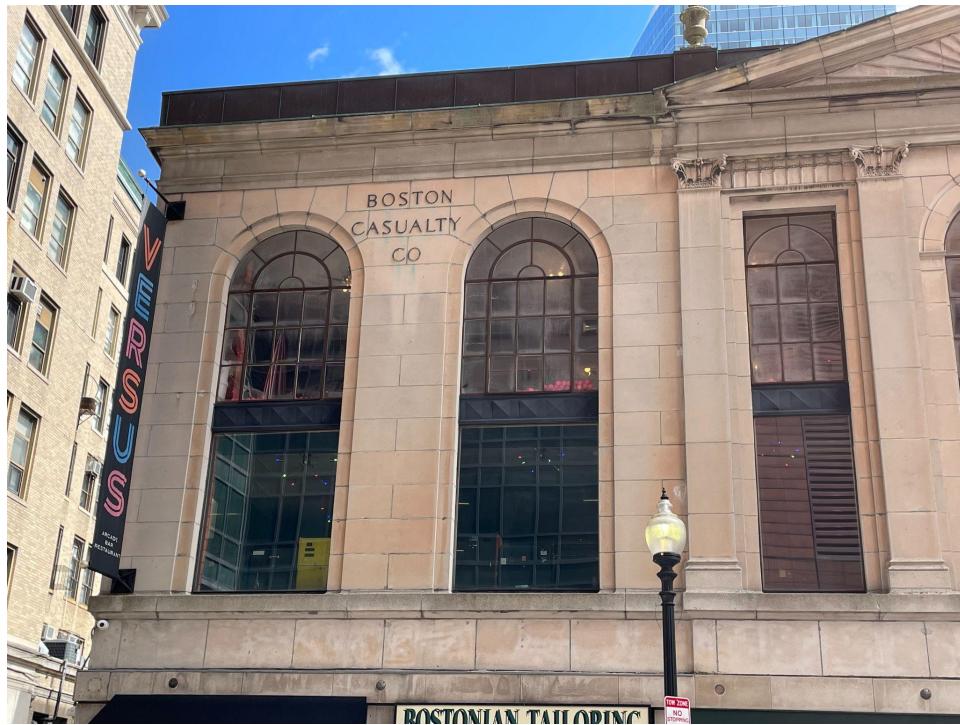
**Figure 11.** Detail showing the upper portion of the Province St. façade (from left to right) bays 1 through 3. Photograph taken from Province St. facing east (March 26, 2023). Photo credit: Mary E. Cirbus.

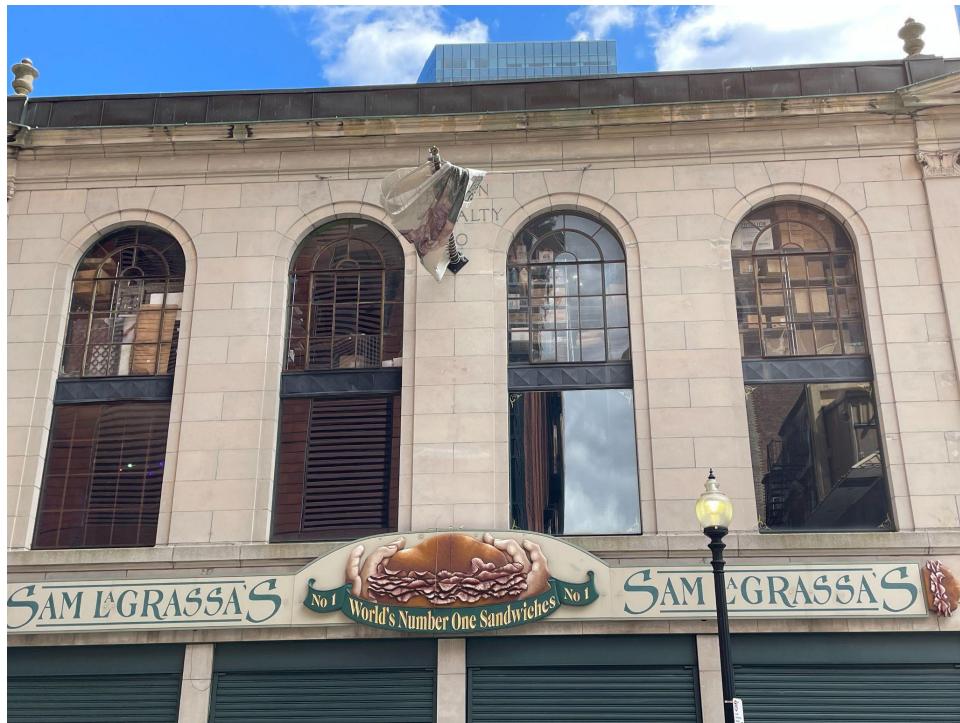
**Figure 13.** Detail showing (from left to right) the upper portion of bays 6 through 9 of Province St. façade. Photograph taken from Province St., facing east (March 26, 2023). Photo credit: Mary E. Cirbus.

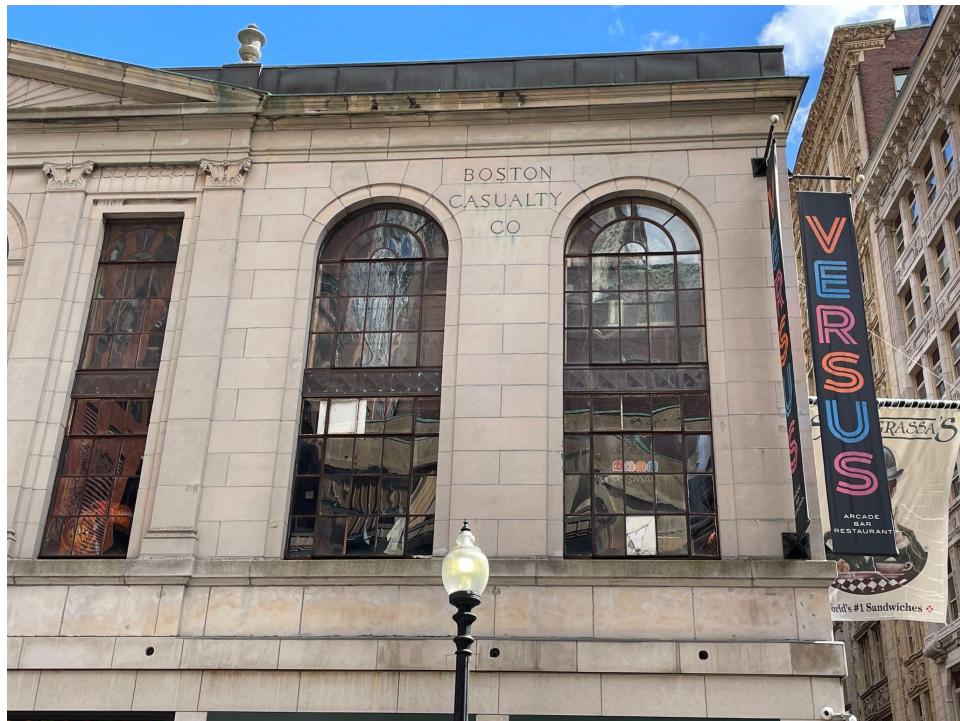
**Figure 15.** Detail showing (from left to right) the upper portions of bays 12 through 14 of Province St. façade. Photograph taken from Province St., facing east (March 26, 2023). Photo credit: Mary E. Cirbus.

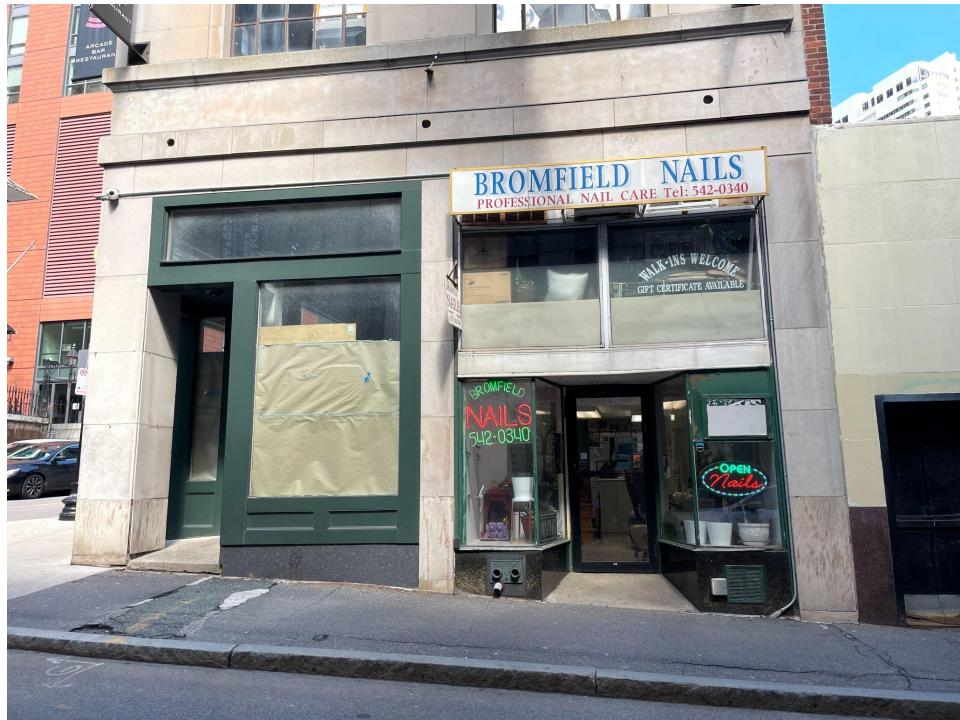
**Figure 16:** Detail image showing modified storefronts on Bromfield St. Photograph taken from Bromfield St., facing north (March 26, 2023). Photo credit: Mary E. Cirbus.

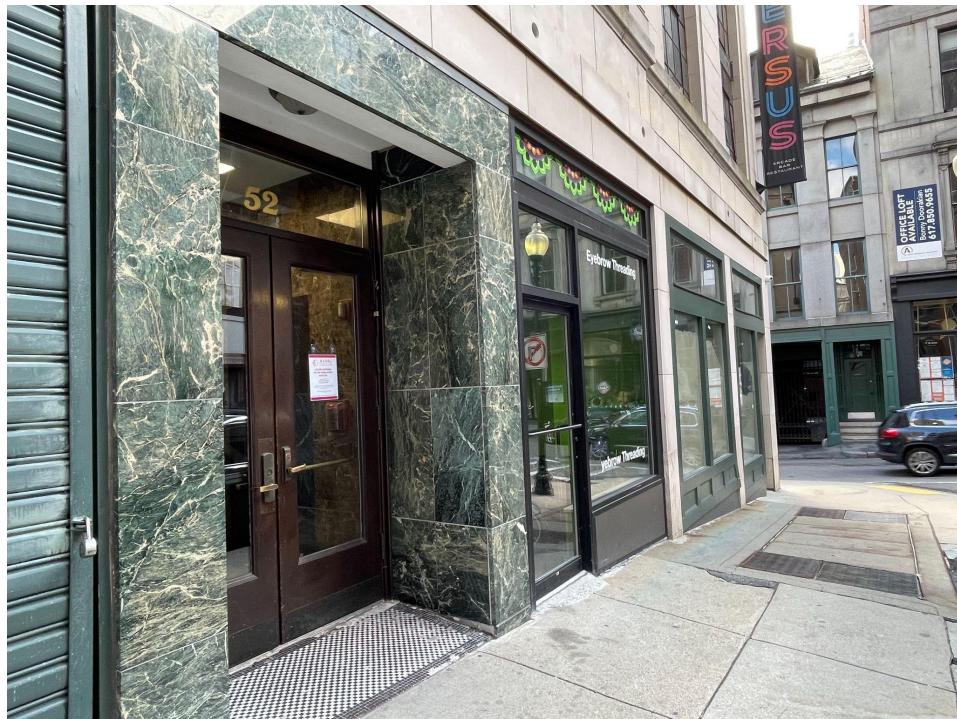
**Figure 17.** Detail image showing modified storefronts on Province St. compared to original facing of green marble (on left). Photograph taken from Province St., facing southeast, towards Bromfield St. (March 26, 2023). Photo credit: Mary E. Cirbus.

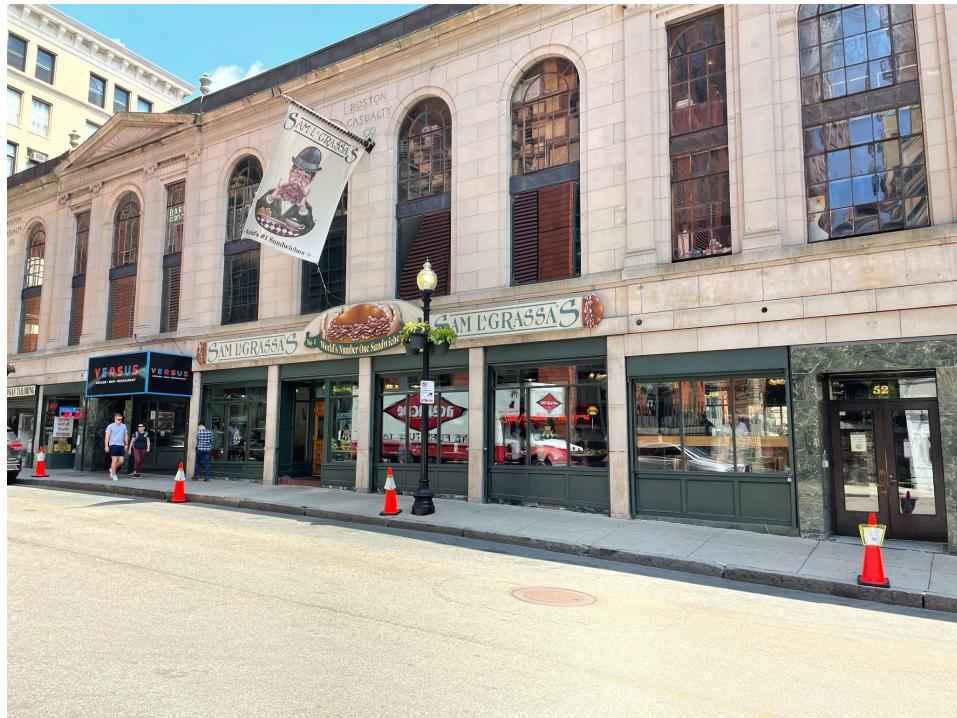
**Figure 18.** Expanded image showing extent of storefront modification on façade. Photograph taken from Province St., facing northeast (May 8, 2023). Photo credit: Mary E. Cirbus.

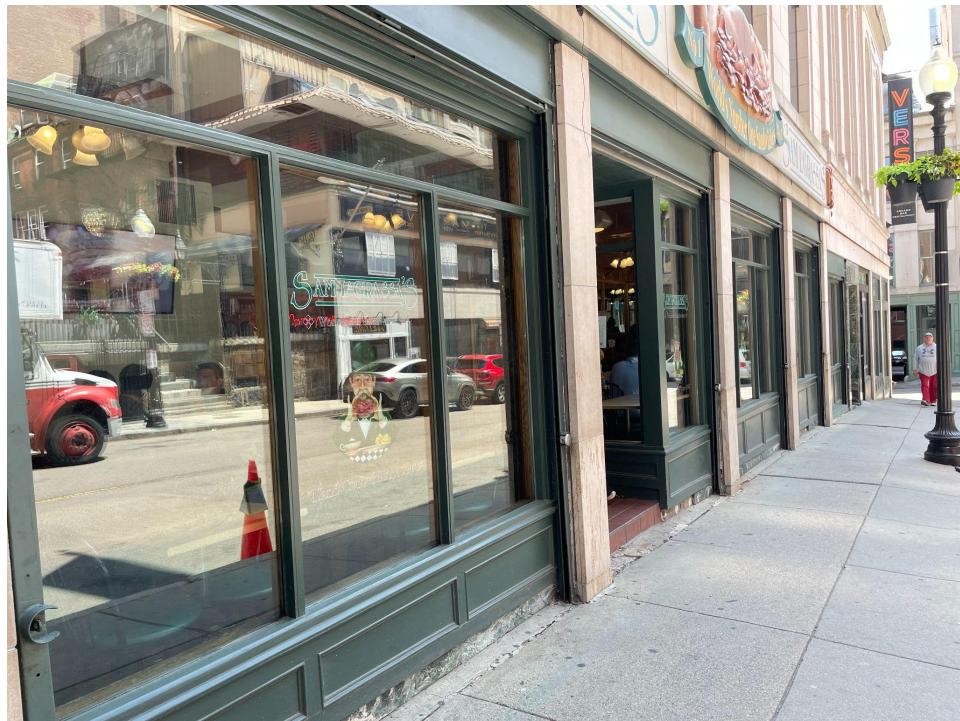
**Figure 19.** Detail image showing modified storefronts on Province St. façade. Photograph taken from Province St., facing southeast towards Bromfield St. (May 8, 2023). Photo credit: Mary E. Cirbus.

The bottom third of the façade consists of a row of storefronts along the street level, capped by a wide sign band and molded water table. A row of metal caps and holes in the cast stone where caps are missing is evenly spaced across the façade, remnants of a former canopy that was historically present (see **Figure 3**). Province St. is not level, and the building is built into the slope of the street. The south elevation (facing Bromfield St.), therefore, sits at a lower level than the Province St. and Province Ct. elevations. The southernmost storefronts of the elevation (toward Bromfield St.), have higher bulkheads and additional cast stone above the windows to accommodate the slope of the street. Cast stone piers separate each of the storefronts, except underneath bays 3 through 5, and 10 through 12. All the storefronts have been modified from their historic design and are constructed of wood and metal materials. Two storefronts maintain an identical mosaic pattern within the recessed entries, which indicates that this feature may be original. Marble cladding is present at the two main entrances to the building, which are located underneath bay 4 and bay 11 (these entrances correspond with the center bay of each temple-front). These entrances also share the same mosaic floor as the previously mentioned two storefronts.

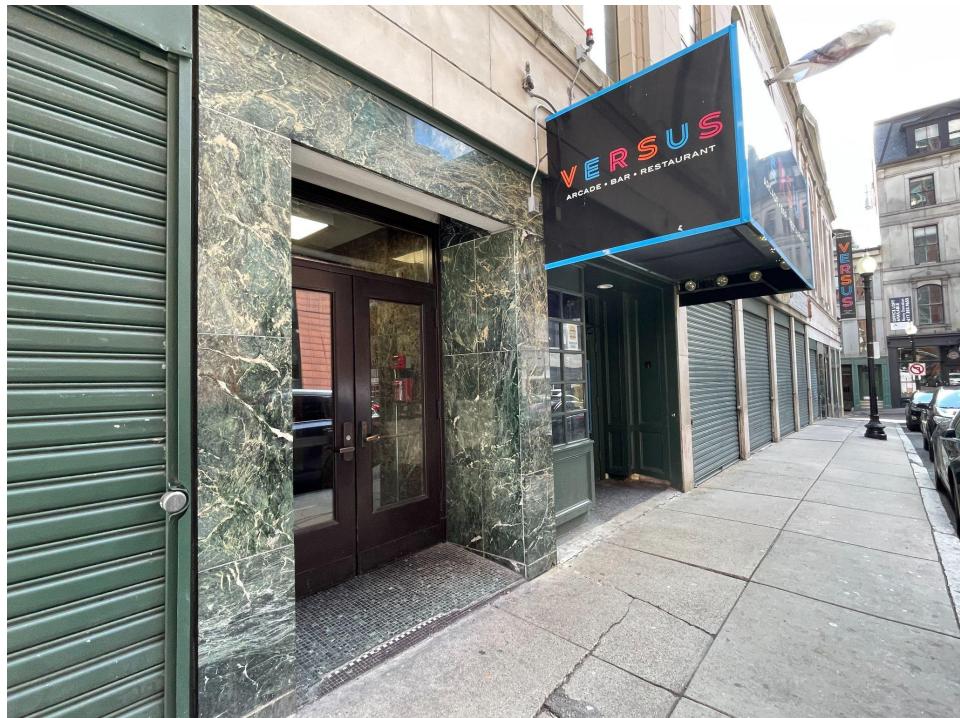
**Figure 20.** Detail image showing another original storefront with marble and recessed entry, as well as modified storefronts along the façade. Photograph taken from Province St., facing southeast, towards Bromfield St. (March 26, 2023). Photo credit: Mary E. Cirbus.

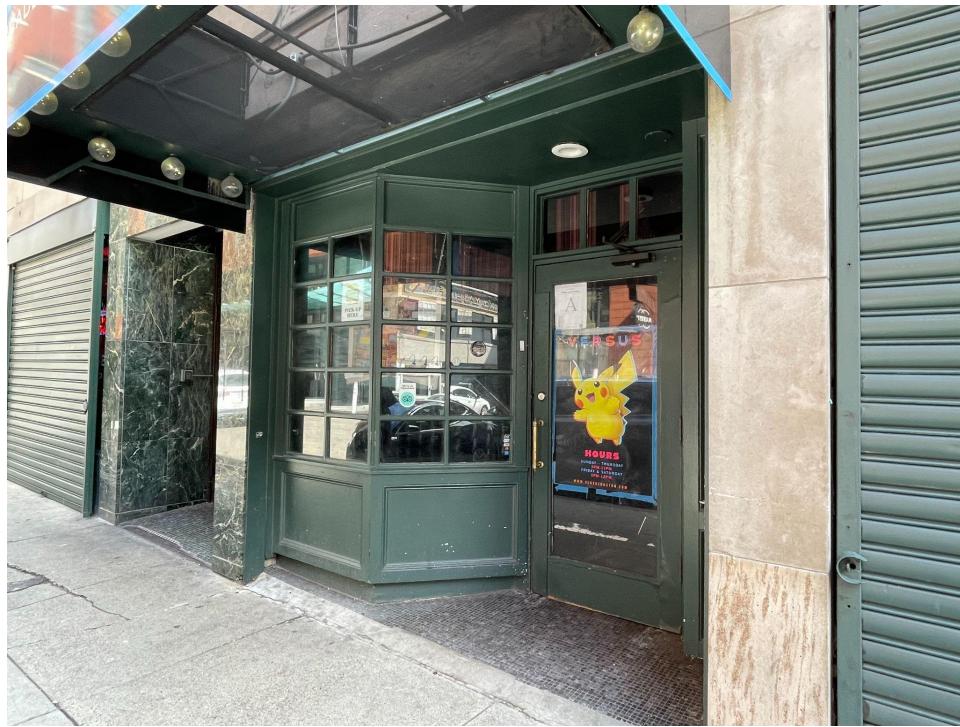
**Figure 21.** Detail image showing modified storefronts on Province St.. Photograph taken from Province St., facing northeast (March 26, 2023). Photo credit: Mary E. Cirbus.

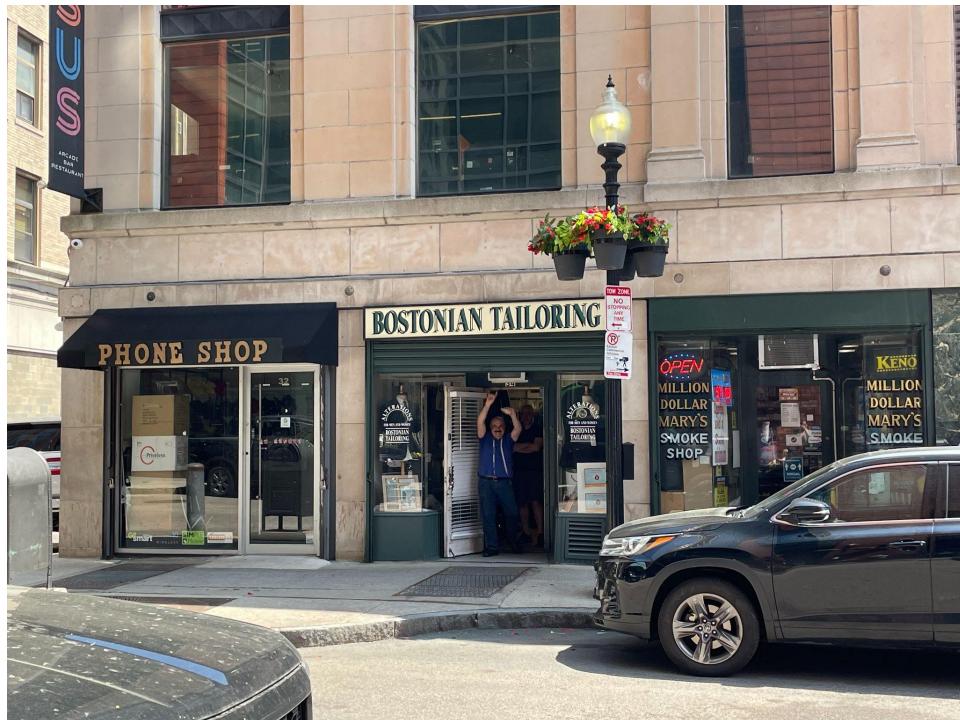
**Figure 22.** Detail image showing modified storefronts on Province St. façade. Photograph taken from Province St., facing northeast (May 8, 2023). Photo credit: Mary E. Cirbus.

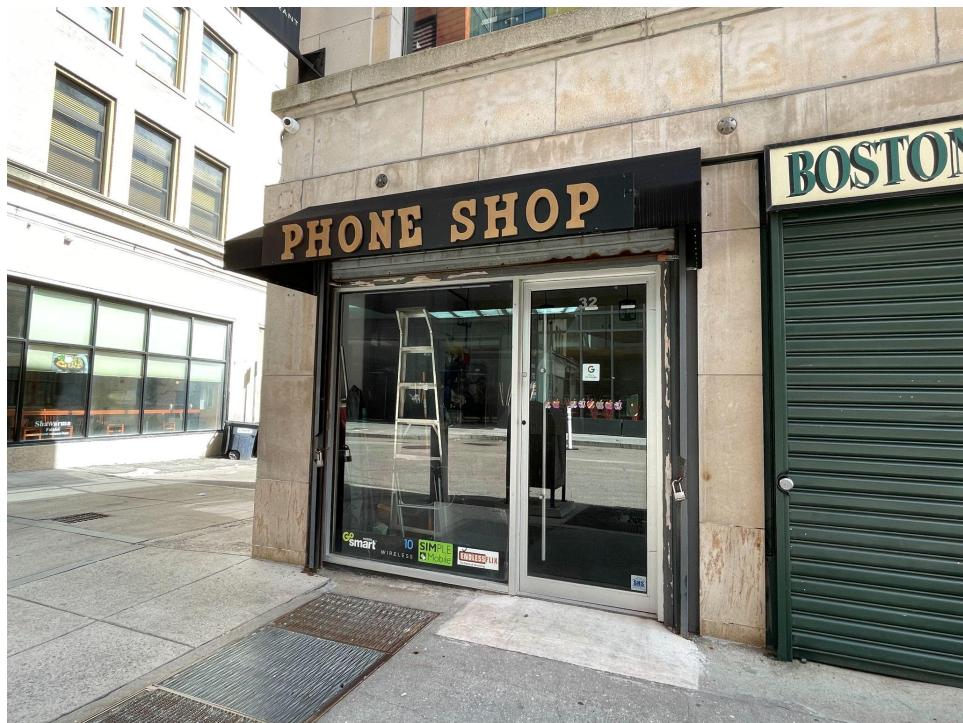
**Figure 23.** Detail showing modified storefronts on Province St.. Province Ct. is visible. Photograph taken from Province St., facing northeast (March 26, 2023). Photo credit: Mary E. Cirbus.

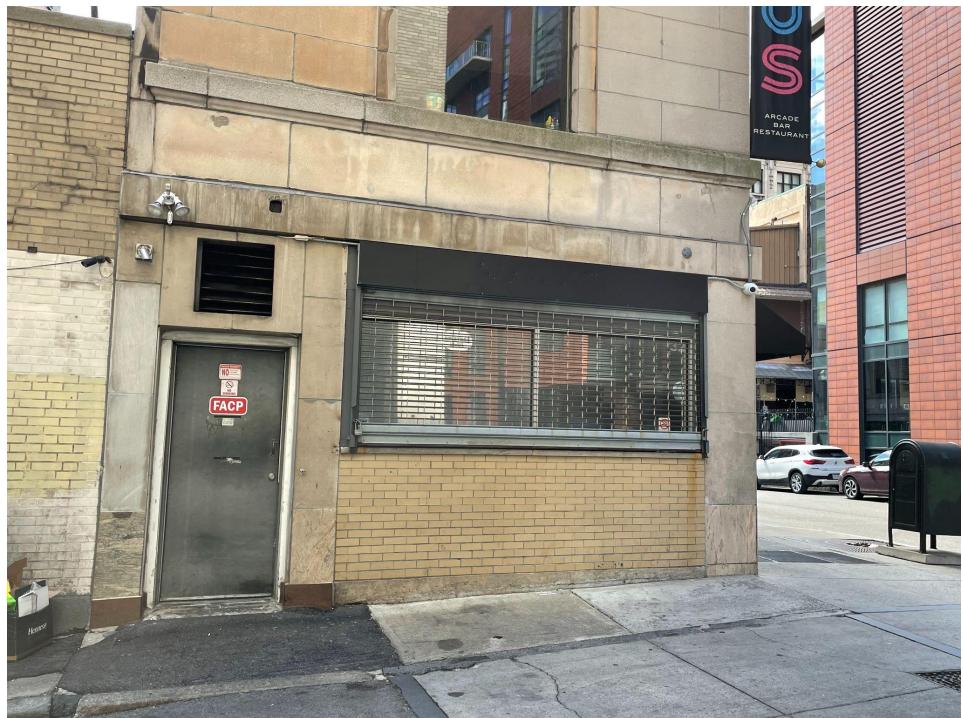
**Figure 24.** Modified storefront at Province Ct. Photograph taken from Province Ct., facing slightly southwest (March 26, 2023). Photo credit: Mary E. Cirbus.

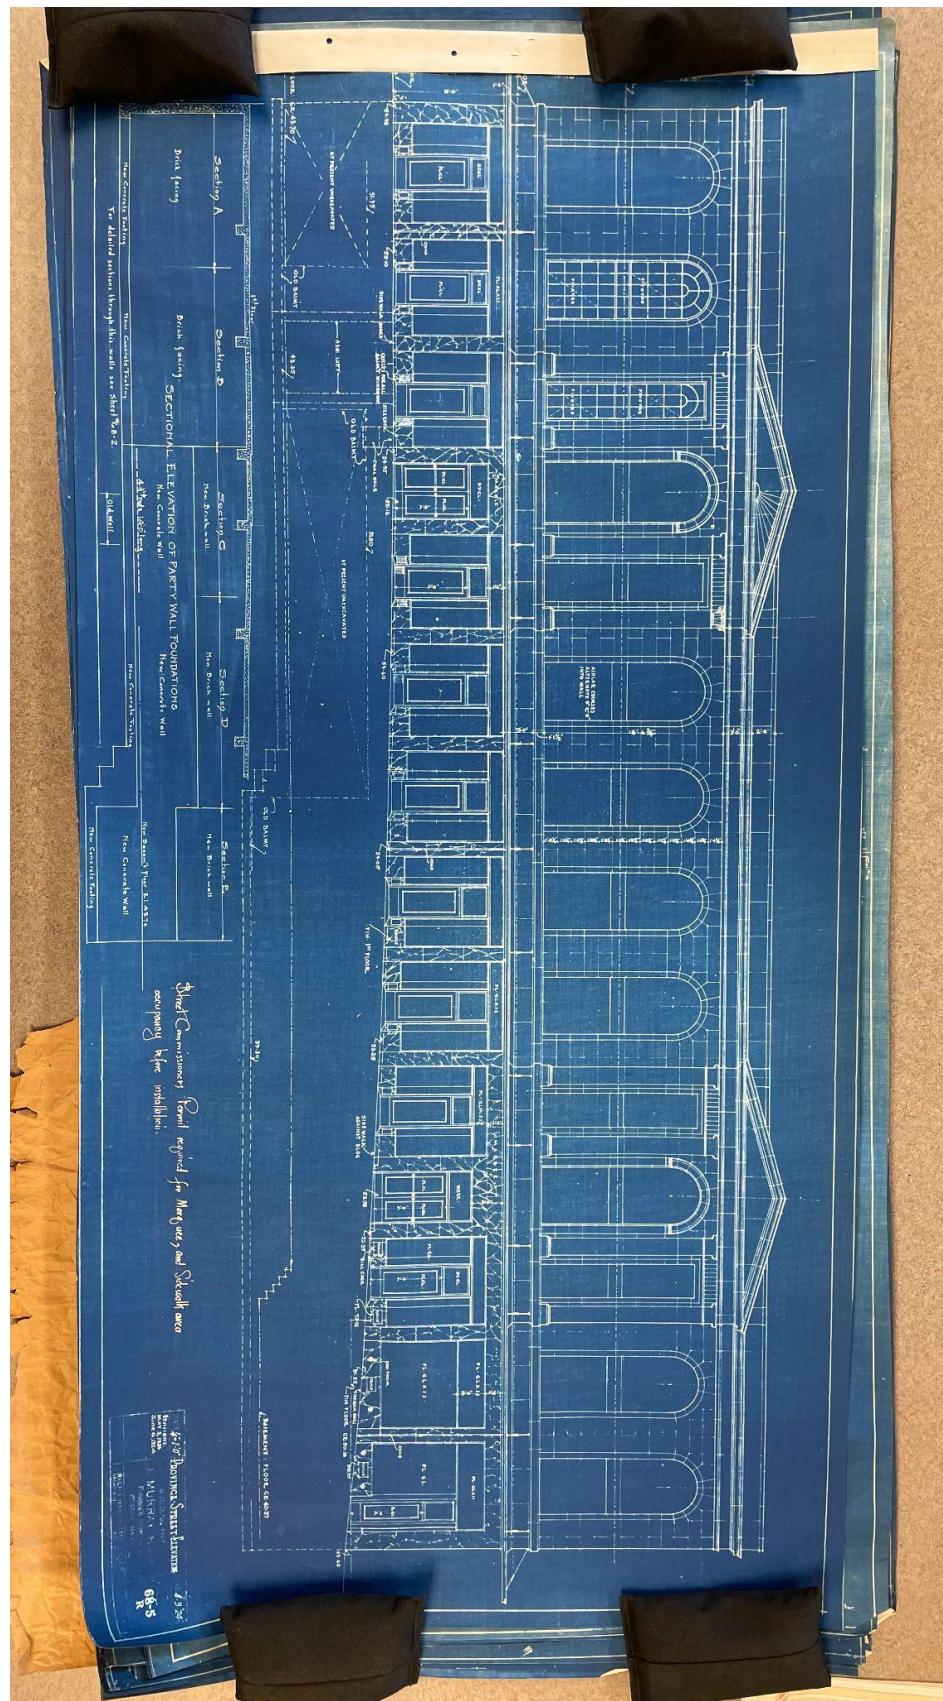
**Figure 28.** Original building plans showing the Province Street façade.  
**Source:** Boston City Archives.

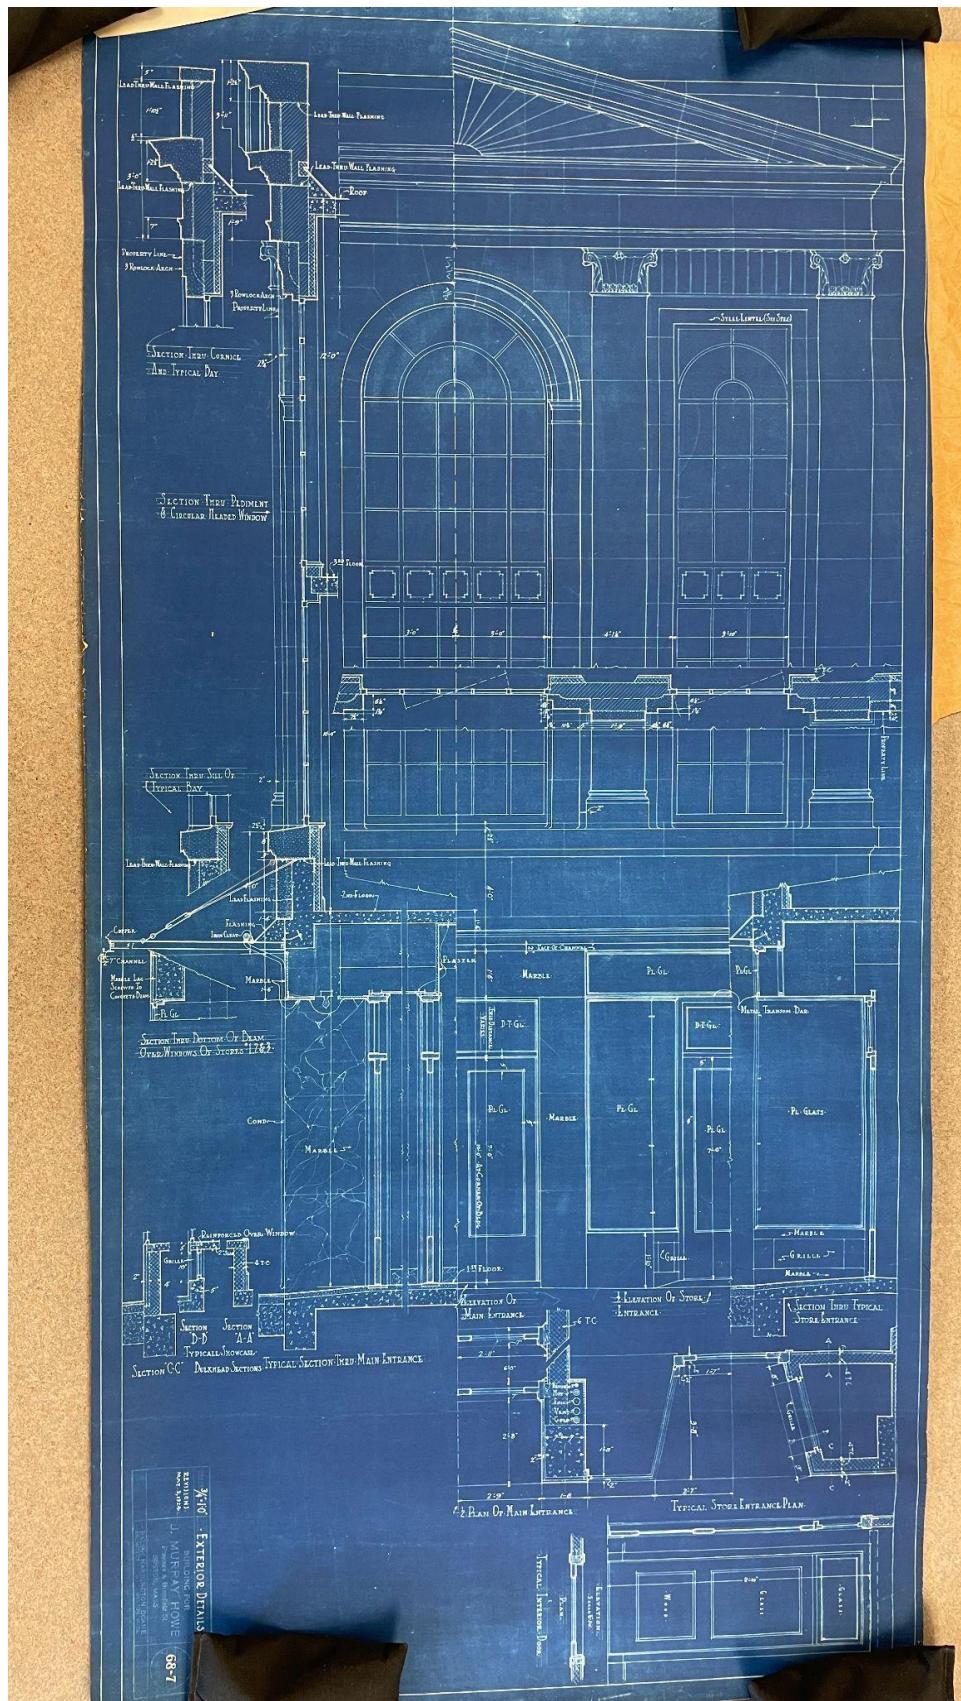
**Figure 29.** Original building plans showing exterior details.

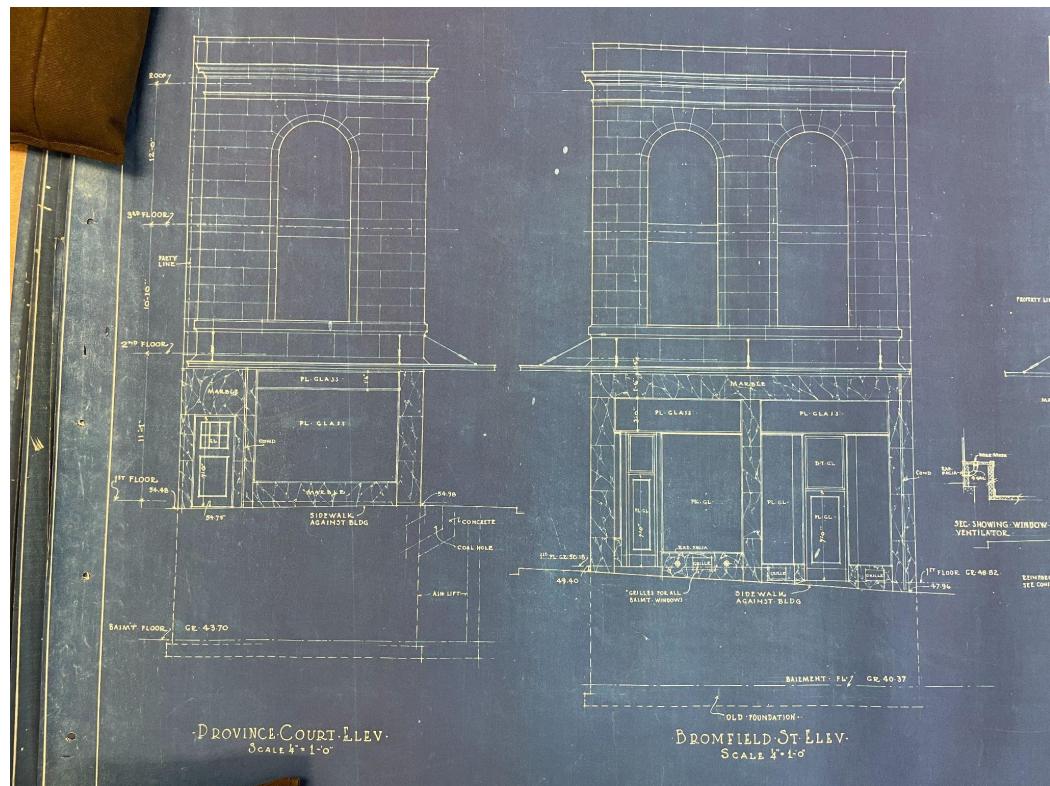
**Figure 30.** Original building plans showing the Bromfield St. elevation and Province Ct. elevation.

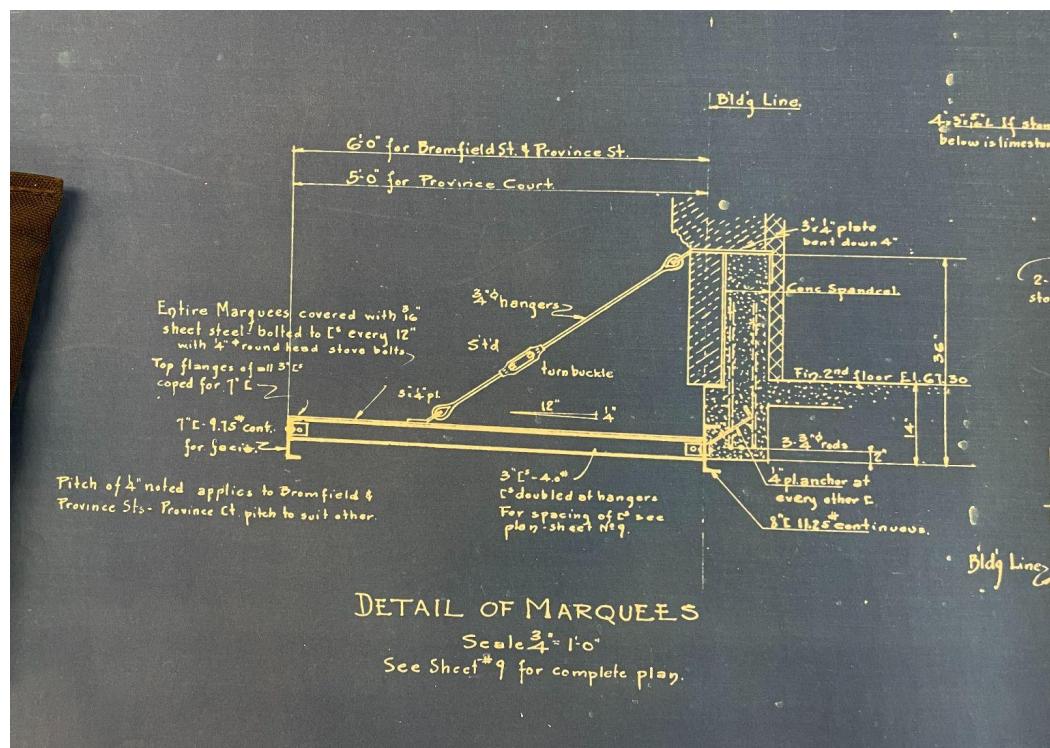
**Figure 31.** Original building plans showing a detail of the marqueses on the street-facing façade and side elevations.

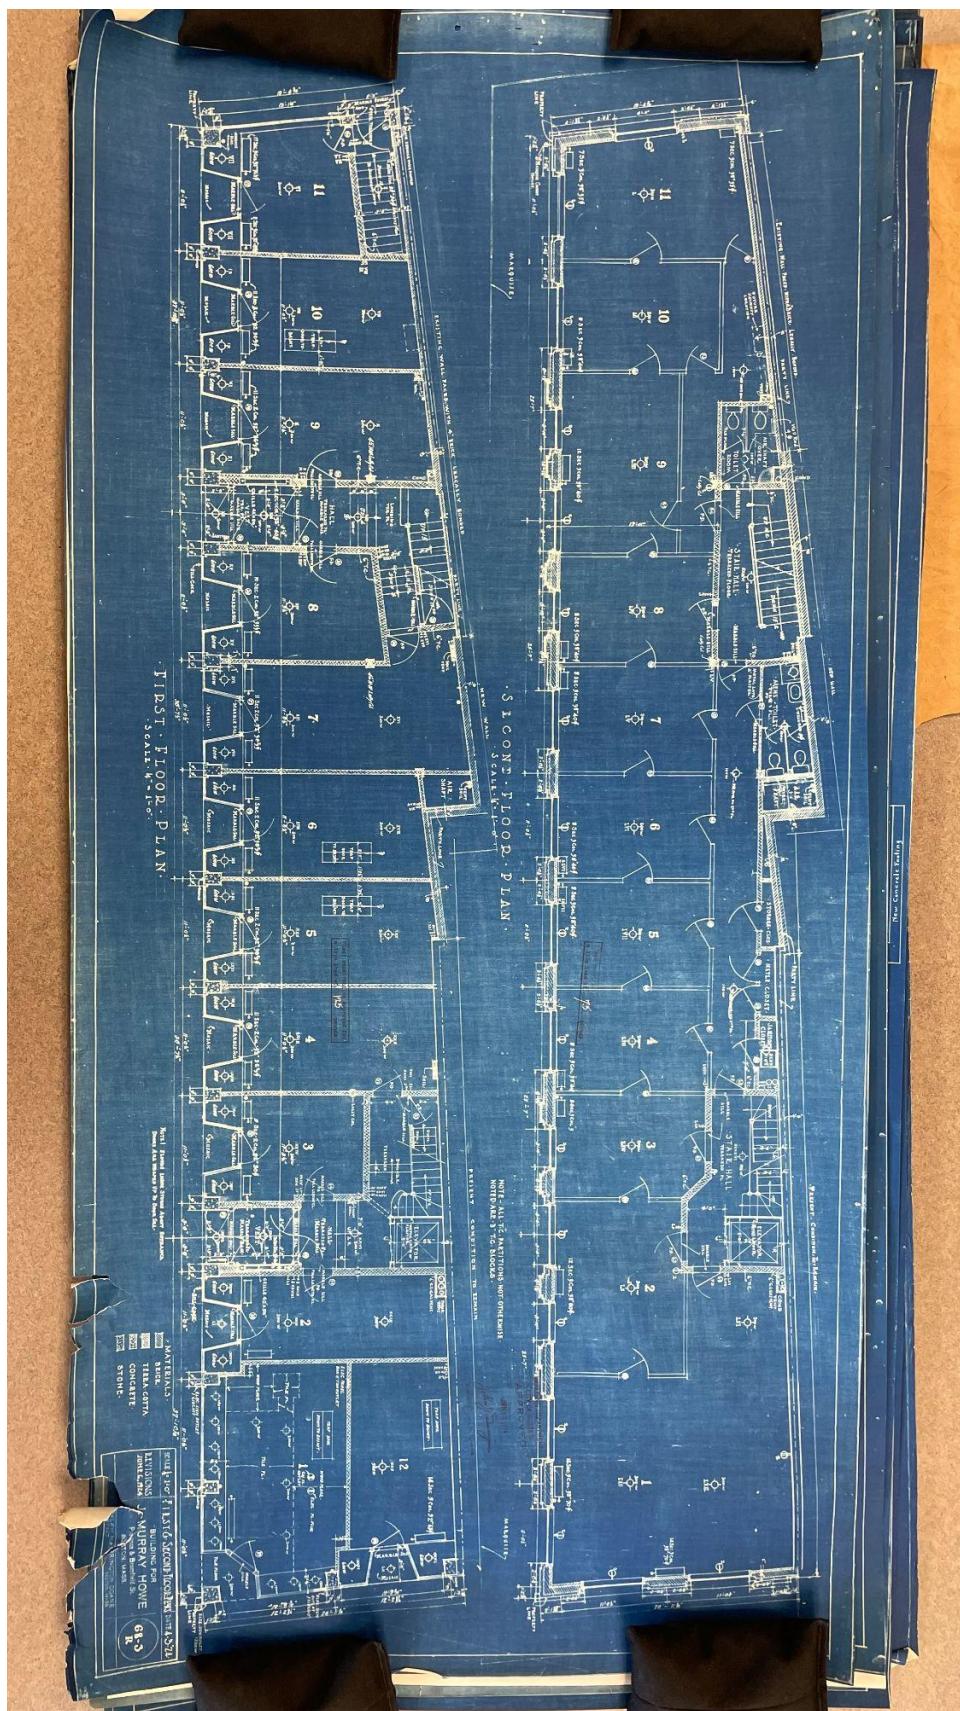
**Figure 32.** Original building plans showing the first and second floor plans.  
**Source:** Boston City Archives.

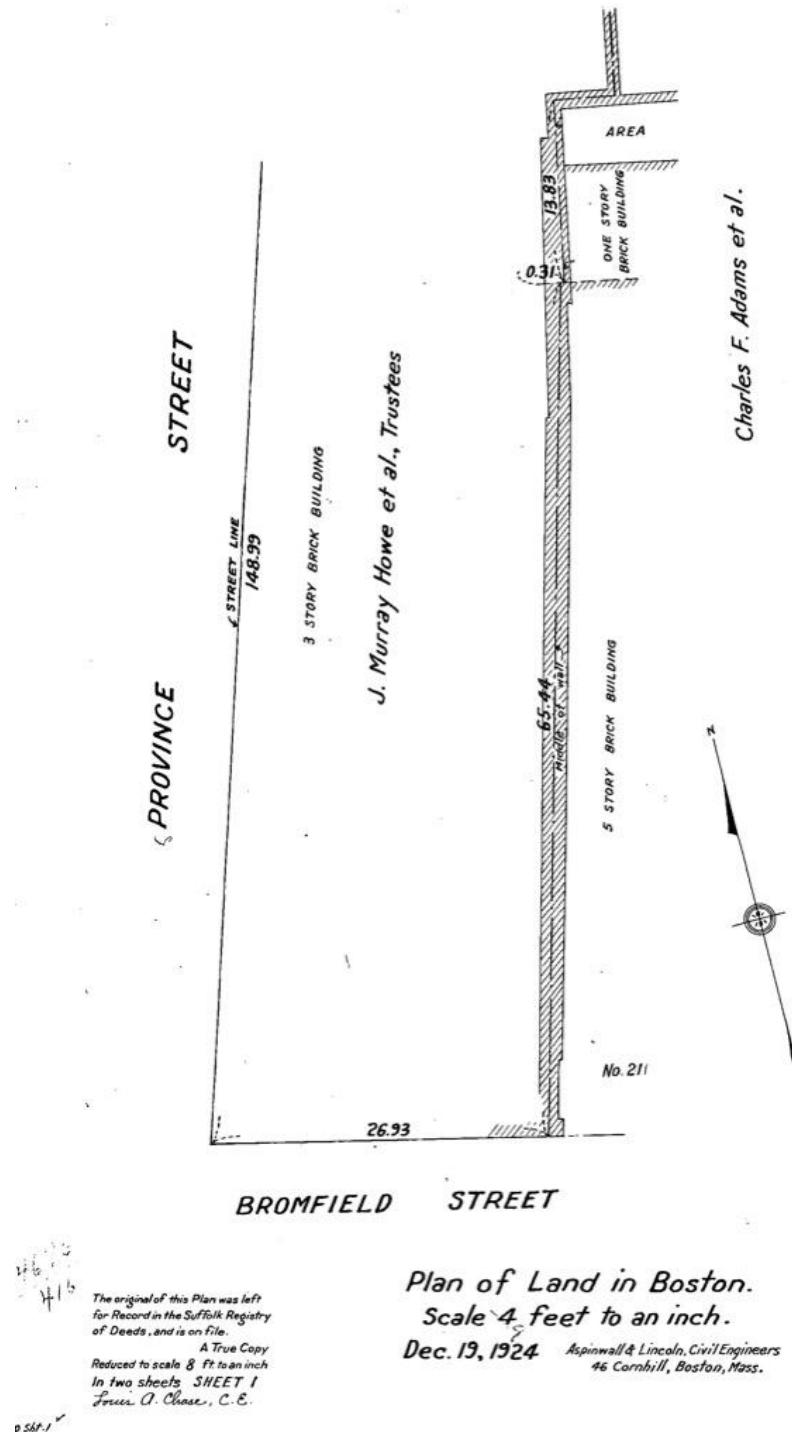
**Figure 33.** Plan of parcel containing Hutchinson Building.
