# **HUTCHINSON BUILDING**

## **BOSTON LANDMARKS COMMISSION**

### **STUDY REPORT**

**The Hutchinson Building  
29 Bromfield Street, Boston, Massachusetts 02108**

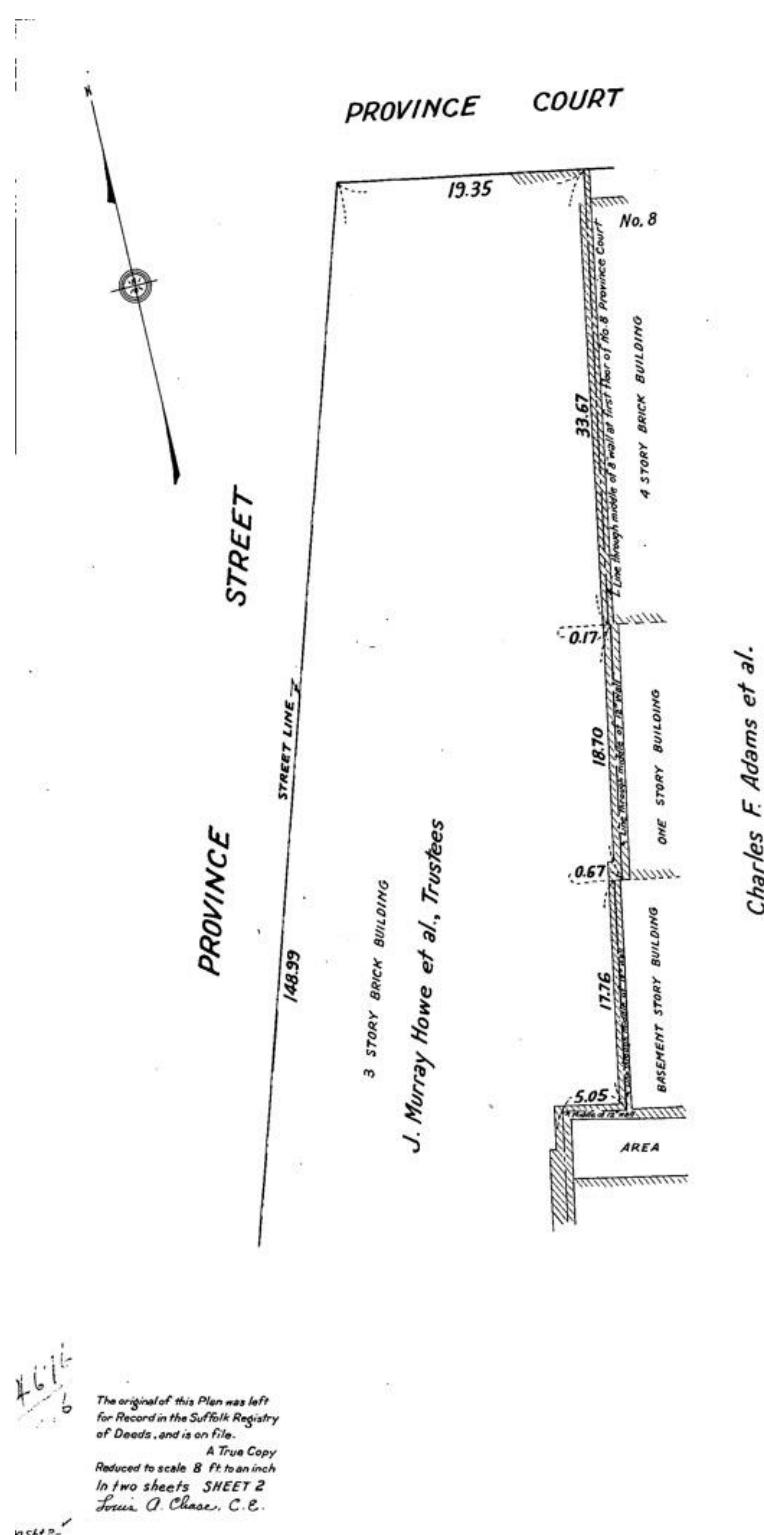
**Figure 34.** Plan of parcel containing Hutchinson Building by Aspinwall & Lincoln, Civil Engineers, December 19, 1924 (Sheet 2), as recorded in the Suffolk Registry of Deeds, Book 4676, Page 416. (Part 2 of 2)

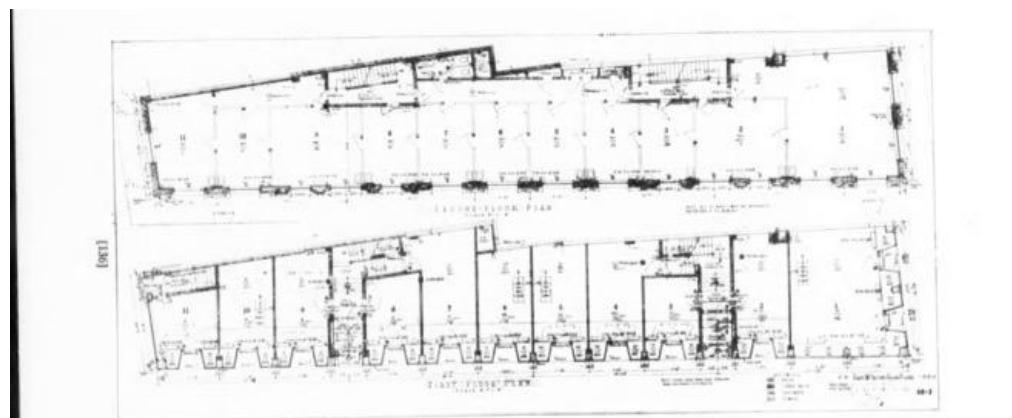
**Figure 37.** First and second floor plans of the Hutchinson Building, drawn by Ralph Harrington Doane, showing the original configuration of the street level footprint, including recessed storefront entries on Bromfield St. and Province St. The storefront at the corner of Province St. and Bromfield St. (bottom right corner), however, differs from the original building plans and shows an entrance on Bromfield St., rather than angled on the corner.

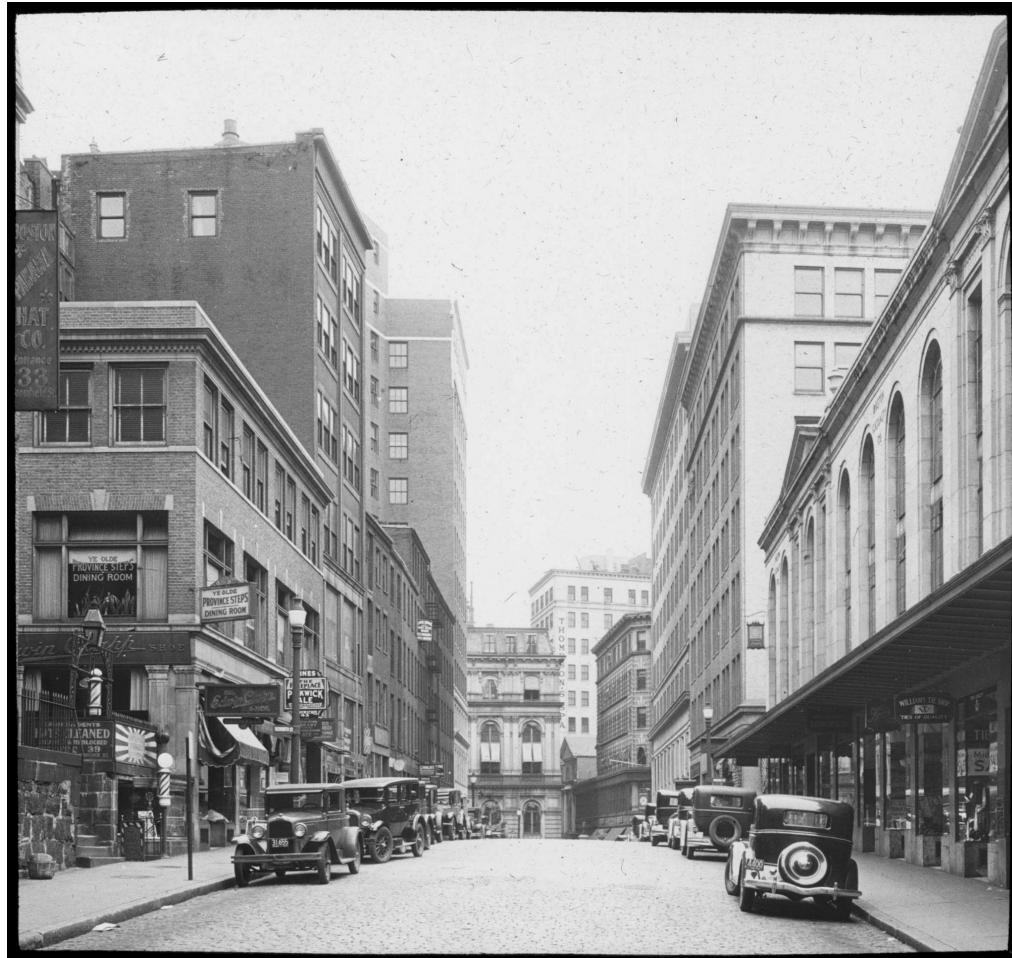
**Figure 38.** A 1934 photograph showing Province St.. The Hutchinson Building is on the right.

original configurations of the recessed entry storefront plan, but it is not decipherable as to whether or not the marble trim was present (see **Figure 38**). The main entrances to the building on Province St. (bays 4 and 11) currently display green and white marble trim.

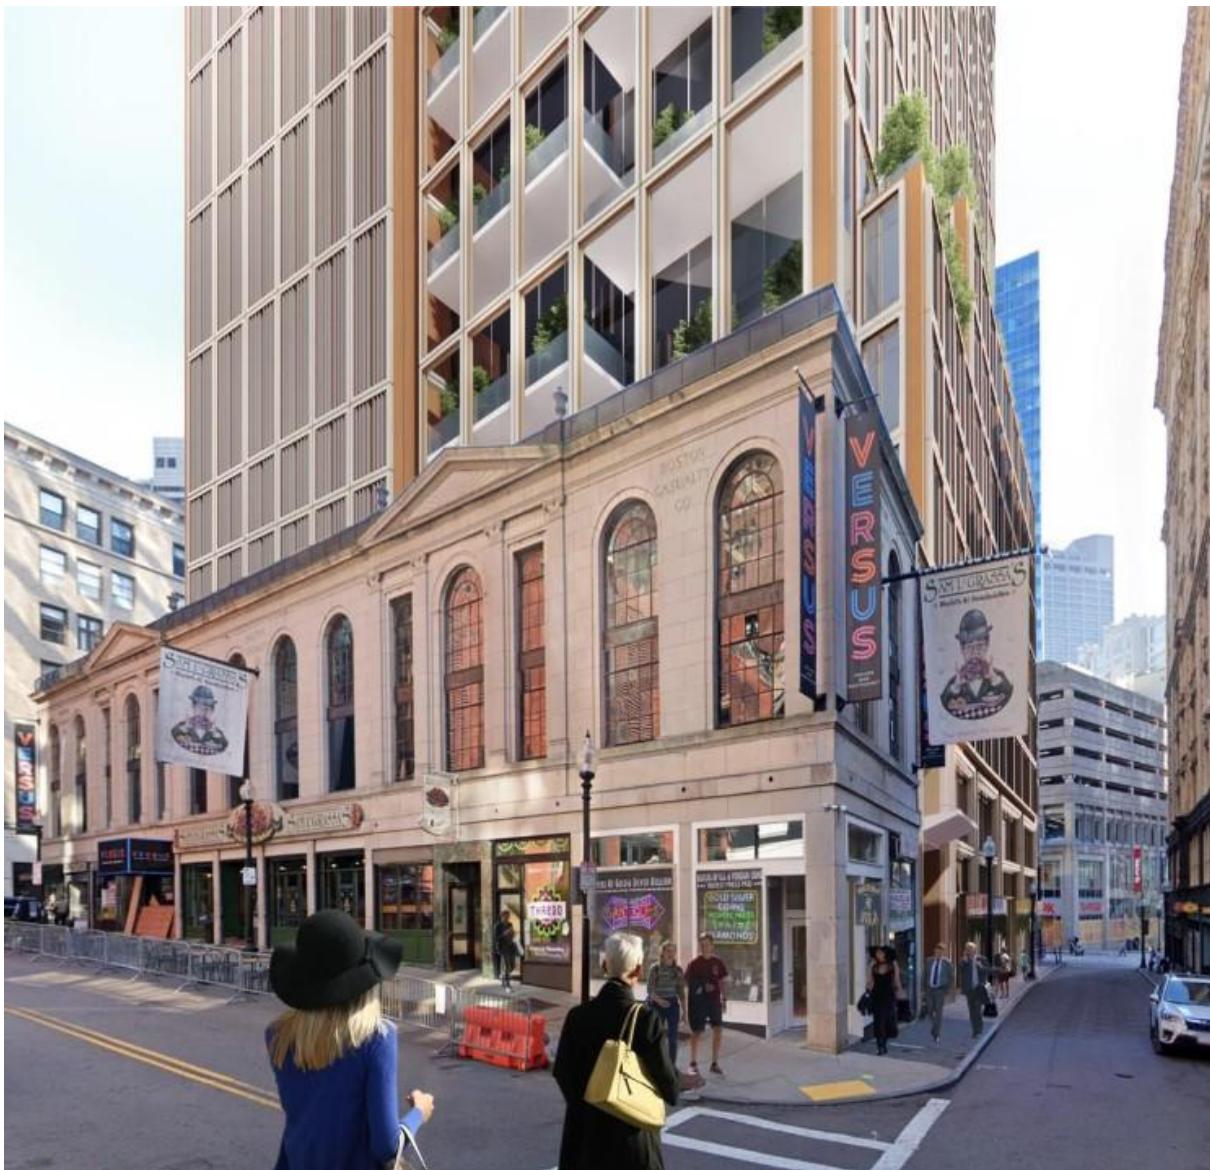
**Figure 43:** The Hutchinson Building in the foreground with the new 11-20 Bromfield rising behind. Image by Credit Arrow Street and the BPDA presentation, November 28, 2023.

and Bromfield St. See **Figures 41-43** for the context of the new building in relation to the Hutchinson Building.

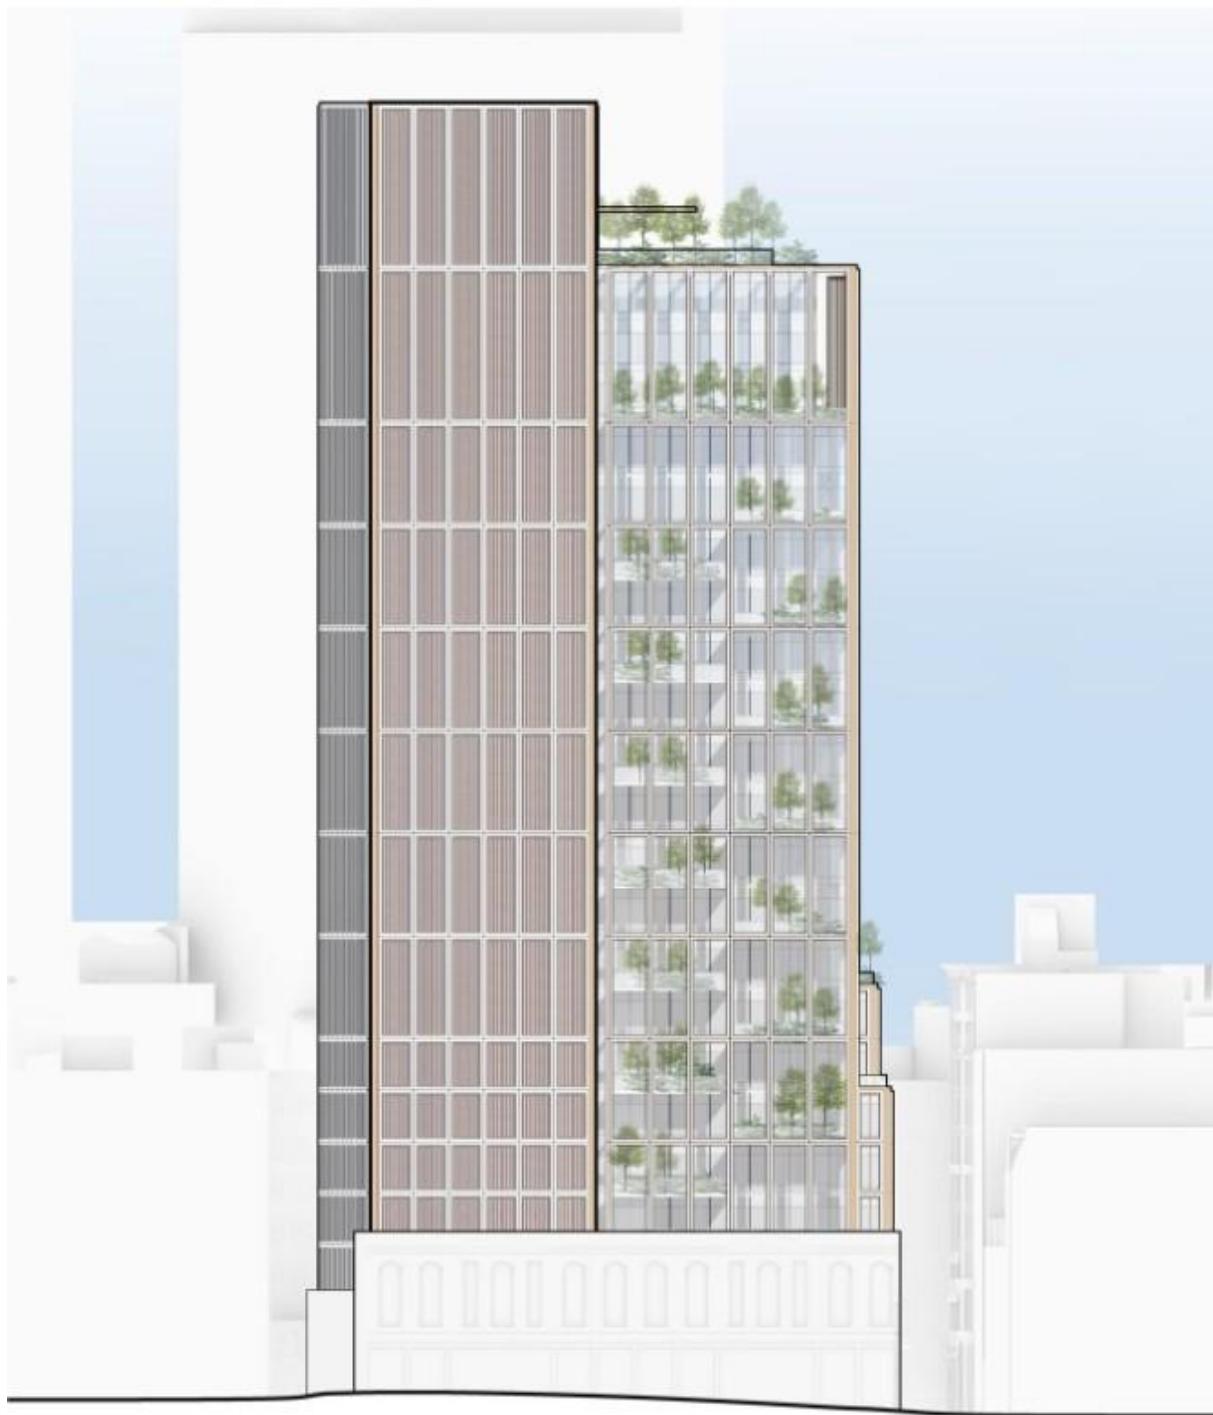
**Figure 43:** Hutchinson Building in the foreground of rendering of proposed development.  
Credit: Arrow Street and the BPDA Presentation Drawings, November 28, 2023

The 11-20 Bromfield Street Project has not yet been approved by the BPDA board.
