NORTH MARKET BUILDING

BOSTON LANDMARKS COMMISSION

STUDY REPORT

Report on the Potential Designation of
North Market Building
300-399 Faneuil Hall Marketplace, Boston, Massachusetts

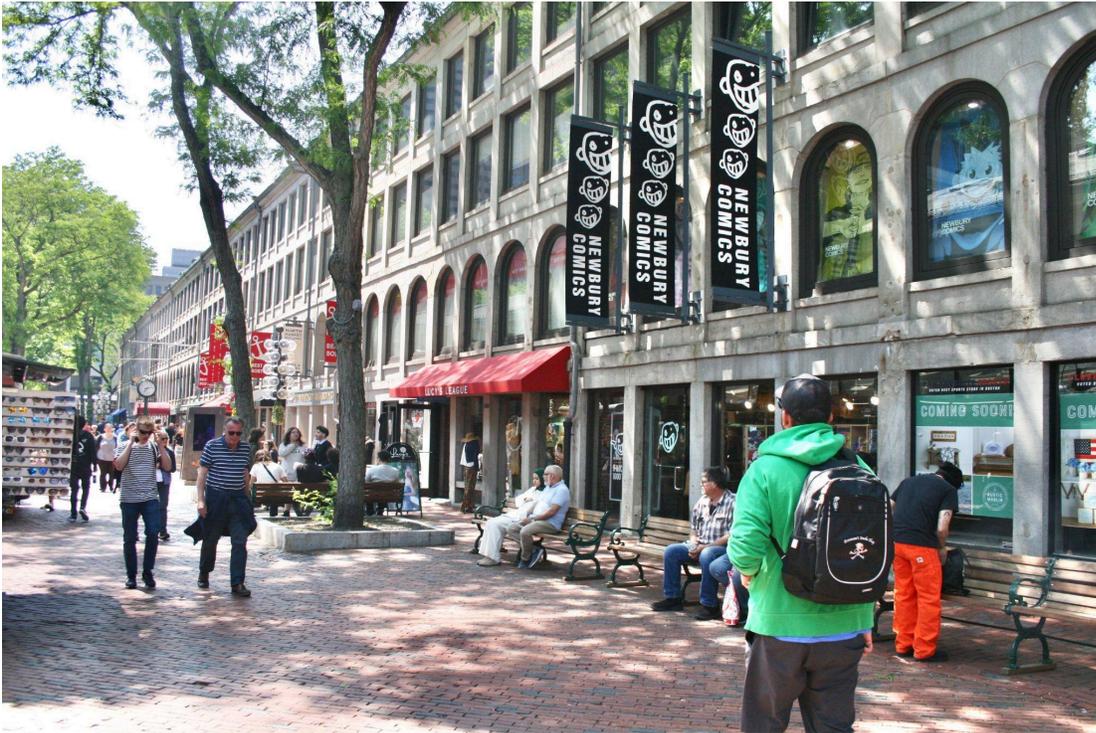
Figure 2. North Market St. façade. View from Commercial St., May 2023. Photo by Kathleen Kelly Broomer.

Located at what was originally the Town Dock, North Market (**Figure 2**) occupies a generally flat site on filled land. Measuring 520 feet long and 50 feet deep, the 4½-story rectangular block with side-gable roof is 93 bays wide on the façade, four bays deep, and 70 bays on the rear elevation. The block consists of 23 attached buildings, most with four-bay granite façades and three-bay brick rear elevations. The single five-bay building, aligned with the rotunda at Quincy Market directly south (**Figure 3**), is flanked by 12 buildings on the east and 10 buildings on the west. The five-bay building incorporates, at ground level, a brick-lined passageway between North Market St. and Clinton St. retaining brick vaults and a flat ceiling (**Figure 4**). The rear elevation of this larger building is four bays wide.

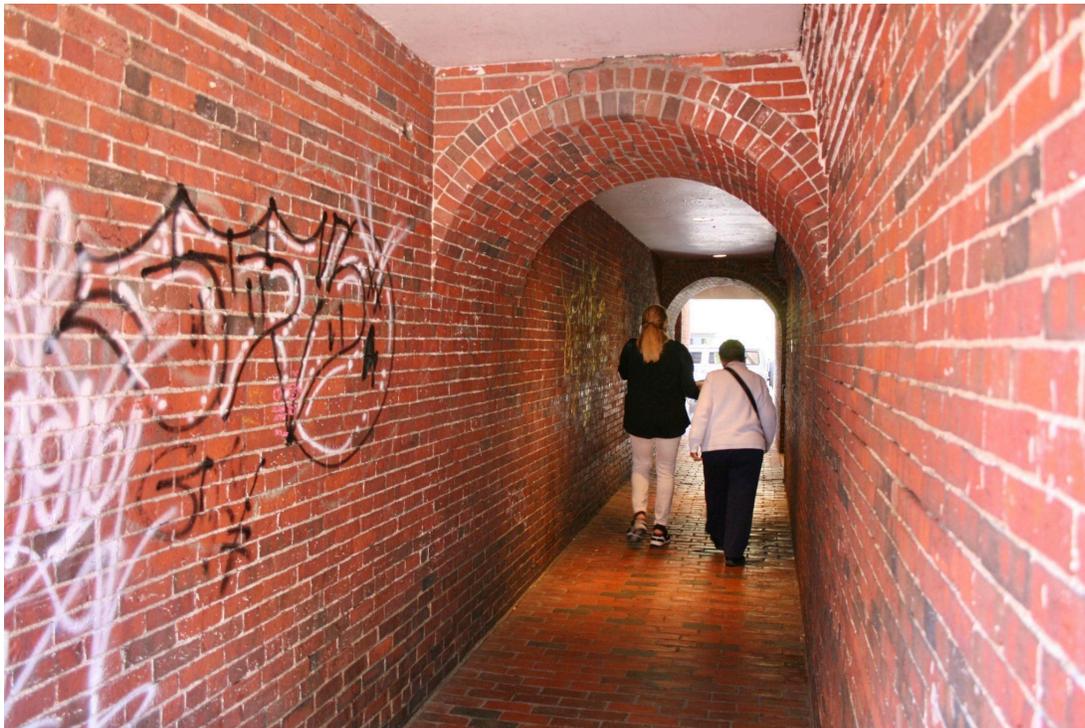
Figure 4. Passageway north from North Market St. to Clinton St., May 2023. Photo by Kathleen Kelly Broomer.

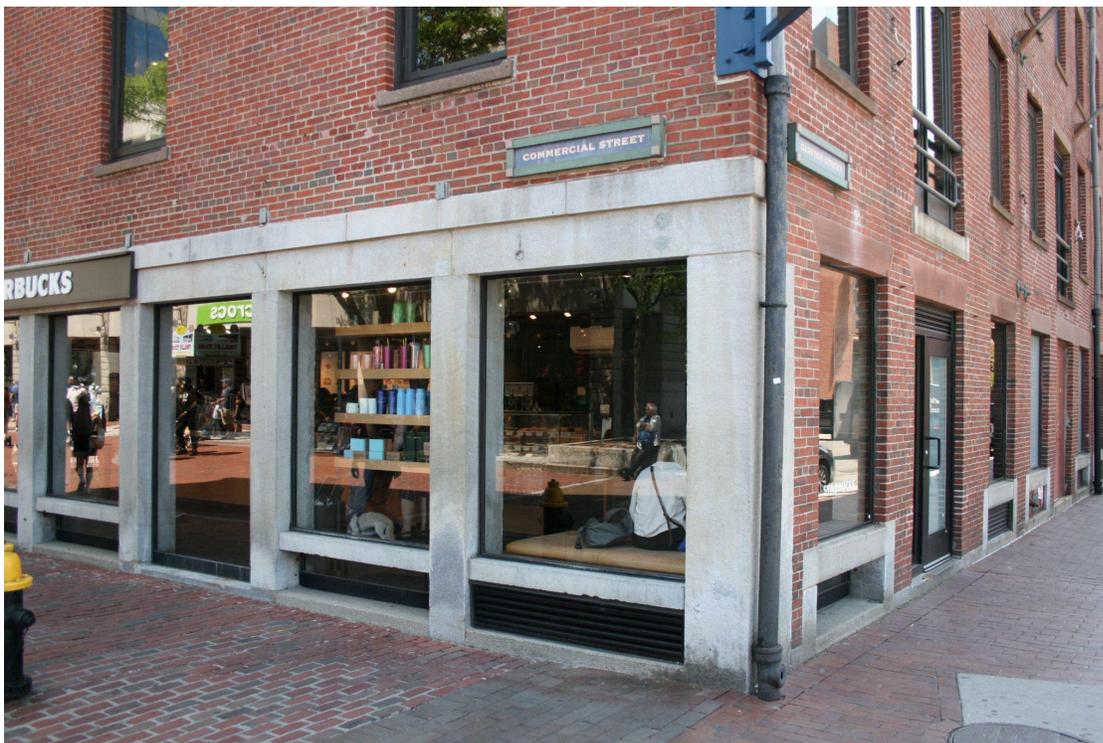
Figure 5. Detail of northeast corner, east elevation on Commercial St. (left) and rear elevation on Clinton St. (right), May 2023. Photo by Kathleen Kelly Broomer.

The entire façade (south elevation) and first story of each side elevation (**Figure 5**) are of trabeated or post and lintel construction, incorporating granite from the Chelmsford vicinity. Trabeated construction includes the round-arched windows on the second story of the façade, where granite posts and lintels shape the arched window heads. The façade incorporates rectangular window openings on the third and fourth stories (**Figure 6**). A granite cornice, punctuated by terra-cotta corbels at the party walls, lines the eave (**Figure 7**).

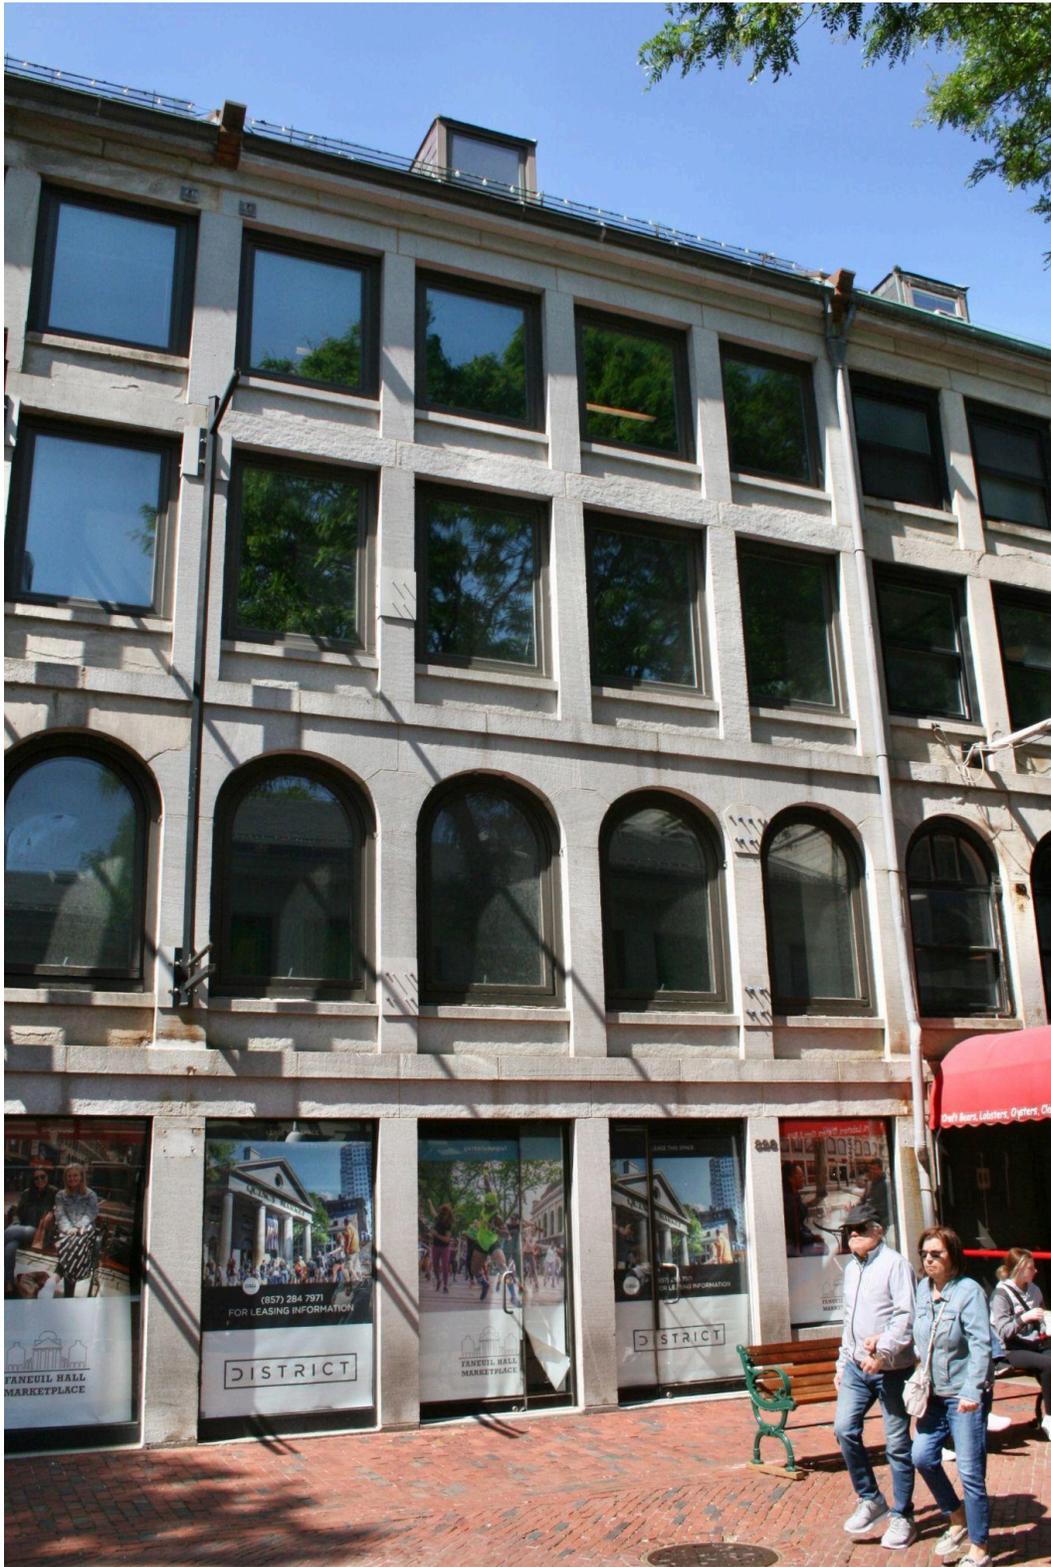
Figure 6. Typical four-bay building on North Market St. façade, May 2023.
Photo by Kathleen Kelly Broomer.

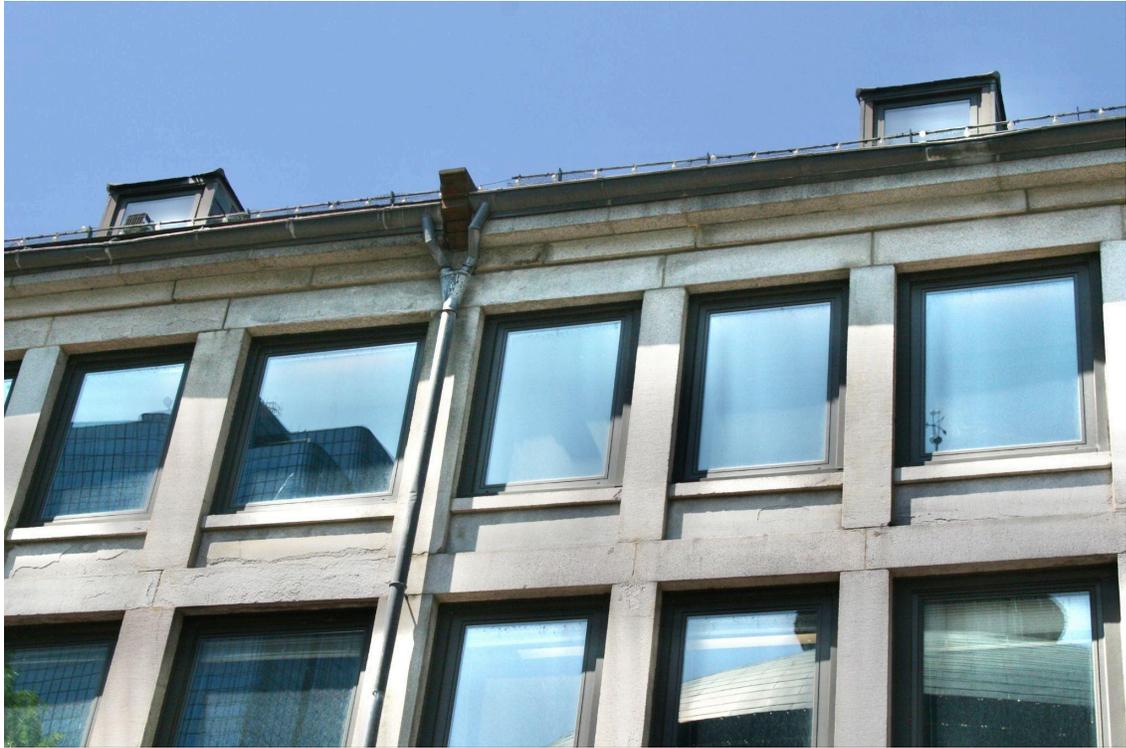
Figure 7. Granite construction detail, North Market St. façade, May 2023. Photo by Kathleen Kelly Broomer.

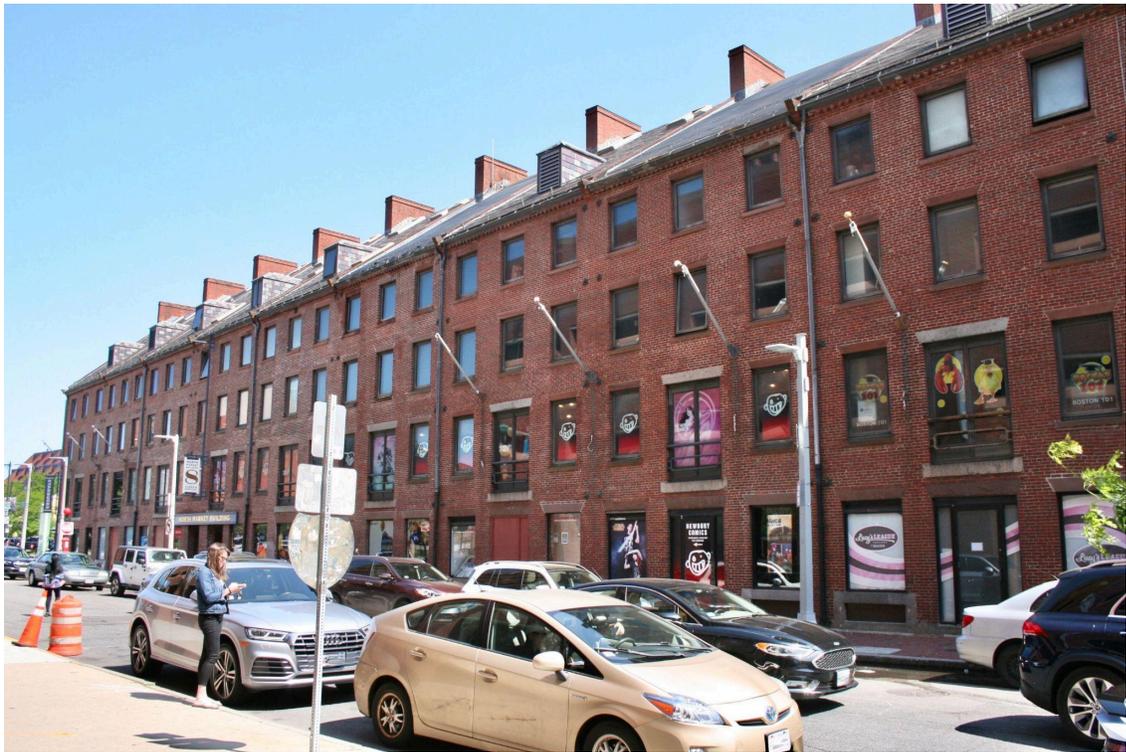
Figure 8. West end of rear elevation on Clinton St., May 2023. Photo by Kathleen Kelly Broomer.

On the rear (north) elevation, as well as the side elevations above the first story, brick wall surfaces are relieved by rectangular window openings trimmed with flared lintels and rectangular sills of sandstone (**Figure 8**). Tie rods with star-shaped face plates are present on brick elevations, arranged in pairs at the party walls of the rear elevation and as single rods on the end walls. A brick dentil course lines the eave (**Figure 9**). Fire escapes, exhaust vents, and metal overhead garage doors remain across the three buildings historically associated with Durgin-Park Market Dining Rooms, now 28-27, 30-29, and 31 Clinton St. (**Figure 10**). Additional buildings at the eastern end of the block also have some vented window openings.

Window openings typically contain modern, one-light, pivoting sash, wood on the second story and aluminum above (**Figures 11, 13, and cover image**). An assortment of late 19th- or early 20th-century wood sash survives in windows on the three buildings historically associated with the Durgin-Park restaurant. Configurations include double-hung sash on the façade (**Figure 17**), with three-light transoms in the round-arched windows of the second story, a single window with 2/2 sash on the façade, and 6/6 sash on the rear elevation (**Figure 10**). Also on the rear elevation, nine buildings at the eastern end of the North Market block retain elongated warehouse-style openings in the center bay on the second floor, indicating loading bays originally and now infilled with modern paired windows (**Figure 8**).

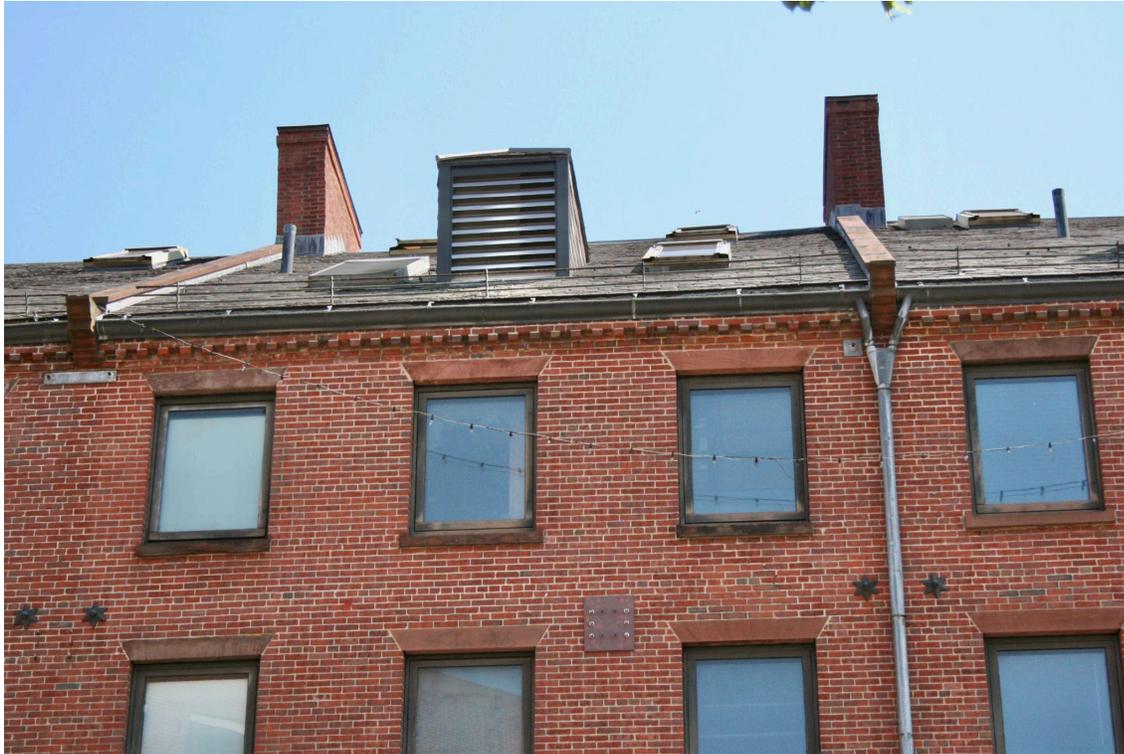
Figure 9. Brick construction detail, rear elevation on Clinton St., May 2023. Photo by Kathleen Kelly Broomer.

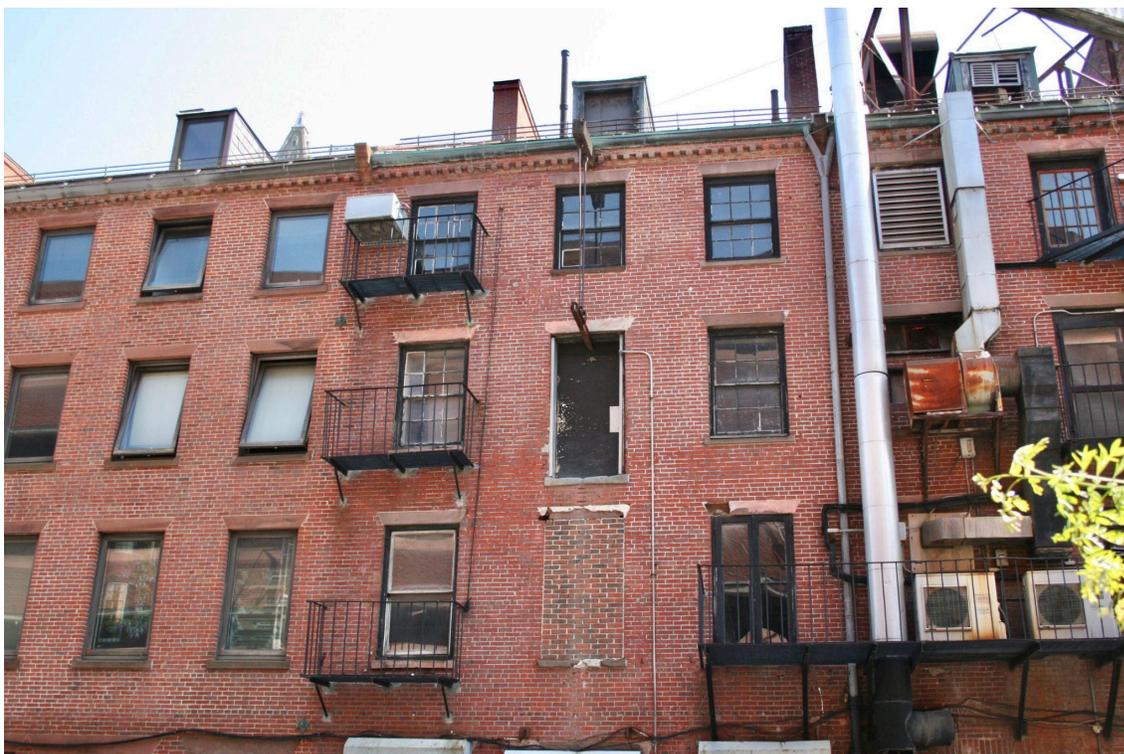
Figure 10. Rear elevation of 28-27 Clinton St. (center) and 30-29 Clinton St. (right), former Durgin-Park restaurant, May 2023. Photo by Kathleen Kelly Broomer.

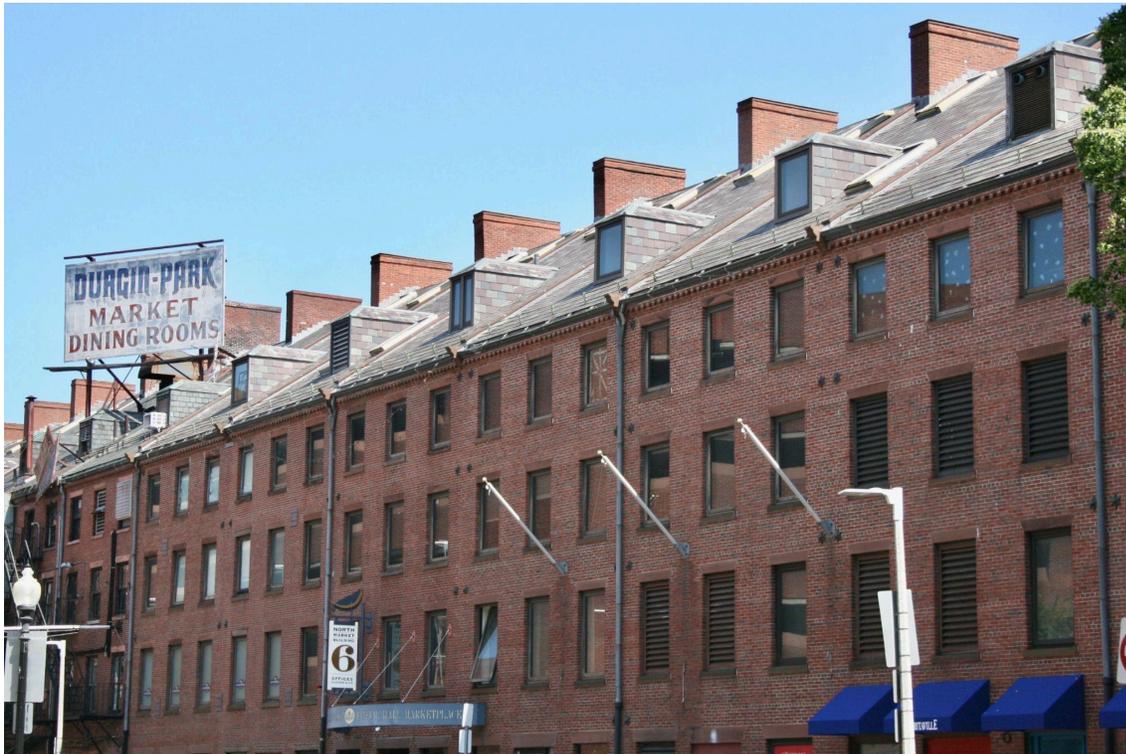
Figure 12. Roofline on Clinton St. rear elevation, May 2023. Photo by Kathleen Kelly Broomer.

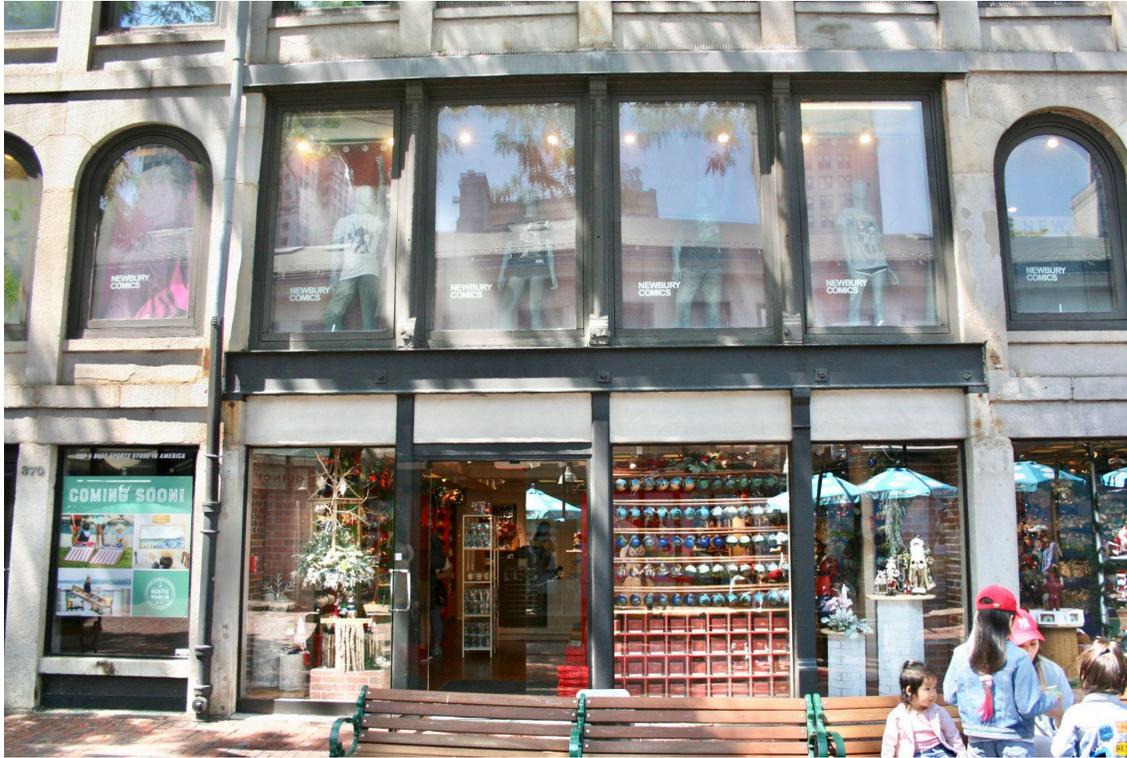
Figure 13. Iron storefront detail, 12 North Market St. façade, May 2023. Photo by Kathleen Kelly Broomer.

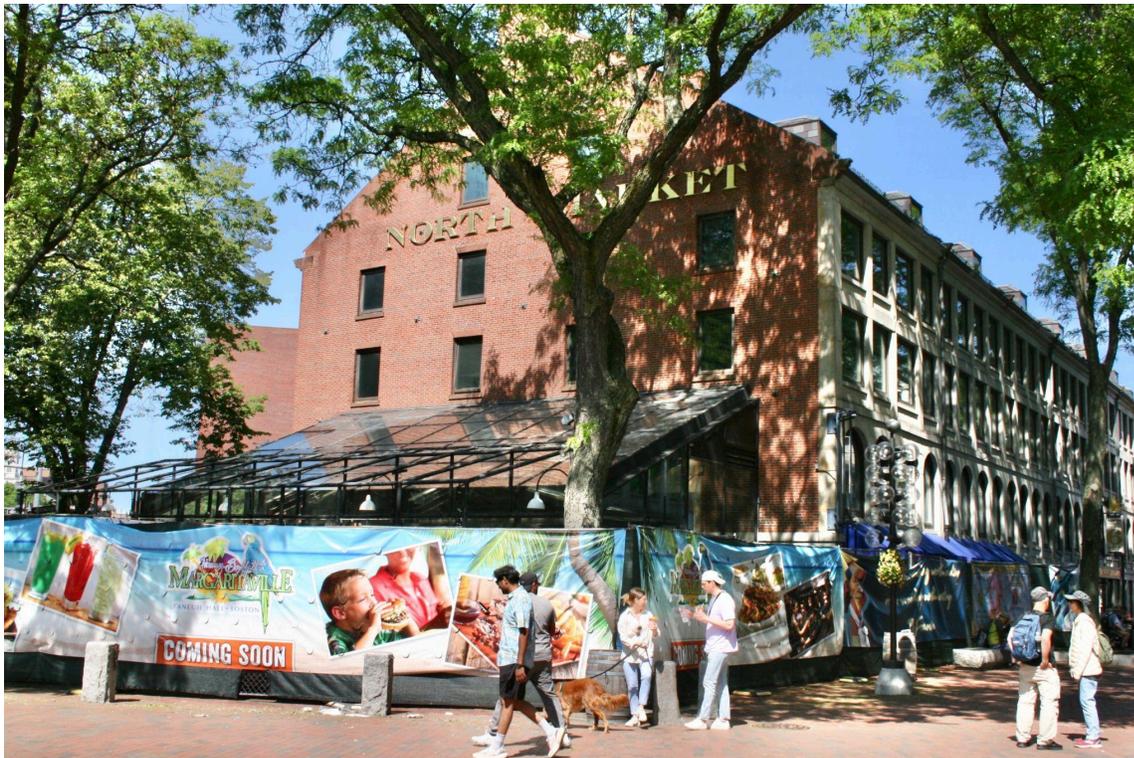
Figure 14. West elevation greenhouse addition. View from the intersection of North Market St. and Merchants Row, May 2023. Photo by Kathleen Kelly Broomer.

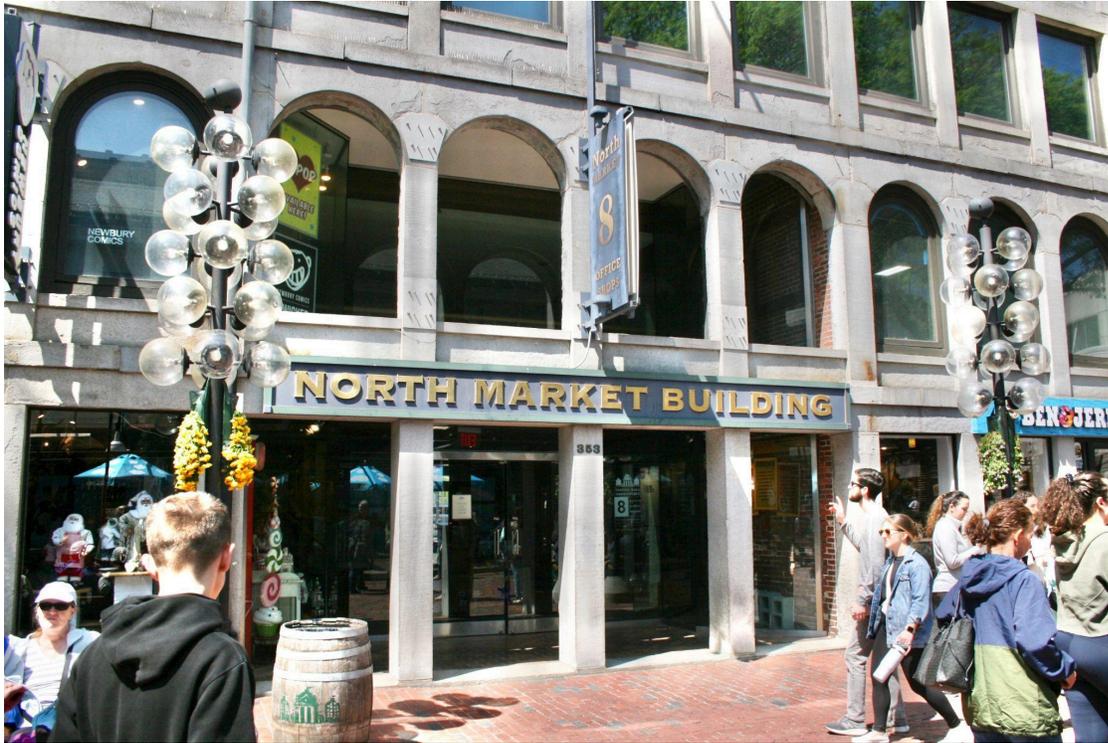
Figure 15. Granite bays converted to integral porches with recessed entries (first and second stories), 8 North Market Building façade, May 2023. Photo by Kathleen Kelly Broomer.

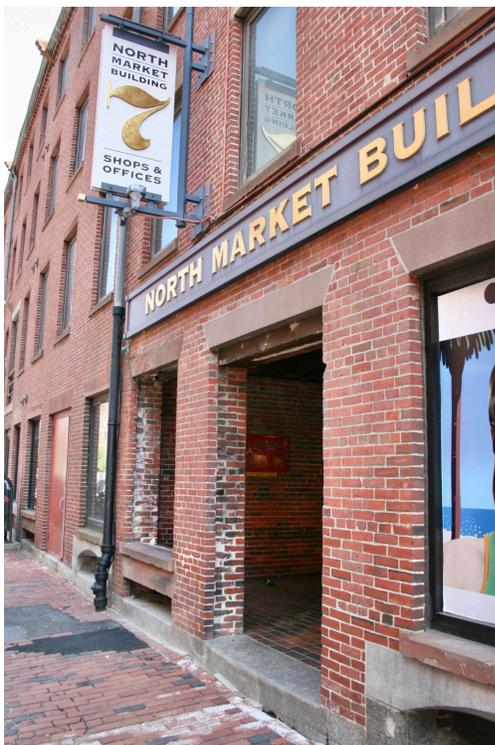
Figure 16. Brick bays converted to integral porch with recessed entry, 7 North Market Building, rear elevation, May 2023. Photo by Kathleen Kelly Broomer.

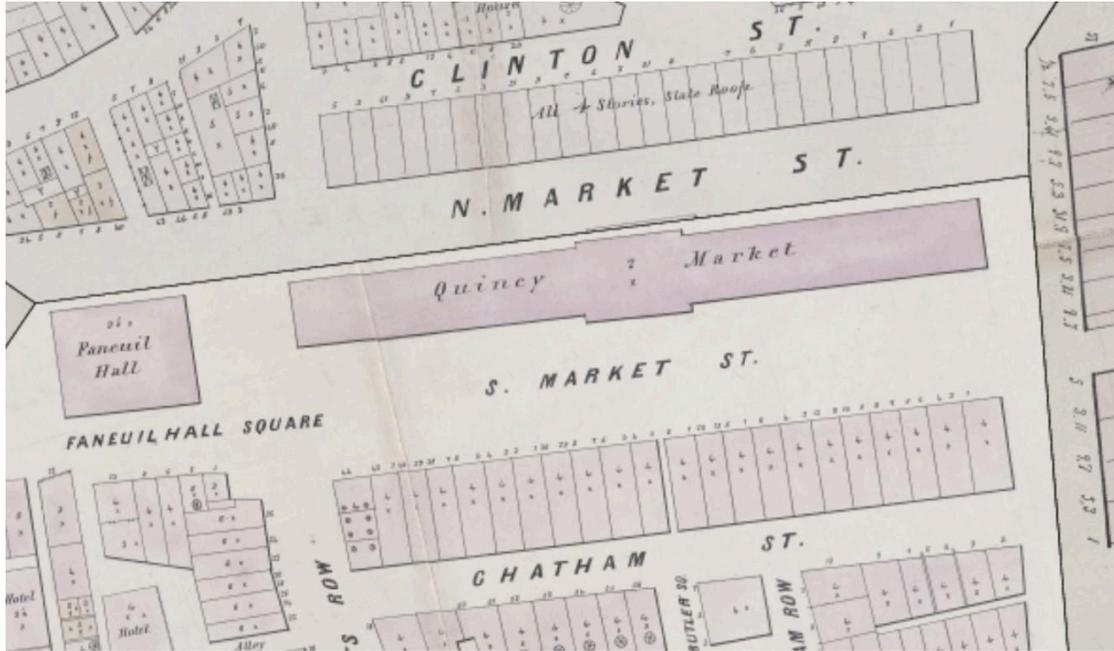
Figure 18. Detail from 1861 Pinney map, highlighting the separate yet contiguous buildings comprising North Market.

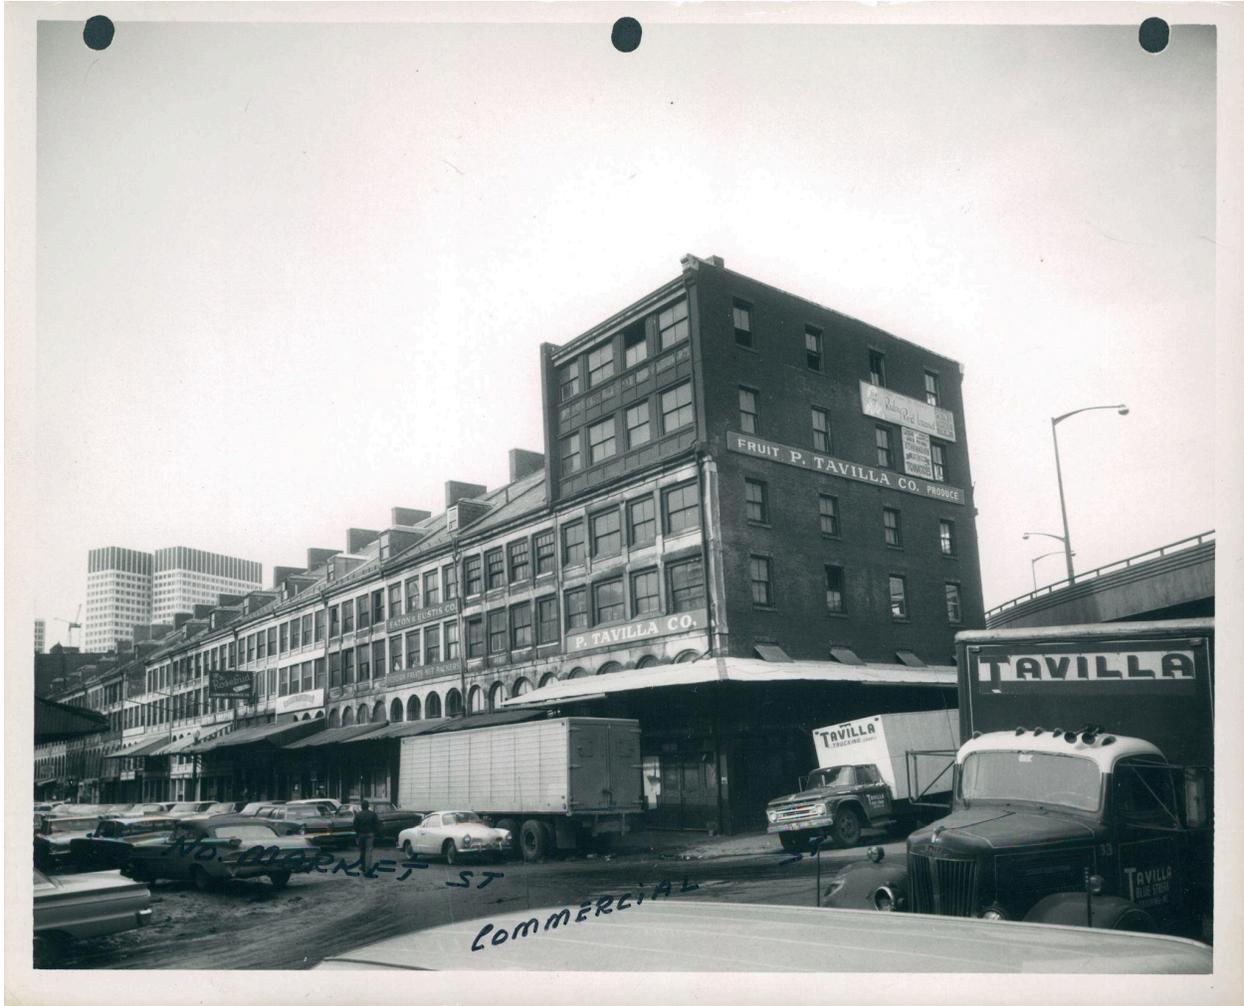
Figure 21. View northwest on North Market St. from intersection with Commercial Street showing the eastern end of North Market, February 12, 1966.

Changing patterns in commerce and transportation precipitated a slow deterioration of the market area after World War II, though commercial spaces in North Market, like most of the other buildings, remained in active use. Construction of the John F. Fitzgerald Expressway (1951-1954, the former Central Artery, demolished), carrying Interstate 93, U. S. Route 1, and State Route 3 in a 3-mile, largely elevated corridor through downtown, had practically severed the physical connection between the wholesale food dealers at Quincy Market and the wharves and warehouses on the waterfront. Boston's decline as a seaport and increasing reliance on trucking to move goods had already overwhelmed the market streets 20 years prior, leading some wholesalers to gradually relocate to other areas. In 1950, the U. S. Department of Agriculture, citing obsolete and unsanitary conditions, recommended that Boston establish a new food distribution center at South Bay and close Quincy Market, though the complex still housed half of the city's wholesalers.²⁸ Deterioration or fire led to the removal of some stories of North Market buildings, both original construction and late-19th-century additions. The building at 19 North Market stood at three stories after the fourth story and attic were removed in 1960 (**Figure 23**). Later, a fire at 1-2 Market St., the easternmost building in the block, caused the removal of the fifth and sixth stories (**Figure 21**) that had been added ca. 1886.

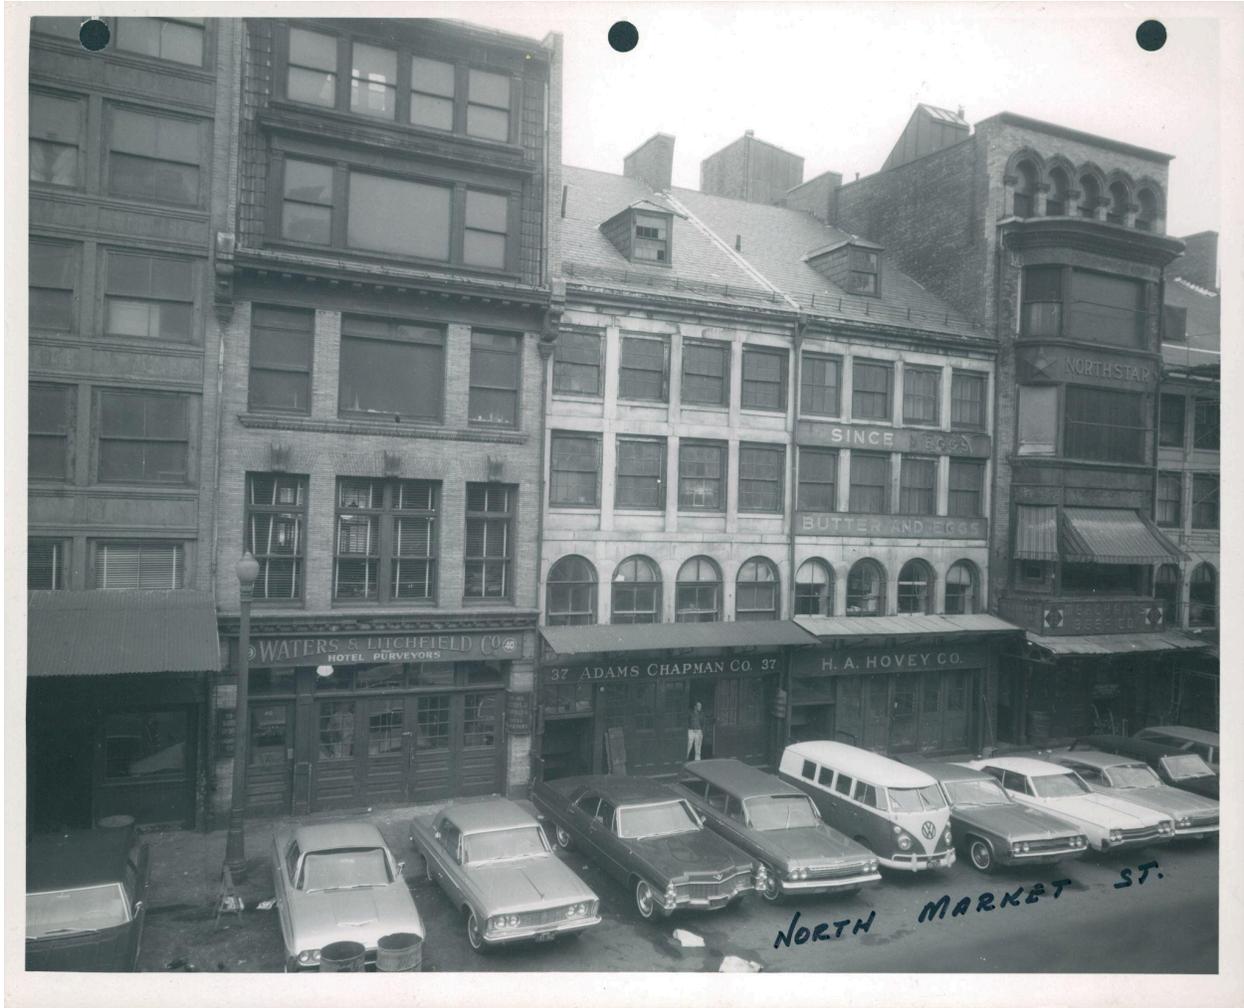
Figure 22. Detail of North Market façade, showing 41, 39-40, 37, 35-36, 33-34, and 30 North Market St. (left to right), April 29, 1966.

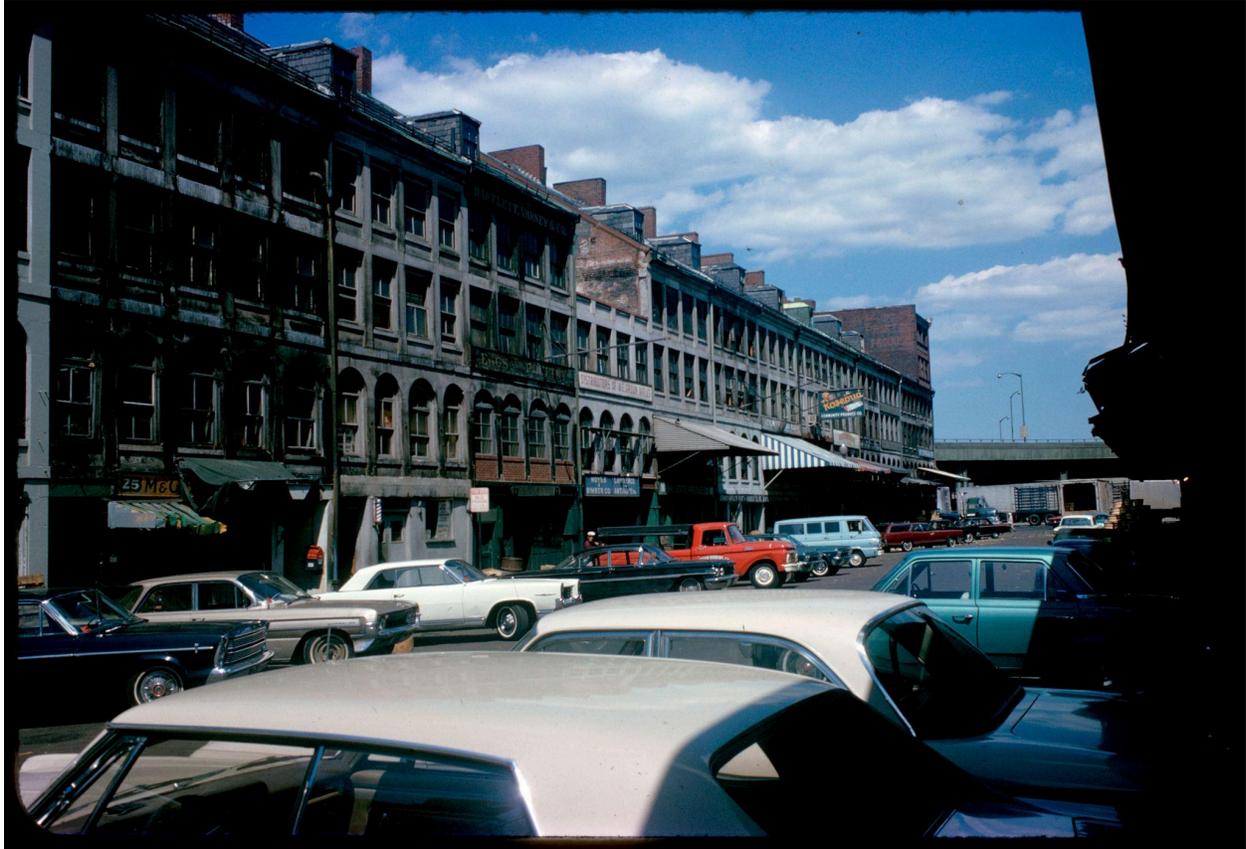
Figure 23. North Market St. View northeast, including 19 North Market St. (at center, behind red truck) after the fourth story and attic were removed. Edmund L. Mitchell, photograph. 1966.

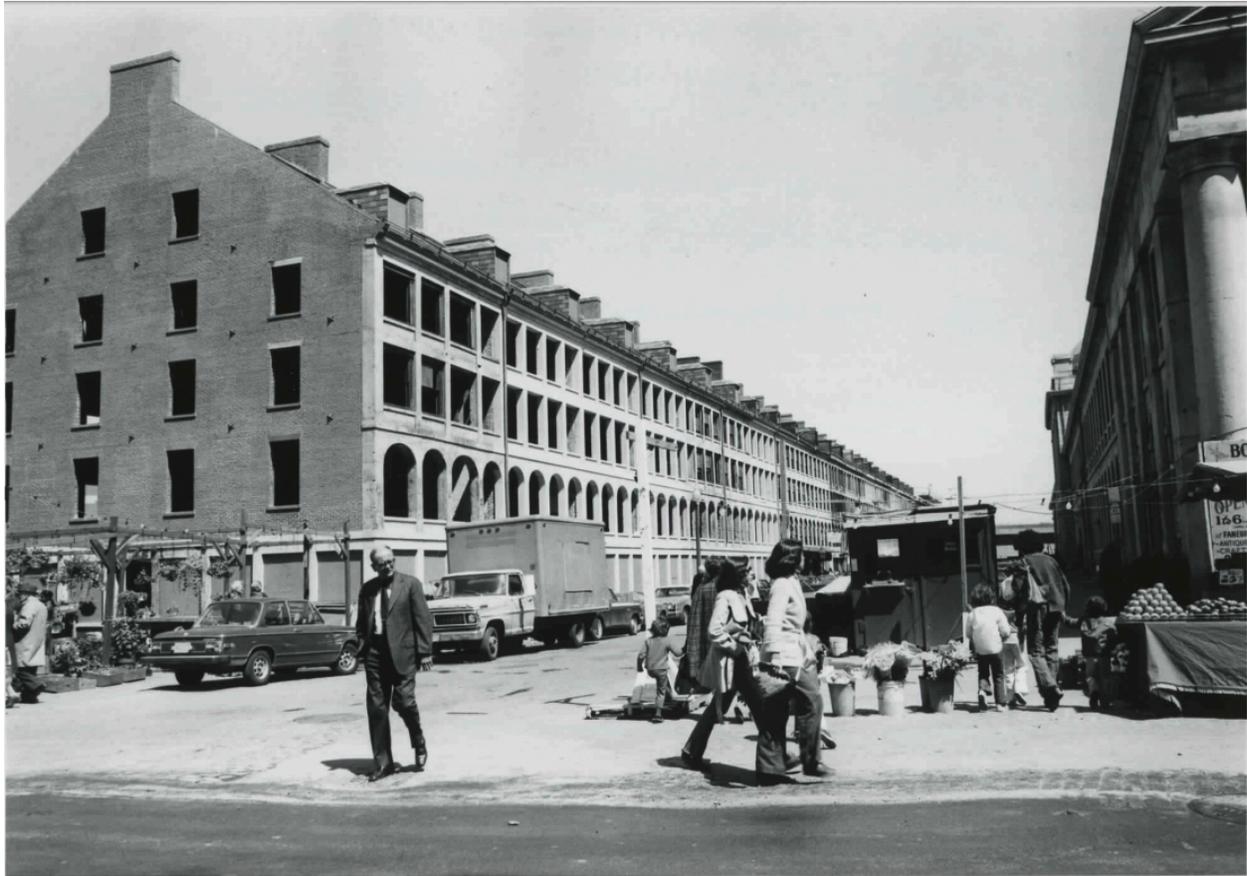
Figure 24. View of North Market St. showing North Market (left) after restoration of exterior to its 1826 appearance. Quincy Market is at the right. April 1975.
