78 Beacon St – Front Entry Restoration

6/4/2025

Description of Work

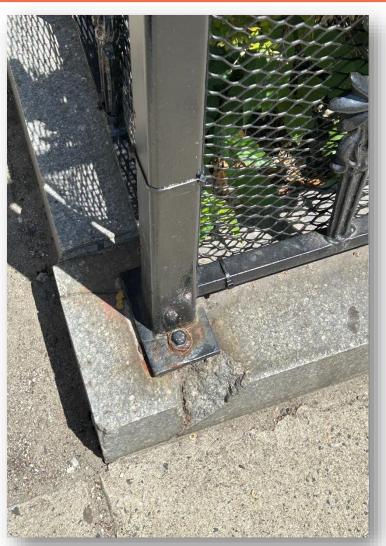
Existing Conditions – Granite Curbs

- Existing granite curbs have deteriorated in several locations.
- Repair curbs using dutchman's where applicable with granite of matching size, color, and finish.
- If curbs cannot be replaced using dutchman's, the stone will be replaced with new granite in matching size, color, and finish
- Existing metal components will be removed and reinstalled.
- Façade is excluded from scope

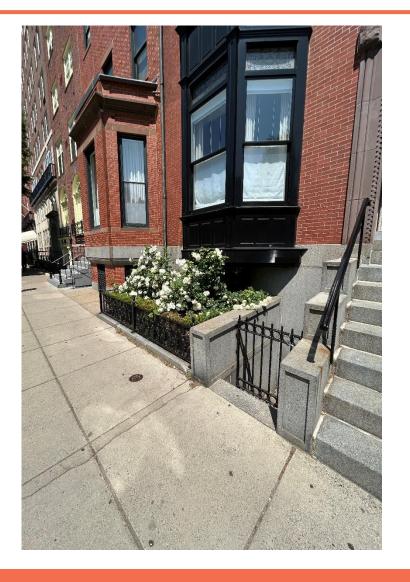
Existing Conditions – Front Entry

Repoint existing staircase using mortar color and composition tha tmatches the original in both texture and color

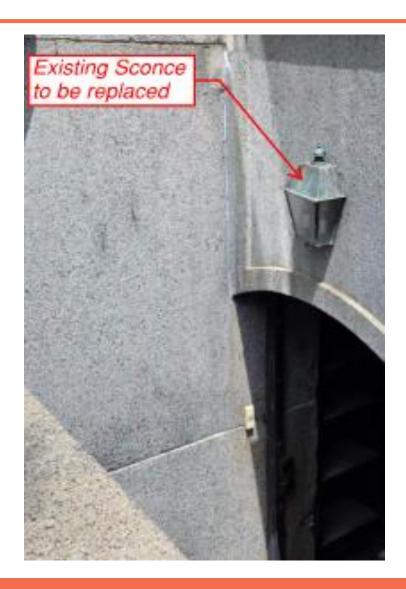
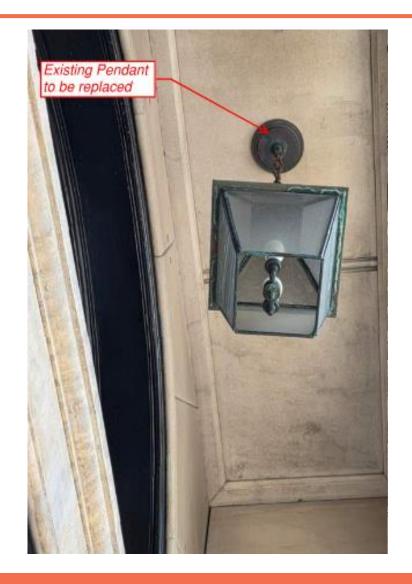
Existing Conditions – Exterior Lights

Replace existing sconces with new fixtures that replicate existing style & finish

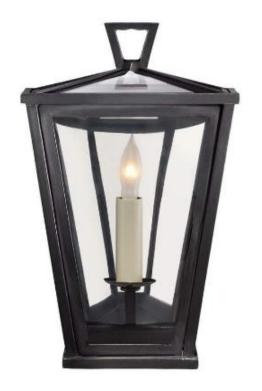
Garden Front Entry Sconce Replacement

Darlana Mini 3/4 Wall Lantern

Height: 10" Width: 6.5" Extension: 6"

Backplate: 5.5" x 7" Trapezoid

Finishes: BZ - Bronze

Glass Options: CG - Clear Glass Socket: E12 Candelabra

Wattage: 60 C11 Weight: 6 Pounds ©EFC DESIGNS
