**HUNTINGTON AVENUE  
/SOUTH HUNTINGTON  
AVENUE E-BRANCH  
ACCESSIBILITY PROJECT**

*Multimodal Needs and  
Opportunities Report*

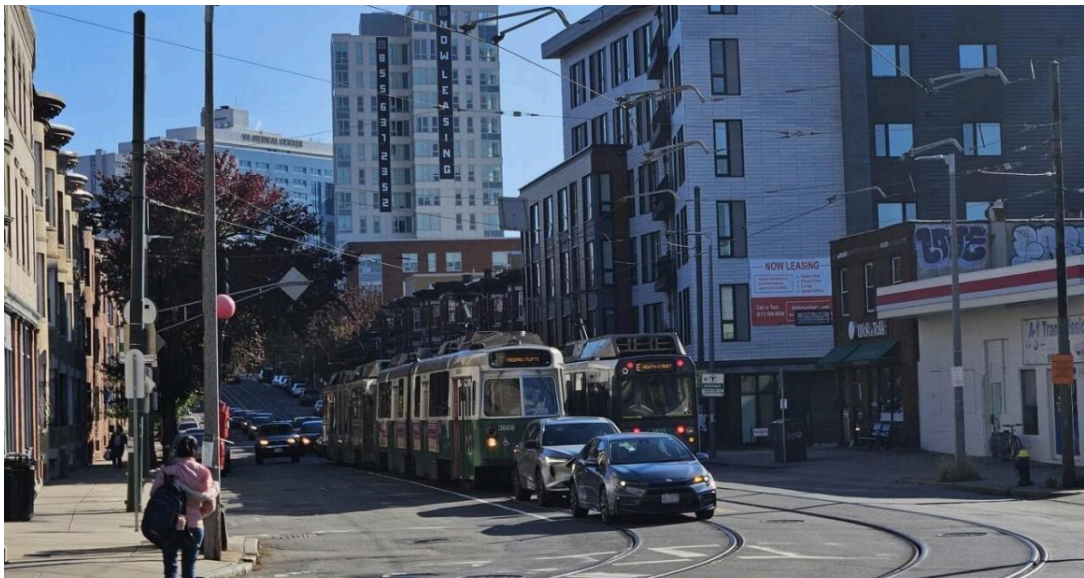
[Green Line E Branch along South Huntington Avenue. Photo Credit: Nelson\Nygaard](#)

Through Brigham Circle, Huntington Avenue is around 100 feet wide, including sidewalks. This area is characterized by a general-purpose traffic lane and shared bus/bike lane in each direction, along with a bidirectional center-running separated transitway and a single lane of parking. For most of the Corridor (area west of Fenwood Road), Huntington Avenue and South Huntington Avenue have a right of way around 80 feet wide, including sidewalks. This section of the Corridor features a general-purpose travel lane, a parking lane, and a shared transit/general-purpose travel lane in each direction.

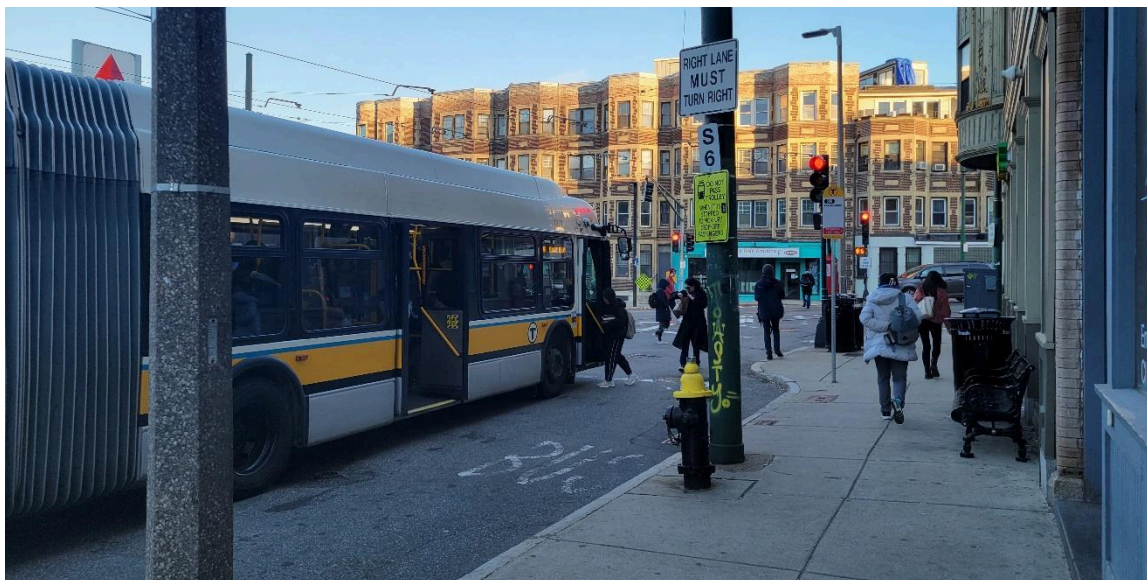
[Passengers boarding MBTA Bus along South Huntington Avenue. Photo Credit: Nelson\Nygaard](#)

Bus stops on Huntington Avenue and South Huntington Avenue allow riders to board and alight at the curb, providing a more accessible transit mode through the Corridor. However, deficient curb ramps, faded crosswalks, parked vehicles, and sloping sidewalks impede full accessibility to and from stops.

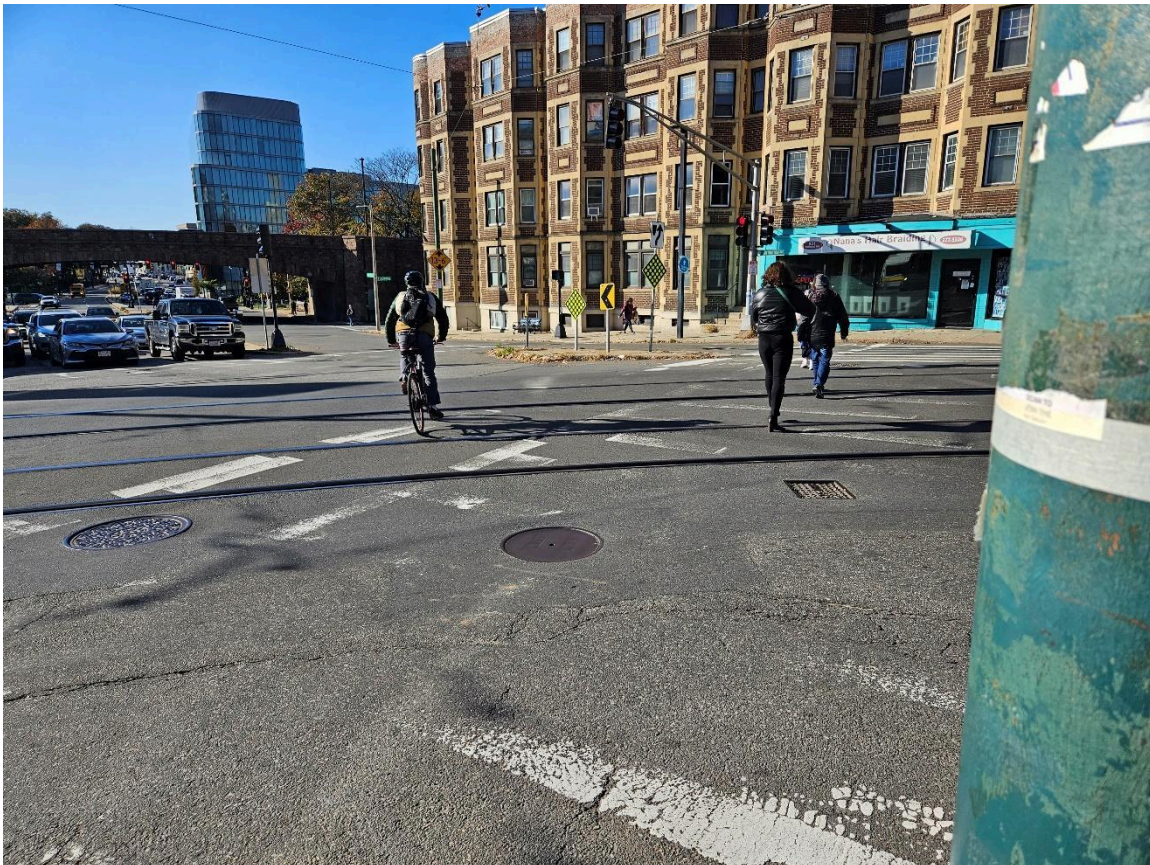
[Transfer location at Back of the Hill Station and Route 39 Stop. Photo Credit: Nelson\Nygaard](#)

A variety of transit services operate through the Corridor. The intersection of Huntington Avenue & South Huntington Avenue is a key transfer point for riders connecting between Route 39 and Route 66, as well as nearby Routes 60/65 and Green Line D branch service at Brookline Village. Transferring between these services requires traveling through the Huntington Avenue/South Huntington Avenue intersection, which can be difficult and hazardous for riders.

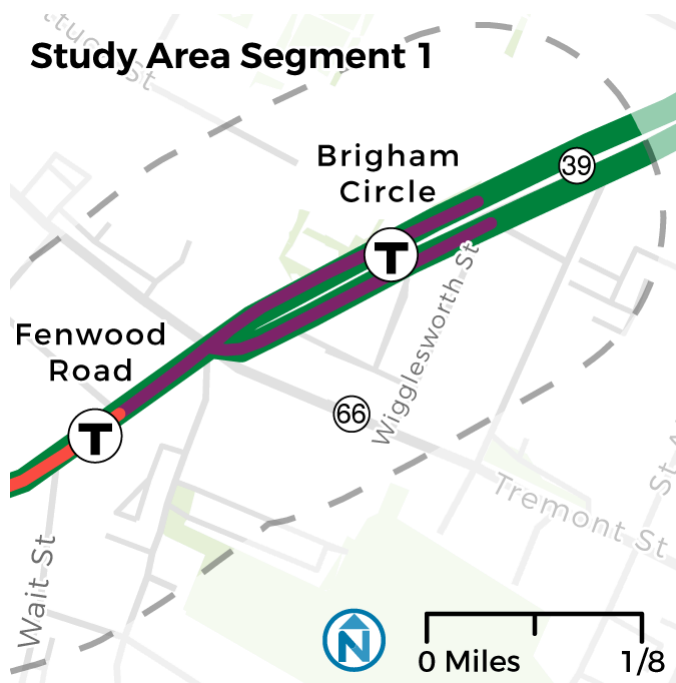
Figure 12: Segment 1 map

- Boardings and alighting occur in the middle of the roadway with oncoming traffic

- Newly designed designated boarding/alighting stations
- Accessibility challenges for transit riders
  - Redesign Intersection
- Slow Speeds for bus routes
  - Consolidate bus stops

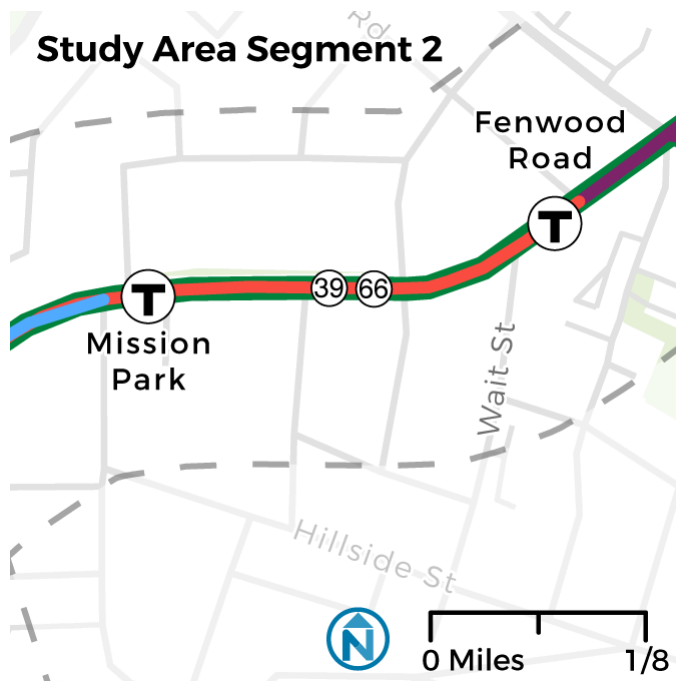
Figure 13: Segment 2 map

- Boardings and alighting occur in the middle of the roadway with oncoming traffic
  - Newly designed designated boarding/alighting stations
- Accessibility challenges for transit riders
  - Redesign Intersection
