The Learning Project

Proposed Expansion at
263 Clarendon Street
BBAC Submission
12/22/2025

Scope Overview

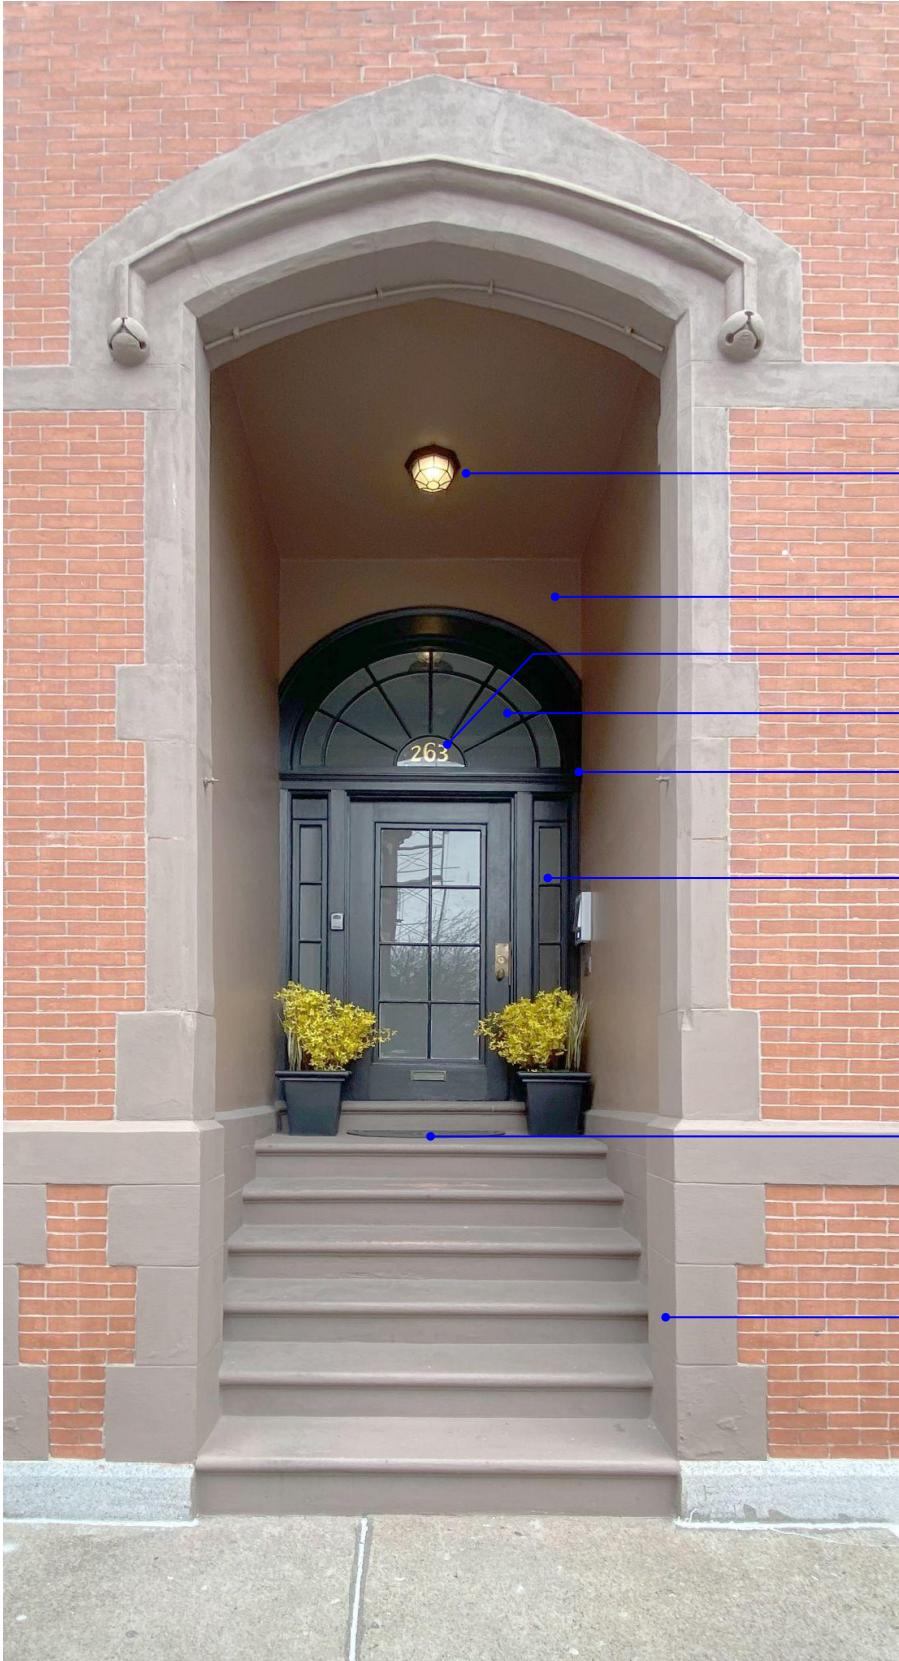
263 Clarendon Street - Existing

Entry Condition

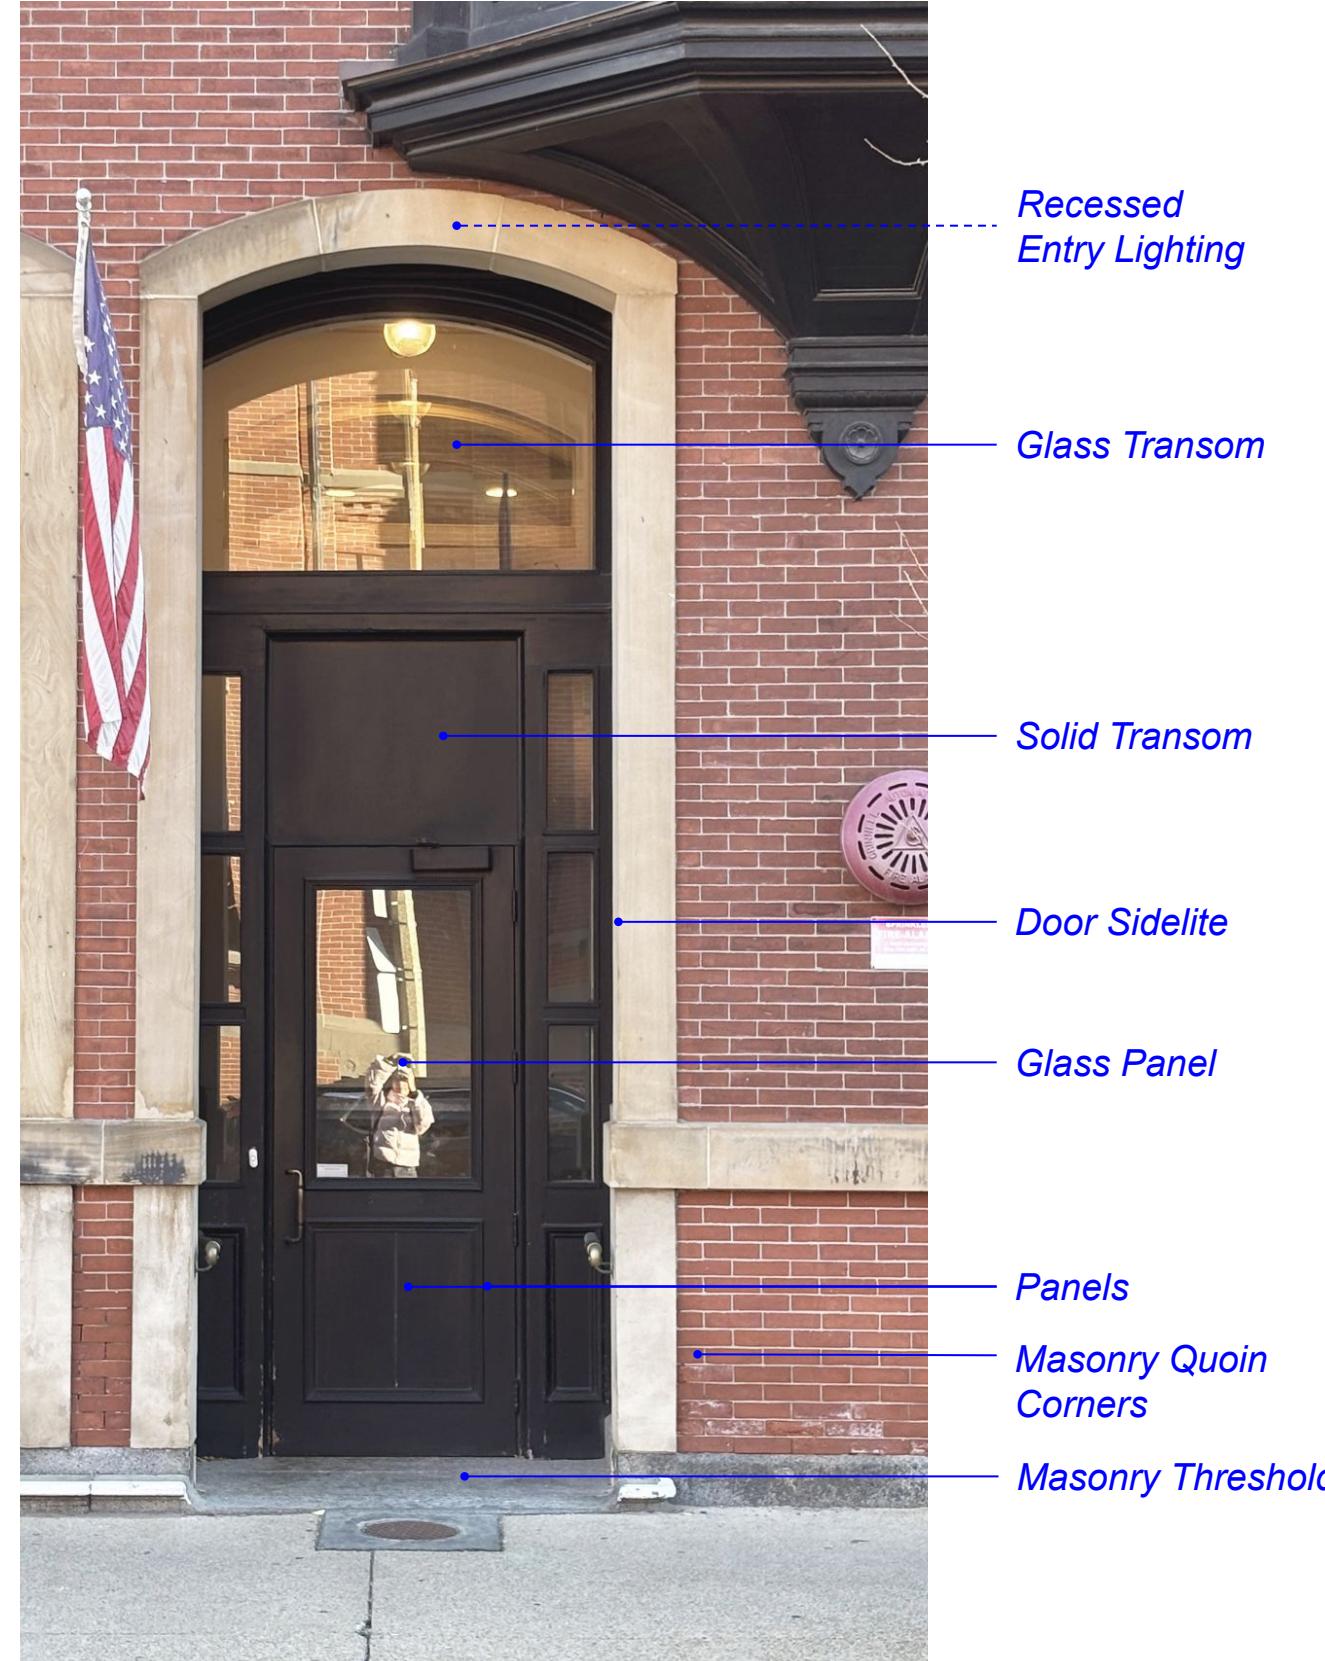
275 Clarendon Street - BBAC Recommendation

The BBAC recommended that 263 Clarendon matches the design of **275 Clarendon**

This project was presented to the BBAC for advisory review on Jan 8, 2025.

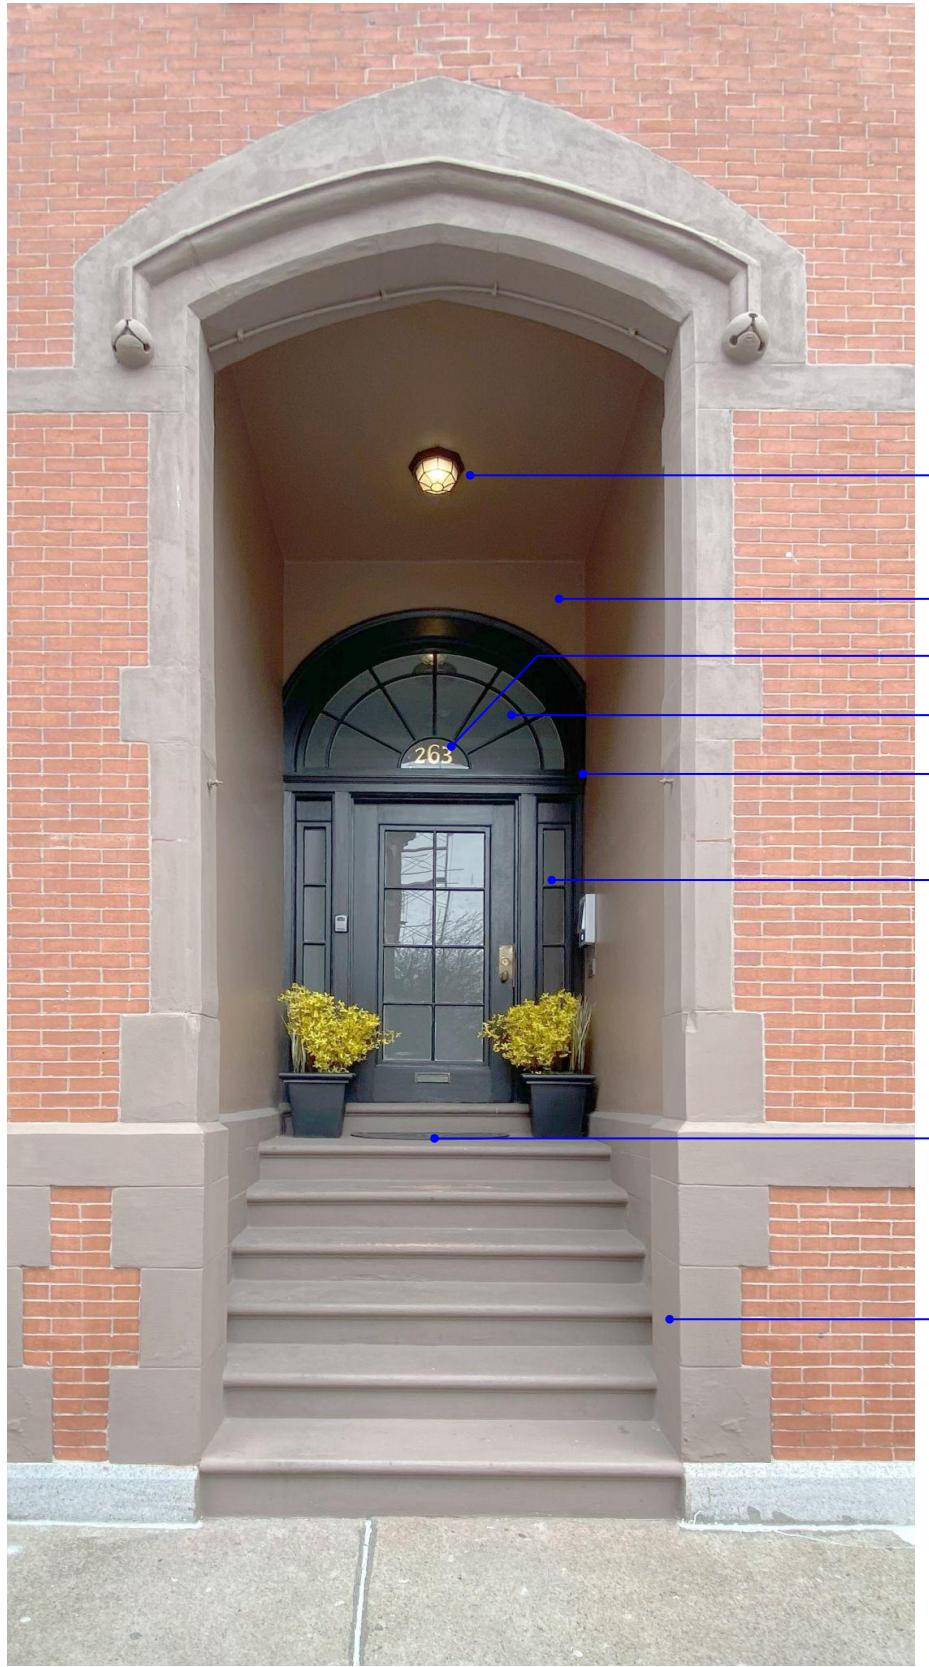
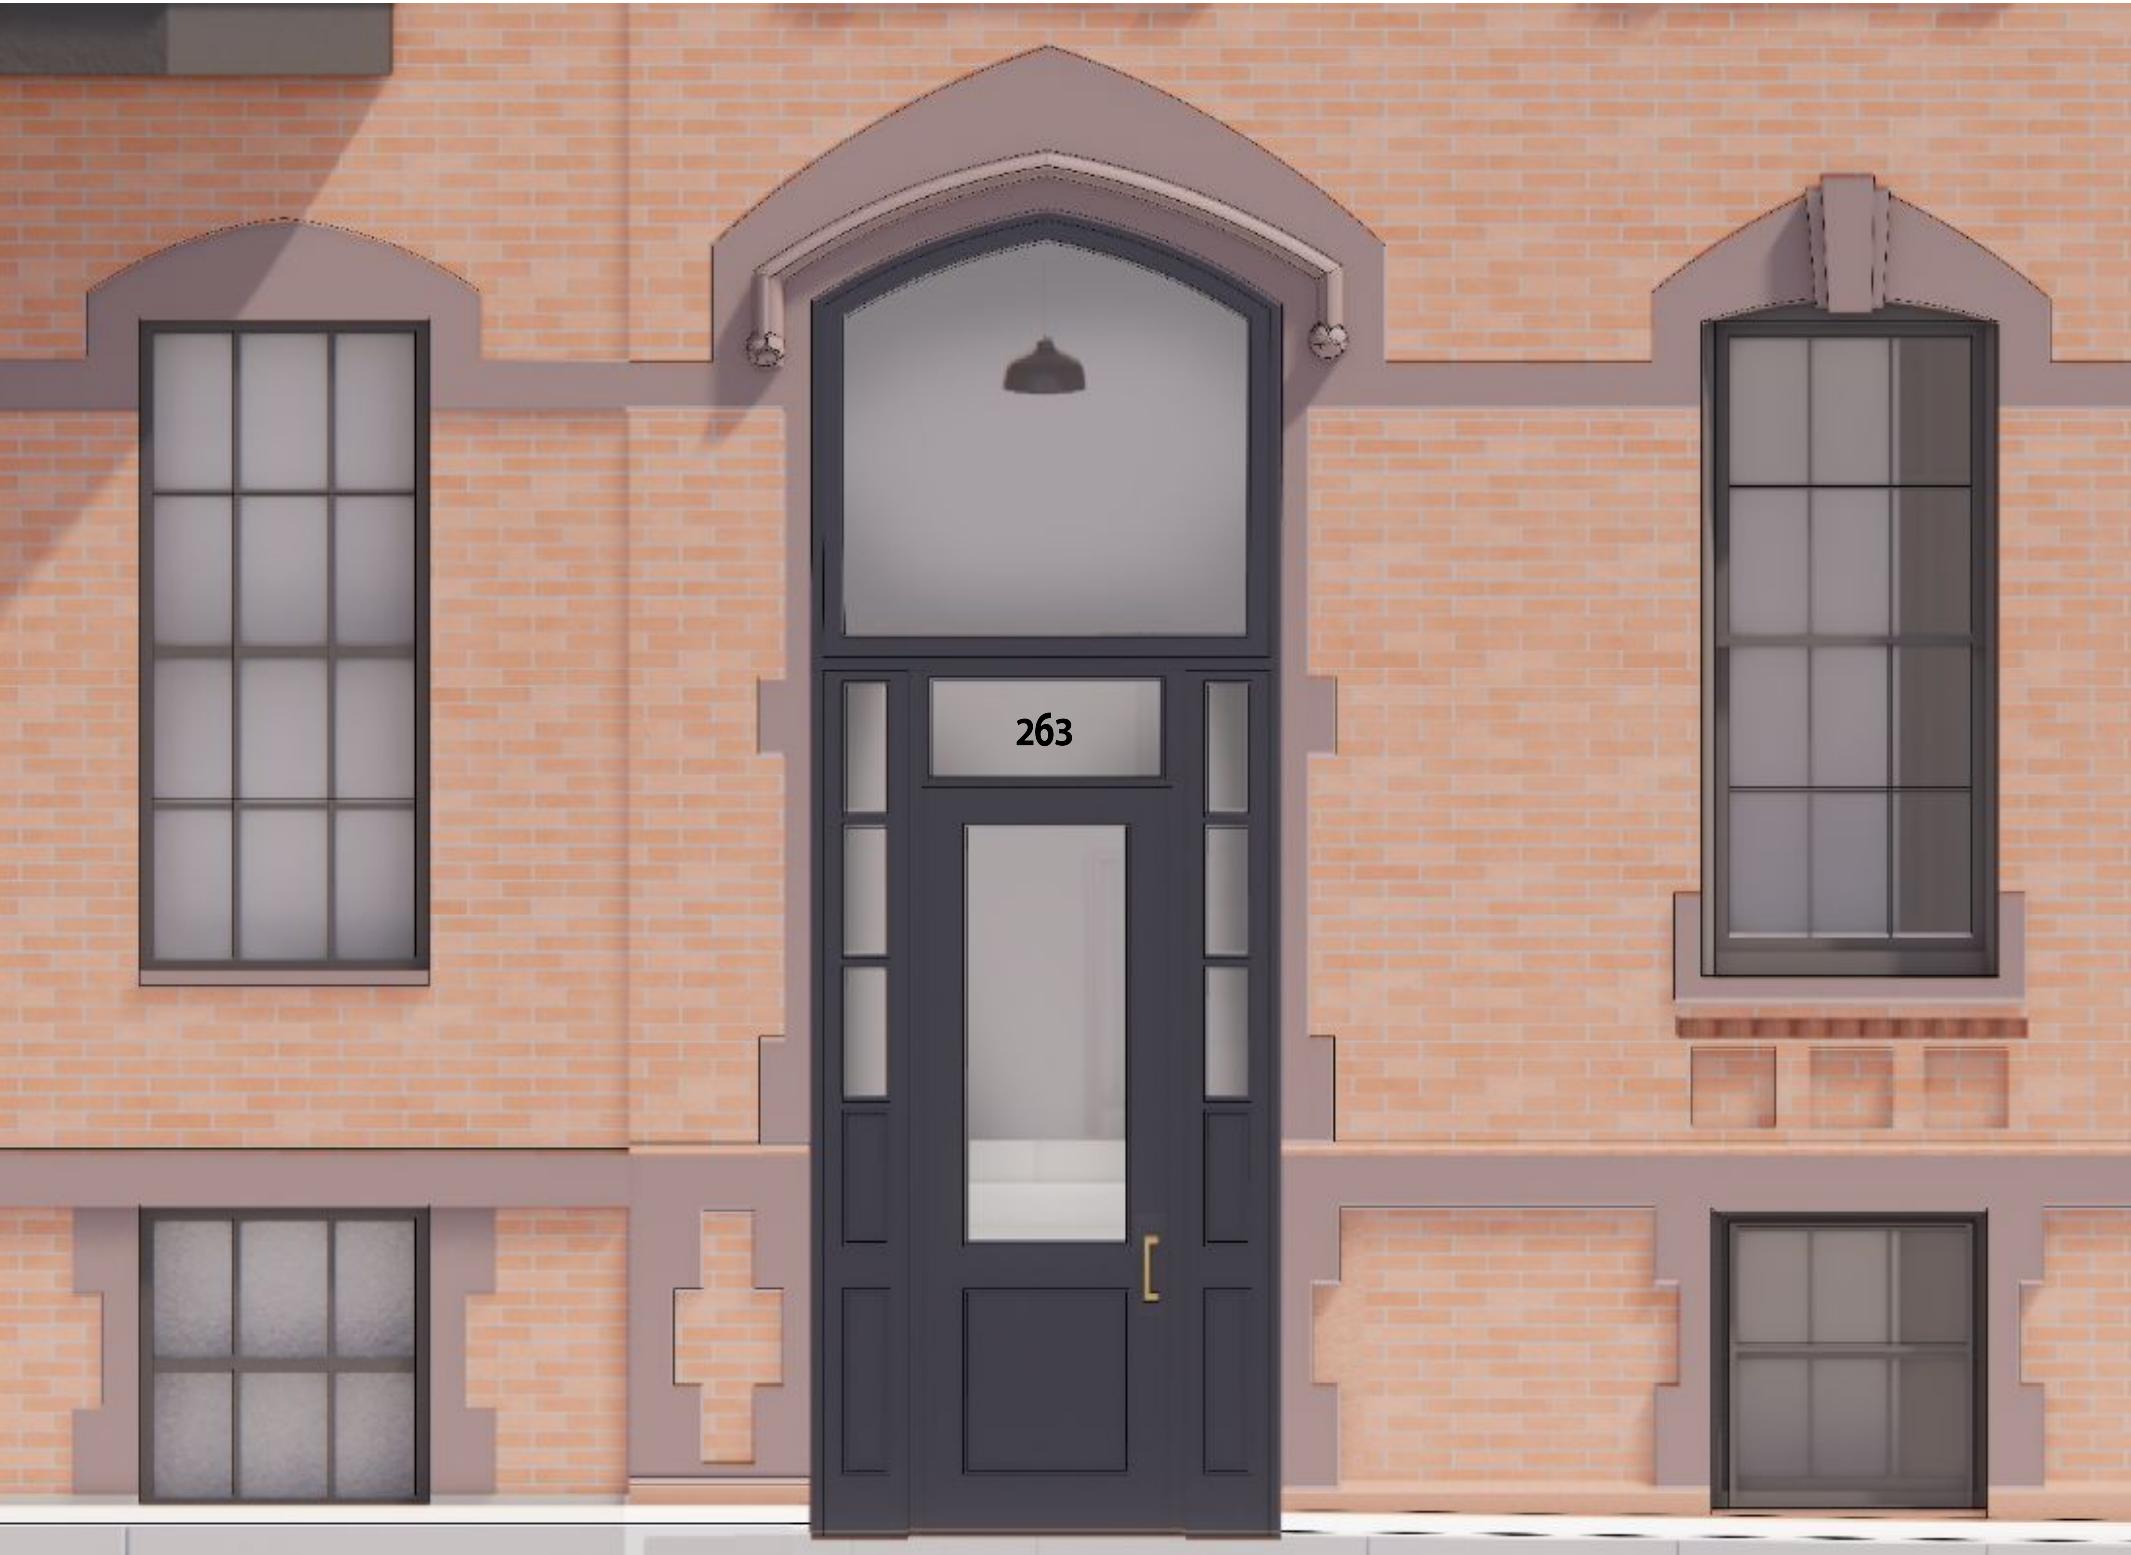
Proposed Entry Design (Option 1)

Option 1 - 9'-0" Door (Utile preferred)

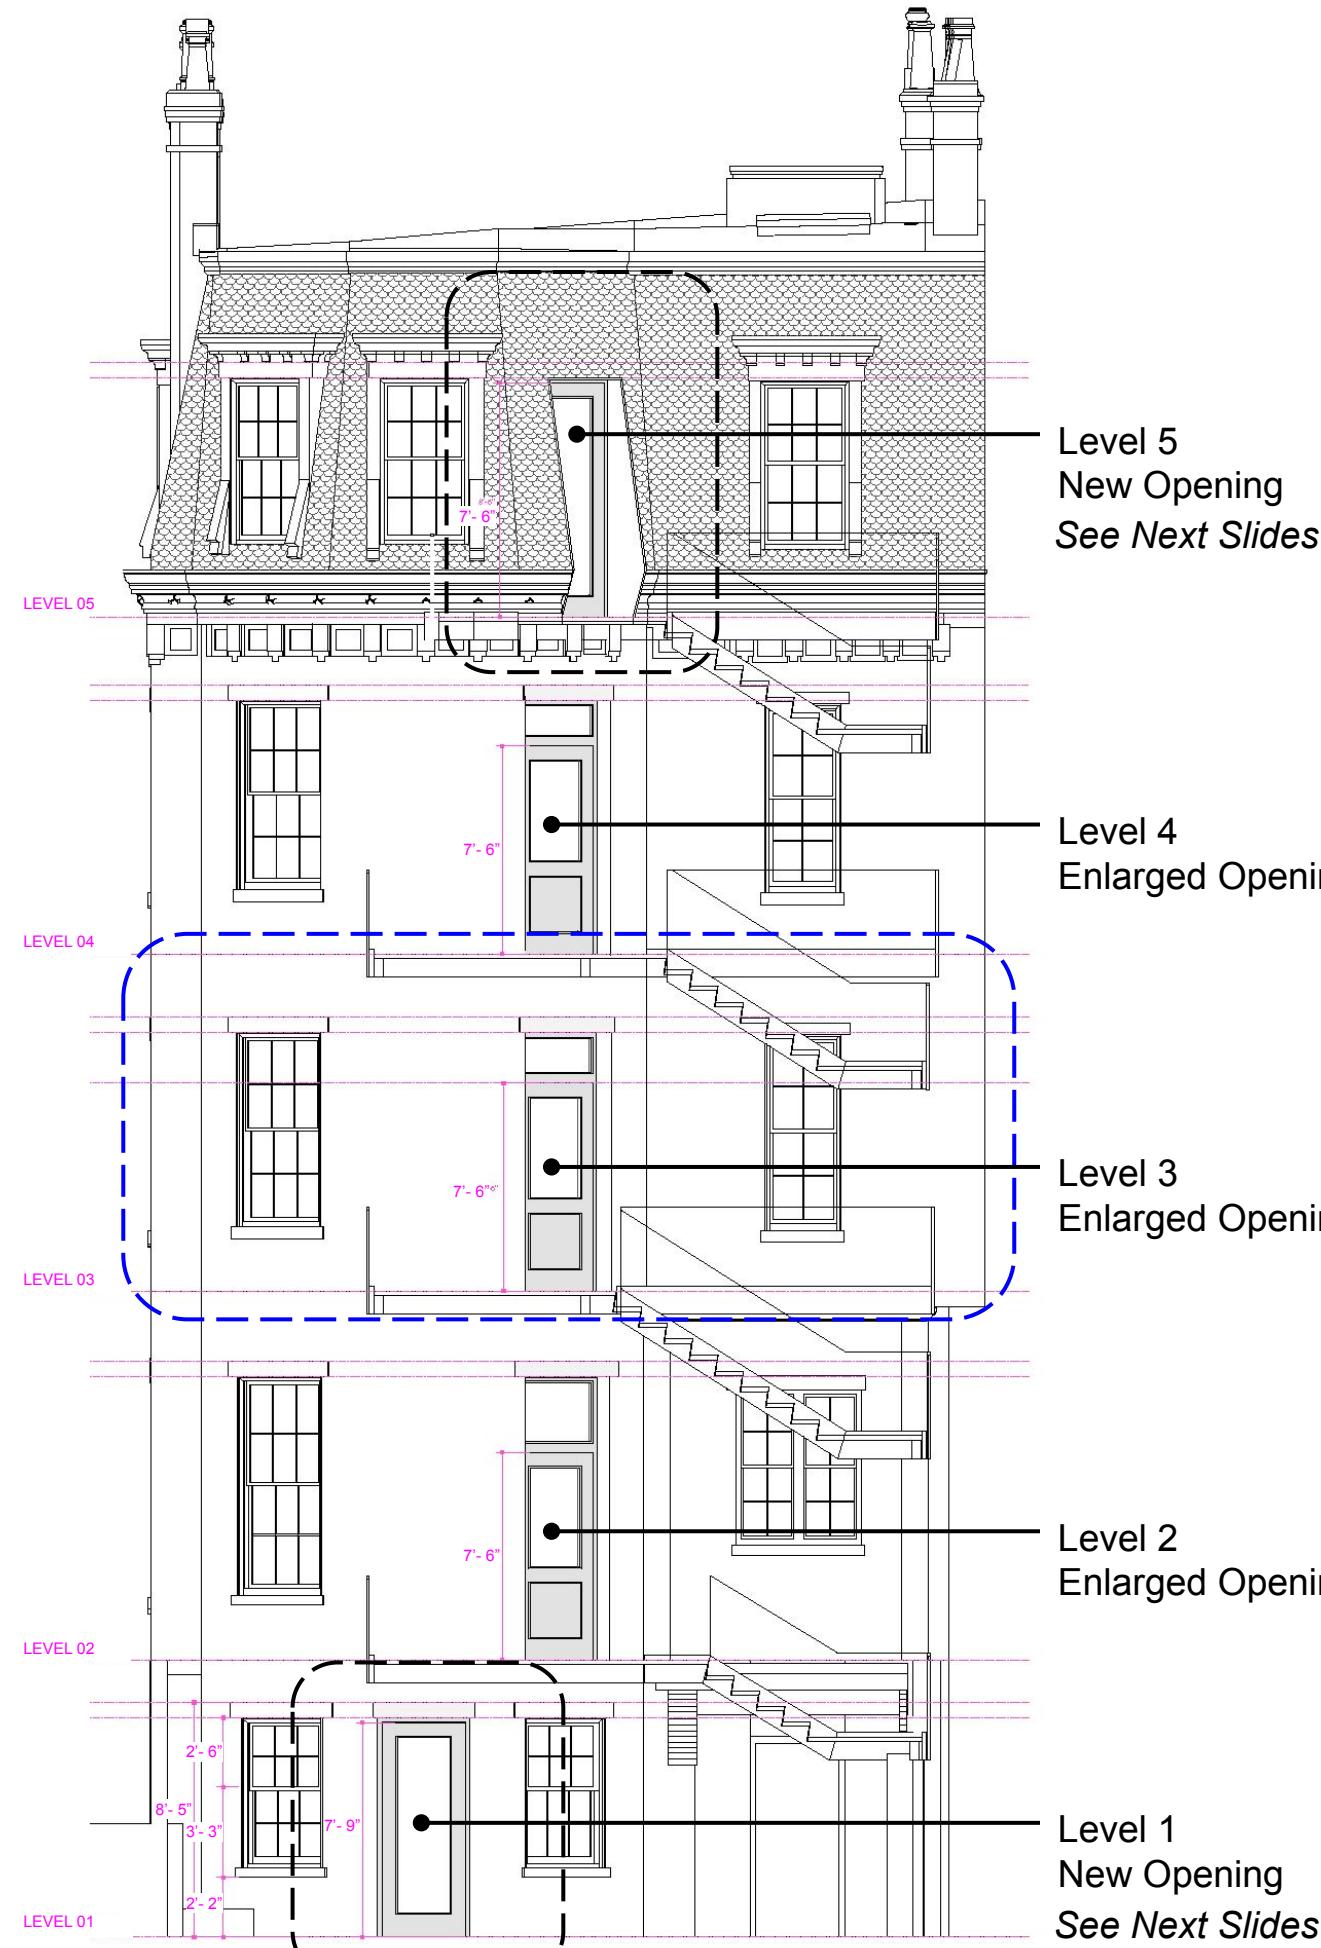
Rear Doors

Level 5
New Opening
See Next Slides

Level 4
Enlarged Opening

Level 3
Enlarged Opening

Level 2
Enlarged Opening

Level 1
New Opening
See Next Slides

Overhead Frame
(to match existing
windows), typ.

Transom

Glass Transom

Lower Panel

Typical Door, Level 3

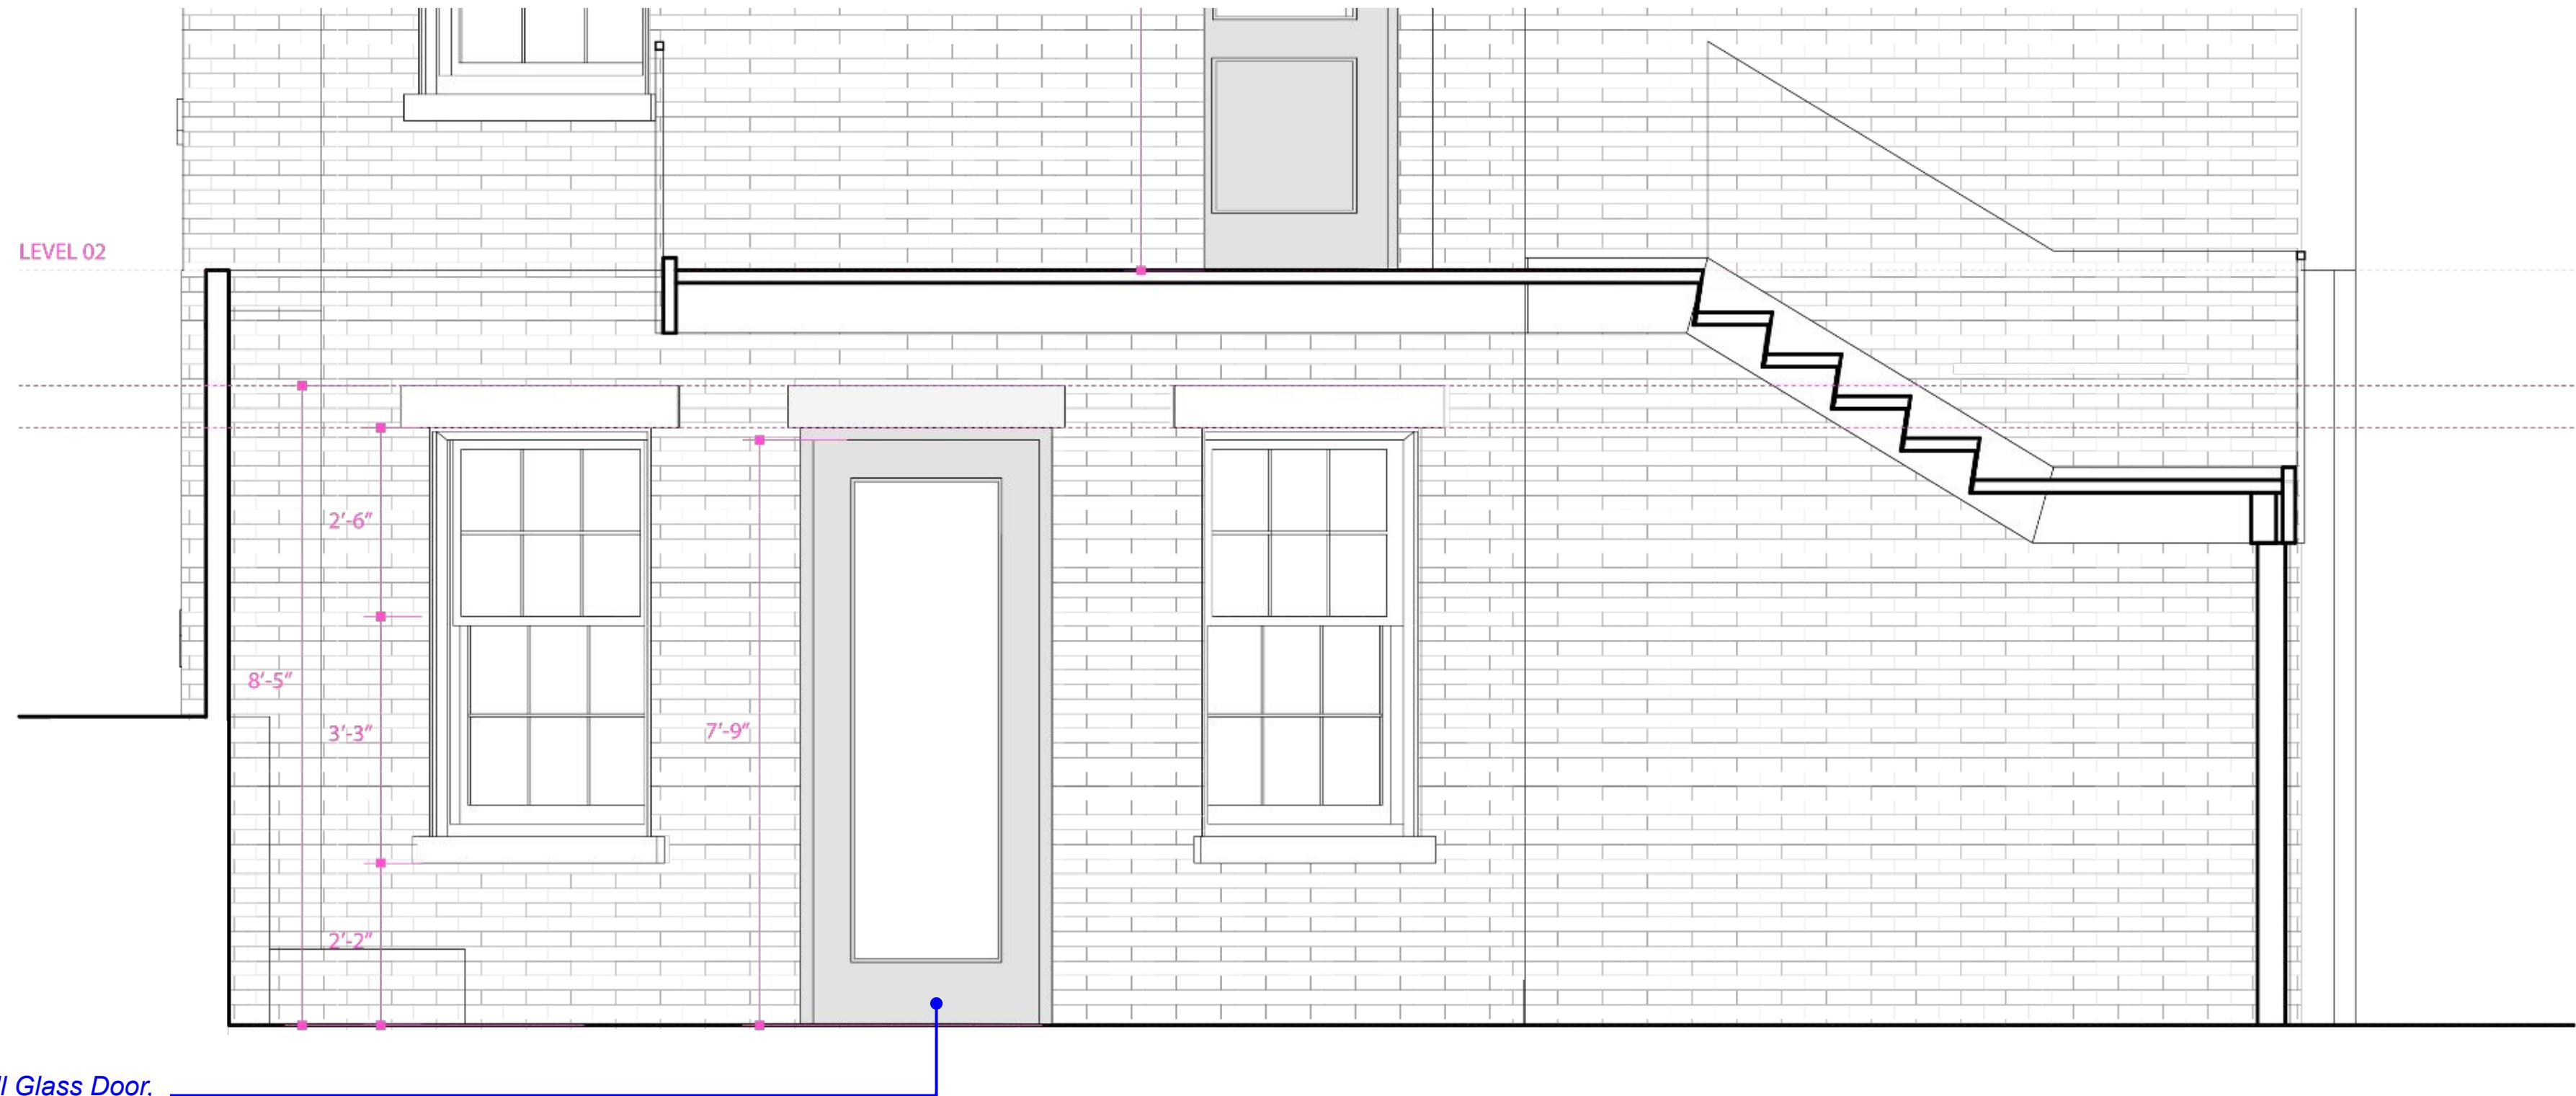
Rear Doors - Level 01

Full Glass Door,
Black

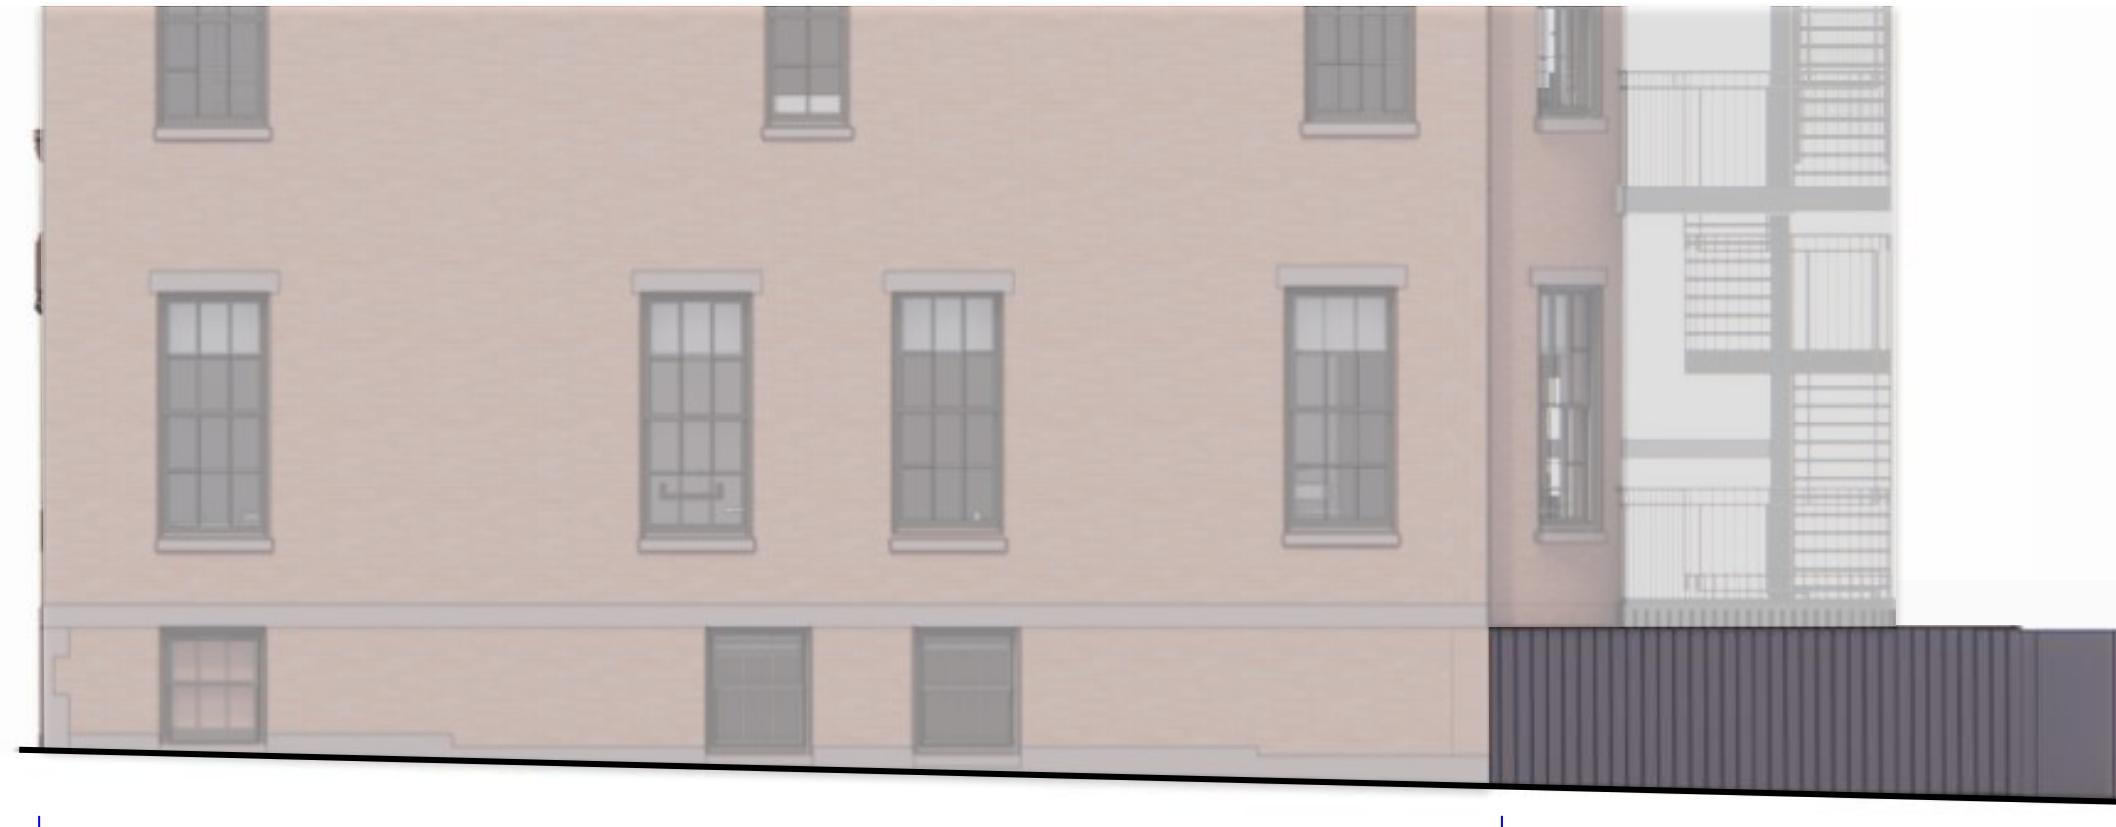
Alley Elevation

Exterior Fence

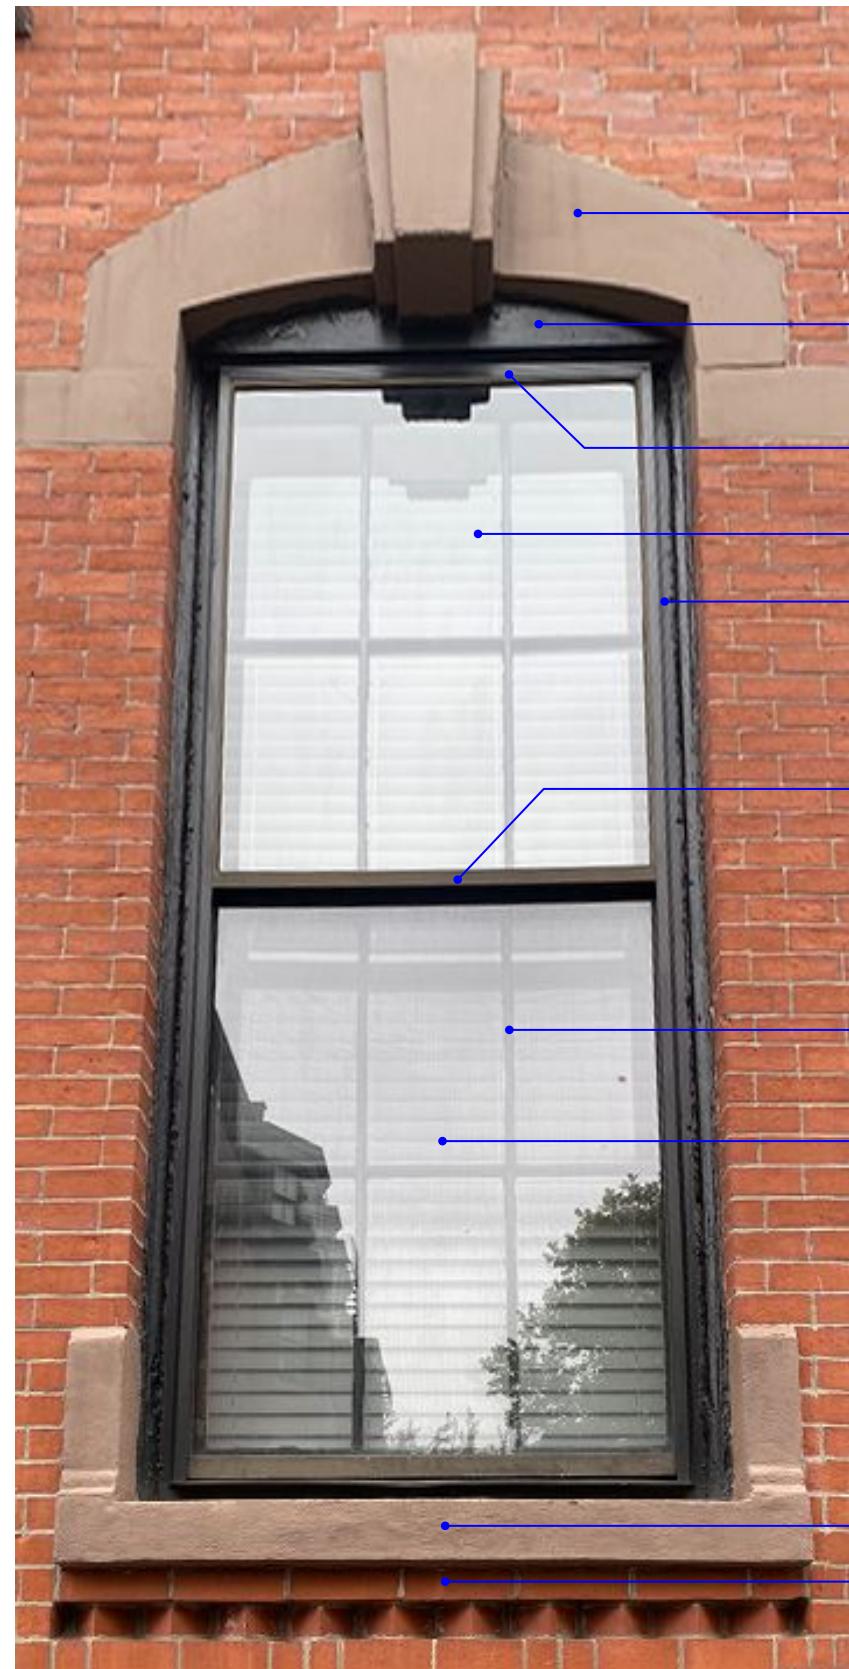
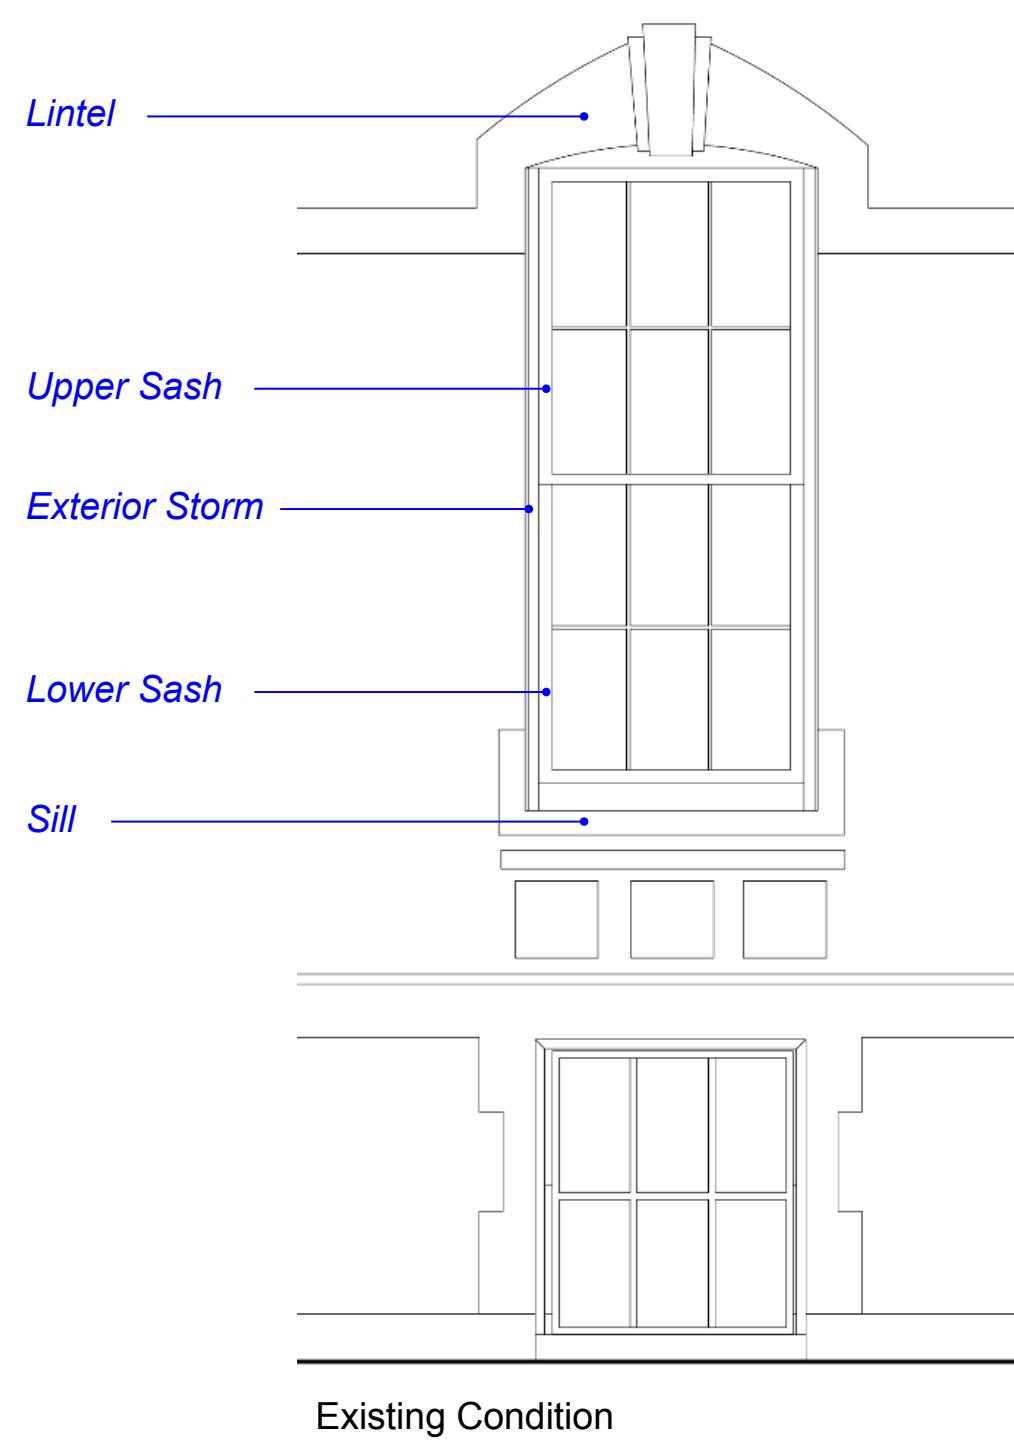
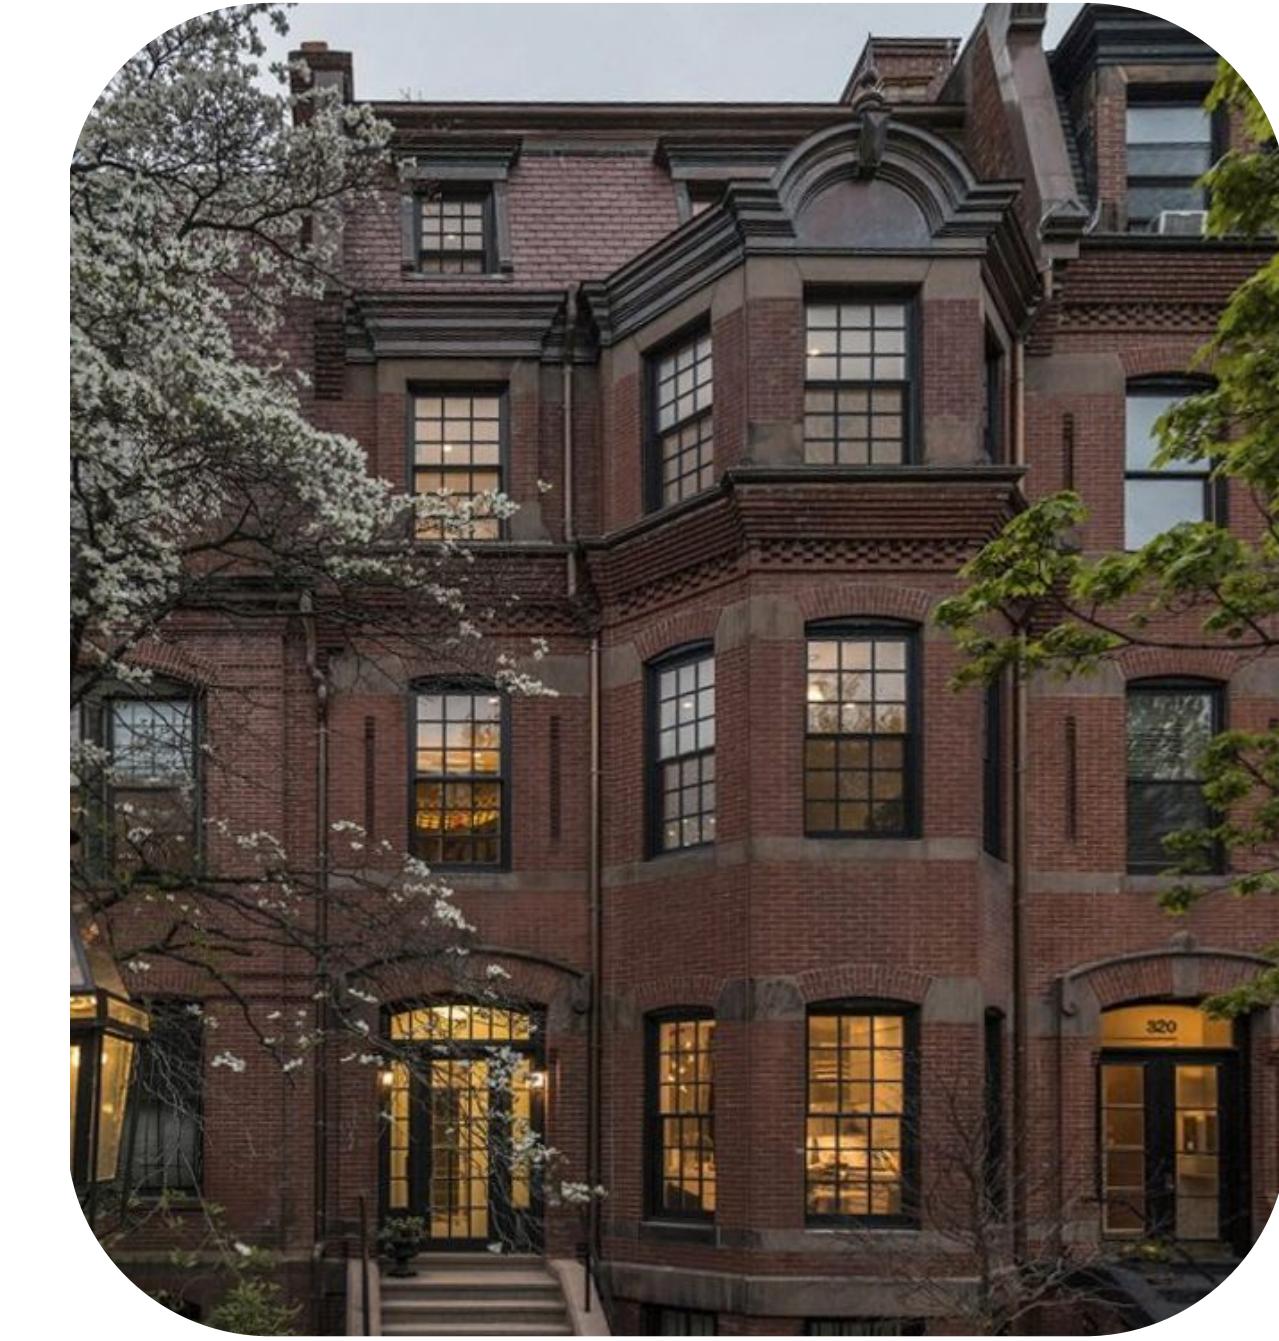
Exterior Windows

This project proposes **replacing all exterior windows** with new wood windows.

- Painted black
- True divided Lite glass
- Historic bevelled/moulded profiles
- Remove exterior storm windows
