The Learning Project

Proposed Expansion at
263 Clarendon Street
BBAC Submission
12/22/2025

Scope Overview

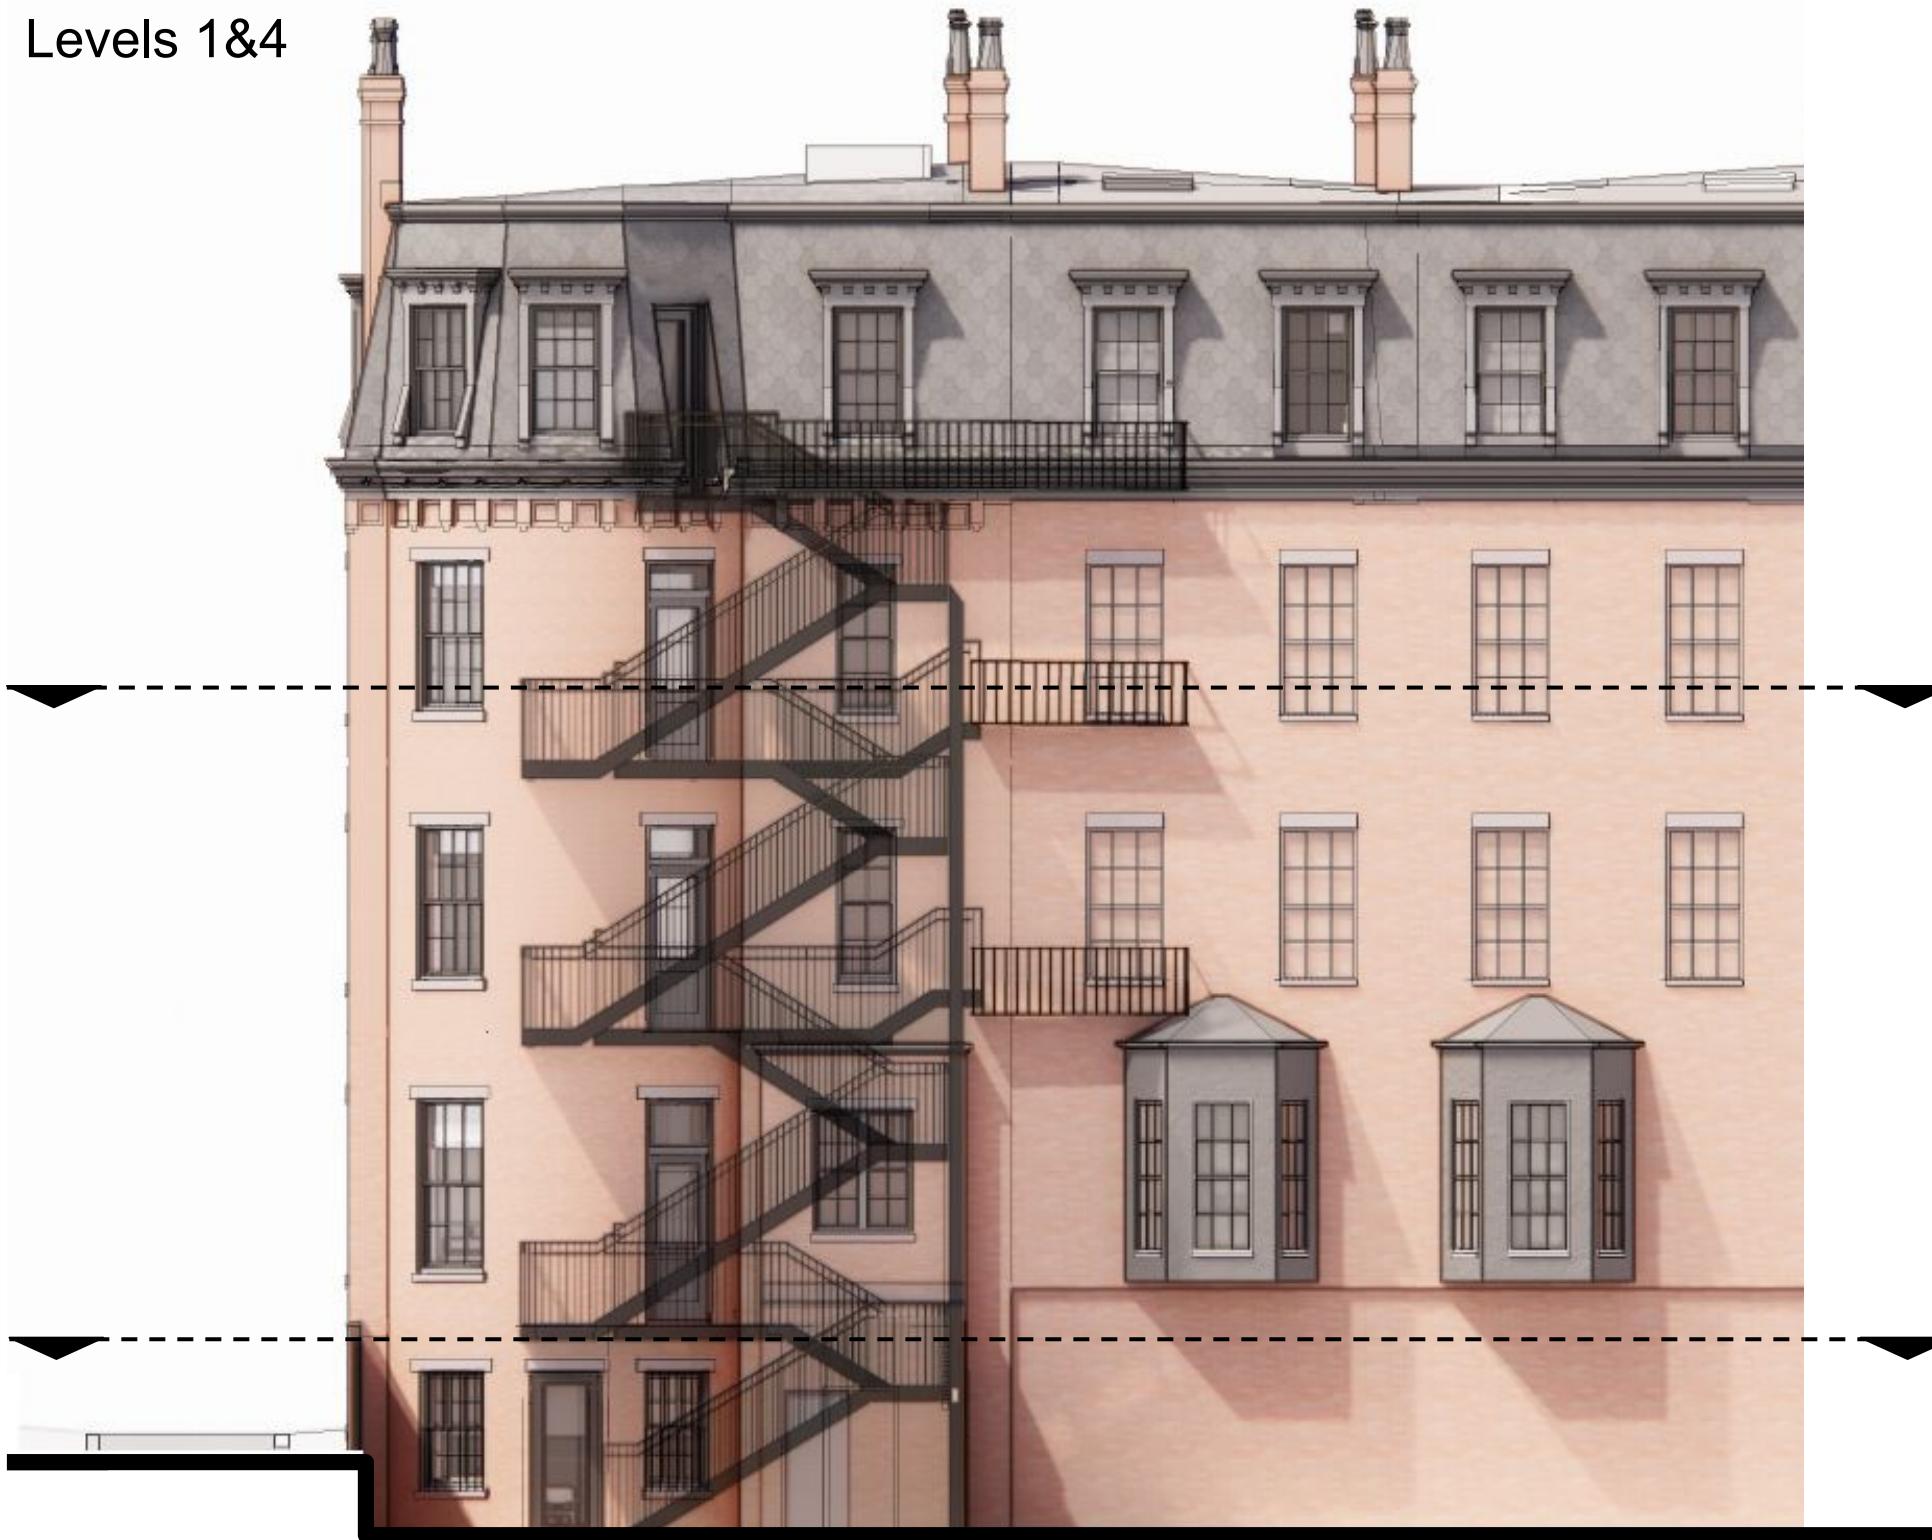
Elevation

Levels 1&4

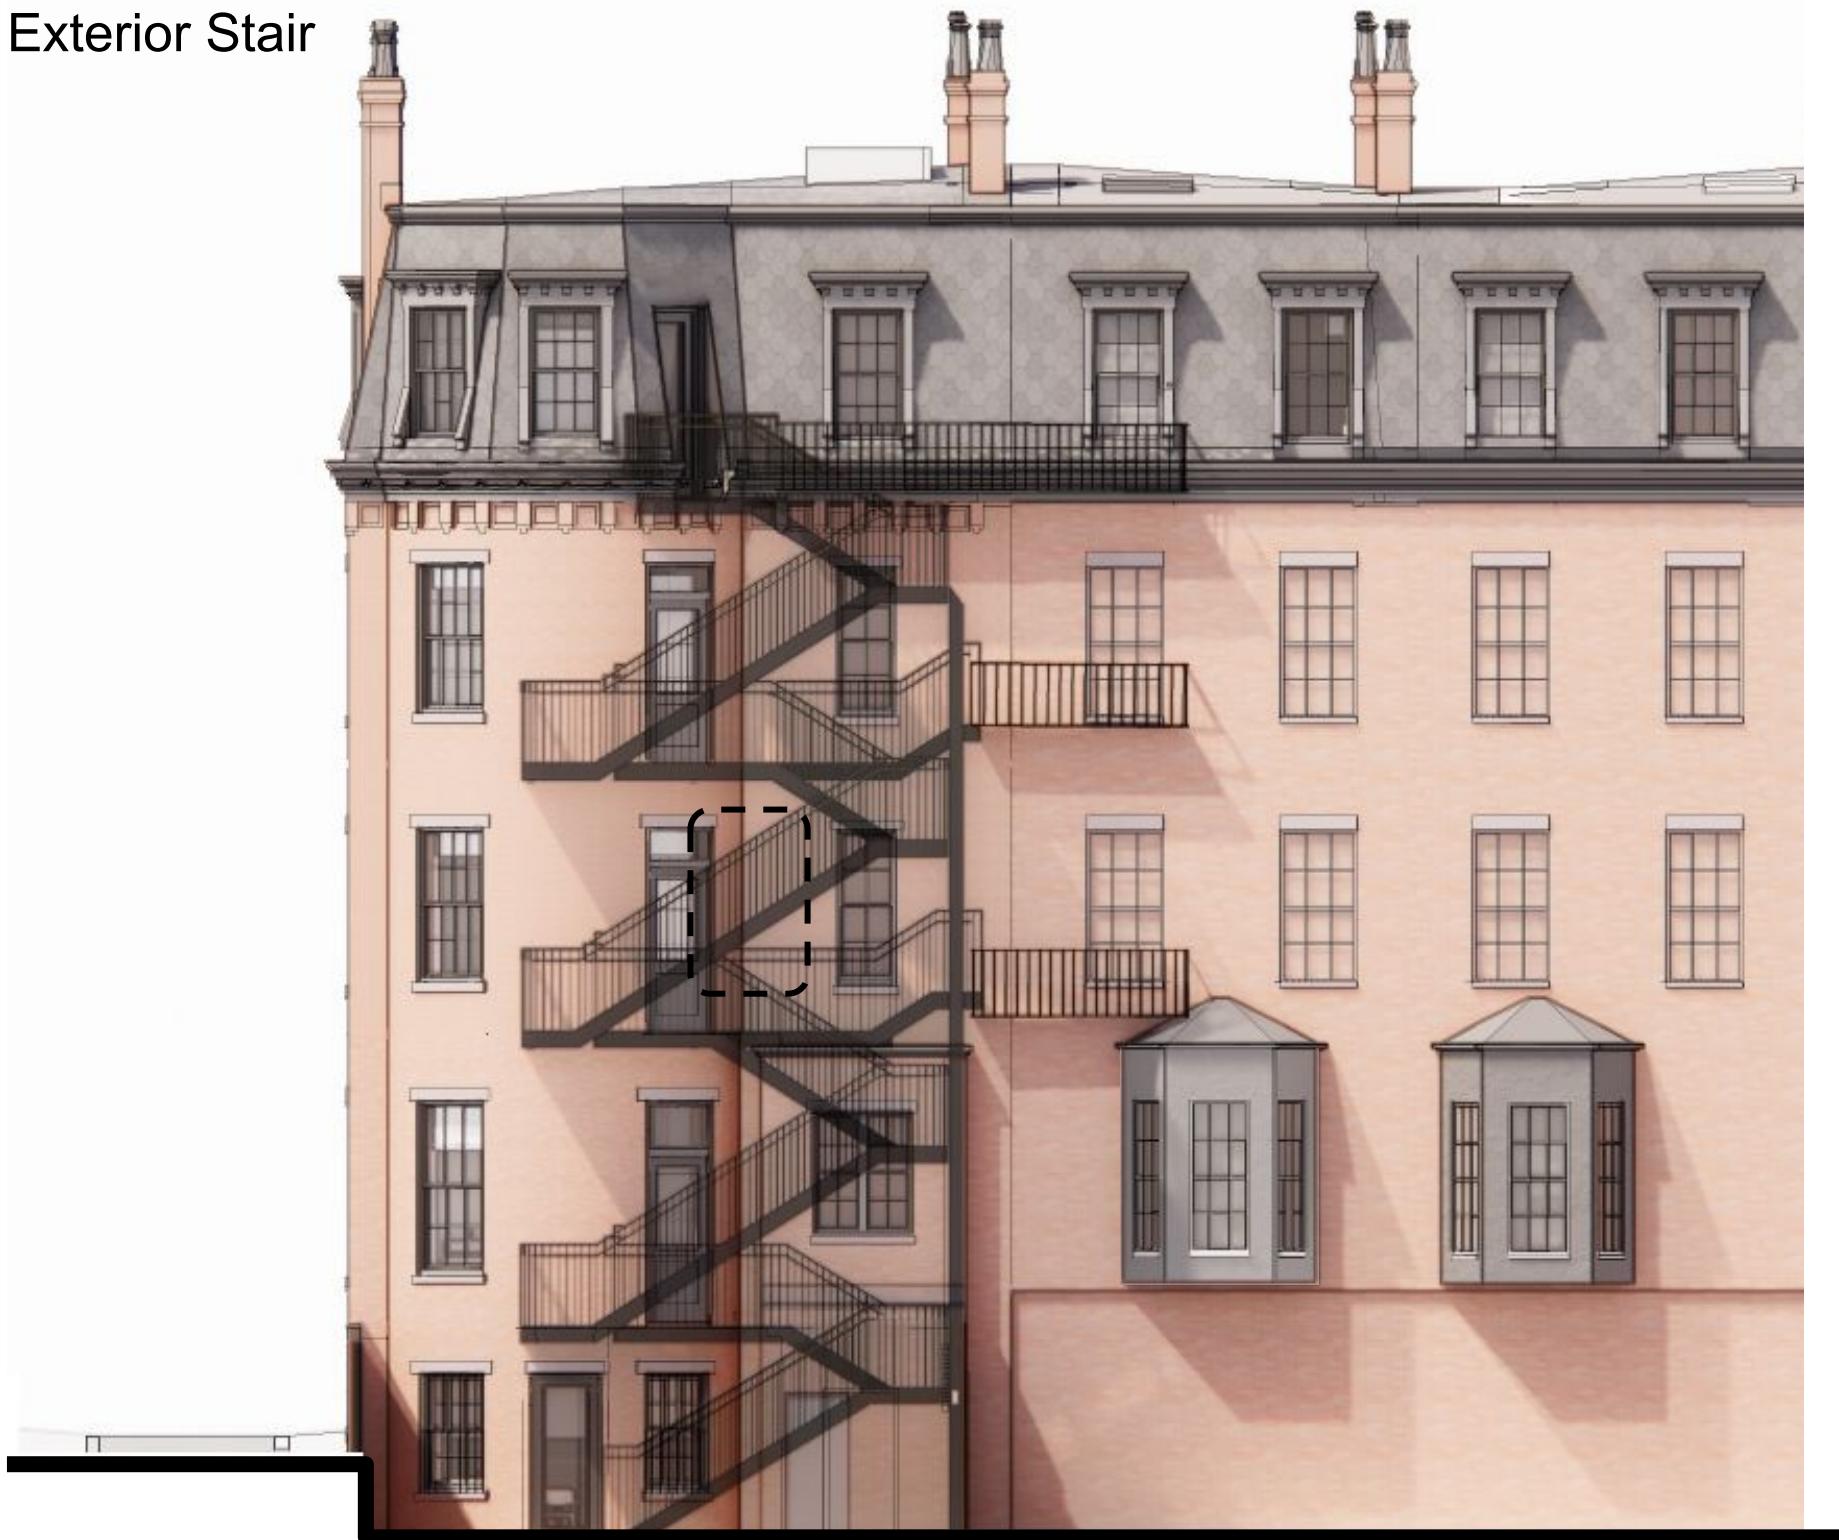
Elevation

Exterior Stair

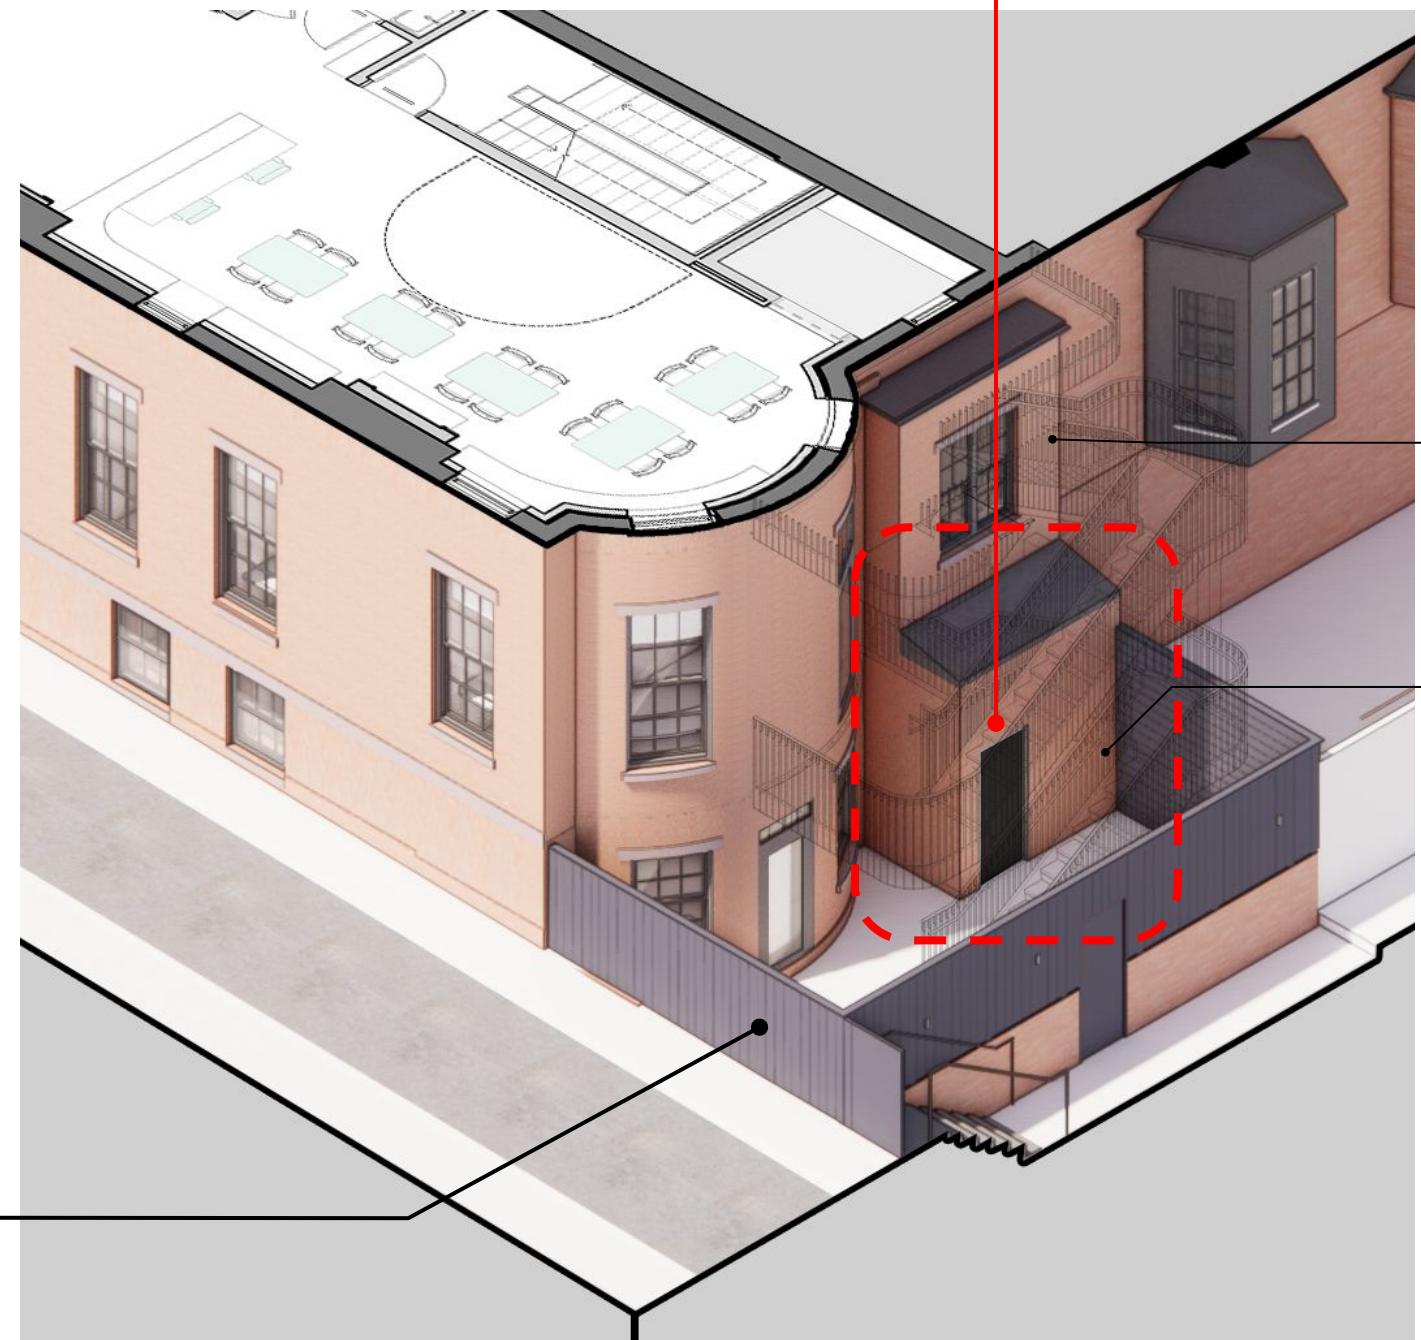
Proposed

New Wood Fence

Additional interior coordination in progress. Utile still determining whether this addition is required, and extents.

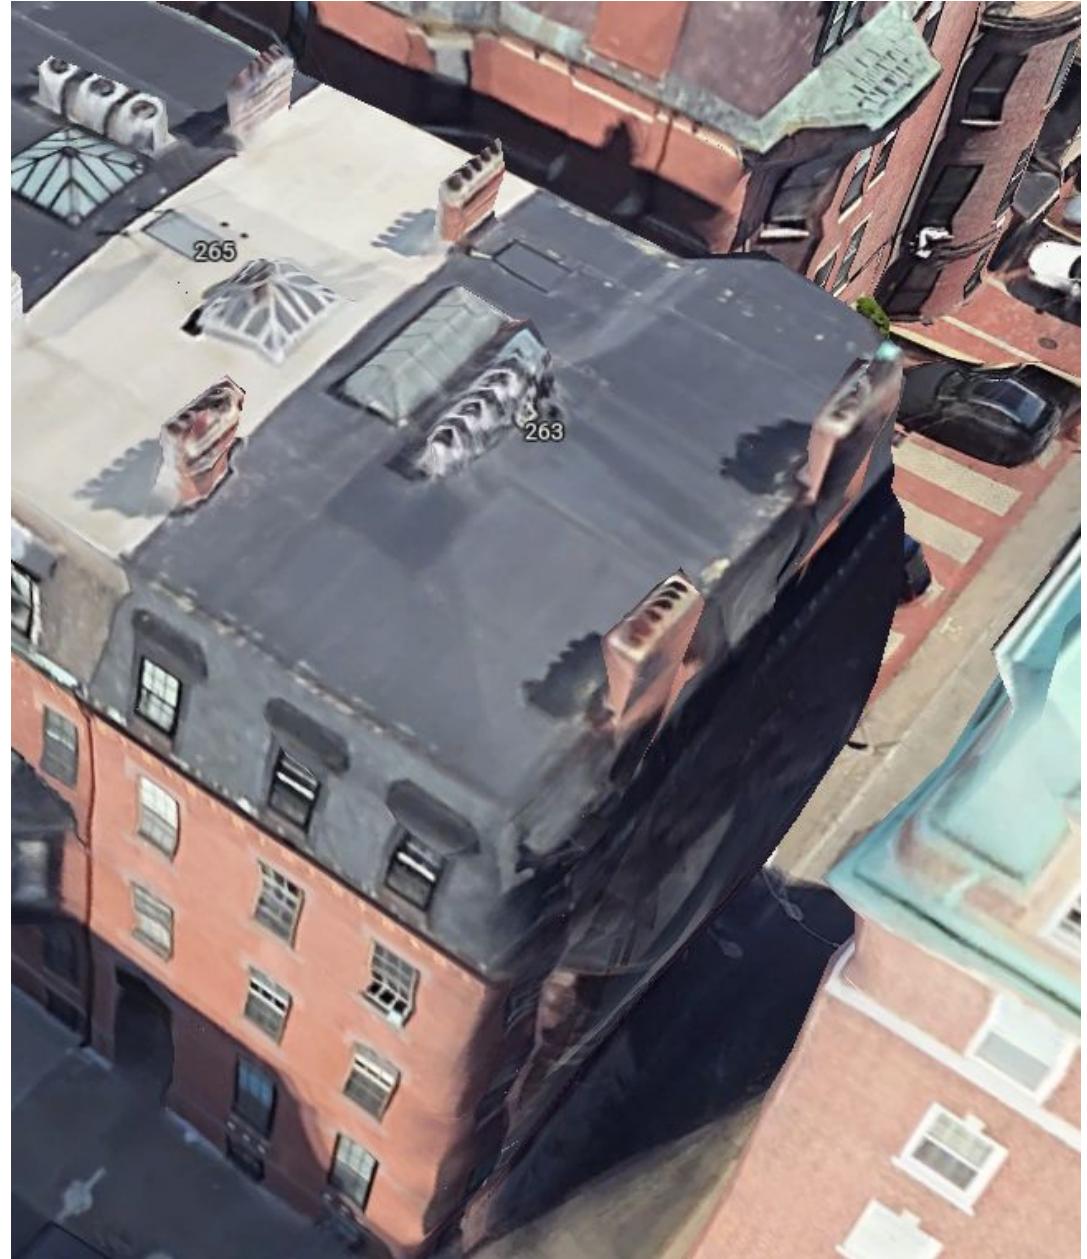
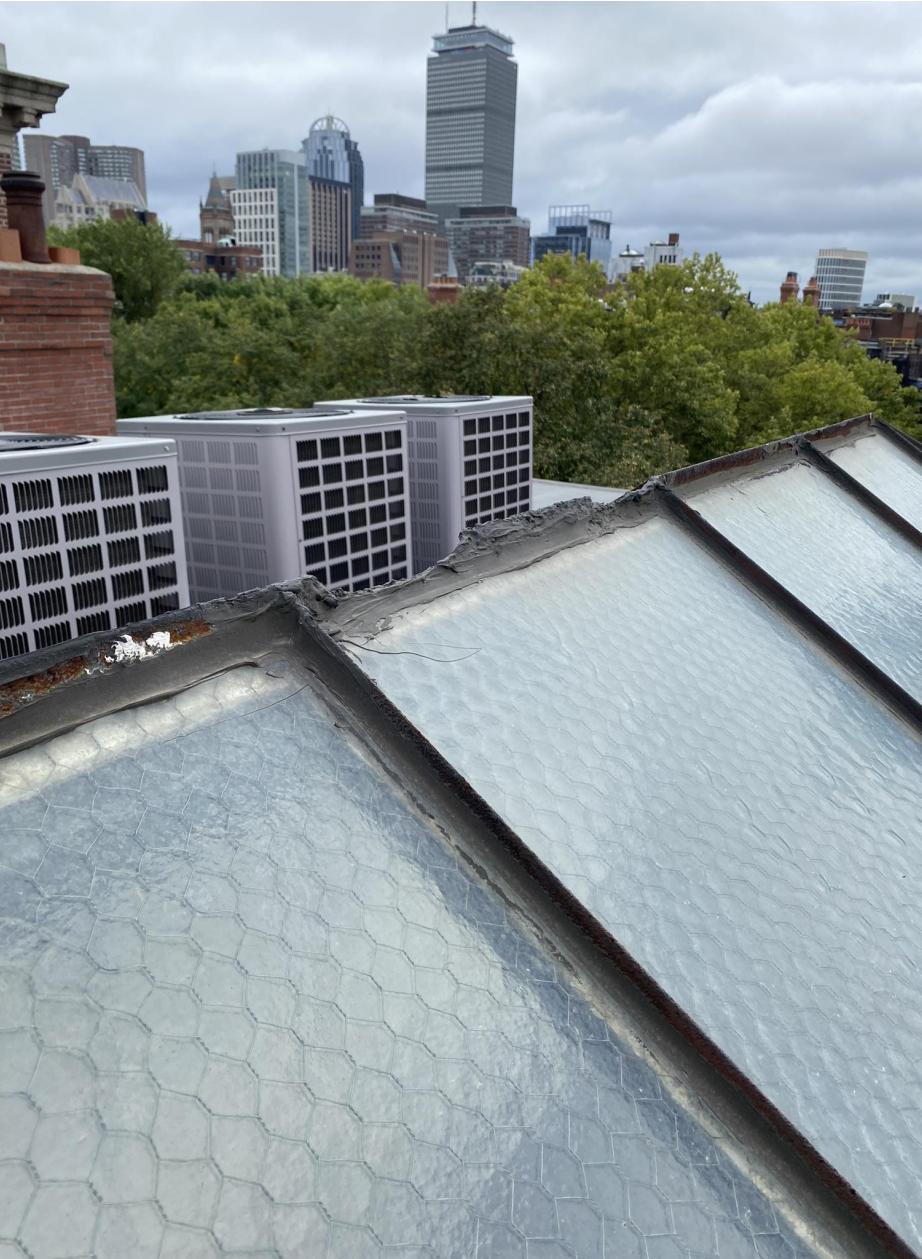
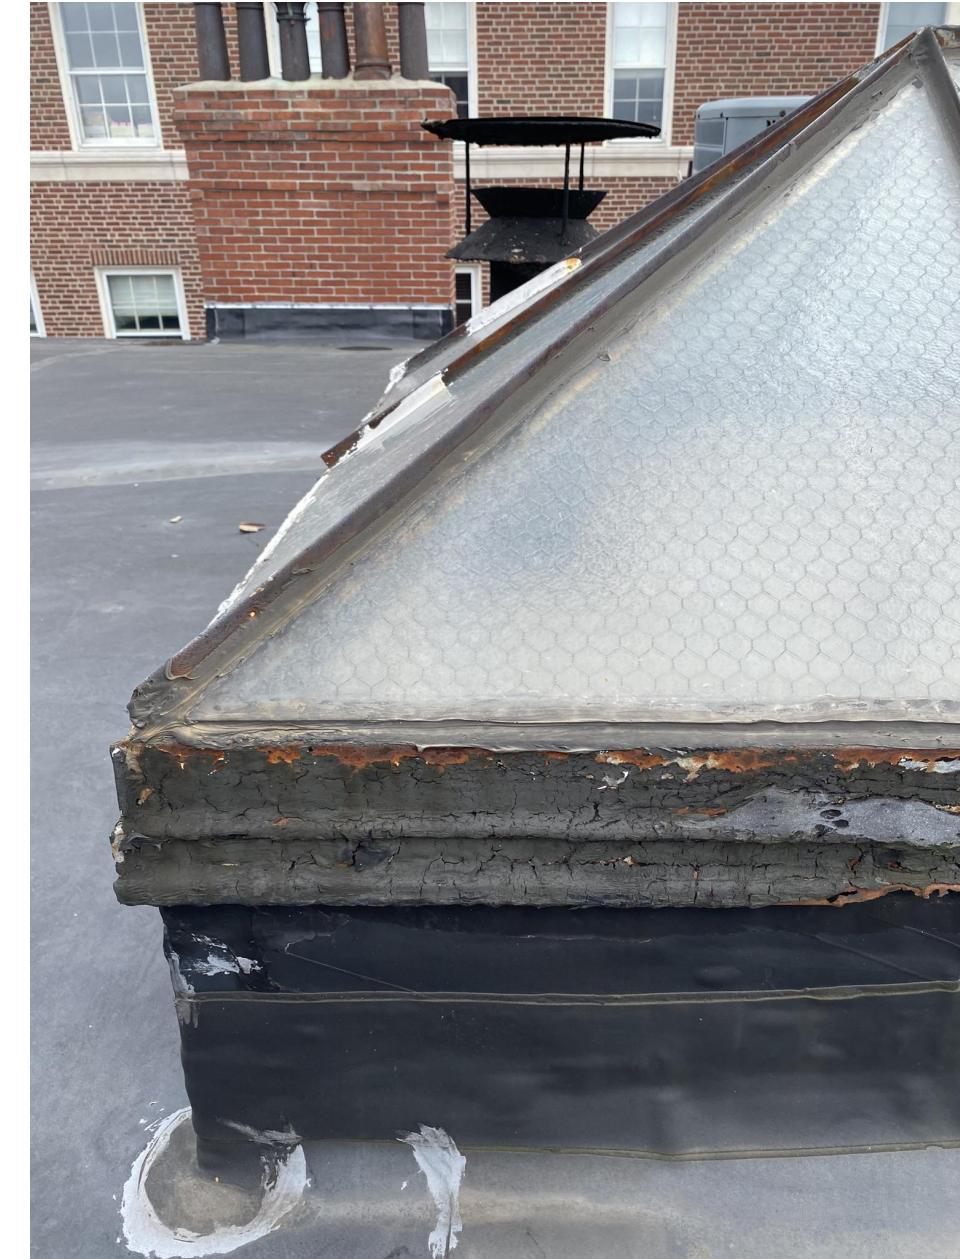
Existing Condition at 263 Clarendon

***The existing Skylight is failing. A new skylight must be provided.
This skylight will be minimally visible from the street level.***

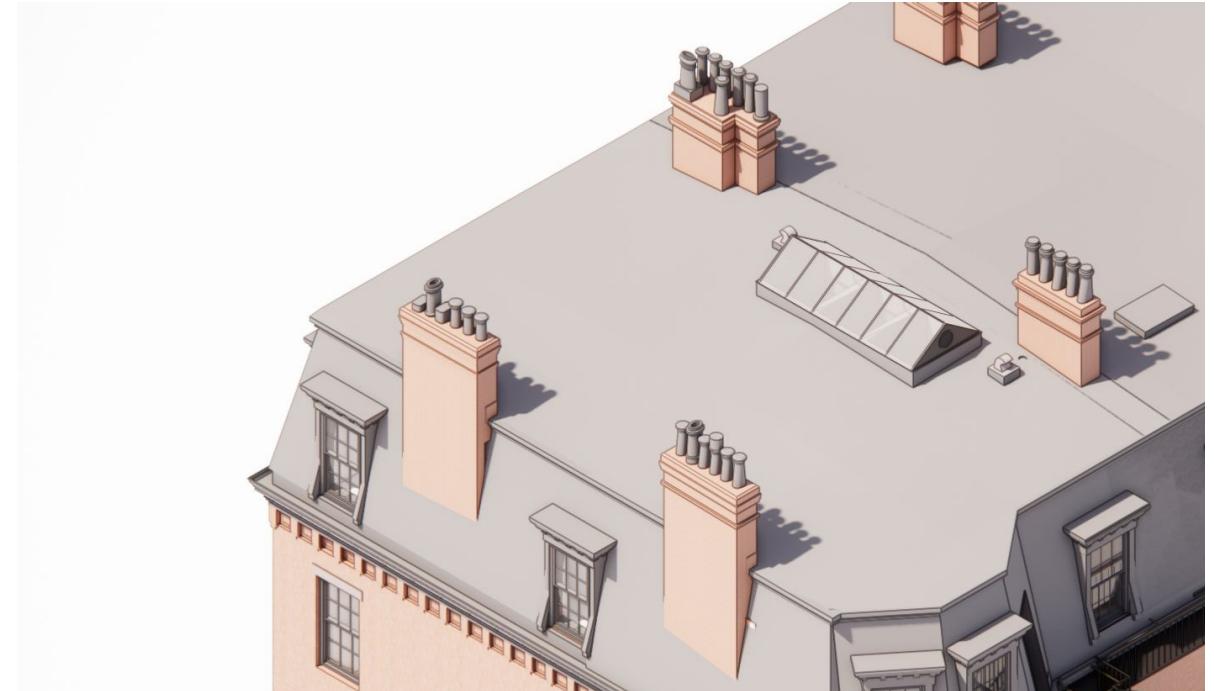
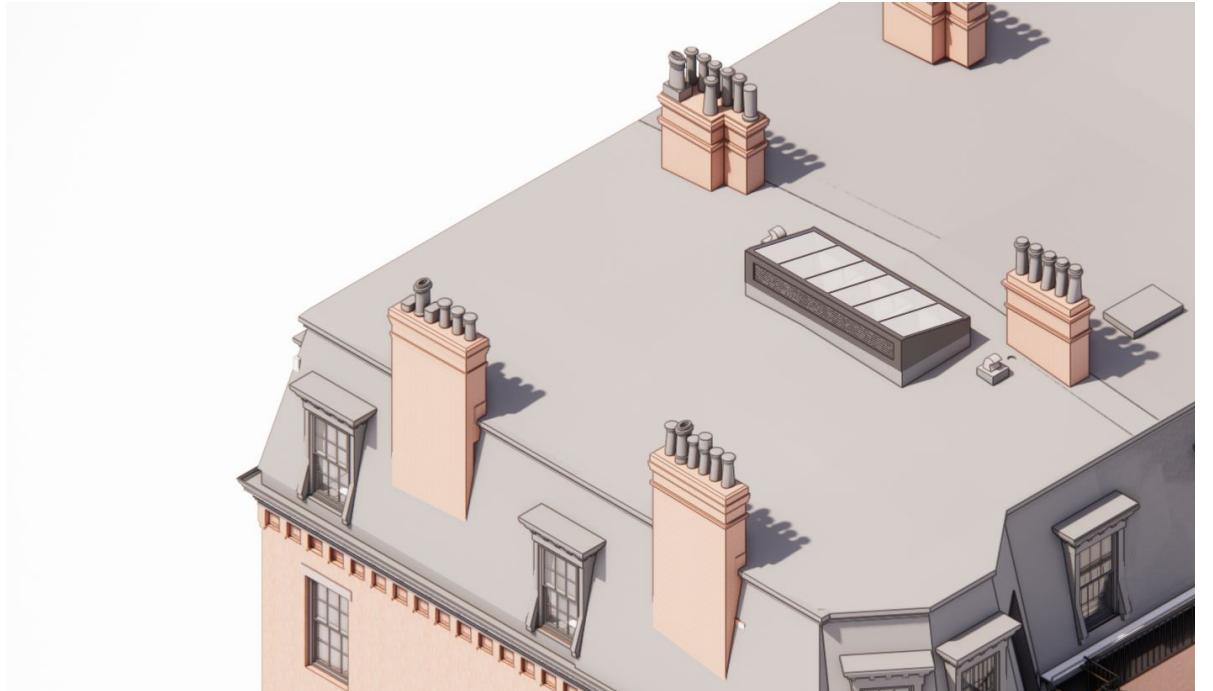
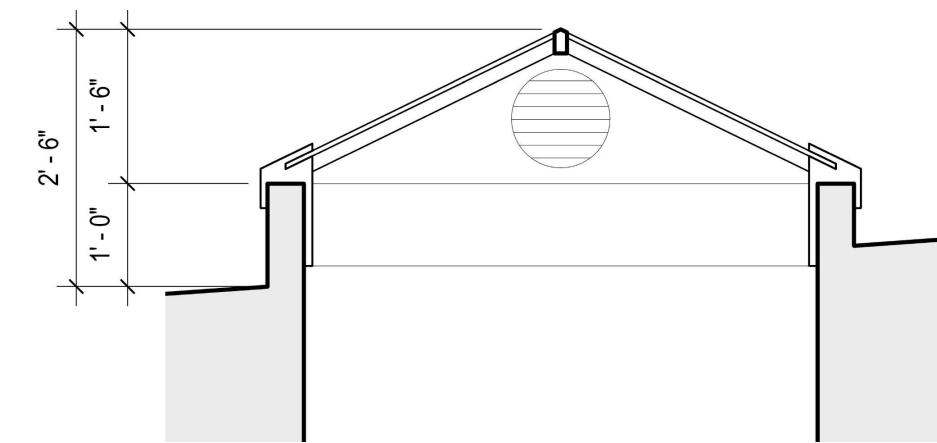
Option 1

Design proposal options

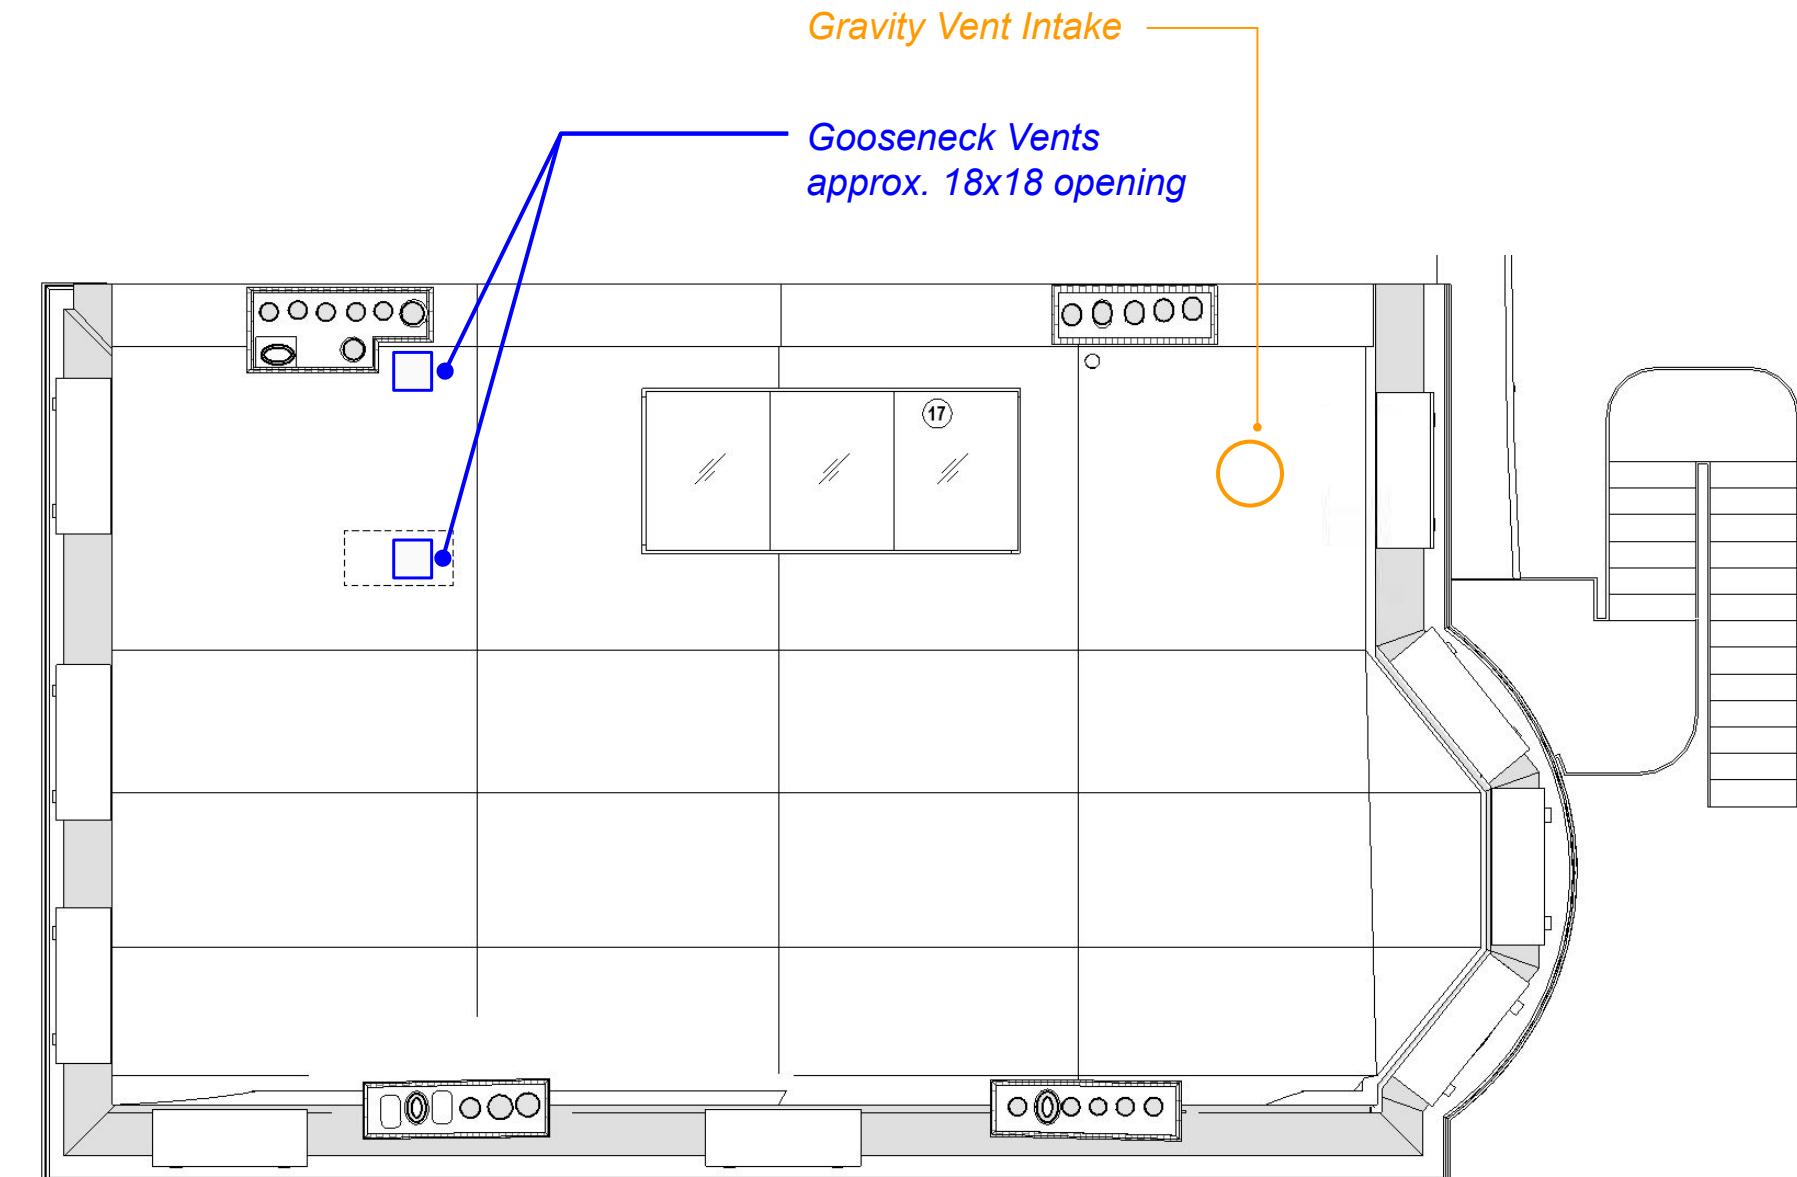
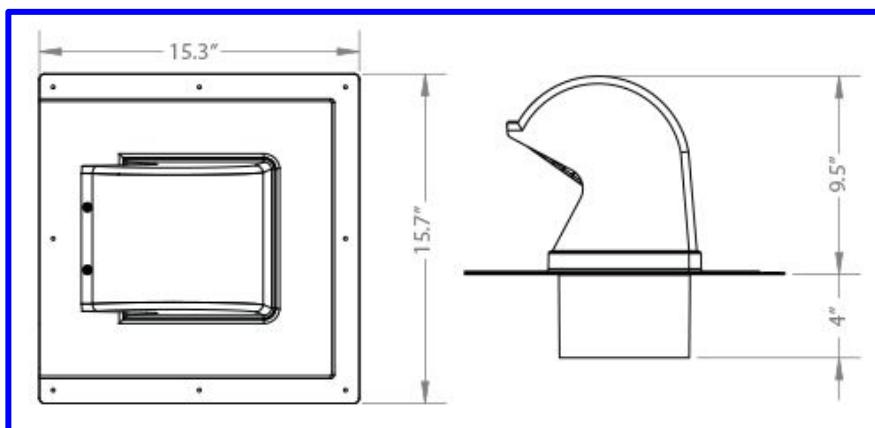
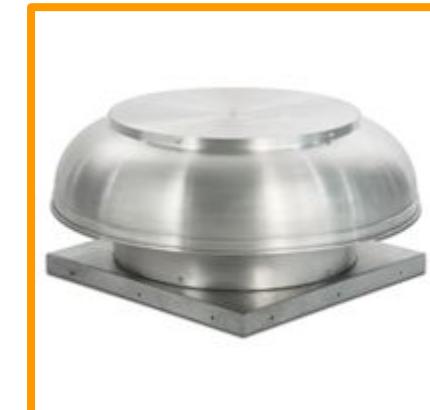
Eliminate (4) Rooftop Condensing Units

Two small gooseneck air vents must be added to the roof with a small curb. These will not be visible from the street. The project is not planning for any mechanical equipment on the roof.
