# Boston Coastal Storm Risk Management Study

## Draft Integrated Feasibility Report and Programmatic Environmental Assessment

### APPENDIX D - ENVIROMENTAL

# INTERTIDAL AND SUBTIDAL HABITAT SURVEYS

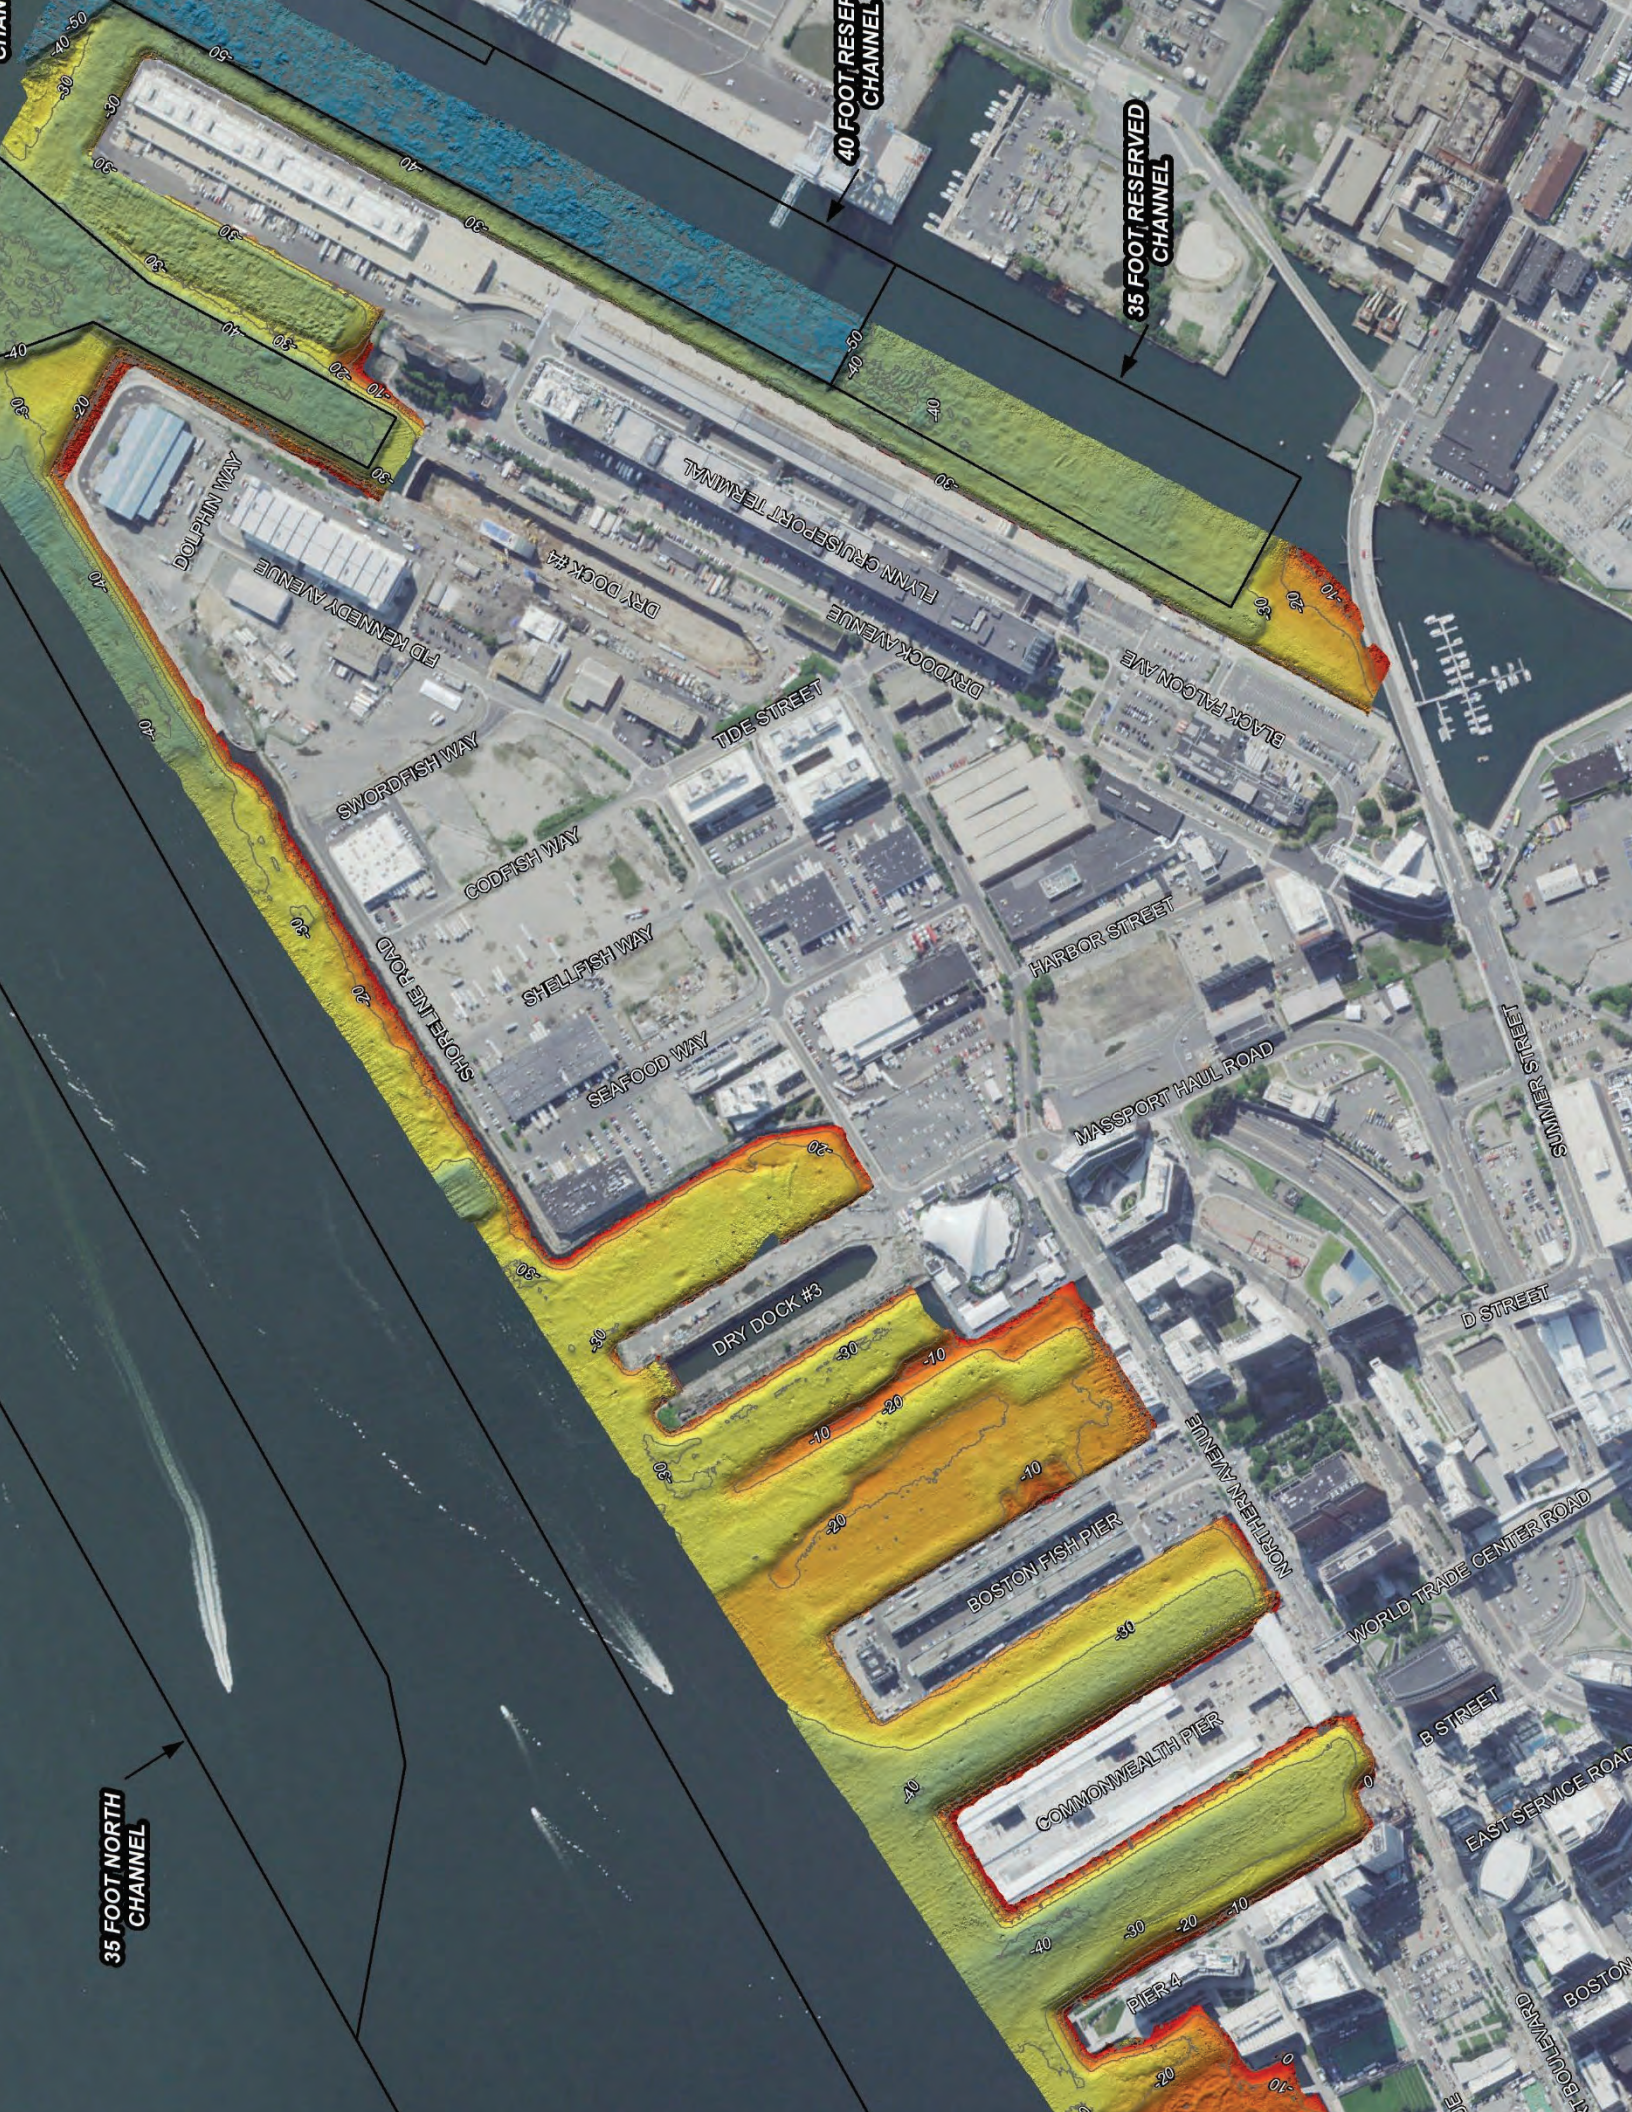
Underwater imagery documented two primary types of benthic habitat along the South Boston Waterfront between the Fort Point Channel and the Raymond L. Flynn Marine Park. Within the basins and seaward of the piers, benthic habitat generally consisted of silt with infaunal invertebrate tubes and burrows (65% of video stations). Adjacent to the seawalls, piers, and other shoreline structures, the underwater video survey documented patches of shell reef habitat primarily composed of live mussel (*Mytilidae* spp.) and mussel shell. These areas (SB-2, SB-5, SB-6, and SB-13) also supported slipper snails (*Crepidula* spp.), barnacles (*Balanidae* spp.), macroalgae, and tunicates (likely *Molgulidae* sp. or *Asciidiella aspersa*). A patch of cobble and gravel habitat with isolated small boulders was documented 150 feet off the historic Pier 2 (now the eastern end of Fan Pier) and supported a sparse cover of ectoprocts and hydroids (SB-11). Video station SB-3 was located within the ruins of historic Navy Pier 7, next to Dry Dock 4, and was characterized by silt mixed with anthropogenic debris including wood fragments and pieces of rope. A sunken barge was identified at SB-14, located in front of the federal courthouse on Fan Pier. The barge supported ectoprocts (*Bugula* sp.), hydroids, solitary tunicates (*Styela clava*), encrusting tunicates (*Didemnum* sp.), and encrusting sponges (*Halichondria panicea*).

Benthic habitat within the Dry Dock #3 Approach Channel and the Reserved Channel was bare silt with infaunal invertebrate tubes and burrows (SB-16 and SB-21). The shallow area to the west of the Reserved Channel was characterized by silty sand with shell hash and infaunal invertebrate tubes and burrows (SB-15). Underwater video stations located adjacent to the concrete gravity wall along the Cruiseport Terminal documented a mix of silt with infaunal invertebrate tubes and burrows (SB-17 and SB-20) and patches of cobble habitat with little-to-no attaching flora or fauna (SB-18 and SB-19). The underwater video survey of the seafloor along the northern face of the Raymond L. Flynn Marine Park was performed in conjunction with the survey of the Boston Harbor Surge Barrier investigation area, and is discussed in detail within section 3.2 of this report.

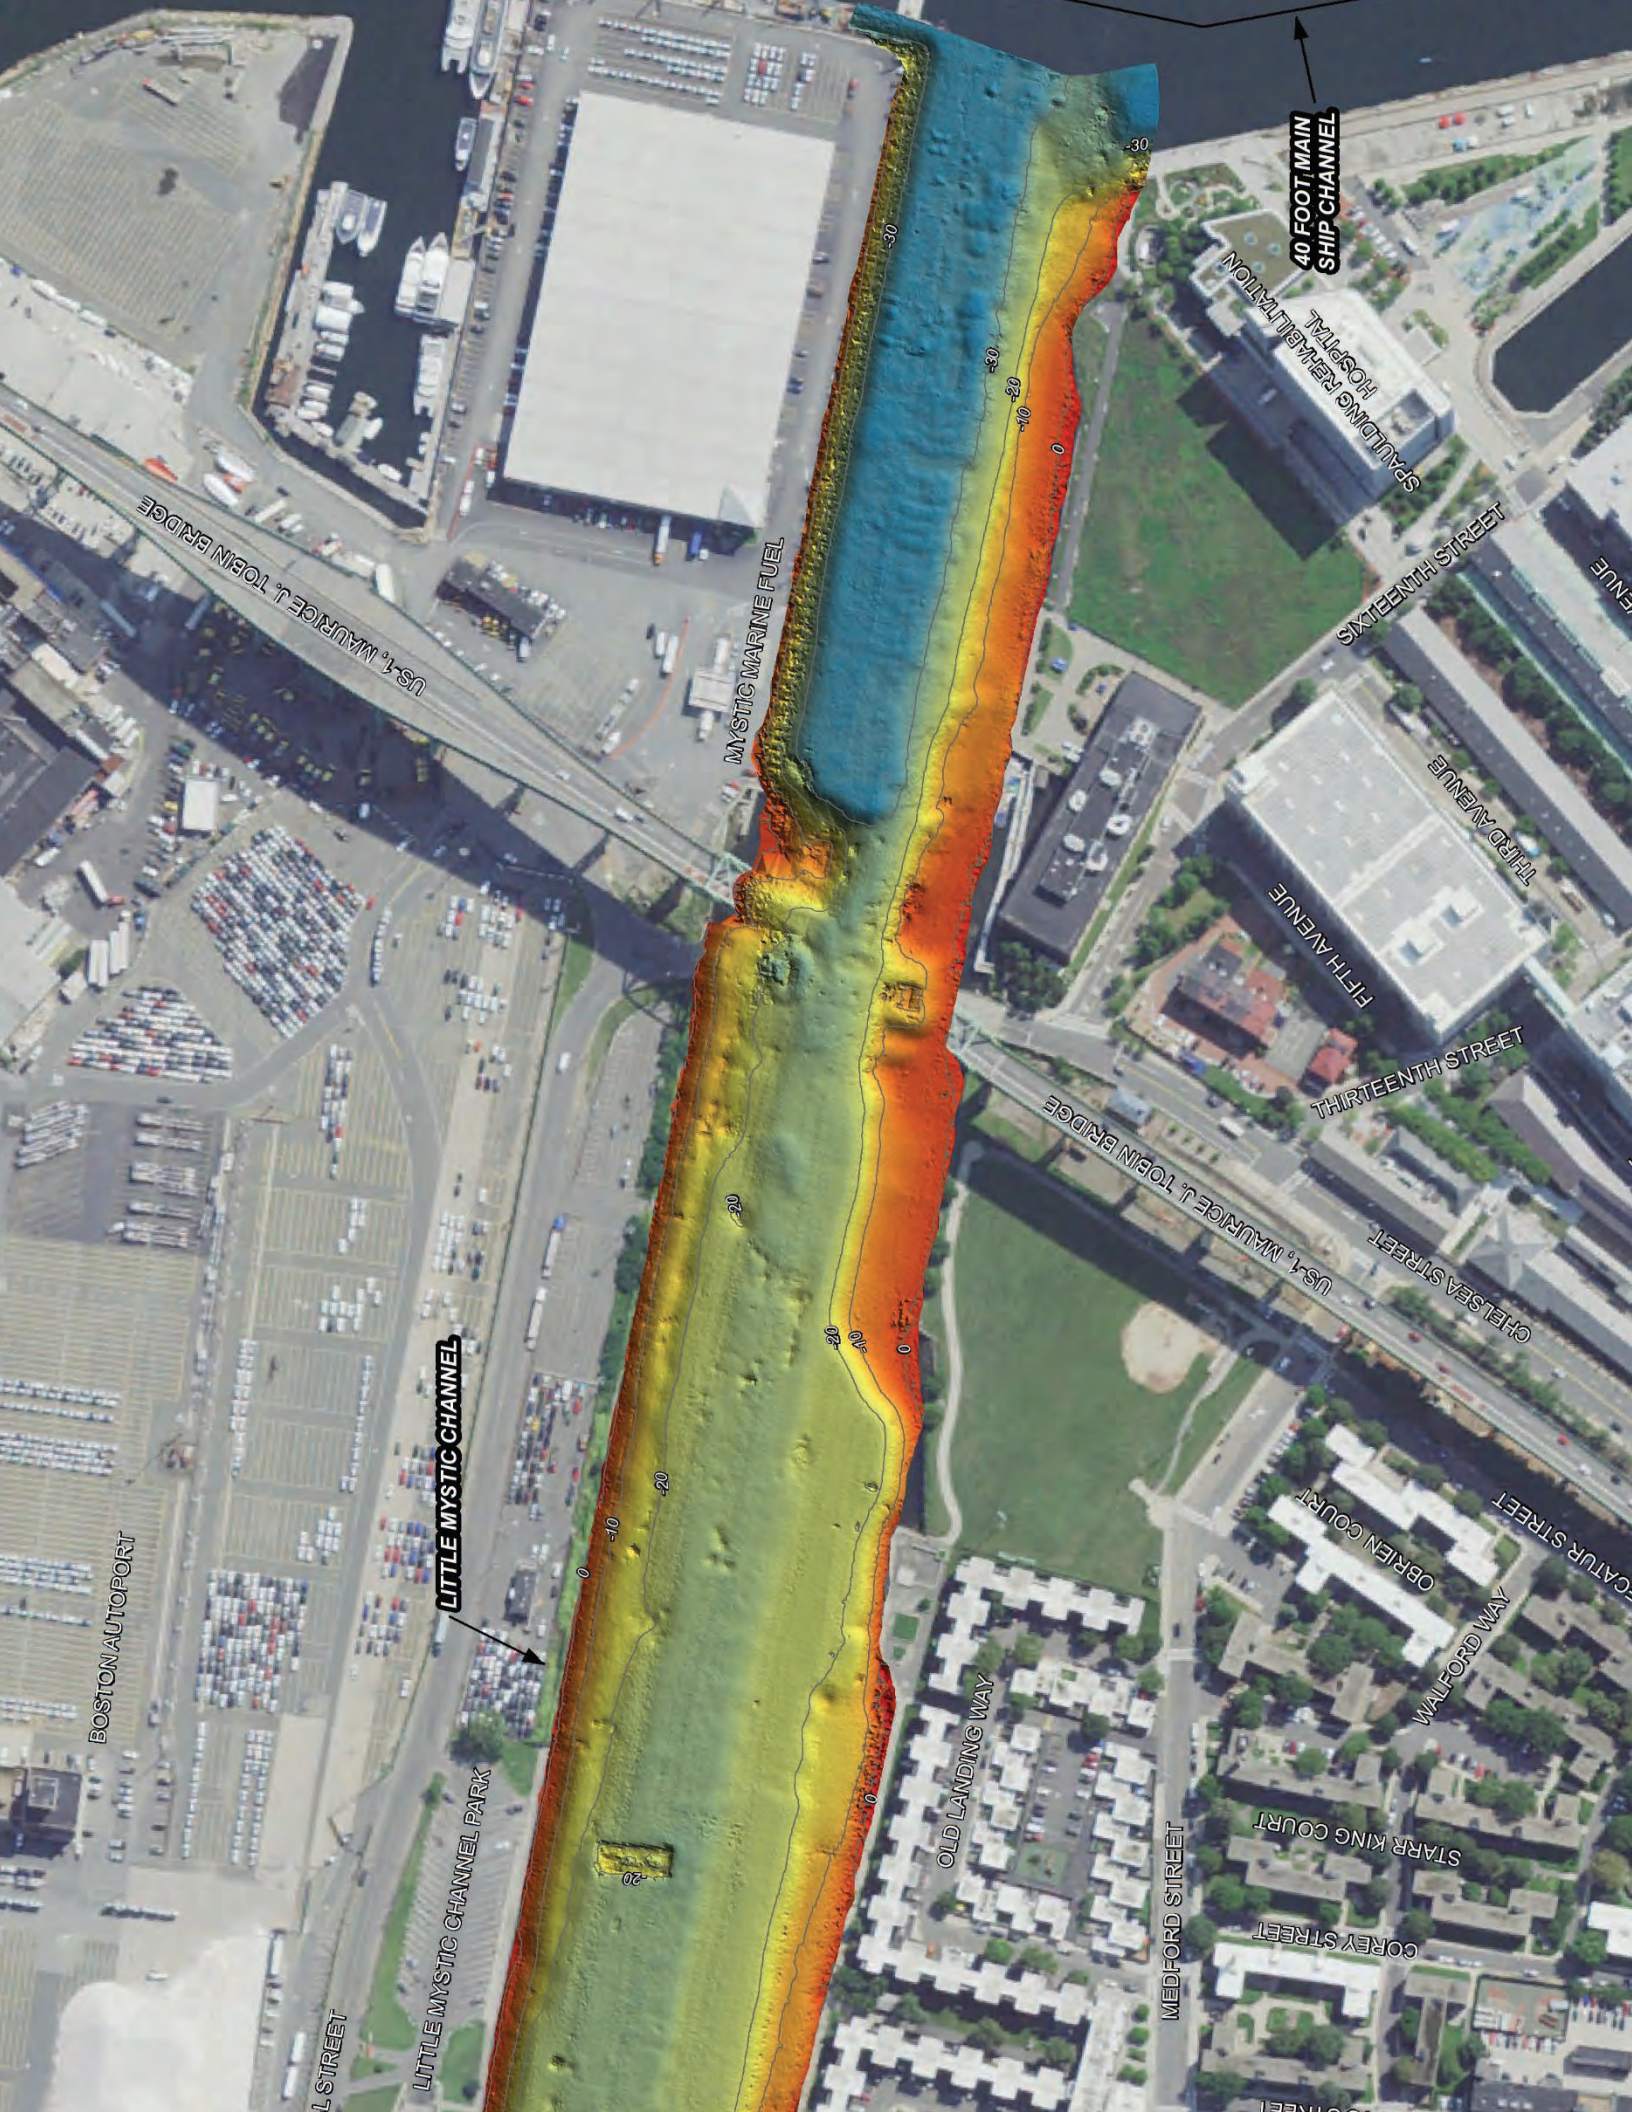
Benthic habitat within the shallow nearshore areas bordering the channel was characterized by gravel and shell with a sparse cover of macroalgae (LM-5). Within the interior of the channel, benthic habitat was typically composed of bare silt with infaunal invertebrate tubes and burrows, and tunicates sparsely attached to scattered anthropogenic debris (LM-2 and LM-7). Near the mouth of the channel, at video station LM-8, submerged pilings and other debris laying on the silty substrate hosted patches of mussels (*Mytilidae* spp.).

The underwater video survey provided additional documentation of the wrecks and debris piles throughout the channel, especially to the west of the Tobin and Chelsea Street Bridges. Video station LM-1 was located on a metal debris pile located on the western end of the channel just south of the boat ramp. The metal debris had dense cover of tunicates, sponges, ectoprocts, and hydroids and rested on a silt bottom with scattered gravel and shell material. Video station LM-3 was positioned on a small sunken vessel covered with a similar assemblage of attached sessile organisms, resting on an ambient silt bottom approximately 420 feet to the east of LM-1. About 60 feet to the east of LM-3 was a large sunken metal barge, mostly covered with a veneer of silt with sparse microbial algal and benthic macroalgal growth but also hosted densely covered patches of tunicates (e.g., *Ciona intestinalis*, *Clavelina* sp., and *Styela clava*), bushy ectoprocts (*Bugula* sp.), and mixed macroalgae. Along the northern edge of the channel, 300 feet west of the Chelsea Street Bridge, the shallow nearshore habitat was covered by anthropogenic metal debris exhibiting a dense cover of mixed macroalgae, bushy ectoprocts, hydroids, encrusting sponges, and tunicates (e.g., *Clavelina* sp. and *Styela clava*).

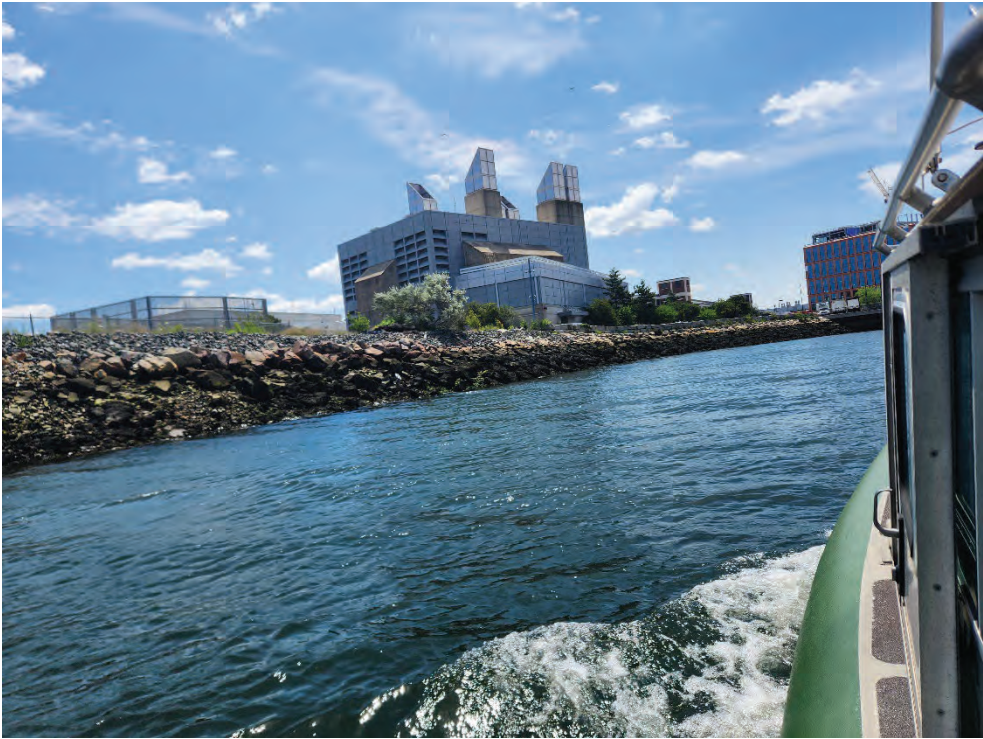
| Survey Area: | South Boston Waterfront | Date: 8/9/2023 |
|---|---|---|
| | <ul style="list-style-type: none"> <li>- Channel between Legal Sea Foods HQ and Dry Dock II</li> <li>- Stone rip-rap</li> <li>- Algae, macroalgae, and upland vegetation</li> </ul> | |

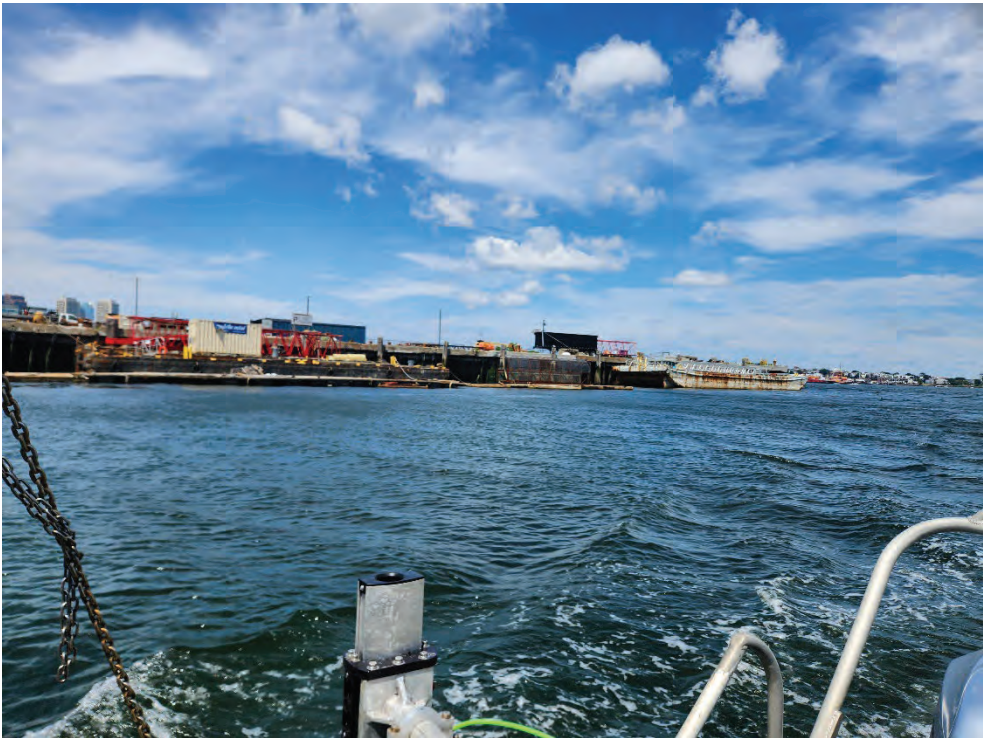
| Survey Area: | South Boston Waterfront | Date: 8/9/2023 |
|---|---|---|
| | <ul style="list-style-type: none"> <li>- Channel between Legal Sea Foods HQ and Dry Dock II</li> <li>- View of eastern pier of Boston Dry Dock II</li> </ul> | |

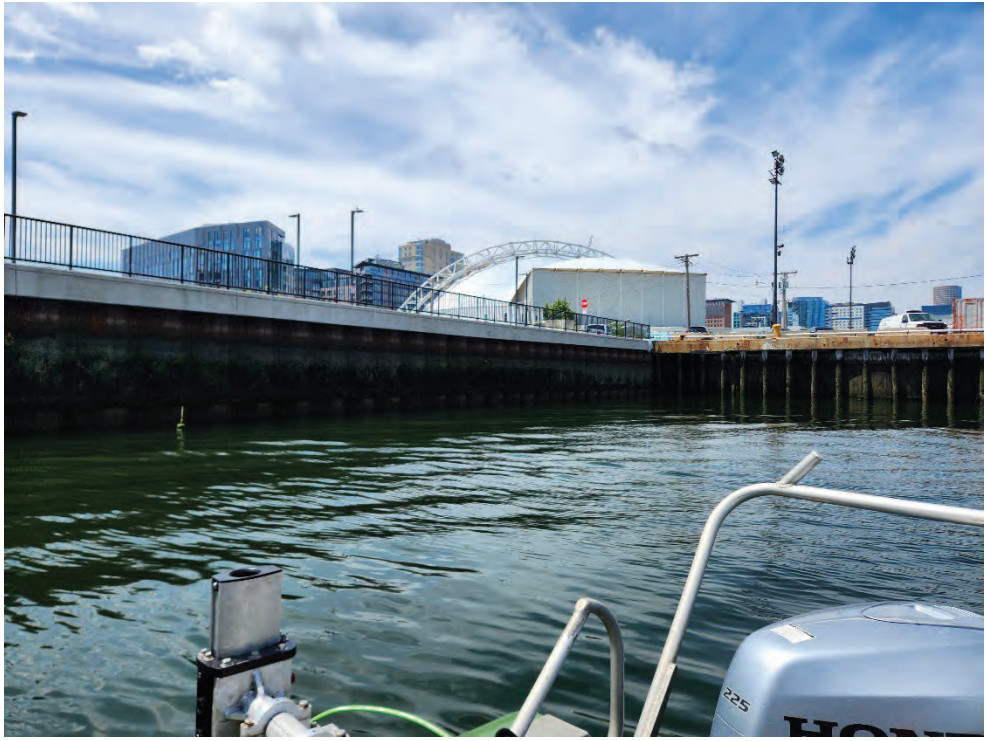
| Survey Area: <i>South Boston Waterfront</i> | Date: <i>8/9/2023</i> |
|---|---|
| | <ul style="list-style-type: none"> <li>- <i>Northern end of channel between Legal Sea Foods HQ and Dry Dock II</i></li> <li>- <i>Steel, wooden bulkheads, wooden pilings</i></li> <li>- <i>Algae</i></li> </ul> |

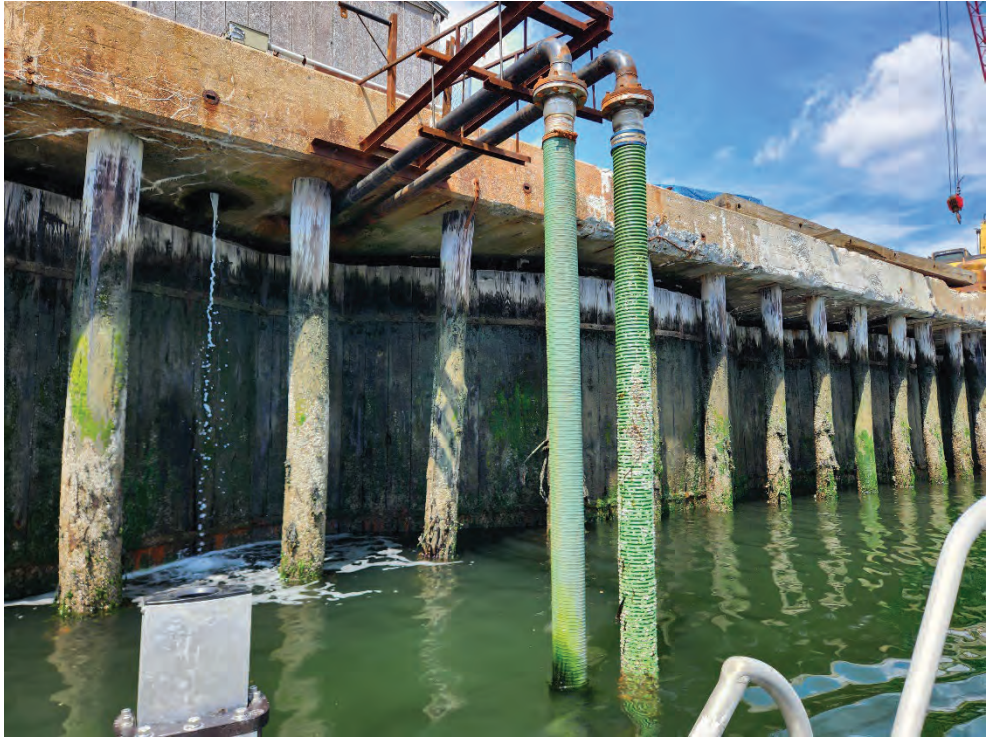
| Survey Area: <i>South Boston Waterfront</i> | Date: <i>8/9/2023</i> |
|---|---|
| | <ul style="list-style-type: none"> <li>- <i>Northern side of channel between Legal Sea Foods HQ and Dry Dock II</i></li> <li>- <i>Wooden bulkhead, wood pilings, concrete slabbing</i></li> <li>- <i>Algae, barnacles</i></li> </ul> |

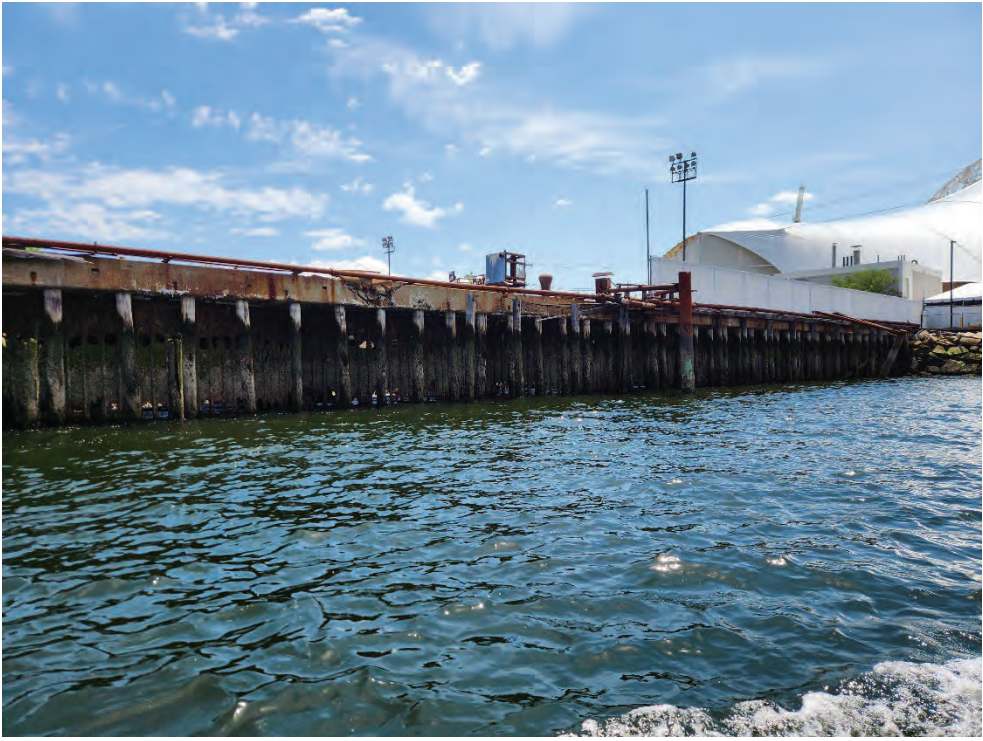
| Survey Area: <i>South Boston Waterfront</i> | Date: <i>8/9/2023</i> |
|---|---|
| | <ul style="list-style-type: none"> <li>- <i>Channel between Dry Dock II and Fish Pier</i></li> <li>- <i>Steel bulkhead, wood pilings, concrete/rebar slabbing</i></li> <li>- <i>Algae, barnacles</i></li> </ul> |

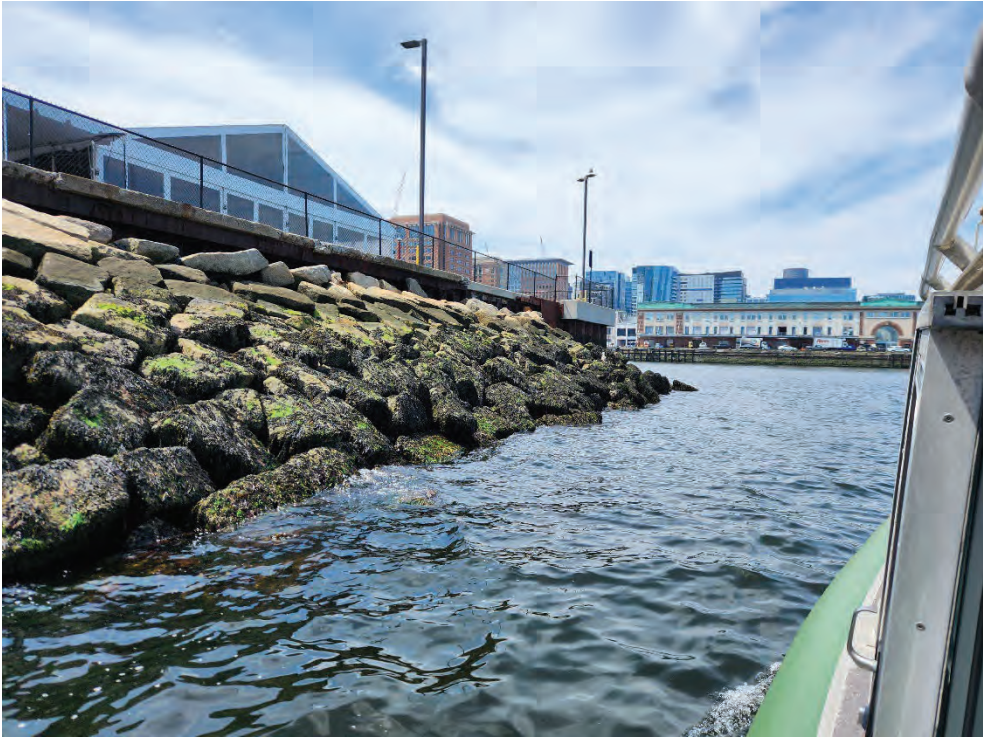
| Survey Area: <i>South Boston Waterfront</i> | Date: <i>8/9/2023</i> |
|---|---|
| | <ul style="list-style-type: none"> <li>- <i>End of channel between Dry Dock II and Fish Pier</i></li> <li>- <i>Stone seawall/ retaining wall</i></li> <li>- <i>Algae and macroalgae</i></li> </ul> |

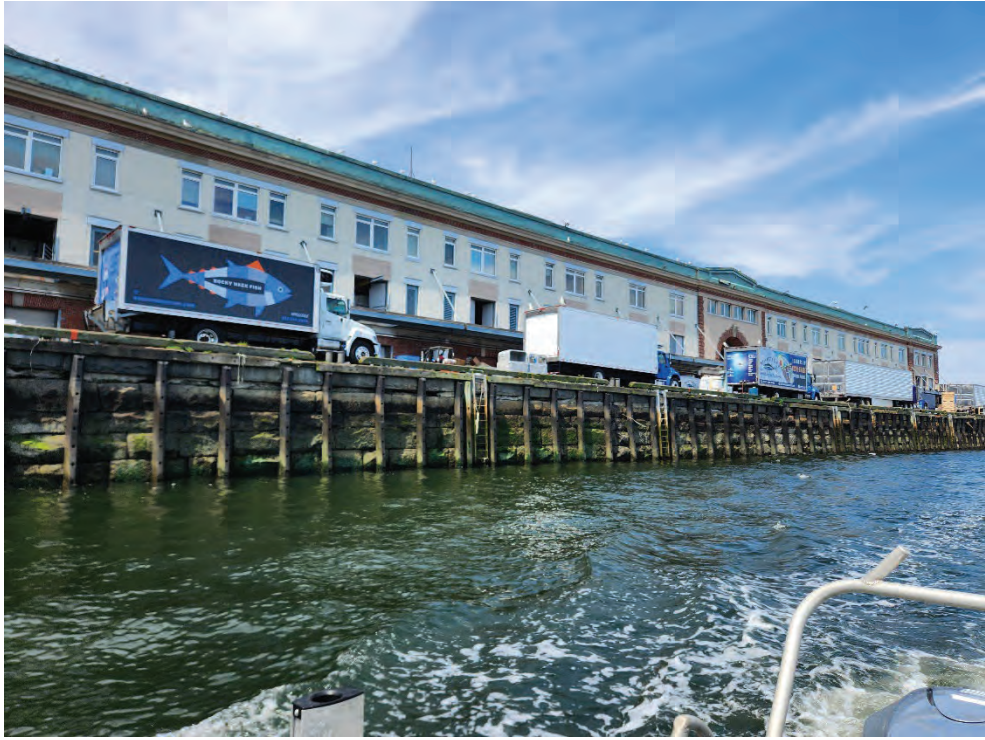
| Survey Area: <i>South Boston Waterfront</i> | Date: <i>8/9/2023</i> |
|---|---|
| | <ul style="list-style-type: none"> <li>- <i>Channel between Dry Dock II and Fish Pier facing the Fish Pier</i></li> <li>- <i>Stone seawall</i></li> <li>- <i>Algae and macroalgae</i></li> </ul> |

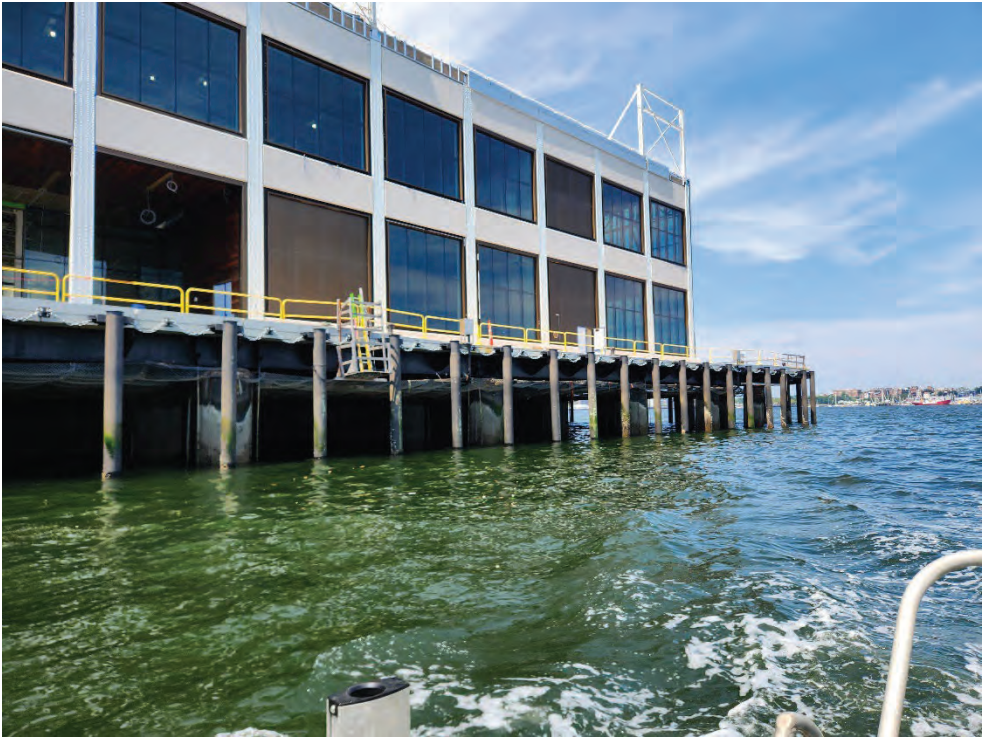
| Survey Area: <i>South Boston Waterfront</i> | Date: <i>8/9/2023</i> |
|---|---|
| | <ul style="list-style-type: none"> <li>- <i>Channel between Fish Pier and Commonwealth Pier</i></li> <li>- <i>Concrete, steel pilings</i></li> </ul> |

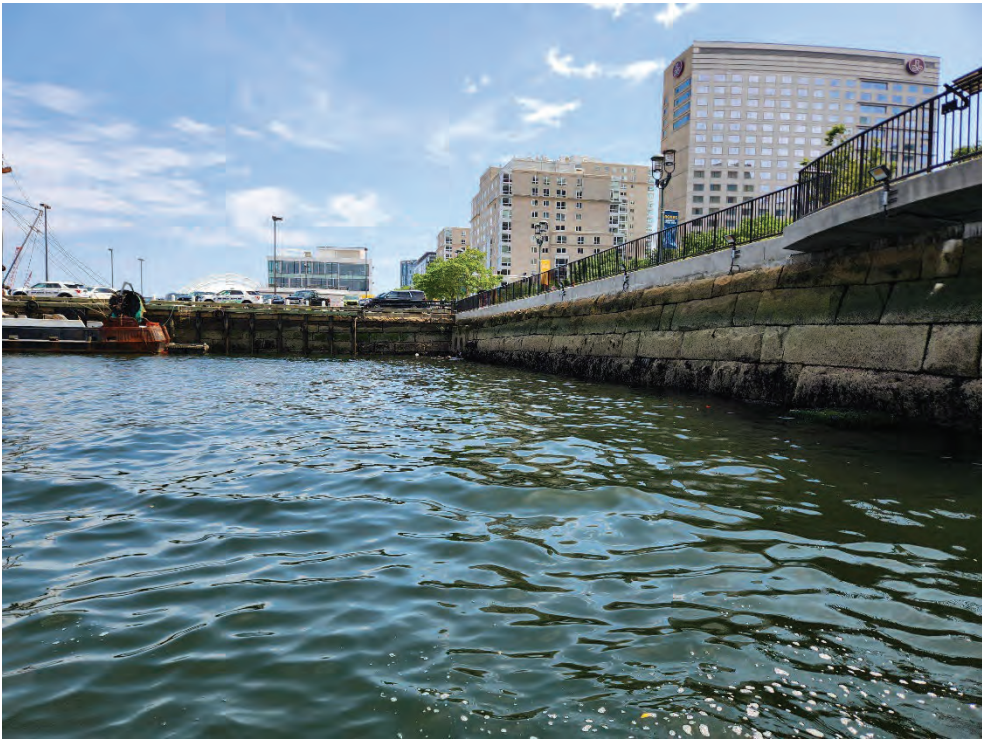
| Survey Area: <i>South Boston Waterfront</i> | Date: <i>8/9/2023</i> |
|---|---|
| | <ul style="list-style-type: none"> <li>- <i>End of channel between Fish Pier and Commonwealth Pier</i></li> <li>- <i>Stone seawall</i></li> <li>- <i>drainage pipes</i></li> <li>- <i>Algae, macroalgae, and barnacles</i></li> </ul> |

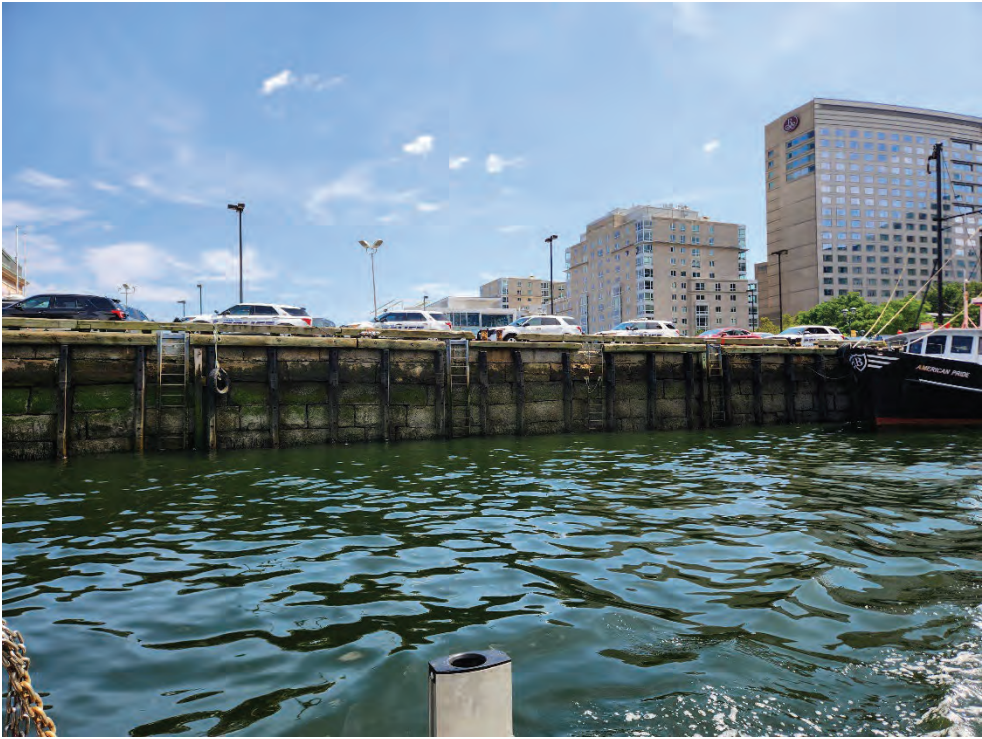
| Survey Area: <i>South Boston Waterfront</i> | Date: <i>8/9/2023</i> |
|---|---|
| | <ul style="list-style-type: none"> <li>- <i>Channel between Fish Pier and Commonwealth Pier facing the Fish Pier</i></li> <li>- <i>Stone seawall/ bulkhead</i></li> </ul> |

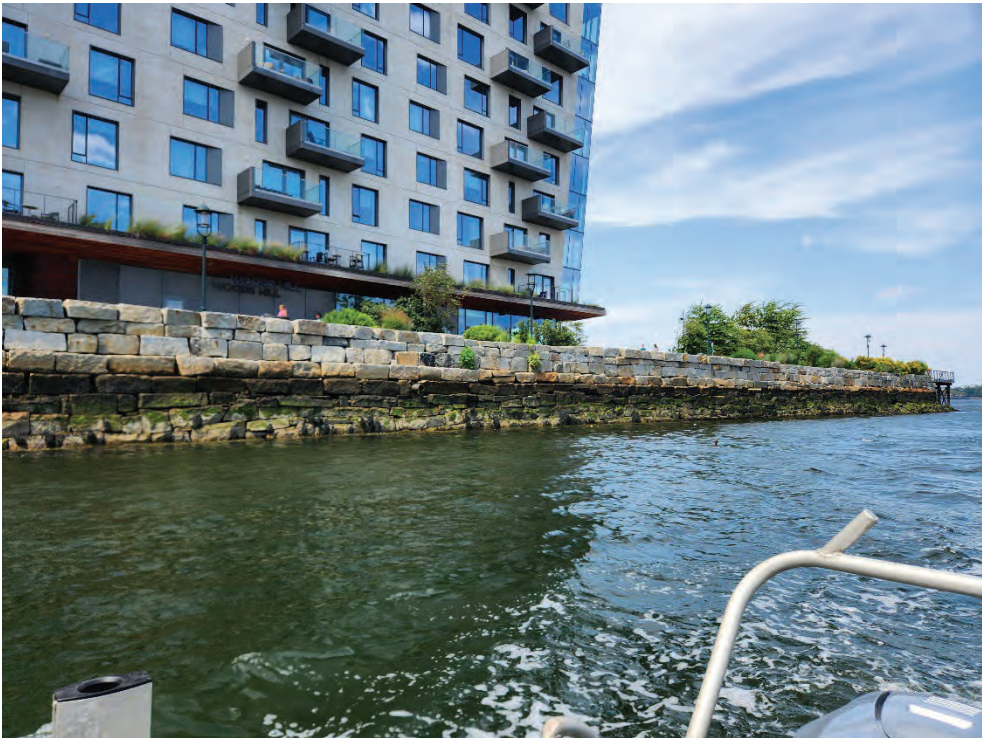
| Survey Area: <i>South Boston Waterfront</i> | Date: <i>8/9/2023</i> |
|---|---|
| | <ul style="list-style-type: none"> <li>- <i>Channel Commonwealth Pier and Pier 4, facing Pier 4</i></li> <li>- <i>Stone seawall</i></li> <li>- <i>Algae, marcoalgae, and barnacles</i></li> </ul> |

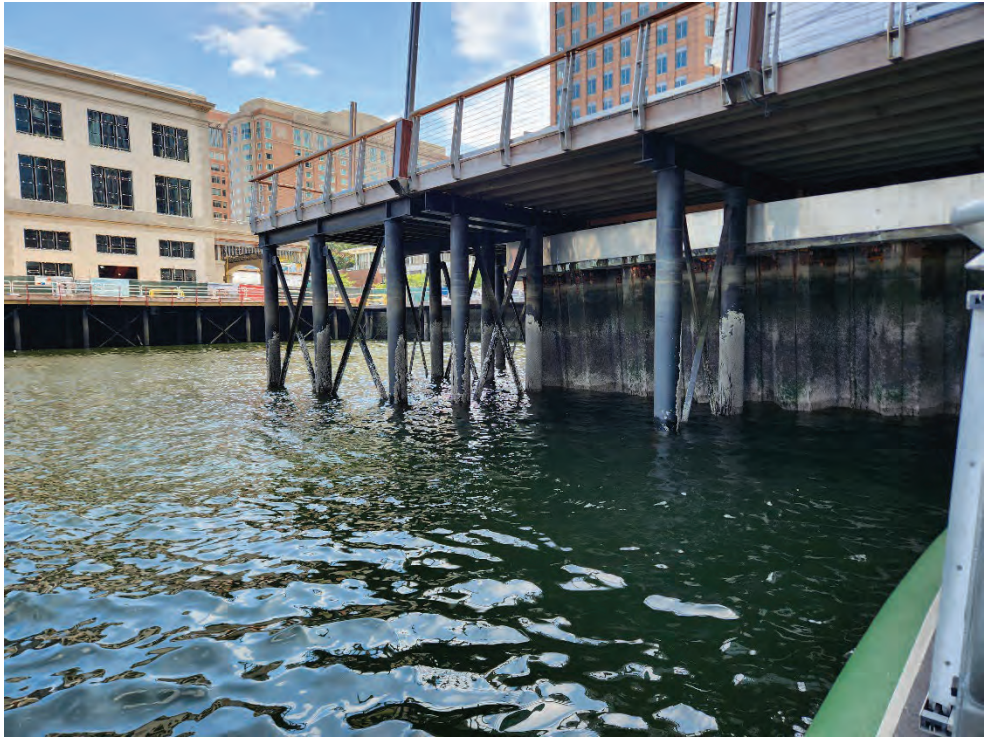
| Survey Area: | South Boston Waterfront | Date: 8/9/2023 |
|---|---|---|
| | <ul style="list-style-type: none"> <li>- End of channel between Commonwealth Pier and Pier 4</li> <li>- Steel bulkhead, pilings</li> <li>- Barnacles</li> </ul> | |

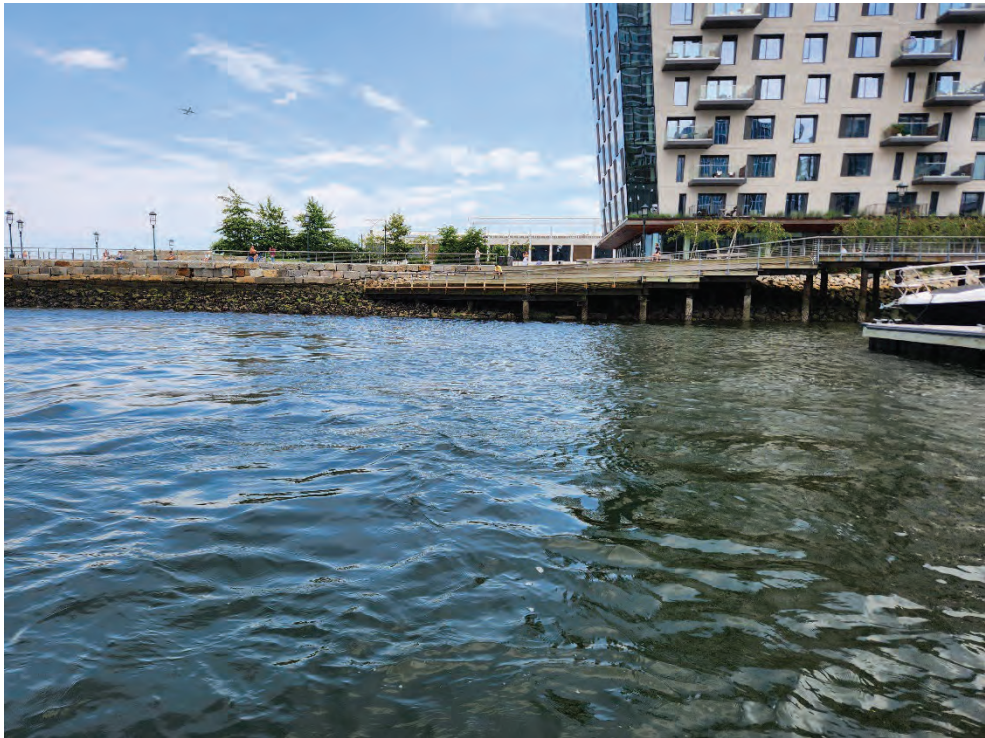
| Survey Area: | South Boston Waterfront | Date: 8/9/2023 |
|---|---|---|
| | <ul style="list-style-type: none"> <li>- Southern side of Fan Pier marina</li> <li>- Stone seawall and rip-rap</li> <li>- Algae and macroalgae</li> </ul> | |

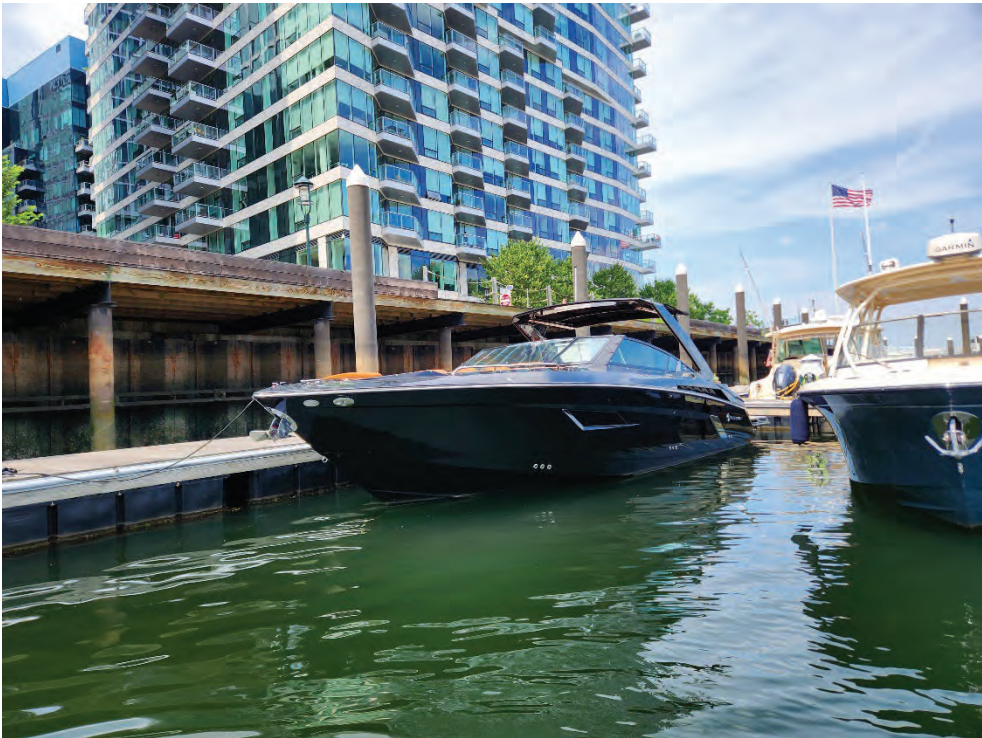
| Survey Area: <i>South Boston Waterfront</i> | Date: <i>8/9/2023</i> |
|---|---|
| | <ul style="list-style-type: none"> <li>- <i>Northern side of Fan Pier marina</i></li> <li>- <i>Steel bulkhead and pilings</i></li> <li>- <i>Floating docks</i></li> </ul> |

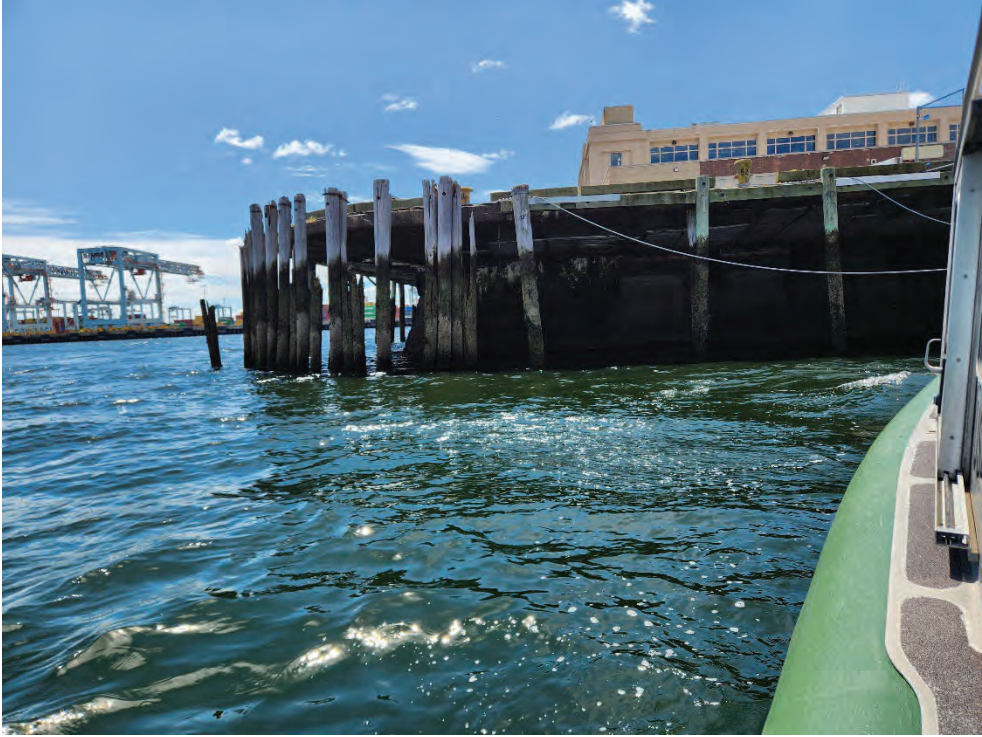
| Survey Area: | Date: |
|---|---|
| | <ul style="list-style-type: none"> <li>- <i>Southern side of Boston Dry Dock III Channel</i></li> <li>- <i>Wood pilings and bulkhead</i></li> </ul> |

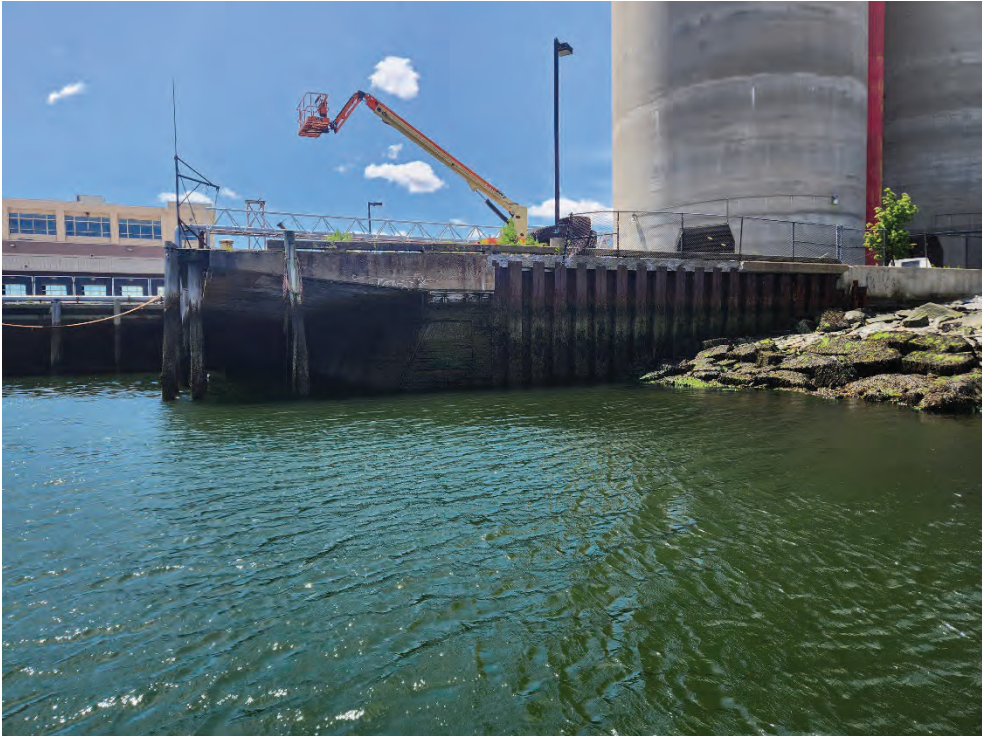
| Survey Area: | Date: |
|---|---|
| | <ul style="list-style-type: none"> <li>- <i>End of Boston Dry Dock III Channel</i></li> <li>- <i>Steel and wooden bulkheads</i></li> <li>- <i>Wood pilings, concrete supports</i></li> <li>- <i>Stone rip-rap</i></li> <li>- <i>Algae and macroalgae</i></li> </ul> |

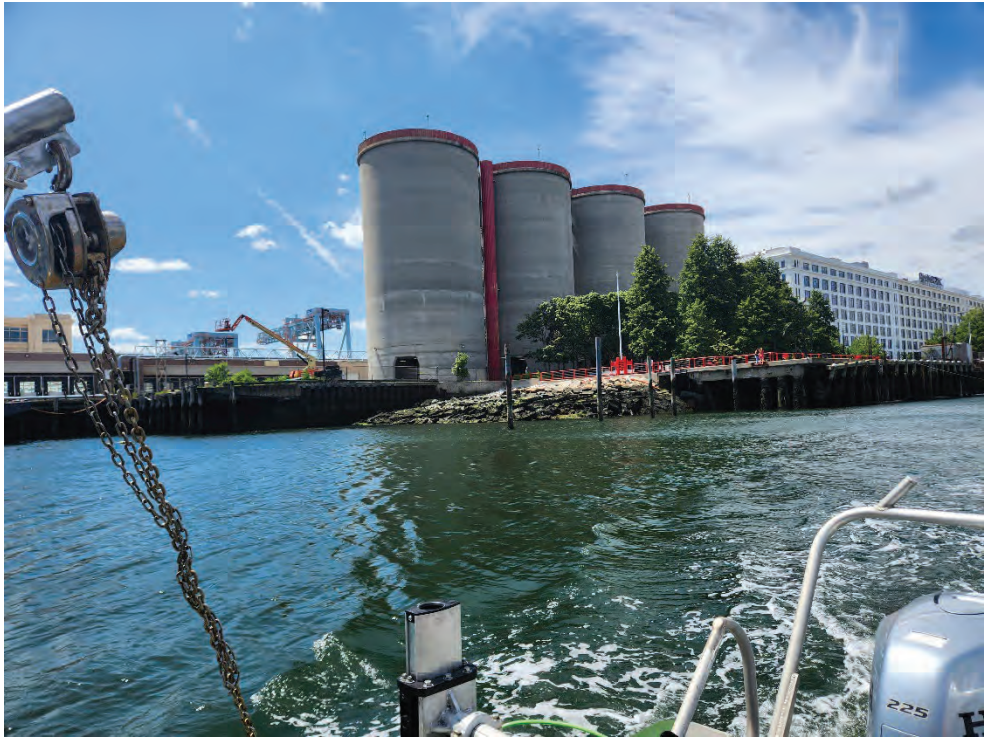
| Survey Area: | Date: |
|---|---|
| | <ul style="list-style-type: none"> <li>- End of Boston Dry Dock III Channel</li> <li>- Steel and wooden bulkheads</li> <li>- Wood pilings, concrete supports</li> <li>- Stone rip-rap</li> <li>- Algae and macroalgae</li> <li>- Upland vegetation (Drydock Green Space park)</li> </ul> |

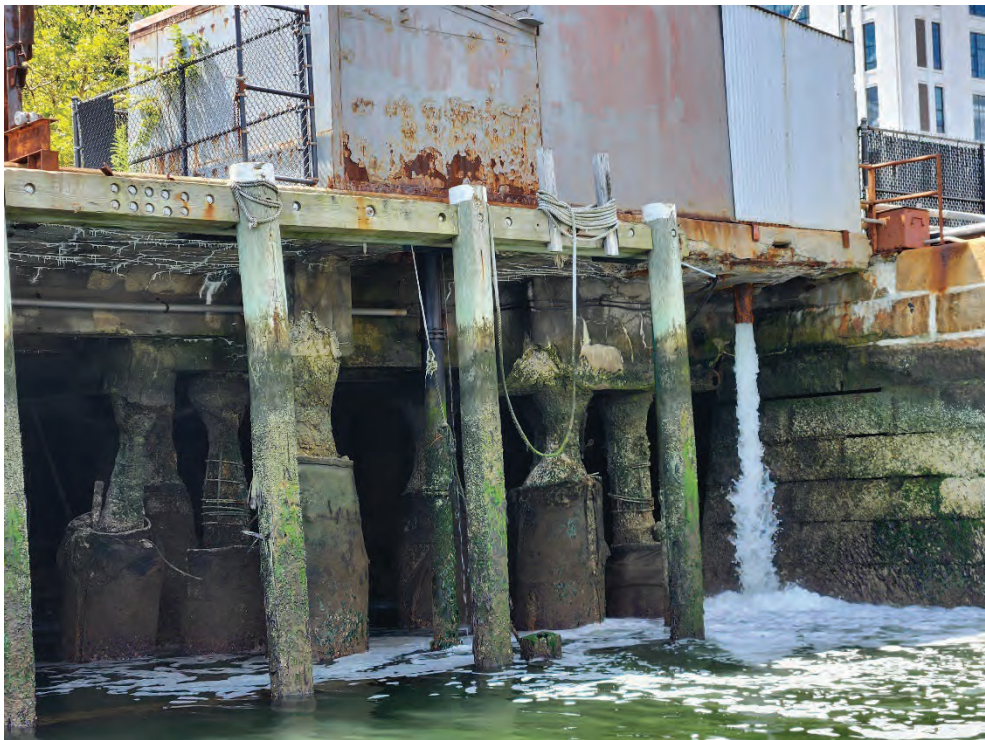
| Survey Area: | Date: |
|---|---|
| | <ul style="list-style-type: none"> <li>- End of Boston Dry Dock III Channel</li> <li>- Stone seawall</li> <li>- Decaying concrete pilings, wood pilings</li> <li>- Dry dock water discharge pipe</li> </ul> |
