# Boston Coastal Storm Risk Management Study

## Draft Integrated Feasibility Report and Programmatic Environmental Assessment

### APPENDIX D - ENVIROMENTAL

# INTERTIDAL AND SUBTIDAL HABITAT SURVEYS

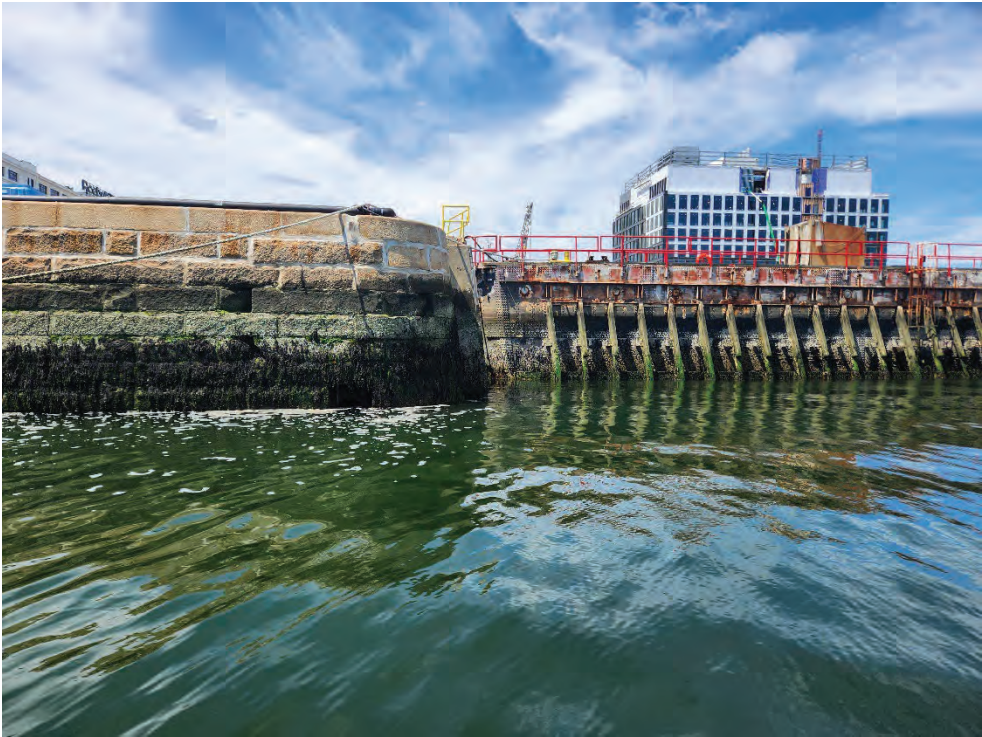
| Survey Area: | Date: |
|---|---|
| | <ul style="list-style-type: none"> <li>- End of Boston Dry Dock III Channel</li> <li>- Stone seawall</li> <li>- Metal dry dock gate with wooden supports</li> <li>- Macroalgae</li> </ul> |

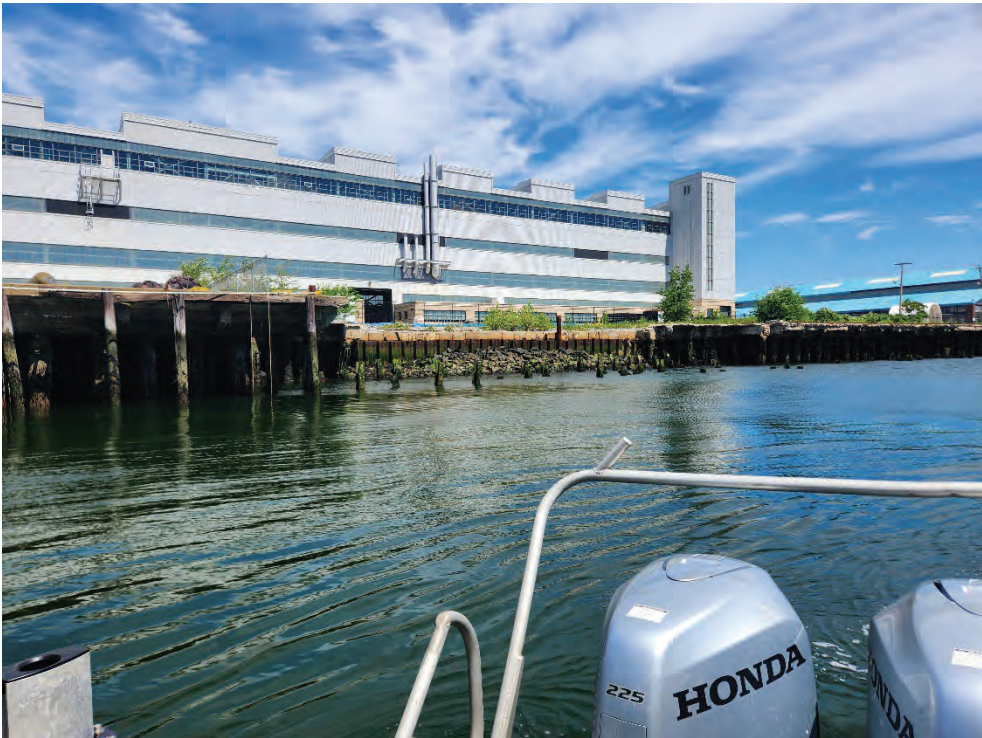
| Survey Area: | Date: |
|---|---|
| | <ul style="list-style-type: none"> <li>- Northern side of Boston Dry Dock III Channel</li> <li>- Decomposing concrete pilings, bulkhead, blocks, and slabs</li> <li>- Wood and steel pilings</li> <li>- Stone slabs</li> <li>- Upland vegetation</li> <li>- Barnacles, algae, macroalgae</li> </ul> |

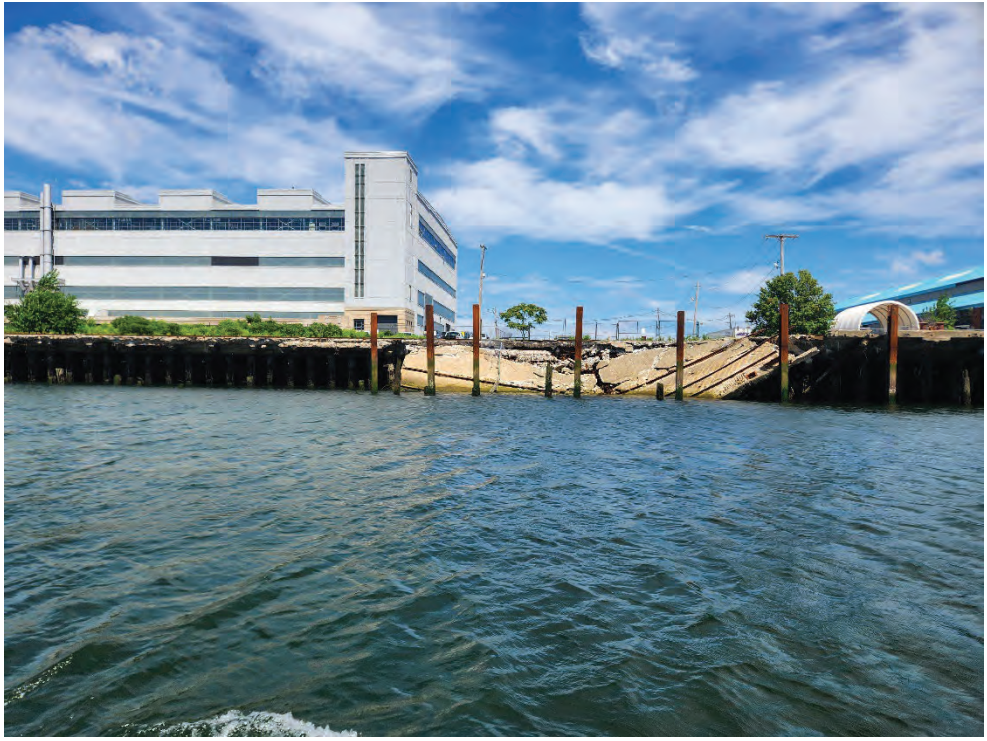
| Survey Area: <i>South Boston Waterfront – Dry Dock / Reserved Channel</i> | Date: <i>8/9/2023</i> |
|---|---|
| | <ul style="list-style-type: none"> <li>- <i>Northern side of Boston Dry Dock III Channel</i></li> <li>- <i>Decomposing concrete pilings, bulkhead, blocks, and slabs</i></li> <li>- <i>Wood and steel pilings</i></li> <li>- <i>Stone slabs</i></li> <li>- <i>Crumbling concrete landing</i></li> <li>- <i>Upland vegetation</i></li> <li>- <i>Barnacles, algae</i></li> </ul> |

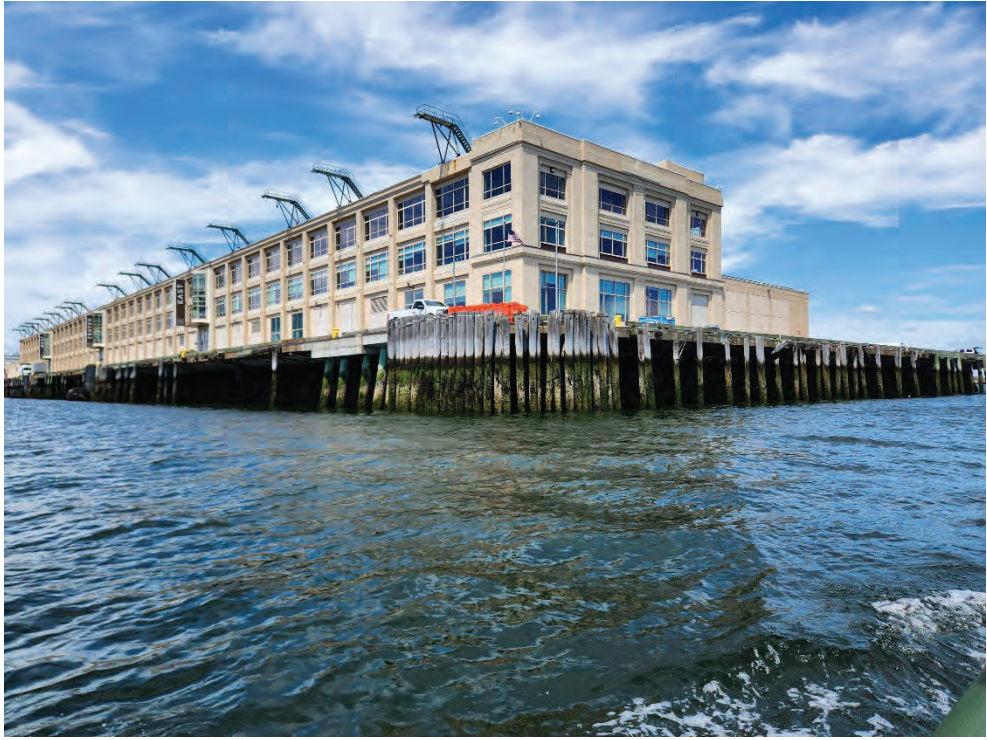
| Survey Area: <i>South Boston Waterfront – Dry Dock / Reserved Channel</i> | Date: <i>8/9/2023</i> |
|---|---|
| | <ul style="list-style-type: none"> <li>- <i>Reserved Channel entrance facing the northern shoreline</i></li> <li>- <i>Wood/concrete pilings</i></li> <li>- <i>Algae, macroalgae, and barnacles</i></li> </ul> |

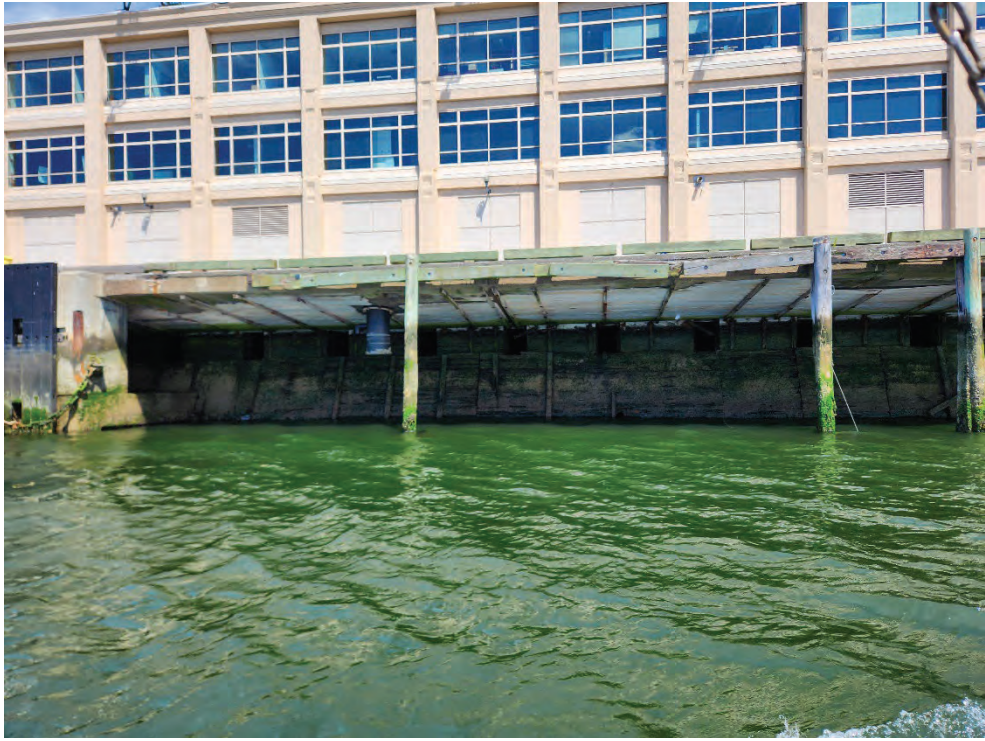
| Survey Area: | South Boston Waterfront – Reserved Channel | Date: 8/9/2023 |
|---|---|---|
| | <ul style="list-style-type: none"> <li>- Reserved Channel facing the northern shoreline</li> <li>- Wood pilings and bulkhead</li> <li>- Concrete support structures</li> <li>- Algae</li> </ul> | |

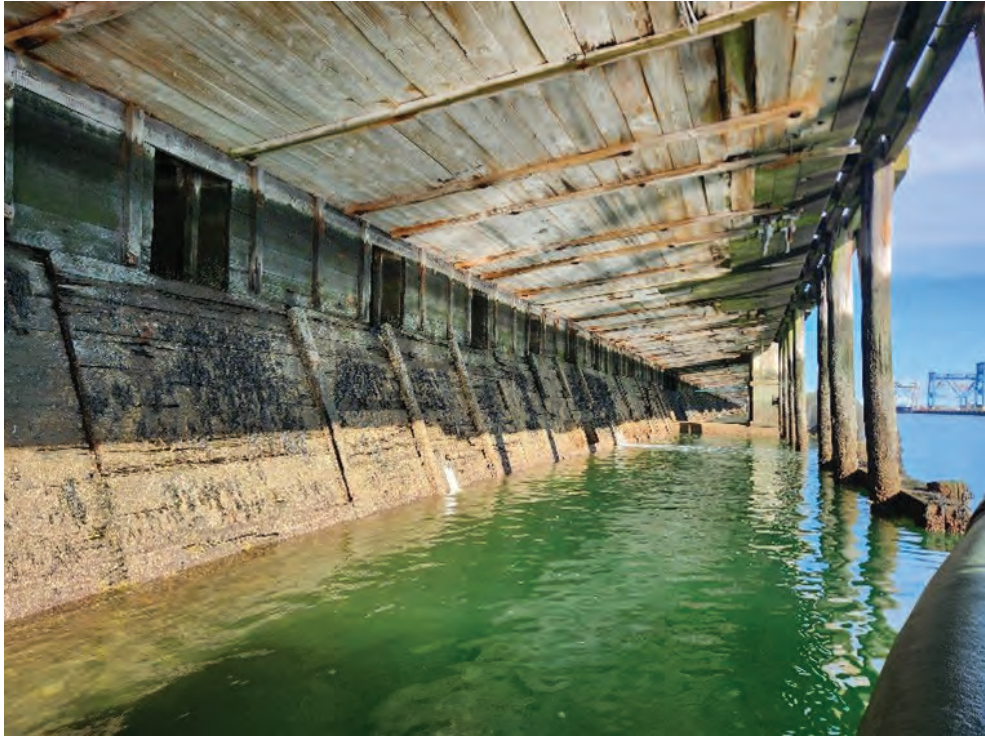
| Survey Area: | South Boston Waterfront – Reserved Channel | Date: 8/9/2023 |
|---|---|---|
| | <ul style="list-style-type: none"> <li>- Reserved Channel northern shoreline</li> <li>- Beneath the pier, adjacent to wooden bulkhead</li> </ul> | |

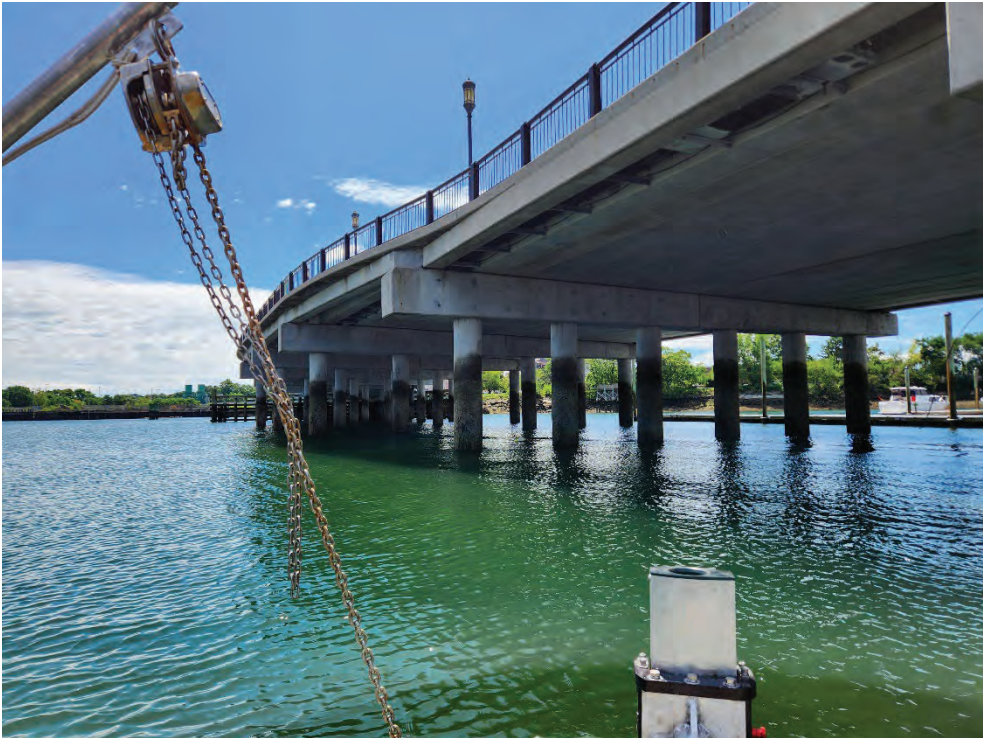
| Survey Area: | South Boston Waterfront – Reserved Channel | Date: 8/9/2023 |
|---|---|---|
| | <ul style="list-style-type: none"> <li>- End of the Reserved Channel</li> <li>- Concrete bridge supports</li> </ul> | |

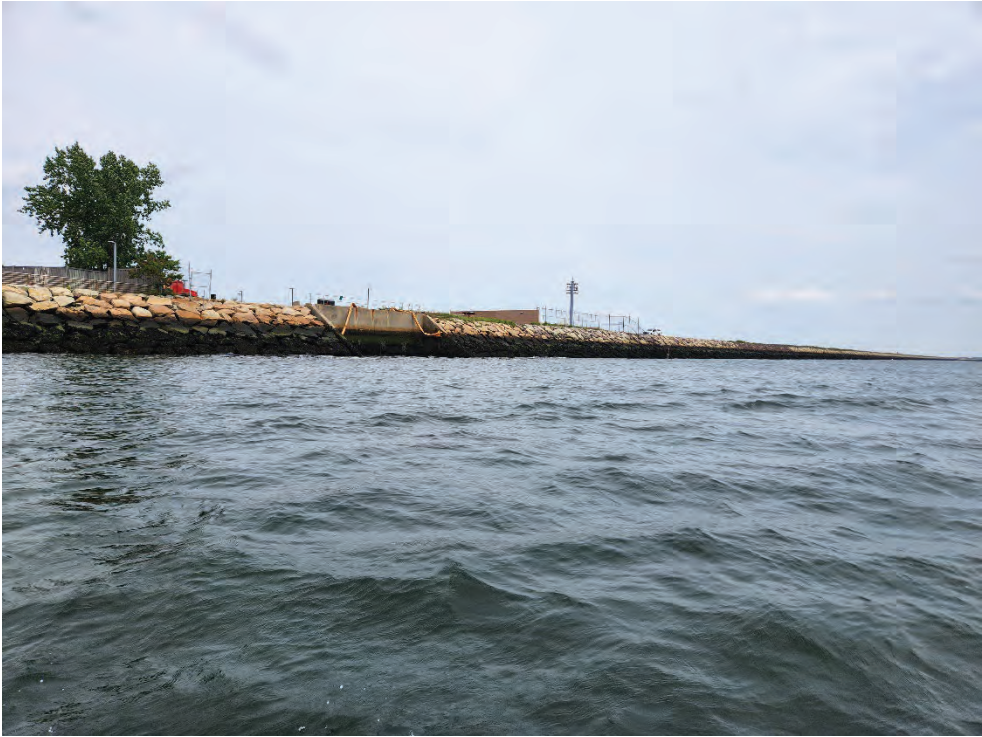
| Survey Area: <i>Boston Harbor Surge Barrier</i> | Date: <i>8/10/2023</i> |
|---|---|
| | <ul style="list-style-type: none"> <li>- <i>Logan Airport southern shoreline</i></li> <li>- <i>Stone seawall</i></li> <li>- <i>Algae and macroalgae</i></li> </ul> |

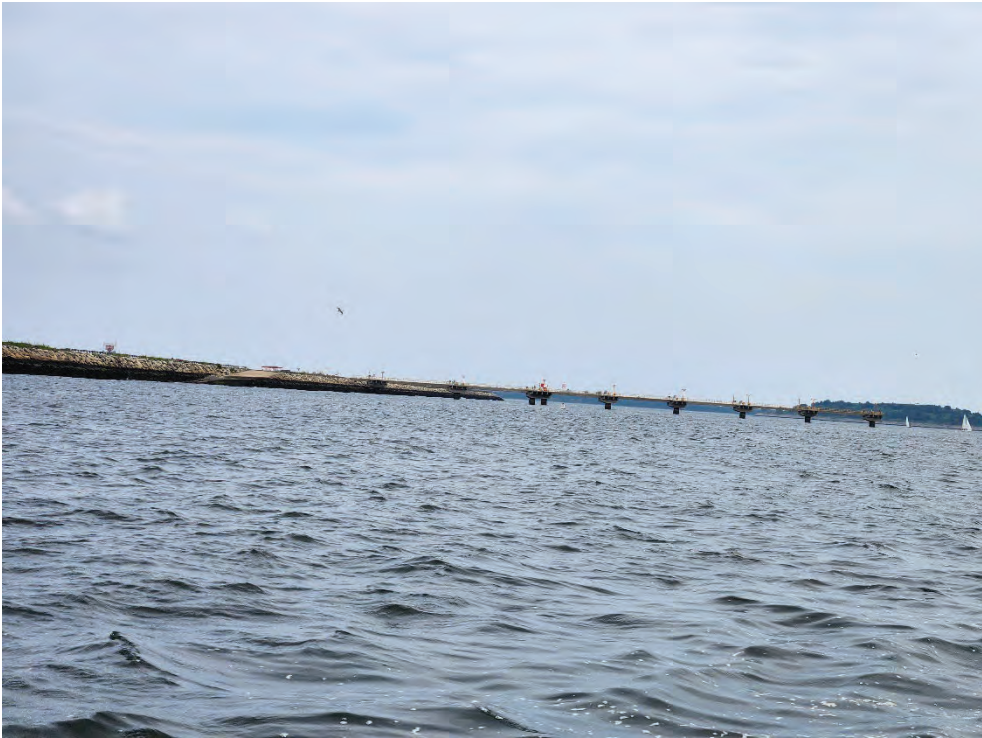
| Survey Area: <i>Boston Harbor Surge Barrier</i> | Date: <i>8/10/2023</i> |
|---|---|
| | <ul style="list-style-type: none"> <li>- <i>Logan Airport southern shoreline</i></li> <li>- <i>Stone seawall</i></li> <li>- <i>Approach Light Line Pier seen in the distance</i></li> </ul> |

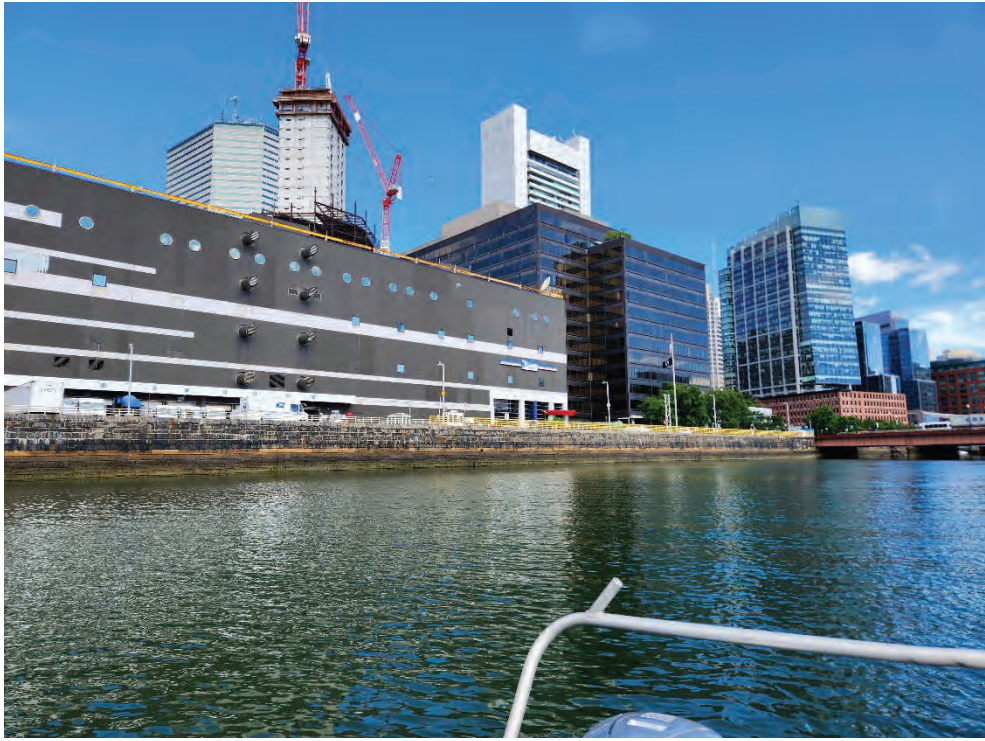
| Survey Area: | Fort Point Channel | Date: 8/9/2023 |
|---|---|---|
| | <ul style="list-style-type: none"> <li>- Fort Point Channel facing the Downtown shoreline</li> <li>- Stone seawall</li> <li>- Algae and macroalgae</li> </ul> | |

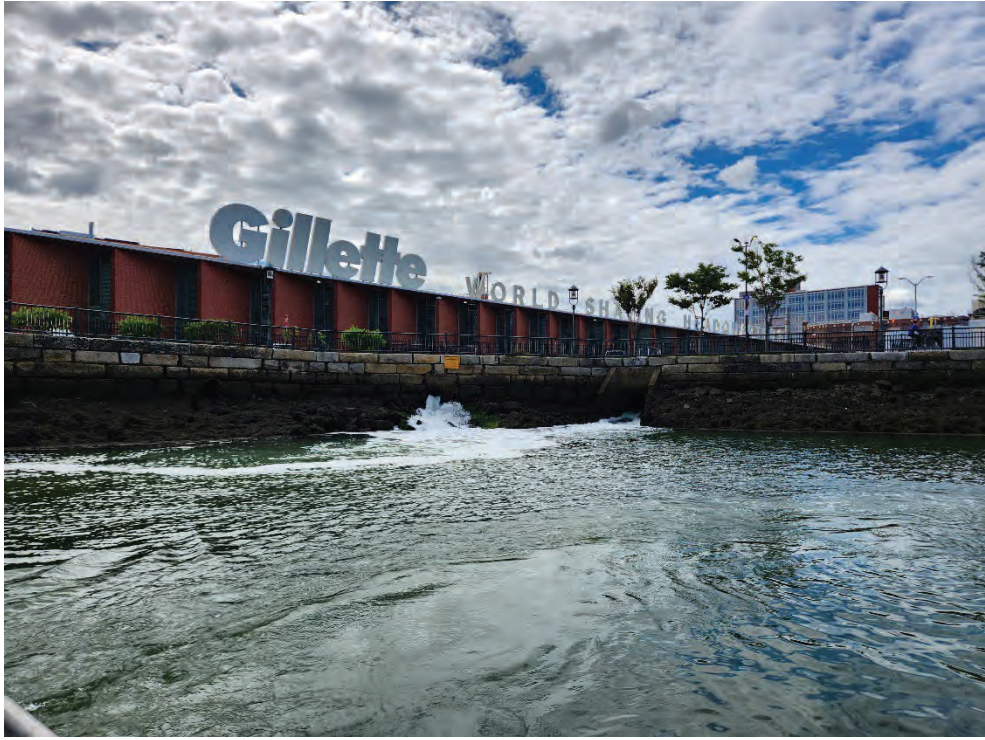
| Survey Area: | Fort Point Channel | Date: 8/9/2023 |
|---|---|---|
| | <ul style="list-style-type: none"> <li>- End of the Fort Point Channel facing the South Boston shoreline</li> <li>- Gillette World Shaving Headquarters</li> <li>- Steel piling-supported concrete slab walkways</li> <li>- Stone seawall</li> <li>- Algae, macroalgae, and barnacles</li> </ul> | |

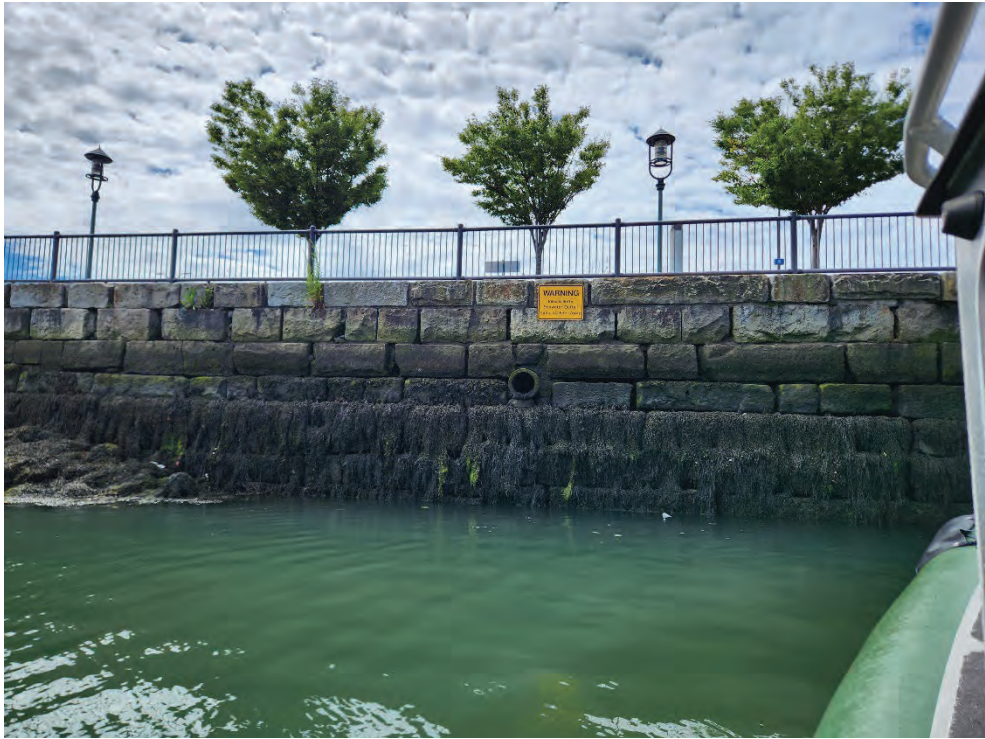
| Survey Area: <i>Fort Point Channel</i> | Date: <i>8/9/2023</i> |
|---|---|
| | <ul style="list-style-type: none"> <li>- <i>End of the Fort Point Channel</i></li> <li>- <i>Stone rip-rap and seawall</i></li> <li>- <i>Drainage pipe</i></li> <li>- <i>Macroalgae spp.</i></li> </ul> |

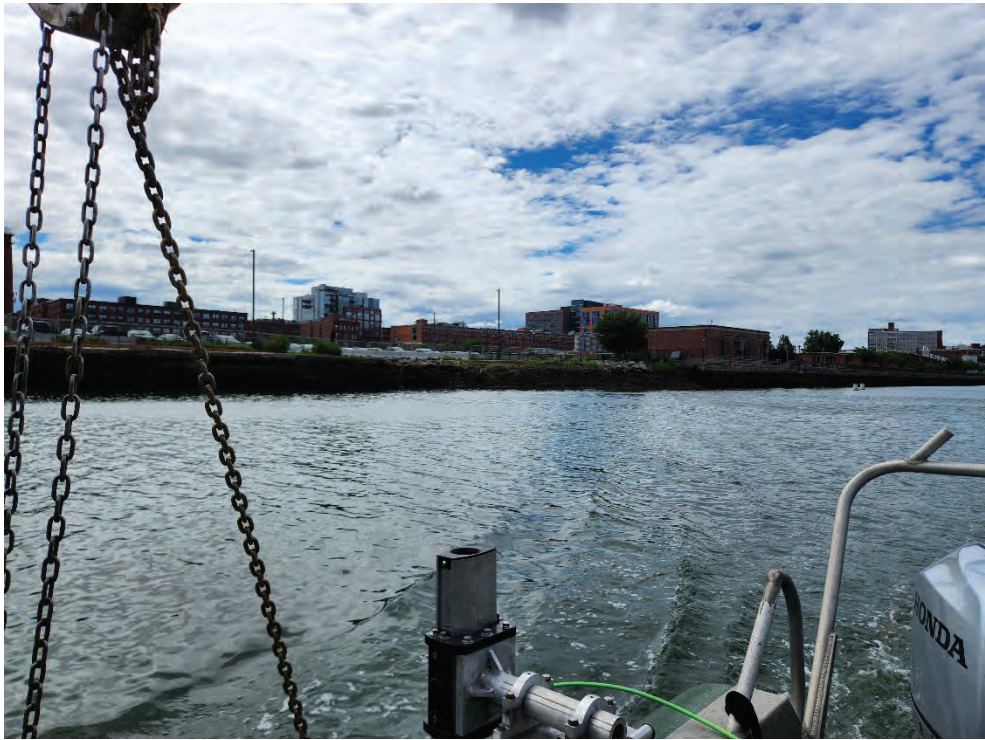
| Survey Area: <i>Fort Point Channel</i> | Date: <i>8/9/2023</i> |
|---|---|
| | <ul style="list-style-type: none"> <li>- <i>Fort Point Channel facing the South Boston shoreline</i></li> <li>- <i>Stone seawall</i></li> <li>- <i>Cobble beach</i></li> <li>- <i>Macroalgae and algae</i></li> <li>- <i>CSO BOS072 station visible in distance</i></li> <li>- <i>Upland vegetation</i></li> </ul> |

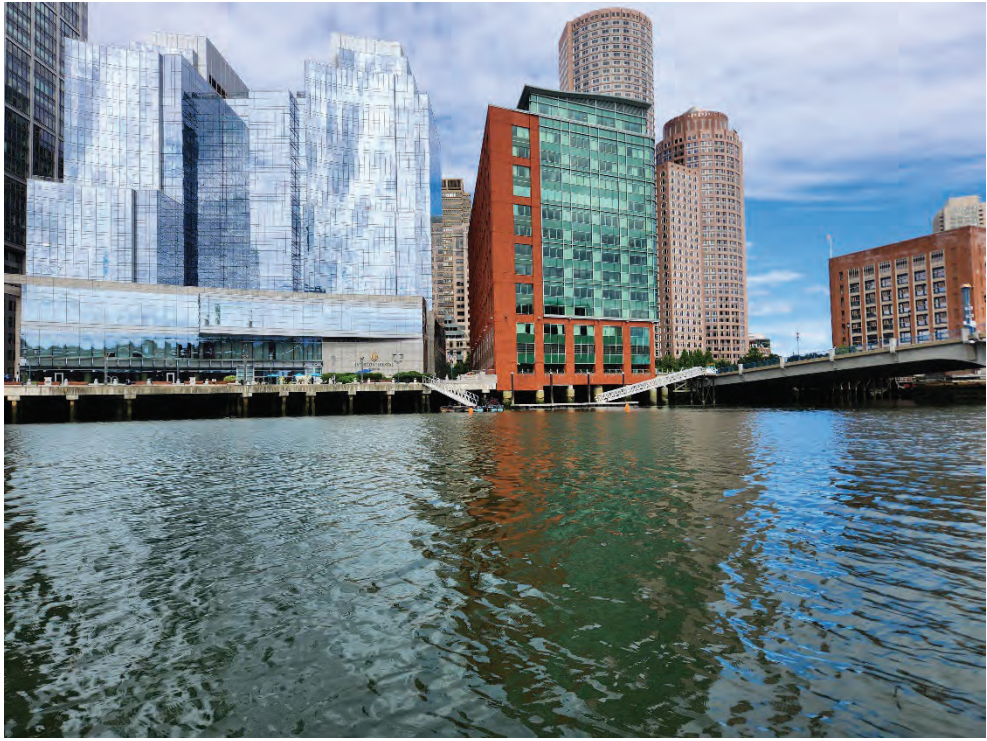
| Survey Area: <i>Fort Point Channel</i> | Date: <i>8/9/2023</i> |
|---|---|
| | <ul style="list-style-type: none"> <li>- <i>Fort Point Channel facing the Downtown shoreline</i></li> <li>- <i>Wood and concrete piling supported, developed shoreline</i></li> <li>- <i>Steel bulkhead underneath</i></li> </ul> |

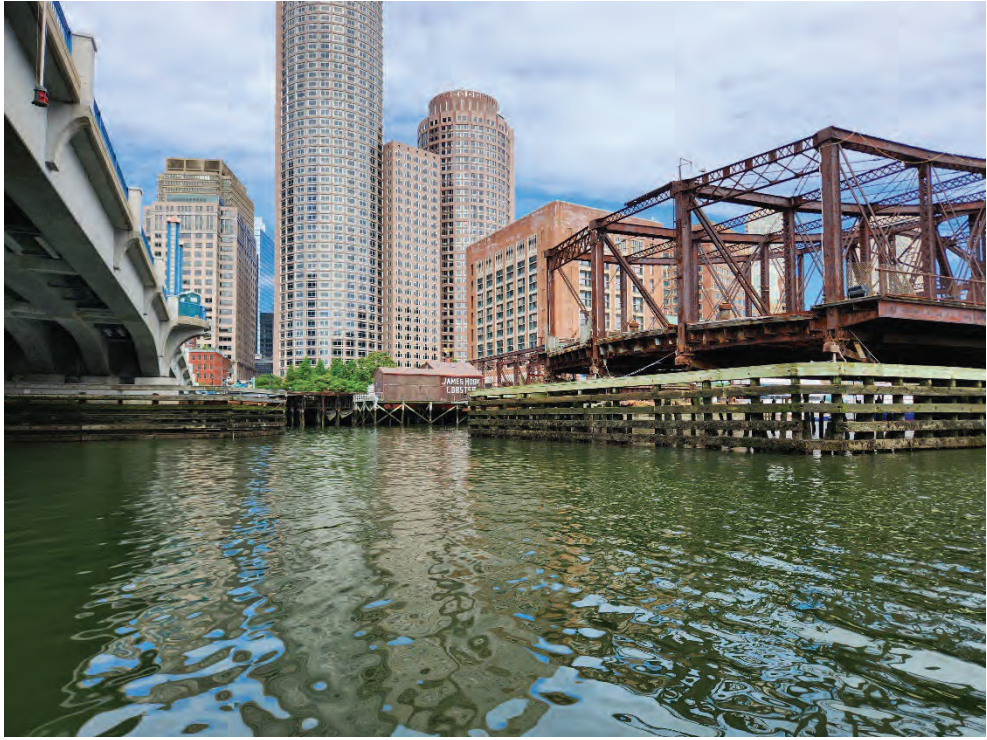
| Survey Area: <i>Fort Point Channel</i> | Date: <i>8/9/2023</i> |
|---|---|
| | <ul style="list-style-type: none"> <li>- <i>Fort Point Channel facing the Downtown shoreline</i></li> <li>- <i>Wood pilings</i></li> <li>- <i>Wood structures encasing bridge piers</i></li> </ul> |

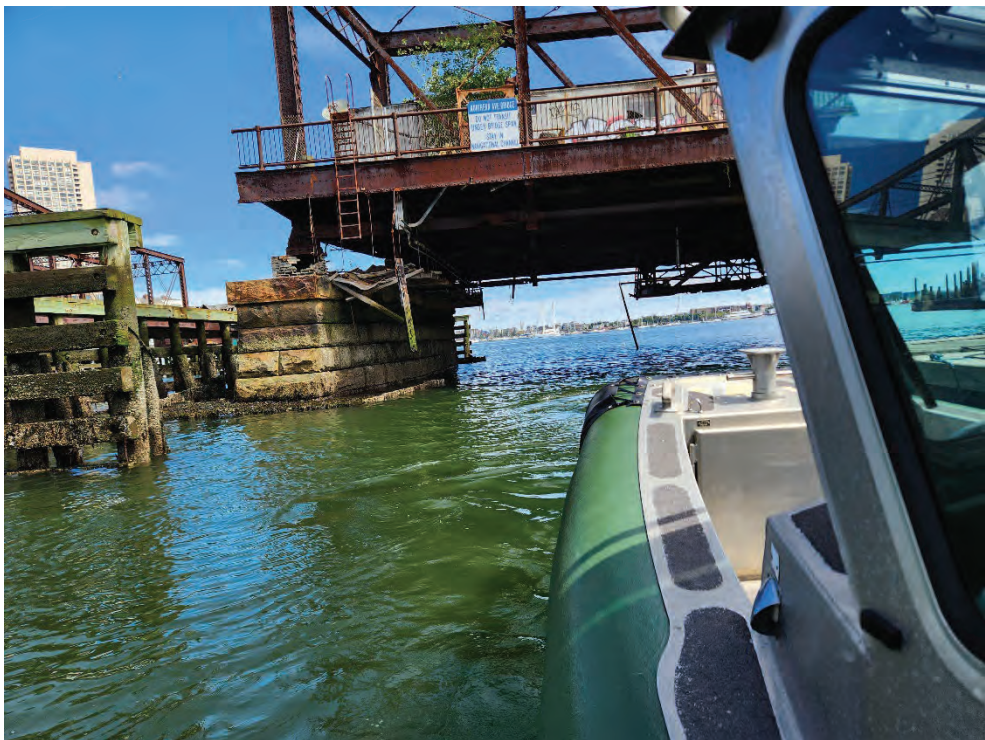
| Survey Area: <i>Fort Point Channel</i> | Date: <i>8/9/2023</i> |
|---|---|
| | <ul style="list-style-type: none"> <li>- <i>Fort Point Channel entrance facing the South Boston shoreline</i></li> <li>- <i>Derelict bridge structures</i></li> <li>- <i>Barnacles, macroalgae</i></li> </ul> |

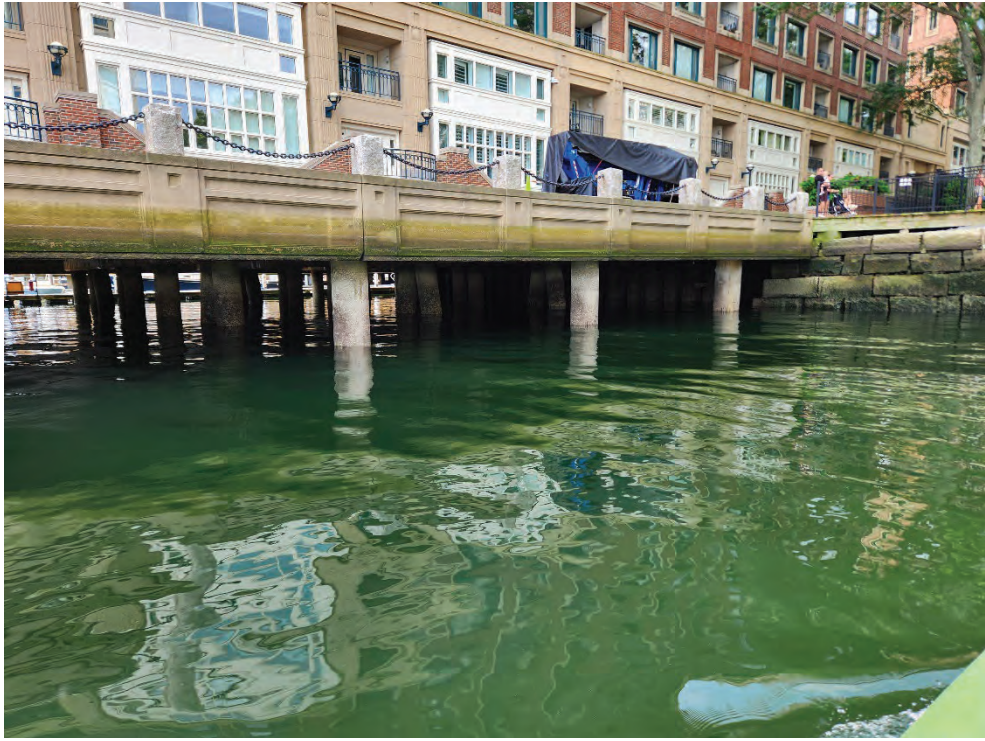
| Survey Area: <i>Downtown Waterfront</i> | Date: <i>8/10/2023</i> |
|---|---|
| | <ul style="list-style-type: none"> <li>- <i>Rowes Wharf</i></li> <li>- <i>Developed, residential shoreline</i></li> <li>- <i>Concrete piling supported wharf</i></li> <li>- <i>Stone seawall</i></li> <li>- <i>Macroalgae and barnacles</i></li> </ul> |

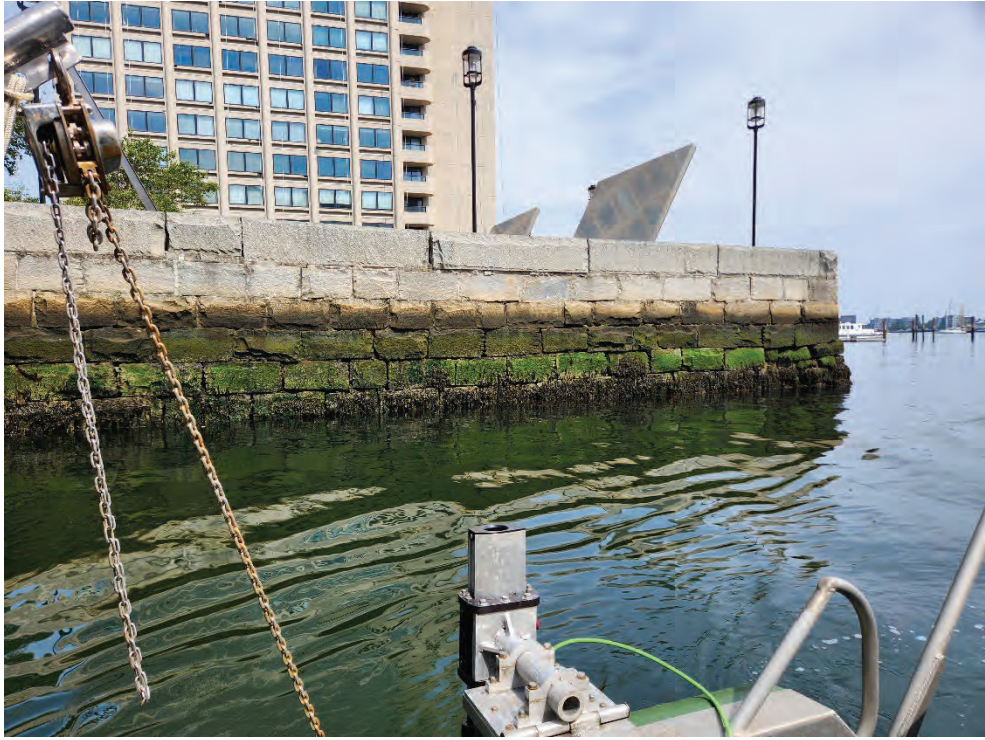
| Survey Area: <i>Downtown Waterfront</i> | Date: <i>8/10/2023</i> |
|---|---|
| | <ul style="list-style-type: none"> <li>- <i>Rowes Wharf</i></li> <li>- <i>Stone seawall</i></li> <li>- <i>Macroalgae and barnacles</i></li> </ul> <p><i>* This characterizes most of the non-piling supported piers and shoreline</i></p> |

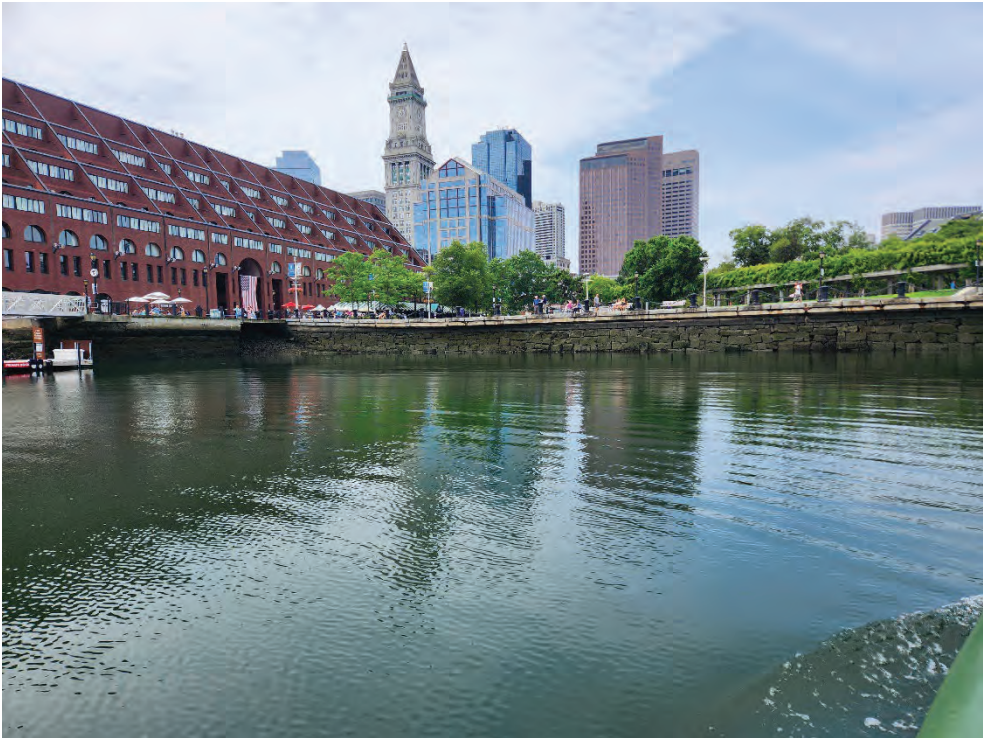
| Survey Area: <i>Downtown Waterfront</i> | Date: <i>8/10/2023</i> |
|---|---|
| | <ul style="list-style-type: none"> <li>- <i>Marriot Hotel, Long Wharf</i></li> <li>- <i>Stone seawall</i></li> <li>- <i>Rocky/cobbly area with emergent drainage pipes</i></li> <li>- <i>Macroalgae</i></li> </ul> |

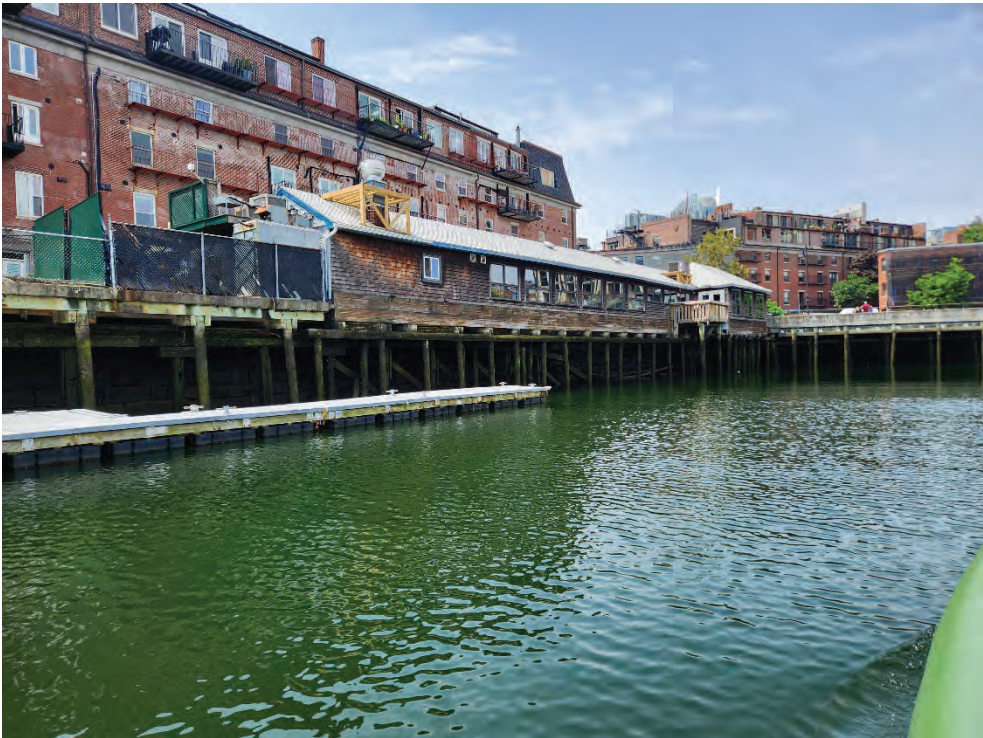
| Survey Area: <i>Downtown Waterfront</i> | Date: <i>8/10/2023</i> |
|---|---|
| | <ul style="list-style-type: none"> <li>- <i>Commercial Wharf</i></li> <li>- <i>Stone seawall</i></li> <li>- <i>Wooden piling supports</i></li> </ul> |

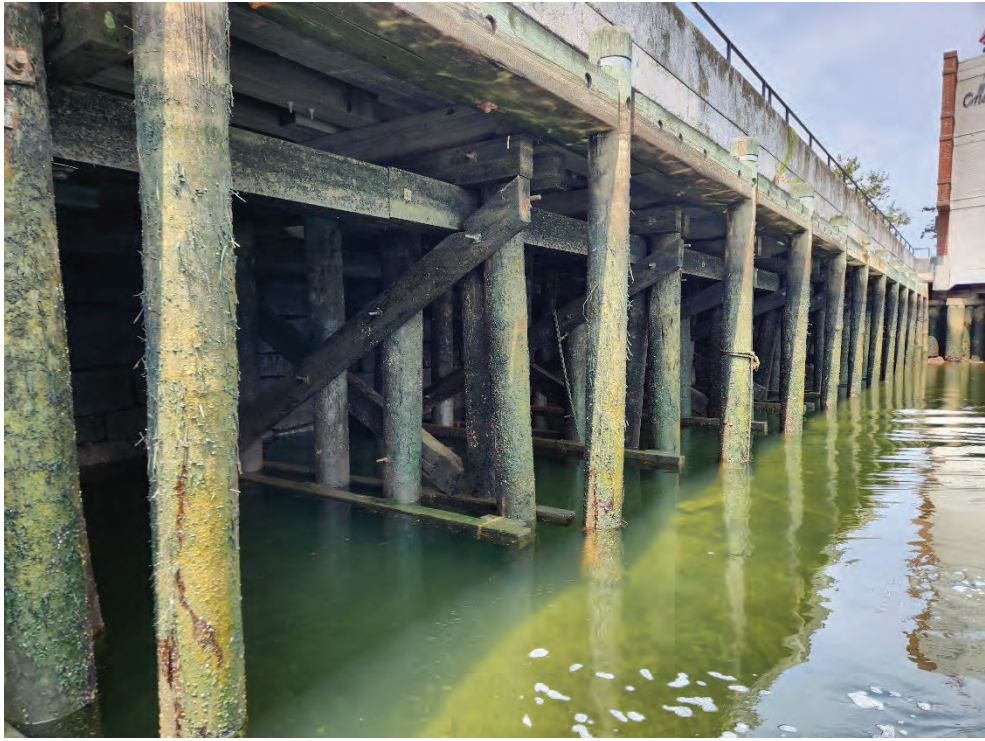
| Survey Area: <i>Downtown Waterfront</i> | Date: <i>8/10/2023</i> |
|---|---|
| | <ul style="list-style-type: none"> <li>- <i>Channel between Commercial Wharf and Lewis Wharf</i></li> <li>- <i>Stone seawall</i></li> <li>- <i>Wooden pilings supporting Harborwalk</i></li> <li>- <i>Algae, macroalgae, and barnacles</i></li> </ul> |

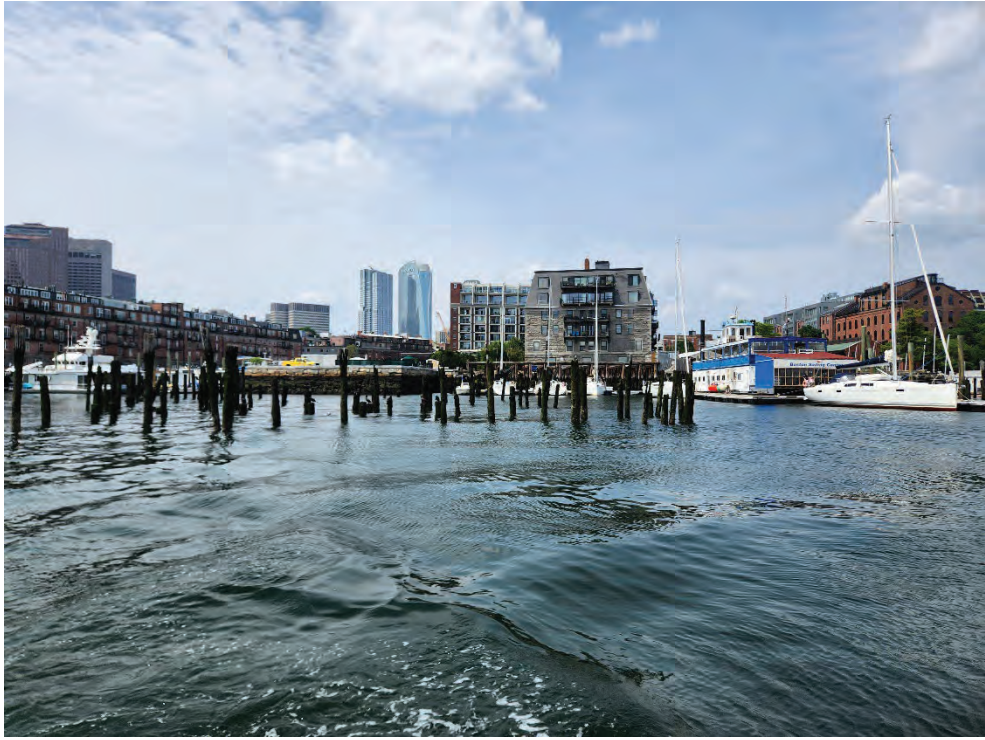
| Survey Area: <i>Downtown Waterfront</i> | Date: <i>8/10/2023</i> |
|---|---|
| | <ul style="list-style-type: none"> <li>- <i>End of Lewis Wharf</i></li> <li>- <i>Derelict wooden pilings</i></li> </ul> |

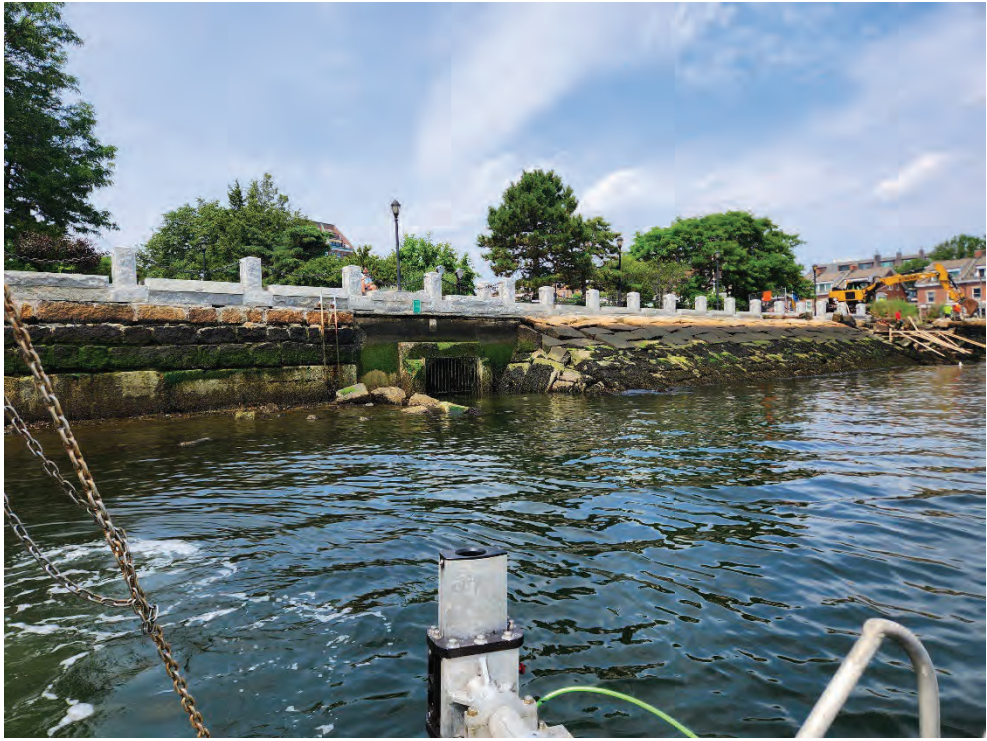
| Survey Area: <i>Downtown Waterfront</i> | Date: <i>8/10/2023</i> |
|---|---|
| | <ul style="list-style-type: none"> <li>- <i>Pilot House Park, Lewis Wharf</i></li> <li>- <i>Stone rip-rap and seawall</i></li> <li>- <i>Drainage pipe</i></li> <li>- <i>Algae and macroalgae</i></li> </ul> |

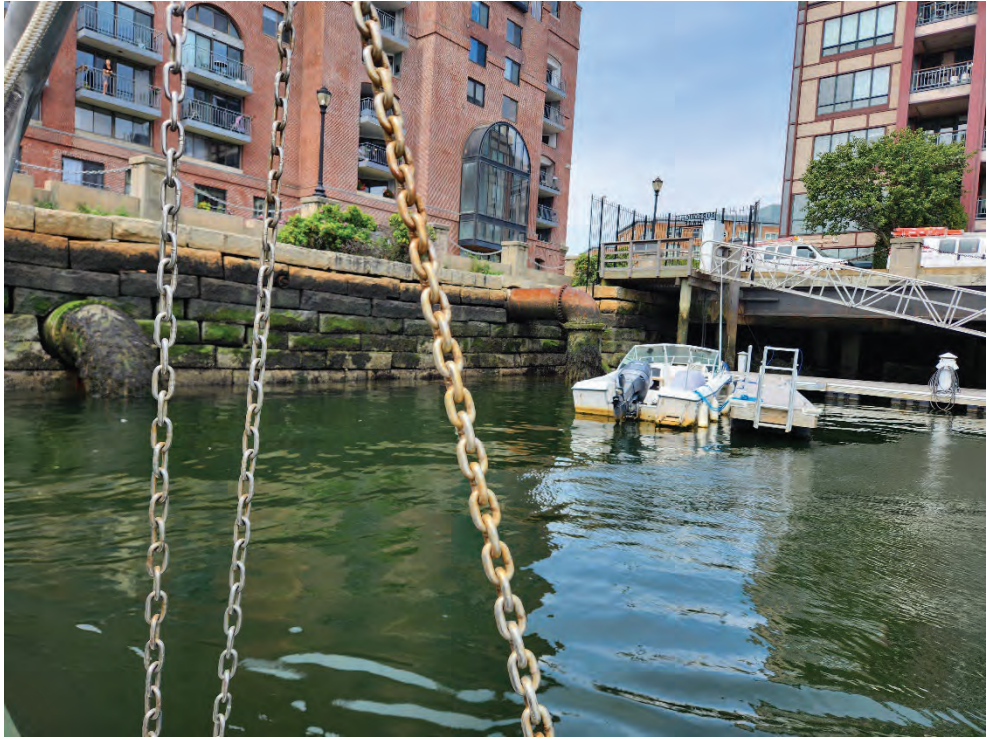
| Survey Area: <i>Downtown Waterfront</i> | Date: <i>8/10/2023</i> |
|---|---|
| | <ul style="list-style-type: none"> <li>- <i>Union Wharf</i></li> <li>- <i>Stone seawall</i></li> <li>- <i>Pipe infrastructure</i></li> <li>- <i>Algae and macroalgae</i></li> </ul> <p><i>*Channel is located directly over Sumner and Callahan Tunnels</i></p> |

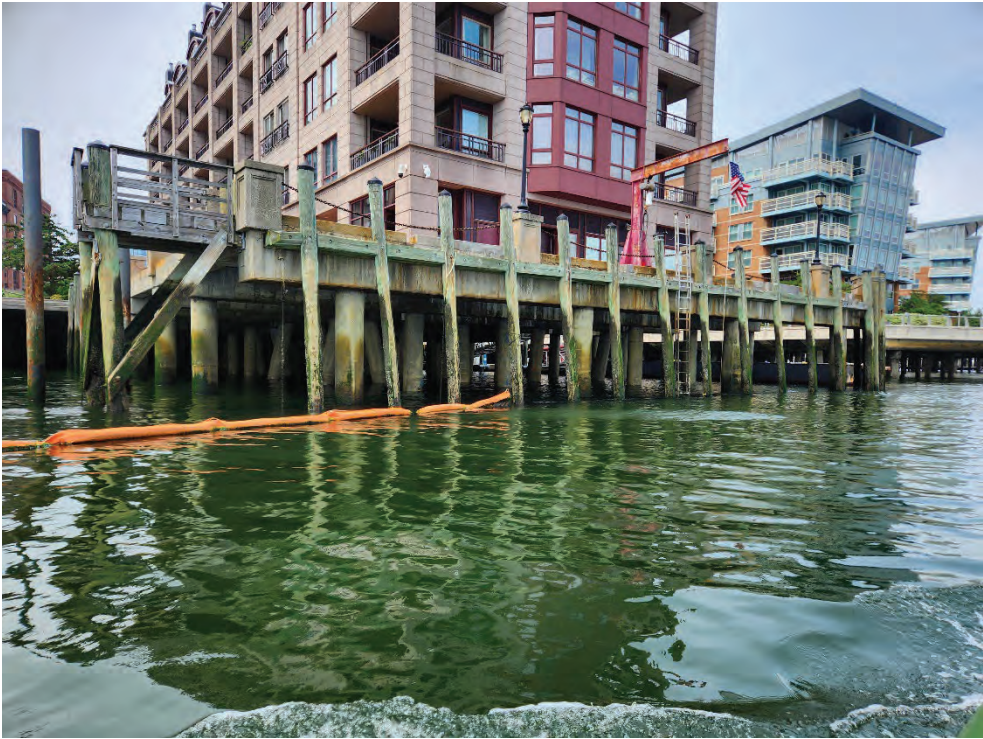
| Survey Area: <i>Downtown Waterfront</i> | Date: <i>8/10/2023</i> |
|---|---|
| | <ul style="list-style-type: none"> <li>- <i>Burroughs Wharf</i></li> <li>- <i>Concrete piling supported pier</i></li> <li>- <i>Algae, barnacles, macroalgae</i></li> </ul> |

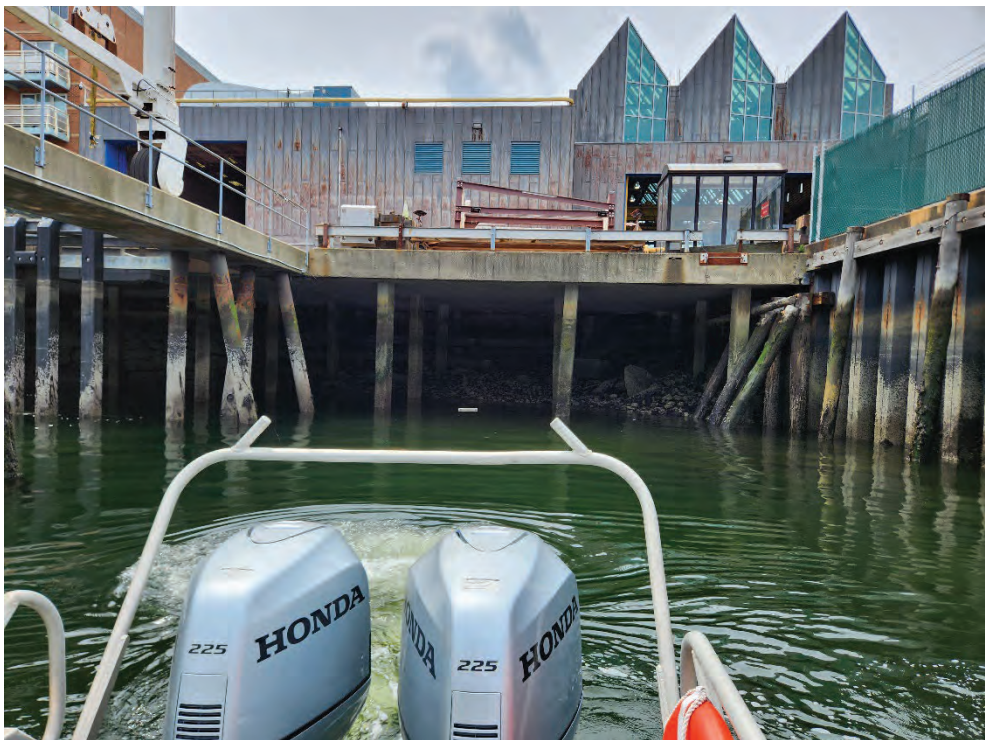
| Survey Area: <i>Downtown Waterfront</i> | Date: <i>8/10/2023</i> |
|---|---|
| | <ul style="list-style-type: none"> <li>- <i>U.S. Coast Guard Station</i></li> <li>- <i>Steel piling-supported concrete slab walkways</i></li> <li>- <i>Stone seawall</i></li> <li>- <i>Algae and barnacles</i></li> </ul> |

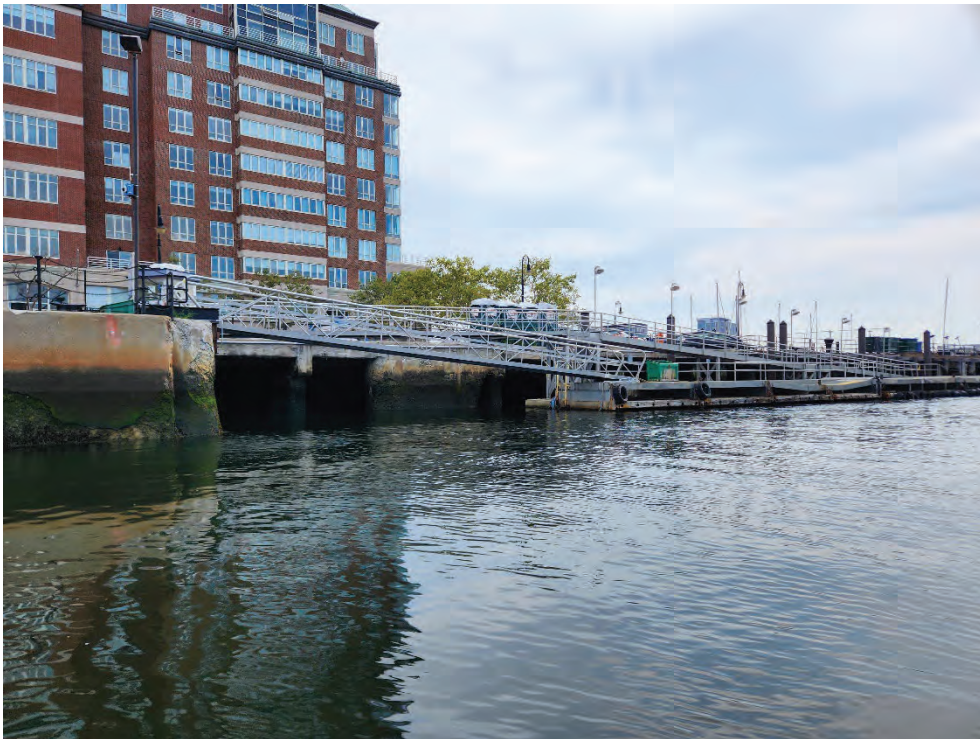
| Survey Area: <i>Charlestown Navy Yard</i> | | Date: <i>8/10/2023</i> |
|---|---|---|
| | <ul style="list-style-type: none"><li>- <i>Entrance of dry dock 2, northern shoreline</i></li><li>- <i>Piling-supported concrete slab pier</i></li><li>- <i>Concrete bulkhead</i></li><li>- <i>Water taxi dock at Charlestown Navy Yard Ferry Terminal</i></li><li>- <i>Algae and macroalgae</i></li></ul> | |

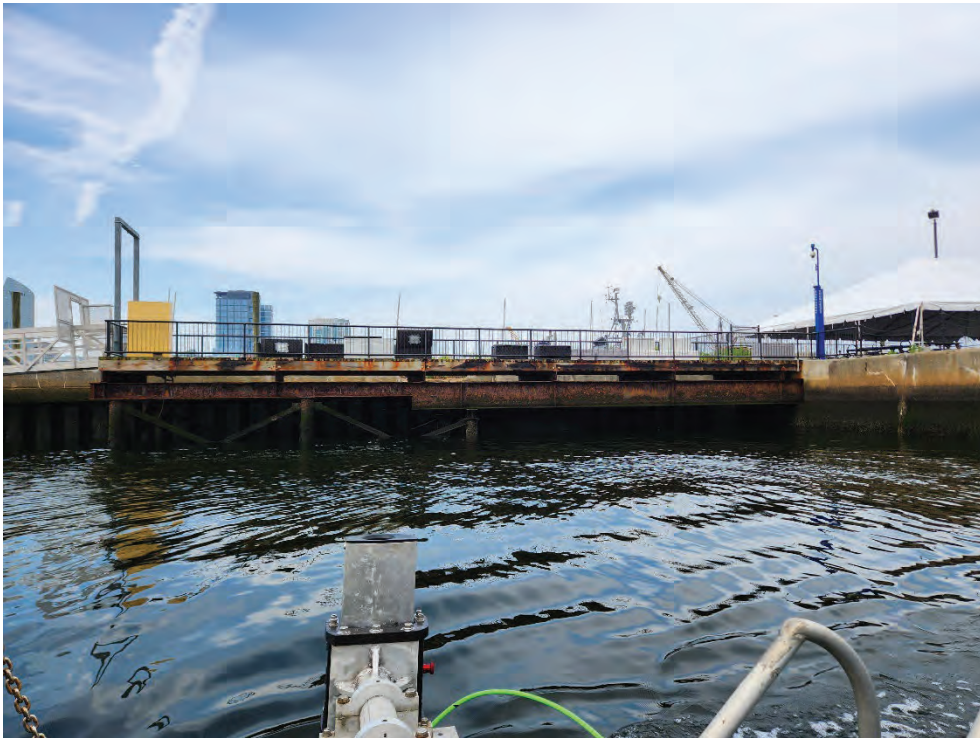
| Survey Area: <i>Charlestown Navy Yard</i> | | Date: <i>8/10/2023</i> |
|---|---|---|
| | <ul style="list-style-type: none"><li>- <i>Entrance of dry dock 2, southern shoreline</i></li><li>- <i>Piling-supported concrete slab pier</i></li><li>- <i>Concrete bulkhead</i></li><li>- <i>Algae and macroalgae</i></li></ul> | |
