# Boston Coastal Storm Risk Management Study

## Draft Integrated Feasibility Report and Programmatic Environmental Assessment

### APPENDIX D - ENVIROMENTAL

# INTERTIDAL AND SUBTIDAL HABITAT SURVEYS

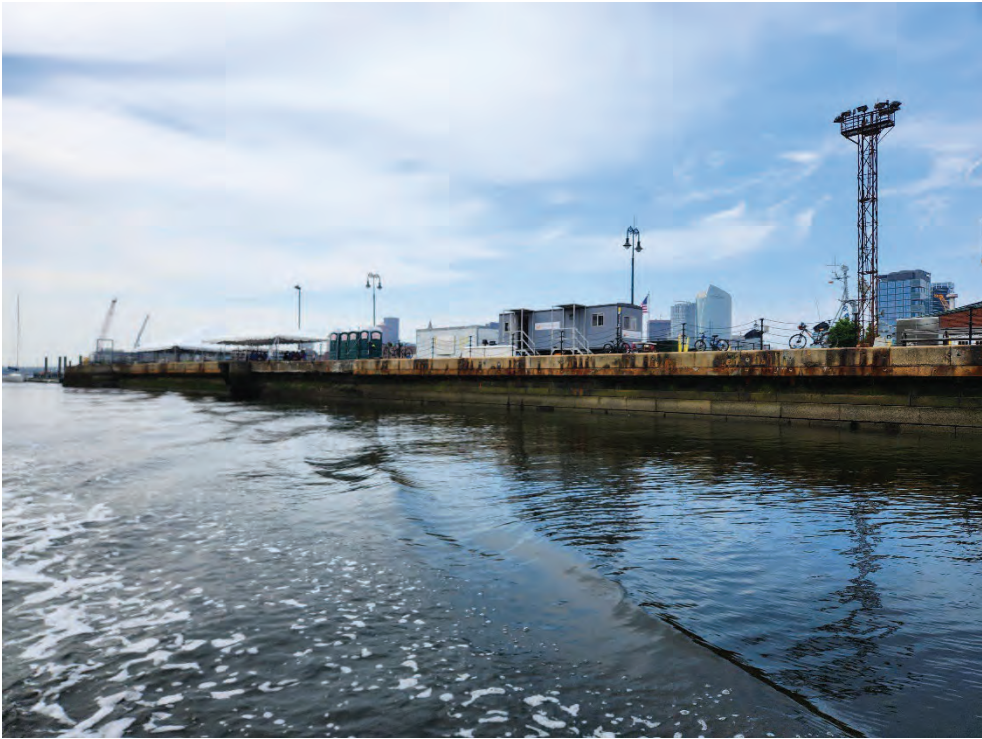
| Survey Area: <i>Charlestown Navy Yard</i> | | Date: <i>8/10/2023</i> |
|---|--|---|
| | | <ul style="list-style-type: none"> <li>- <i>Dry dock 2 interior, southern shoreline</i></li> <li>- <i>Stone dry dock wall</i></li> <li>- <i>Algae and macroalgae</i></li> </ul> |

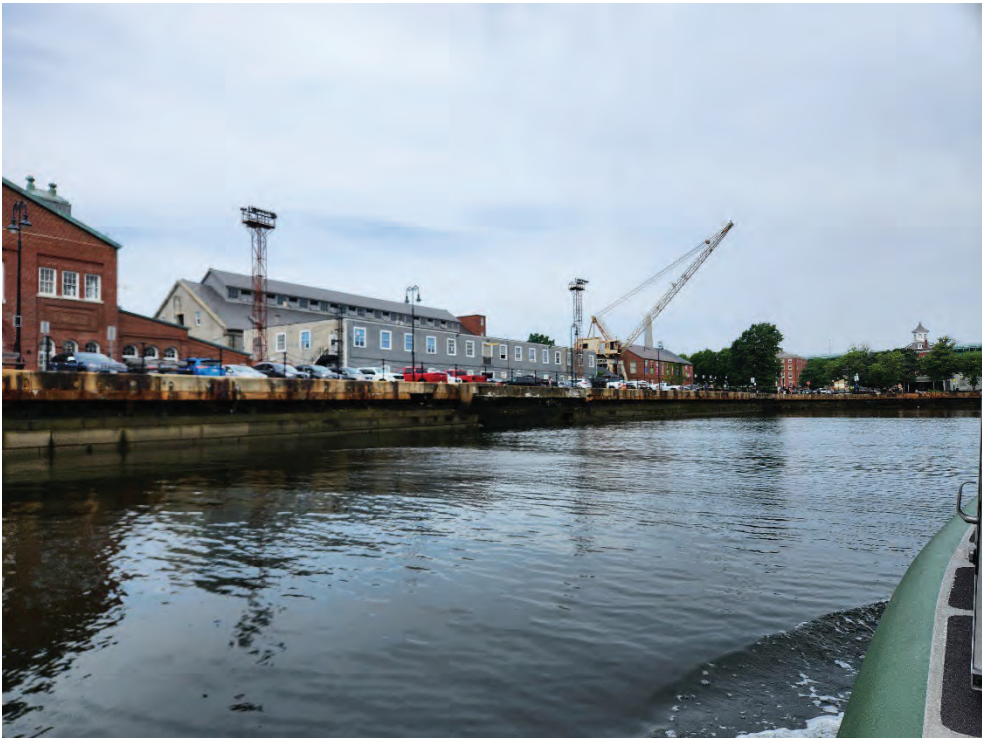
| Survey Area: <i>Charlestown Navy Yard</i> | | Date: <i>8/10/2023</i> |
|---|--|---|
| | | <ul style="list-style-type: none"> <li>- <i>Dry dock 2 interior, southern shoreline</i></li> <li>- <i>Stone dry dock wall</i></li> <li>- <i>Algae and macroalgae</i></li> </ul> |

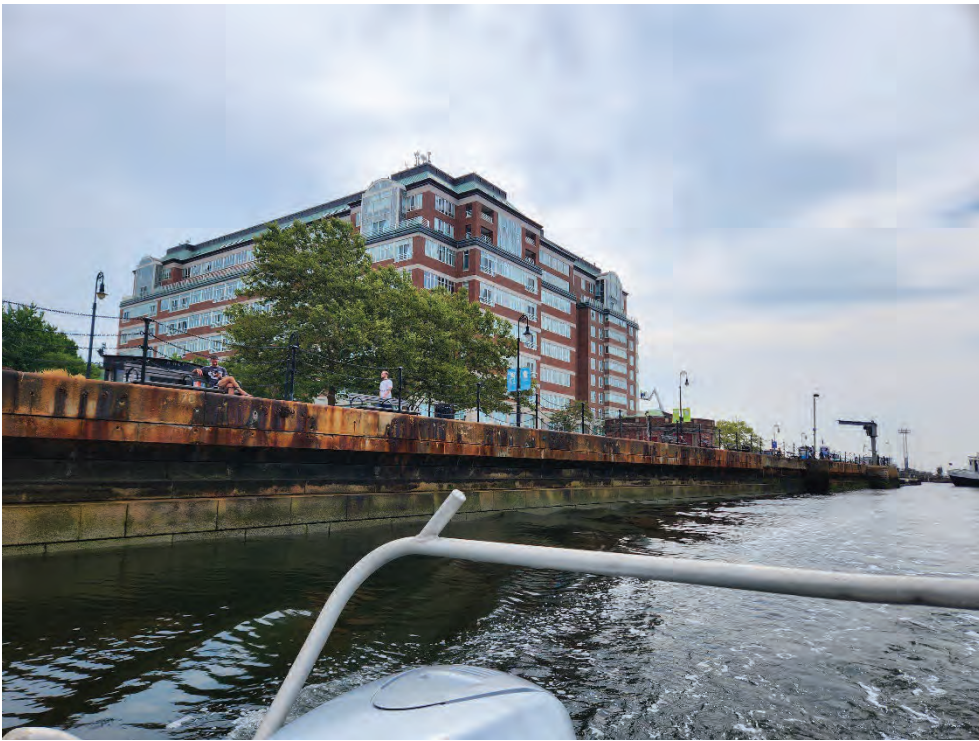
| Survey Area: <i>Charlestown Navy Yard</i> | | Date: <i>8/10/2023</i> |
|---|---|---|
| | <ul style="list-style-type: none"><li>- <i>Dry dock 2 interior, northern shoreline</i></li><li>- <i>Stone dry dock wall</i></li><li>- <i>Algae and macroalgae</i></li></ul> | |

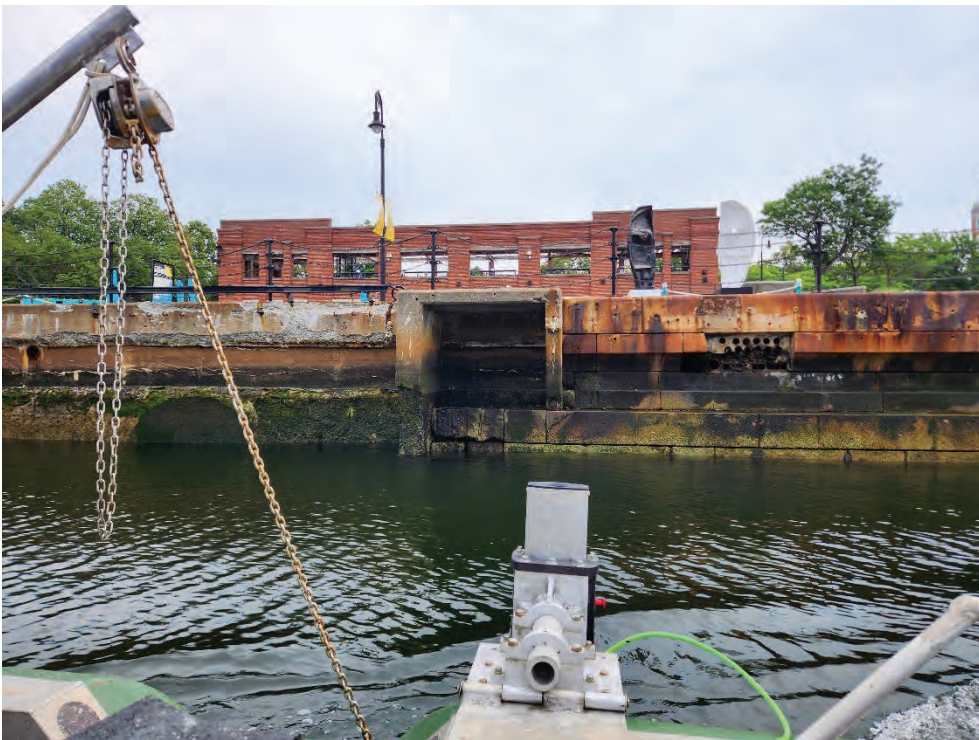
| Survey Area: <i>Charlestown Navy Yard</i> | | Date: <i>8/10/2023</i> |
|---|---|---|
| | <ul style="list-style-type: none"><li>- <i>Dry dock 2 interior, northern shoreline</i></li><li>- <i>Stone dry dock wall</i></li><li>- <i>Algae and macroalgae</i></li></ul> | |

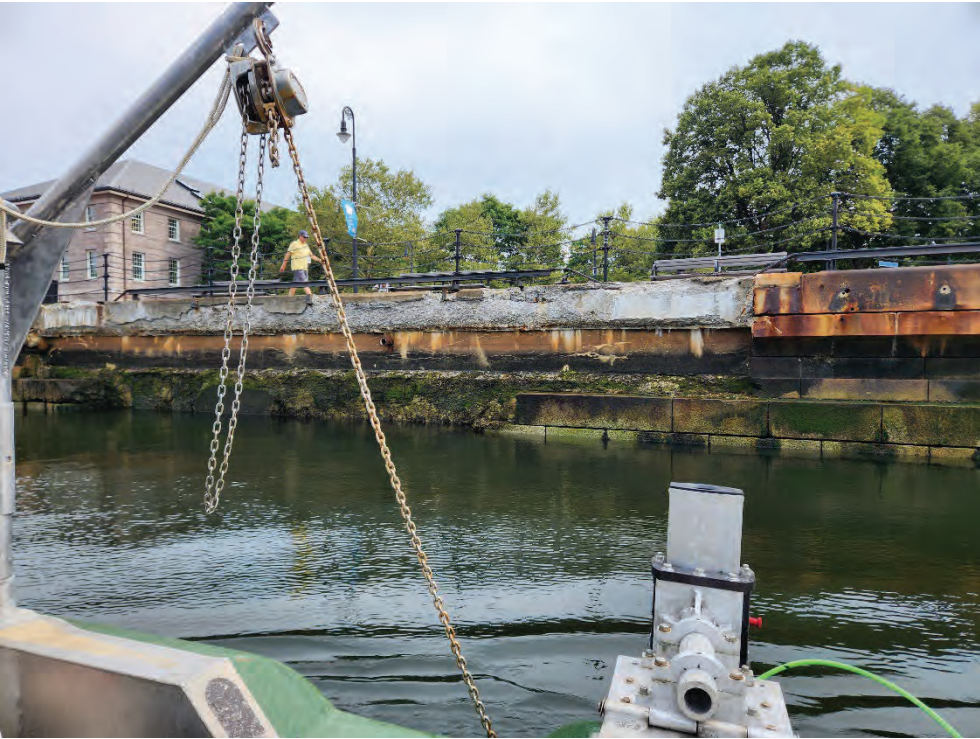
| Survey Area: <i>Charlestown Navy Yard</i> | Date: <i>8/10/2023</i> |
|---|---|
| | <ul style="list-style-type: none"> <li>- <i>Dry dock 2 interior, northern shoreline</i></li> <li>- <i>Stone dry dock wall</i></li> <li>- <i>Algae and macroalgae</i></li> </ul> |

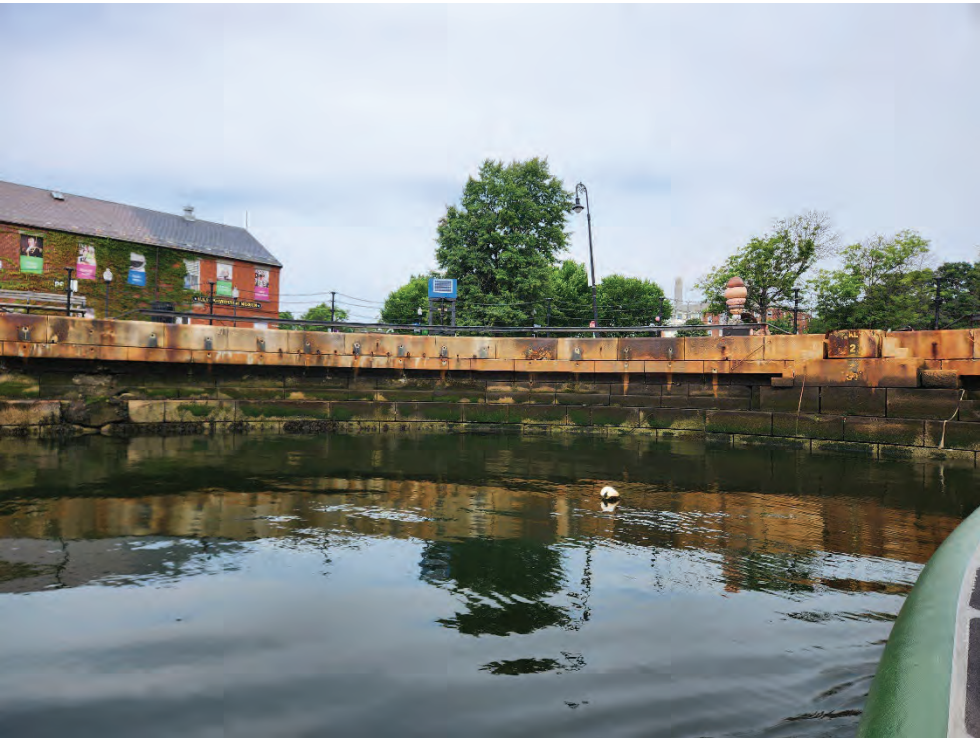
| Survey Area: <i>Charlestown Navy Yard</i> | Date: <i>8/10/2023</i> |
|---|---|
| | <ul style="list-style-type: none"> <li>- <i>Dry dock 2 interior, head/southern shoreline</i></li> <li>- <i>Stone dry dock wall</i></li> <li>- <i>Algae and macroalgae</i></li> </ul> |

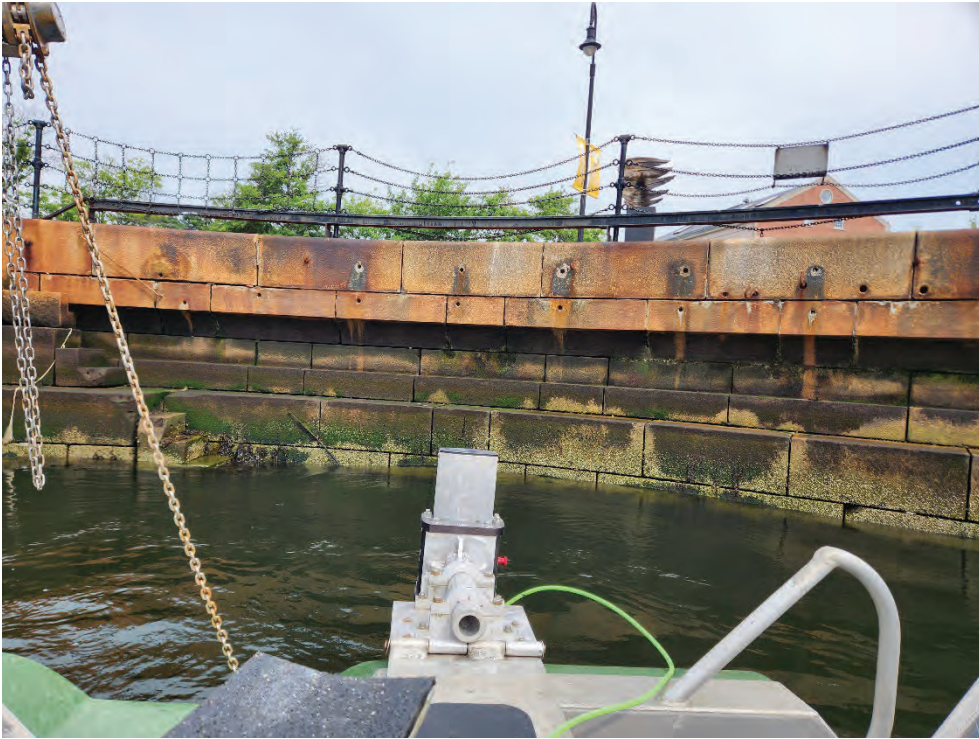
| Survey Area: <i>Charlestown Navy Yard</i> | | Date: <i>8/10/2023</i> |
|---|---|---|
| | <ul style="list-style-type: none"><li>- <i>Dry dock 2 interior, head</i></li><li>- <i>Stone dry dock wall</i></li><li>- <i>Algae and macroalgae</i></li></ul> | |

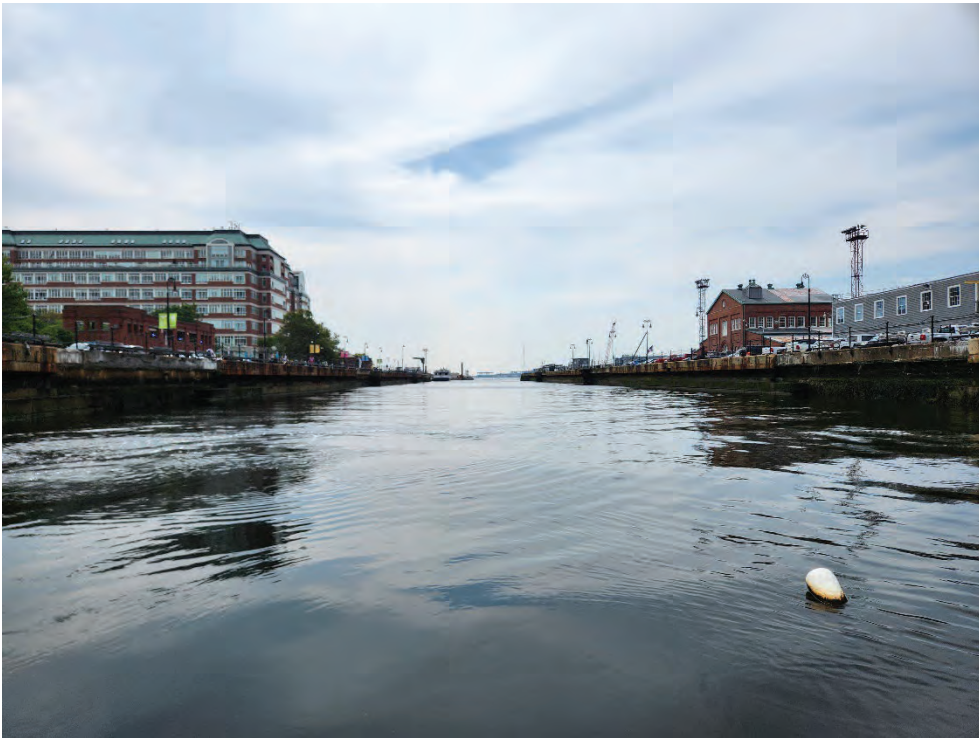
| Survey Area: <i>Charlestown Navy Yard</i> | | Date: <i>8/10/2023</i> |
|---|---|---|
| | <ul style="list-style-type: none"><li>- <i>Dry dock 2 interior, looking toward entrance</i></li><li>- <i>Stone dry dock wall</i></li><li>- <i>Algae and macroalgae</i></li></ul> | |

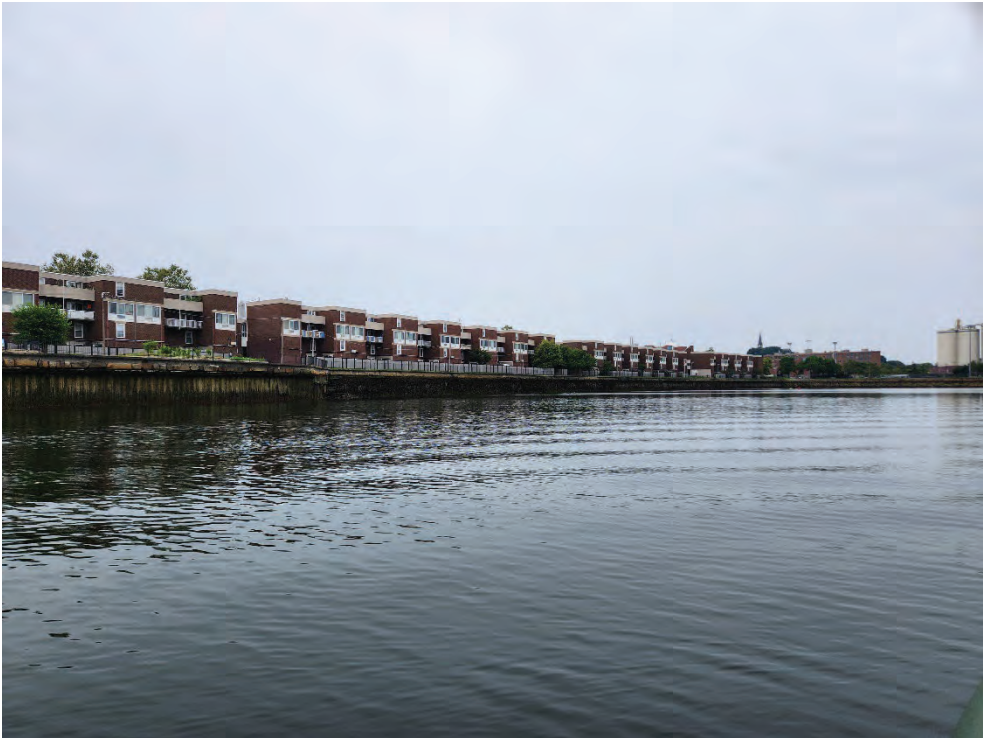
| Survey Area: <i>Little Mystic Channel</i> | Date: 8/7/2023 |
|---|---|
| | <ul style="list-style-type: none"> <li>- <i>Little Mystic Channel facing the southern shoreline</i></li> <li>- <i>Developed, residential area</i></li> <li>- <i>Sheetpile bulkhead and stone seawall</i></li> <li>- <i>Apartment building complex</i></li> </ul> |

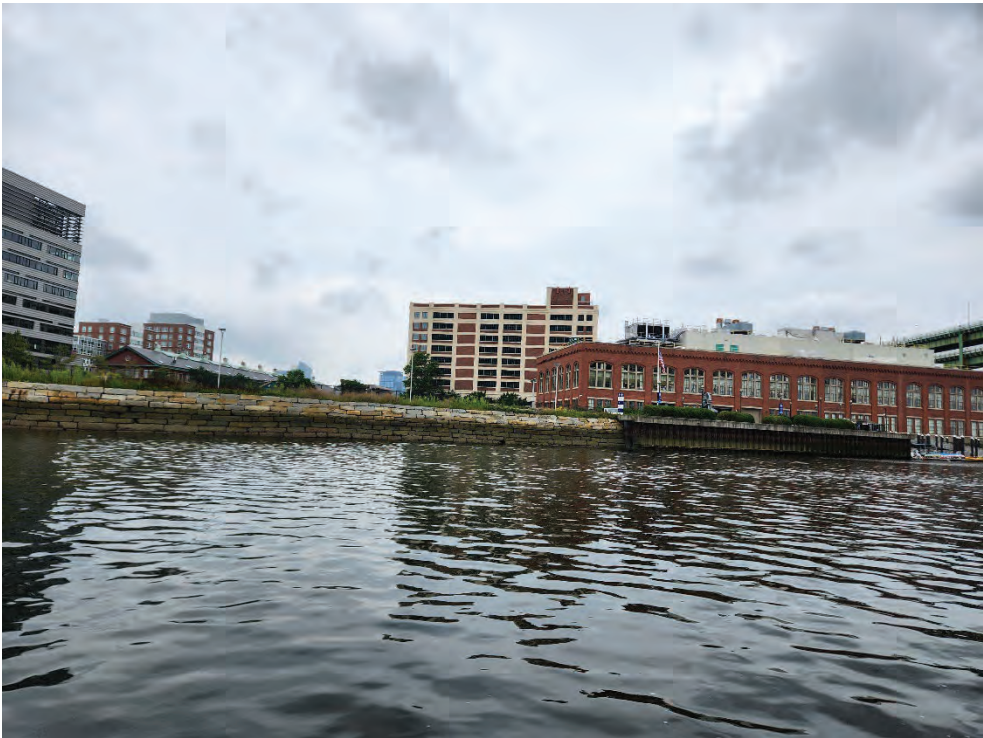
| Survey Area: <i>Little Mystic Channel</i> | Date: 8/7/2023 |
|---|---|
| | <ul style="list-style-type: none"> <li>- <i>Little Mystic Channel facing the southern shoreline</i></li> <li>- <i>Sheetpile bulkhead and stone seawall</i></li> <li>- <i>Landscaped upland vegetation</i></li> </ul> |

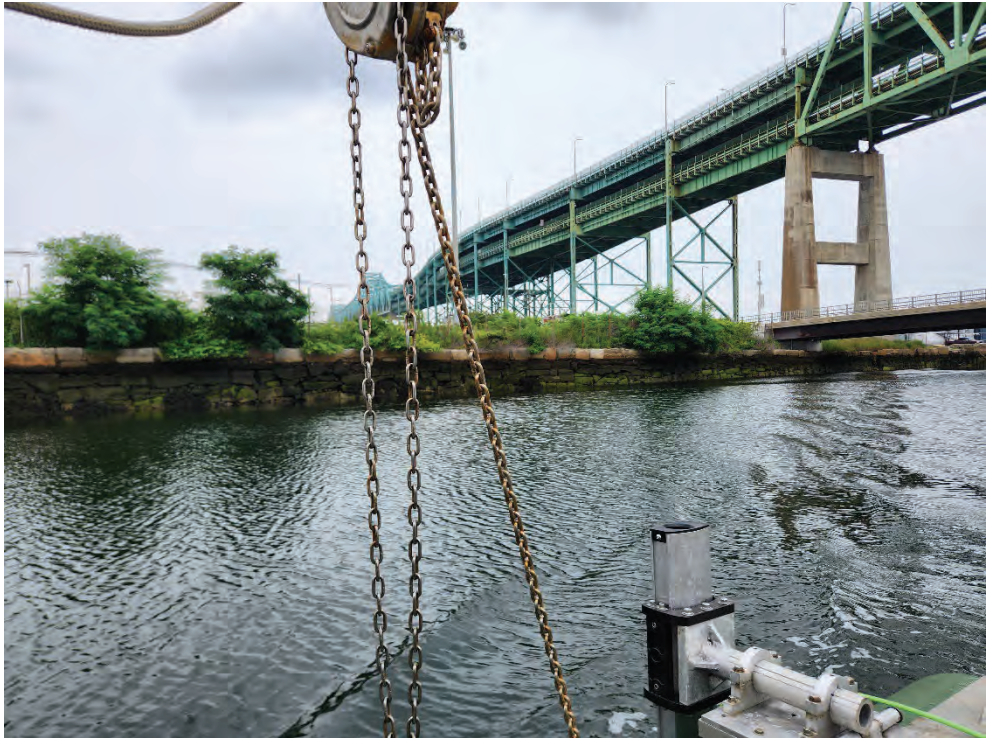
| Survey Area: <i>Little Mystic Channel</i> | Date: <i>8/7/2023</i> |
|---|---|
| | <ul style="list-style-type: none"> <li>- <i>Little Mystic Channel facing the northern shoreline</i></li> <li>- <i>Stone seawall</i></li> <li>- <i>Macroalgae and upland vegetation</i></li> <li>- <i>Chelsea Street and Tobin Bridges</i></li> </ul> |

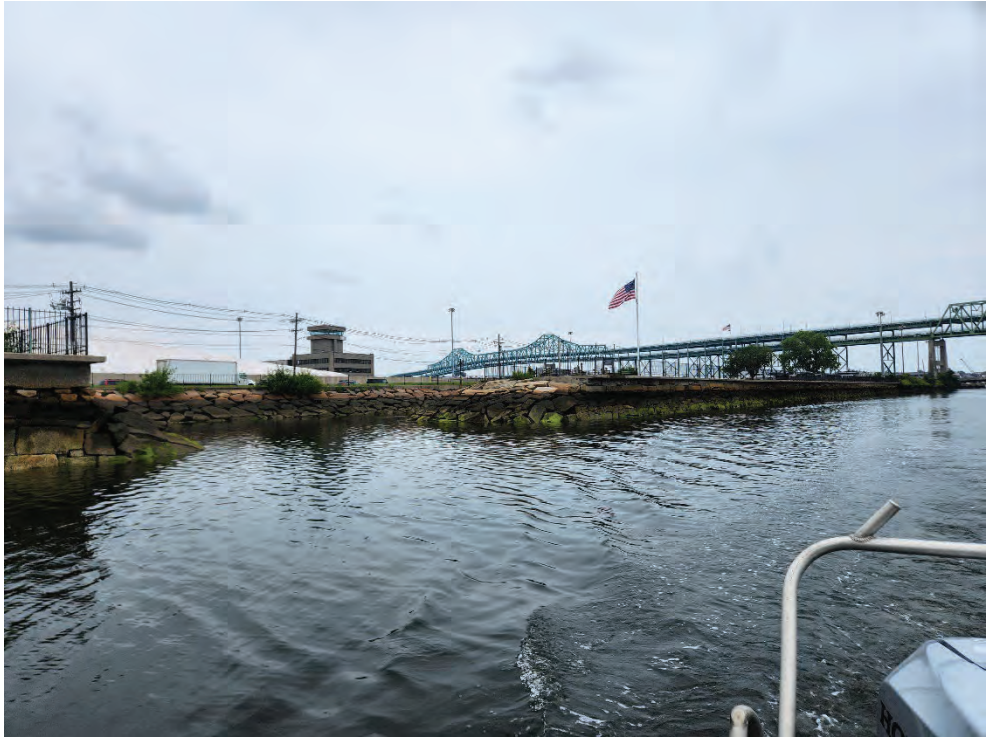
| Survey Area: <i>Little Mystic Channel</i> | Date: <i>8/7/2023</i> |
|---|---|
| | <ul style="list-style-type: none"> <li>- <i>Little Mystic Channel facing the northern shoreline</i></li> <li>- <i>Stone seawall</i></li> <li>- <i>Entrance to boat ramp</i></li> <li>- <i>Macroalgae</i></li> </ul> |

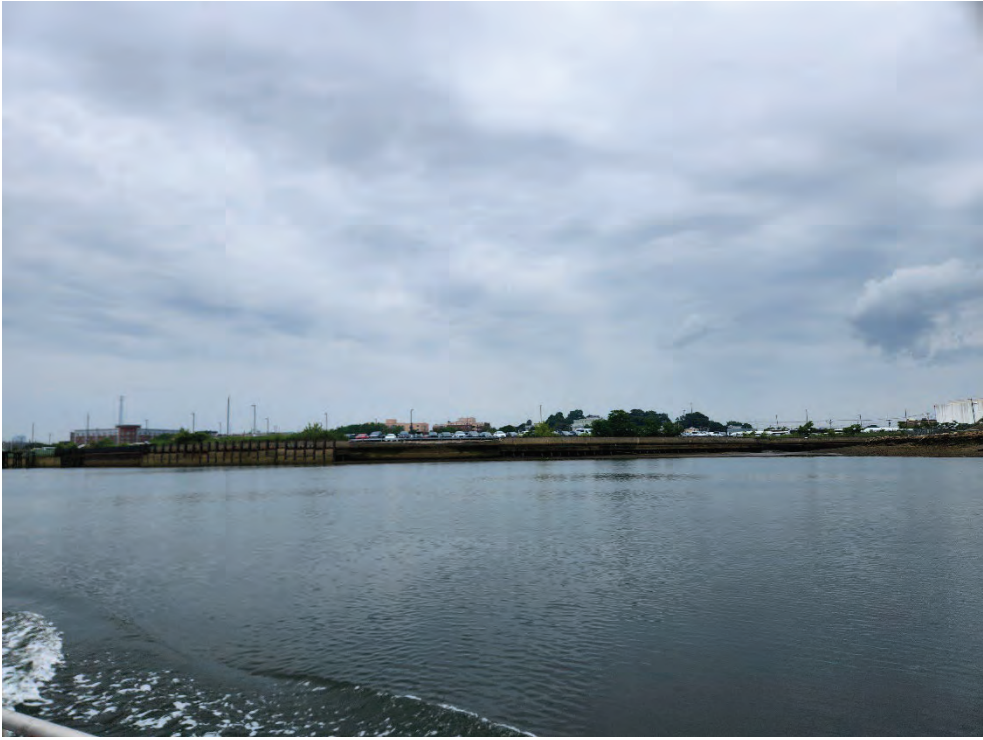
| Survey Area: <i>Chelsea River</i> | Date: <i>8/7/2023</i> |
|---|---|
| <p>A wide-angle photograph of the Chelsea River. The water is calm and reflects the overcast sky. In the background, a long, low shoreline is visible, featuring a mix of industrial buildings, a cobble beach, and a piling-supported bulkhead. The sky is filled with heavy, grey clouds.</p> | <ul style="list-style-type: none"> <li>- <i>Chelsea River facing the Chelsea shoreline</i></li> <li>- <i>Piling-supported shoreline</i></li> <li>- <i>Bulkhead and rock retention wall</i></li> <li>- <i>Cobble beach</i></li> </ul> |

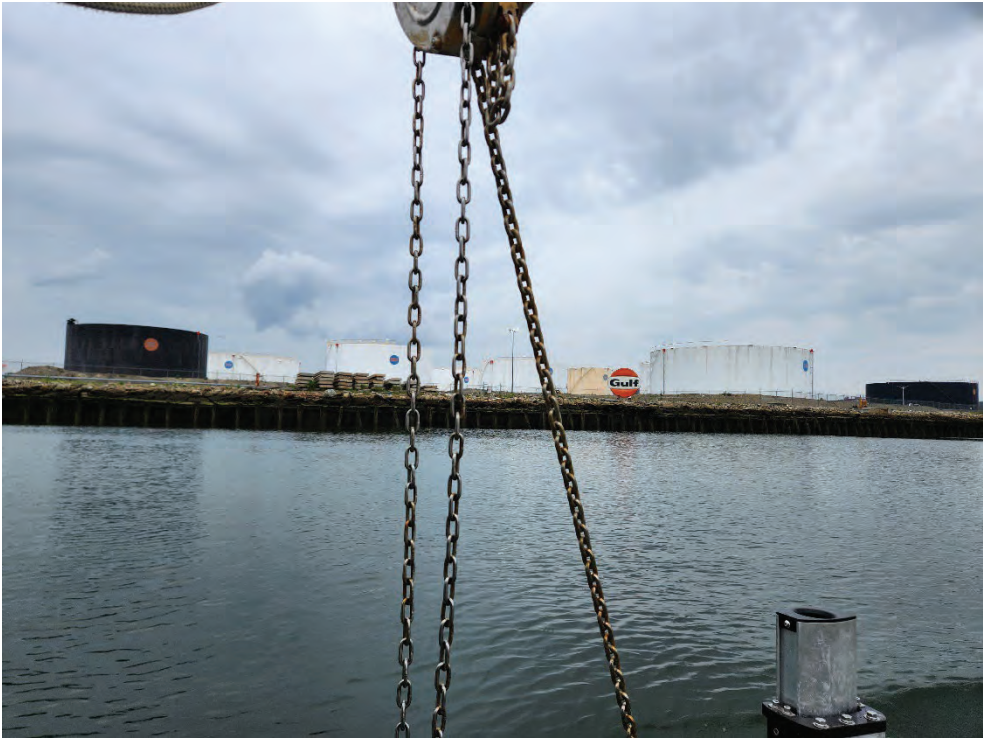
| Survey Area: <i>Chelsea River</i> | Date: <i>8/7/2023</i> |
|---|---|
| <p>A photograph taken from a boat, looking across the Chelsea River. In the foreground, a metal chain hangs from a pulley. The river is calm, reflecting the sky. In the background, an industrial area is visible, featuring several large white and black storage tanks, a building with a 'Gulf' logo, and a piling-supported bulkhead. The sky is overcast.</p> | <ul style="list-style-type: none"> <li>- <i>Chelsea River facing the Chelsea shoreline</i></li> <li>- <i>Bulkhead and piling-supported shoreline</i></li> <li>- <i>Industrial area with fuel storage tanks</i></li> </ul> |

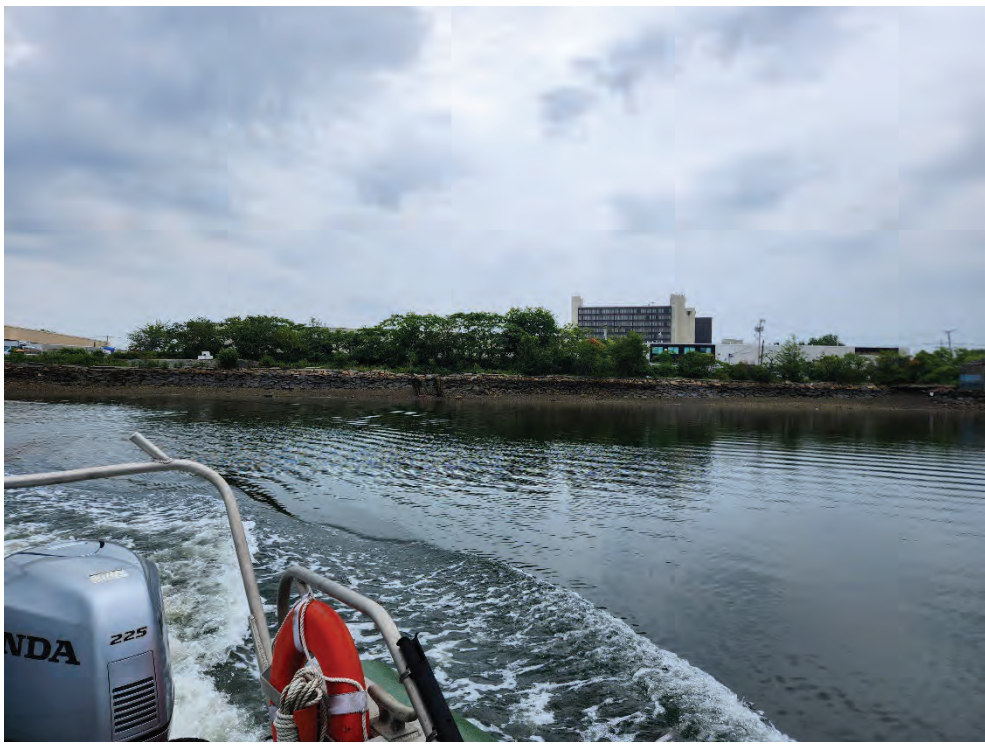
| Survey Area: <i>Chelsea River</i> | Date: <i>8/7/2023</i> |
|---|---|
| | <ul style="list-style-type: none"> <li>- <i>Chelsea River facing the East Boston shoreline</i></li> <li>- <i>Stone seawall</i></li> <li>- <i>Marine debris</i></li> <li>- <i>Sandy/gravelly/cobbly beach</i></li> <li>- <i>Upland vegetation</i></li> </ul> |

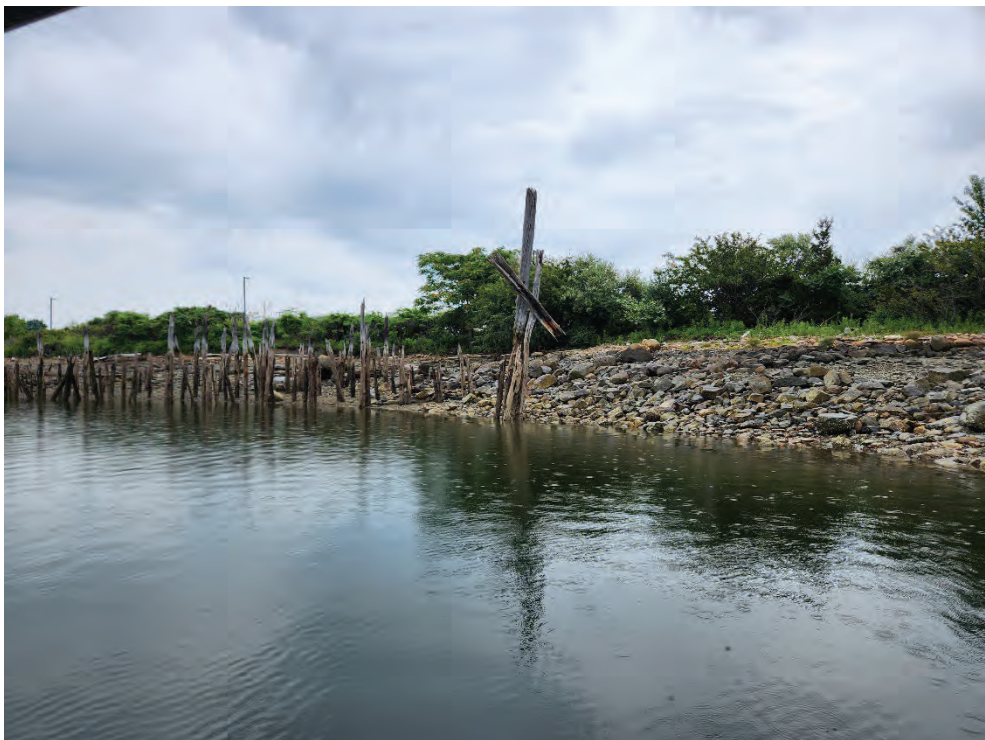
| Survey Area: <i>Chelsea River</i> | Date: <i>8/7/2023</i> |
|---|---|
| | <ul style="list-style-type: none"> <li>- <i>Chelsea River facing the East Boston shoreline</i></li> <li>- <i>Rocky shoreline</i></li> <li>- <i>Derelict pilings</i></li> <li>- <i>Barnacles</i></li> <li>- <i>Upland vegetation</i></li> </ul> |

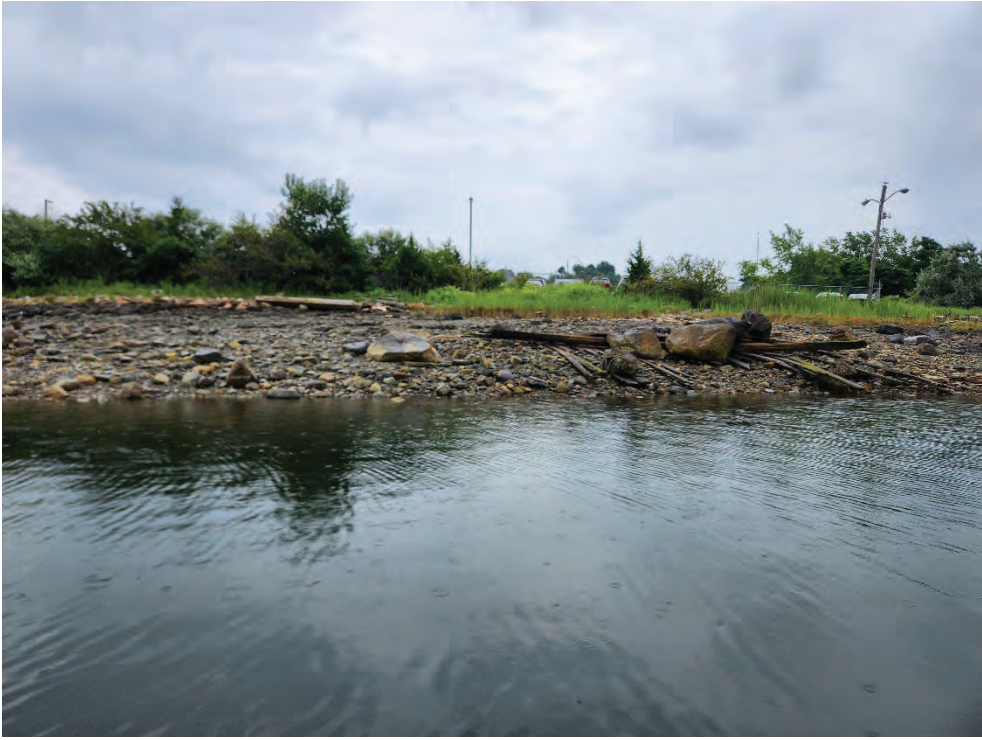
| Survey Area: <i>Chelsea River</i> | Date: 8/7/2023 |
|---|---|
| | <ul style="list-style-type: none"> <li>- <i>Chelsea River facing the East Boston shoreline</i></li> <li>- <i>Rocky shoreline</i></li> <li>- <i>Driftwood and marine debris</i></li> <li>- <i>Marsh grass</i></li> <li>- <i>Upland vegetation</i></li> </ul> |

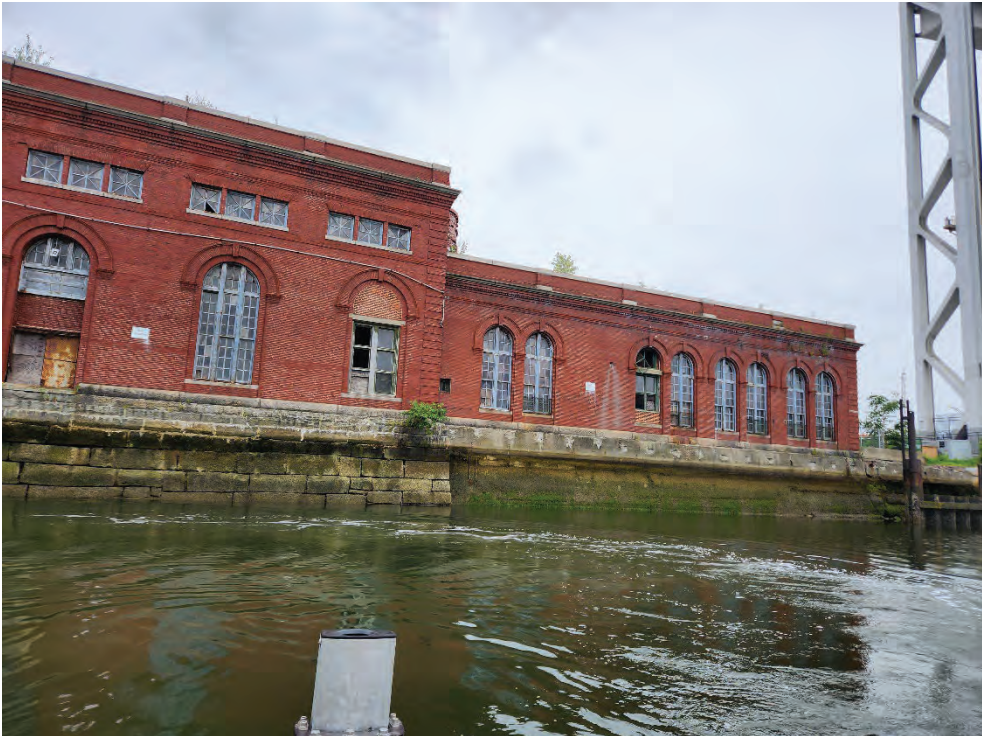
| Survey Area: <i>Chelsea River</i> | Date: 8/7/2023 |
|---|---|
| | <ul style="list-style-type: none"> <li>- <i>Chelsea River facing the East Boston shoreline</i></li> <li>- <i>Abandoned industrial building</i></li> <li>- <i>Stone bulkhead/ seawall</i></li> <li>- <i>Algae &amp; macroalgae</i></li> </ul> |

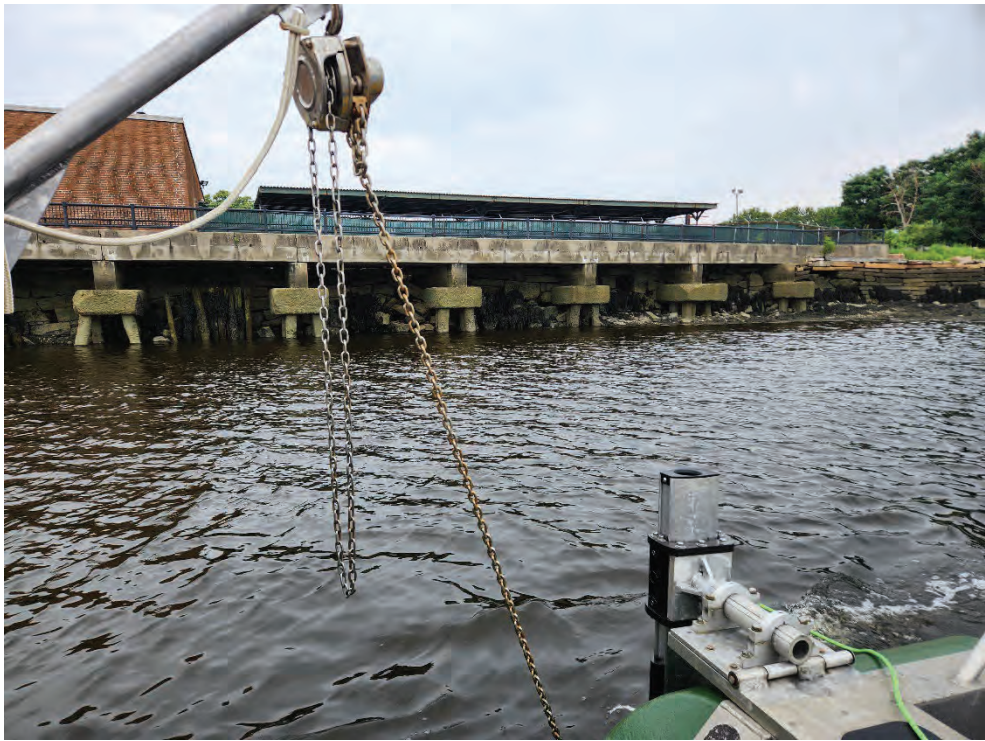
| Survey Area: <i>Neponset River</i> | Date: <i>8/10/2023</i> |
|---|---|
| | <ul style="list-style-type: none"> <li>- <i>Western shoreline, Neponset Trail</i></li> <li>- <i>Concrete slab walkway and support structure forward of stone seawall</i></li> <li>- <i>Derelict wood pilings</i></li> <li>- <i>Algae &amp; macroalgae</i></li> </ul> |

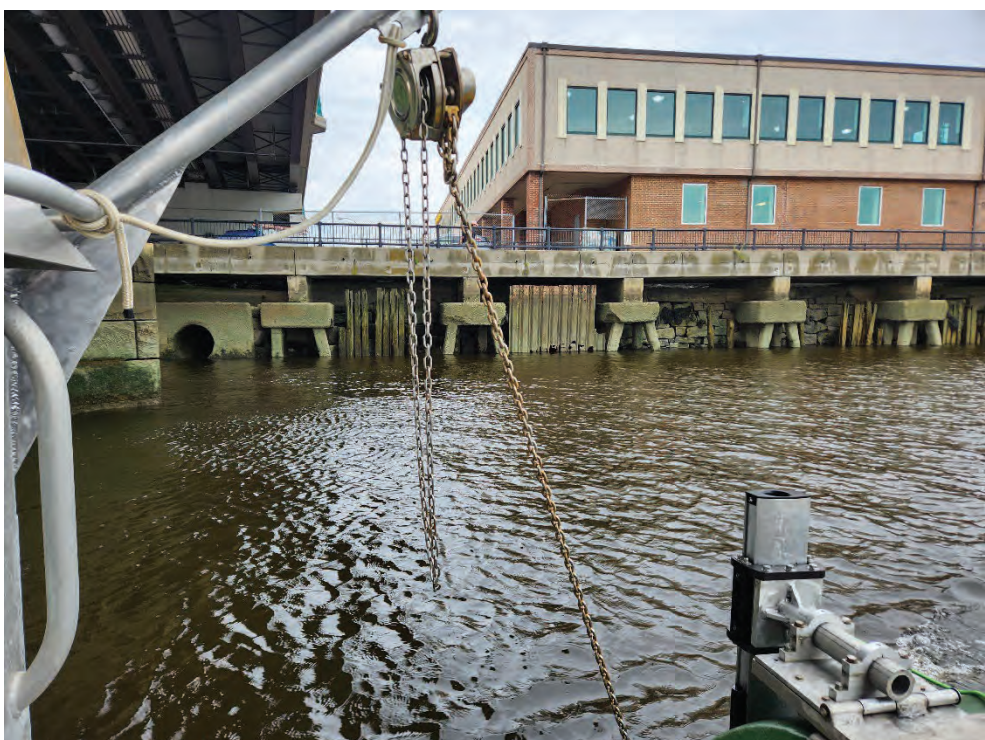
| Survey Area: <i>Neponset River</i> | Date: <i>8/10/2023</i> |
|---|---|
| | <ul style="list-style-type: none"> <li>- <i>Western shoreline, Neponset Trail and Planet Fitness building</i></li> <li>- <i>Concrete slab walkway and support structure forward of stone seawall</i></li> <li>- <i>Derelict wood pilings and sheetpile section</i></li> <li>- <i>Drainage outfall</i></li> <li>- <i>Stone and concrete pier of Neponset Bridge</i></li> <li>- <i>Algae &amp; macroalgae</i></li> </ul> |

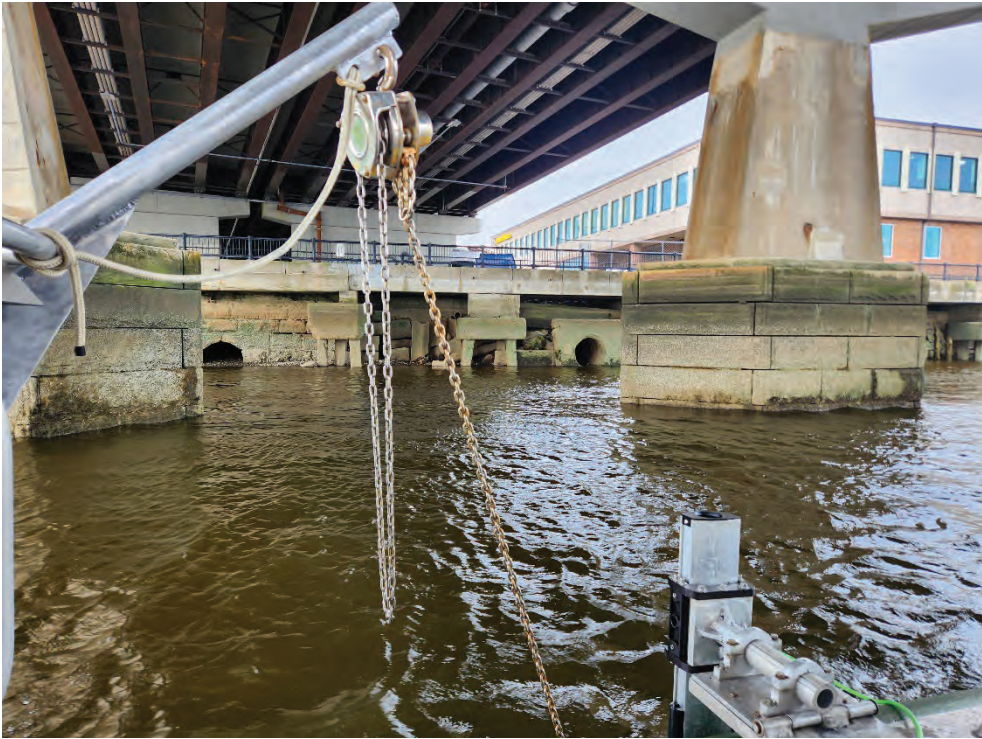
| Survey Area: <i>Neponset River</i> | Date: <i>8/10/2023</i> |
|---|---|
| | <ul style="list-style-type: none"> <li>- <i>Western shoreline, Neponset Trail and Planet Fitness building</i></li> <li>- <i>Concrete slab walkway and support structure forward of stone seawall</i></li> <li>- <i>Drainage outfalls</i></li> <li>- <i>Stone and concrete piers of Neponset Bridge</i></li> <li>- <i>Algae and macroalgae</i></li> </ul> |

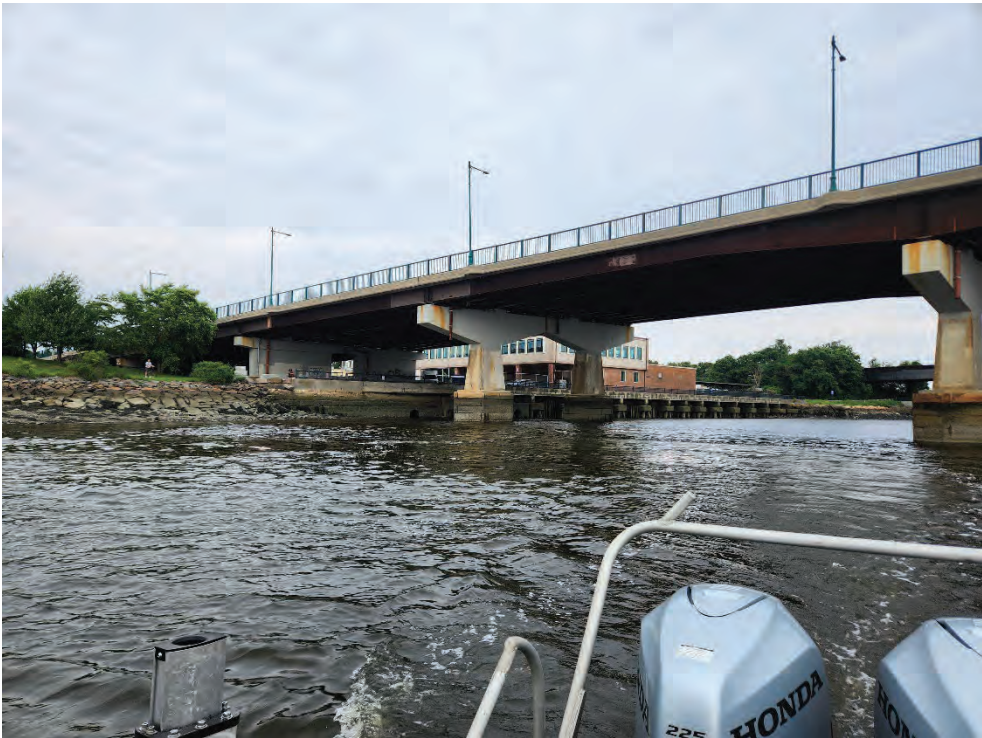
| Survey Area: <i>Neponset River</i> | Date: <i>8/10/2023</i> |
|---|---|
| | <ul style="list-style-type: none"> <li>- <i>Western shoreline, Neponset Trail and Planet Fitness building</i></li> <li>- <i>Neponset Bridge structure</i></li> <li>- <i>Rip rap seawall</i></li> </ul> |

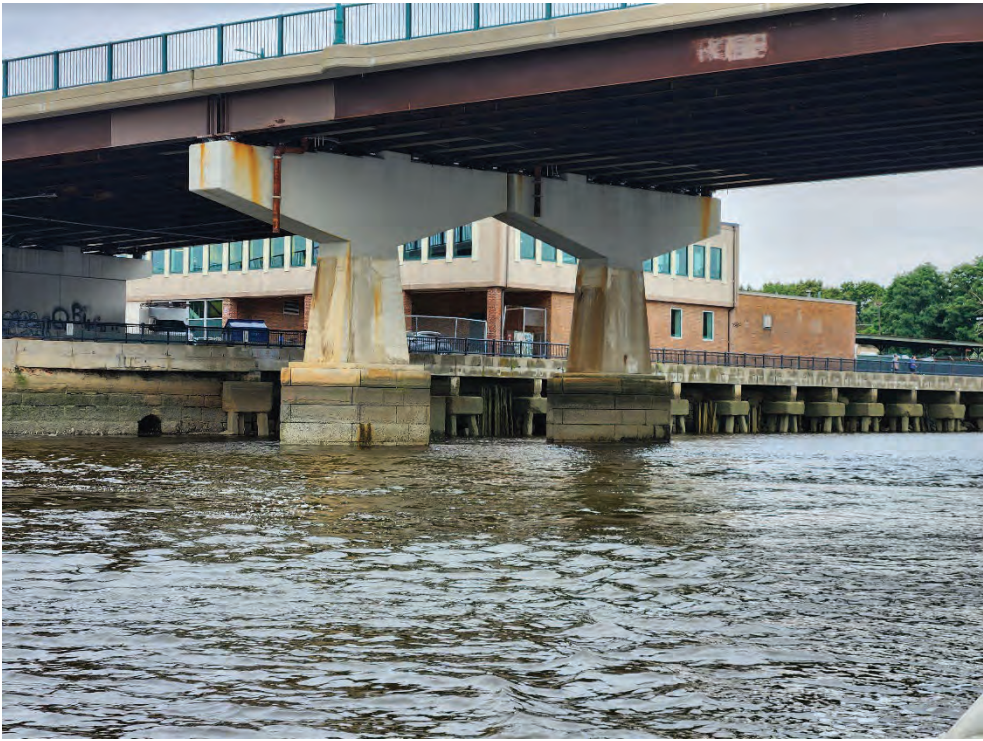
| Survey Area: <i>Neponset River</i> | Date: <i>8/10/2023</i> |
|---|---|
| | <ul style="list-style-type: none"> <li>- <i>Western shoreline, Neponset Trail and Planet Fitness building</i></li> <li>- <i>Concrete slab walkway and support structure forward of stone seawall</i></li> <li>- <i>Drainage outfalls</i></li> <li>- <i>Stone and concrete piers of Neponset Bridge</i></li> </ul> |

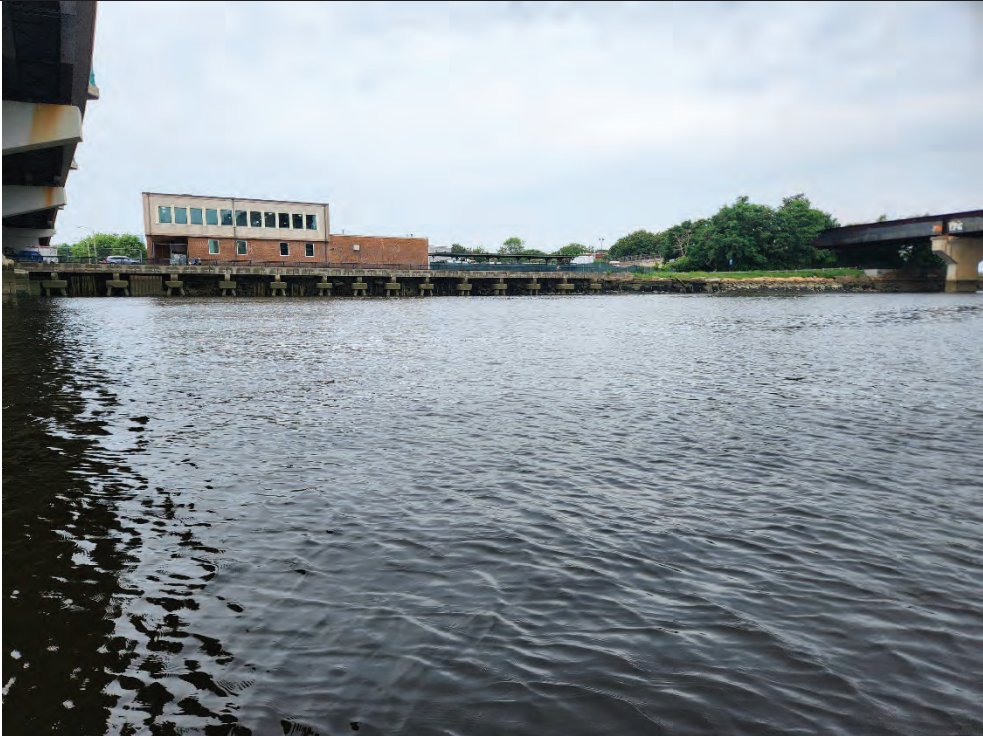
| Survey Area: <i>Neponset River</i> | Date: <i>8/10/2023</i> |
|---|---|
| | <ul style="list-style-type: none"> <li>- <i>Western shoreline, Neponset Trail and Planet Fitness building</i></li> <li>- <i>Concrete slab walkway and support structure forward of stone seawall</i></li> <li>- <i>Neponset-Anderson Rail Road Bridge</i></li> </ul> |

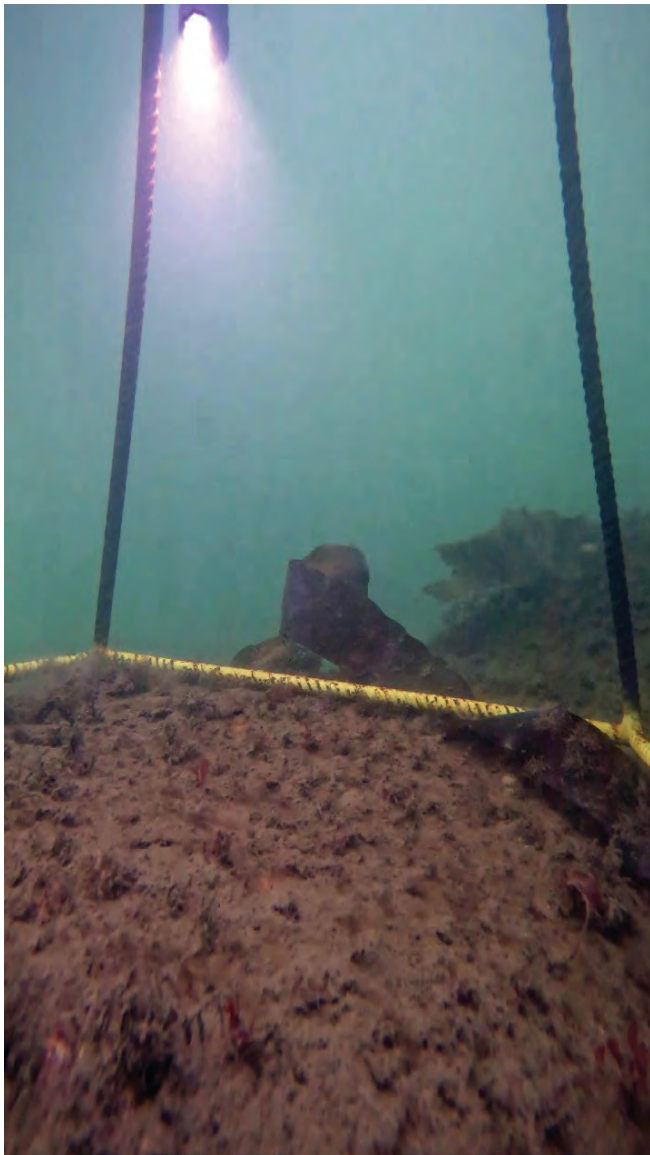
| Sunken barge with attached ectoprocts, hydroids, and mixed macroalgae (including kelp). Located near Fan Pier, in front of the Federal Courthouse. | | | | | | | | | | | |

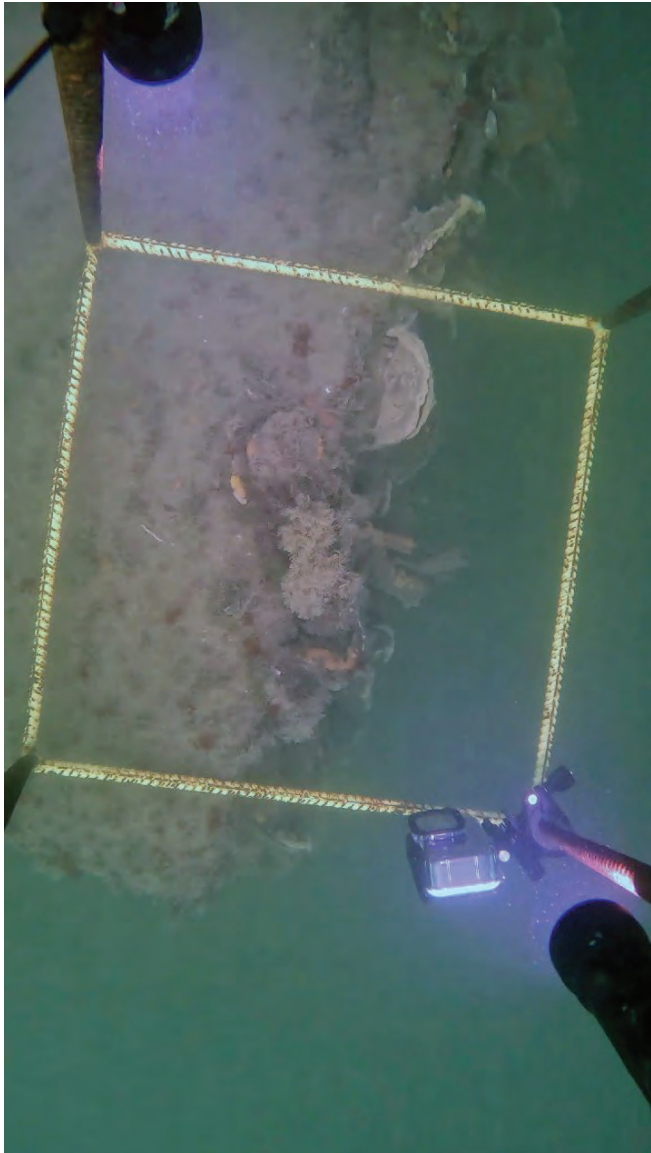
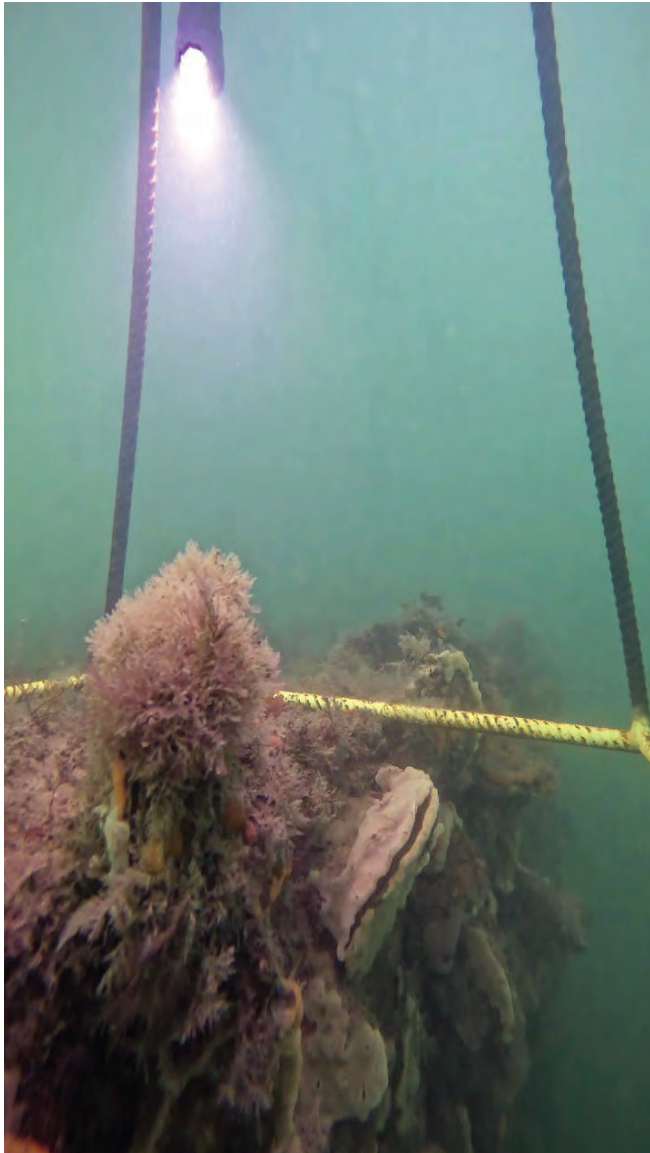
| Sunken barge with attached ectoprocts ( <i>Bugula</i> sp.), hydroids, solitary tunicates ( <i>Styela clava</i> ), encrusting tunicates ( <i>Didemnum</i> sp.), and encrusting sponges ( <i>Halichondria panicea</i> ). Located near Fan Pier, in front of the Federal Courthouse. | | | | | | | | | | | |
