# Boston Coastal Storm Risk Management Study

## Draft Integrated Feasibility Report and Programmatic Environmental Assessment

### APPENDIX D - ENVIROMENTAL

# INTERTIDAL AND SUBTIDAL HABITAT SURVEYS

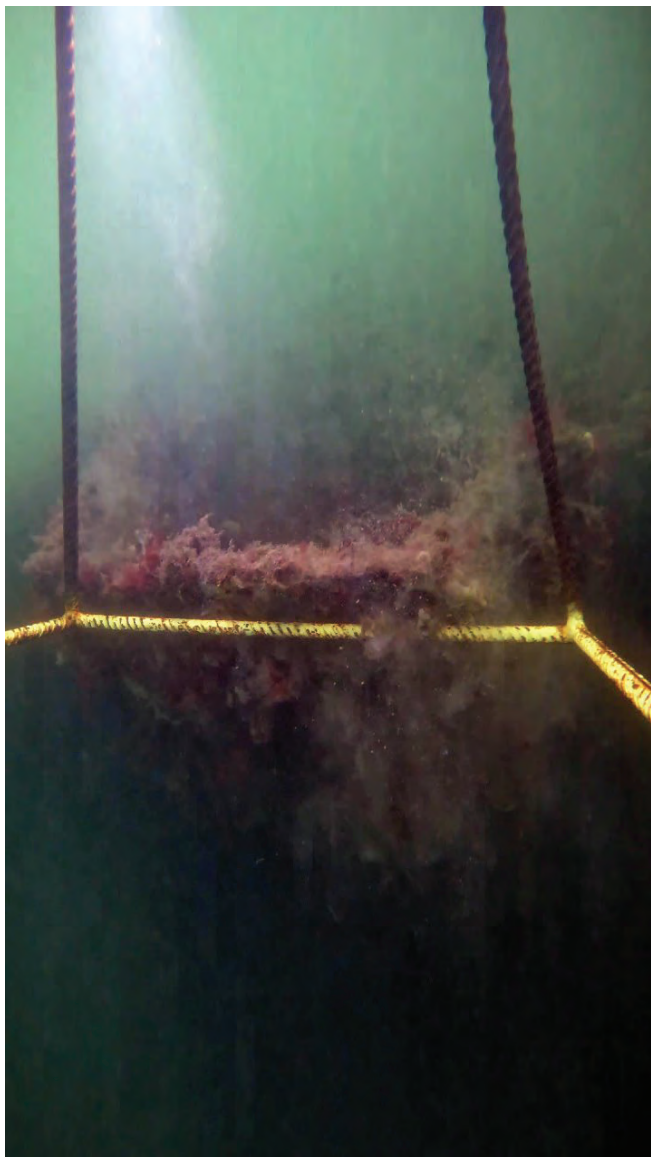
| Southern edge of the MBTA tunnel structure. Large corrugated sheet pile retaining wall with attached macroalgae, tunicates, ectoprocts and/or hydroids. Video captures taken at slightly different moments to enhance view of structure. Located between Seaport Boulevard and the Congress Street Bridge. | | | | | | | |

The underwater video survey also documented features associated with the MBTA and Massachusetts Turnpike tunnels. The underwater video transect at FP-3 documented a sheet pile bulkhead along the southern edge of the MBTA tunnel. The top of the tunnel was covered with tunicates (likely Molgulidae sp., *Styela clava*, or *Ascidella aspersa*), which are typically found attached to hard substrate. Video transect FP-9 clearly showed the scoured edges of the I-90 concrete tunnel structure elevated above the silt seafloor. The top of the tunnel was covered in a thick layer of filamentous macroalgae with patches of what appeared to be crushed ballast stone. This stone was also present along either side of the tunnel structure.

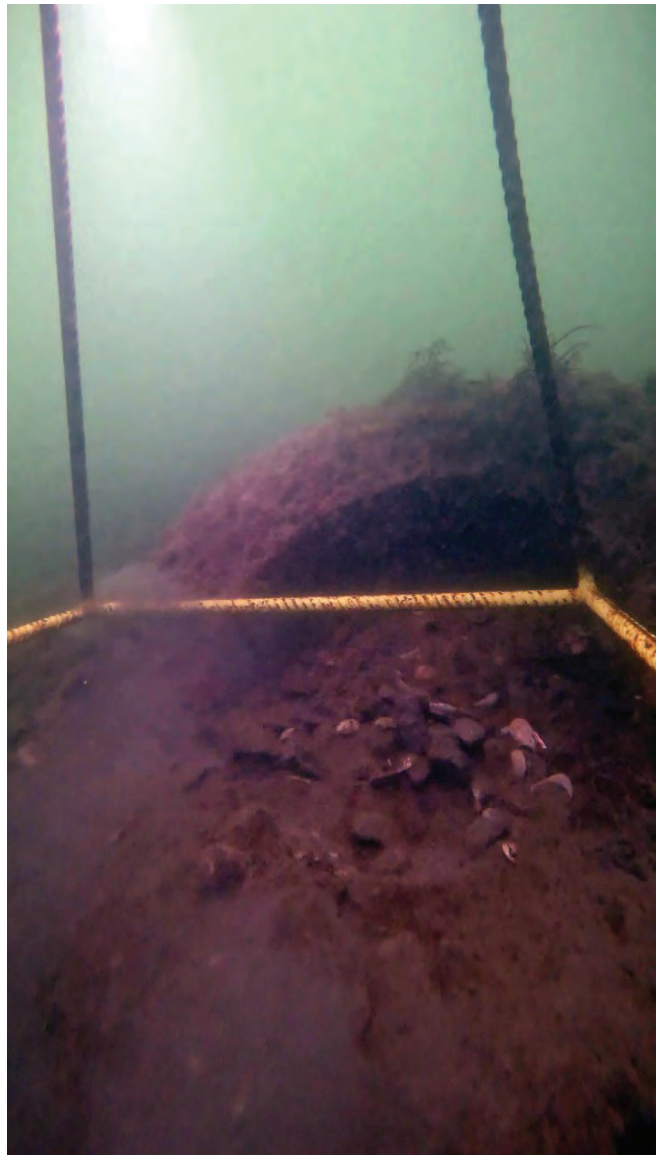
| Notes:<br><br>Approximately 50 feet south of the MBTA tunnel. Silt and shells. Large circular metal object (anthropogenic debris) visible in both plan- and prfoile-view images. Algal and macroalgal growth. Located between Seaport Boulevard and the Congress Street Bridge. | | | | | | | |

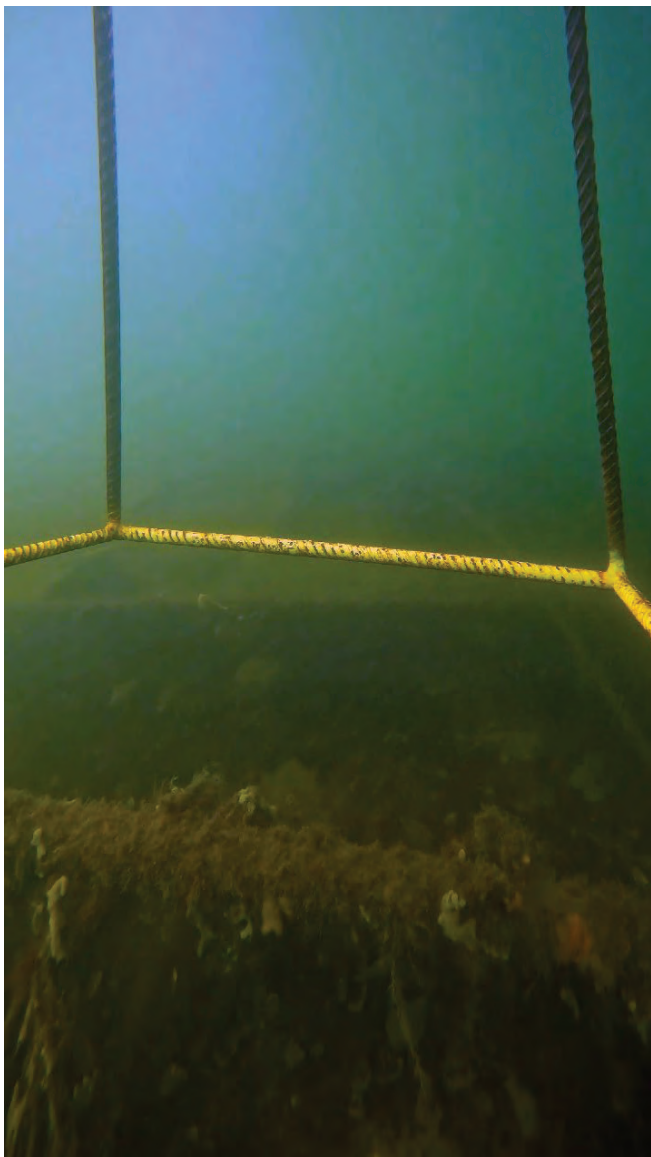
| Large sunken metal barge with attached sponges, tunicates, ectoprocts, and hydroids. Located approximately 350 feet south of the Summer Street Bridge. | | | | | | | | | | | | | |

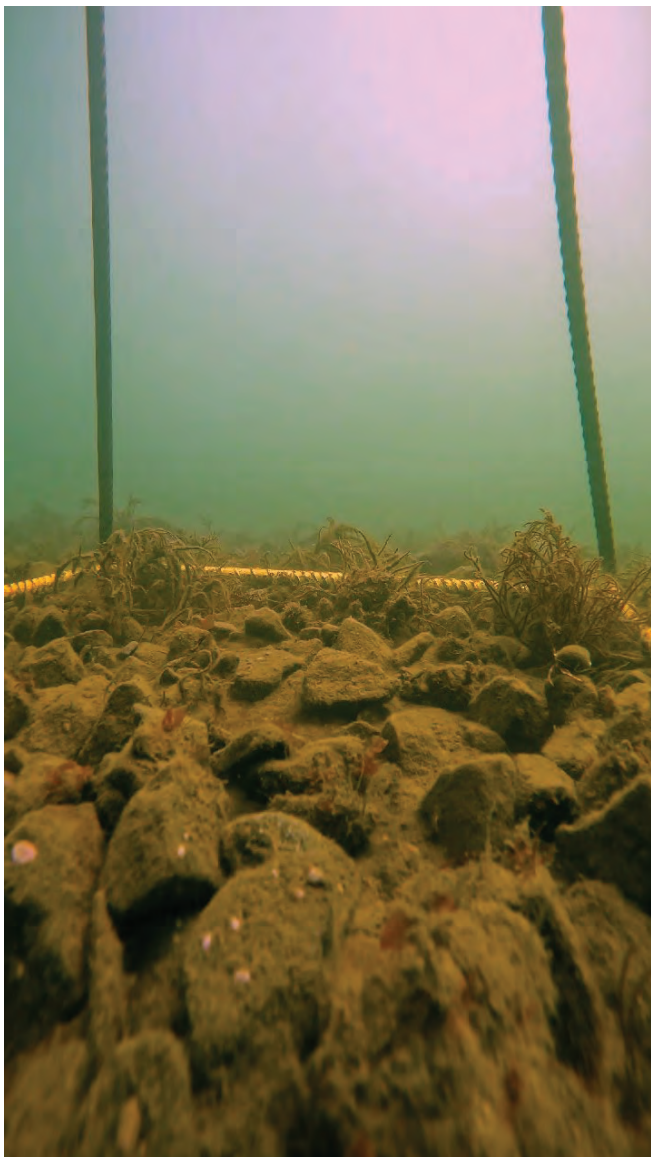
| Gravel with attached mixed macroalgae. Located on the western edge of Fort Point Channel between Summer Street and the Fort Point Channel Tunnel. | | | | | | | |

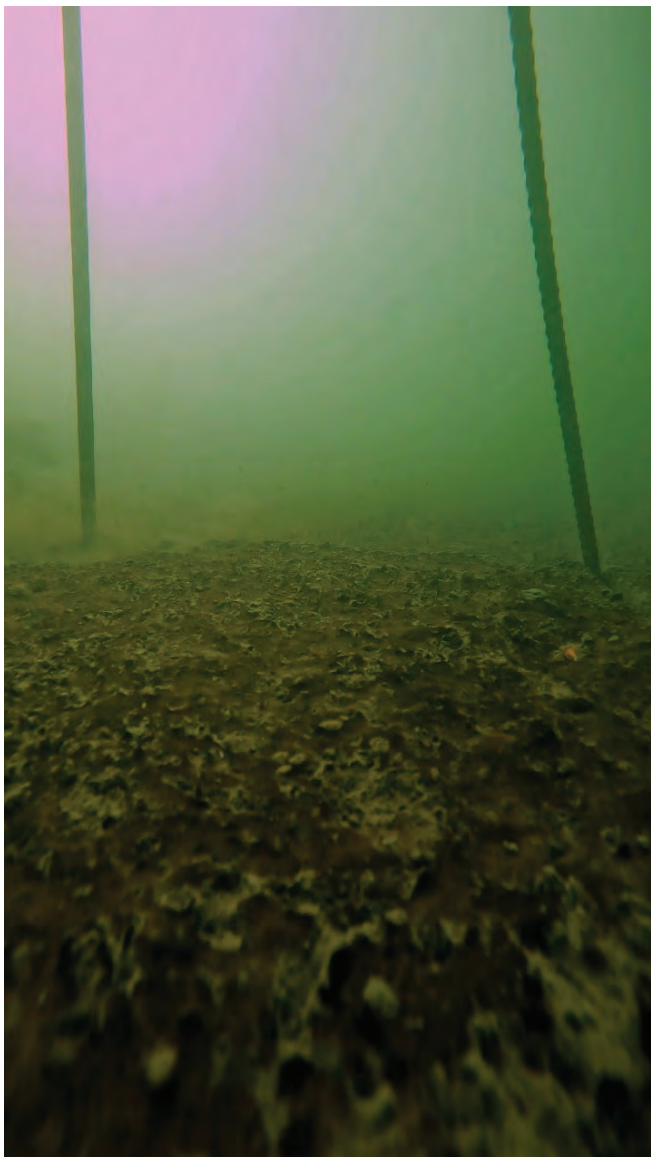
| Silt with dense cover of microbial algae. Located just north of the Fort Point Channel Tunnel (Central Artery/Tunnel Project; built in 1994). | | | | | | | |

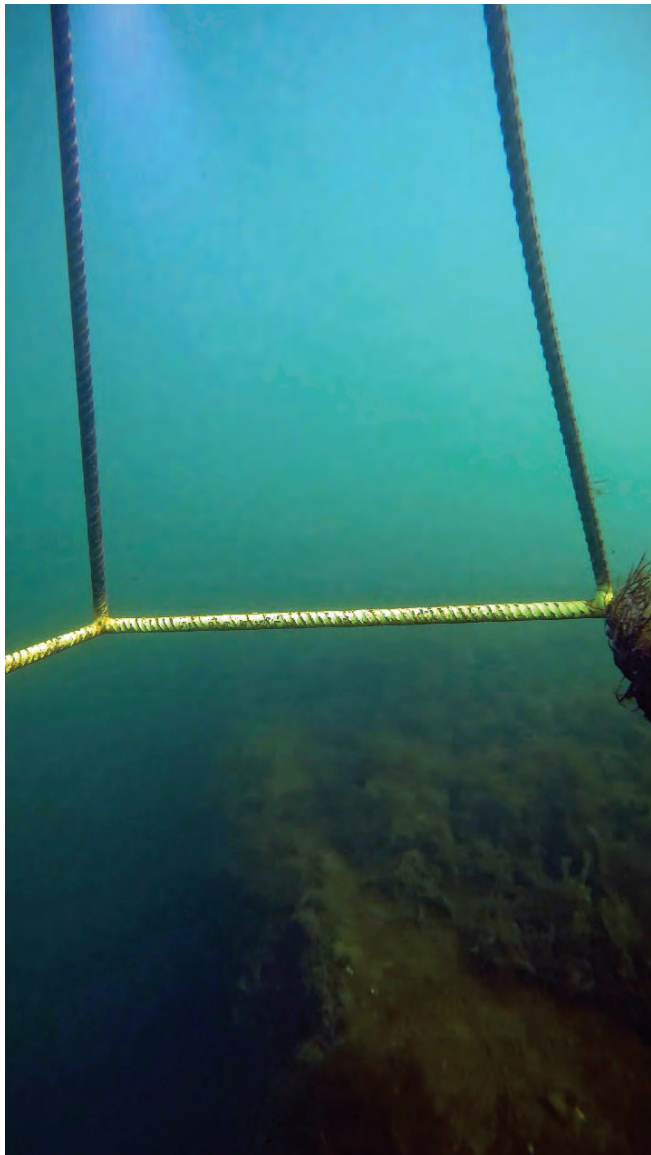
| Notes:<br><br>Concrete tunnel tube scoured and exposed above ambient seafloor to the north. Concrete substrate with a think layer of silt, microbial algae, and filamentous macroalgae. Located on the northern edge of the Fort Point Channel Tunnel. | | | | | | | |

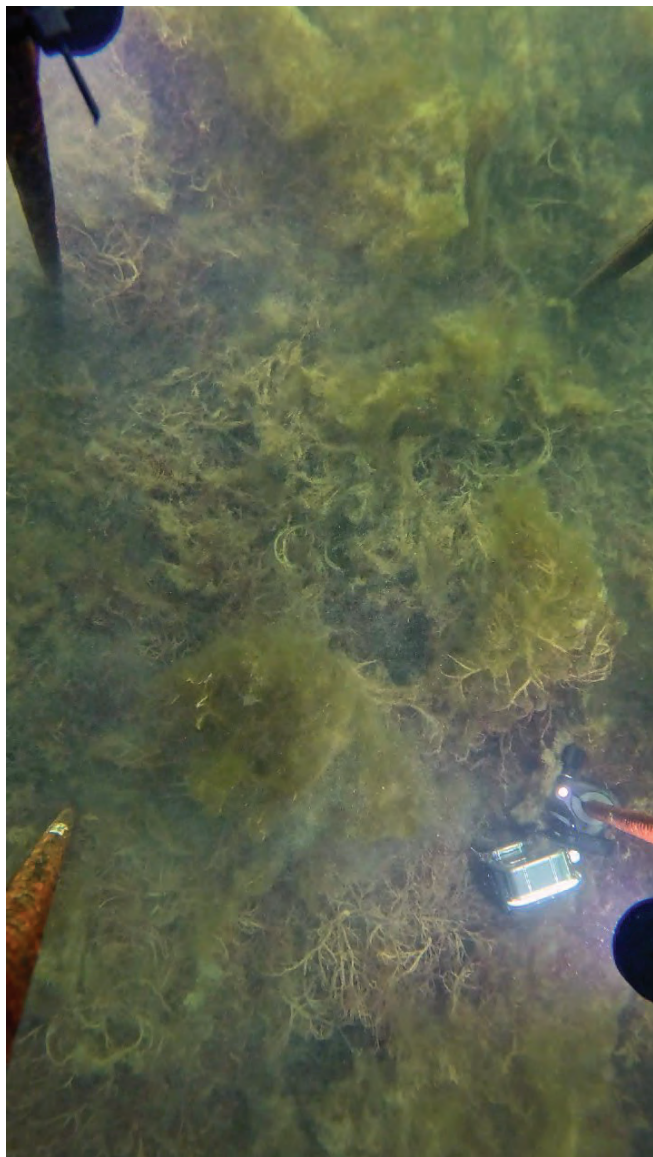
| Notes:<br><br>Concrete substrate with a thick layer of mixed macroalgae and microbial algae. Located on top of the Fort Point Channel Tunnel. | | | | | | | |

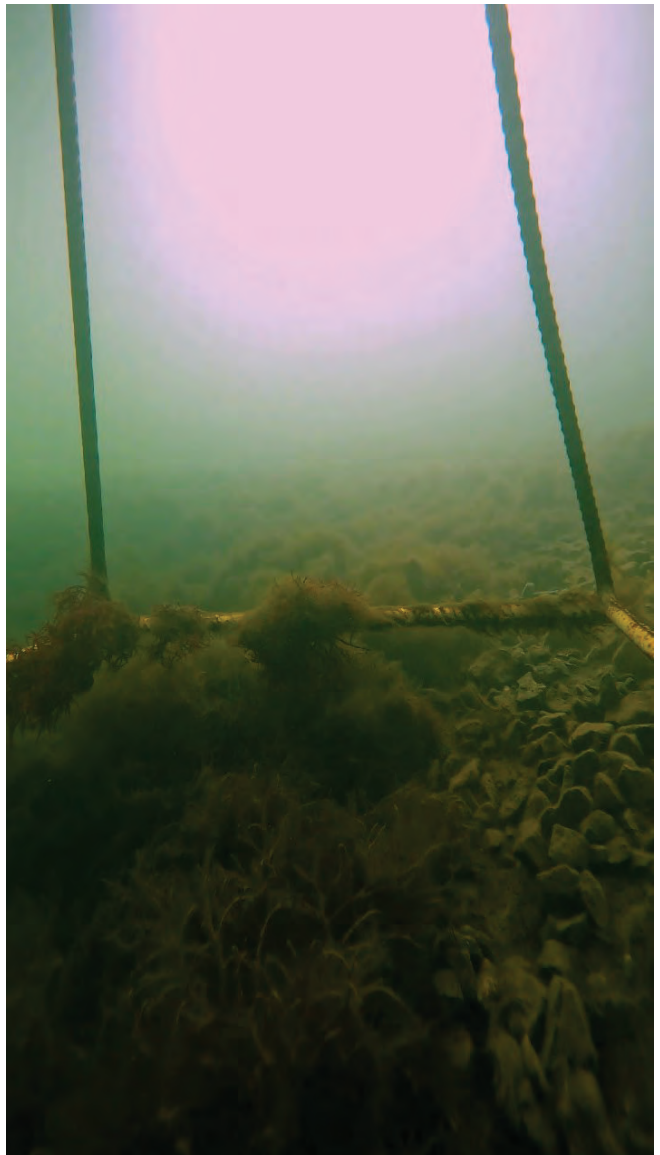
| Notes:<br><br>Gravel with a moderate cover of filamentous macroalgae. Located on the southern edge of the westbound tube/ northern edge of the eastbound tube sections of the Fort Point Channel Tunnel. | | | | | | | |

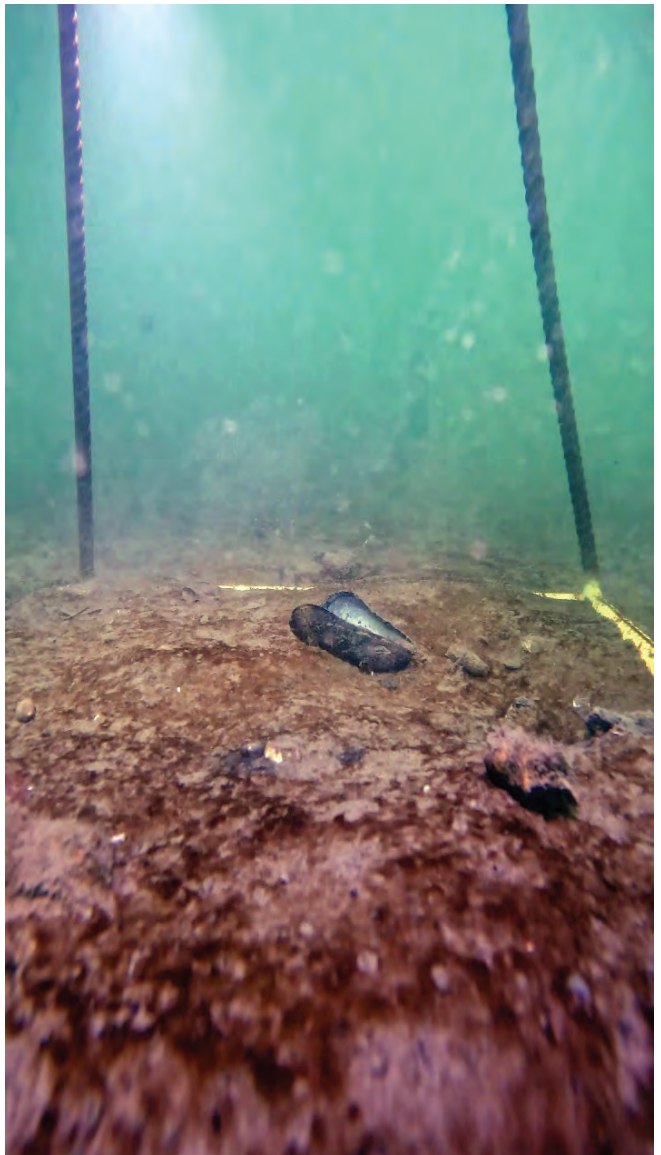
| <p>Silt and shells with a thin cover of microbial algae and several tunicates (likely Molgulidae spp.). Corrugated metal pipe with attached tunicates and sponges visible in plan-view image. Several tunicates are also attached to shell rubble. These structures are part of a combined sewer overflow (CSO) outfall adjacent to an MWRA stormwater station on the eastern edge of the Fort Point Channel.</p> | | | | | | | |

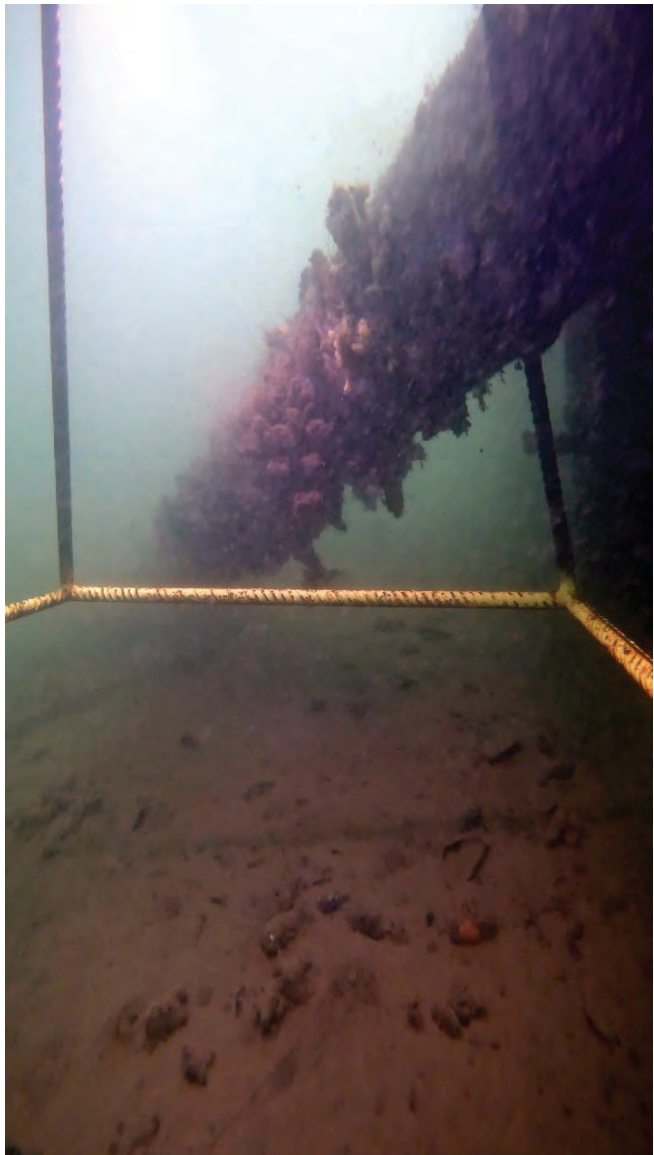
| Notes:<br><br>Silt with shells and large anthropogenic structure including a fallen wooden piling. Structures covered with tunicates, sponges, ectoprocts, and hydroids. These features are adjacent to the Gillette cooling water intake structure on the eastern edge of the Fort Point Channel. | | | | | | | |

pipings observed during video transect FP-11 were associated with the Gillette cold water intake structure, though it was not possible to tell if they were active or derelict features.

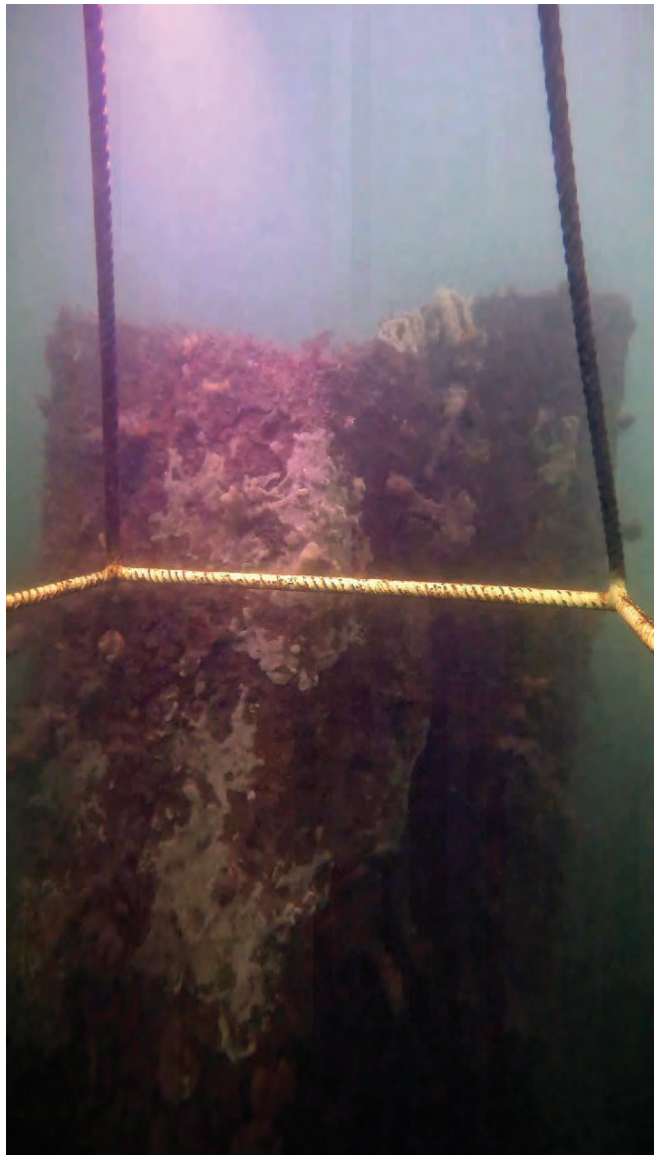
| Sheet pile projecting into the waterway adjacent to the Gillette cooling water intake structure on the eastern edge of the Fort Point Channel. The structure was covered in encrusting tunicates (likely Didemnum sp.) and/or sponges. Video captures taken at slightly different moments to enhance view of structure. | | | | | | | | | | | | | |

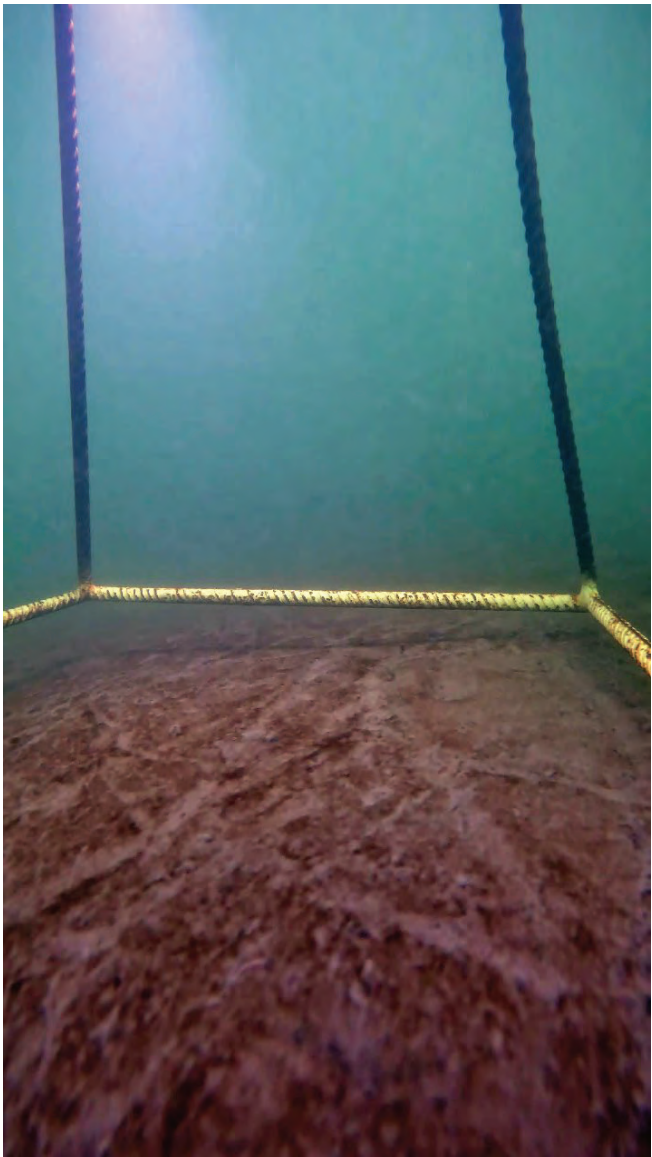
| Bare silt with a thin layer of microbial algae and epifaunal invertebrate tracks. Ambient seafloor adjacent to the Gillette cooling water intake structure on the eastern edge of the Fort Point Channel. | | | | | | | | | | | | | |

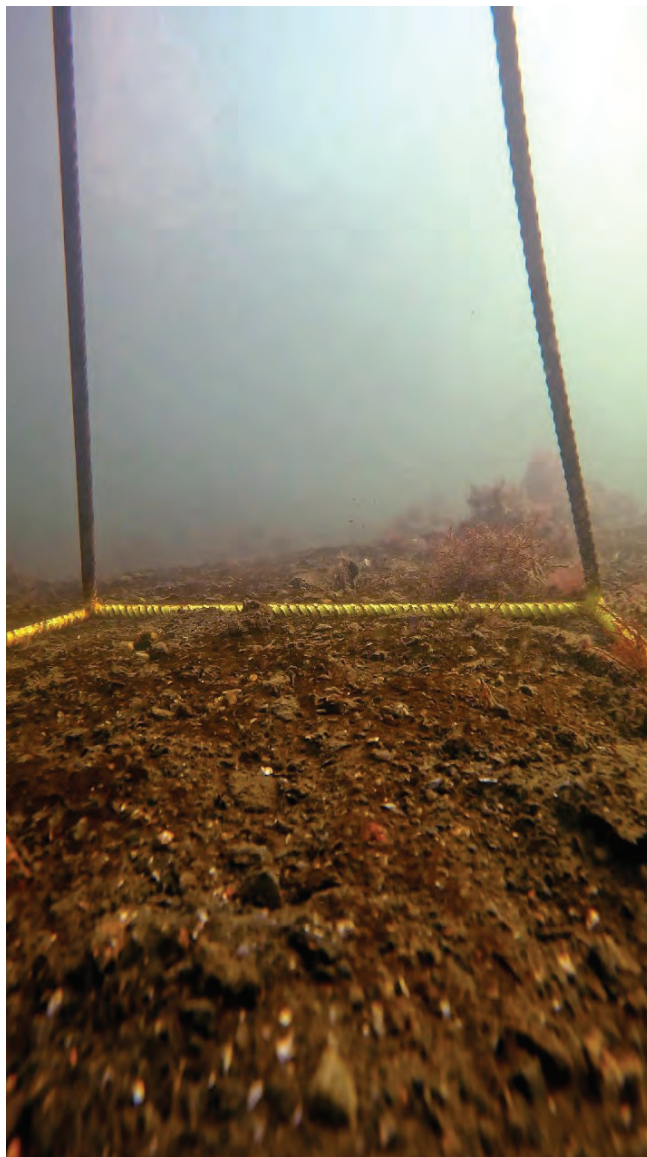
*Gravel with shell hash/rubble, anthropogenic debris, and a thin layer of microbial algae. Located on the eastern edge of the Fort Point Channel adjacent to Fan Point Pier.*

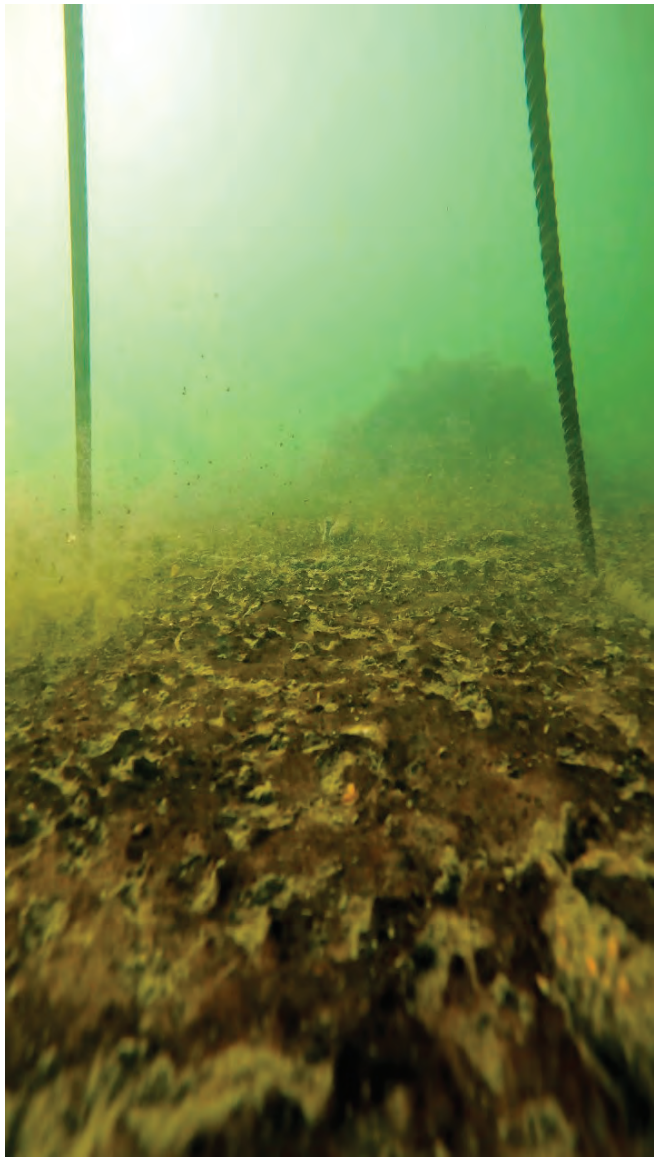
| Silt with shell hash/rubble, anthropogenic debris, and a thick layer of microbial algae. Located on the eastern edge of Fort Point Channel adjacent to Martin's Park. | | | | | | | | | | | | | |

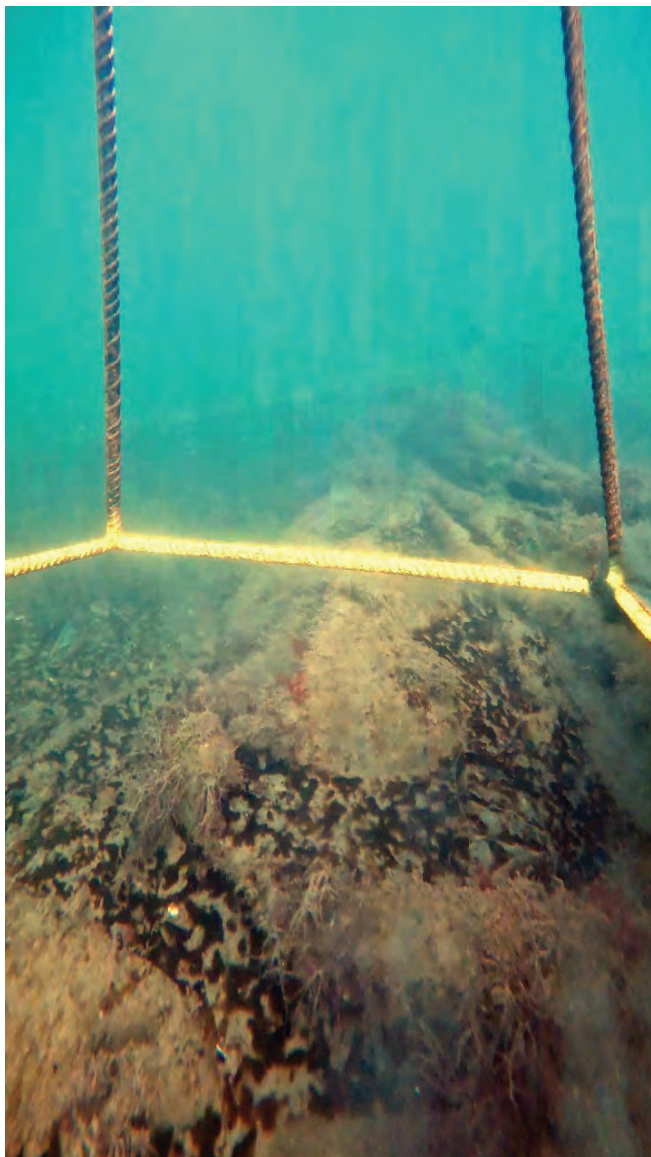
| Indeterminate anthropogenic debris (possibly heavy fabric) with dense cover of microbial algae and sparse small tufts of filamentous macroalgae. Located on the eastern edge of Fort Point Channel adjacent to Martin's Park. | | | | | | | |

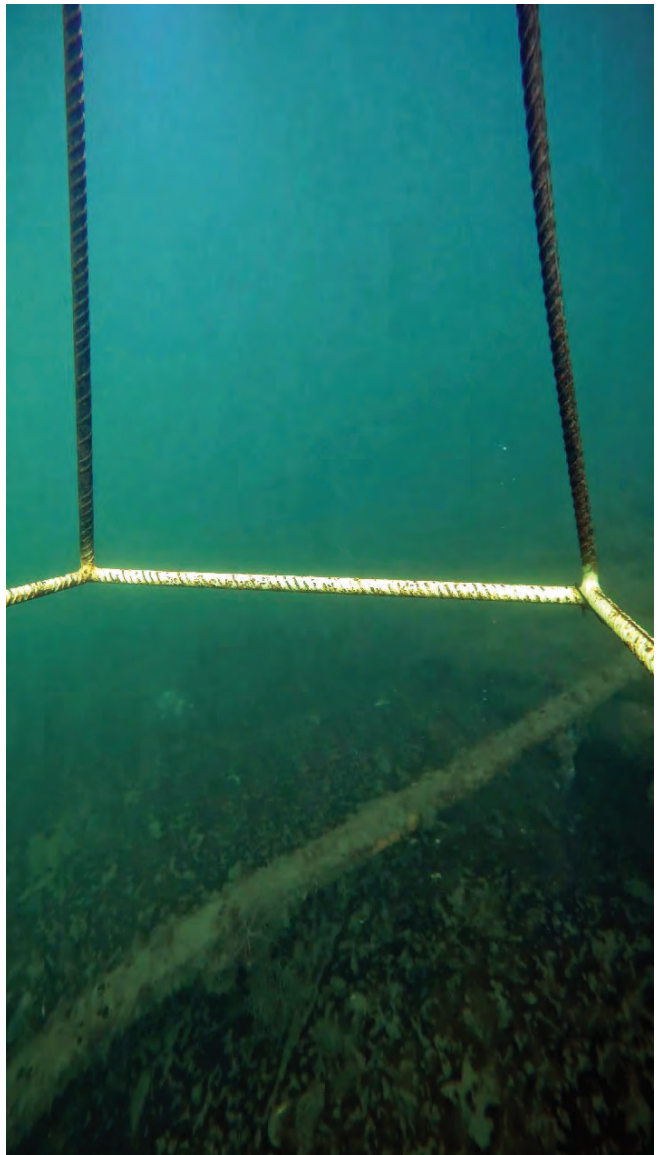
| <p>Notes:</p> <p>Silt with a thick cover of microbial algae and scattered anthropogenic debris. Elongated metal rail visible in both plan- and profile-view images. Located on the eastern edge of Fort Point Channel adjacent to Martin's Park.</p> | | | | | | | |

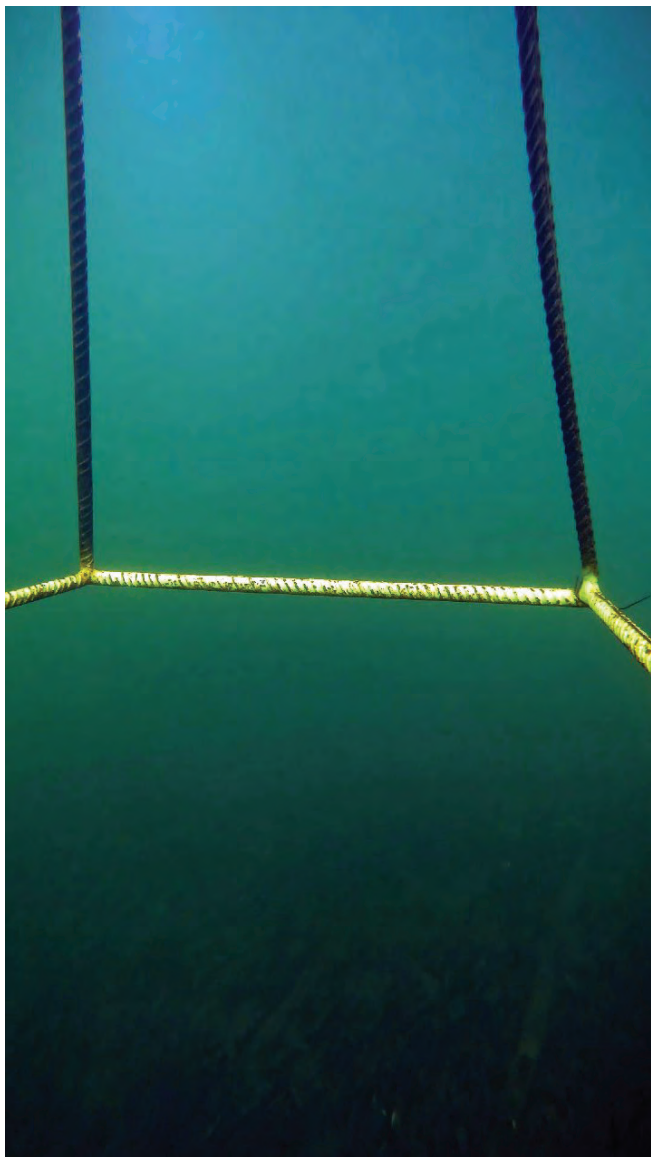
| Silt with a thick cover of microbial algae and scattered anthropogenic debris. Two parrallel metal rails visible in plan-view image. Located on the eastern edge of Fort Point Channel adjacent to Martin's Park. | | | | | | | |

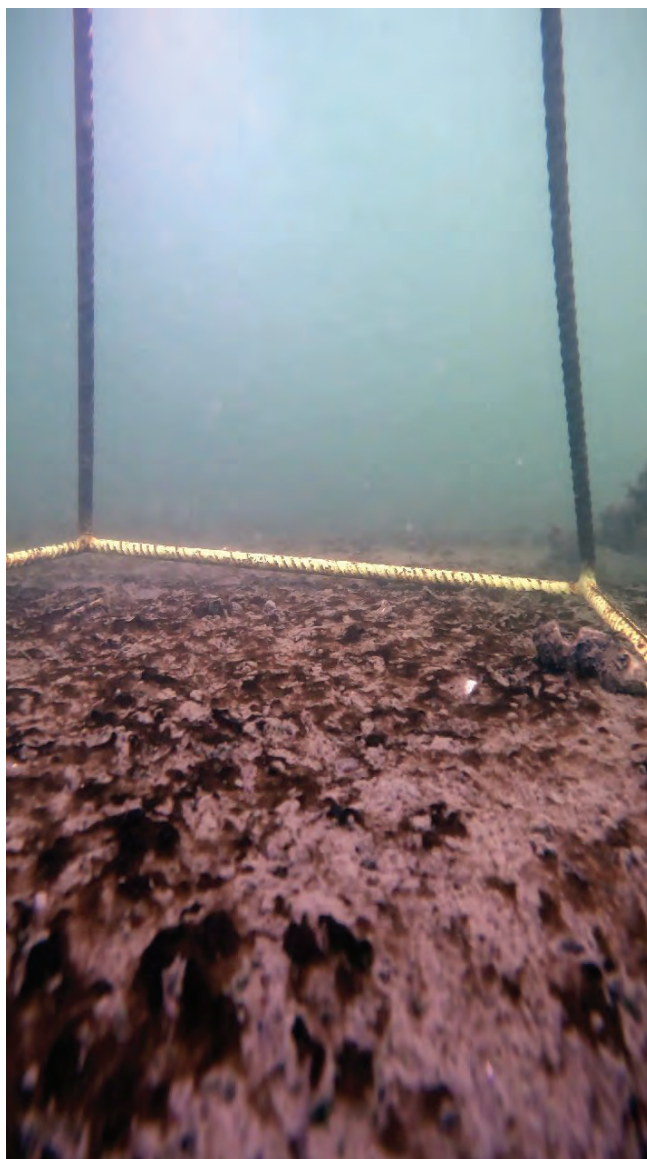
Silt with trace shell hash and a moderate cover of microbial algae. Spider crab (*Majoidea* sp.) present. Located at the mouth of the Fort Point Channel adjacent to the Federal Courthouse.

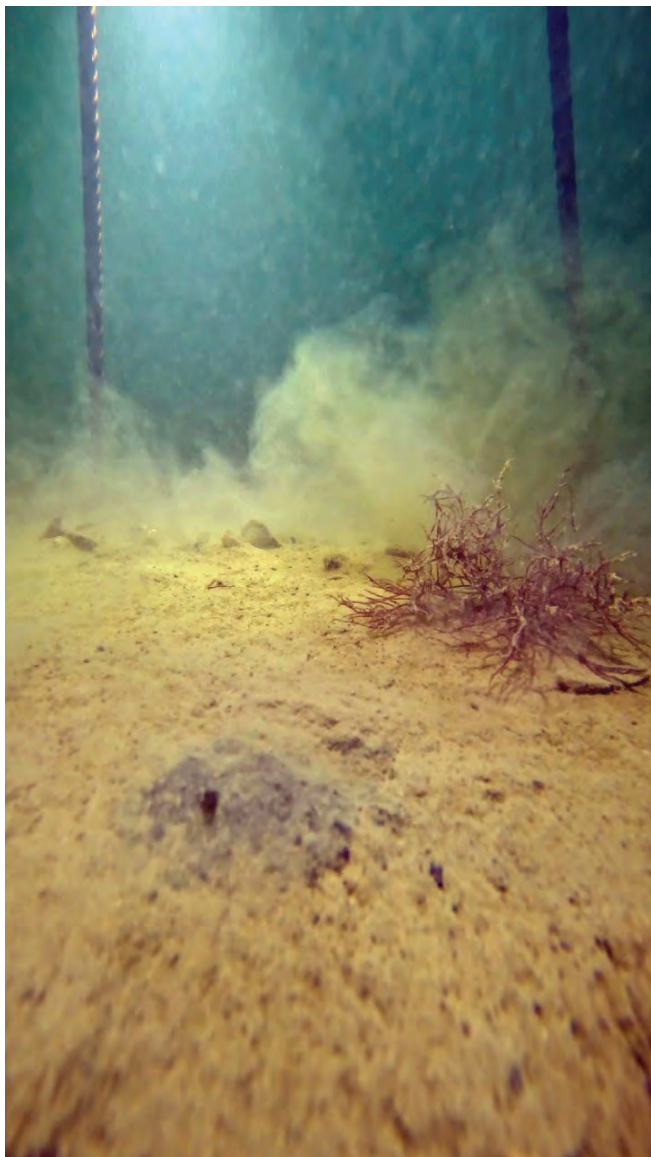
| Silt with sparse shell rubble. Evidence of bioturbation (small burrow with unearthed unoxidized sediment) present. Small tuft of red filamentous macroalgae present. Located between Battery and Burroughs Wharves. | | | | | | | |

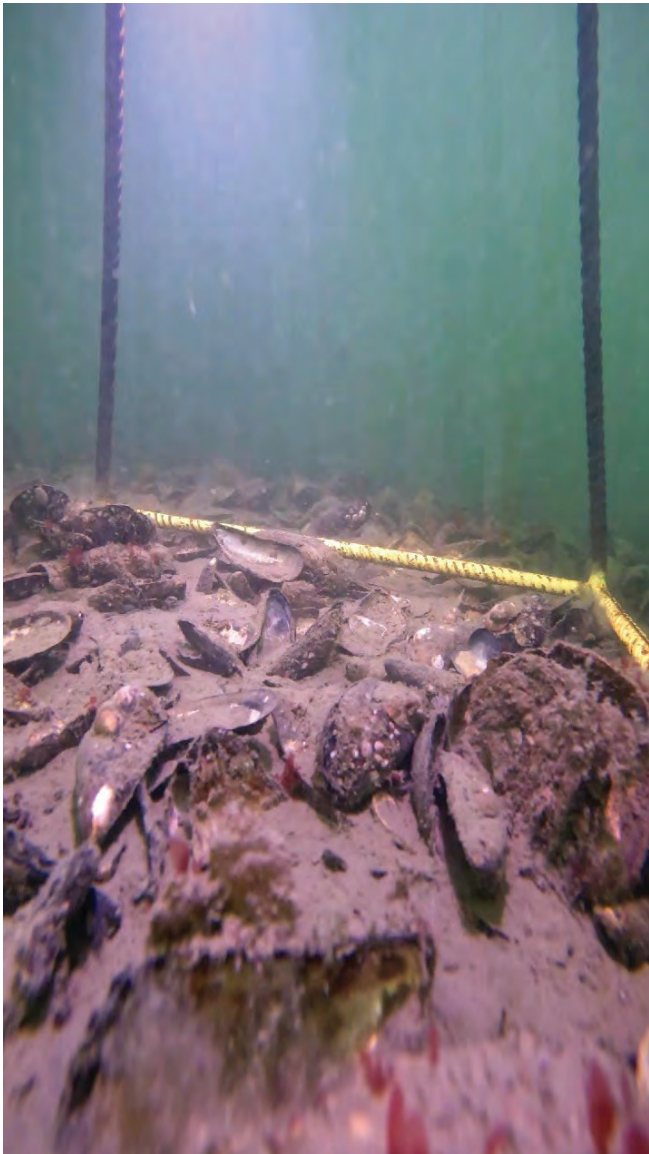
| Silt and mussel shell rubble with attached hydroids and trace red sheet macroalgae. Located adjacent to Burroughs Wharf and the Callahan Tunnel. | | | | | | | |

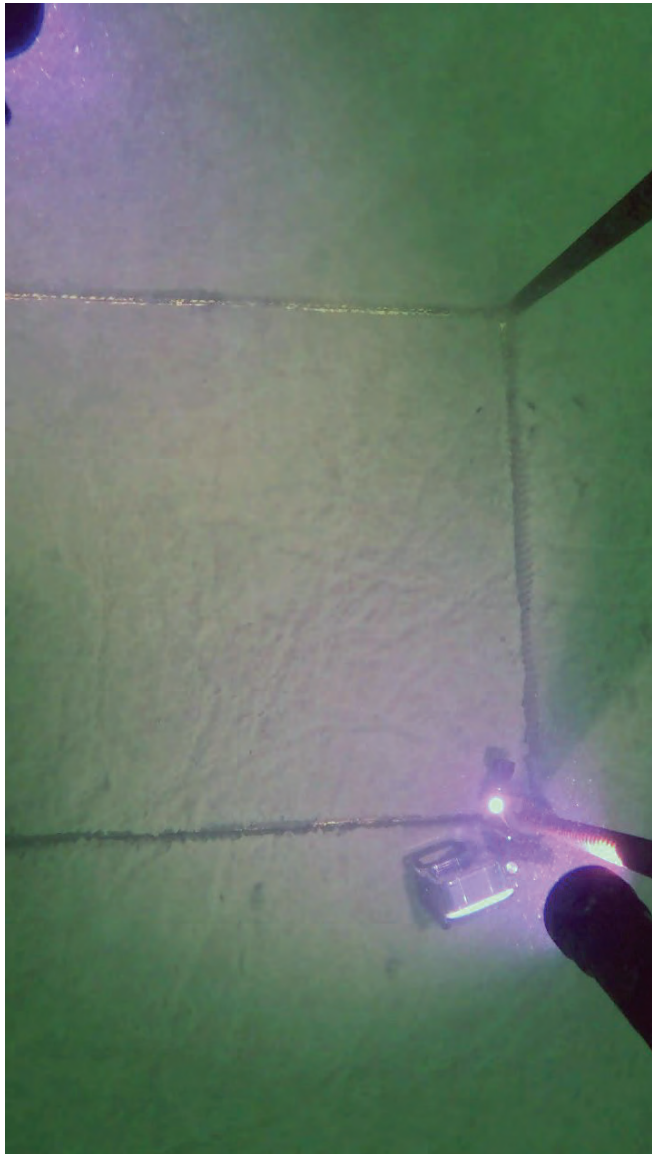
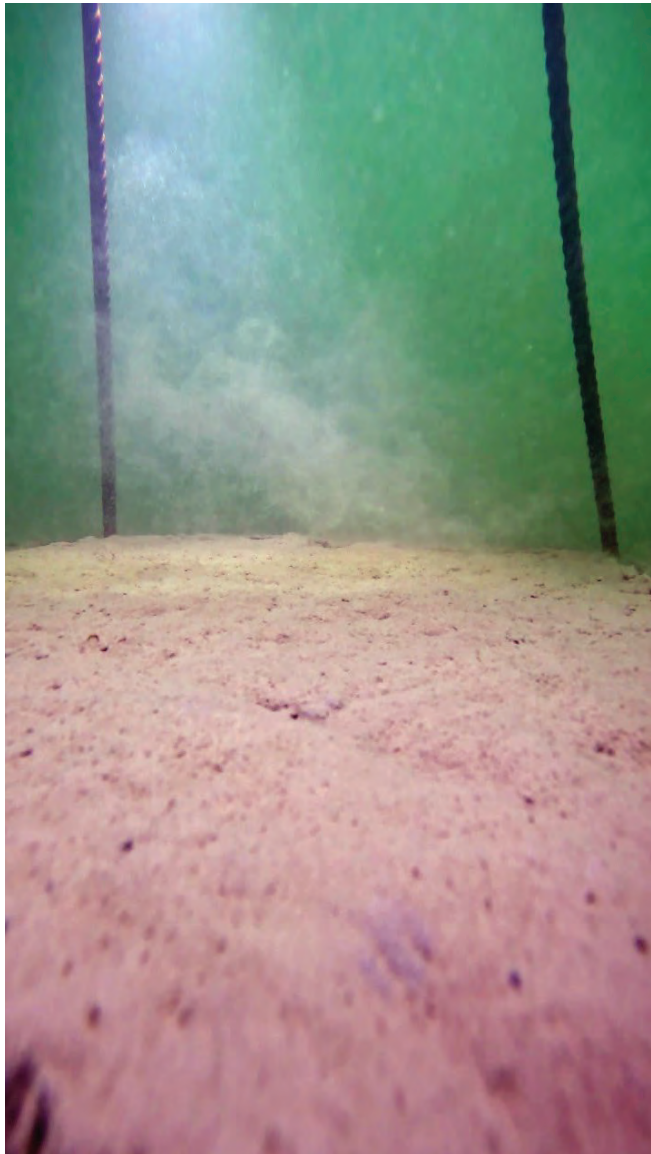
| Bare silt; epifaunal invertebrate tracks visible on sediment surface. Located between Burroughs and Union Wharves. | | | | | | | |

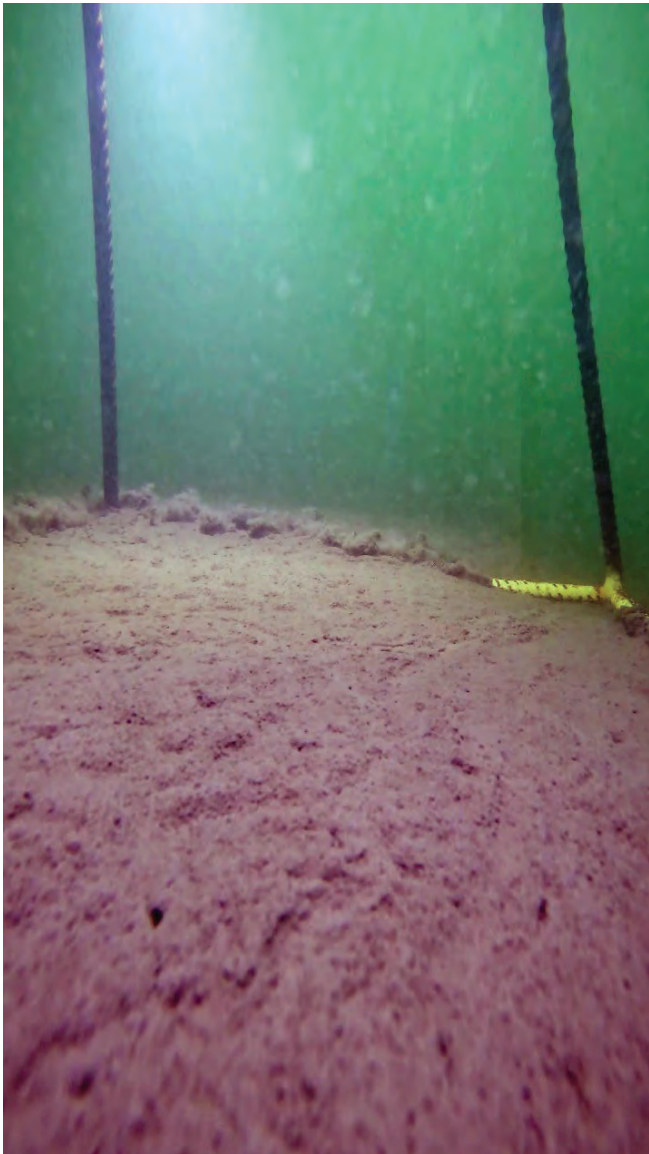
| Bare silt with sparse small infaunal invertebrate burrows. Located near Union Wharf. | | | | | | | |

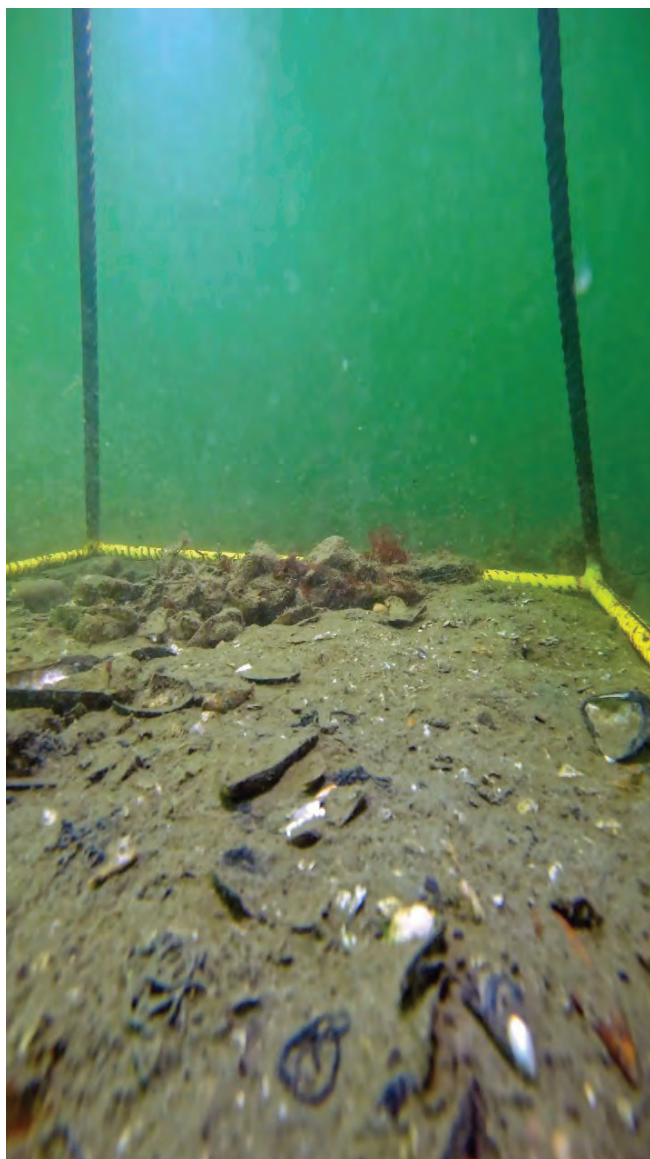
*Silty sand with gravel and shell hash/rubble. Sparse cover of red sheet macroalgae. Infaunal invertebrate castings visible on sediment surface. Possibly ectoprocts and/or hydroids attached to hard substratum. Located adjacent to Union Wharf.*

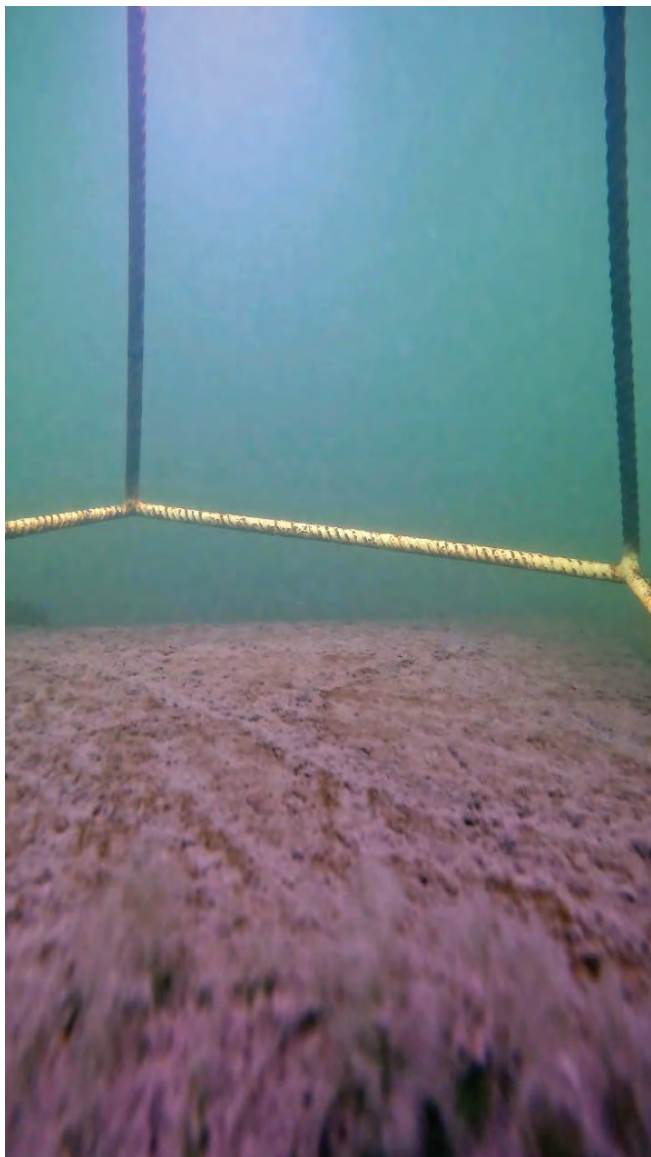
| Bare silt; epifaunal invertebrate tracks visible on sediment surface. Located near Sargent's Wharf. | | | | | | | | | | | |

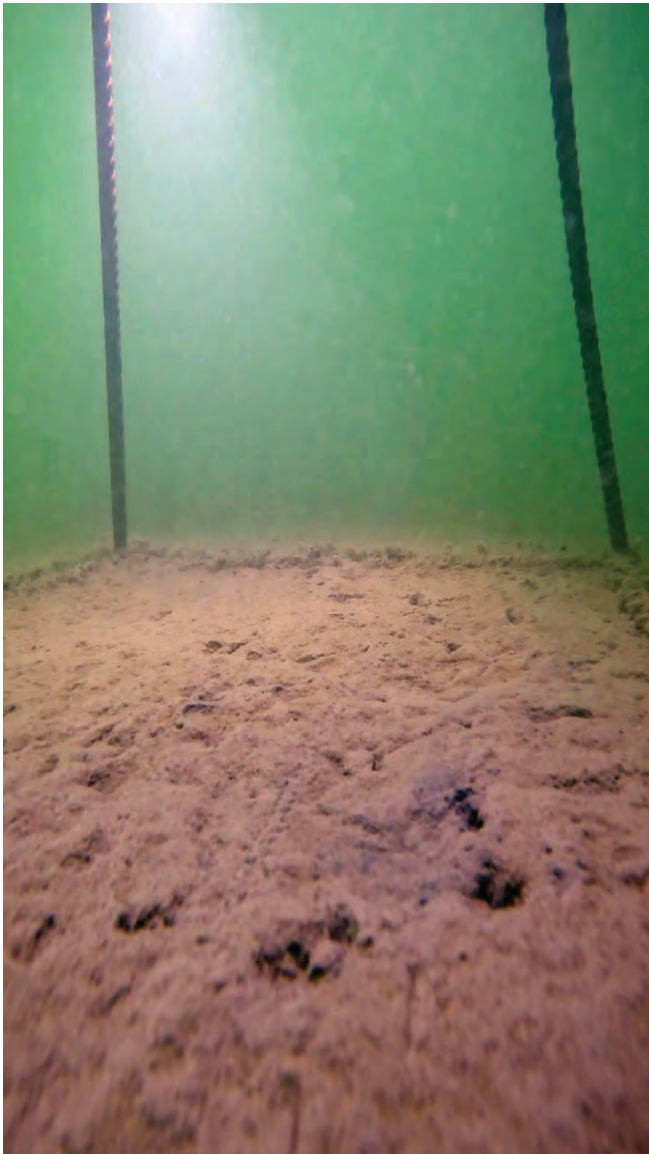
| Bare silt with infaunal invertebrate burrows and epifaunal invertebrate tracks. Located near Sargent's Wharf. | | | | | | | |

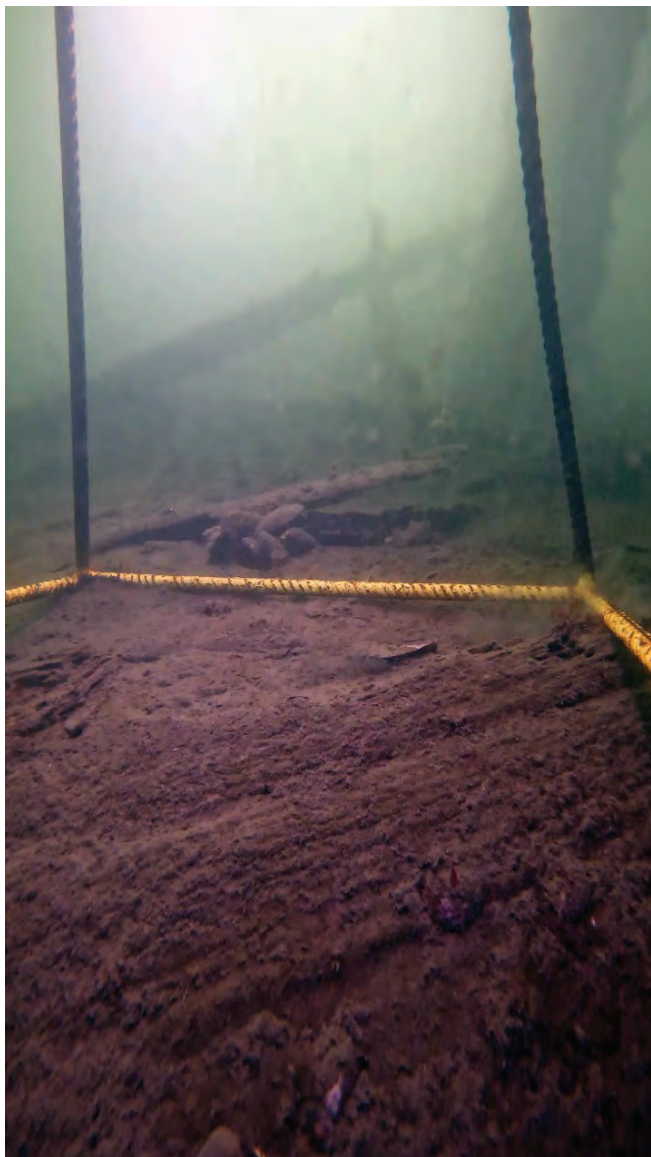
| Large anthropogenic wooden debris. Upright wooden piling and wooden support legs visible in profile-view image. Patch of mussels (Mytilidae sp.) attached to the wood substrate. Located in the footprint of a historic wharf (currently a derelict piling field) near Lewis Wharf. | | | | | | | |

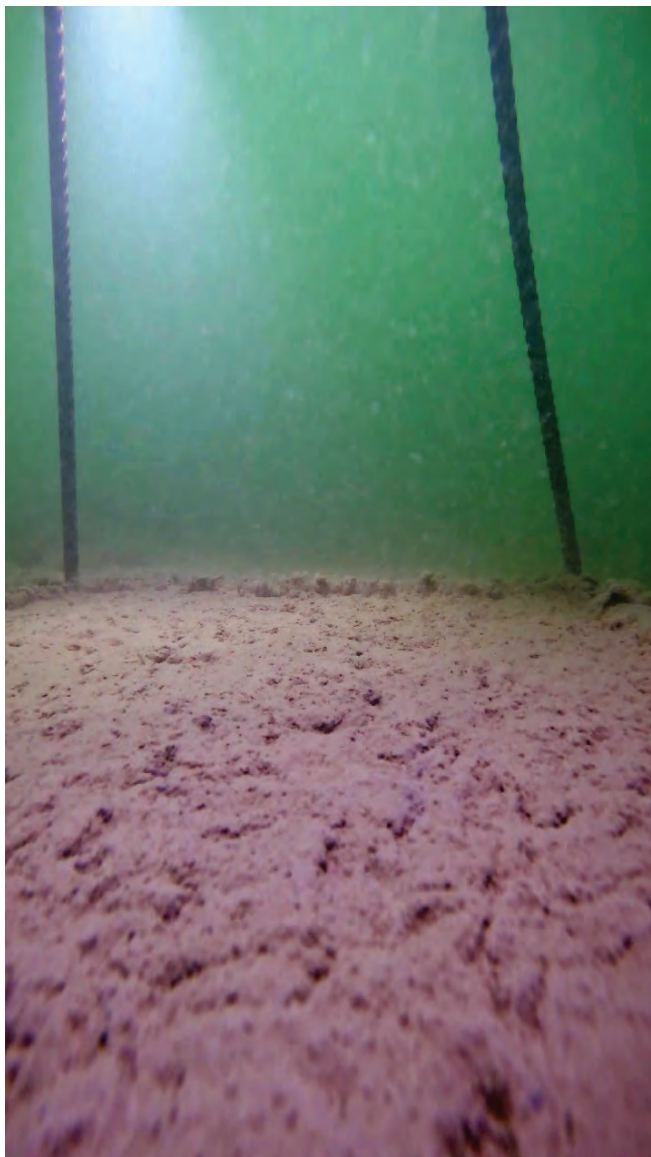
| Bare silt; small infaunal invertebrate tubes and burrows present. Located near Commercial Wharf. | | | | | | | |
