# Boston Coastal Storm Risk Management Study

## Draft Integrated Feasibility Report and Programmatic Environmental Assessment

### APPENDIX D - ENVIROMENTAL

# INTERTIDAL AND SUBTIDAL HABITAT SURVEYS

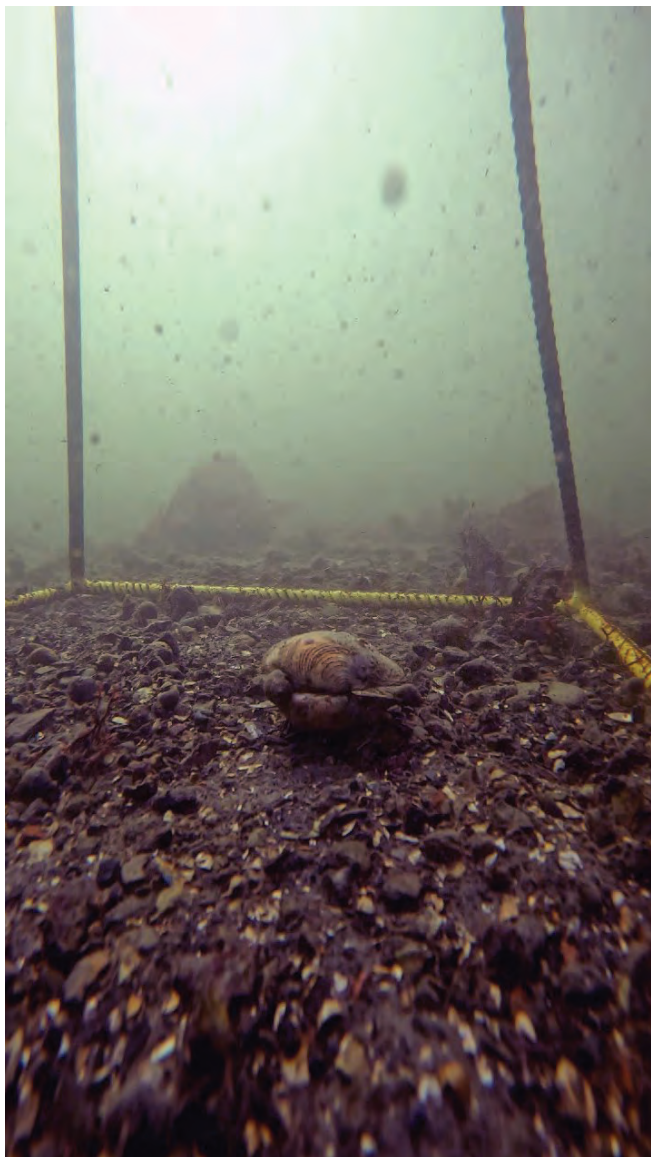
| Gravel with shell hash/rubble. Located between Commercial and Long Wharves, adjacent to Christopher Columbus Waterfront Park. | | | | | | | |

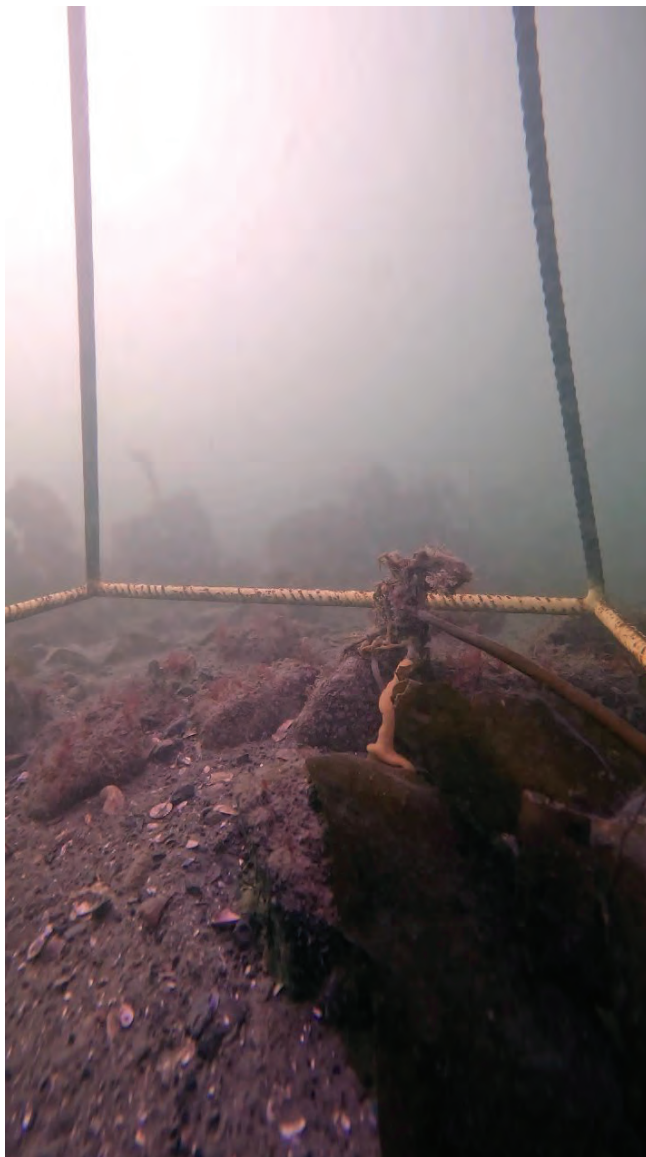
*Gravelly/ shelly sand with interspersed cobbles. Sparse cover of mixed macroalgae, including kelp (likely *Saccharina* sp.) attached to hard substratum. Encrusting sponge (likely *Halichondria panicea*) visible growing on the kelp stipe. Located between Commercial and Long Wharves.*

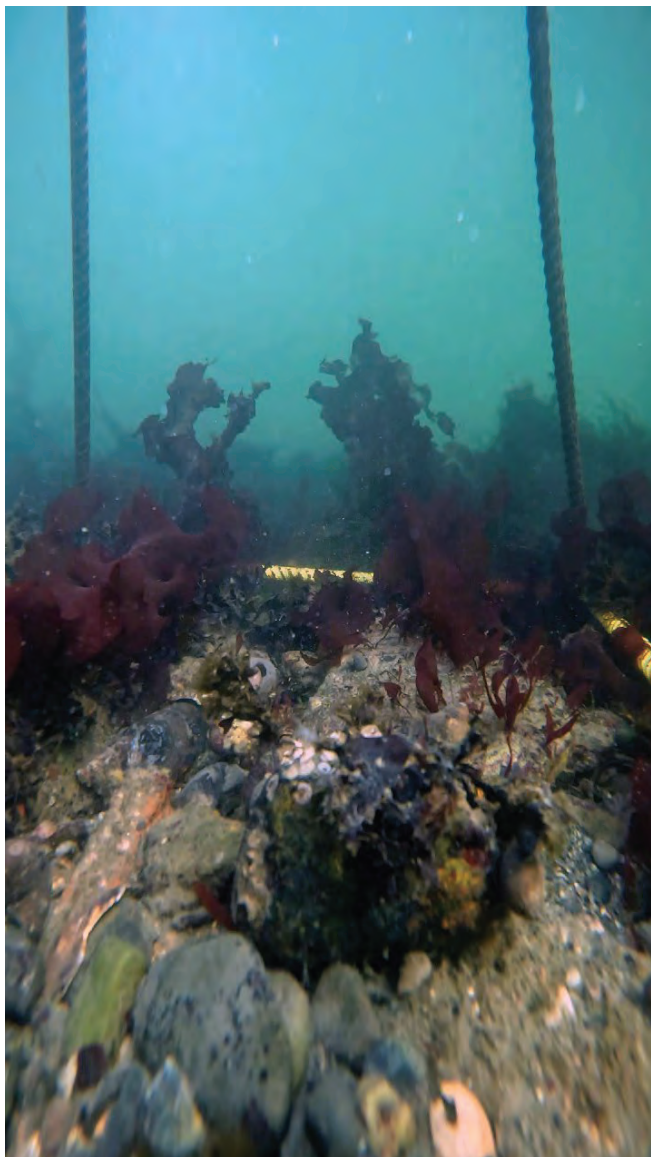
| Gravel and cobbles with moderate to dense cover of mixed macroalgae. Located adjacent to Central Wharf in front of the Boston Aquarium. | | | | | | | | | | | |

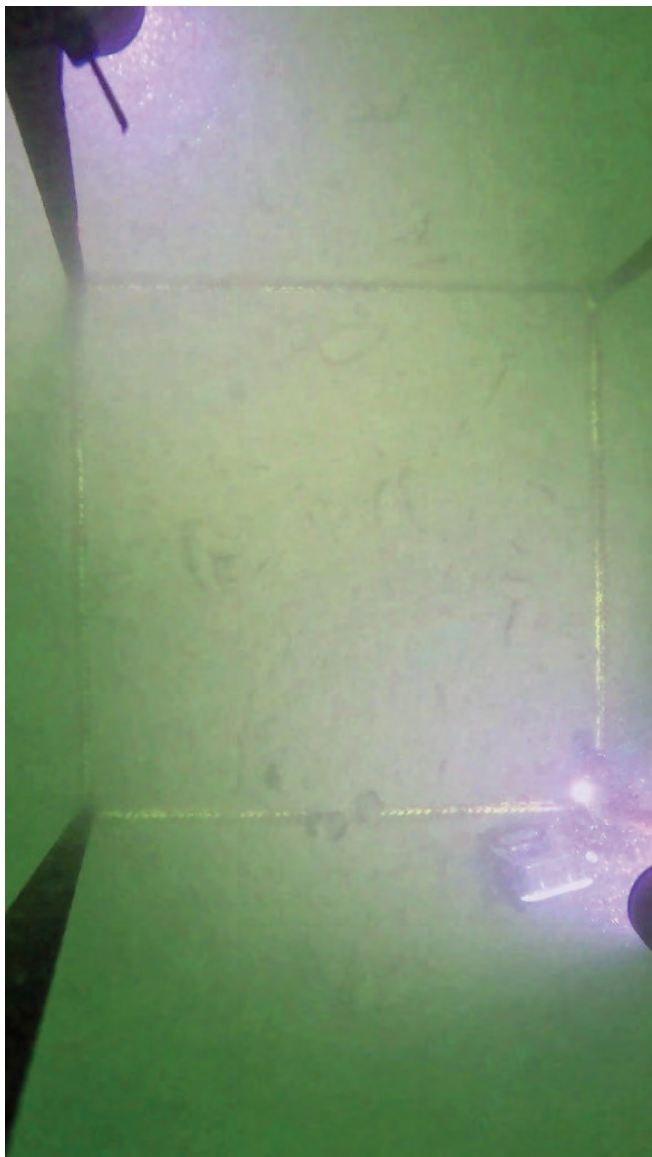
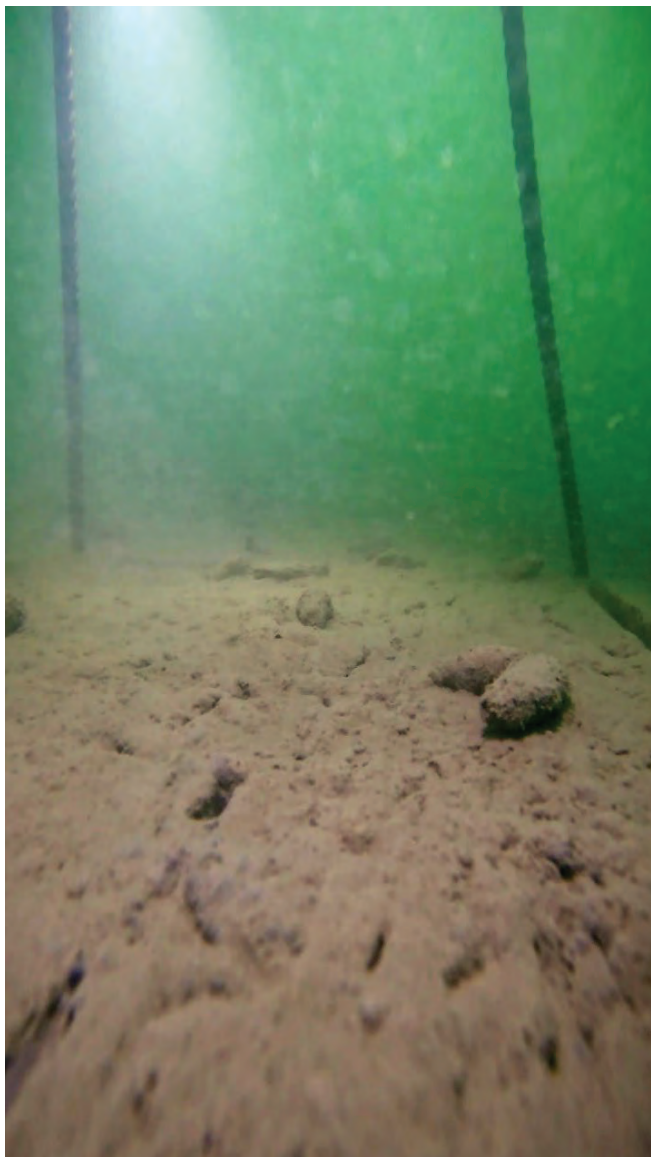
| Bare silt with infaunal invertebrate burrows and several tunicates (likely Molgulidae sp., Styaela clava, or Ascidiella aspersa). Located near Central and India Wharves. | | | | | | | |

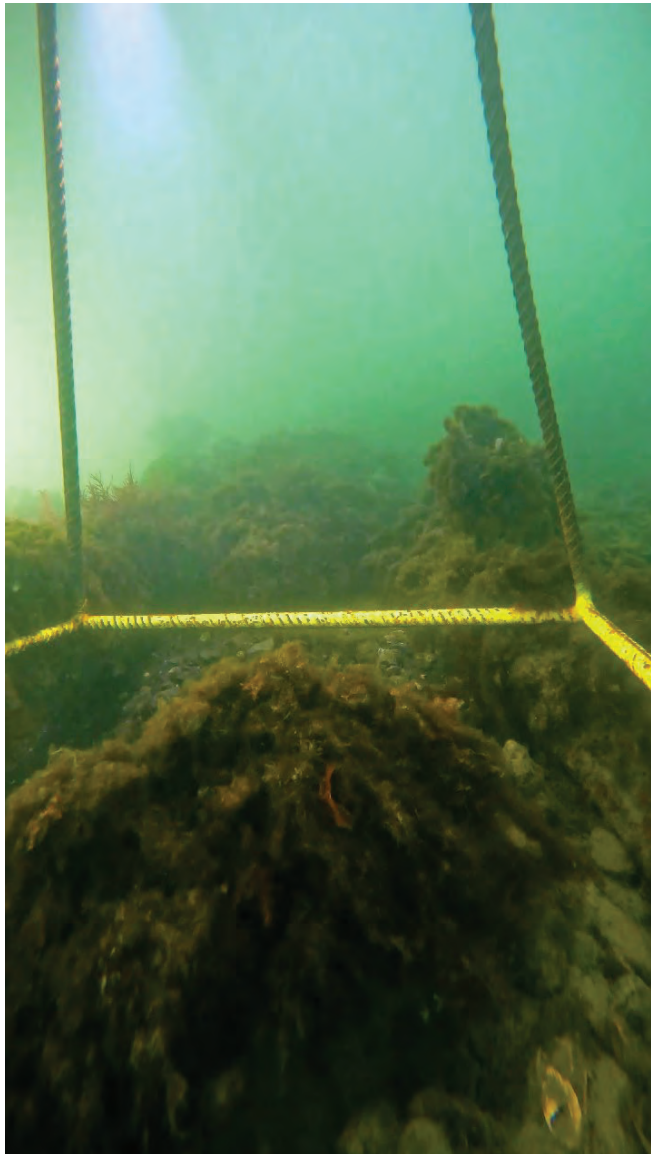
| Gravel with shell hash/ rubble. Large anthropogenic structure (wood and metal) with attached mixed macroalgae present. Located adjacent to India Wharf in the footprint of a historic wharf structure. | | | | | | | |

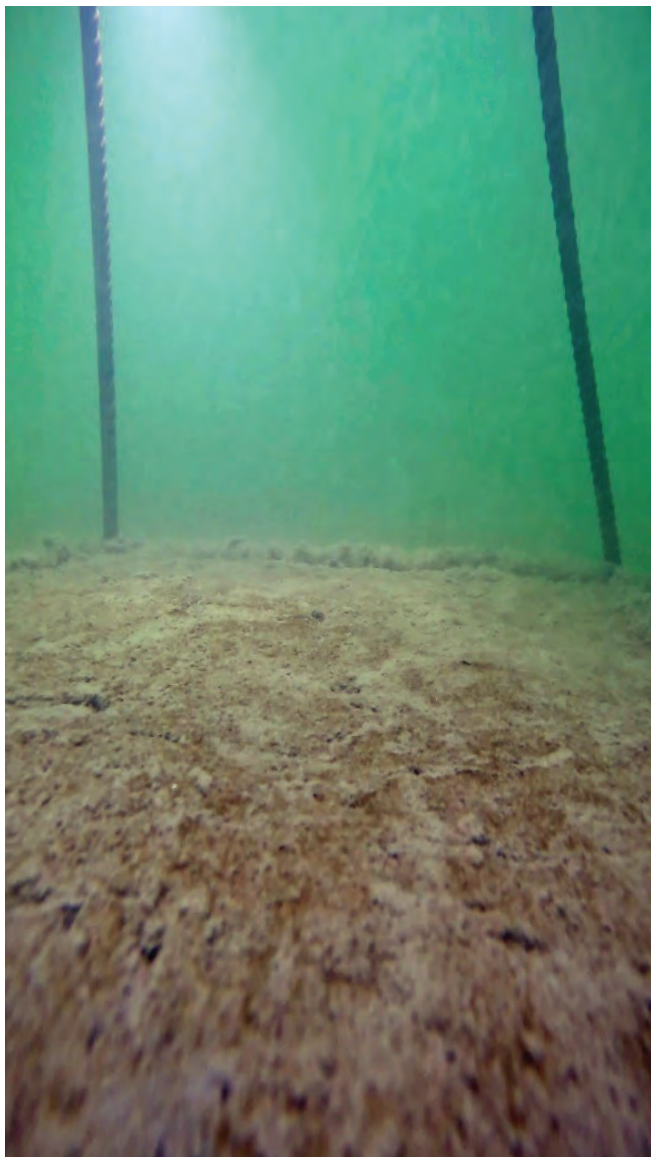
| Bare silt. Located near Rowes Wharf. | | | | | | | |

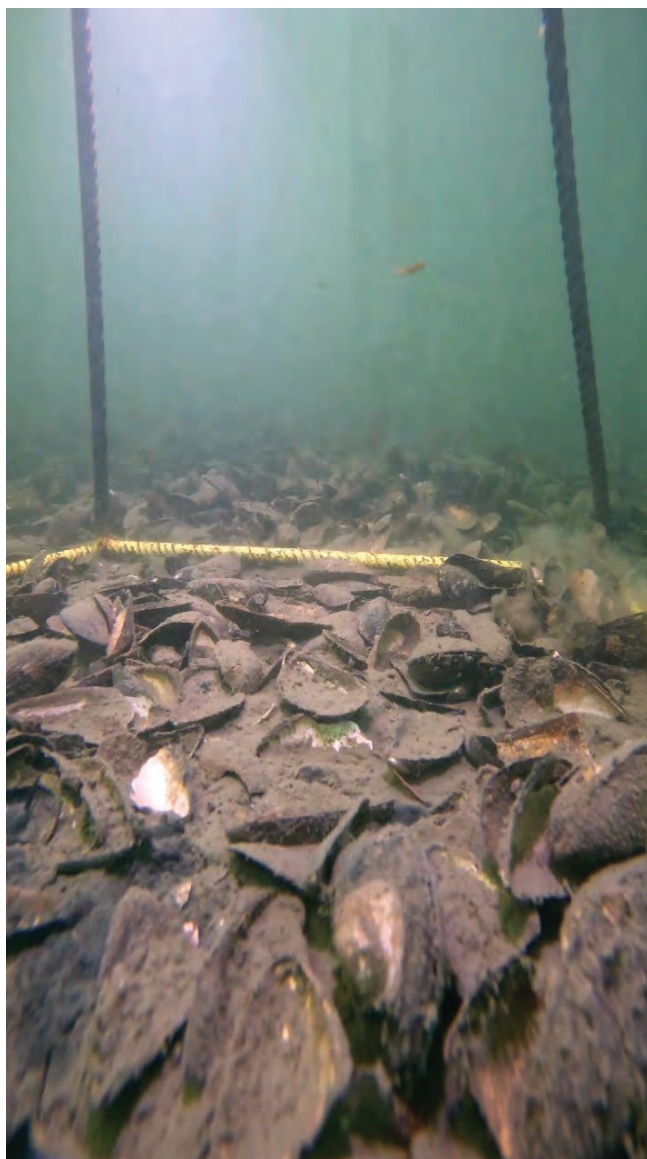
*Shell rubble reef comprised of mostly mussel (Mytilidae spp.) shells. Located adjacent to Rows Wharf, near the mouth of the Fort Point Channel.*

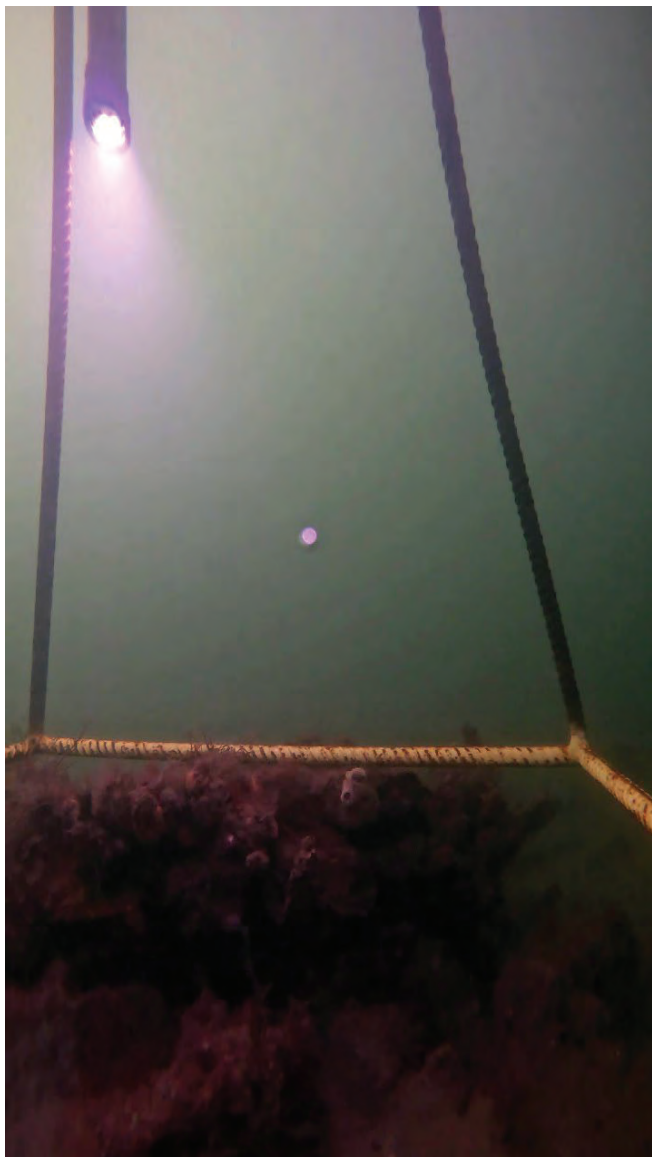
| Anthropogenic metal debris with dense cover of tunicates, sponges, ectoprocts, and hydroids. Located on the western end of Little Mystic Channel just south of the boat ramp. | | | | | | | |

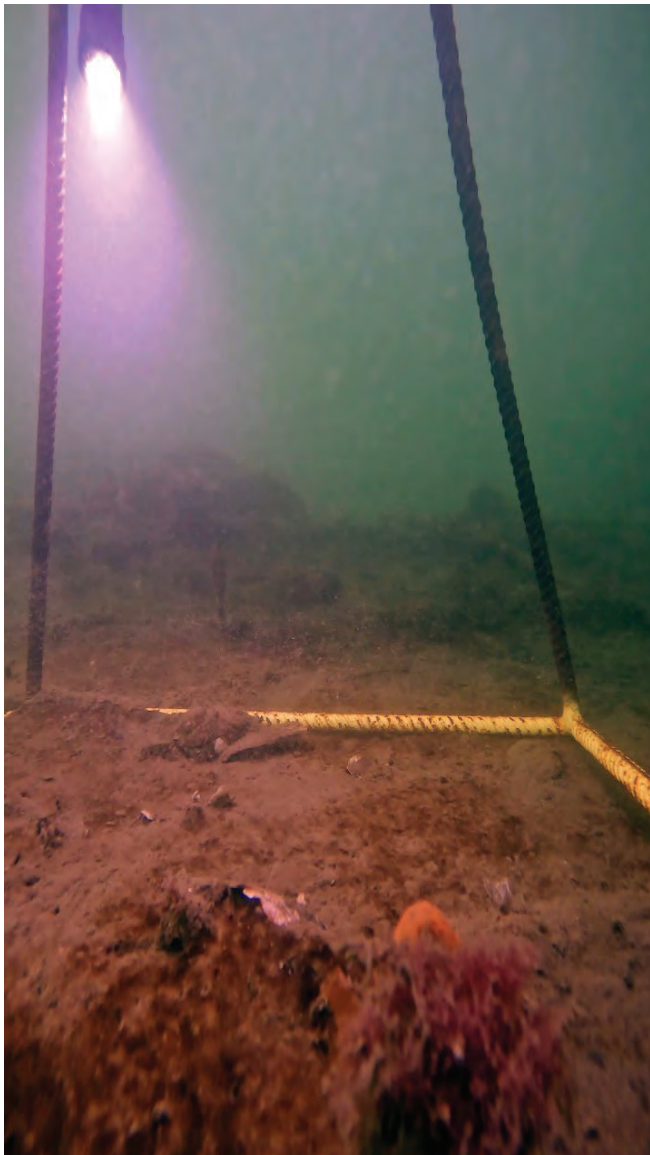
| Notes:<br><br><i>Deck of large sunken barge covered in silt and shells. Thin cover of microbial algae visible. Trace encrusting sponges and filamentous macroalgae. Located towards the western end of Little Mystic Channel.</i> | | | |

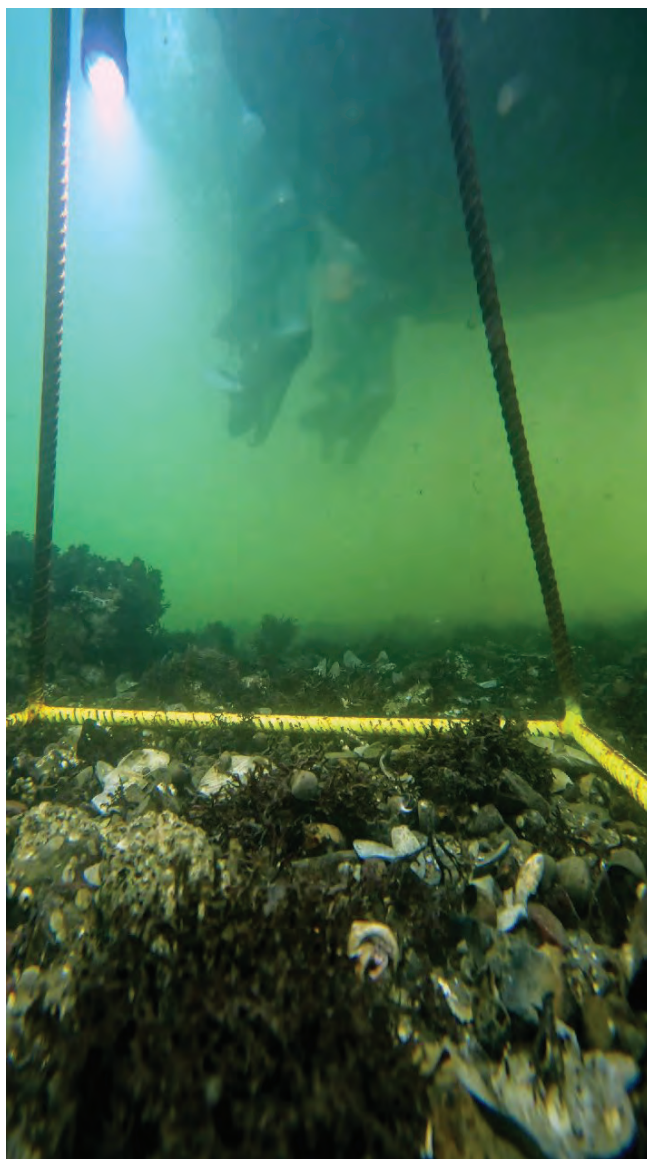
*Gravel and shells with sparse cover of leathery/leafy macroalgae (likely Chondrus crispus). Located on the southern edge of Little Mystic Channel adjacent to Barry Field.*

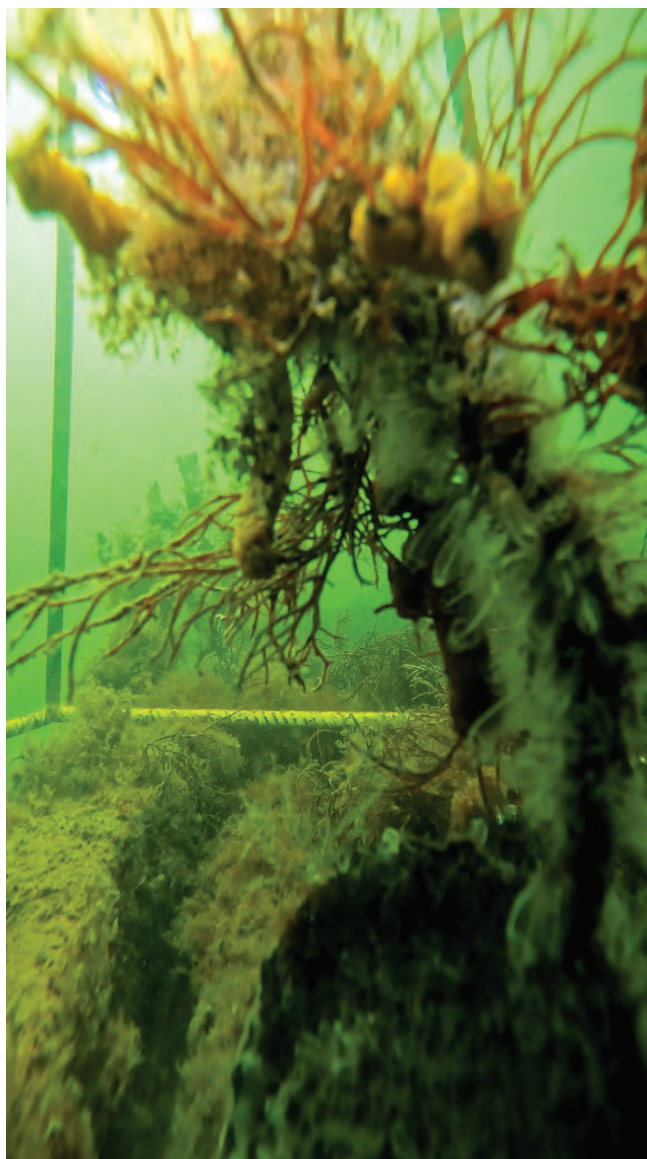
*Anthropogenic metal debris with dense cover of mixed macroalgae, bushy ectoprocts (Bugula sp.), hydroids, encrusting sponges and tunicates (Clavelina lepadiformis and Styela clava). Located on the northern edge of Little Mystic Channel approximately 300 feet west of the Chelsea Street Bridge.*

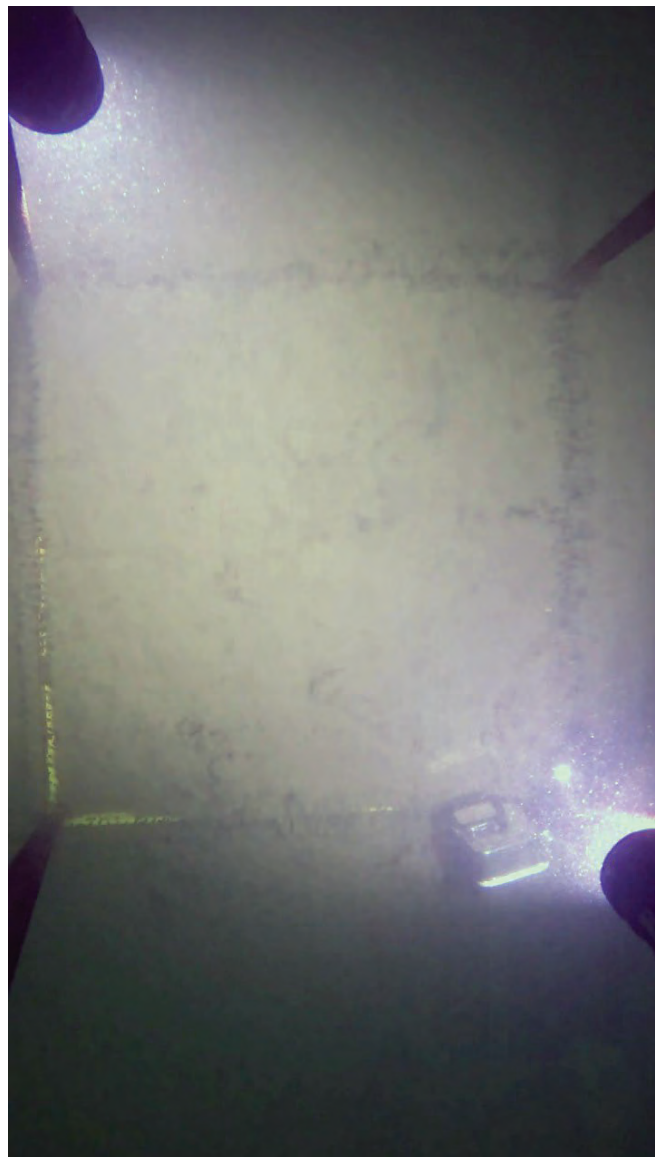
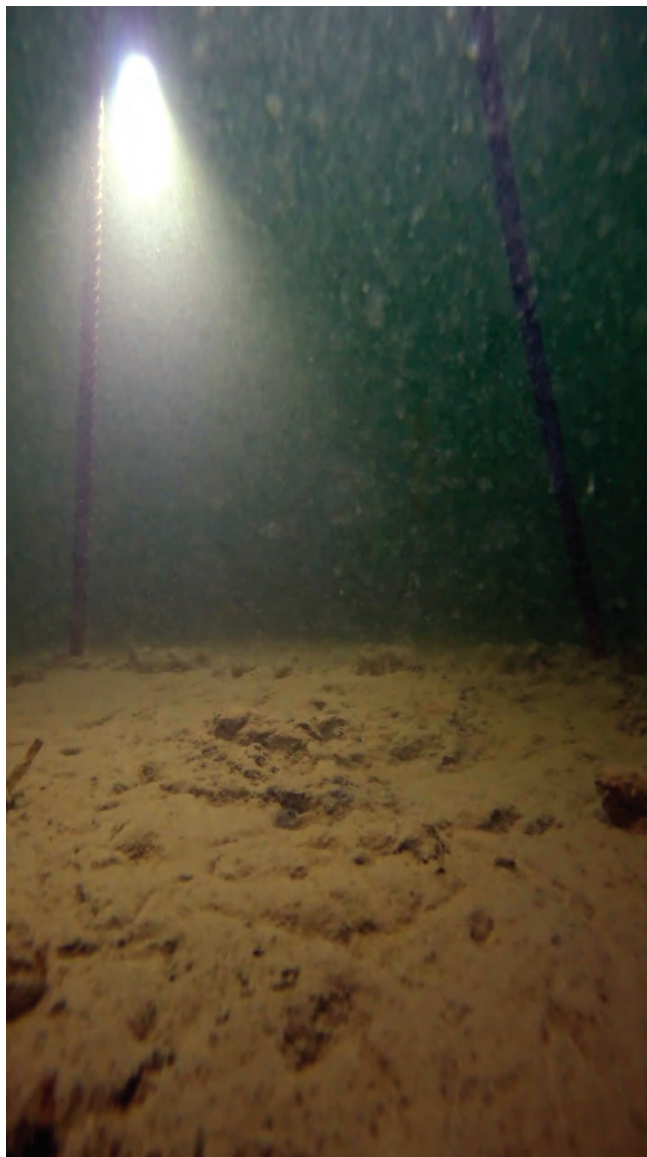
*Bare silt with infaunal invertebrate tubes and burrows. Several tunicates (likely Molgulidae sp., Styaela clava, or Ascidiella aspersa) present as well. Located near Mystic Marine Fuel.*

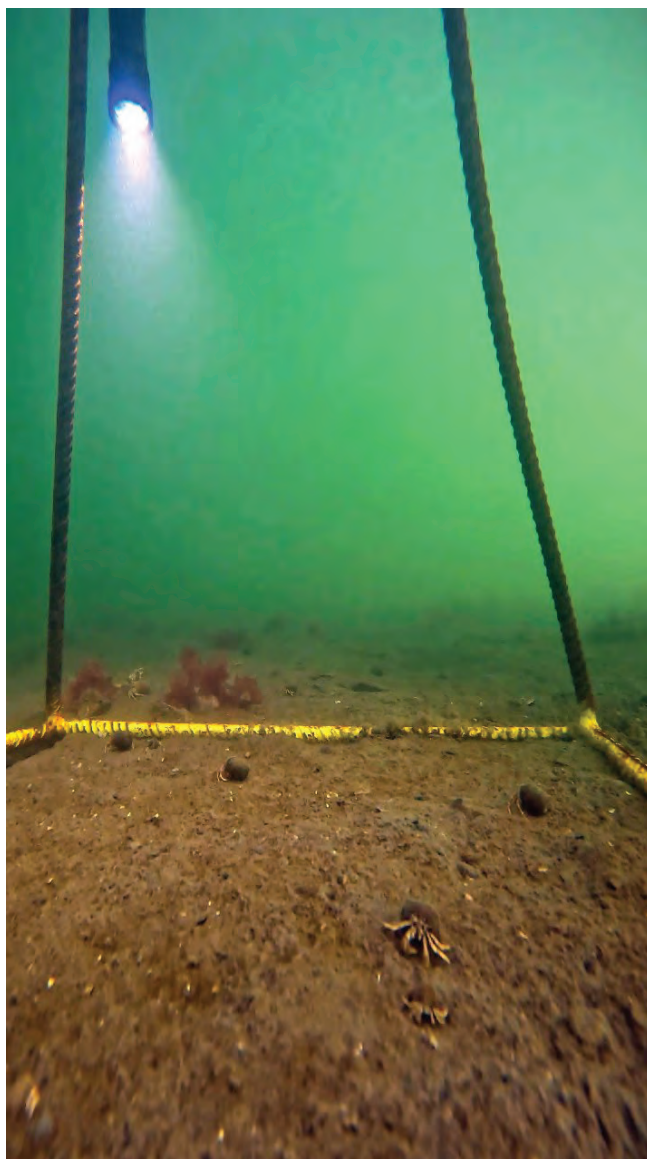
Sand with sparse gravel and shell hash. Several hermit crabs (*Paguridae* sp.) present. Sparse cover of red sheet macroalgae and tunicates (likely *Molgulidae* sp., *Styela clava*, or *Ascidella aspersa*) attached to hard substratum. Located near the East Boston shoreline, outside of the federal channel.

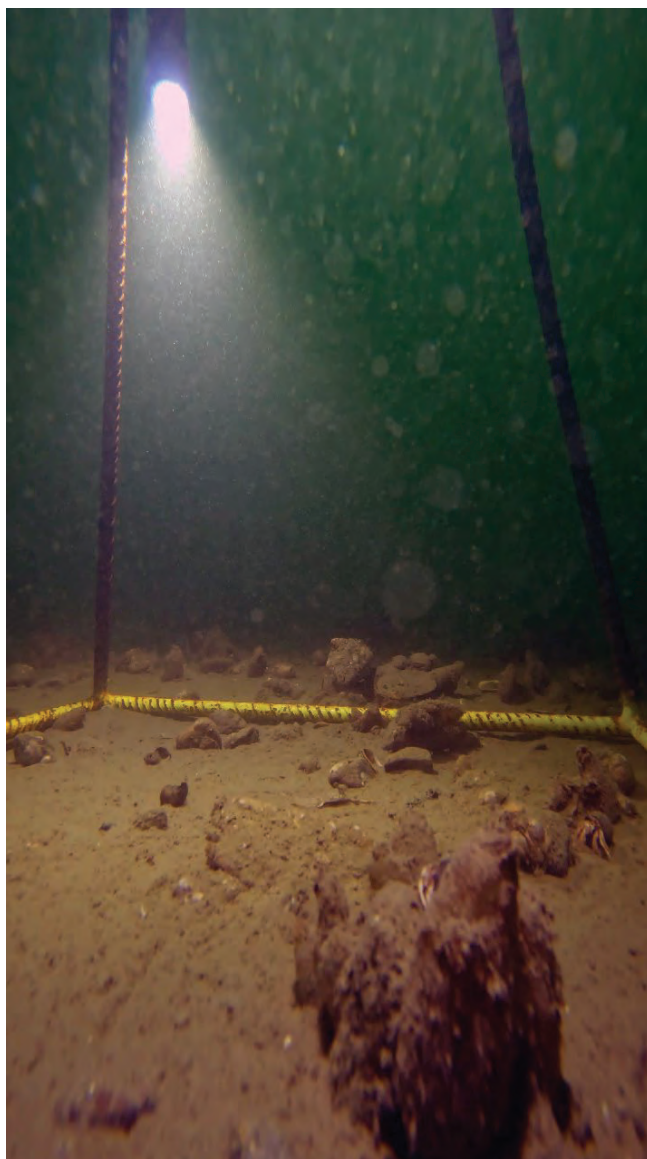
*Sandy silt with sparse to moderate gravel and shell hash/rubble. Juvenile flounder (Pleuronectiformes sp.) present within quadrat. Located within the 35-foot Chelsea River Channel.*

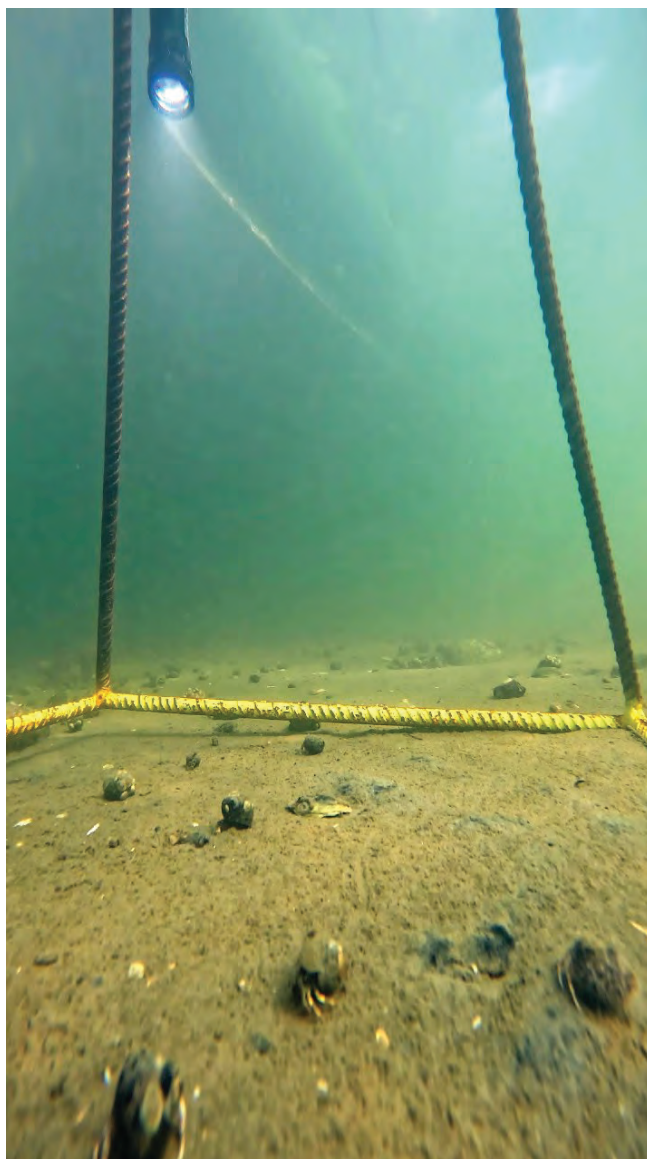
Profile View

*Sand with sparse shell hash/rubble and gravel. Several hermit crabs (Paguridae sp.) present. Located near the East Boston shoreline, outside of the federal channel.*

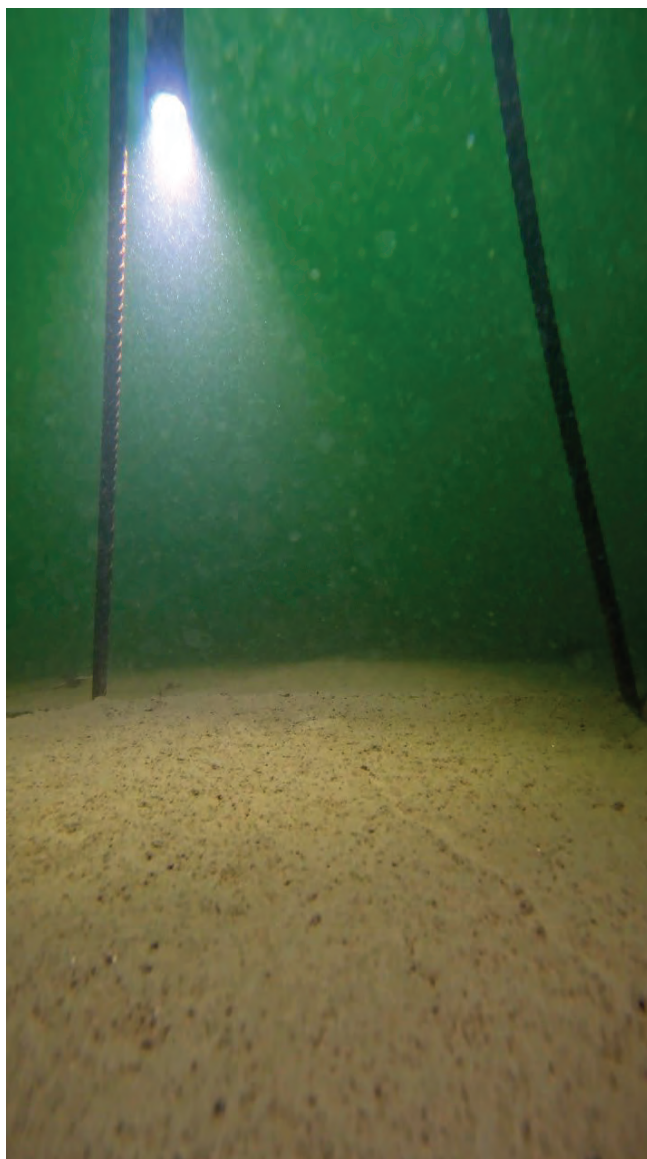
Profile View

Bare silt with sparse small infaunal invertebrate tubes and burrows. Hermit crab (*Paguridae* sp.) and corresponding tracks present. Adult flounder (*Pleuronectiformes* sp.) visible in background of the profile-view image. Located within the 35-foot Chelsea River Channel.

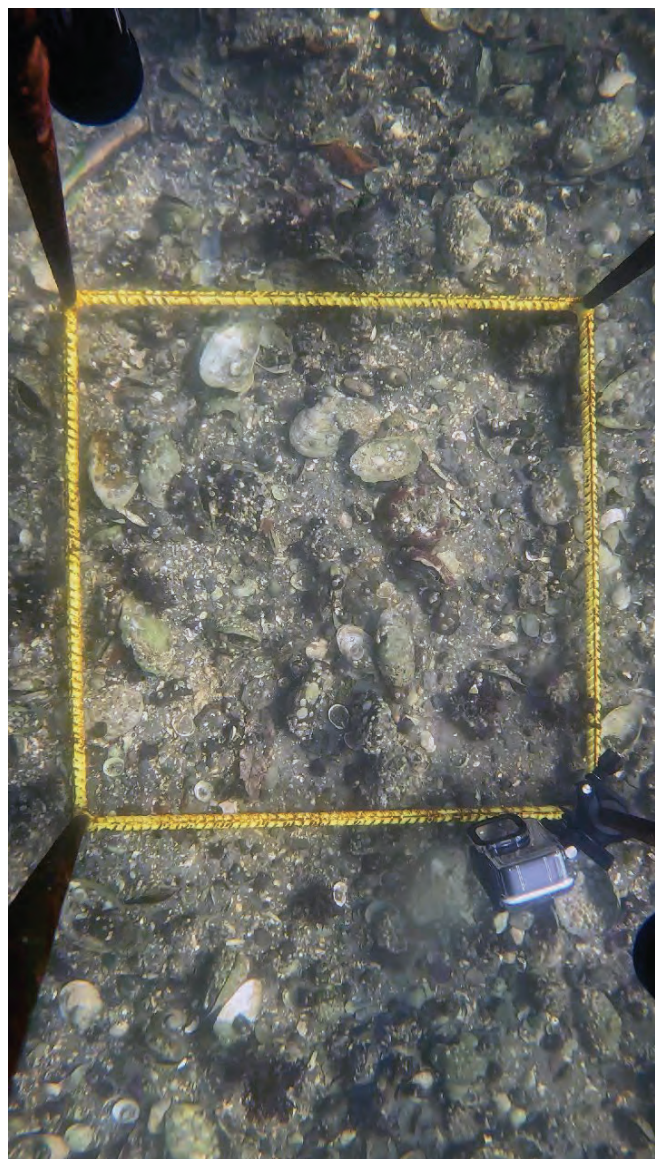
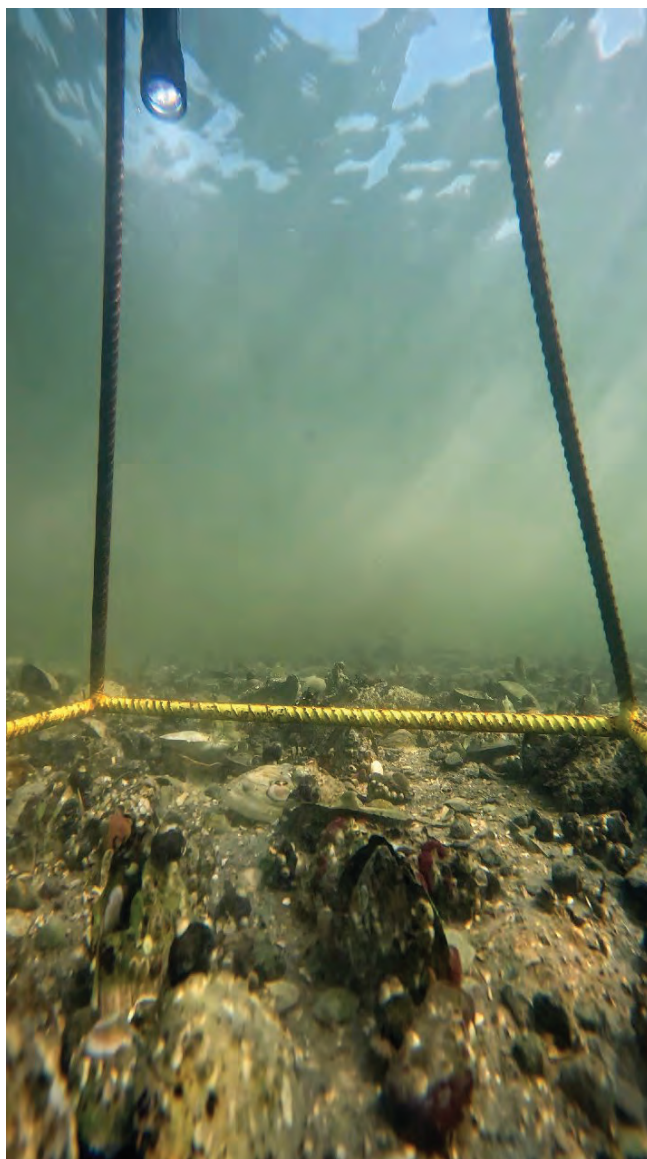
Plan View

*Gravel and shell debris with a moderate cover of barnacles (Balanidae spp.). Located near the East Boston shoreline, outside of the federal channel.*

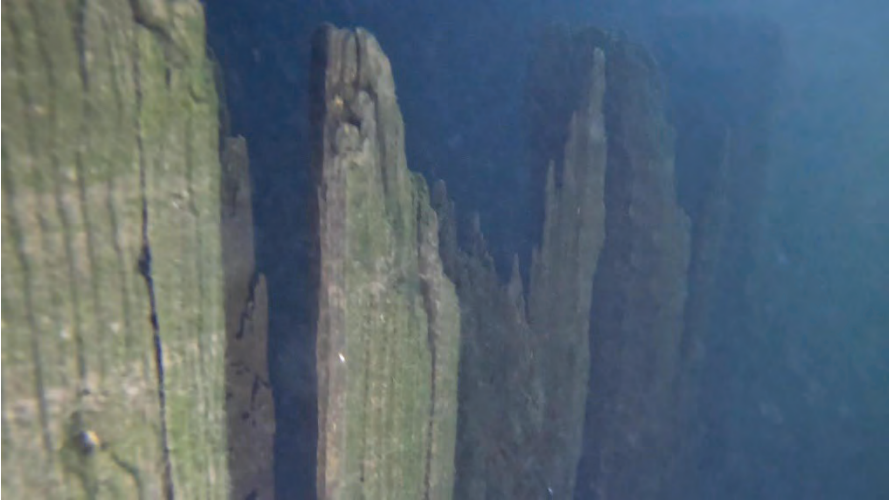
| Survey Area: <i>Neponset River – Western Shoreline Seawall</i> | | Date: <i>10/26/2023</i> |
|---|--|---|
| | | <ul style="list-style-type: none"> <li>- <i>Derelict pilings forward of concrete seawall structure</i></li> </ul> |

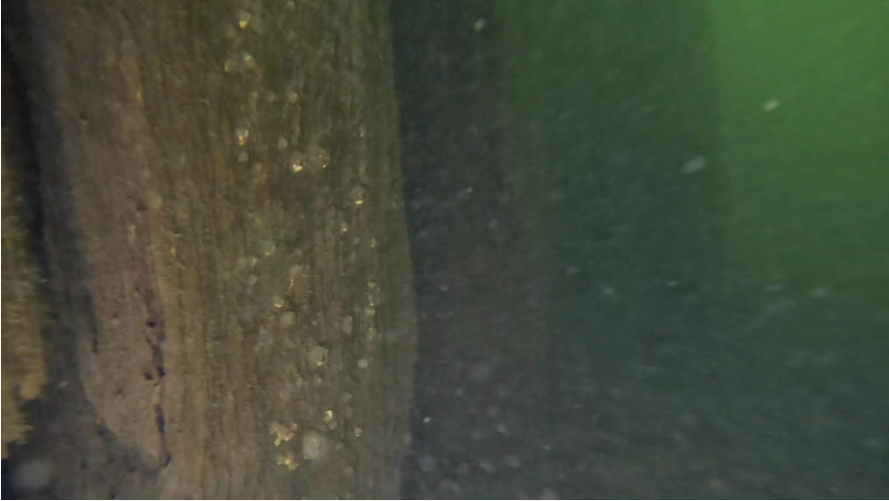
| Survey Area: <i>Neponset River – Western Shoreline Seawall</i> | | Date: <i>10/26/2023</i> |
|---|--|---|
| | | <ul style="list-style-type: none"> <li>- <i>Base of derelict pilings forward of concrete seawall structure</i></li> <li>- <i>Algae, barnacles</i></li> </ul> |

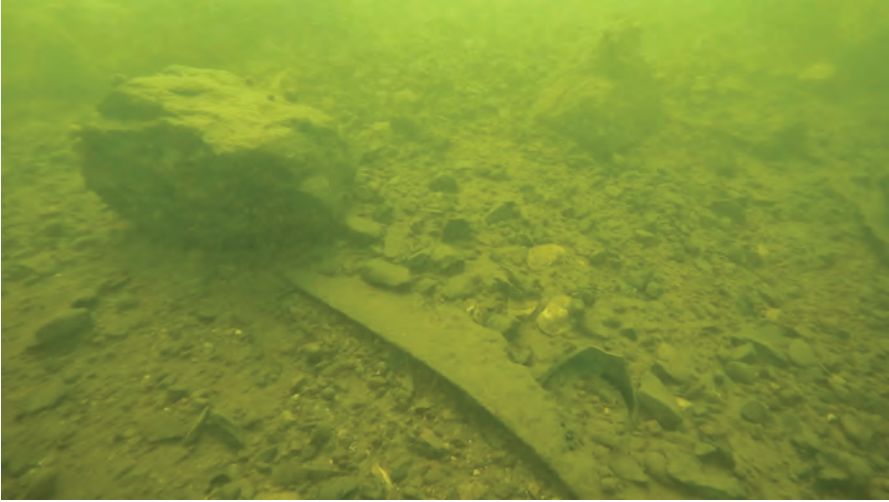
| Survey Area: <i>Neponset River Western Shoreline – Intertidal/Shallow Subtidal Flat</i> | | Date: <i>10/26/2023</i> |
|---|--|---|
| | | <ul style="list-style-type: none"> <li>- <i>Sandy gravel and shell with small boulders and anthropogenic debris adjacent to western seawall</i></li> </ul> |

Benthic habitat within the intertidal and shallow subtidal riverbed along the western shoreline was characterized by sandy gravel and shell substrate with isolated small boulders, stone blocks, and scattered pieces of metallic and woody anthropogenic debris. Filamentous algae and a sparse cover of macroalgae were observed attached to hard substratum in this area. The deeper subtidal flats and adjacent channel slope consisted of bare silt with visible epifaunal invertebrate tracks. A thin layer of microbial algae was present along portions of the silty flat. The riverbed adjacent to the bridge pier structures consisted of scoured cobble, gravel, and shell rubble with no apparent biota. The upper portions of the pier structures supported filamentous algal growth and barnacles, with several crabs observed on the granite blocks.

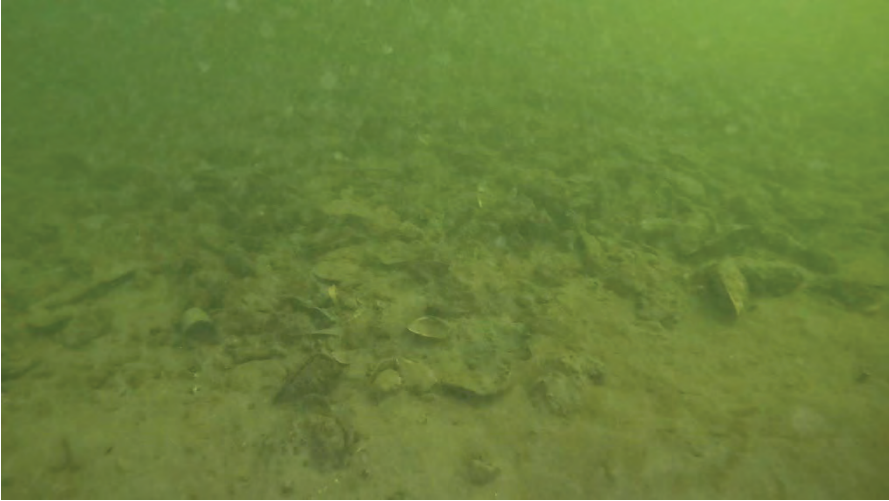
| Survey Area: <i>Neponset River Western Shoreline – Intertidal/Shallow Subtidal Flat</i> | | Date: <i>10/26/2023</i> |
|---|--|---|
| | | <ul style="list-style-type: none"> <li>- <i>Edge of shoreline adjacent coarse material, sand gravel and shell transitioning to sandy silt</i></li> </ul> |

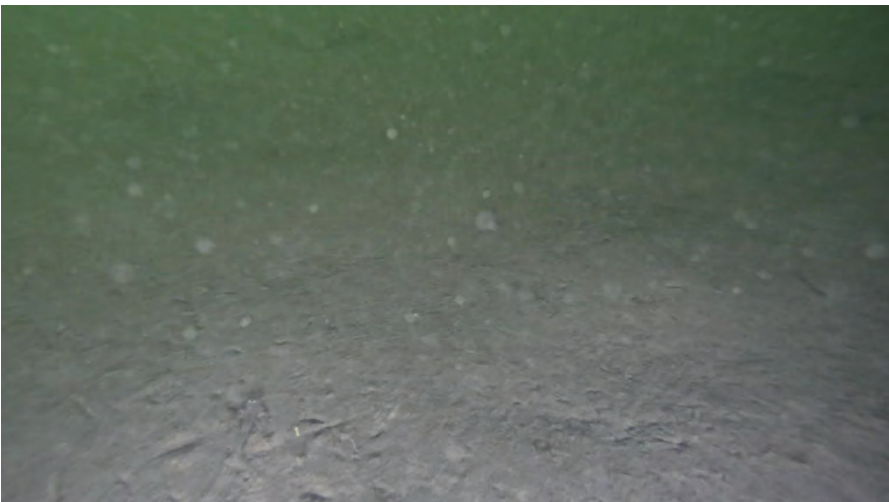
| Survey Area: <i>Neponset River – Subtidal Flat/ Channel Side Slope</i> | | Date: 10/26/2023 |
|---|--|---|
| | | - Bare silt with epifaunal invertebrate tracks visible |

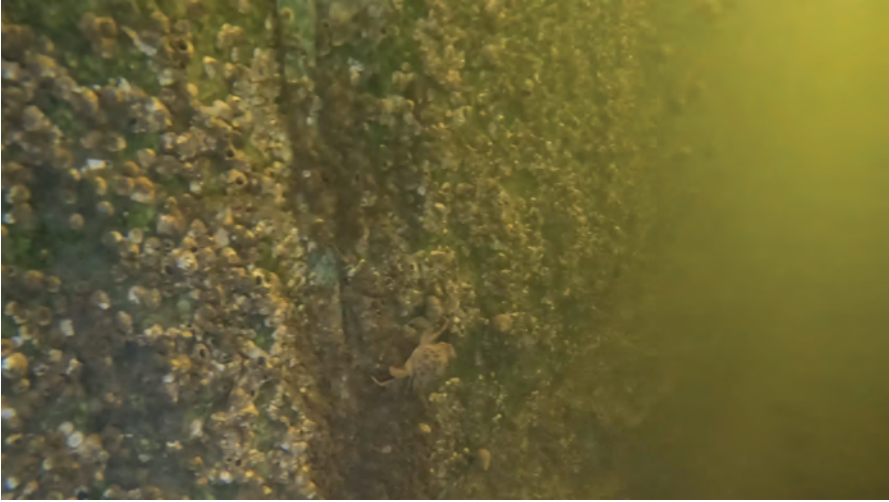
| Survey Area: <i>Neponset River – Bridge Piers and Adjacent Riverbed</i> | | Date: 10/26/2023 |
|---|--|---|
| | | <ul style="list-style-type: none"> <li>- Granite pier blocks in water column with algal growth, barnacles, and a crab visible on the structure</li> </ul> |

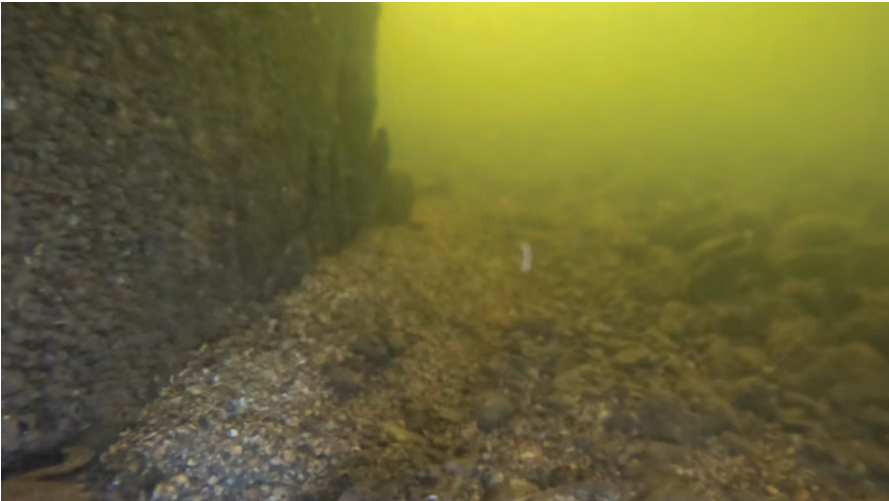
| Survey Area: <i>Neponset River – Bridge Piers and Adjacent Riverbed</i> | | Date: 10/26/2023 |
|---|--|---|
| | | <ul style="list-style-type: none"> <li>- Base of the closest bridge pier structure with adjacent scoured coarse sediment</li> </ul> |
