BBAC Submission

Additions and Alterations to the Ames Mansion 306 Dartmouth Street Boston, Massachucets

Roof Plans

Existing and Historic Photographs

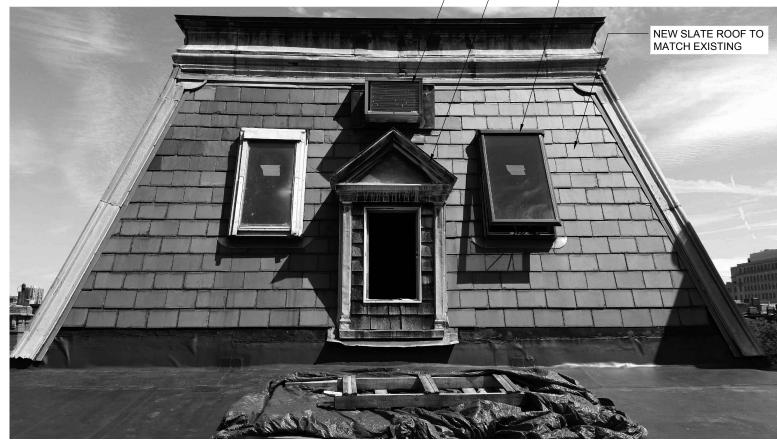
01 EXISTING CONDITIONS OF TOWER ROOF ACCESS N.T.S.

## THROUGH WALL AC UNIT TO BE REMOVED

TO BE REMOVED AND REPLACED WITH NEW SURROUND AND FRENCH DOORS

SKYLIGHTS TO BE
 REMOVED AND REPLACED
 WITH LUNETTES

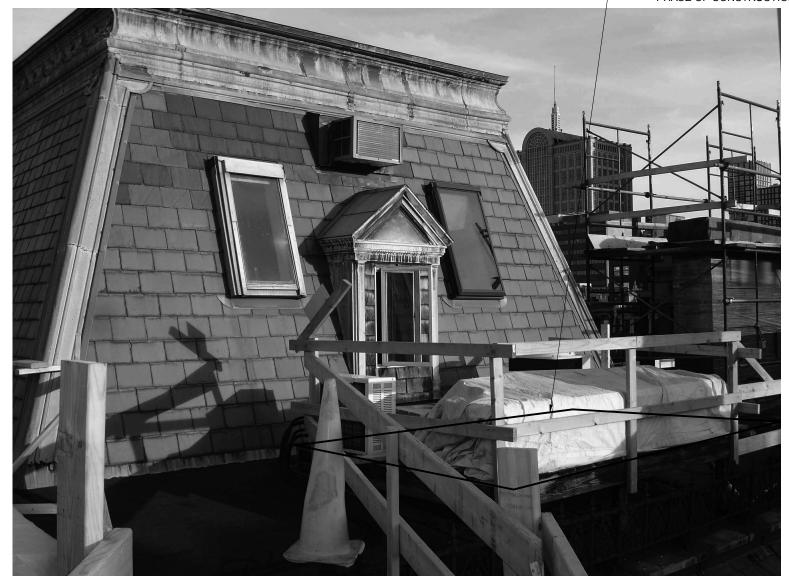
01 EXISTING CONDITIONS OF TOWER ROOF ACCESS N.T.S.

EXISTING MECHANICAL EQUIPMENT AND EXISTING WOOD DECK (REMOVED DURING PREVIOUS PHASE OF CONSTRUCTION)

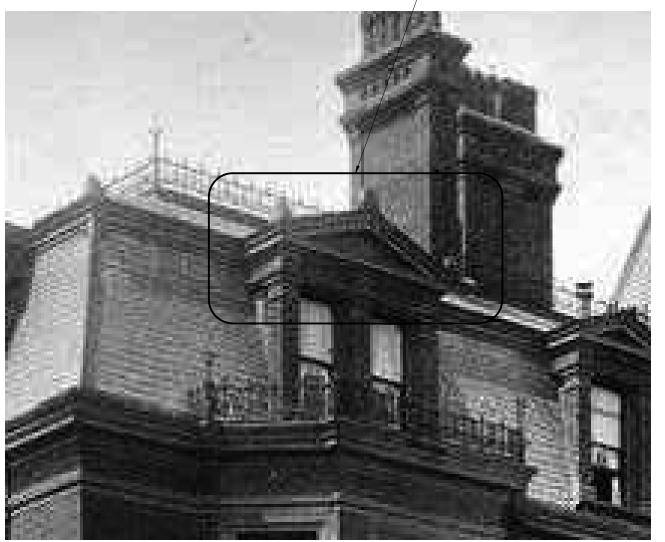
01 HISTORIC PHOTOGRAPH - CIRCA 1885 N.T.S.

ORIGINAL ACROTERION TO BE MATCHED.
