FEASIBILITY STUDY  
WASHINGTON IRVING MIDDLE SCHOOL  
105 CUMMINS HIGHWAY  
ROSLINDALE, MA

JULY 21, 2022

**BOSTON PUBLIC SCHOOLS  
CITY OF BOSTON  
WASHINGTON IRVING SCHOOL RENOVATION/ADDITION PROJECT  
ROSLINDALE, MA.**

**FEASIBILITY STUDY**

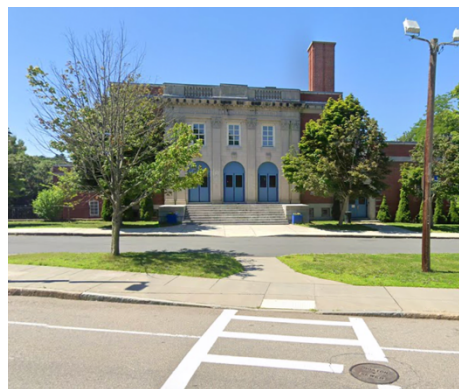
The Cummins Highway Entry is the historic front of the school. The front has been modified so that a bus drop off loop cuts between the grand stair at the Auditorium and the sidewalk along Cummins Highway. This was once an axis that connected the school to the sidewalk. The Auditorium doors are no longer functional, and trees have been planted that obscure the public view of the building.

*Current Cummins Hgwy View*

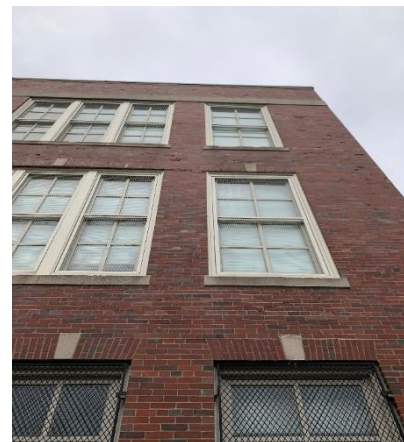
At several locations around the perimeter of the building, the exterior steel lintels (over window and door openings) were observed to be moderately to severely rusted with a noticeable downward deflection. In some locations at the bearing ends of

the loose steel lintels, the mortar is dislodged and loose as a result of jacking forces from the rusted steel lintels.

Rusted steel lintels above windows and damaged / weathered brick will require re-bricking and re-pointing.

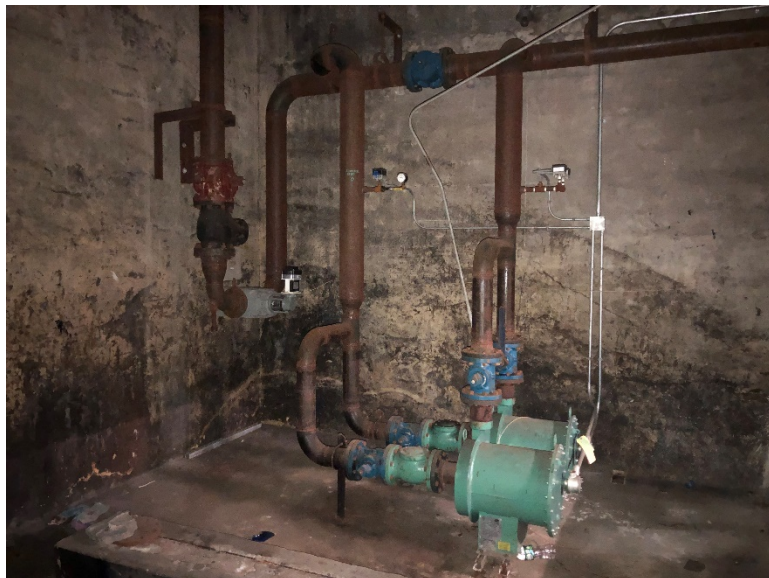
The observable gas piping appears to be steel with welded or threaded fittings, and appears to be in good condition.

***Photo 5:** Gas Pressure Booster System*

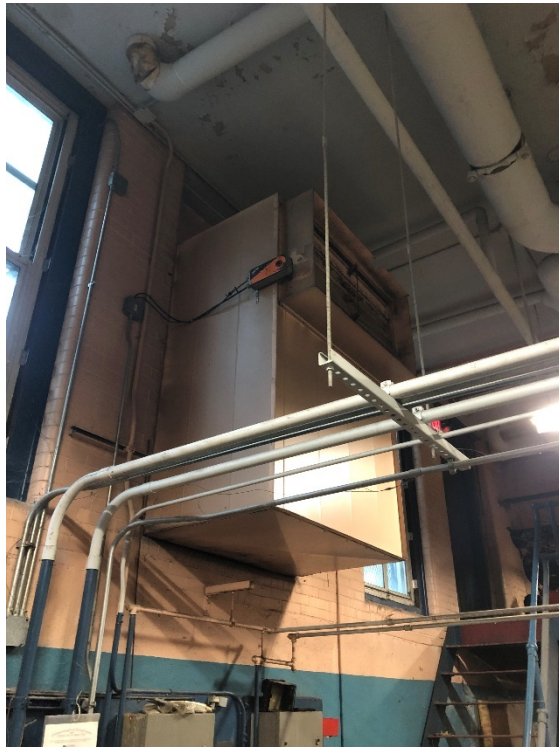
the boiler room exterior wall. The louver is equipped with a motor operated damper. It appears that this damper is interconnected with the heating boilers. There is only one combustion air opening at the top of the duct.

*Photo 6: Combustion Air Duct*

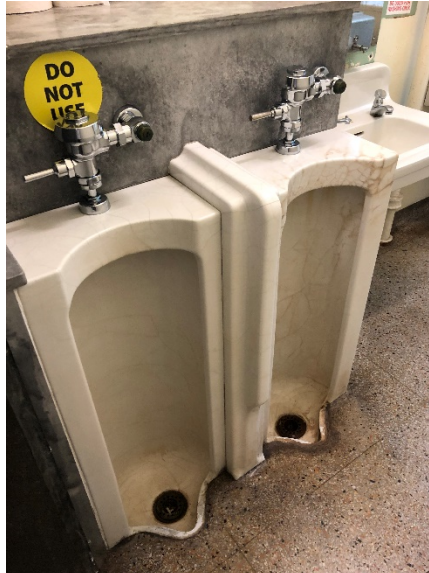
Sanitary plumbing fixtures throughout the building consist of vitreous china floor mounted water closets, and wall mounted urinals and lavatories. The boy's restroom also includes the original floor mounted urinals, which are no longer allowed to be installed in Massachusetts. Restrooms are equipped with floor drains and hose bibbs. It is doubtful that the floor drains are equipped with trap primers. Some hose bibbs have been retrofitted with vacuum breakers. Faucets and flush valves are the mechanical type. The majority of lavatory faucets have separate handles and spouts for hot and cold water.

*Photo 10: Floor Mounted Urinals*

The majority of the plumbing fixtures, while dated, are still in good condition and functional. Some fixtures are damaged. A substantial portion of the fixtures do not meet current code requirements and would be affected by renovation. In addition, water closets and urinals may have to be replaced if they cannot function satisfactorily with the newer water conserving flush valves. Whether the project consists of a renovation or addition, all fixtures should be updated or replaced to meet code and efficiency requirements.

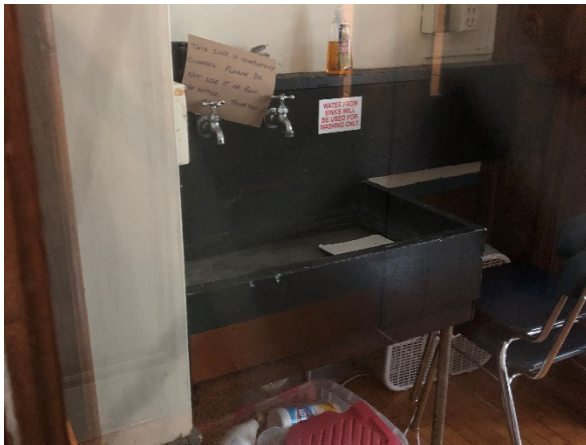
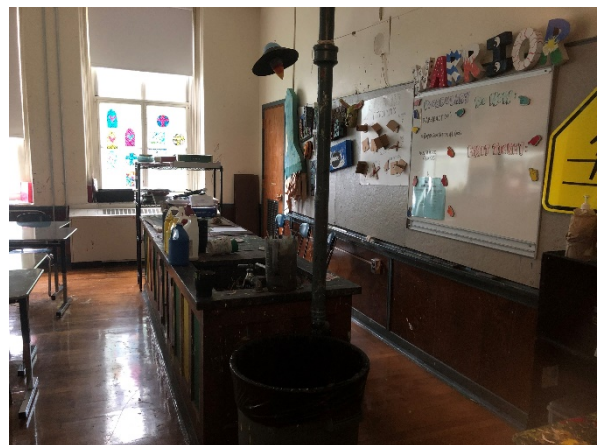
There are some science and art room sinks which appear to be phenolic. Some are freestanding and some are integral to the countertop. Faucets appear to be equipped with vacuum breakers. Waste and vent piping does not appear to be the high-silicon acid resistant type cast iron, and appears to be connected directly to the sanitary drain and vent system.

*Photos 14 & 15: Art and Science Sinks*

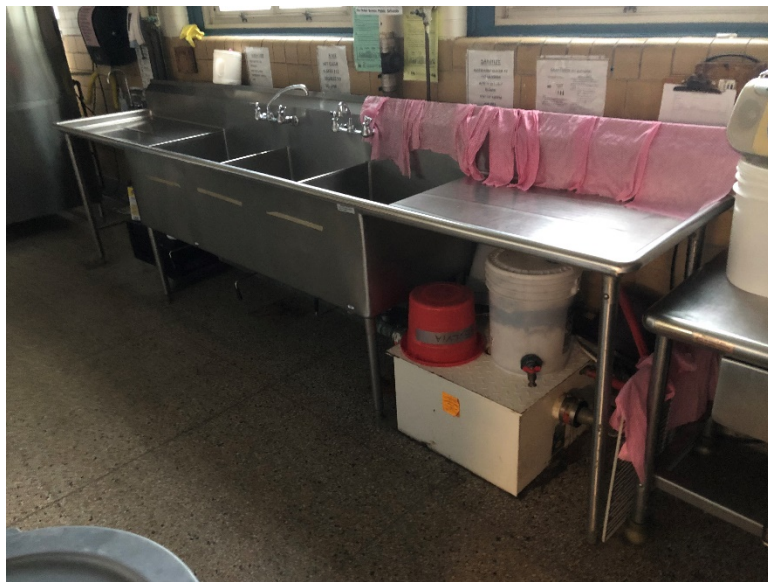
The kitchen includes a three-bay stainless steel scullery sink, a stainless steel hand sink, floor drains, and two grease interceptors. One interceptor is recessed in the floor, the other sits on the floor and is connected to the scullery sink. The recessed interceptor appears to have been abandoned in place. There are no separate restrooms for the kitchen staff.

***Photo 16:** Scullery Sink & Grease Interceptor*

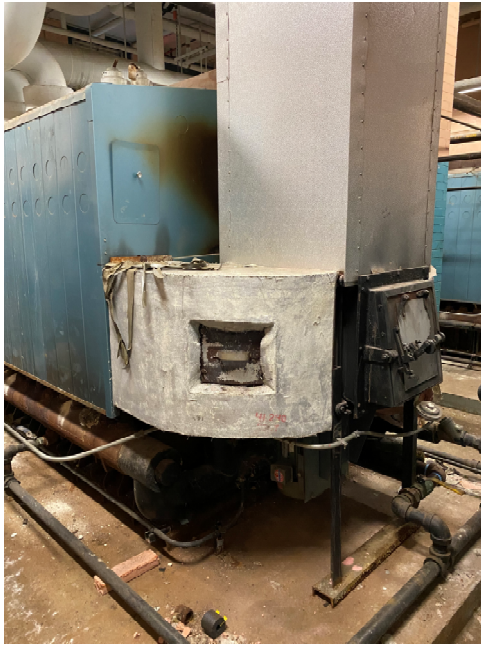
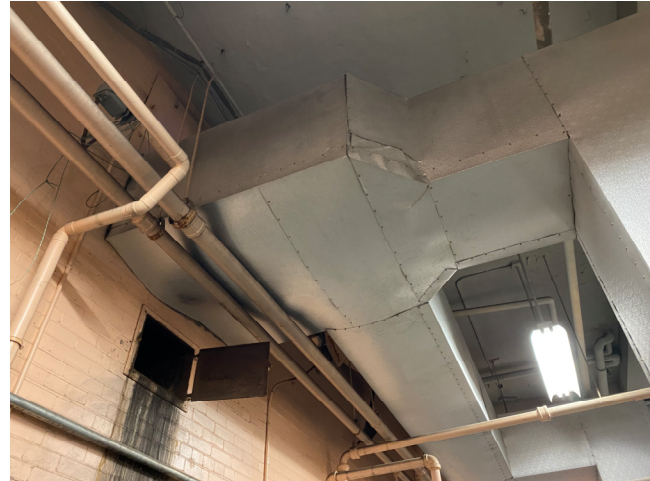
Flue gases associated with each boiler rise and connect to an existing boiler breeching main. Each boiler was observed to be equipped with an induced draft fan at the rear of the boiler that exhausts flue gases into the breeching main. The inducer fan and the vertical breeching section were observed to be old but in fair condition. The main boiler breeching extends and connects to a vertical masonry chimney. The chimney was observed to be provided with a clean-out at the bottom. The internal condition of the chimney was not verified. Combustion air (CA) for the boilers is provided by CA intake duct connected to intake louvers on the boiler room exterior wall. There is only one opening at the top of the duct equipped with a motor operated damper.

Photos 5 & 6: Existing boiler flue exhaust inducer fan section.

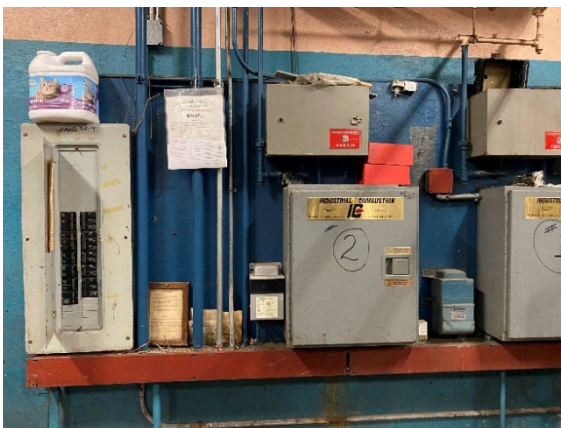
The sub-panelboards located throughout the building provide power to lighting, receptacles, mechanical equipment and miscellaneous loads. Most panels appeared to be at capacity. There were little to no spare circuit spaces for future loads. Most of the sub-panels were installed in Corridors and small storage rooms.

*Feeder Circuit Breaker Panels*

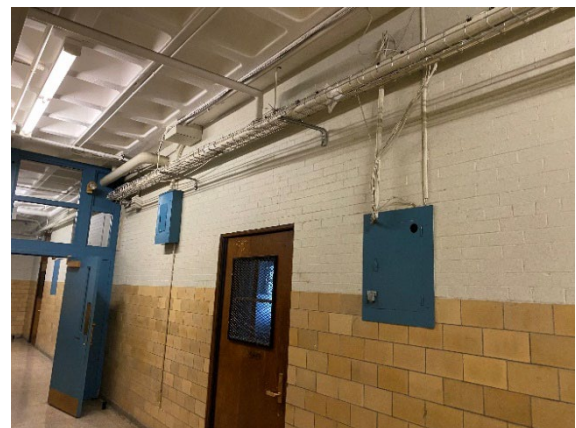
*Corridor Feeder Circuit Breaker Panels*

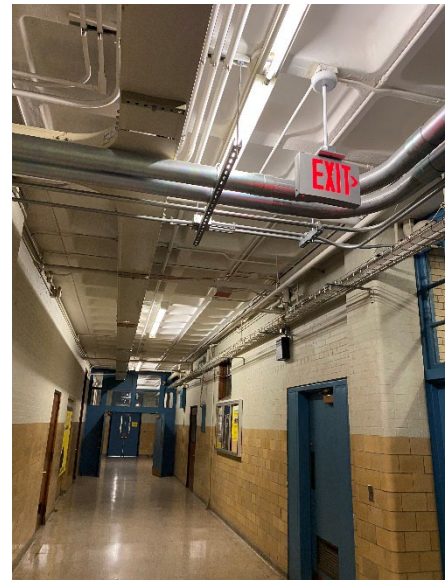
The lighting consists mostly of surface-mount and pendant-mount 2-lamp, surface-mount acrylic lens, fluorescent light fixtures. They appeared to be 32-watt T8 lamps installed. The fixtures throughout appeared to be in poor condition. Classrooms, Corridors and large public areas appeared dim. The lighting does not meet the energy conservation code, as stipulated in Article 13 of the Massachusetts State Building Code, 8th Edition. Local wall mounted switches are used for lighting control. There was minimal occupancy sensor control observed. The corridor lighting is controlled with key switches at each end of the corridors.

*Corridor Surface 1'x4' - 1 lamp fixtures*

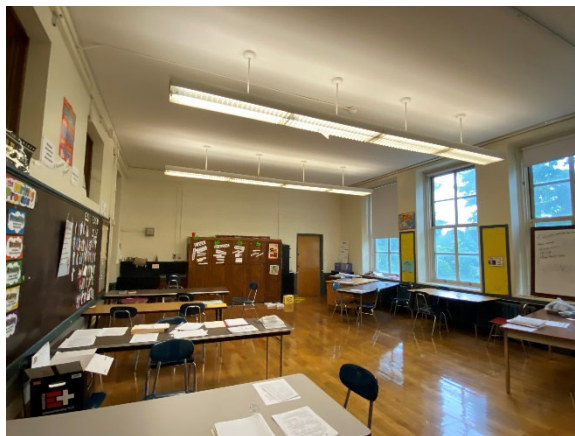
*Classroom Pendant 1'x4' - 2 lamp fixtures*
