North Wall Summary 300 Summer Street

Fort Point Channel Landmark District Application for Design Approval

29 September 2016

300 Summer Street – North Wall

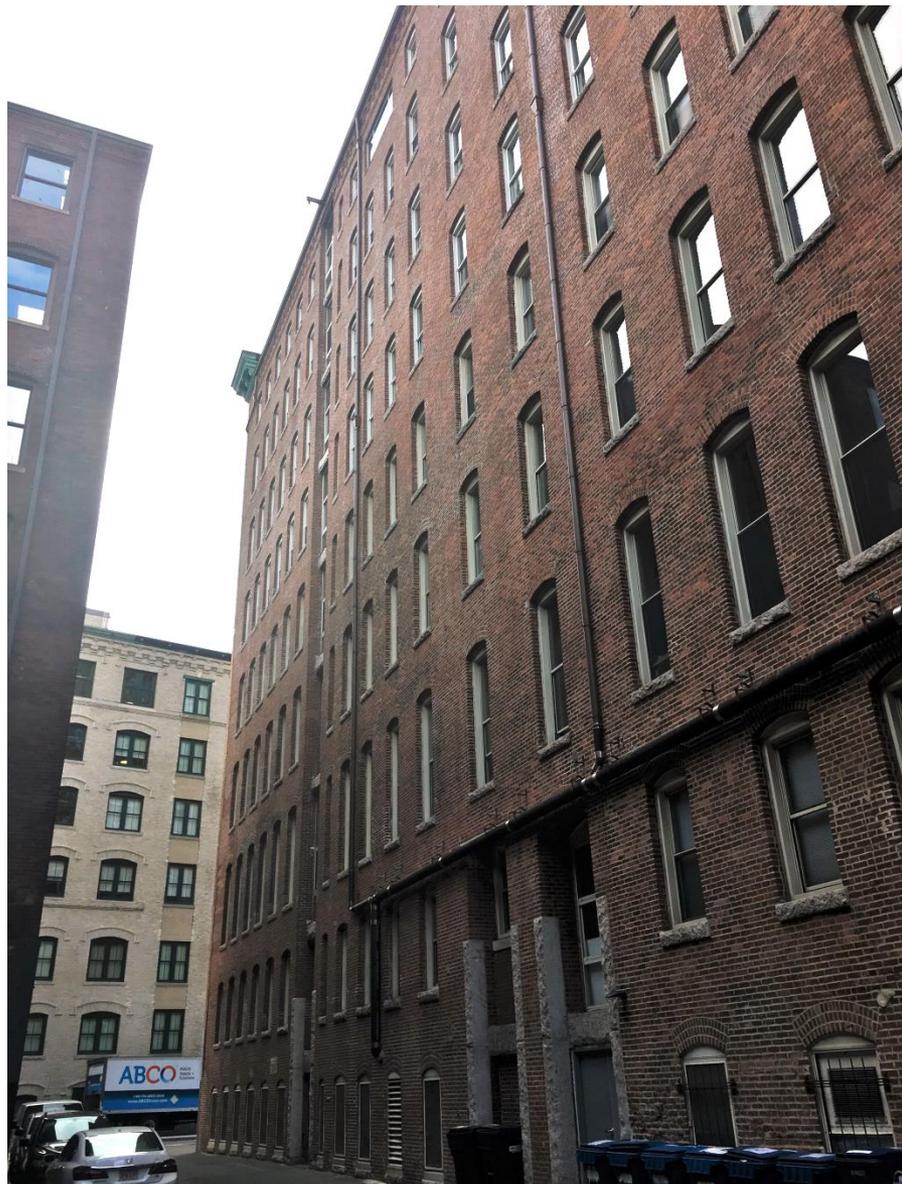
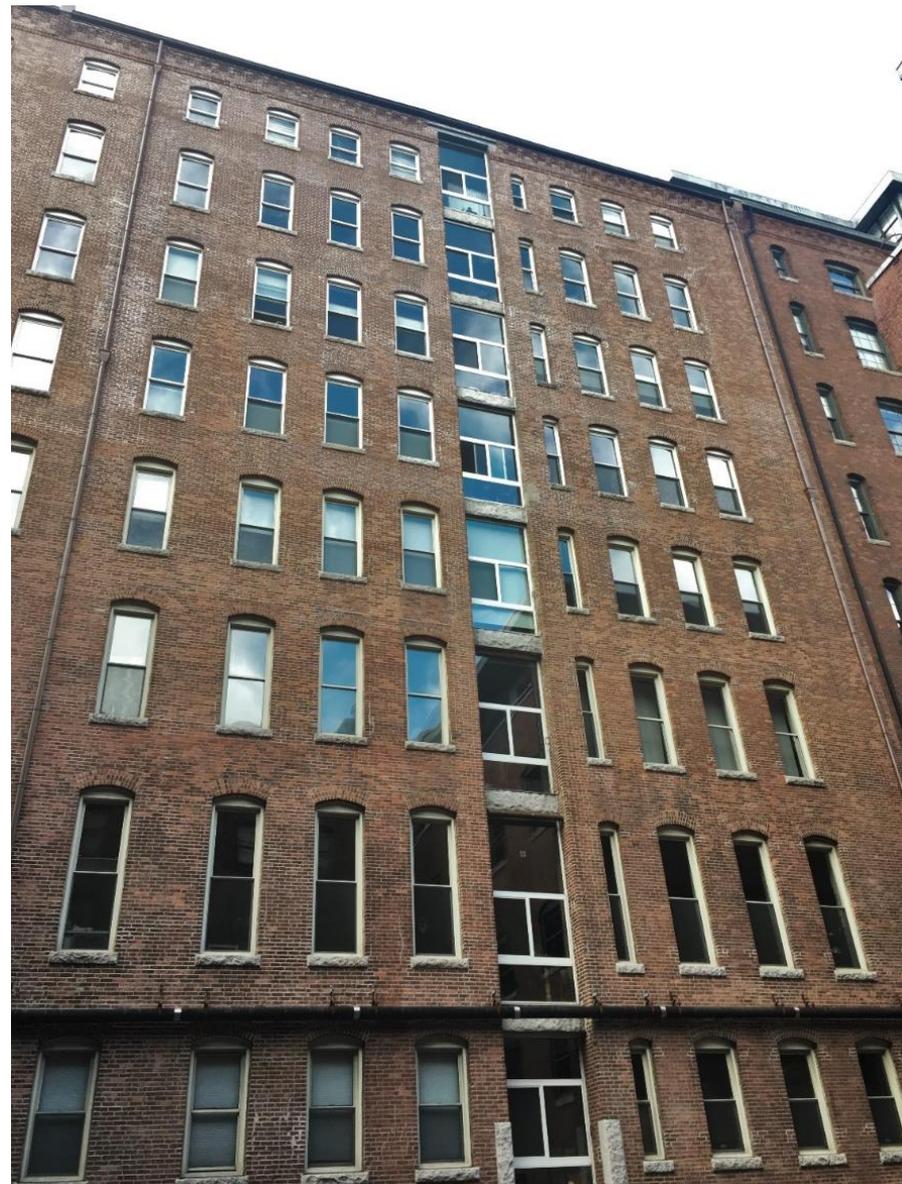
North Wall – Existing Condition

North Wall Masonry

The existing north wall has full mortar joint. The brick masonry units are typically "soft" or a lesser quality brick with higher absorption properties. Some brick have a loss of the fireskin and some spalling, which increases absorption through the brick.

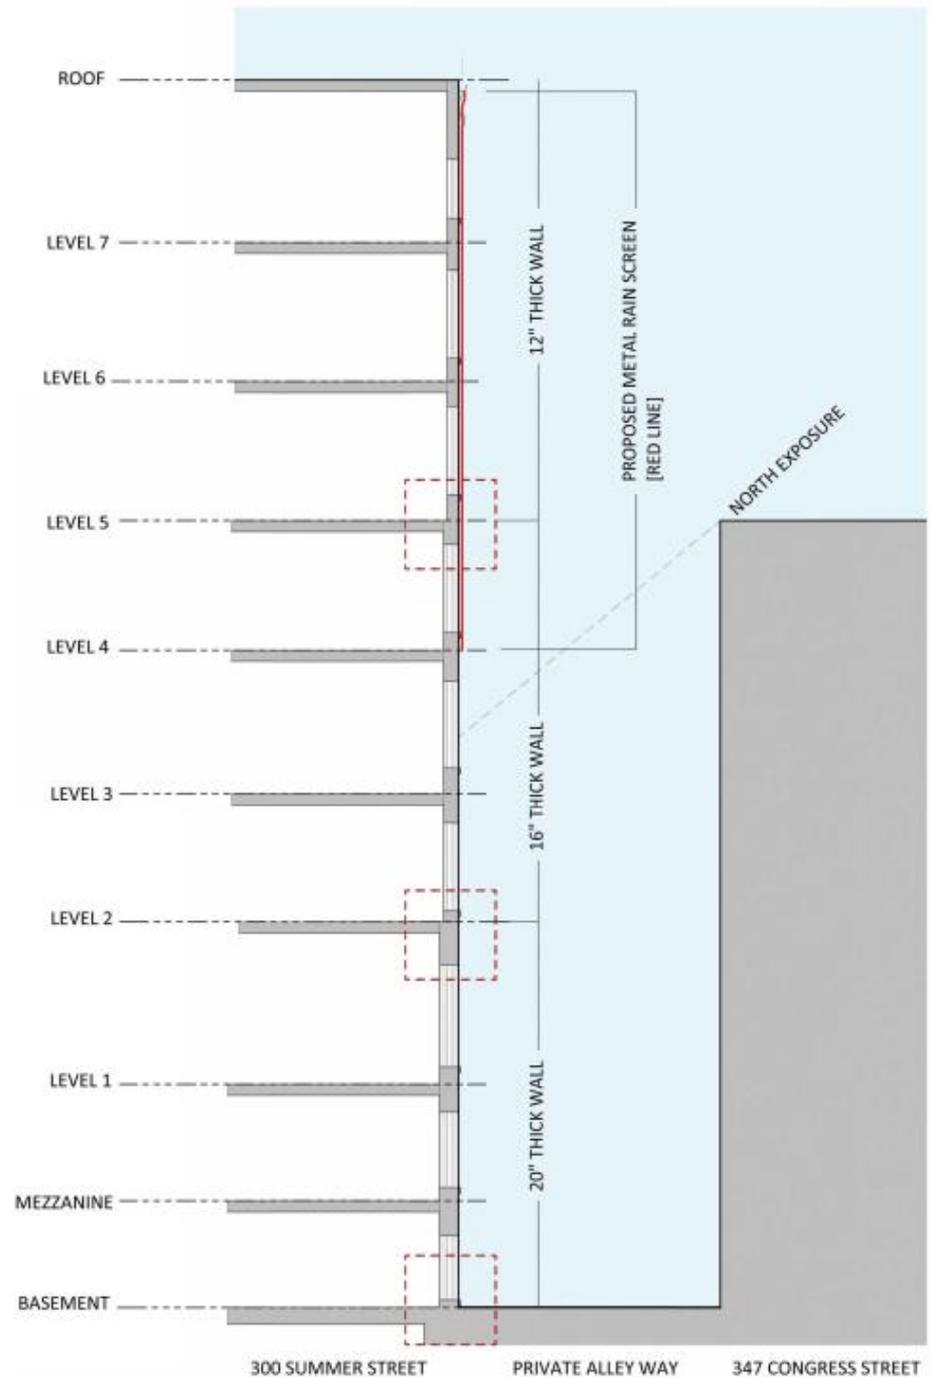
Section North Wall and Neighboring Building

Even with a properly maintained wall, leakage can occur through the brick masonry if it is exposed to a sufficient volume of water. The vulnerability depends upon the wall thickness; the walls at 300 Summer are thinner at upper floors and become narrower at window jambs and beam pockets.

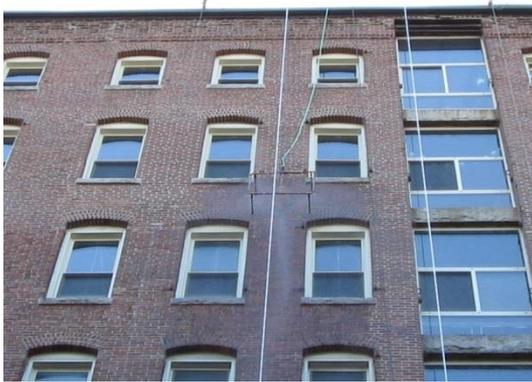
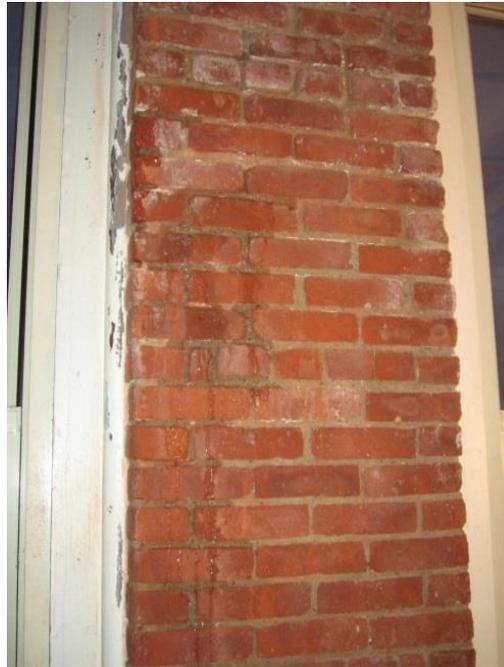
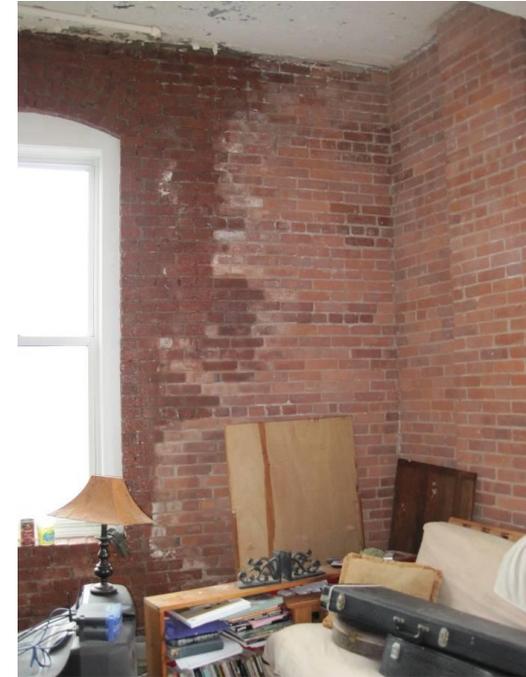
North Wall History and Repairs

Investigation - Leakage on upper floors, above windows, around beam pockets

Leaks reported around windows, beam pockets, and from ceiling above.

SGH water tested windows, masonry and flooded gutter. Leaks through window and masonry; most leakage attributed to windows though produced leaks through masonry spandrel after multiple hours of testing

Leaks observed during continuous heavy rains

Repairs - Point deteriorated mortar and step cracking. Applied Siloxane water repellent coating above the fifth floor

Repairs - Point 100% at upper floors and spot pointing on lower floors. Replace floors 4-7 double hung windows and picture windows. Replace window sealant on floors A-3. Replace roof, gutter, and downleaders.

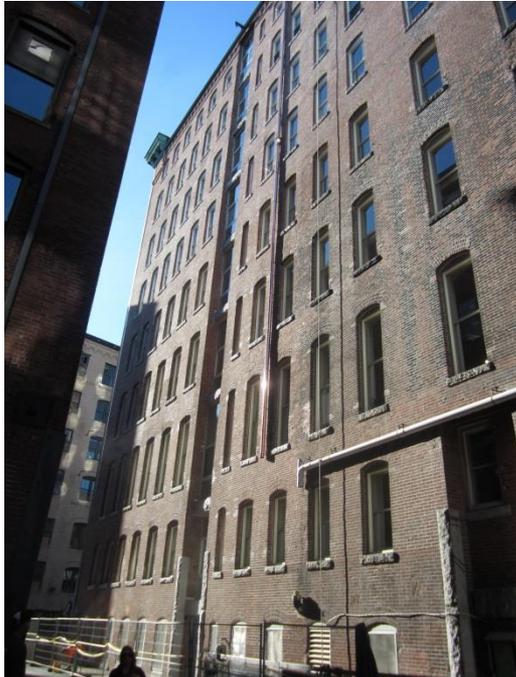
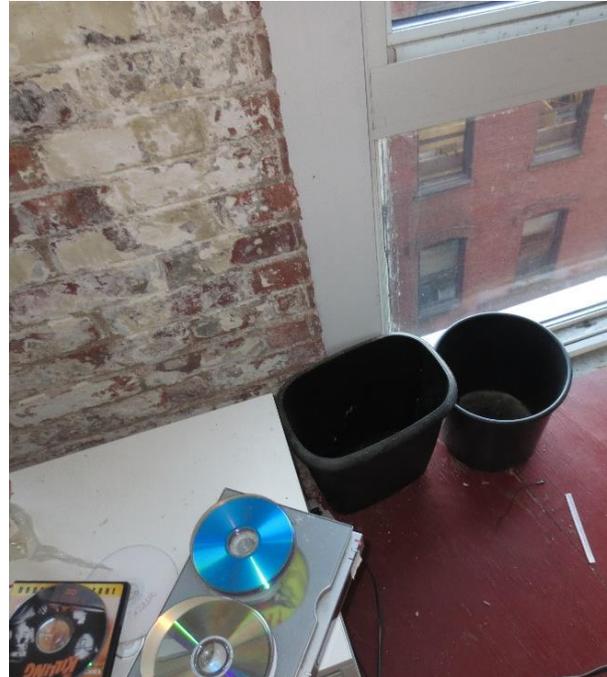
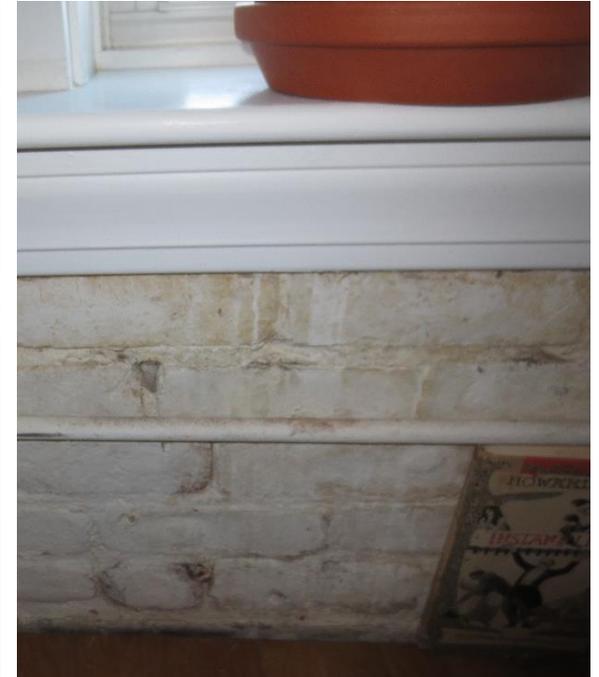
North Wall History and Repairs

Leaks observed (November 2012)

Leaks observed (January 2013)

Repairs – Point additional areas and rebuild bulged masonry and isolated lintels. Clean masonry and apply Cleaning & clear sealer (Protectosil Chem-Trete BSM 400). Modify Stormwater piping.
