CERTIFICATE OF APPROPRIATENESS APPLICATION

Re: 2 Park Street / Selective Masonry Repairs and Window Restoration

Park Street Church

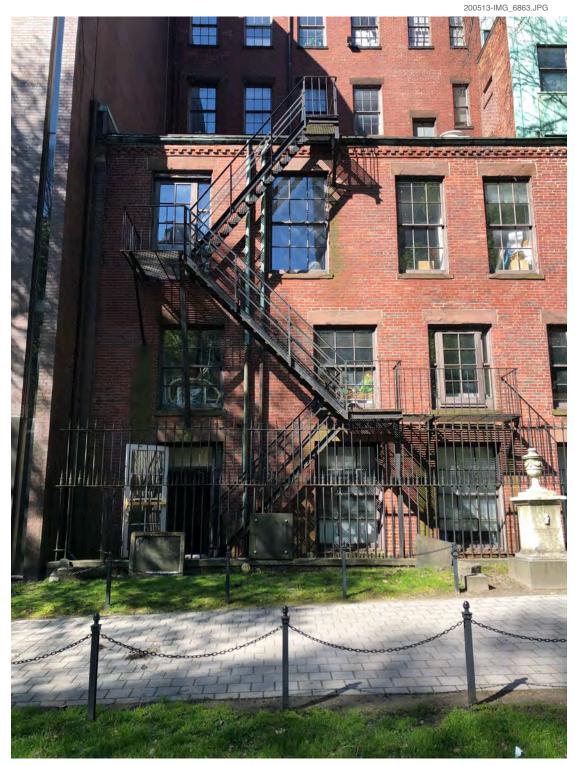
REAR FACADE OF 2 PARK STREET FROM GRANARY BURYING GROUND

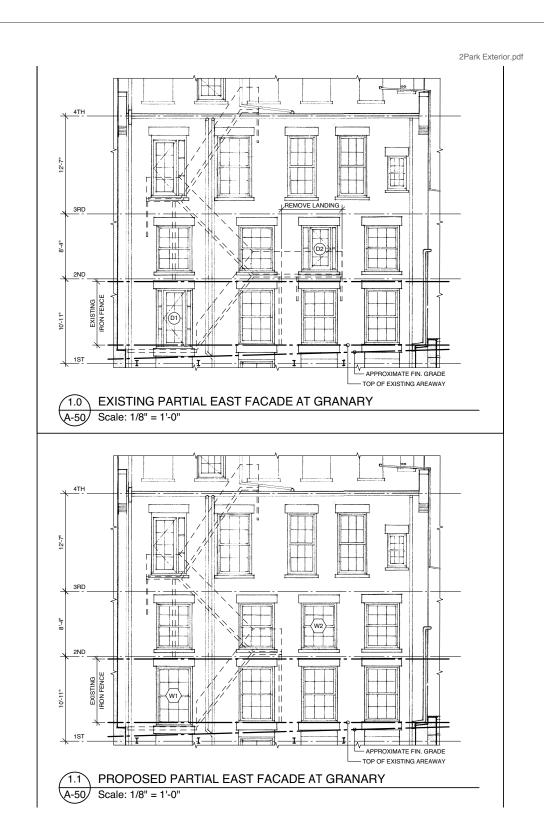
EXISTING FACADE: Remove Exit Doors D1 & D2; Remove Fire Escape Landing @ Second Floor Exit

PROPOSED FACADE: Replicate Missing Windows in W1 and D1 to Match Adjacent Sash
