FEASIBILITY STUDY  
WASHINGTON IRVING MIDDLE SCHOOL  
105 CUMMINS HIGHWAY  
ROSLINDALE, MA

FINAL REPORT

JULY 21, 2022

**BOSTON PUBLIC SCHOOLS  
CITY OF BOSTON  
WASHINGTON IRVING SCHOOL RENOVATION/ADDITION PROJECT  
ROSLINDALE, MA.**

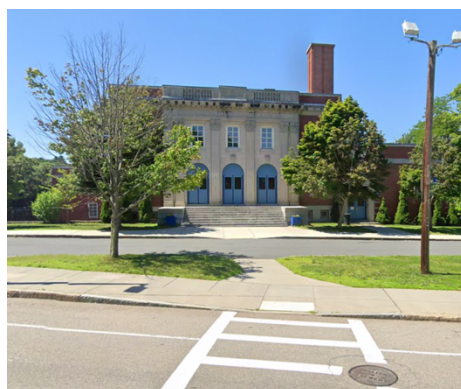
The Cummins Highway Entry is the historic front of the school. The front has been modified so that a bus drop off loop cuts between the grand stair at the Auditorium and the sidewalk along Cummins Highway. This was once an axis that connected the school to the sidewalk. The Auditorium doors are no longer functional, and trees have been planted that obscure the public view of the building.

*Current Cummins Hgwy View*

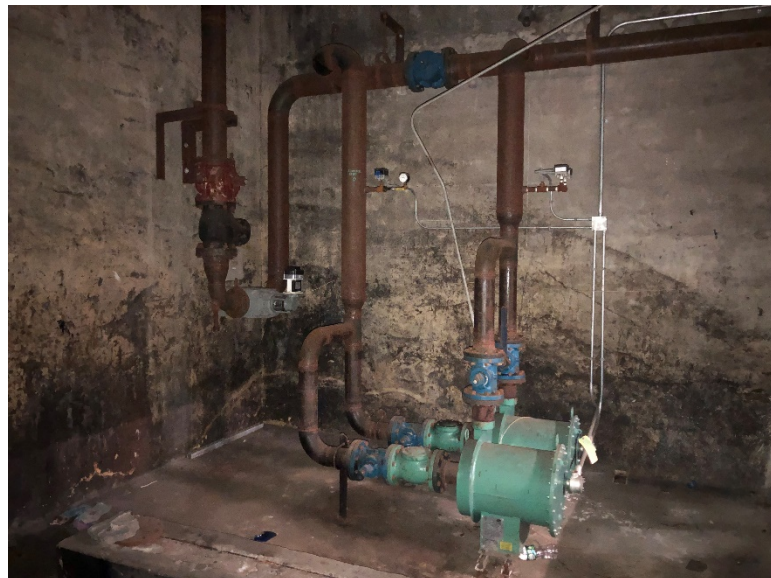
**Photo 5:** Gas Pressure Booster System

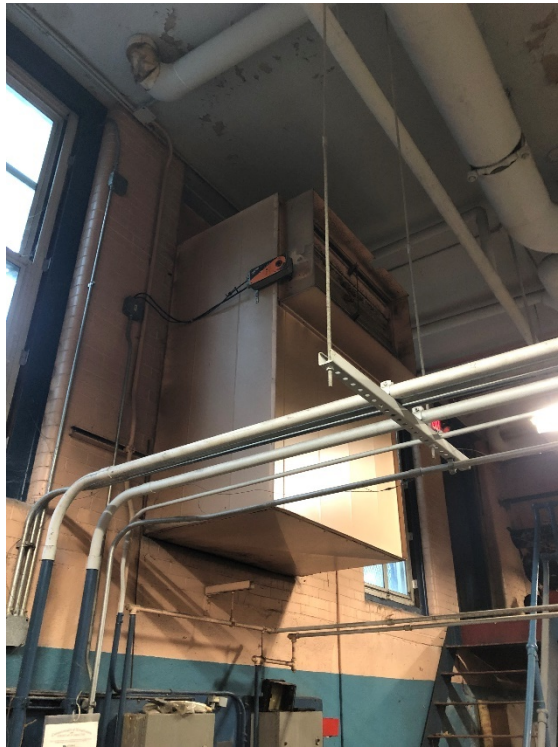
the boiler room exterior wall. The louver is equipped with a motor operated damper. It appears that this damper is interconnected with the heating boilers. There is only one combustion air opening at the top of the duct.

**Photo 6:** *Combustion Air Duct*

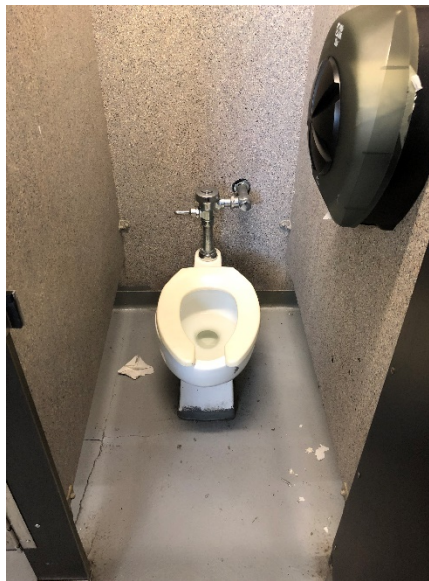
**Photo 7:** Typical Water Closet

The majority of the plumbing fixtures, while dated, are still in good condition and functional. Some fixtures are damaged. A substantial portion of the fixtures do not meet current code requirements and would be affected by renovation. In addition, water closets and urinals may have to be replaced if they cannot function satisfactorily with the newer water conserving flush valves. Whether the project consists of a renovation or addition, all fixtures should be updated or replaced to meet code and efficiency requirements.

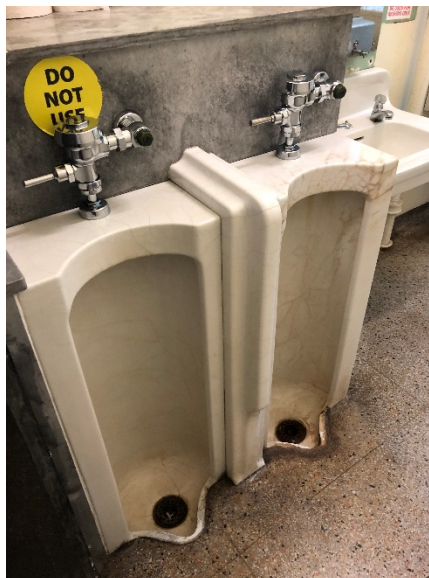
Sanitary plumbing fixtures throughout the building consist of vitreous china floor mounted water closets, and wall mounted urinals and lavatories. The boy's restroom also includes the original floor mounted urinals, which are no longer allowed to be installed in Massachusetts. Restrooms are equipped with floor drains and hose bibbs. It is doubtful that the floor drains are equipped with trap primers. Some hose bibbs have been retrofitted with vacuum breakers. Faucets and flush valves are the mechanical type. The majority of lavatory faucets have separate handles and spouts for hot and cold water.

**Photo 10:** *Floor Mounted Urinals*

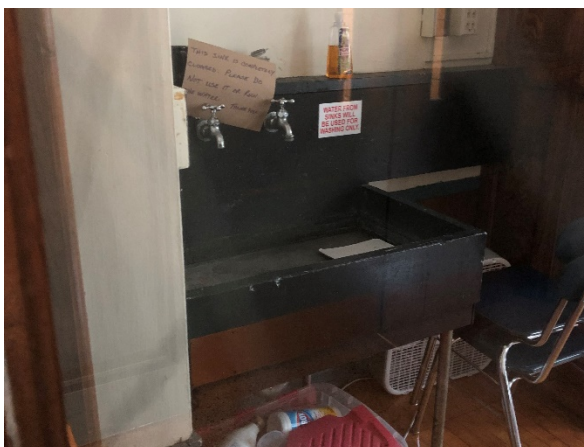
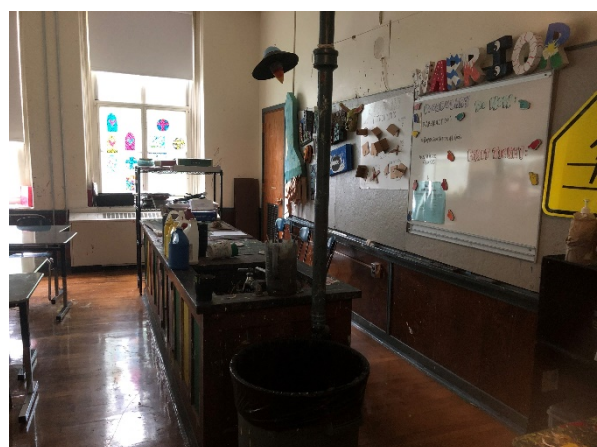
There are some science and art room sinks which appear to be phenolic. Some are freestanding and some are integral to the countertop. Faucets appear to be equipped with vacuum breakers. Waste and vent piping does not appear to be the high-silicon acid resistant type cast iron, and appears to be connected directly to the sanitary drain and vent system.

***Photos 14 & 15: Art and Science Sinks***

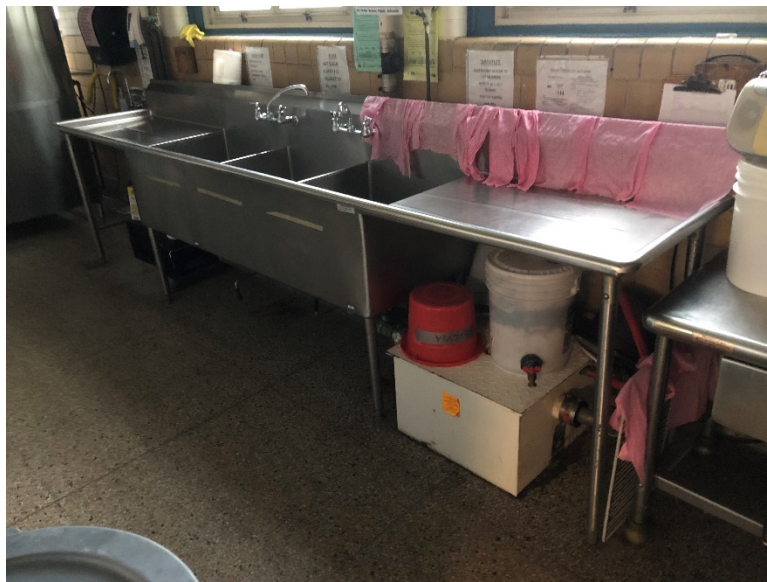
The kitchen includes a three-bay stainless steel scullery sink, a stainless steel hand sink, floor drains, and two grease interceptors. One interceptor is recessed in the floor, the other sits on the floor and is connected to the scullery sink. The recessed interceptor appears to have been abandoned in place. There are no separate restrooms for the kitchen staff.

***Photo 16:*** Scullery Sink & Grease Interceptor

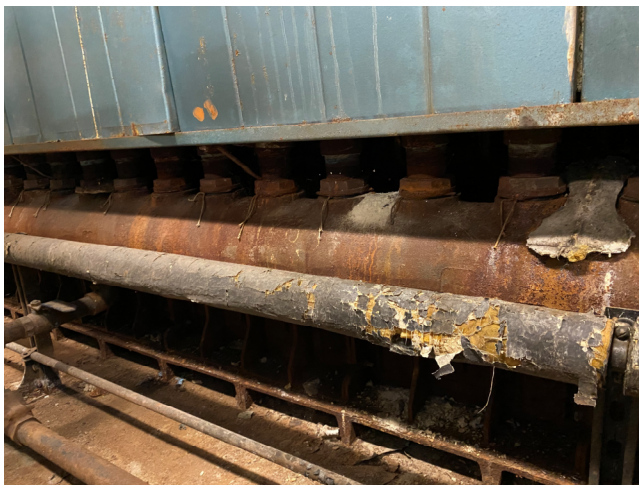
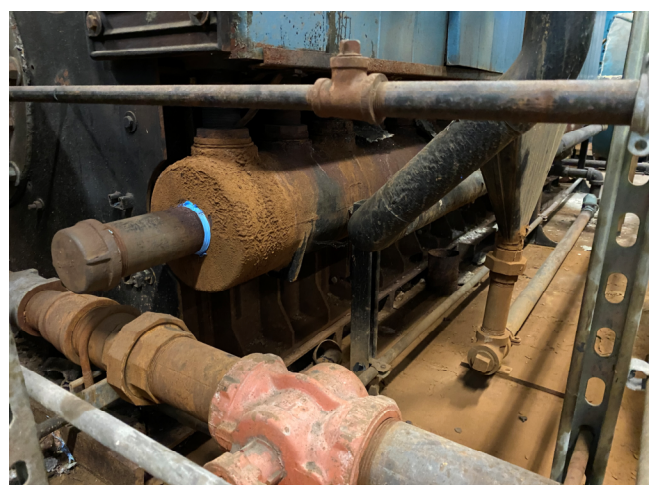
There are two (2) existing steam heating boilers serving the building. The boilers are each HB Smith, 450 Mills standard efficiency cast iron sectional boilers with 22 sections and have a net IBR capacity of 4,394.4 MBH. The boilers include a gas/oil burner (dual fuel), Model #MM-105S as manufactured by Industrial Combustion Inc. It was noted that currently the boiler operates only on natural gas. The sectional boilers and burners seem to be original to the building and were observed to be old but in fair condition. Each boiler was observed to be equipped with a McDonnell & Miller (M&M) low water cut-off (LWCO) and flow controls. The existing return headers under the boiler were observed to be in deteriorating condition with rust and leaks.

Photos 3 & 4: Existing return headers under the boiler.

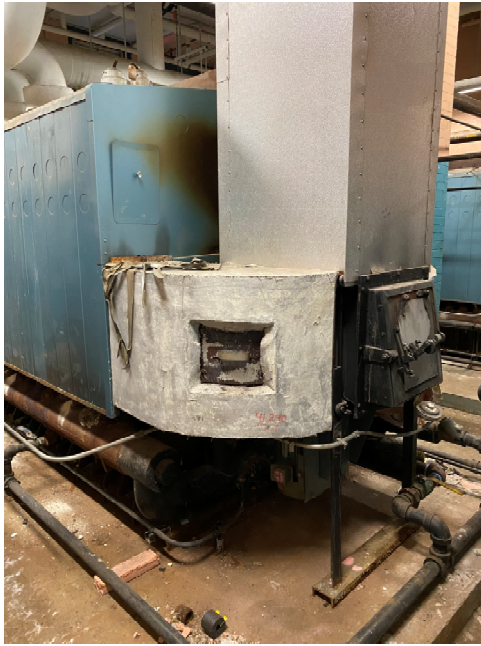
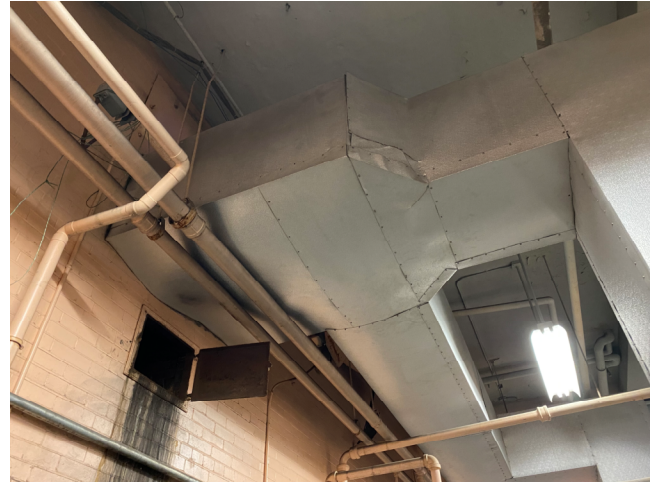
Flue gases associated with each boiler rise and connect to an existing boiler breeching main. Each boiler was observed to be equipped with an induced draft fan at the rear of the boiler that exhausts flue gases into the breeching main. The inducer fan and the vertical breeching section were observed to be old but in fair condition. The main boiler breeching extends and connects to a vertical masonry chimney. The chimney was observed to be provided with a clean-out at the bottom. The internal condition of the chimney was not verified. Combustion air (CA) for the boilers is provided by CA intake duct connected to intake louvers on the boiler room exterior wall. There is only one opening at the top of the duct equipped with a motor operated damper.

Photos 5 & 6: Existing boiler flue exhaust inducer fan section.

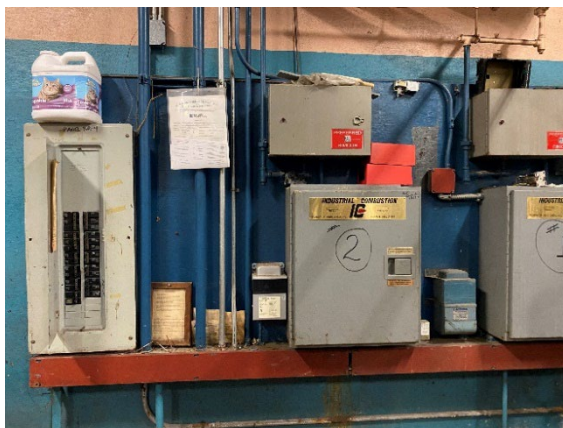
The sub-panelboards located throughout the building provide power to lighting, receptacles, mechanical equipment and miscellaneous loads. Most panels appeared to be at capacity. There were little to no spare circuit spaces for future loads. Most of the sub-panels were installed in Corridors and small storage rooms.

*Feeder Circuit Breaker Panels*

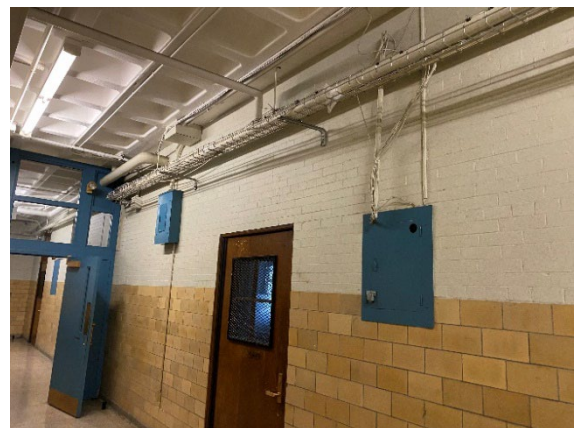
*Corridor Feeder Circuit Breaker Panels*

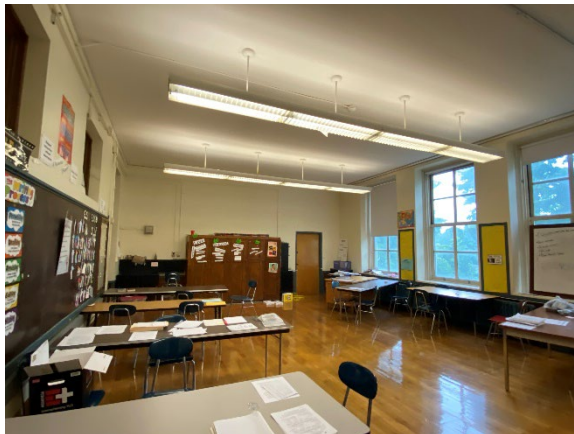
The lighting consists mostly of surface-mount and pendant-mount 2-lamp, surface-mount acrylic lens, fluorescent light fixtures. They appeared to be 32-watt T8 lamps installed. The fixtures throughout appeared to be in poor condition. Classrooms, Corridors and large public areas appeared dim. The lighting does not meet the energy conservation code, as stipulated in Article 13 of the Massachusetts State Building Code, 8th Edition. Local wall mounted switches are used for lighting control. There was minimal occupancy sensor control observed. The corridor lighting is controlled with key switches at each end of the corridors.

*Classroom Pendant 1'x4' - 2 lamp fixtures*

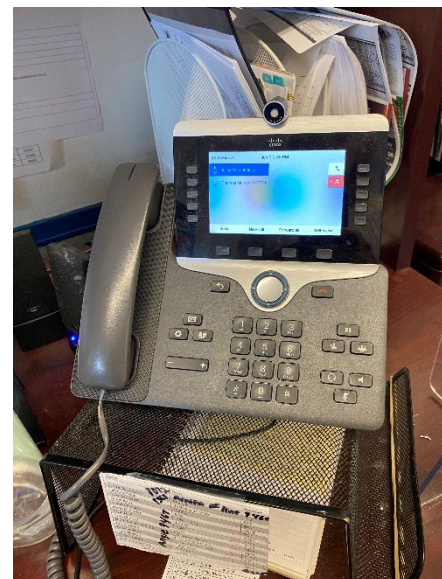
*New Telephone System*
