EXISTING EGRESS PATH (FROM GARDEN LEVEL UNIT ENTRY TO SIDEWALK):

Diagram of Demolition Scope & Impacted Area

1 Plan of Proposed Conditions
Scale: 1/4" = 1'-0"

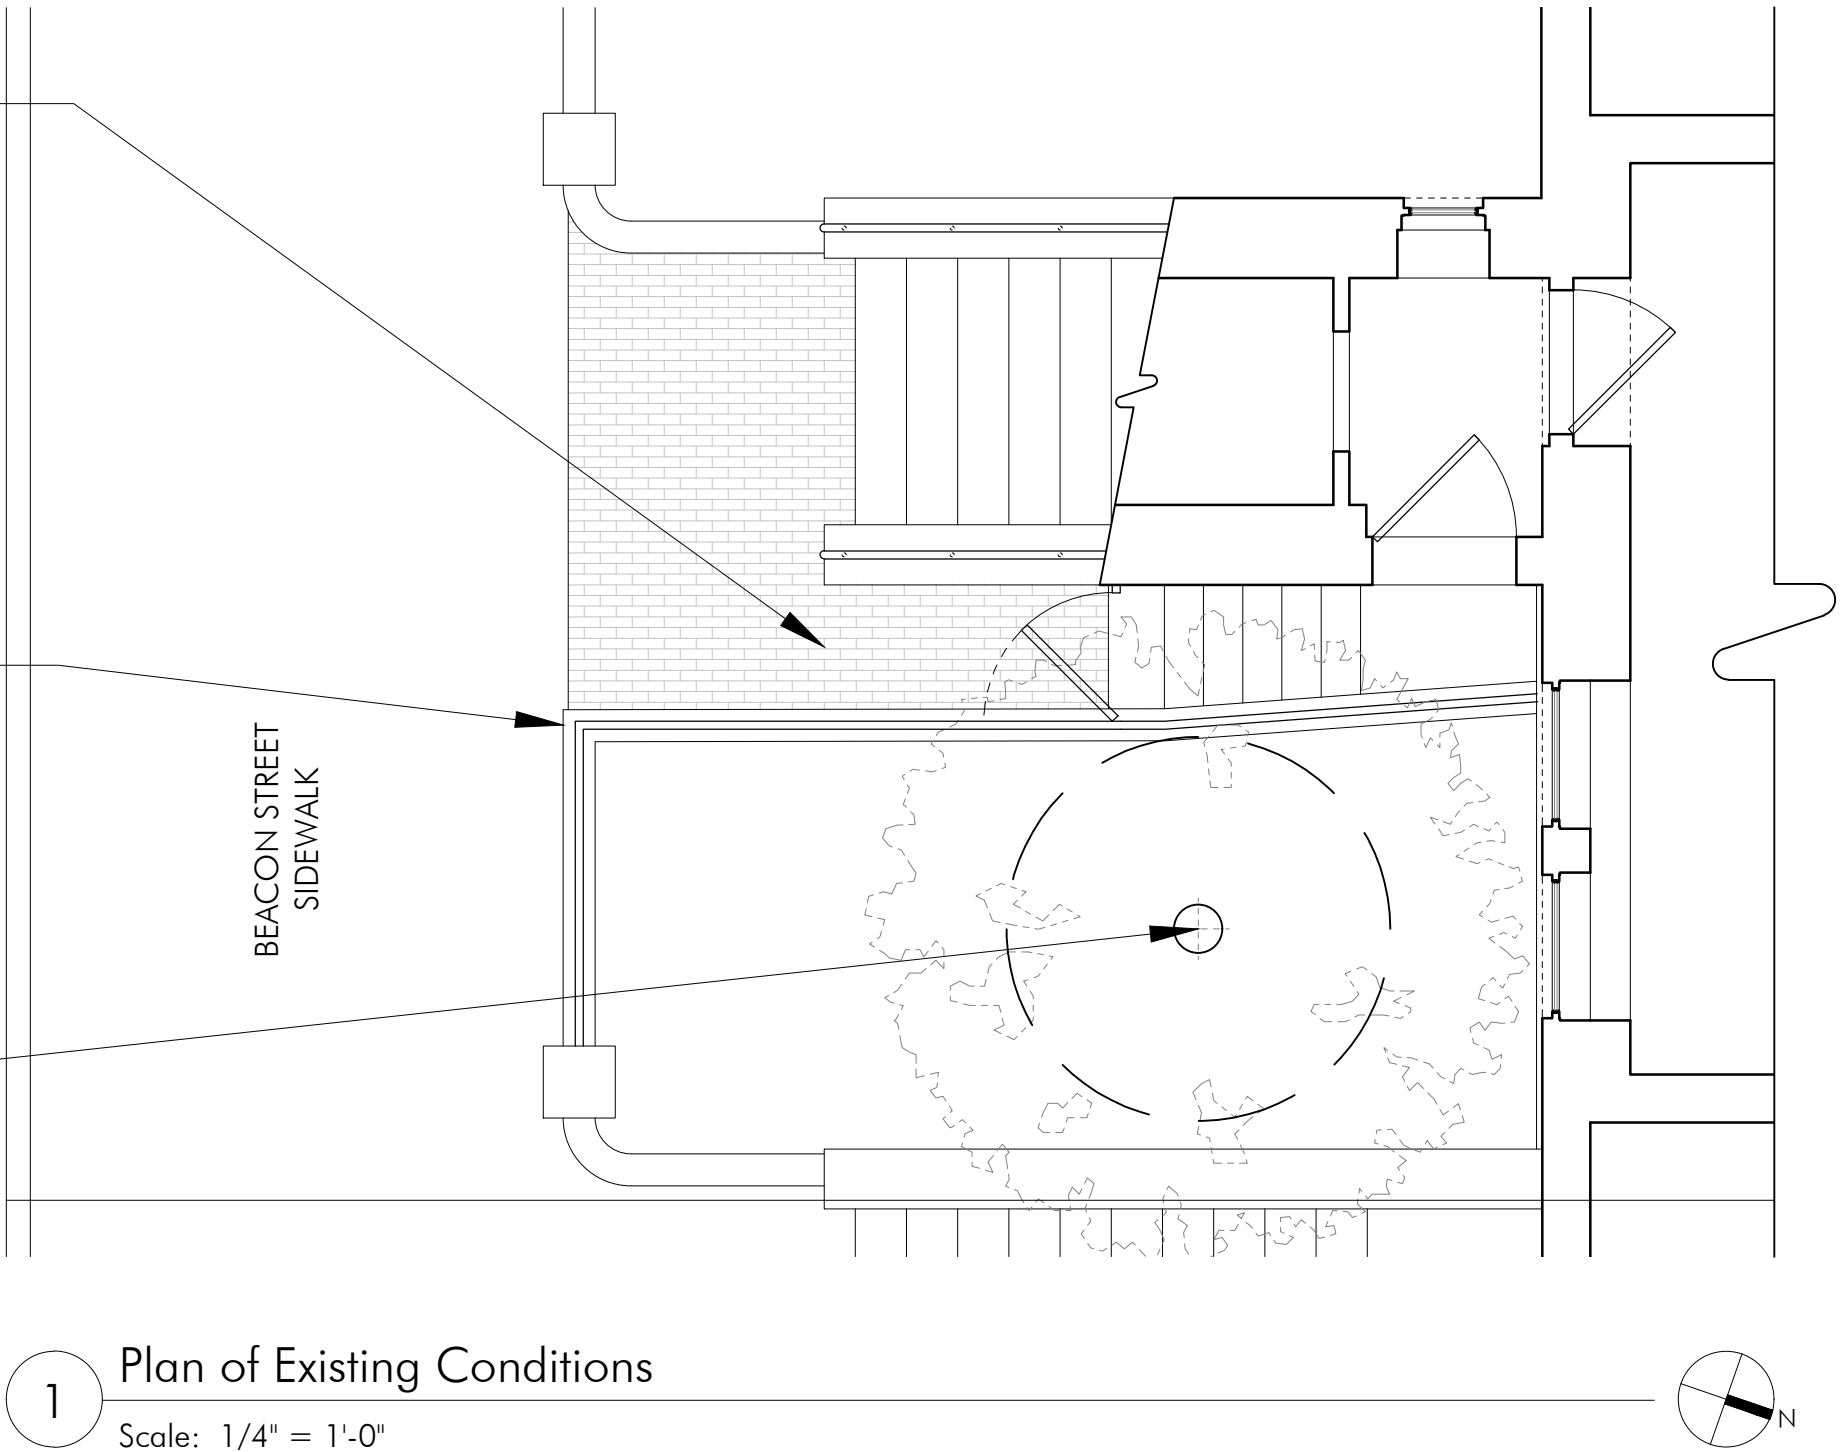
1

IMPACT AT EXISTING EGRESS PATH (TRANSITION TO SIDEWALK)

IMPACT AT EXISTING EGRESS PATH (GARDEN LEVEL UNIT ENTRY)

IMPACT AT EXISTING RETAINING WALL

IMPACT AT EXISTING PEAR TREE:

- TRENCHING OVERLAPS WITH ROOT SYSTEM (BASED ON VISIBLE LATERAL / OBLIQUE ROOTS).
- SIGNIFICANT PORTION OF EXISTING ROOT SYSTEM TO BE CUT BACK (POSES RISK OF COMPROMISING TREE HEALTH & STABILITY PER ARBORIST'S ASSESSMENT) SHOWN DIAGRAMMATICALLY IN RED.
- REMOVE EXCESS SOIL AND PREPARE GARDEN FOR REGRADING & LEVELING.
- ±10" OF ROOT COLLAR TO BE EXPOSED & PARTIALLY CUT BACK (POSES RISK OF COMPROMISING TREE HEALTH & STABILITY PER ARBORIST'S ASSESSMENT)

- REMOVE EXISTING DISPLACED RED BRICK PAVERS & REPLACE IN KIND (PER MASON RECOMMENDATION).
- PREPARE FOR LEVELING OF WALKING SURFACE.

- REMOVE & SALVAGE EXISTING SOLID GRANITE TREADS.
- REMOVE EXISTING WALKING SURFACE MATERIAL AT LANDING.
- PREPARE FOR LEVELING OF WALKING SURFACE & IMPROVED DRAINAGE.

- REMOVE EXISTING IRON FENCE & GATE.
- REMOVE & SALVAGE EXISTING GRANITE (CURB & RECLAIMABLE PORTIONS OF WALL). *GENERAL NOTE: IF SALVAGED GRANITE IS DEEMED UNSUITABLE FOR REUSE (AS VENEER OR OTHER APPLICATION), PARGE BELOW GRANITE CURB AND TINT/PAINT VISIBLE AREAS HC-69 (OR APPROVED EQUAL) TO MATCH APPEARANCE (CONSISTENCY AND TEXTURE) OF ADJACENT STOOP AND SIMILAR CONDITIONS SHOWN IN PRECEDENT IMAGERY.*
- PREPARE GARDEN & PATHWAY BY TRENCHING ALONG WEST & NORTH PERIMETER. TRENCH TO BE 36"-42" WIDE TO ACCOMMODATE CONSTRUCTION EQUIPMENT, NEW RETAINING WALL ASSEMBLY, AND NEW WATERPROOFING & DRAINAGE.
